DEKRA's commission No. : PKOL(W)/LODZ/99770/24/12/27
commission/ damage No. : 23/012703
Date of commission: 27-12-2024

Vehicle data

Measurement of thickness of the vehicle lacquer coating

PHOTOGRAPHIC DOCUMENTATION

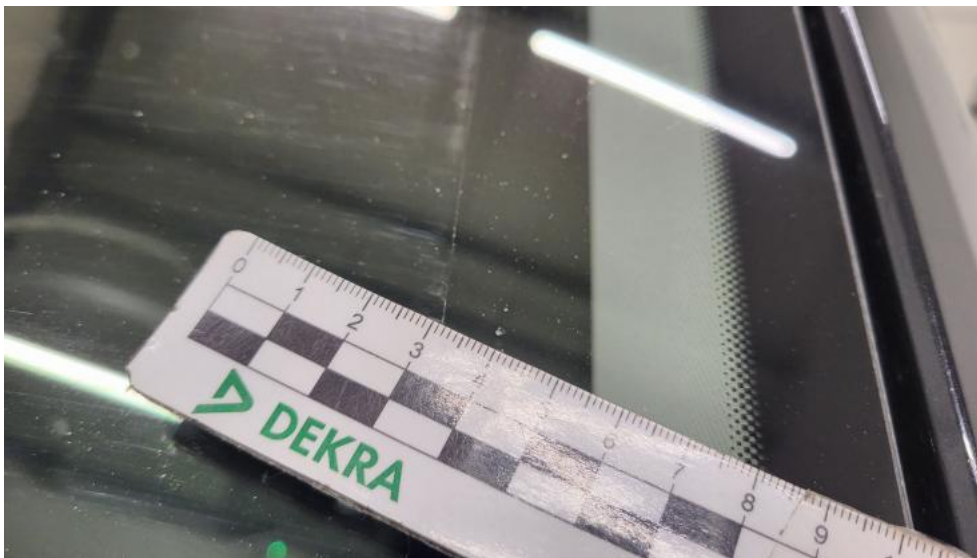
Photo 39.

Szyba czołowa - Rysa/odprysk 1

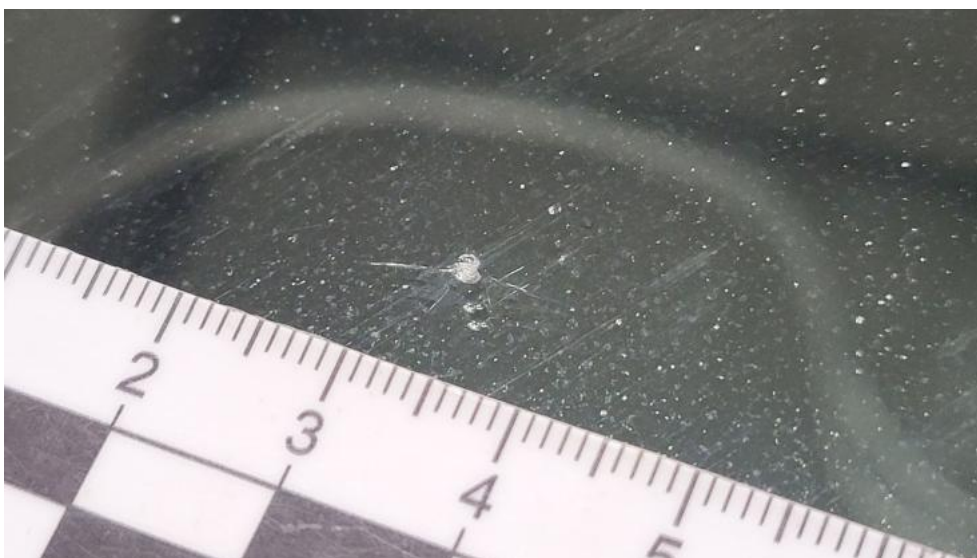
Photo 40.

Szyba czołowa - Pęknięcie/rozerwanie 1

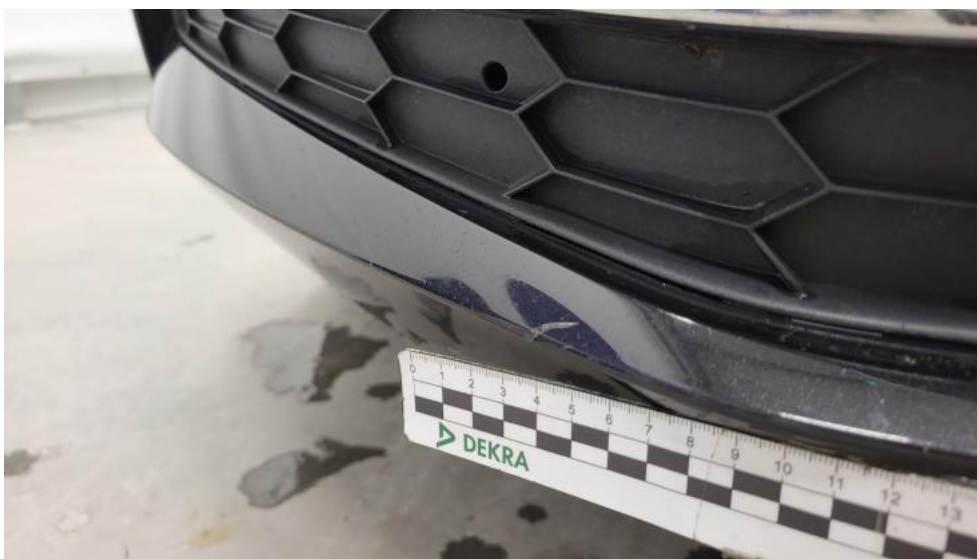
Photo 41.
Zderzak - Rysa/odprysk 1

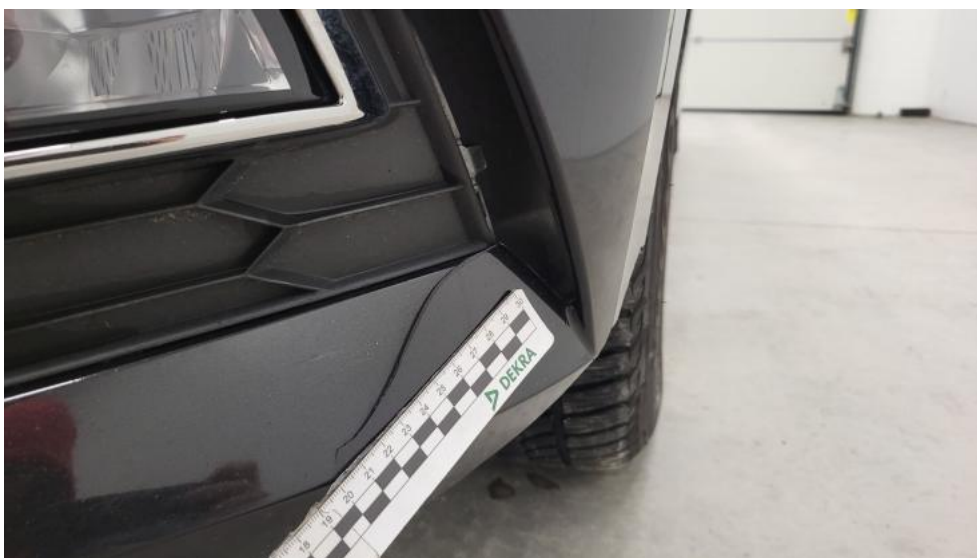
Photo 42.
Zderzak - Pęknięcie/rozerwanie 1

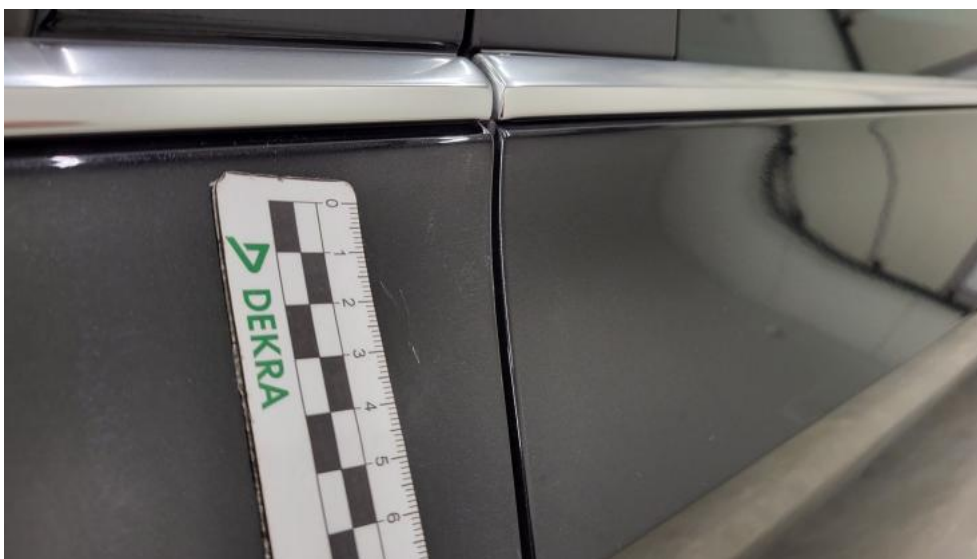
Photo 45.

Drzwi przed L - Rysa/odprysk 1

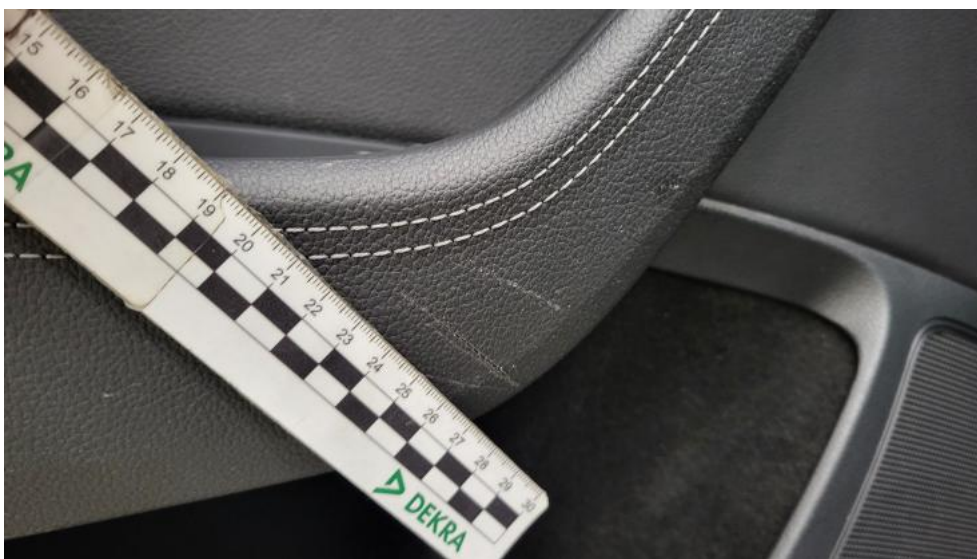
Photo 47.

Uchwyt drzwi tyl L - Rysa/odprysk 1
