DEKRA's commission No. : PKOL(W)/LODZ/83675/24/10/29  
commission/ damage No. : 49053  
Date of commission: 29-10-2024

**Vehicle data**

Group of objects (Eurotax)	cars
EC code (Eurotax)	0128698
Manufacturer	VOLKSWAGEN
Model	Passat Alltrack [B8] 15-19
Type / version	Passat Alltrack 2.0 TDI SCR 4Mot. DSG7
Body type	KOM
Number of doors / seats	5/5
Curb weight [kg]	1700
Gross vehicle weight [kg]	2320
Wheelbase 1/2	2789
Engine type	Automatic ignition
Supercompression	turbocompressor with intercooler
Pollution reduction system	KSC
Emission standard	EURO 6
Engine capacity [ccm]	1968
Engine Power [hp/kW]	190/140
Gearbox	automatic 7- gear
Registration /record No.	KR4KH41
VIN / serial number	WVWZZZ3CZKE044636
Date of first registration	05-03-2019
Date of next. tech. test	15-03-2025
Year of manufacture	2019
Readout [km]	85 022 (read)
Body color / type of coating	black/METALIK

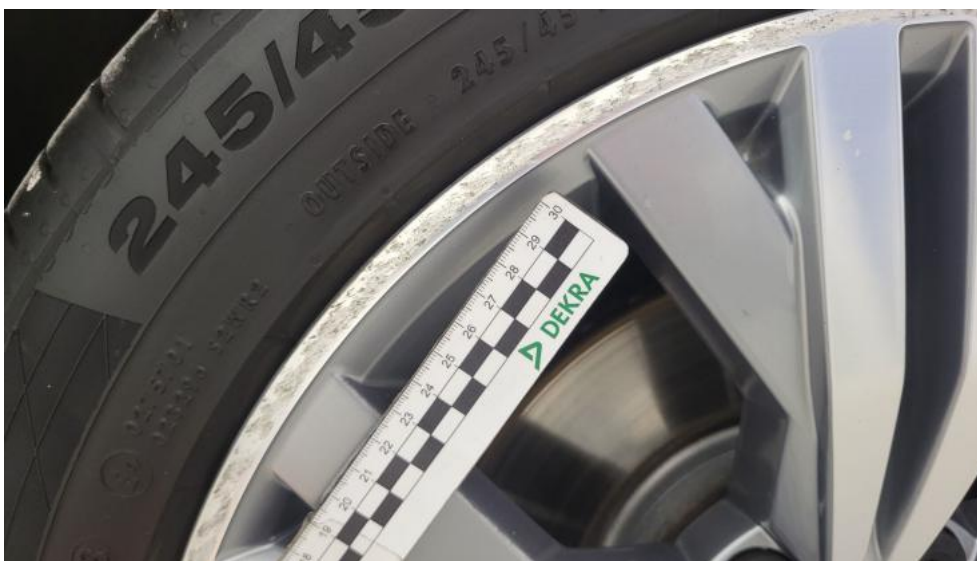
**Photo 51.**

Felga aluminiowa przednia P - Rysa/odprysk 1

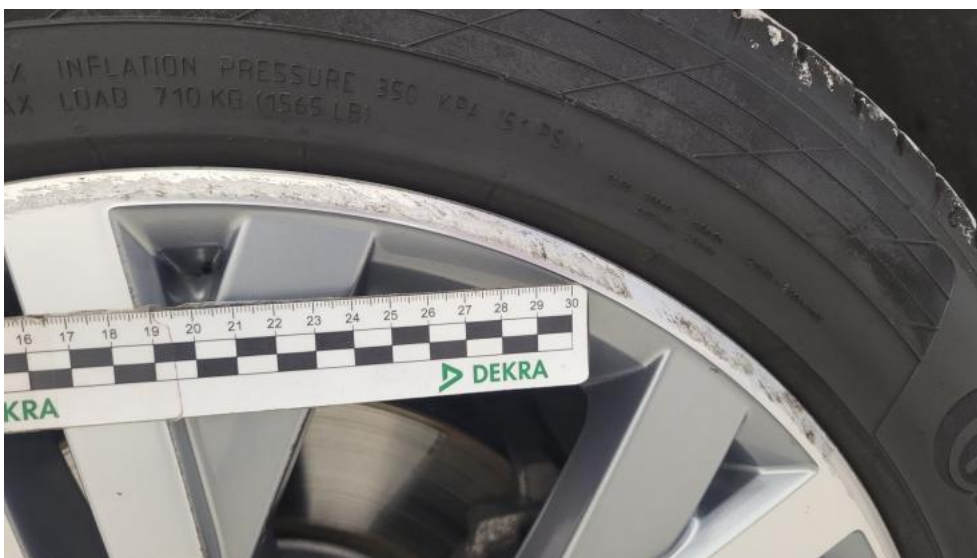
**Photo 52.**

Felga aluminiowa przednia P - Rysa/odprysk 2

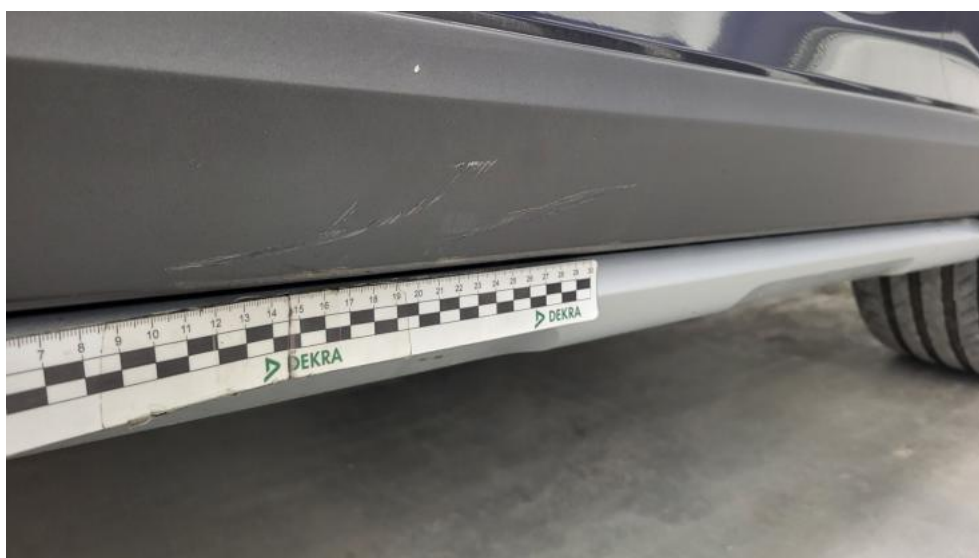
**Photo 54.**  
Listwa drzwi przednich P - Rysa/odprysk 1

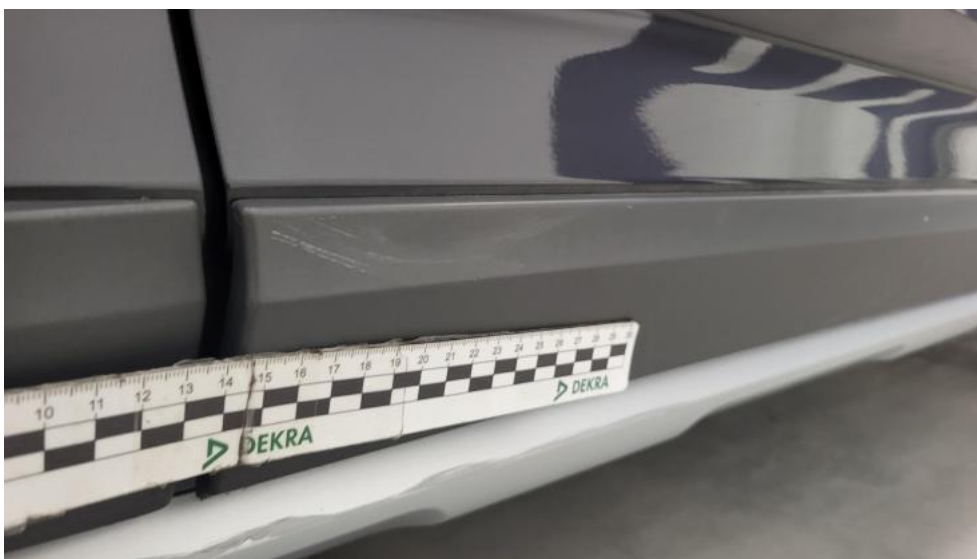
**Photo 55.**

Listwa drzwi przednich P - Rysa/odprysk 2

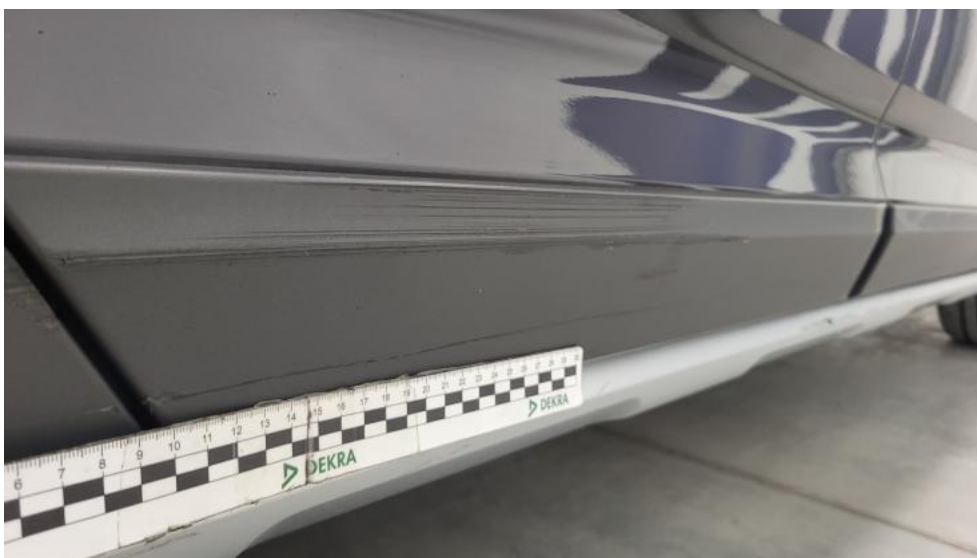
**Photo 56.**

Listwa drzwi tylnych P - Rysa/odprysk 1

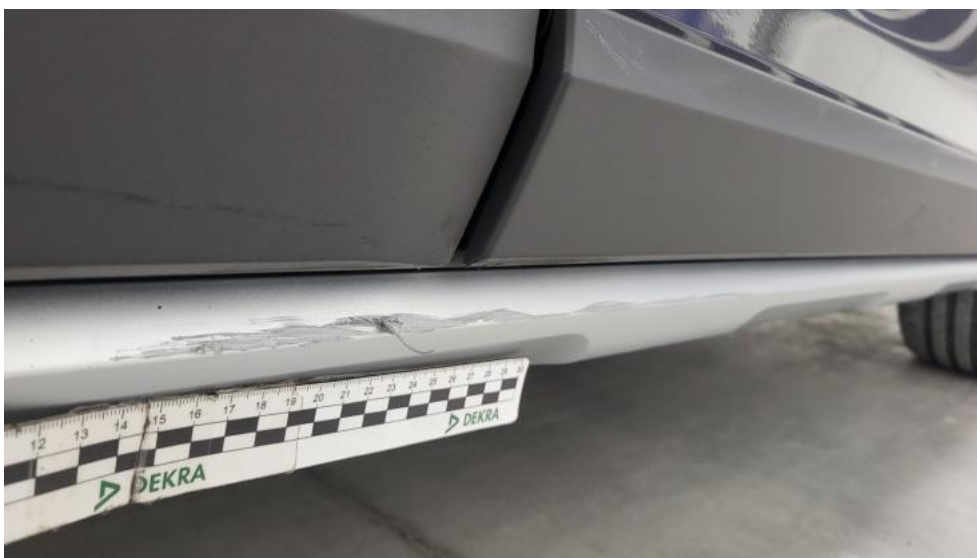
**Photo 60.**

Próg P - Rysa/odprysk 1

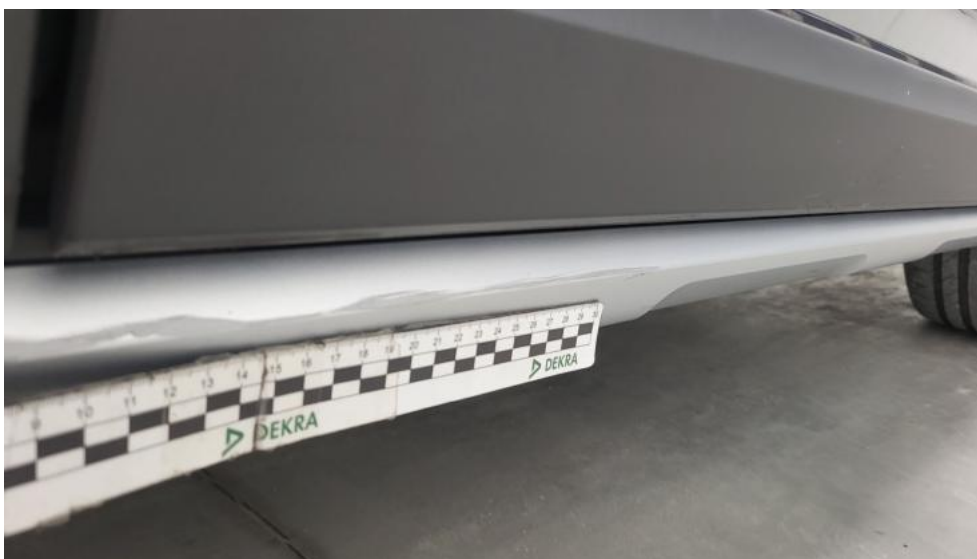
**Photo 61.**  
Próg P - Rysa/odprysk 2

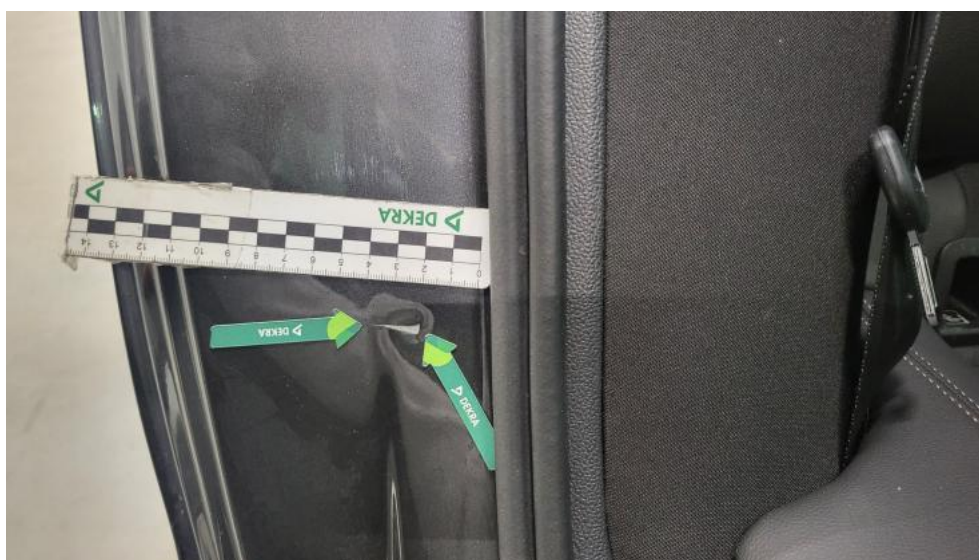
**Photo 64.**  
Błotnik tylny P / Ściana boczna P - Wgniecenie/odkształcenie 1

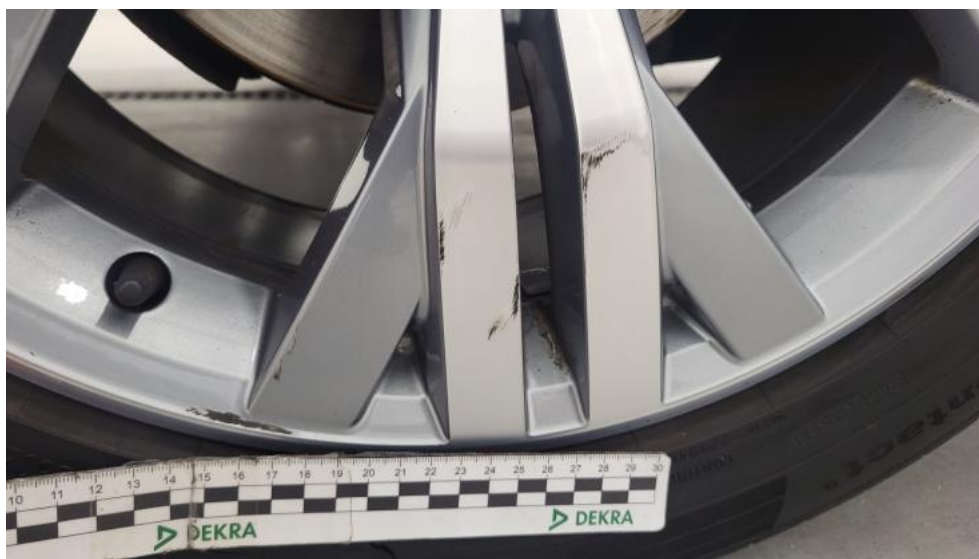
**Photo 65.**  
Felga aluminiowa tylna P - Rysa/odprysk 1

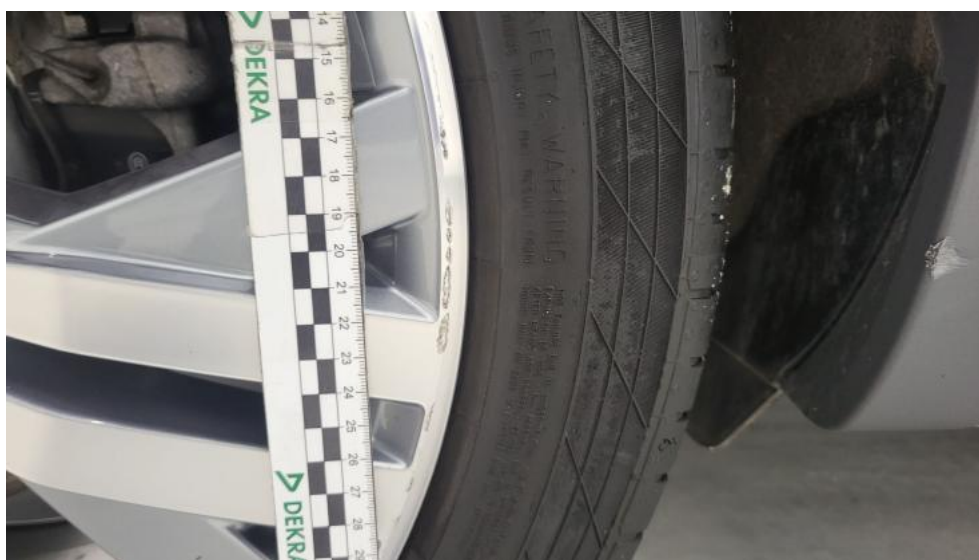
**Photo 66.**  
Felga aluminiowa tylna P - Rysa/odprysk 2

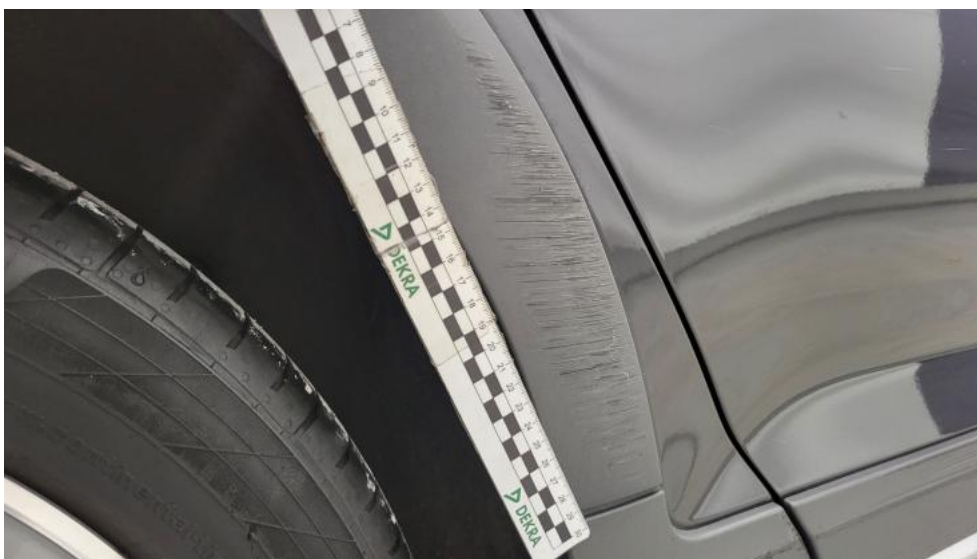
**Photo 67.**

Listwa krawędzi błotnika tyl P - Rysa/odprysk 1

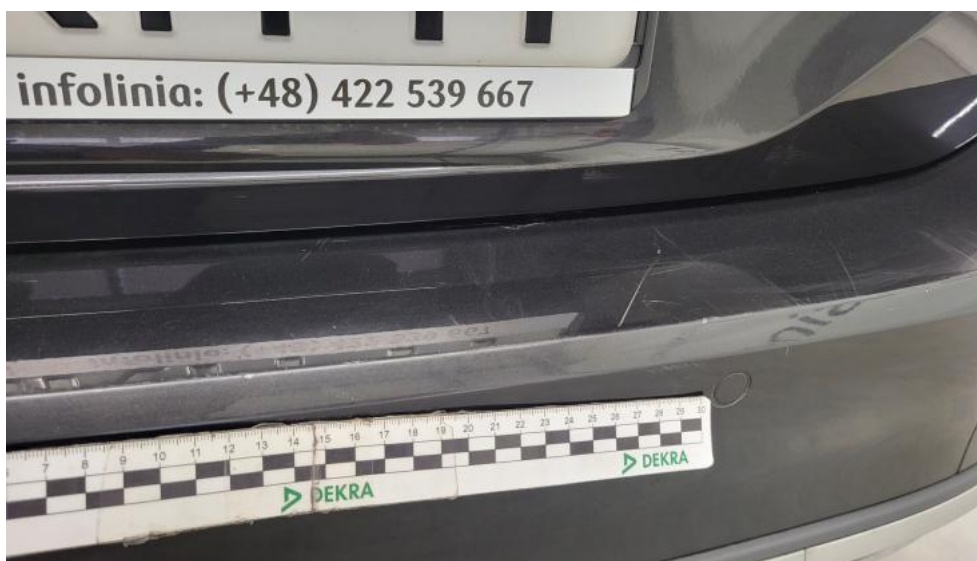
**Photo 71.**

Zderzak tylny - Rysa/odprysk 2

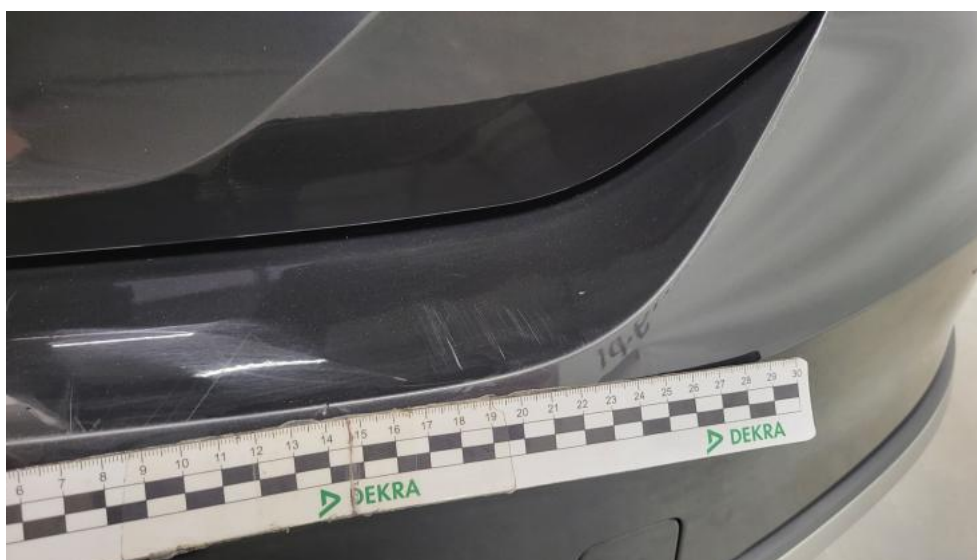
**Photo 72.**

Zderzak tylny() - Rysa/odprysk 3

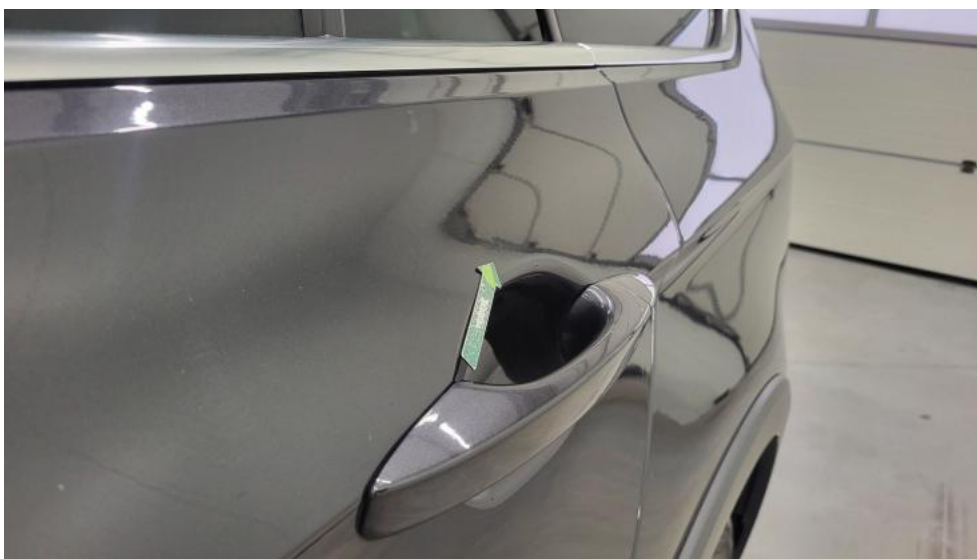
**Photo 83.**  
Drzwi tylne L - Wgniecenie/odkształcenie 1

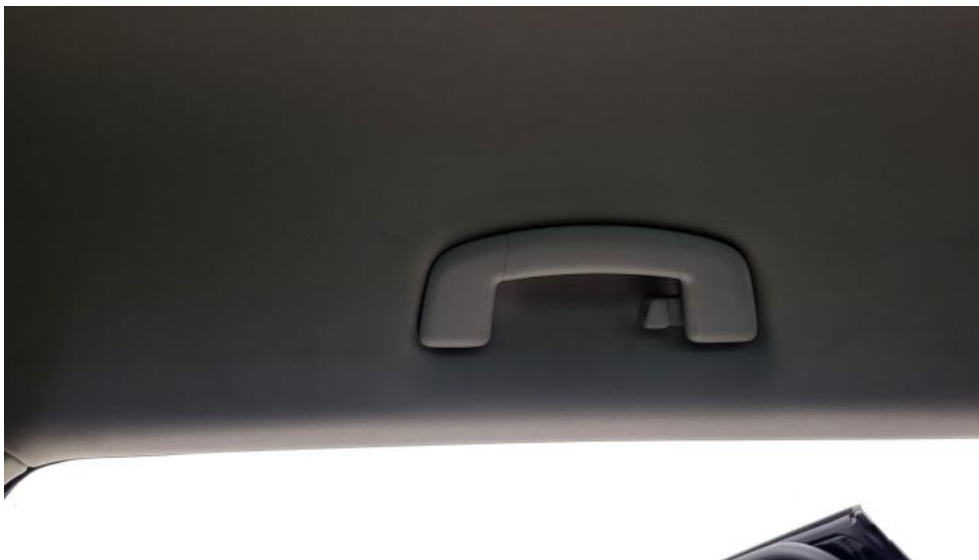
**Photo 87.**  
Podsufitka - Inne 2

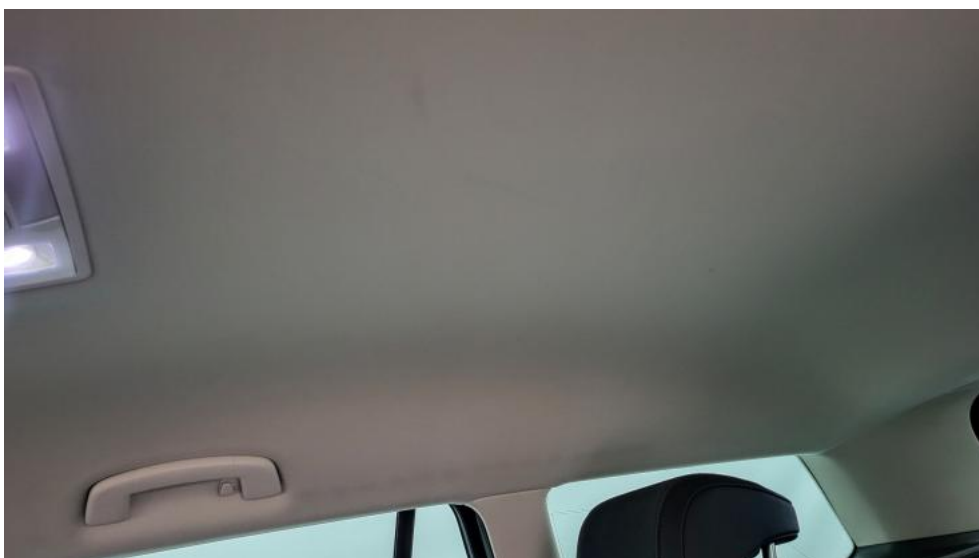
**Photo 88.**  
Podsufitka() - Inne 3
