DEKRA's commission No. : PKOL(W)/LODZ/85332/26/09/11  
commission/ damage No. : 24/037897  
Date of commission: 11-09-2026

**DEKRA Poland - Headquarters**  
02-673 Warszawa, ul. Konstruktorska 12A

| Model | Arteon 20-23 |
| Type / version | Arteon 2.0 TSI Essence DSG |

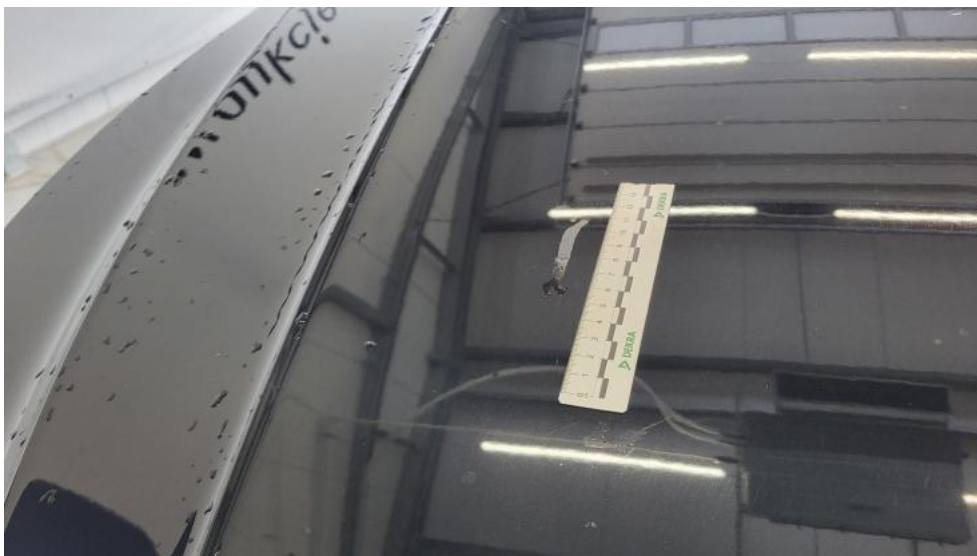
**Photo 39.**

Pokrywa komory silnika - Inne 1

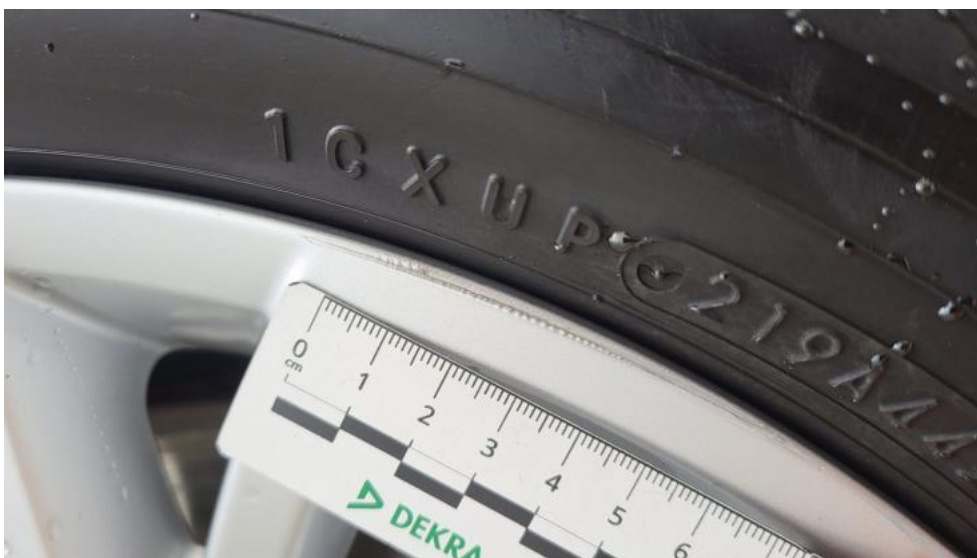
**Photo 40.**

Felga aluminiowa przednia P - Rysa/odprysk 1

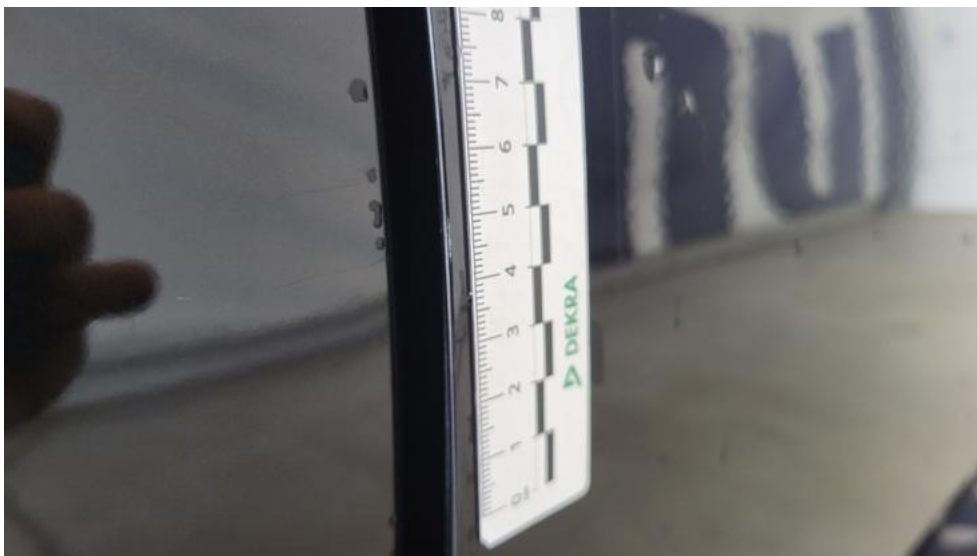
**Photo 41.**

Drzwi przednie P - Rysa/odprysk 1

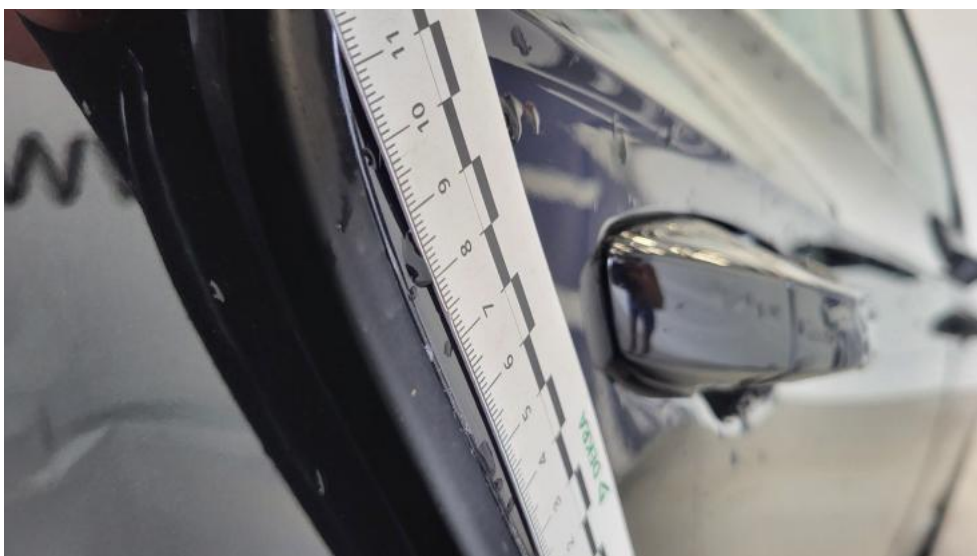
**Photo 42.**

Drzwi tylne P - Rysa/odprysk 1

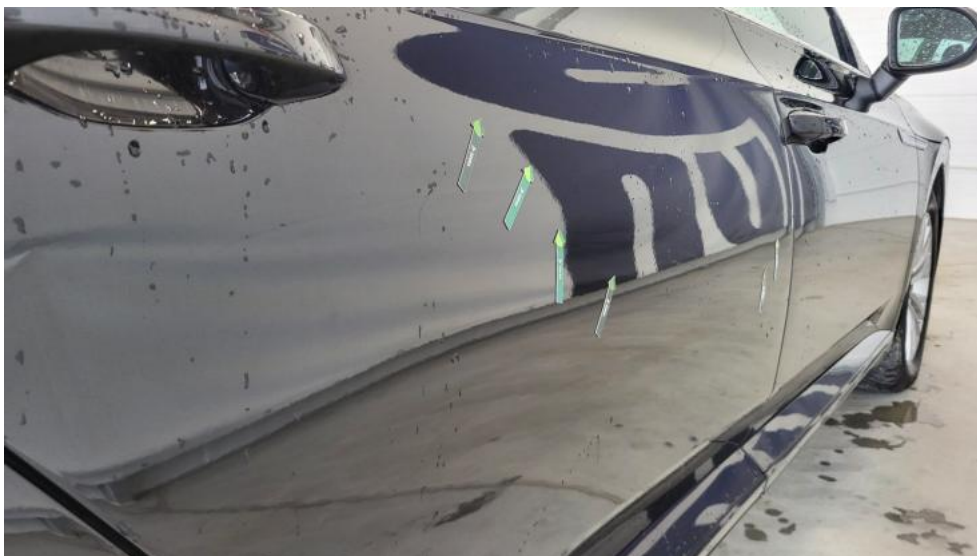
**Photo 43.**

Drzwi tylne P - Wgniecenie/odkształcenie 1

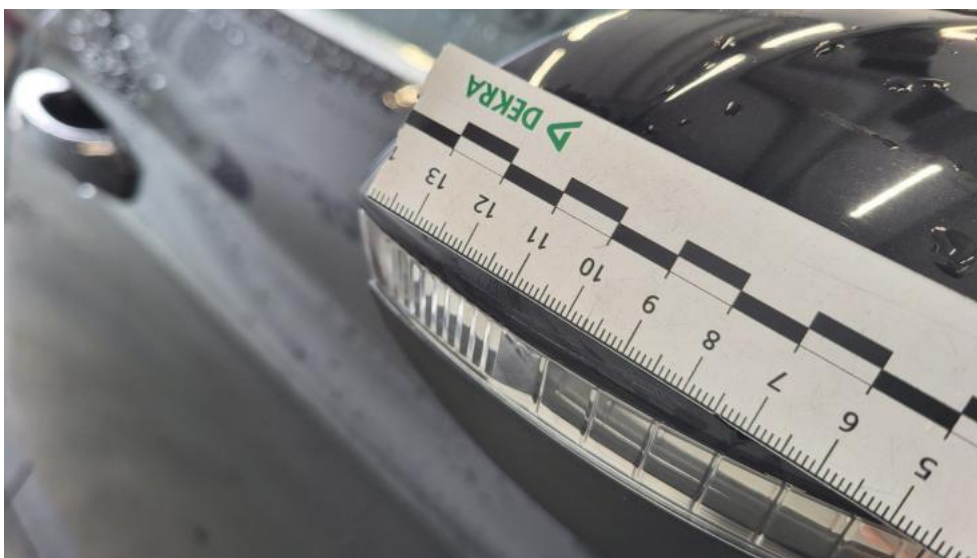
**Photo 44.**

Lusterko zew P - Rysa/odprysk 1

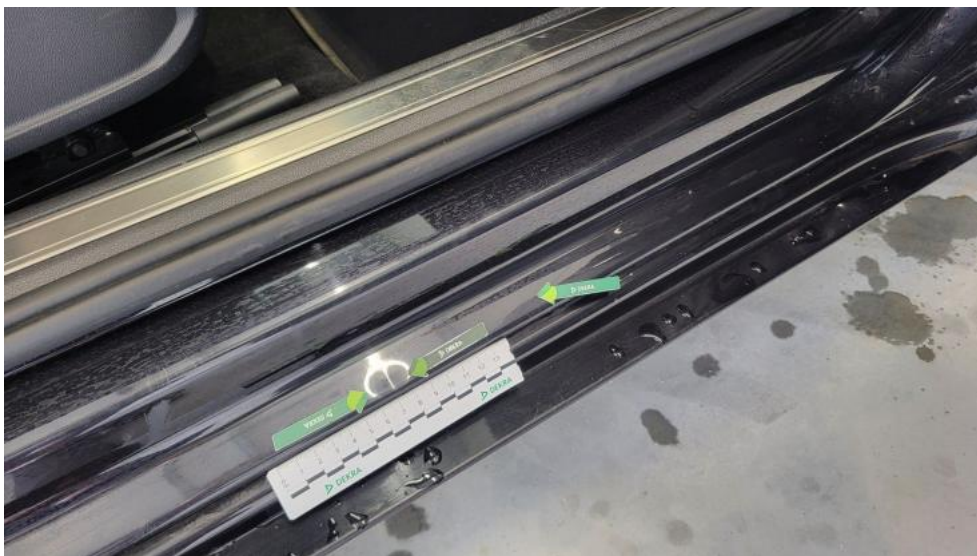
**Photo 45.**

Próg P - Wgniecenie/odkształcenie 1

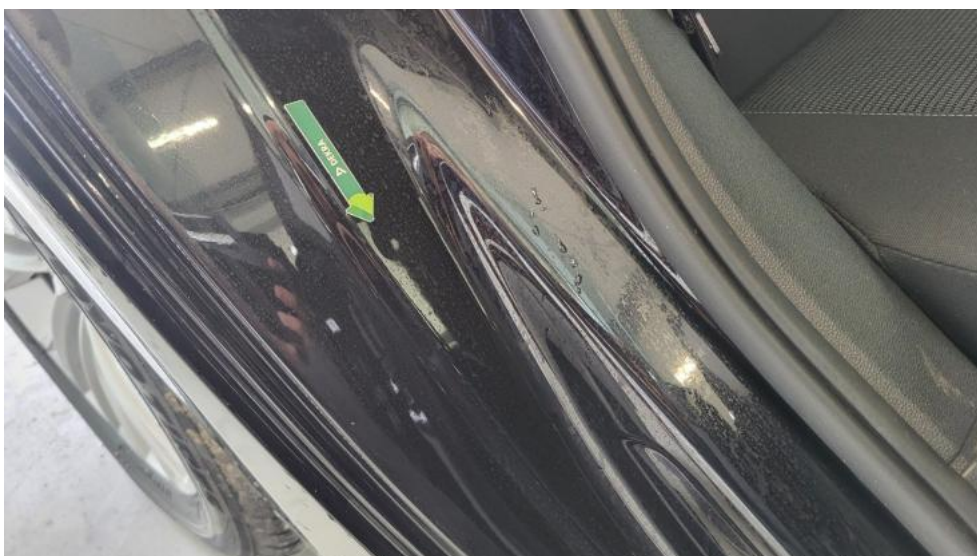
**Photo 46.**

Ścianka tylna P / Ścianka boczna P - Wgniecenie/odkształcenie 1

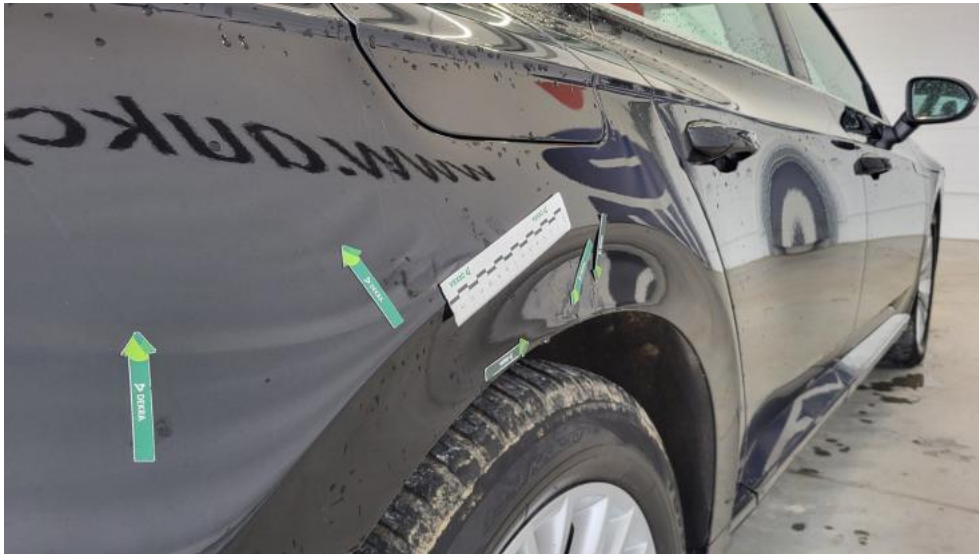
**Photo 47.**

| No. of controlled item | Controlled item | Measured range of thickness of the lacquer coat [ $\mu\text{m}$ ] |
|---|---|---|
| 11 | Right rear fender | 150 - 2000 |

Błotnik tylny P / Ściana boczna P - Wgniecenie/odkształcenie 2

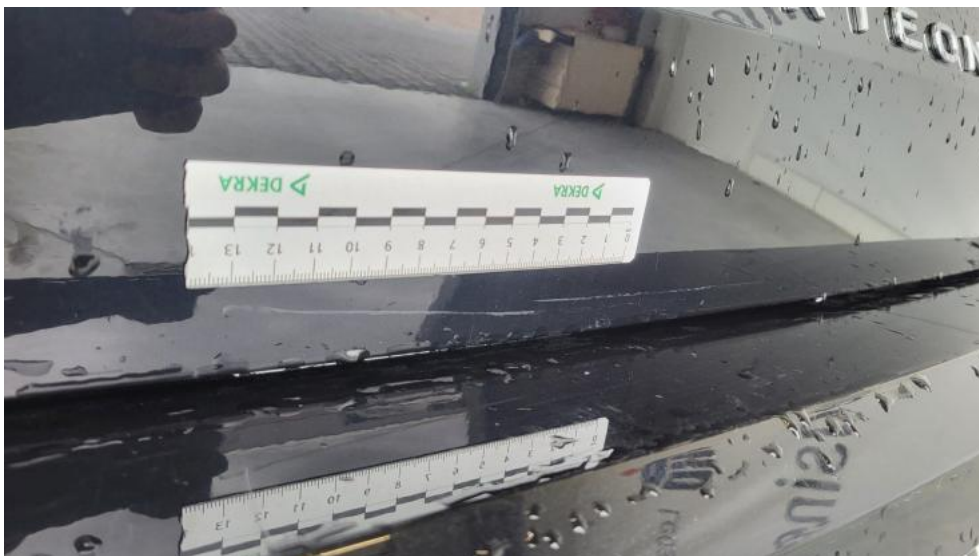
**Photo 48.**

Pokrywy bagażnika - Rysa/odprysk 1

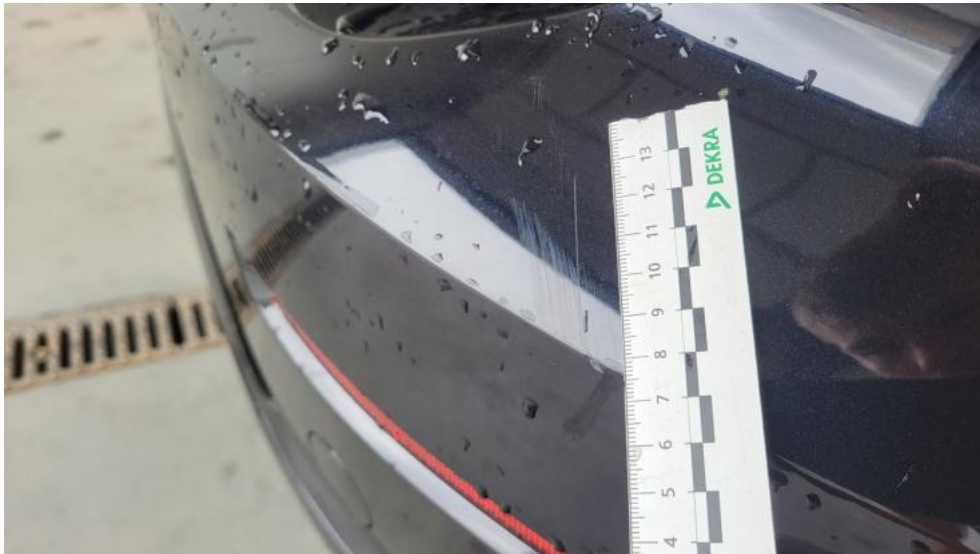
**Photo 49.**

Zderzak tylny - Rysa/odprysk 1

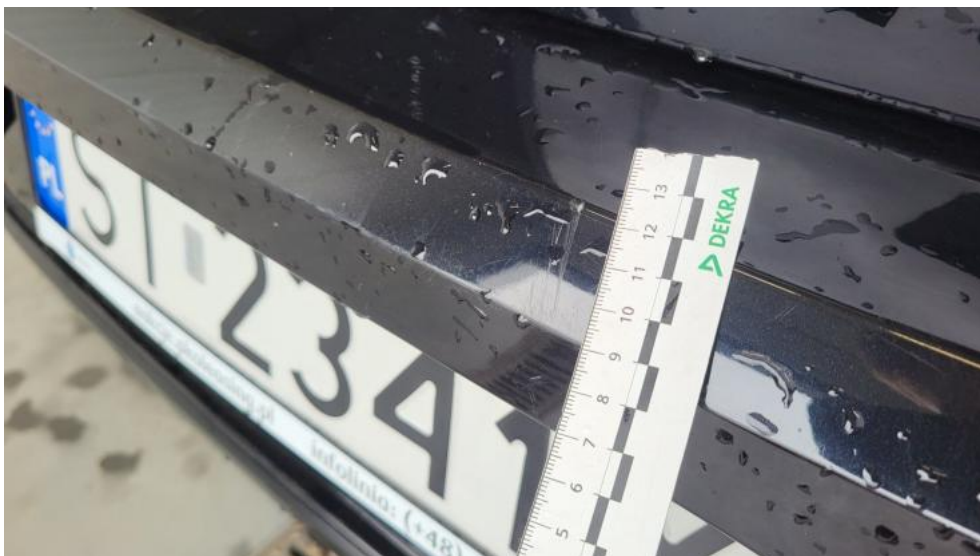
**Photo 50.**

Zderzak tylny - Rysa/odprysk 2

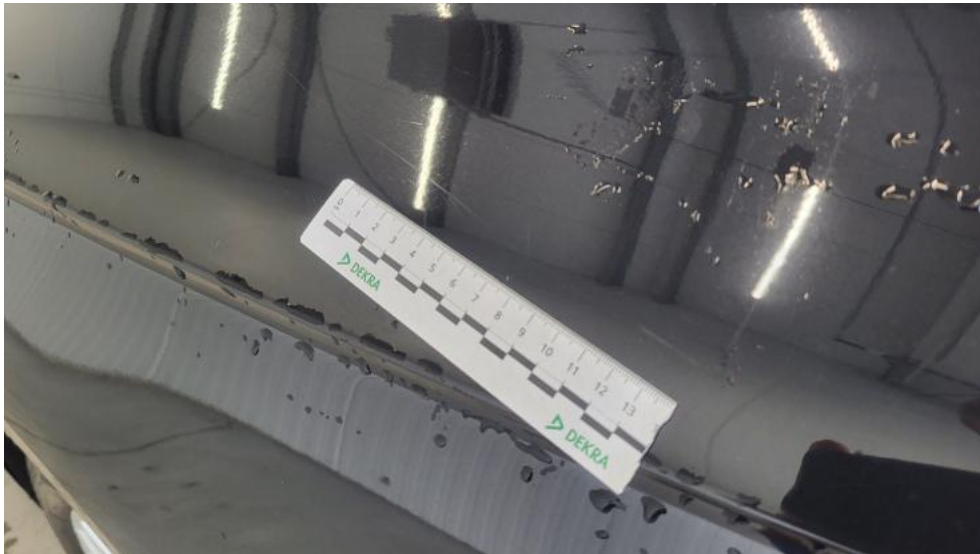
**Photo 53.**

Błotnik tylny L / Ściana boczna L - Rysa/odprysk 1

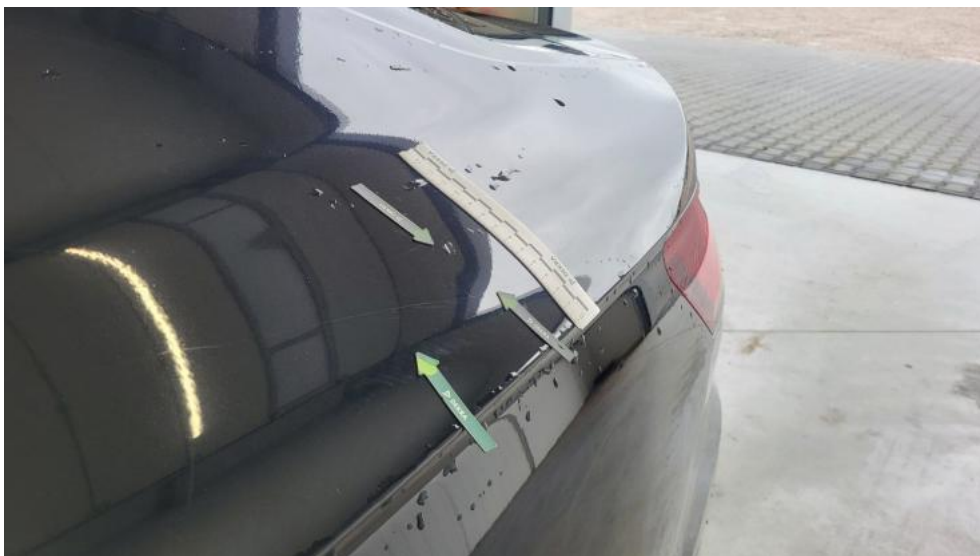
**Photo 54.**

Błotnik tylny L / Ściana boczna L - Wgniecenie/odkształcenie 1

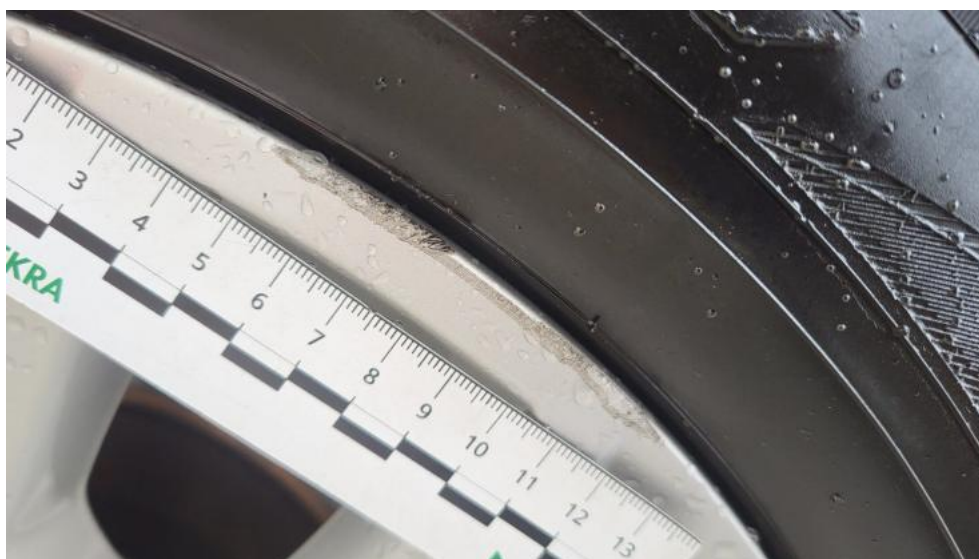
**Photo 55.**

Felga aluminiowa tylna L - Rysa/odprysk 1

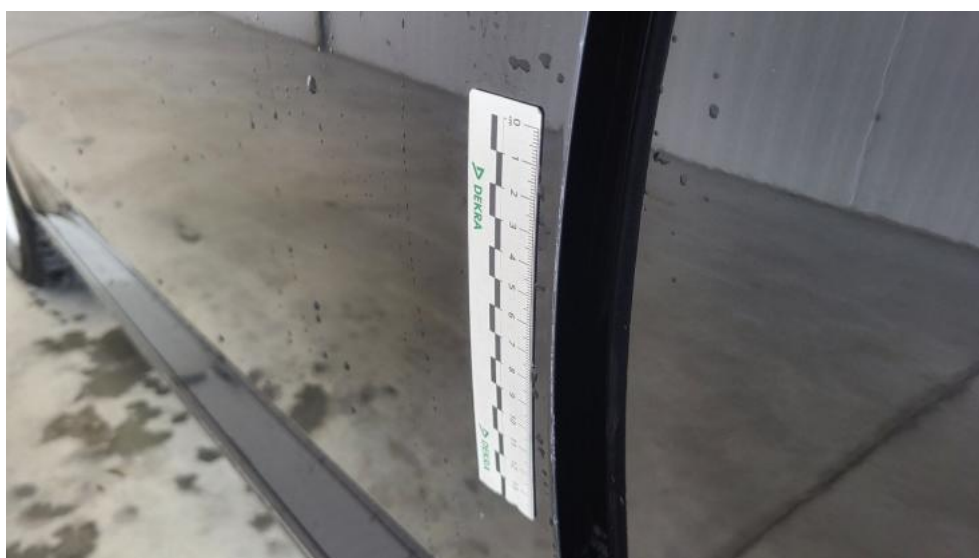
**Photo 56.**

Drzwi przed L - Rysa/odprysk 1

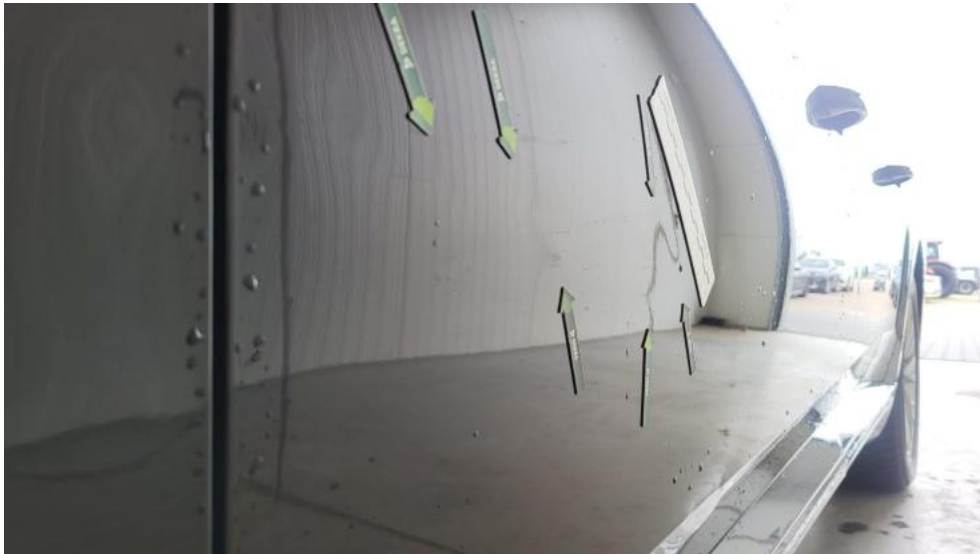
**Photo 57.**

Drzwi przed L - Wgniecenie/odkształcenie 1

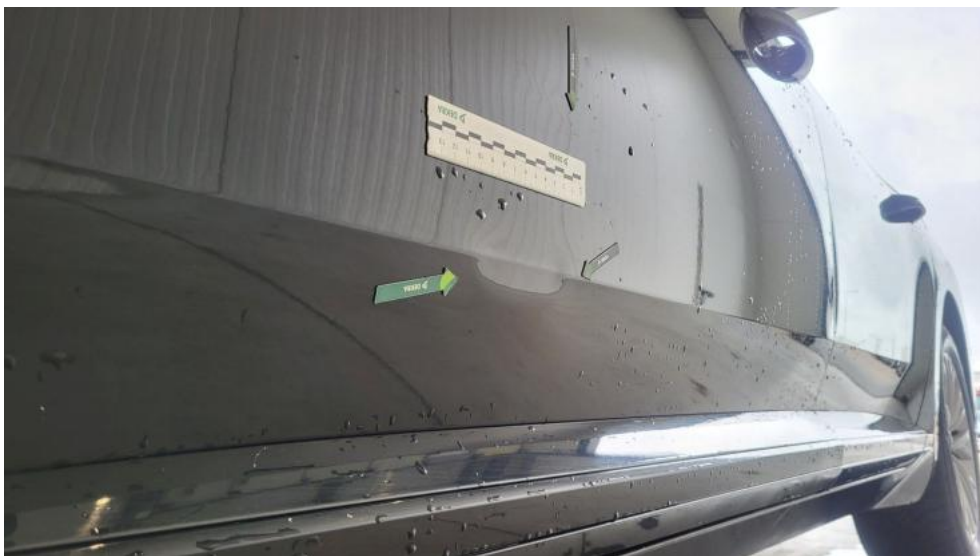
**Photo 58.**

Drzwi przed L - Wgniecenie/odkształcenie 2

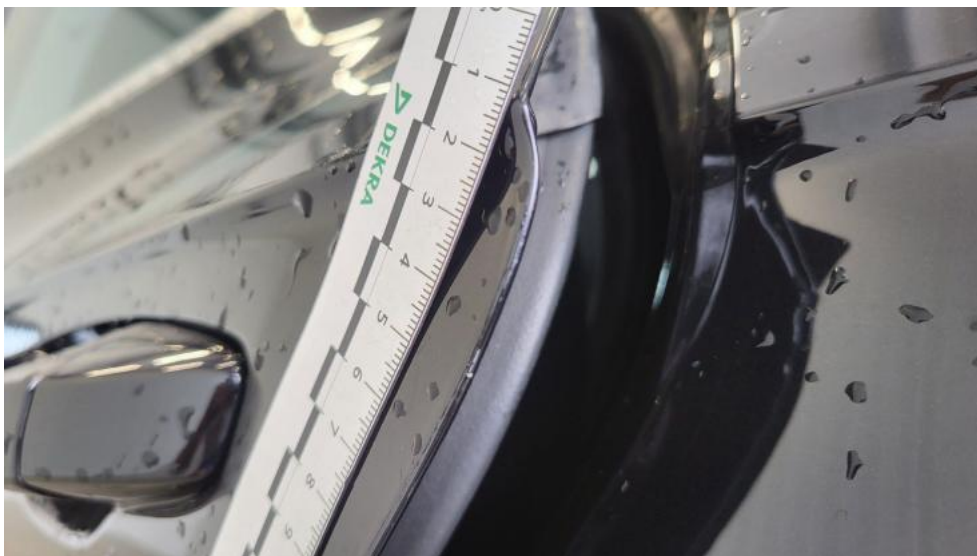
**Photo 59.**

Drzwi tylne L - Rysa/odprysk 1

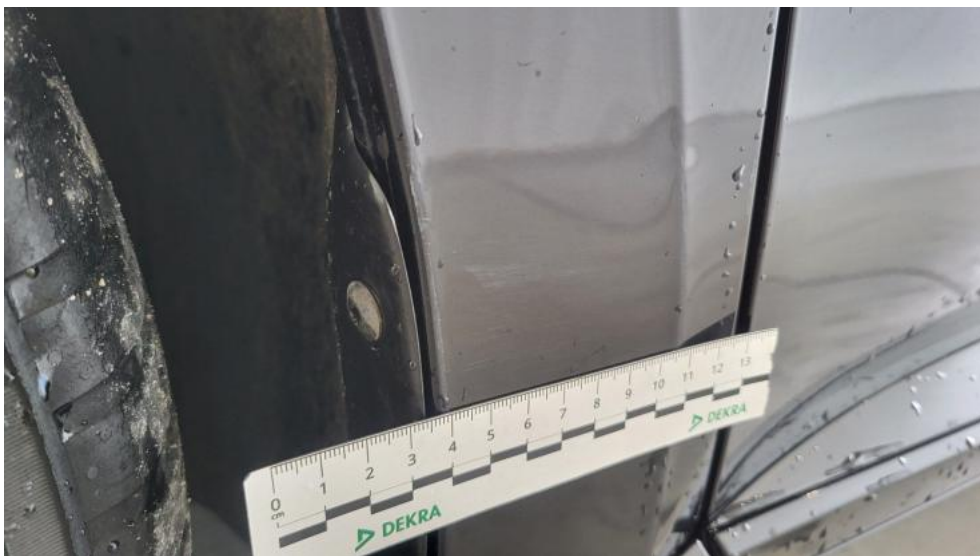
**Photo 62.**

Błotnik przedni L - Rysa/odprysk 1

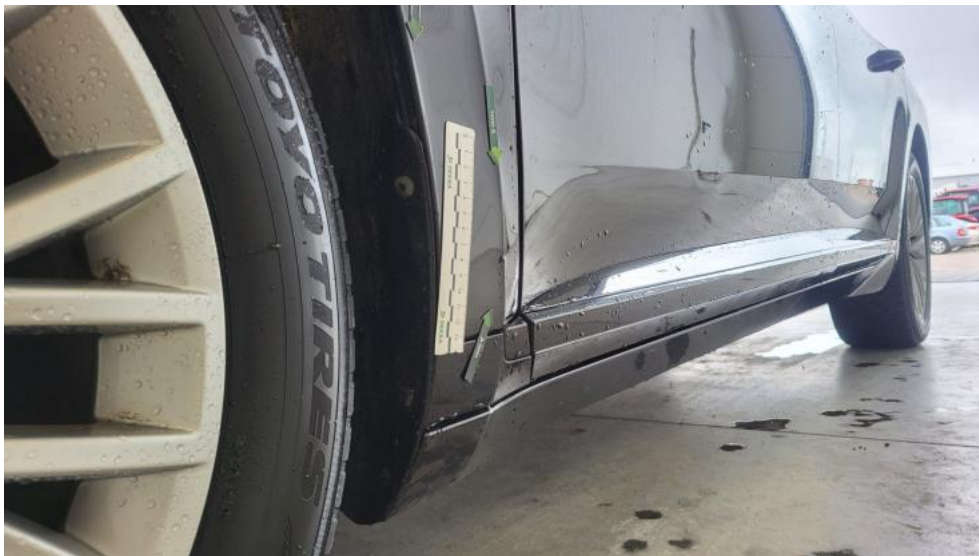
**Photo 63.**

Błotnik przedni L - Wgniecenie/odkształcenie 1

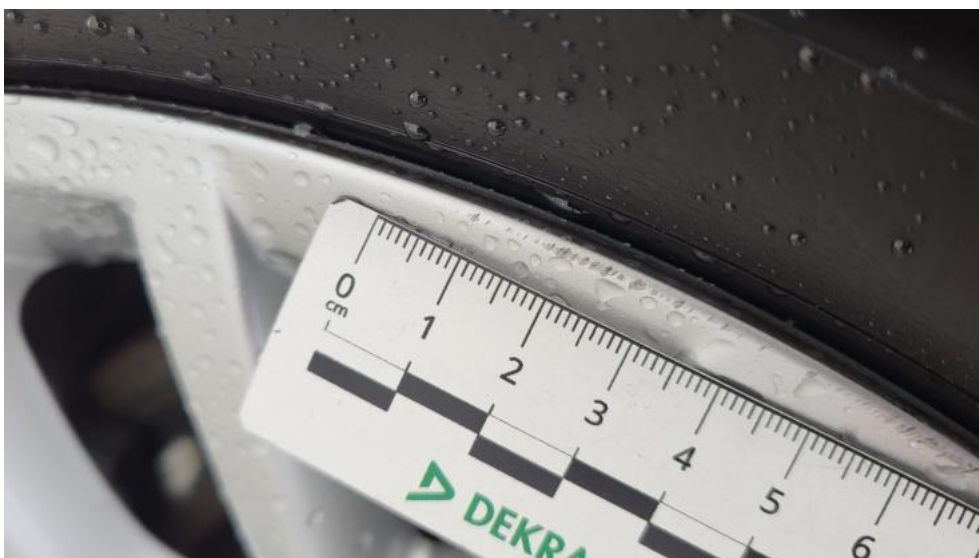
**Photo 64.**

Felga Aluminiowa przednia L - Rysa/odprysk 1

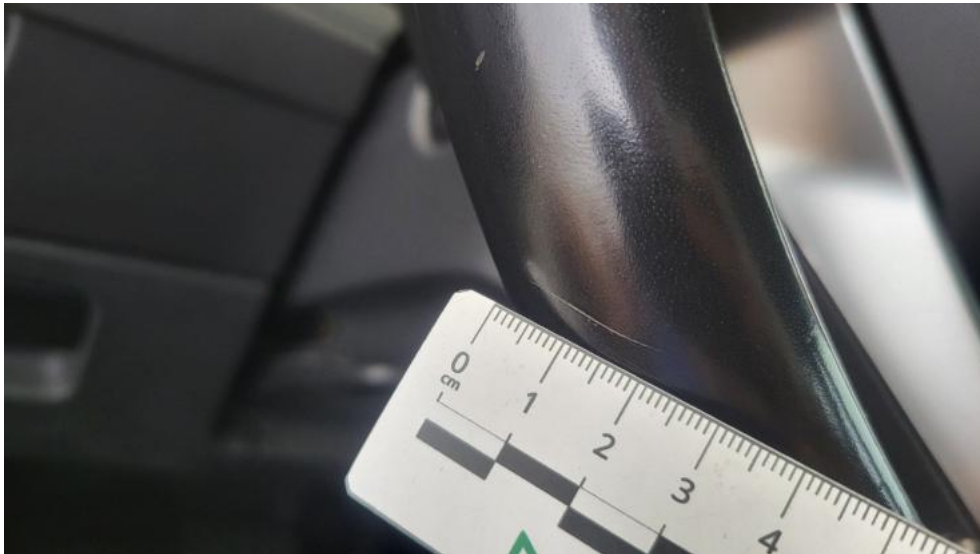
**Photo 65.**

Koło kierownicy - Rysa/odprysk 1

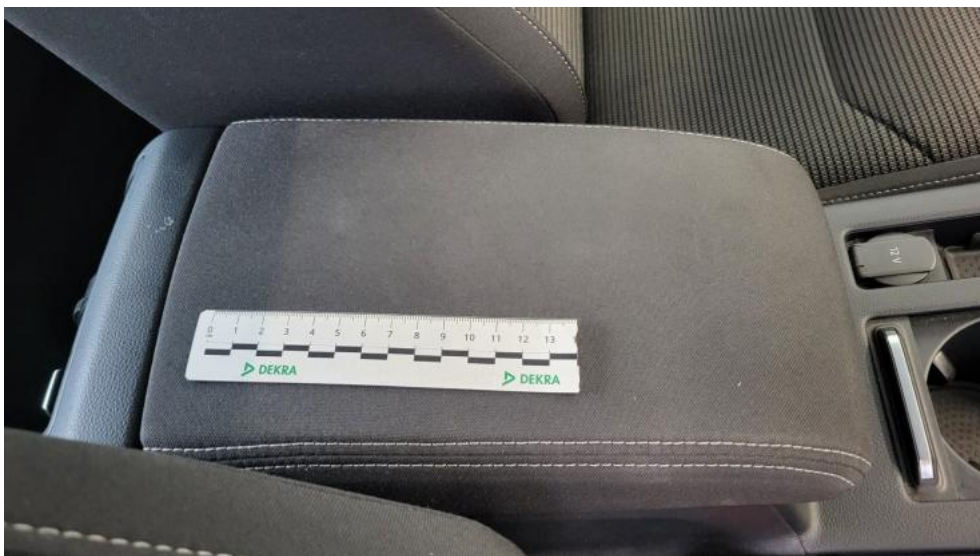
**Photo 66.**

Podłokietnik środkowy przedni - Inne 1

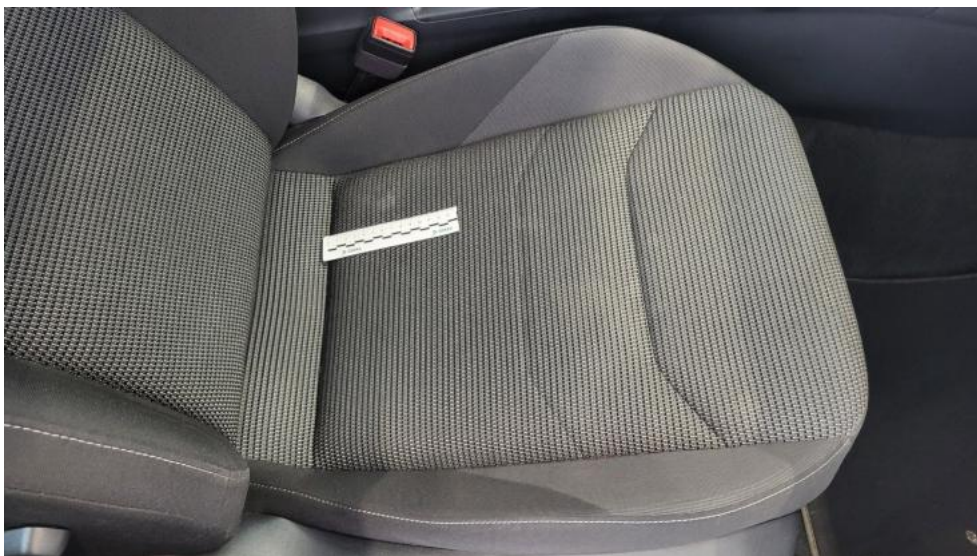
**Photo 67.**

Fotel prz. praw. - Inne 1

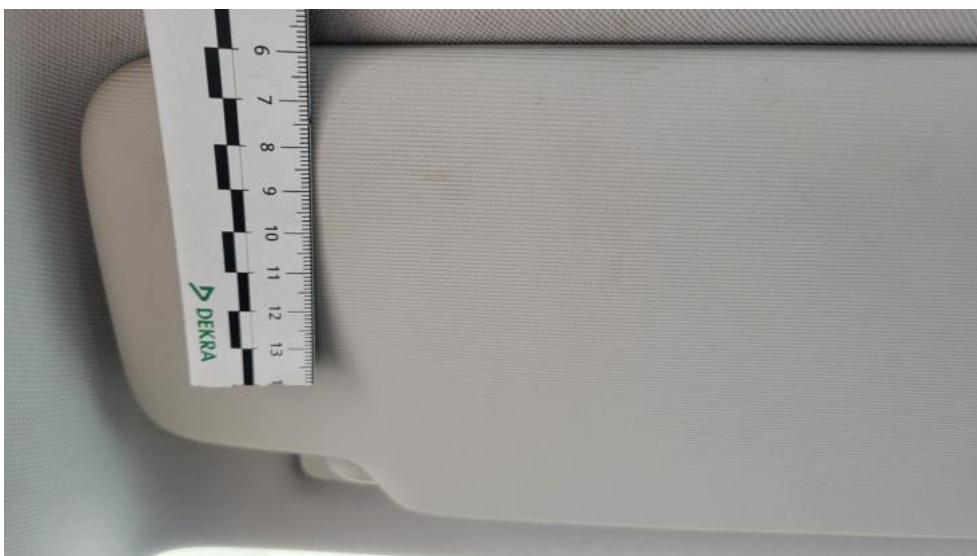
**Photo 68.**

Osłona p/słoneczna lewa - Inne 1

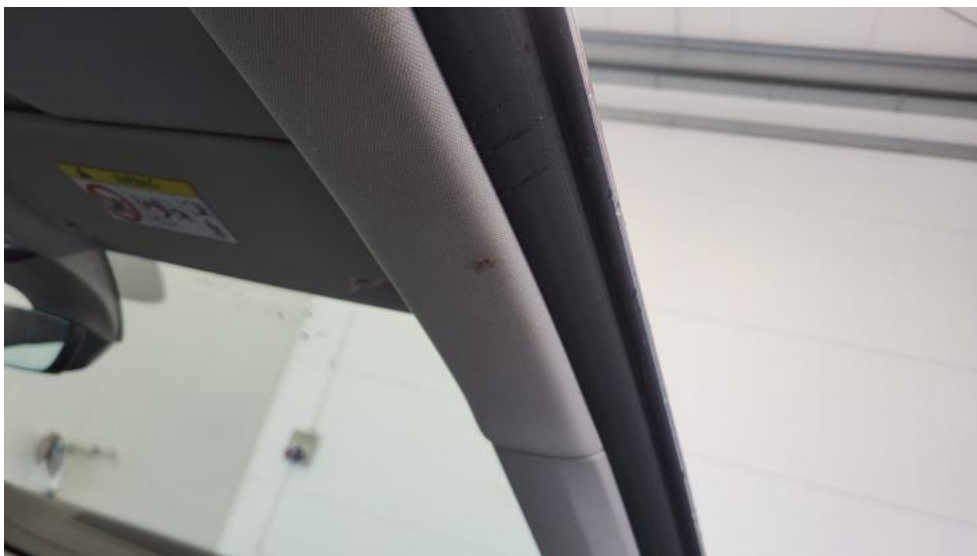
**Photo 69.**

Podsufitka - Inne 1

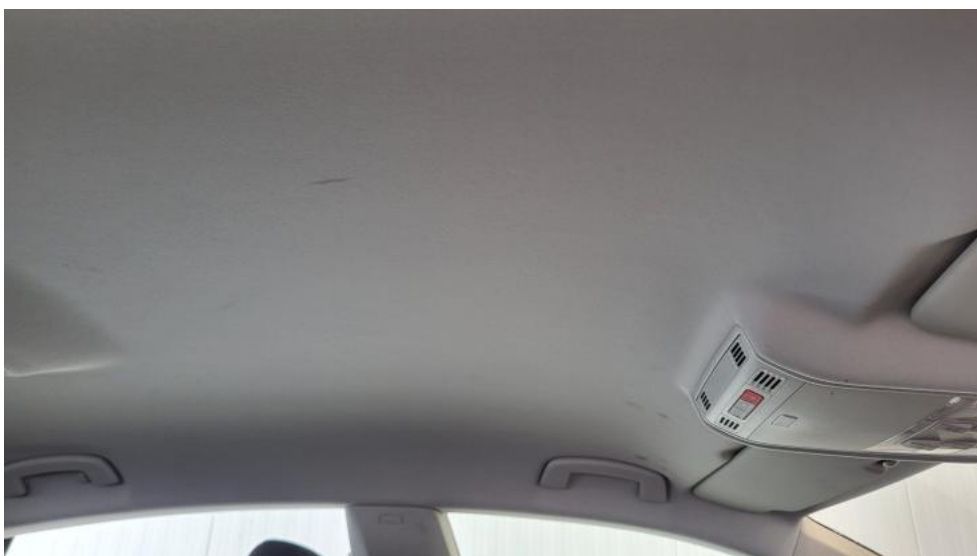
**Photo 70.**

Podsufitka - Inne 2

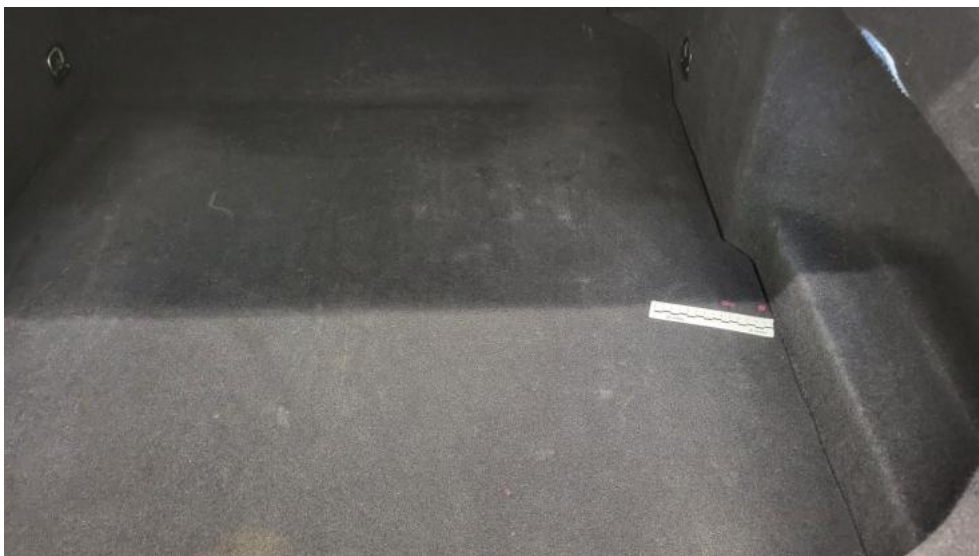
**Photo 72.**

Wykładzina podłogi bagażnika - Inne 1

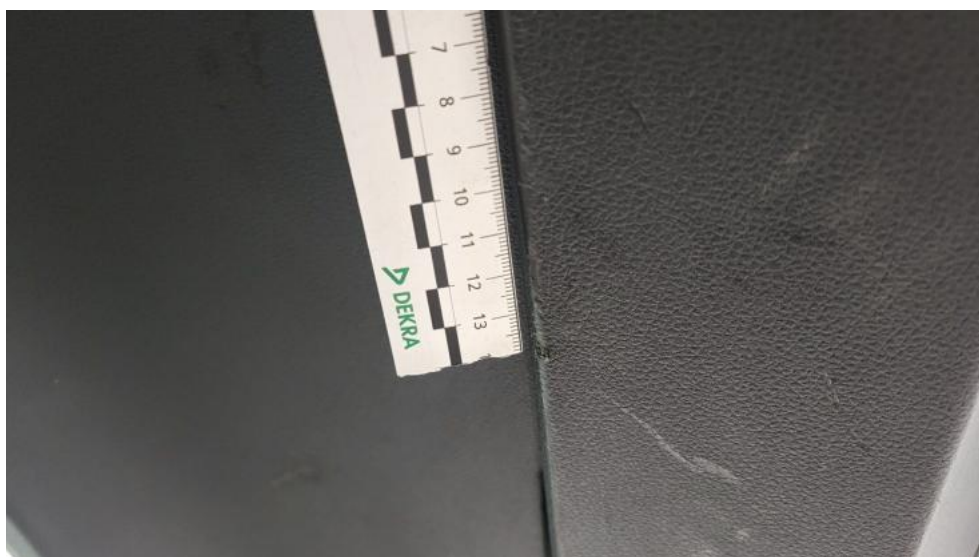
**Photo 73.**

Wykładzina pokrywy tylnej - Rysa/odprysk 1
