DEKRA's commission No. : PKOL(W)/LODZ/61207/26/07/03  
commission/ damage No. : 25/013062  
Date of commission: 03-07-2026

| Manufacturer | BMW |
| Model | Seria 5 Touring [G31] 20-23 |
| VIN / serial number | WBA51AJ080CK90023 |

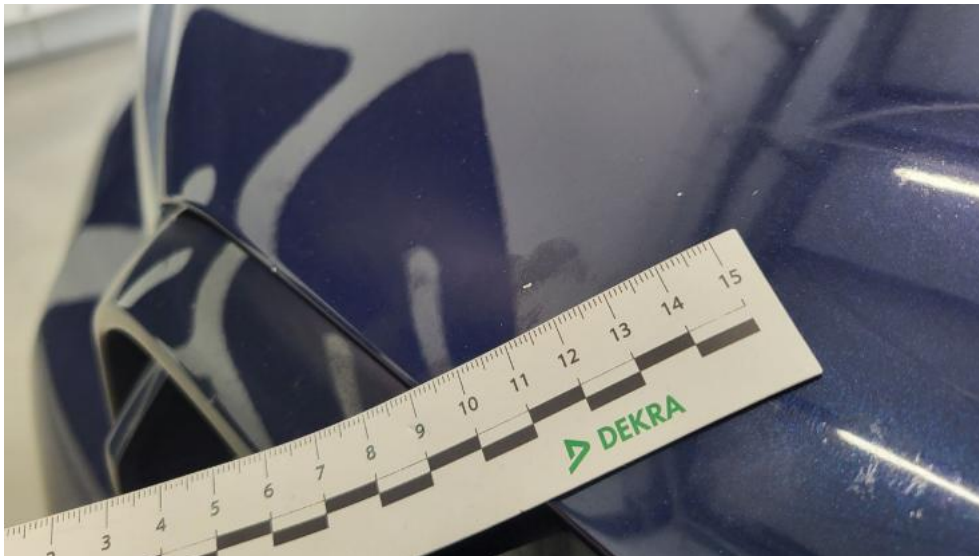
**Photo 47.**

Pokrywa komory silnika - Rysa/odprysk 2

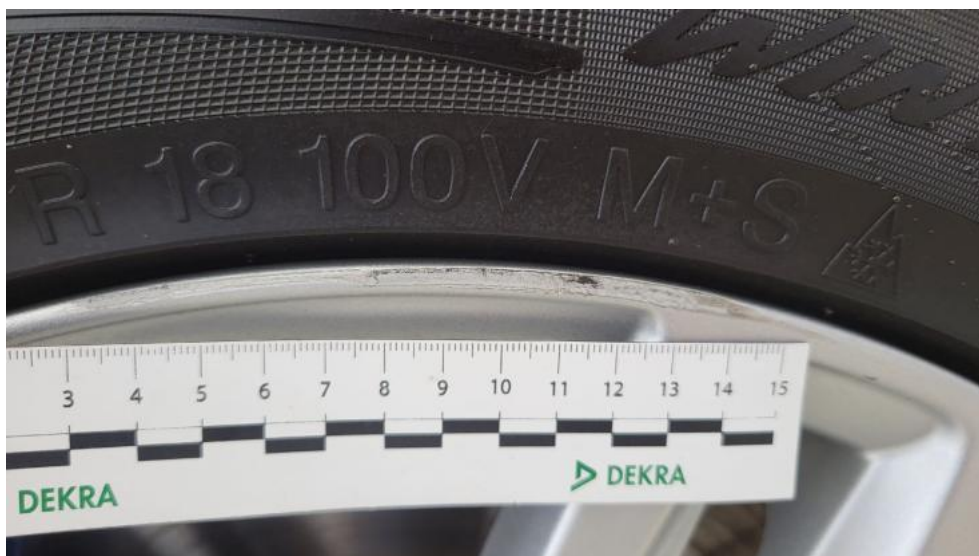
**Photo 48.**

Felga aluminiowa przednia P - Rysa/odprysk 1

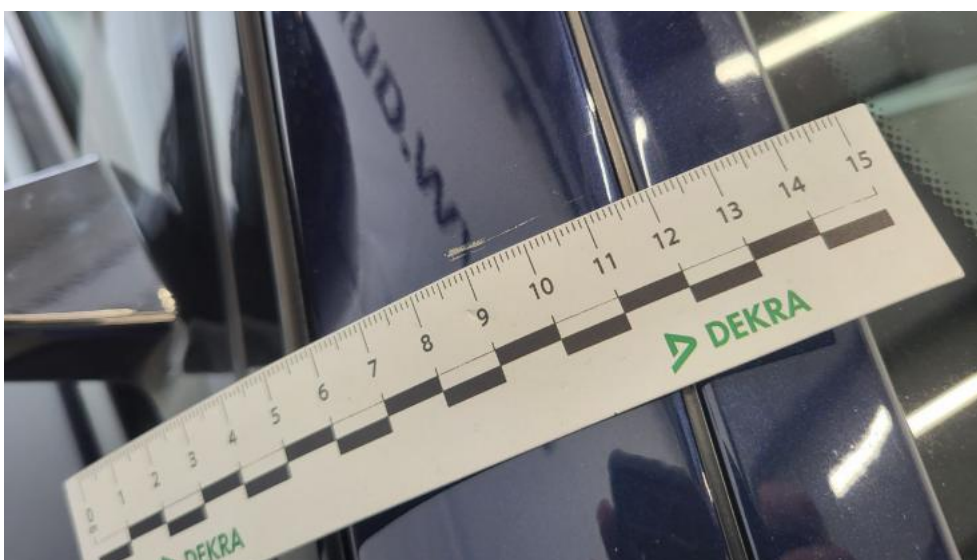
**Photo 50.**

Słupek przedni P - Rysa/odprysk 1

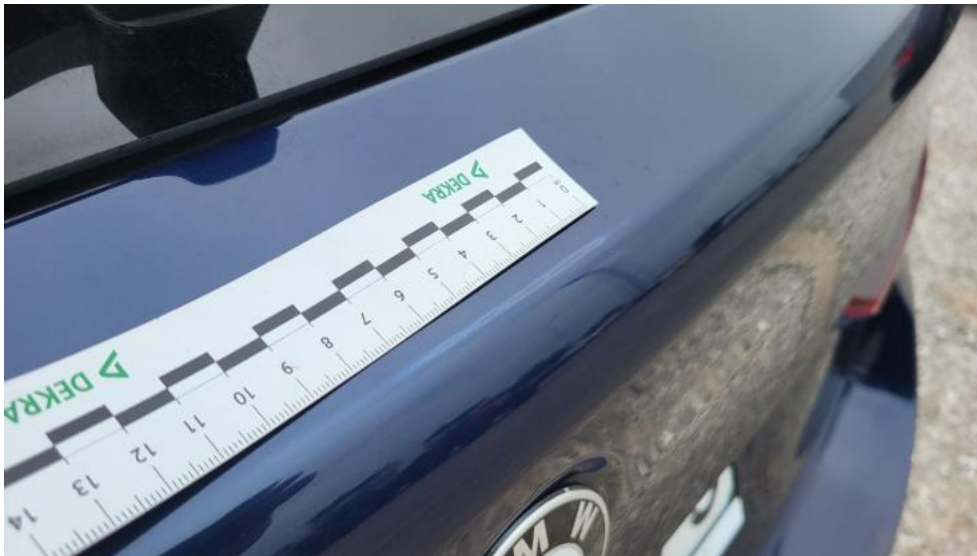
**Photo 53.**

Pokrywy bagażnika - Rysa/odprysk 2

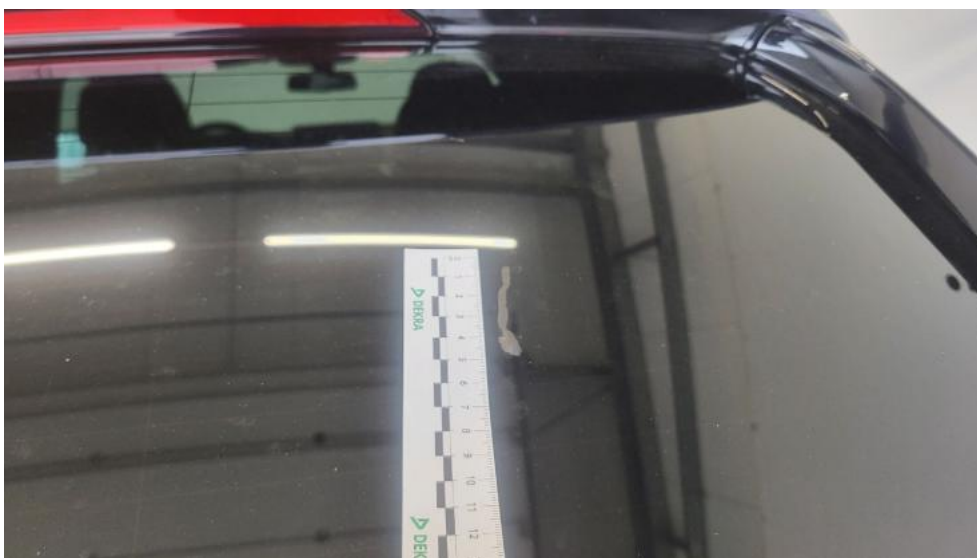
**Photo 54.**

Szyba tylna - Inne 1

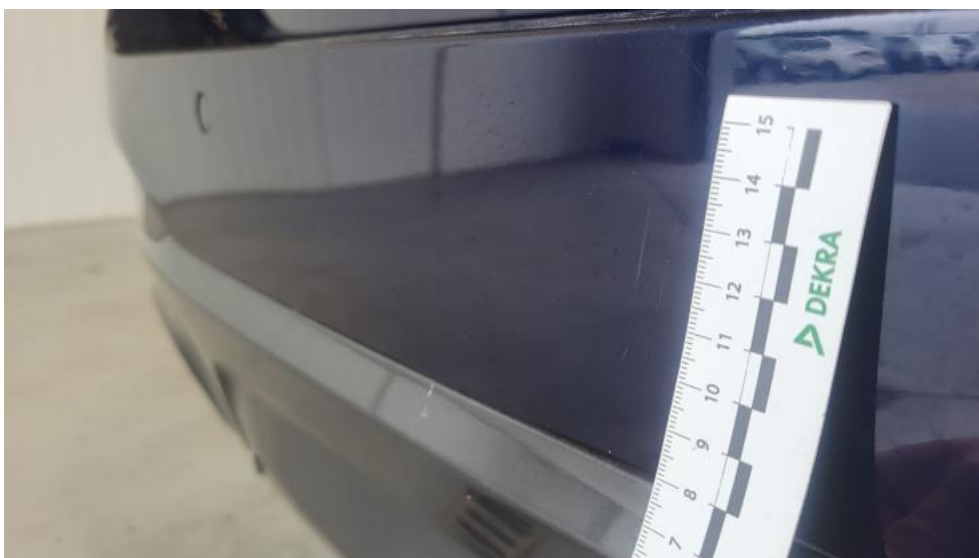
**Photo 56.**

Zderzak tylny - Rysa/odprysk 1

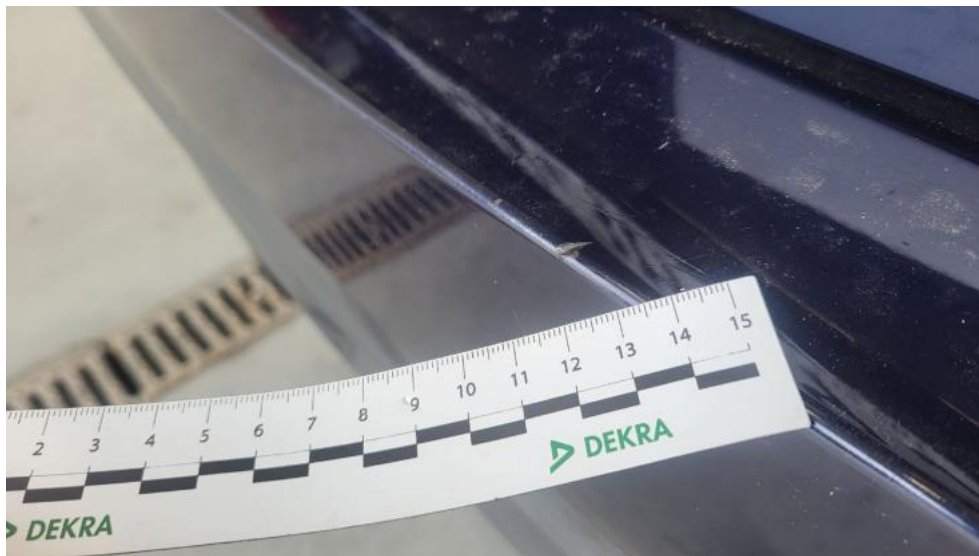
**Photo 57.**

Zderzak tylny - Rysa/odprysk 2

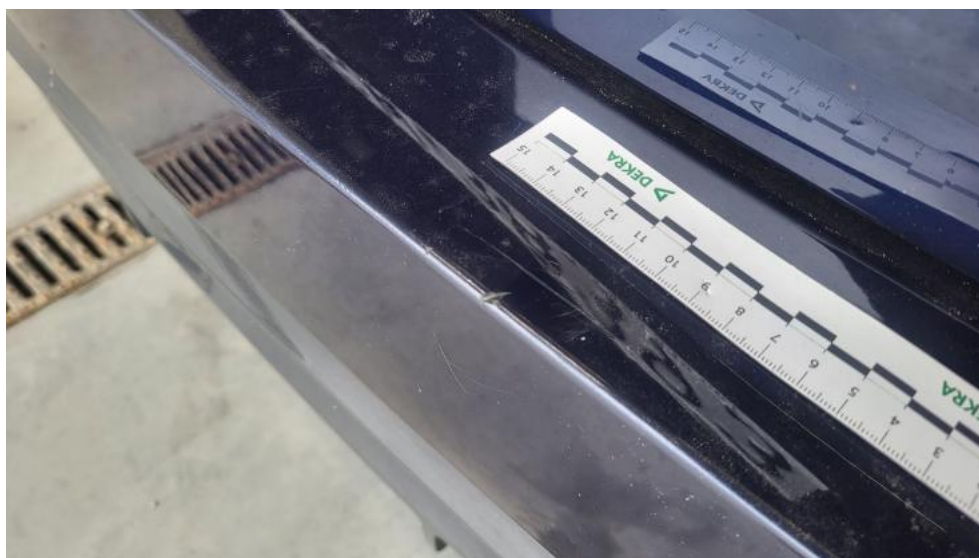
**Photo 58.**

Zderzak tylny - Wgniecenie/odkształcenie 1

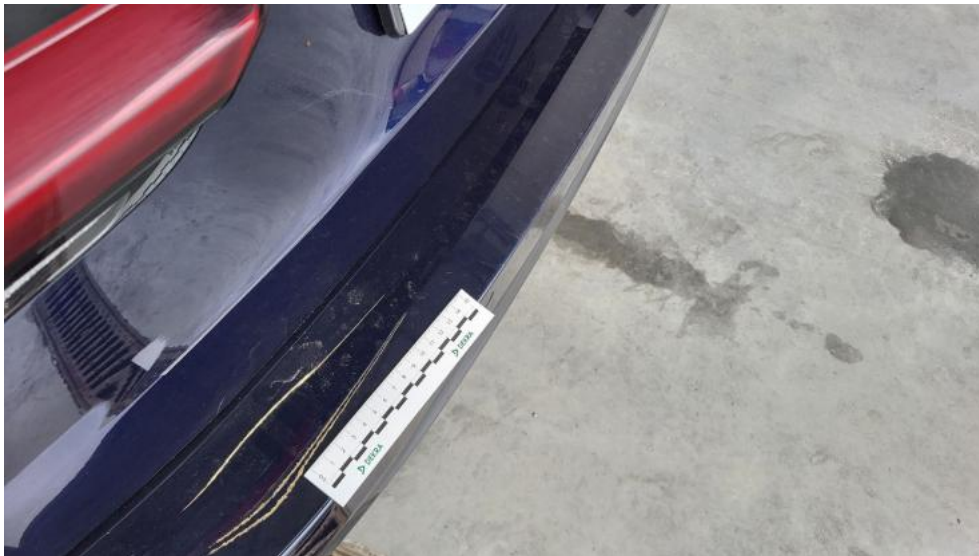
**Photo 59.**

Zderzak tylny - Wgniecenie/odkształcenie 2

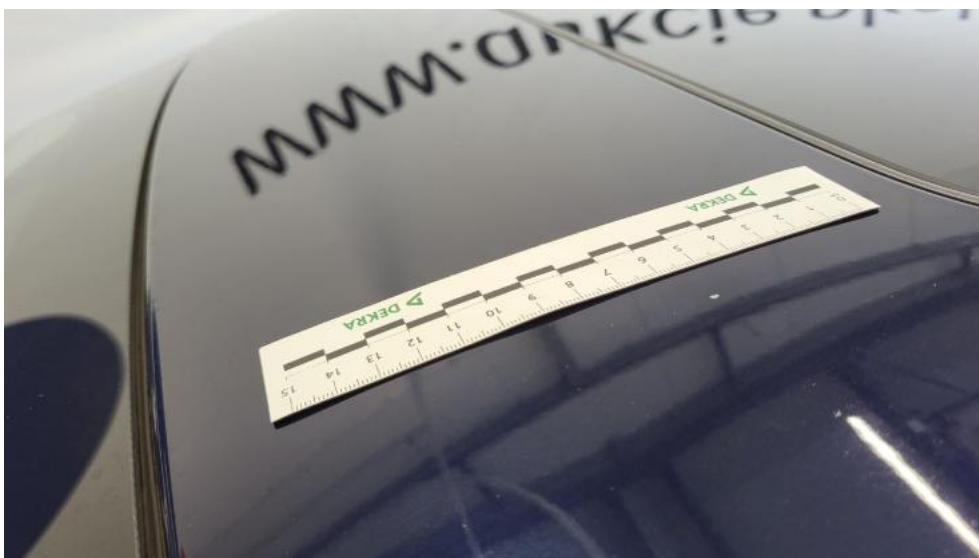
**Photo 60.**

Dach - Rysa/odprysk 1

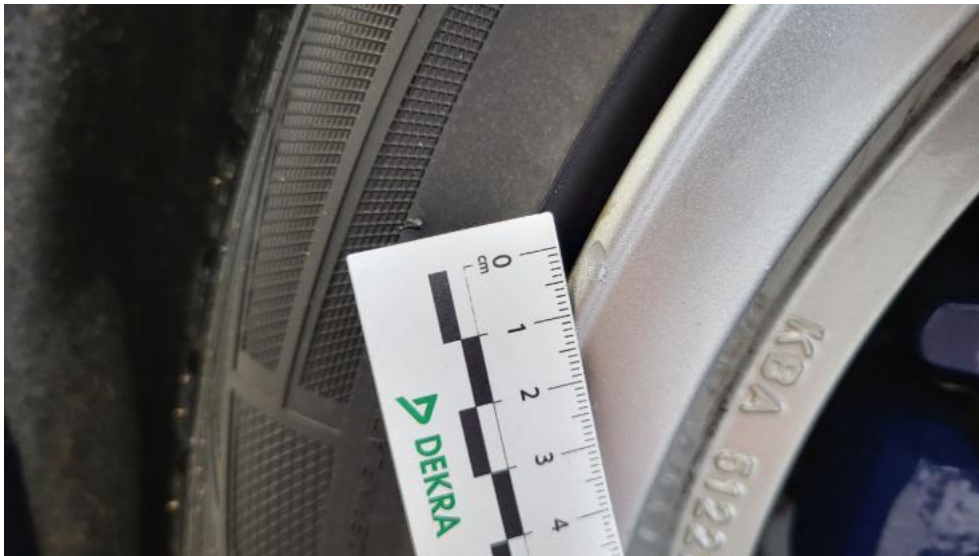
**Photo 63.**

Felga aluminiowa tylna L - Rysa/odprysk 1

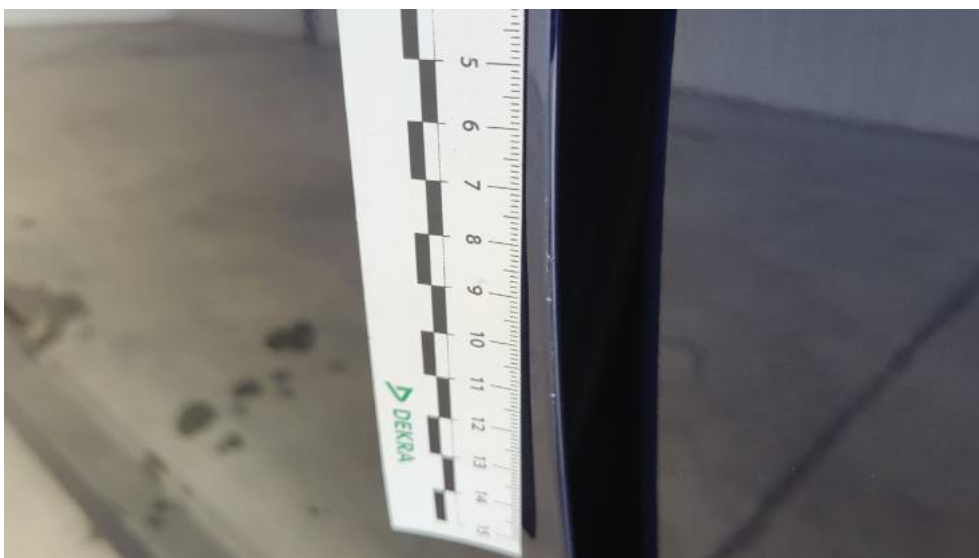
**Photo 64.**

Drzwi przed L - Rysa/odprysk 1

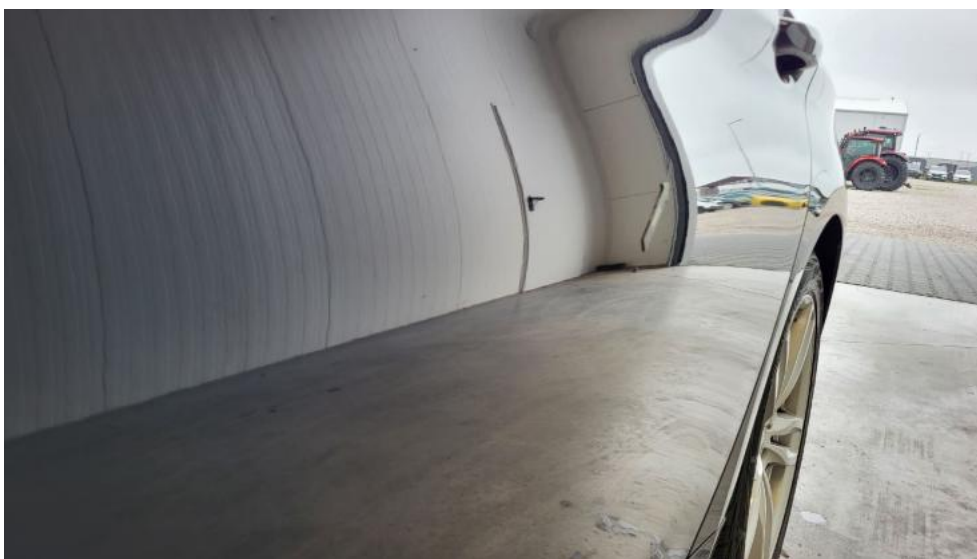
**Photo 65.**

Drzwi tylne L - Wgniecenie/odkształcenie 1

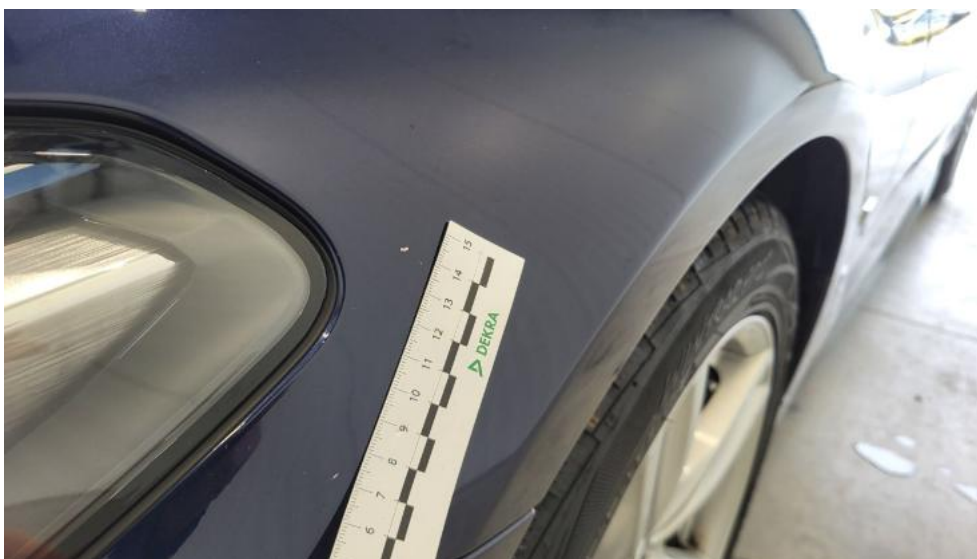
**Photo 67.**

Błotnik przedni L - Rysa/odprysk 1

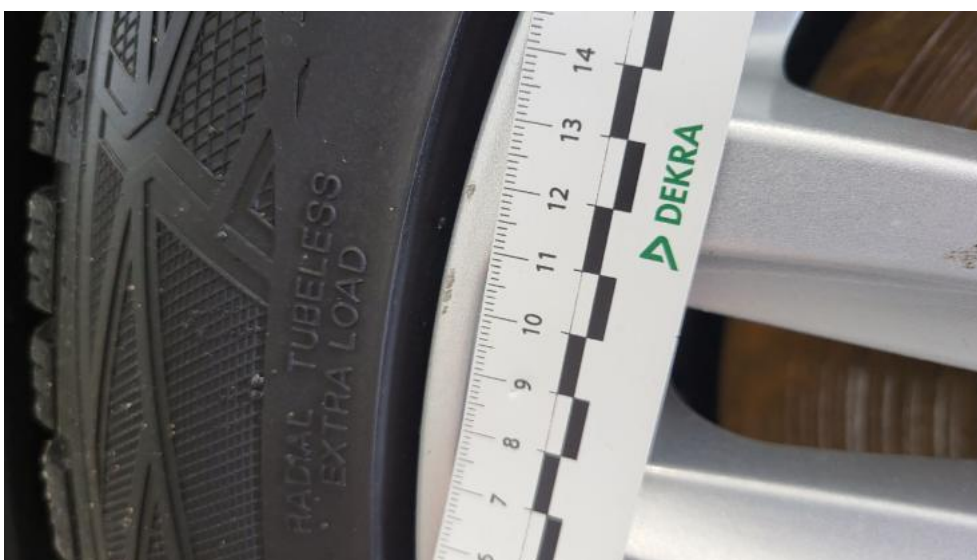
**Photo 68.**

Felga Aluminiowa przednia L - Rysa/odprysk 1

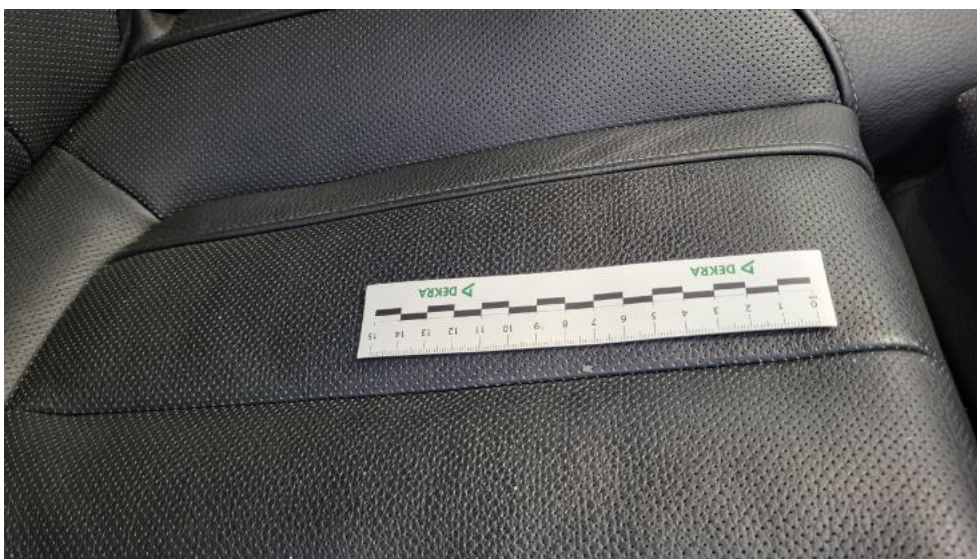
**Photo 69.**

Fotel prz. praw. - Rysa/odprysk 1
