DEKRA's commission No. : PKOL(W)/LODZ/47487/26/05/22  
 commission/ damage No. : 20/K00302  
 Date of commission: 22-05-2026

**DEKRA Poland - Headquarters**  
 02-673 Warszawa, ul. Konstruktorska 12A

**Vehicle data**

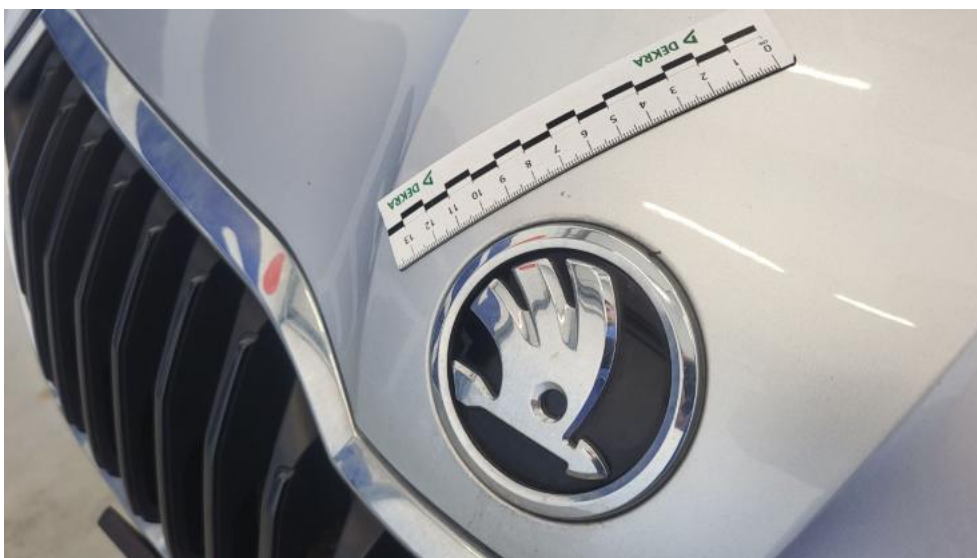
**Photo 40.**  
Pokrywa komory silnika - Rysa/odprysk 1

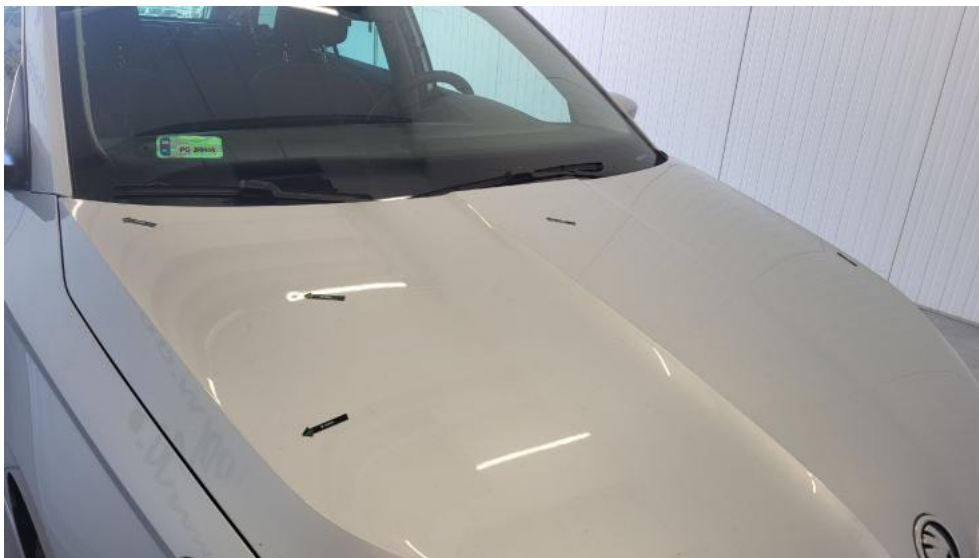
**Photo 41.**

Pokrywa komory silnika - Wgniecenie/odkształcenie 1

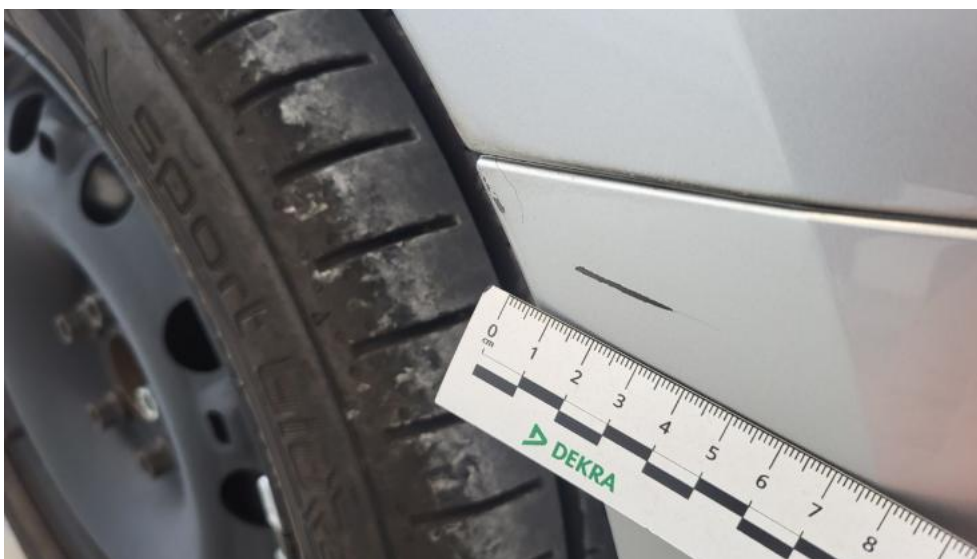
**Photo 45.**  
Zderzak - Rysa/odprysk 2

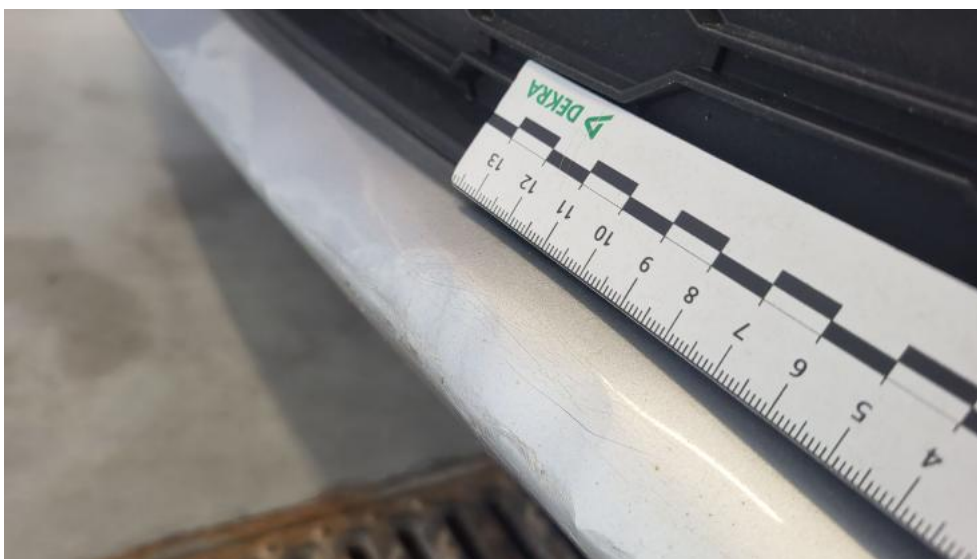
**Photo 47.**  
Zderzak - Pęknięcie/rozerwanie 1

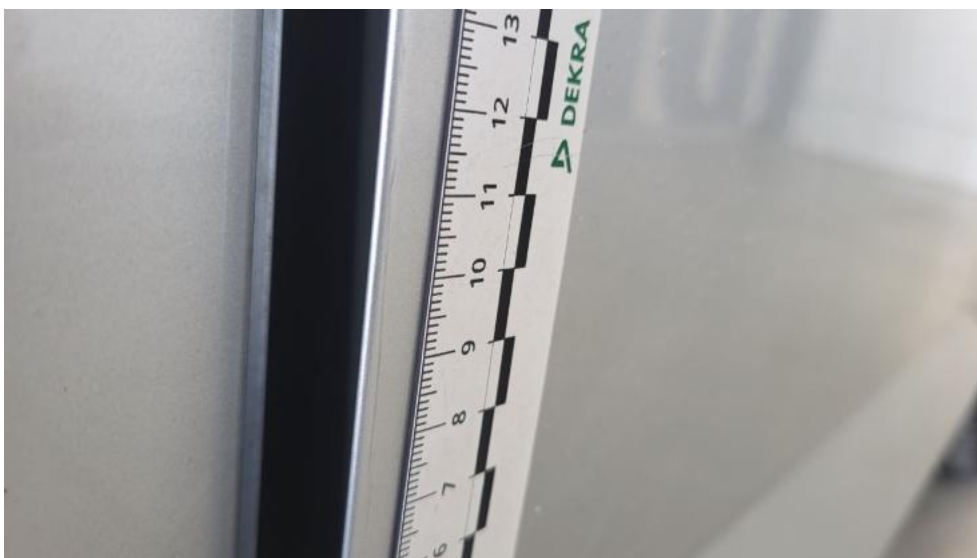
**Photo 48.**  
Drzwi przednie P - Rysa/odprysk 1

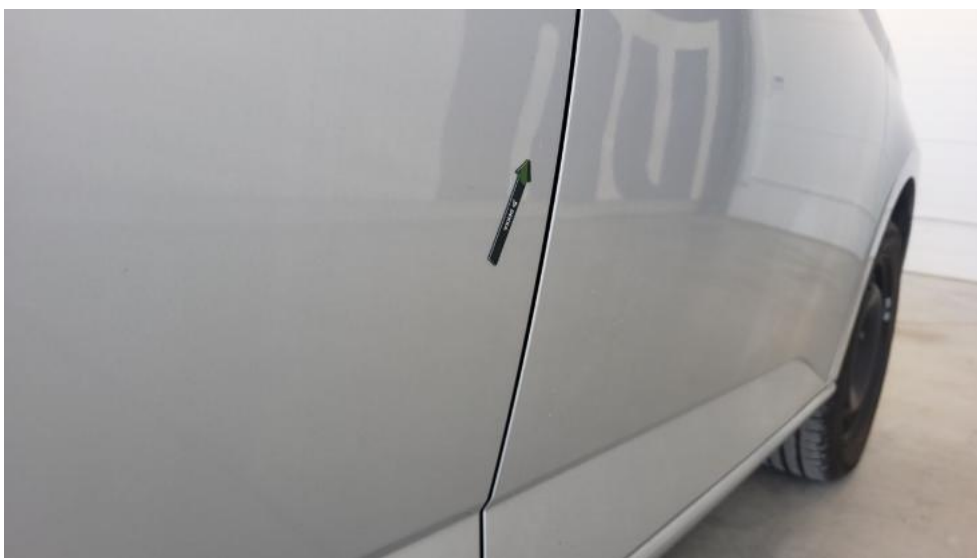
**Photo 50.**

Drzwi tylne P - Wgniecenie/odkształcenie 1

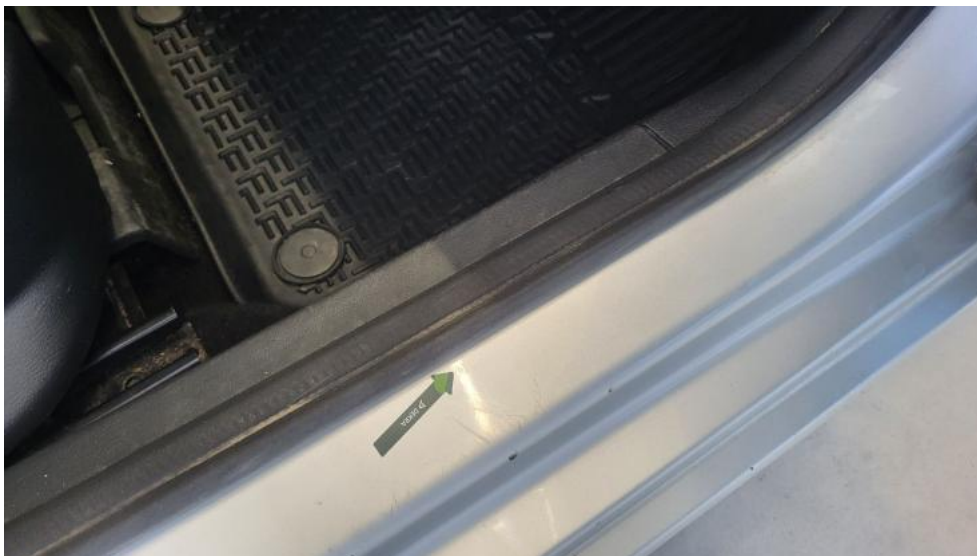
**Photo 51.**  
Próg P - Wgniecenie/odkształcenie 1

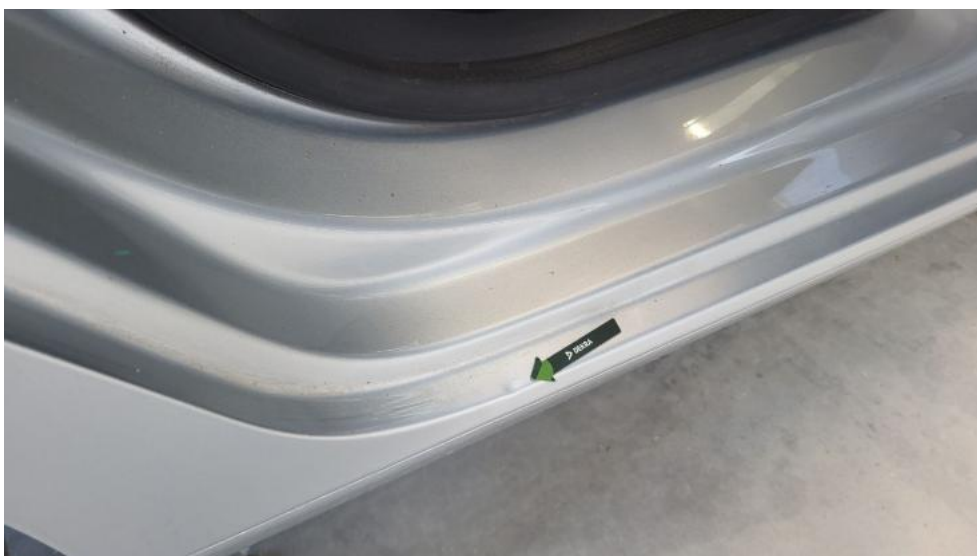
**Photo 52.**  
Próg P - Wgniecenie/odkształcenie 2

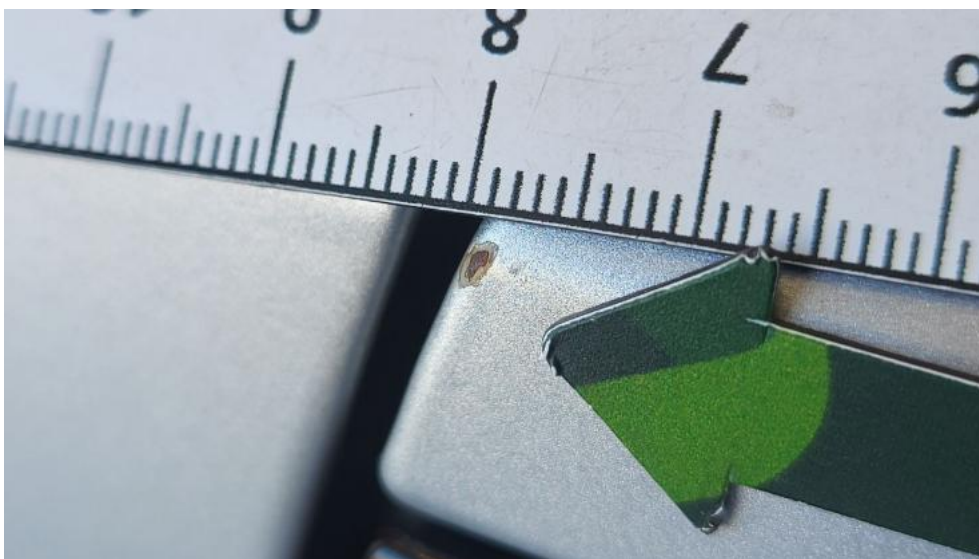
**Photo 57.**

Błotnik tylny P / Ściana boczna P - Inne 1

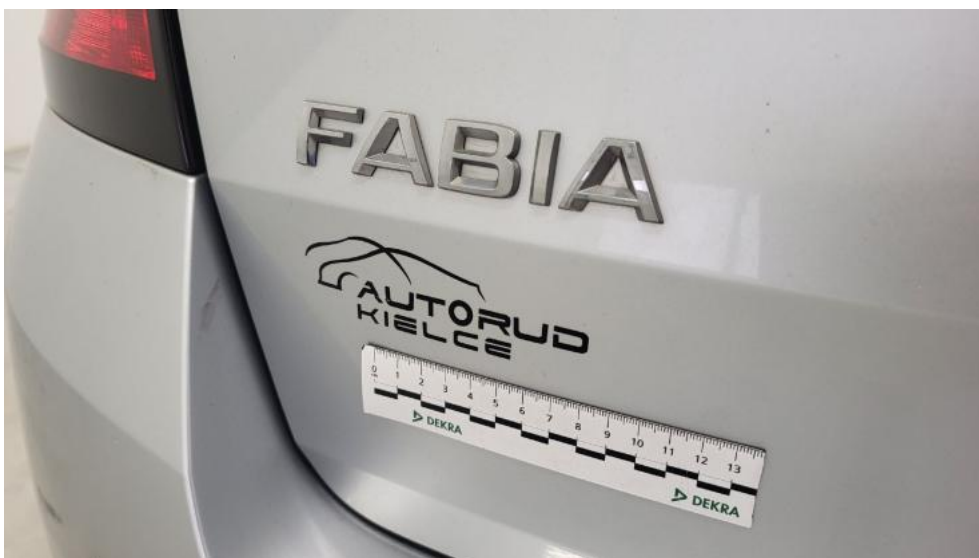
**Photo 58.**

Pokrywy bagażnika - Inne 1

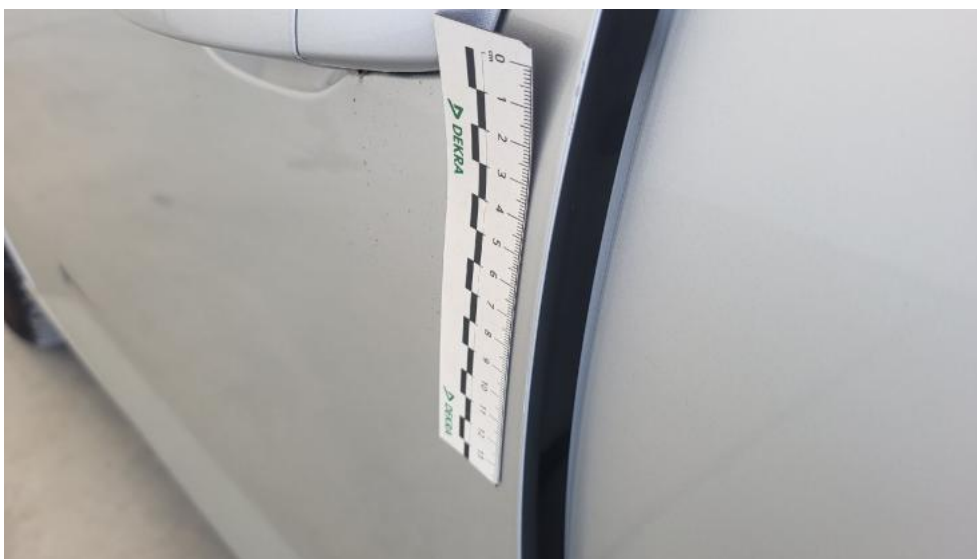
**Photo 65.**

Drzwi przed L - Rysa/odprysk 1

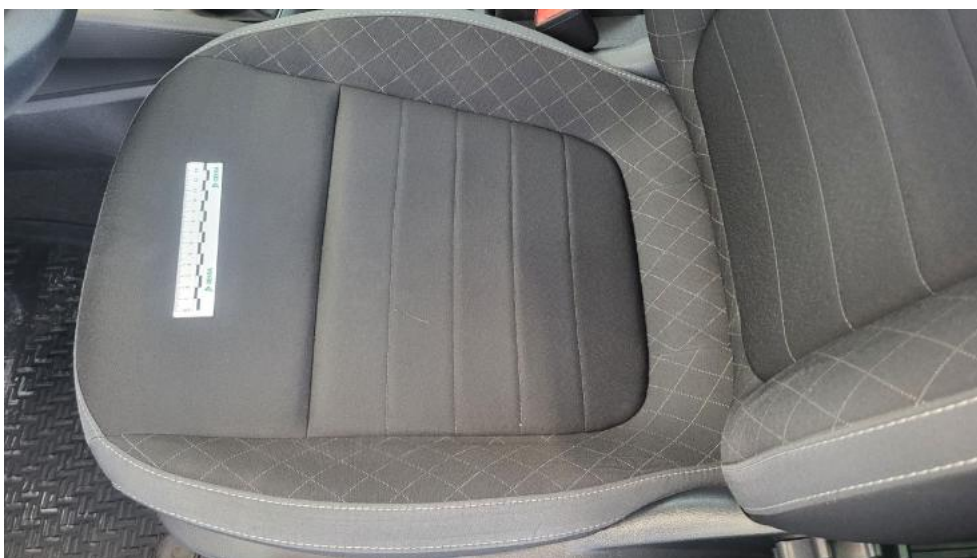
**Photo 68.**  
Fotel prz. lew. - Inne 1
