DEKRA's commission No. : PKOL(W)/LODZ/84289/26/09/08  
commission/ damage No. : DW/WA/2009/001/D  
Date of commission: 08-09-2026

**DEKRA Poland - Headquarters**  
02-673 Warszawa, ul. Konstruktorska 12A

| Manufacturer | BMW |
| Model | Seria 3 Gran Turismo [F34] 16-20 |

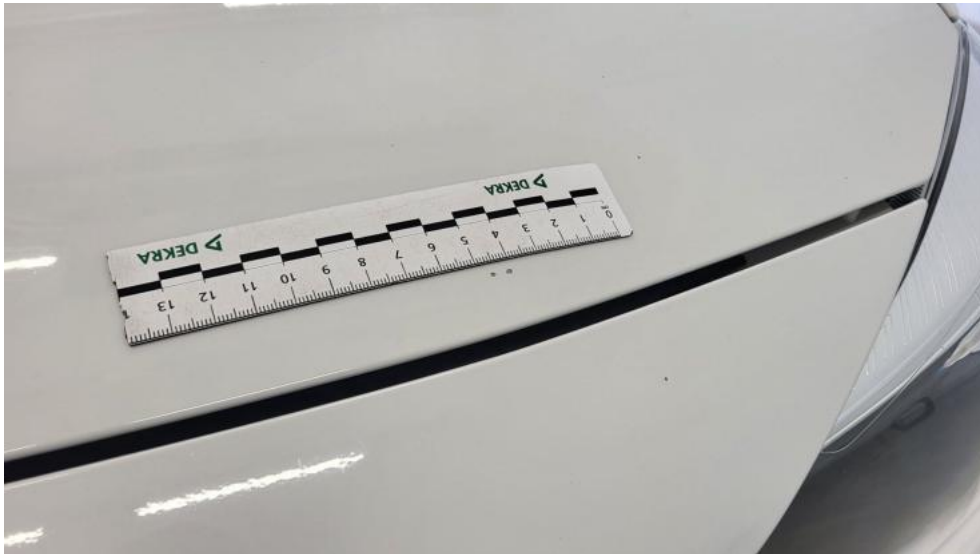
**Photo 39.**

Pokrywa komory silnika - Rysa/odprysk 1

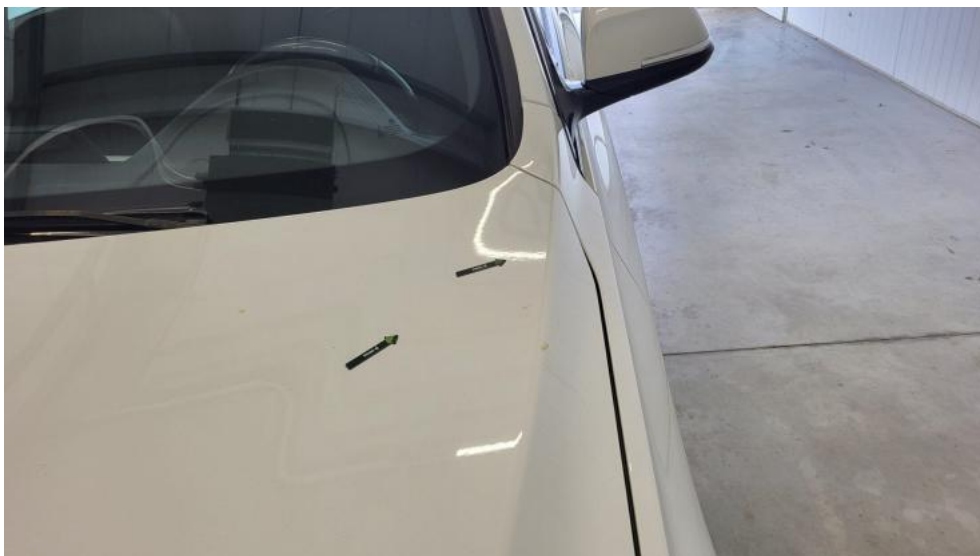
**Photo 40.**

Pokrywa komory silnika - Wgniecenie/odkształcenie 1

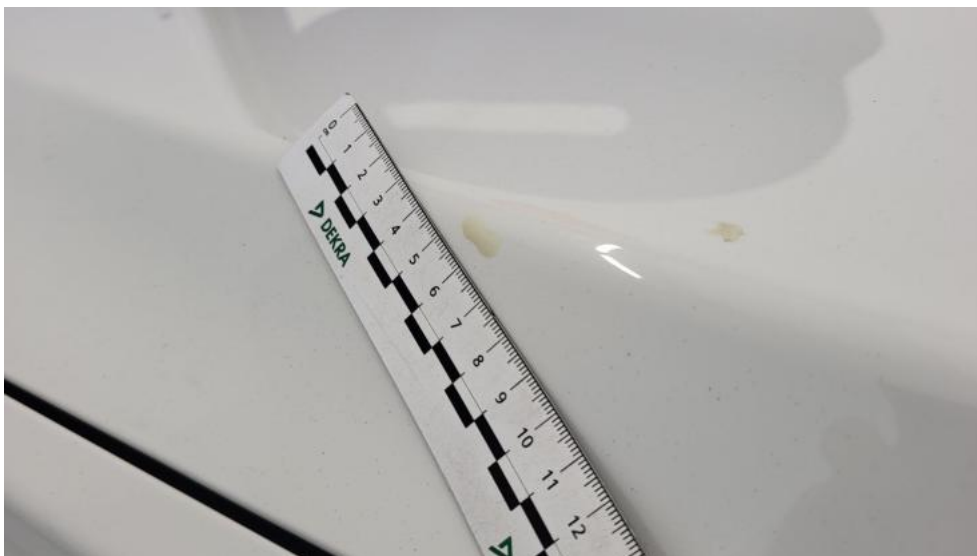
**Photo 41.**

Pokrywa komory silnika - Inne 1

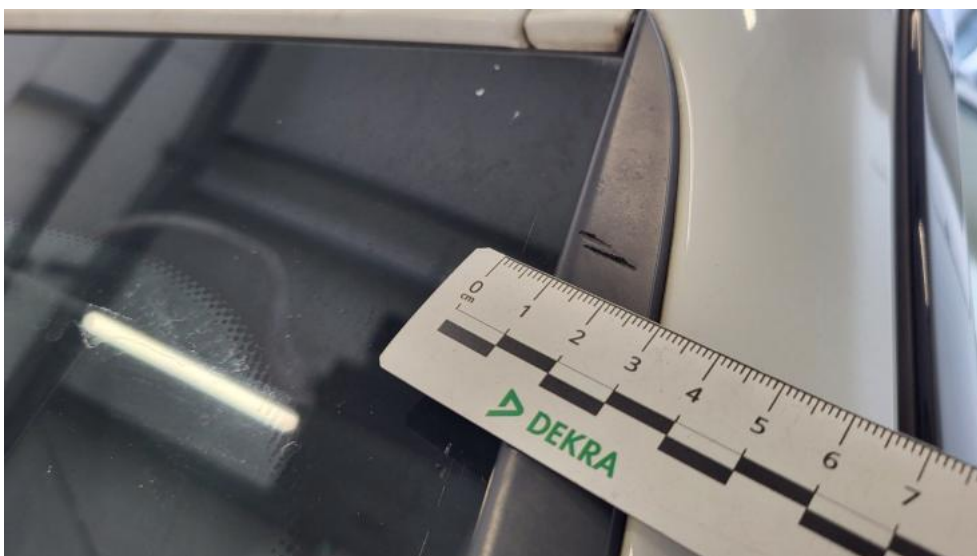
**Photo 42.**

Uszczelka/listwa szyby czołowej - Rysa/odprysk 1

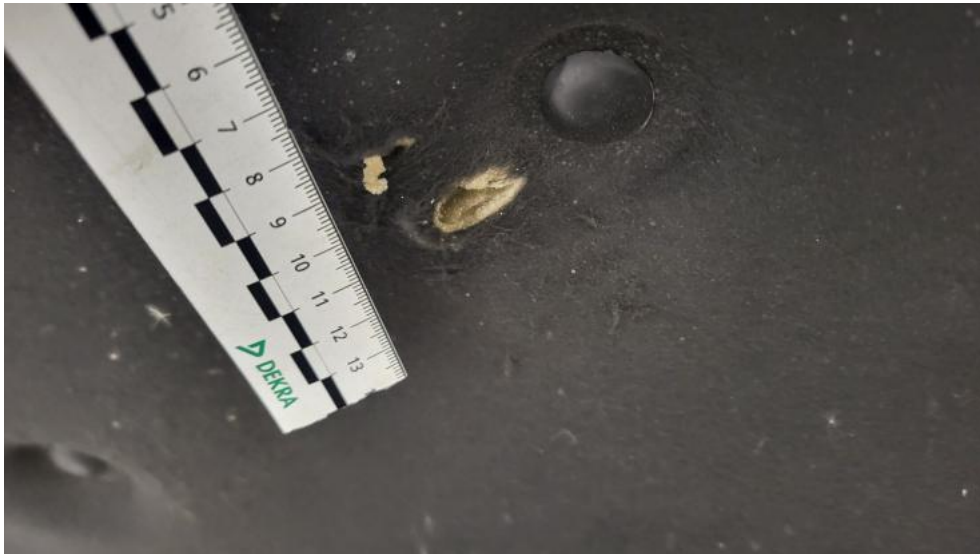
**Photo 43.**

Wykładzina pokrywy komory silnika - Pęknięcie/rozerwanie 1

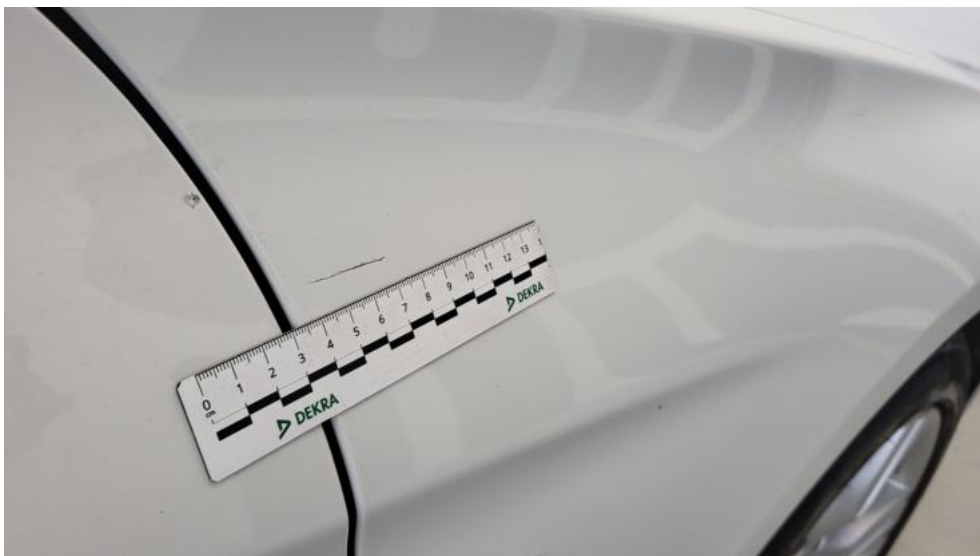
**Photo 44.**

Błotnik przedni P - Rysa/odprysk 1

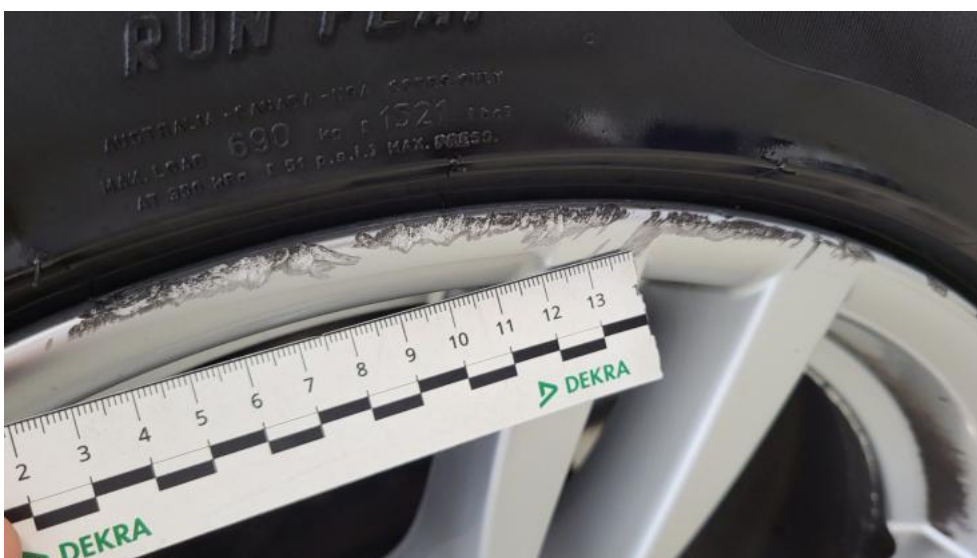
**Photo 46.**

Felga aluminiowa przednia P - Rysa/odprysk 1

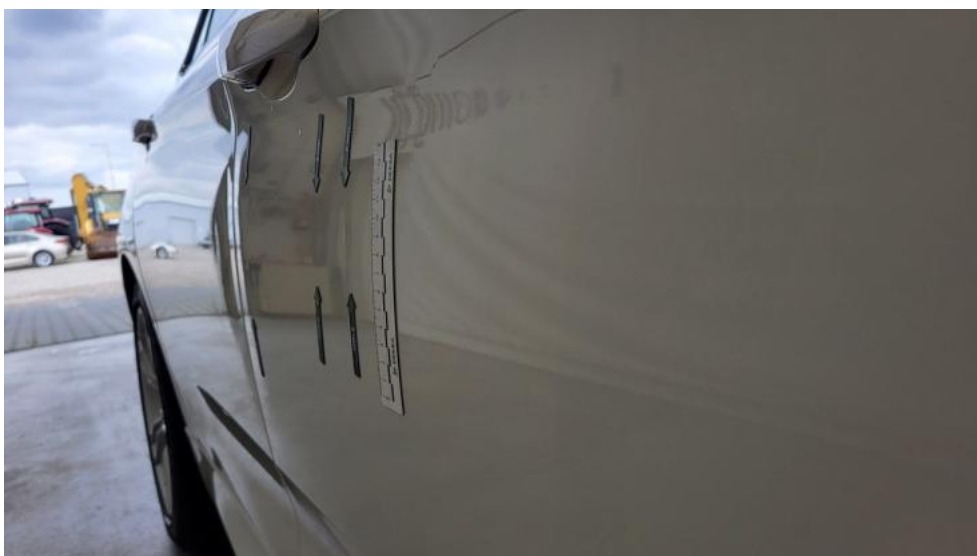
**Photo 48.**

| No. of controlled item | Controlled item | Measured range of thickness of the lacquer coat [ $\mu\text{m}$ ] |
|---|---|---|
| 15 | Front right door | 150 - 200 |

Drzwi przednie P - Wgniecenie/odkształcenie 1

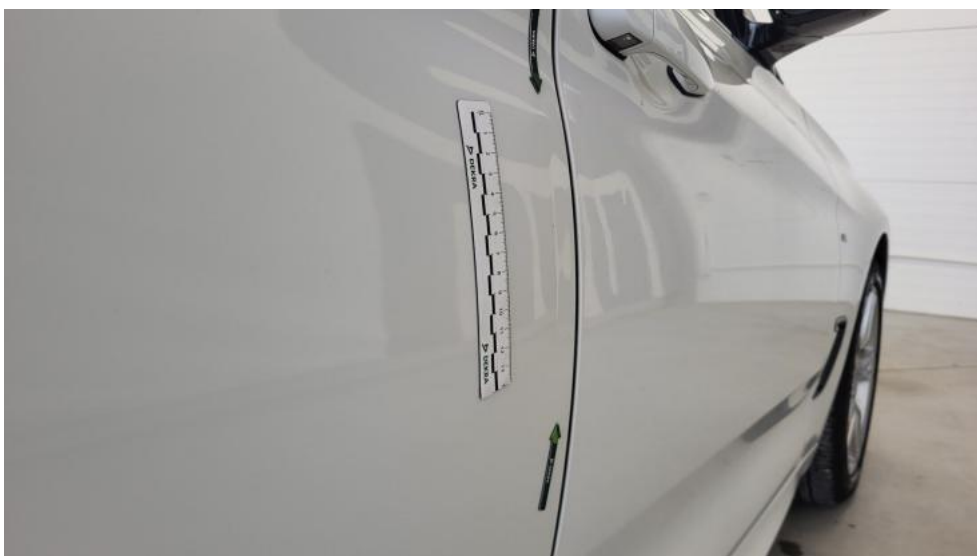
**Photo 50.**

| No. of controlled item | Controlled item | Measured range of thickness of the lacquer coat [ $\mu\text{m}$ ] |
|---|---|---|
| 12 | Right rear door | 150 - 1000 |

Drzwi tylne P - Wgniecenie/odkształcenie 1

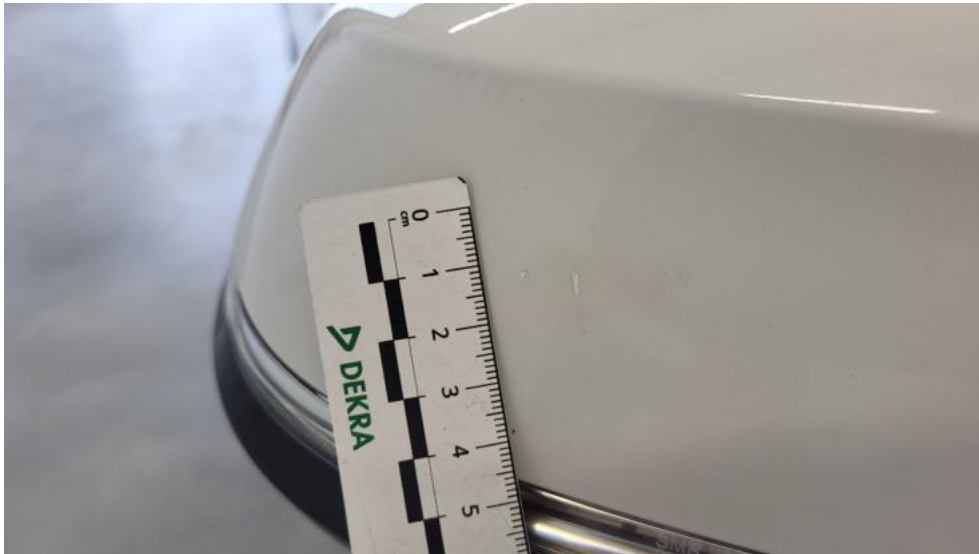
**Photo 51.**

Lusterko zew P - Rysa/odprysk 1

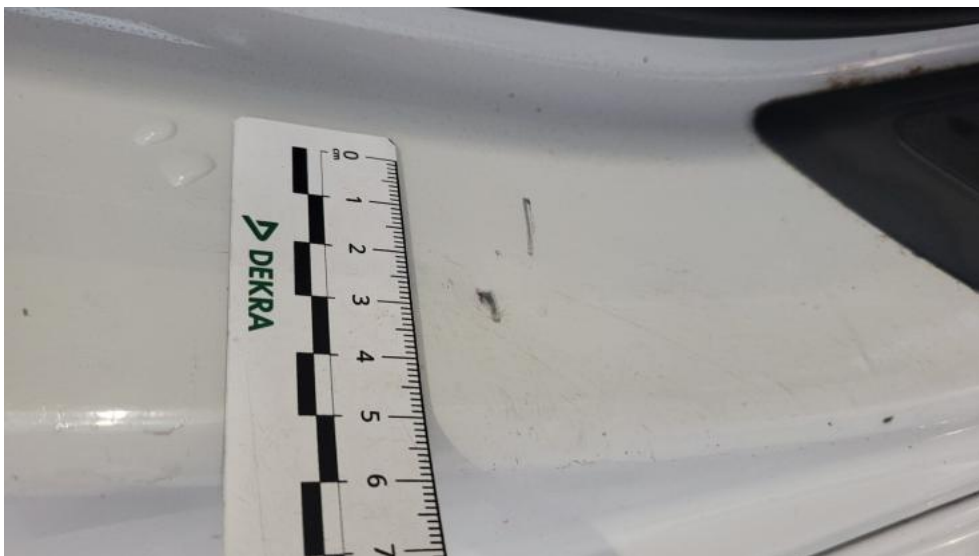
**Photo 52.**

Próg P - Rysa/odprysk 1

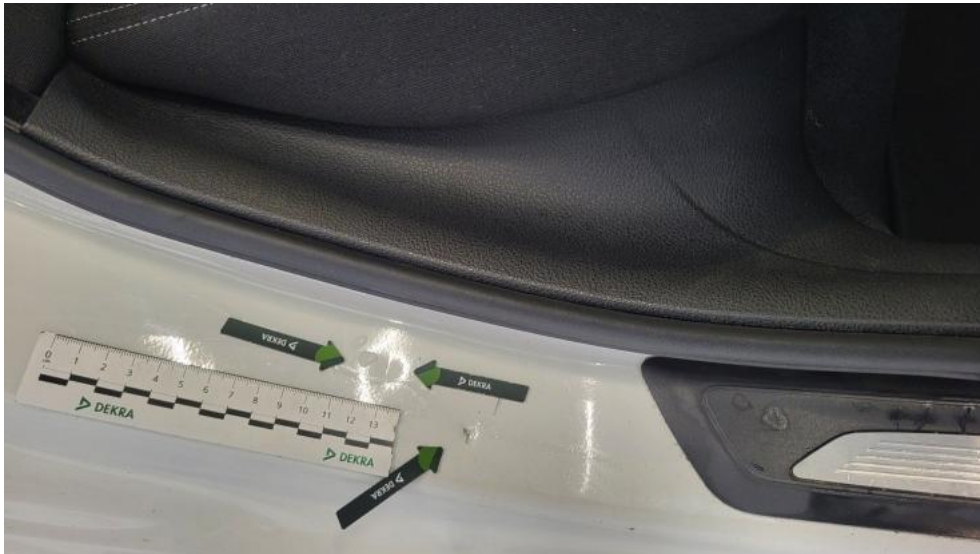
**Photo 53.**

Próg P - Wgniecenie/odkształcenie 1

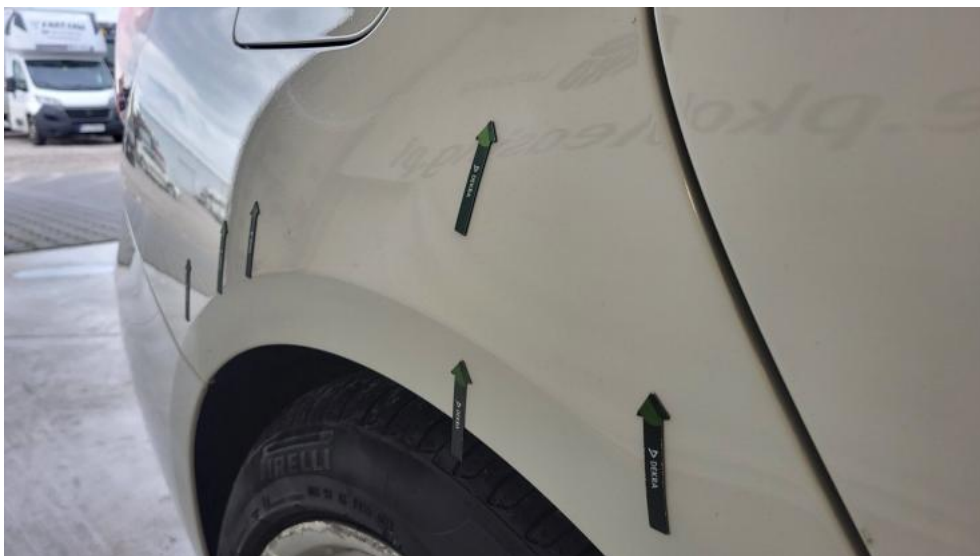
**Photo 54.**

| No. of controlled item | Controlled item | Measured range of thickness of the lacquer coat [ $\mu\text{m}$ ] |
|---|---|---|
| 11 | Right rear fender | 150 - 1000 |

Błotnik tylny P / Ściana boczna P - Wgniecenie/odkształcenie 1

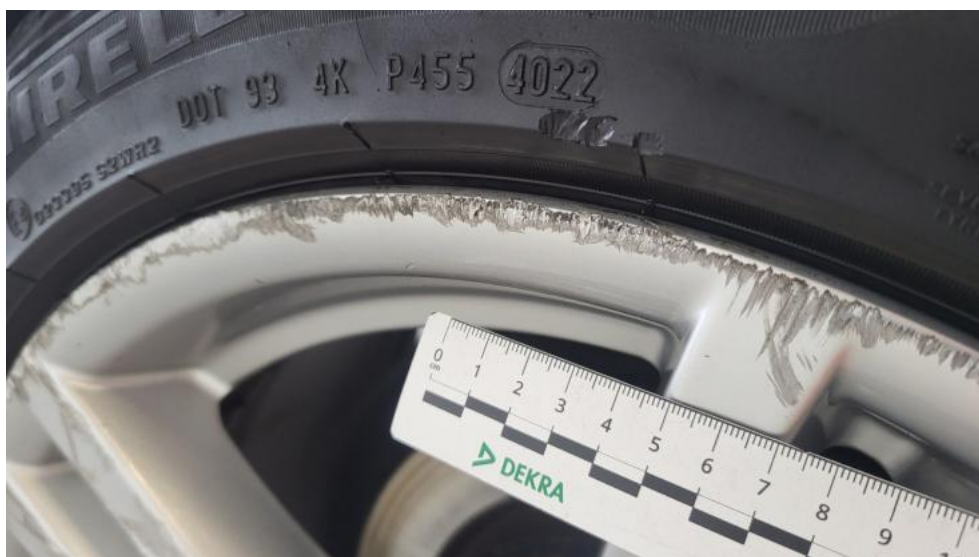
**Photo 55.**

Felga aluminiowa tylna P - Rysa/odprysk 1

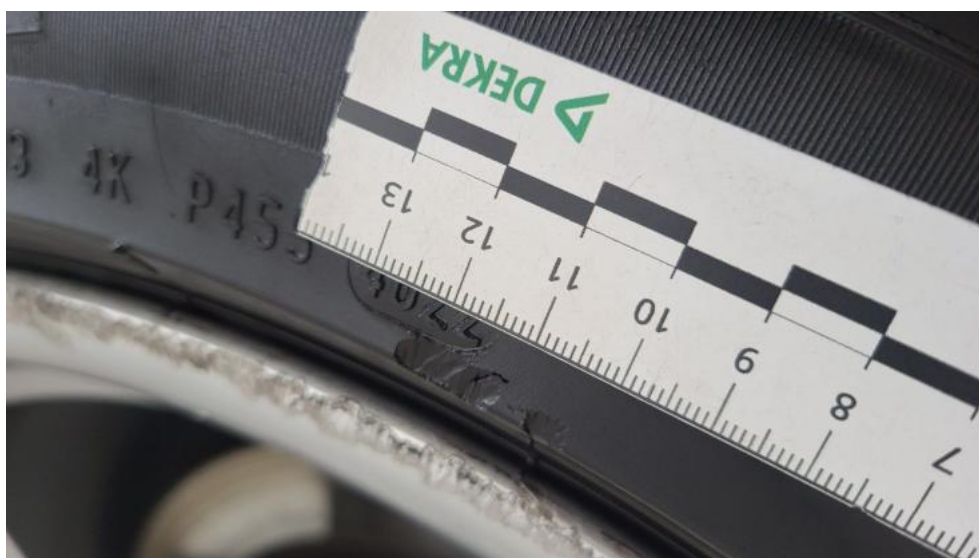
**Photo 56.**

Opona tylna P - Pęknięcie/rozerwanie 1

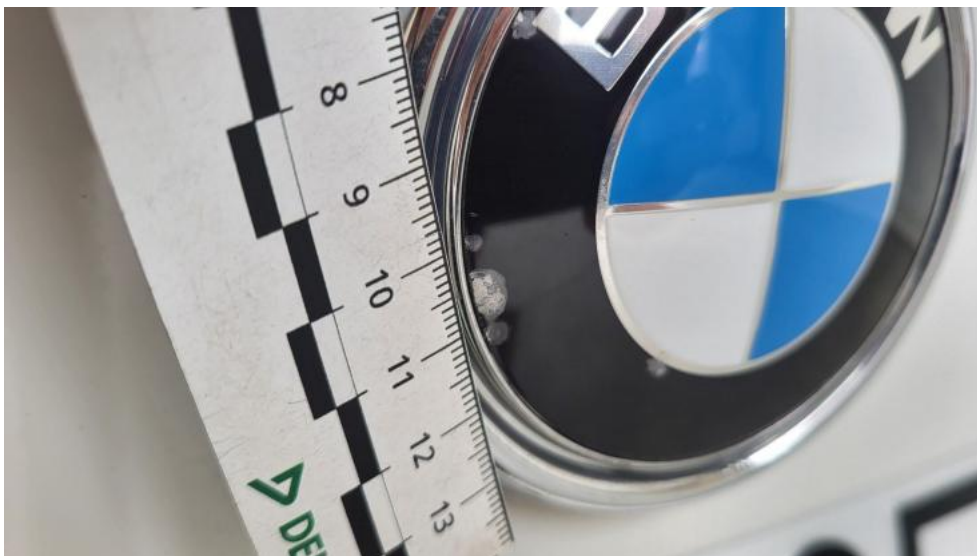
**Photo 57.**

Emblemat tylny - Inne 1

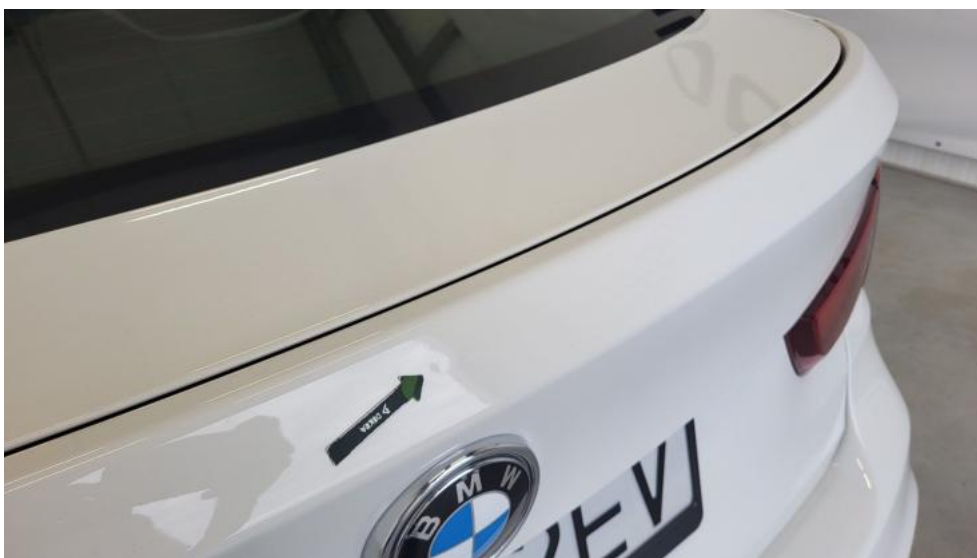
**Photo 58.**

Pokrywy bagażnika - Wgniecenie/odkształcenie 1

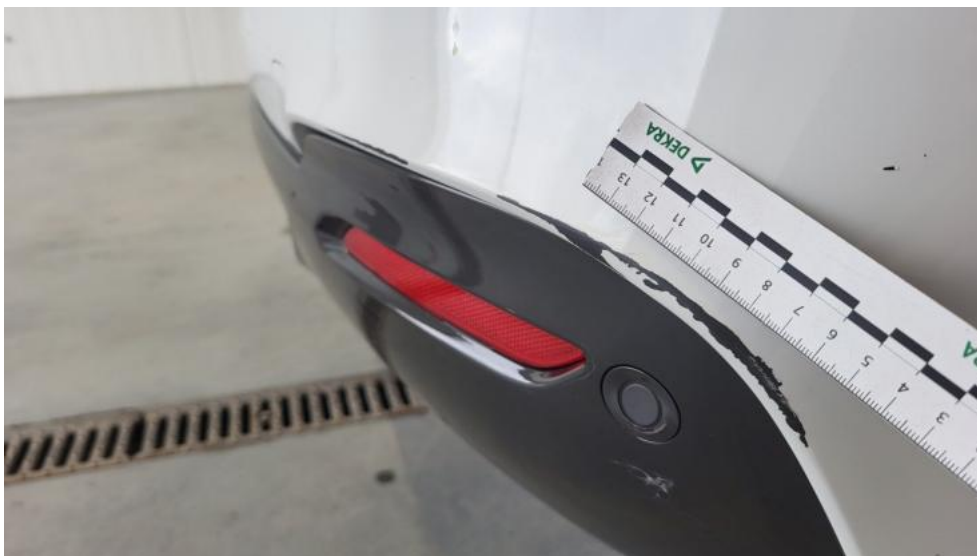
**Photo 59.**

Zderzak tylny - Rysa/odprysk 1

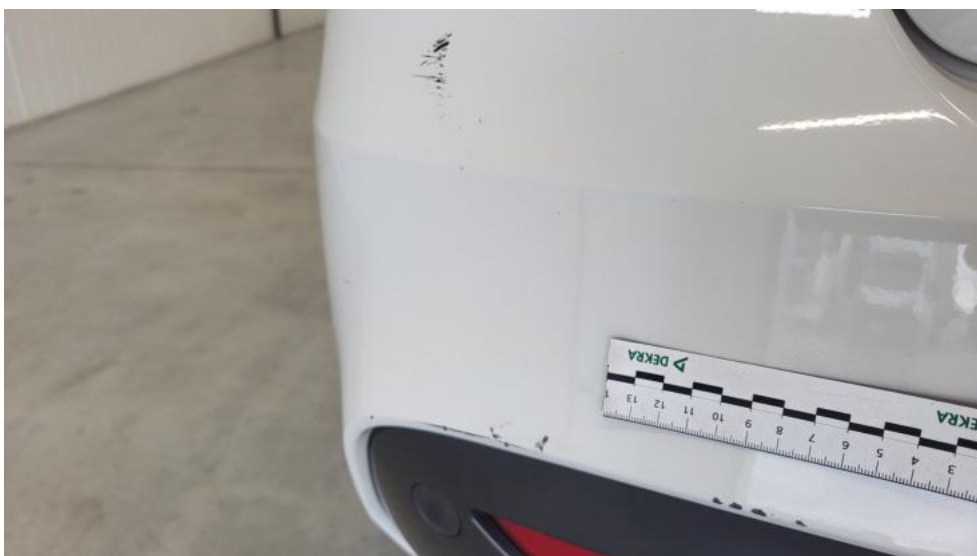
**Photo 60.**

Zderzak tylny - Rysa/odprysk 2

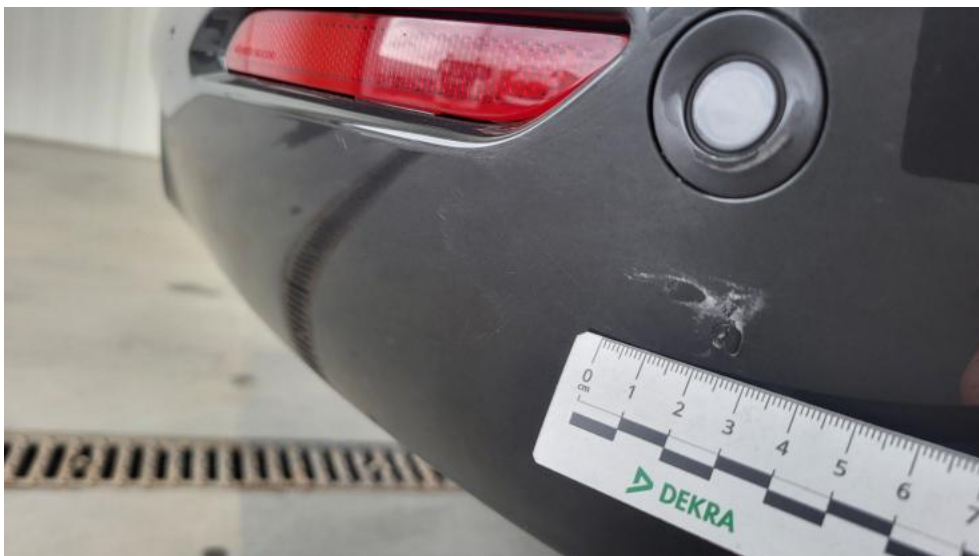
**Photo 62.**

Zderzak tylny cz dolna - Rysa/odprysk 1

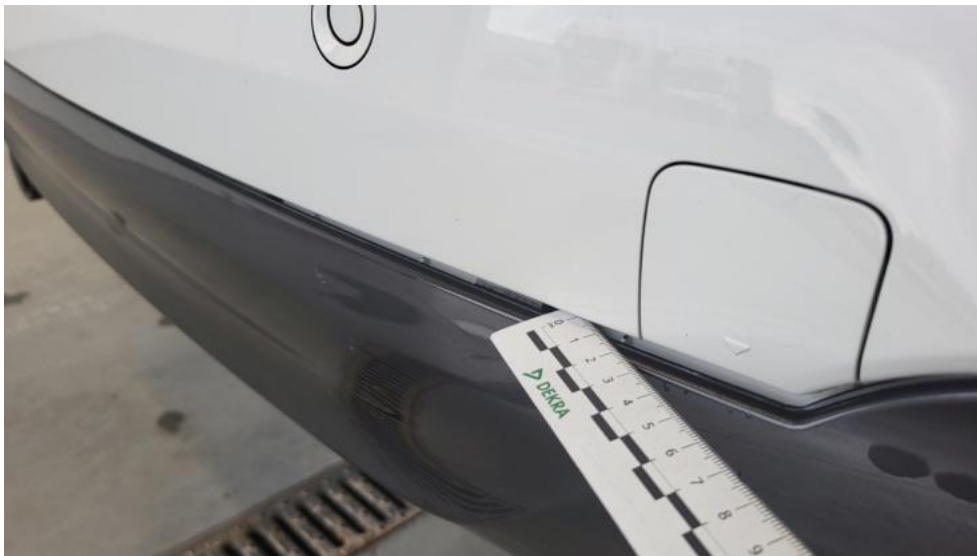
**Photo 63.**

Zderzak tylny cz dolna - Inne 1

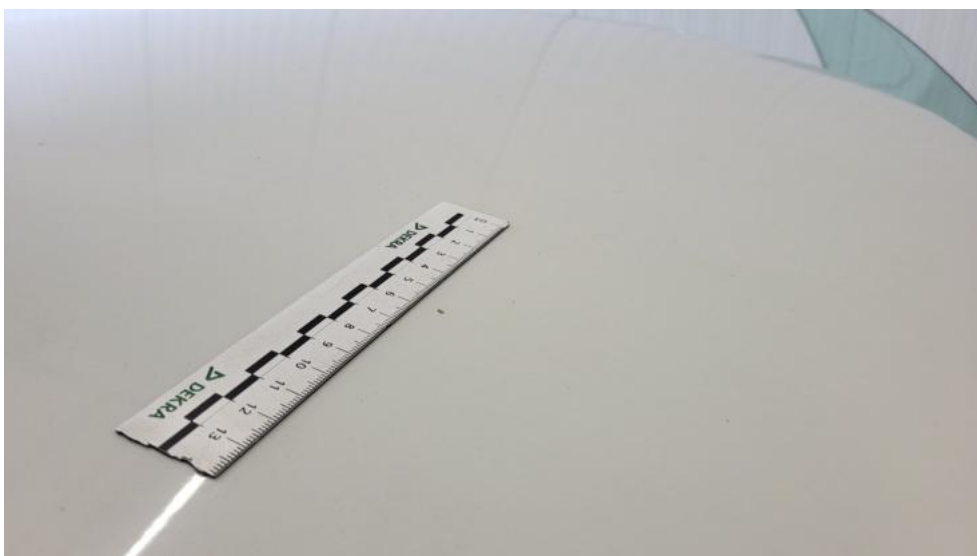
**Photo 64.**

Dach - Rysa/odprysk 1

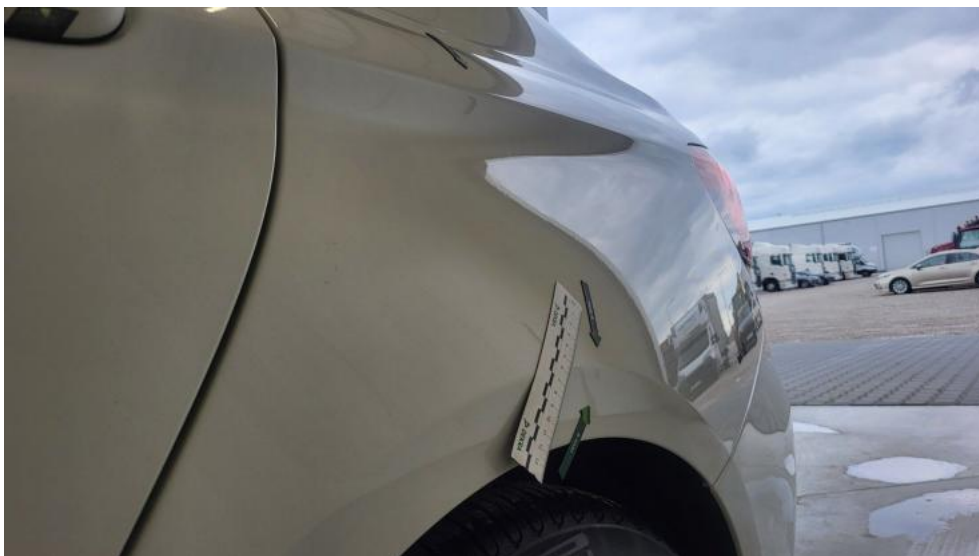
**Photo 66.**

Błotnik tylny L / Ściana boczna L - Wgniecenie/odkształcenie 1

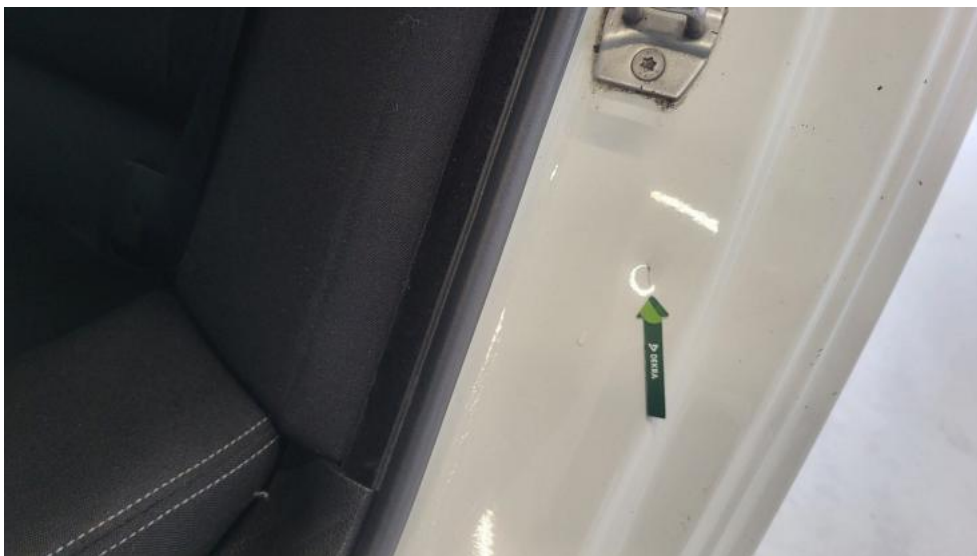
**Photo 67.**

Błotnik tylny L / Ściana boczna L - Wgniecenie/odkształcenie 2

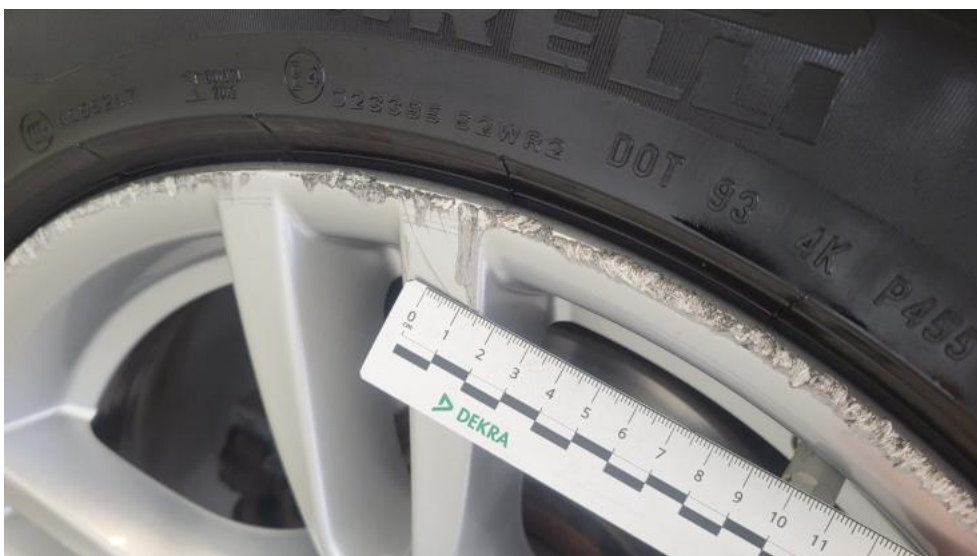
**Photo 68.**

Felga aluminiowa tylna L - Rysa/odprysk 1

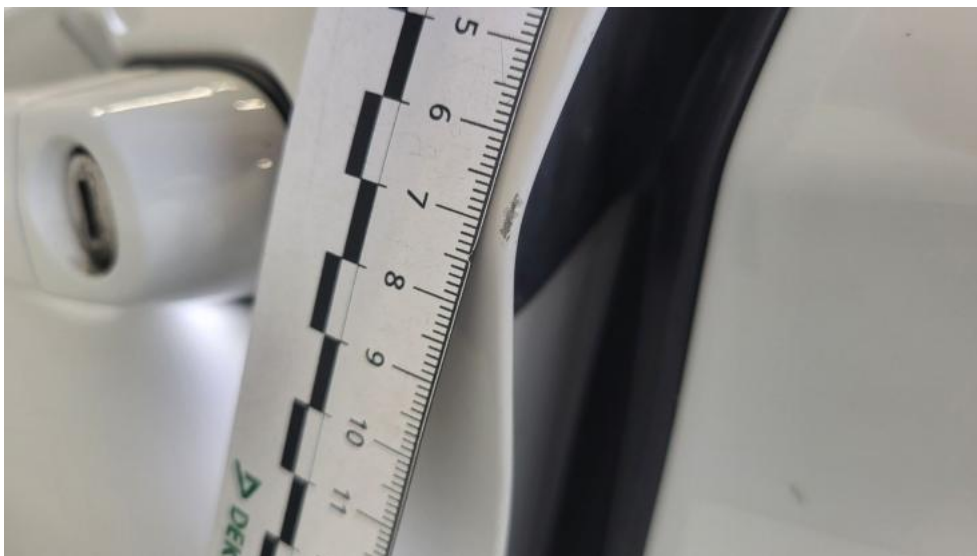
**Photo 69.**

Drzwi przed L - Rysa/odprysk 1

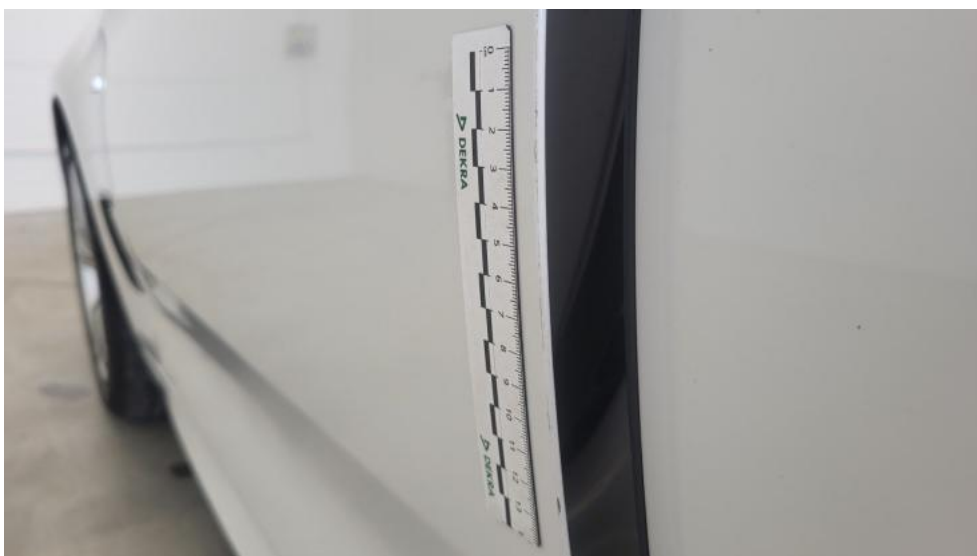
**Photo 70.**

Drzwi przed L - Rysa/odprysk 2

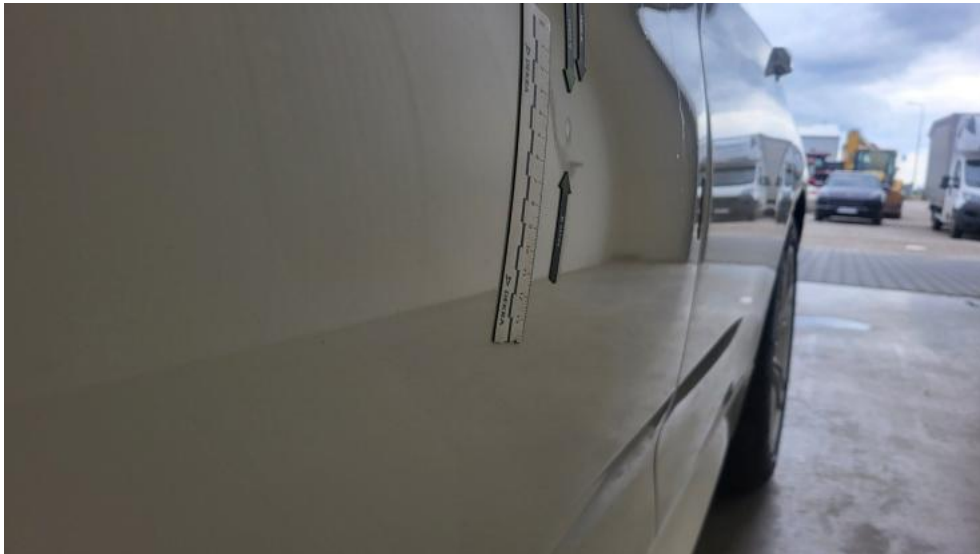
**Photo 71.**

Drzwi przed L - Wgniecenie/odkształcenie 1

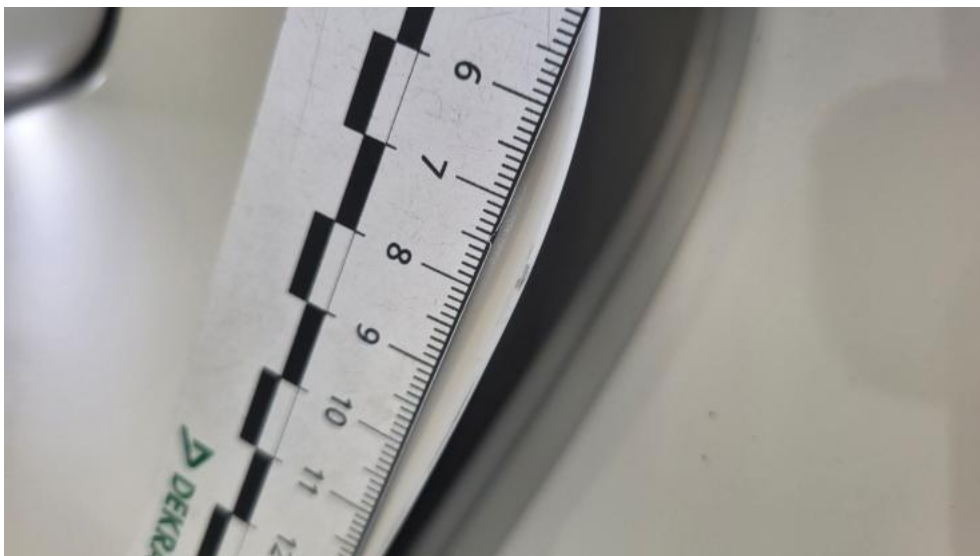
**Photo 72.**

Drzwi tylne L - Rysa/odprysk 1

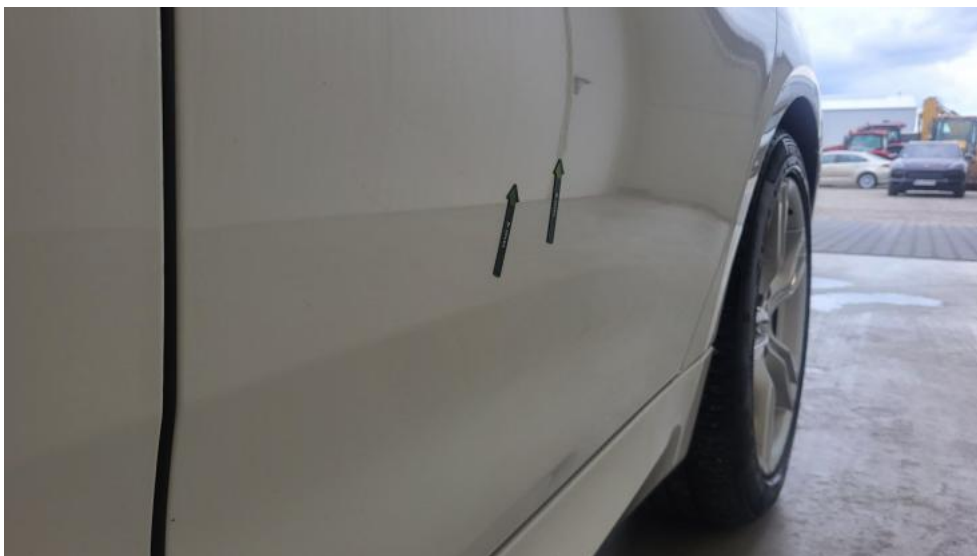
**Photo 73.**

Drzwi tylne L - Wgniecenie/odkształcenie 1

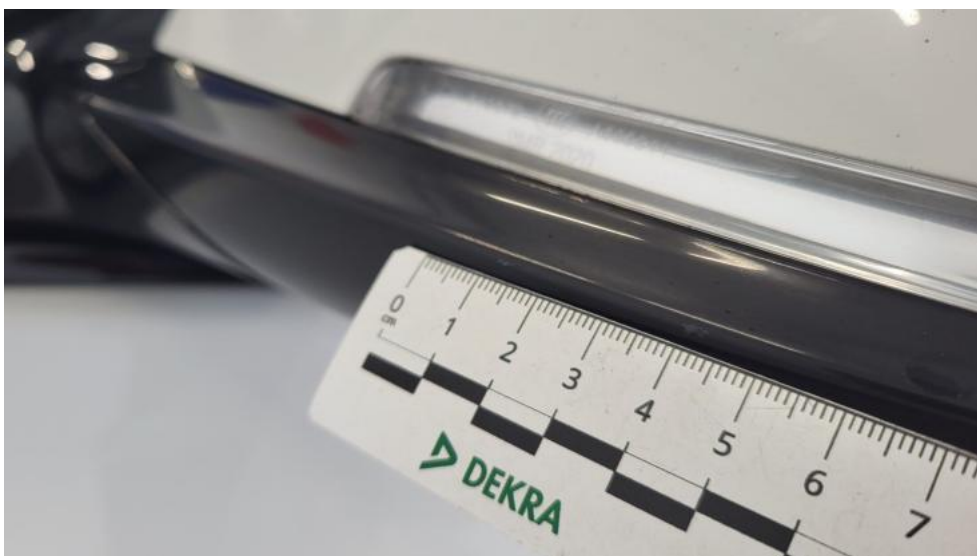
**Photo 74.**

Lusterko zew L - Rysa/odprysk 1

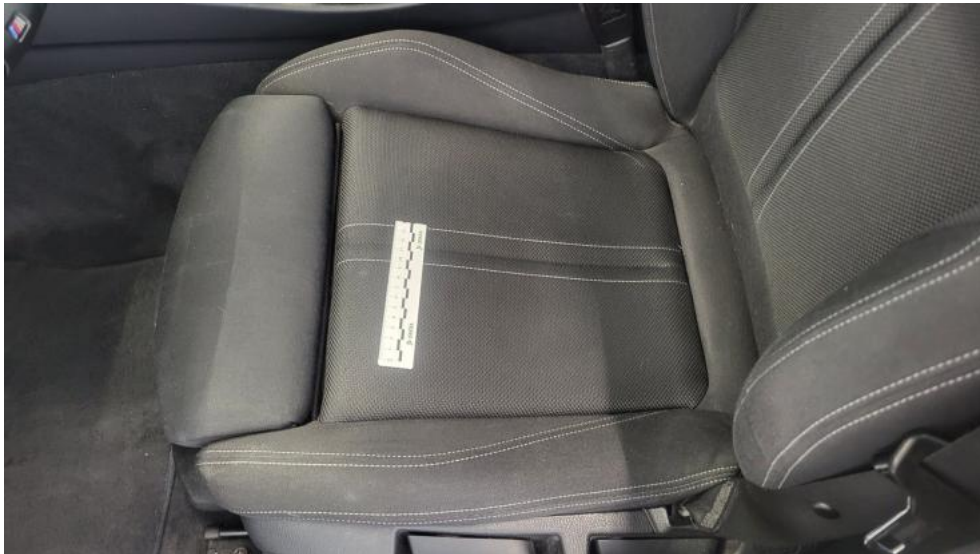
**Photo 77.**

Fotel prz. lew. - Inne 1

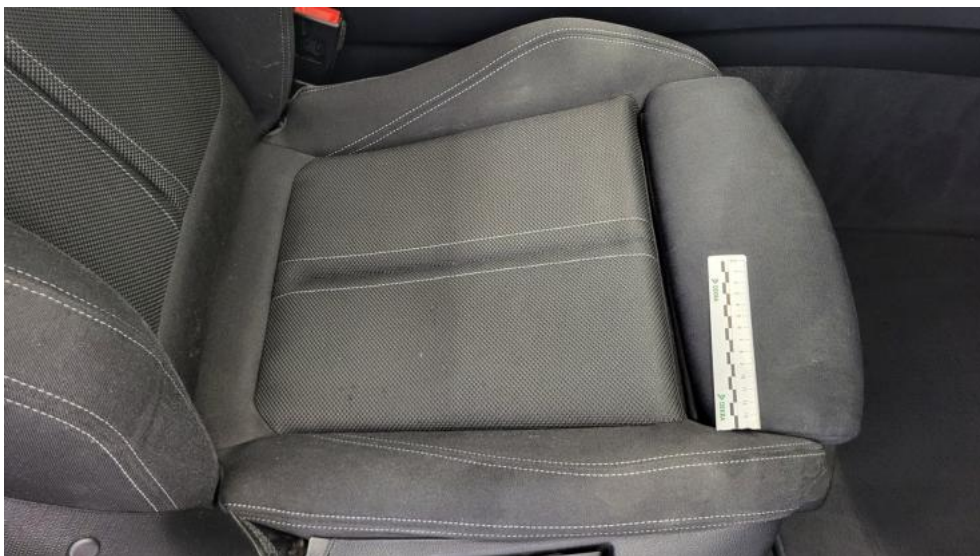
**Photo 78.**

Fotel prz. praw. - Inne 1

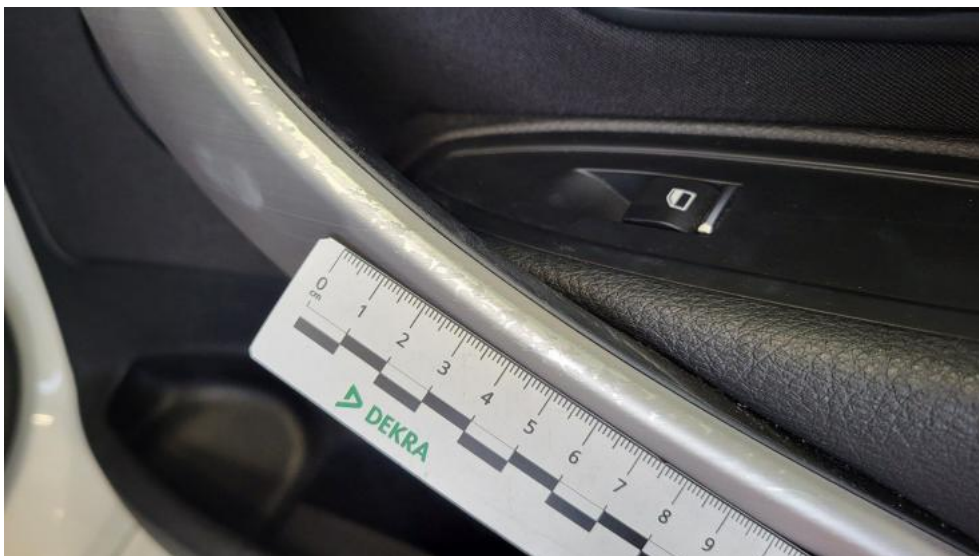
**Photo 82.**

Uchwyt drzwi prze P - Rysa/odprysk 1

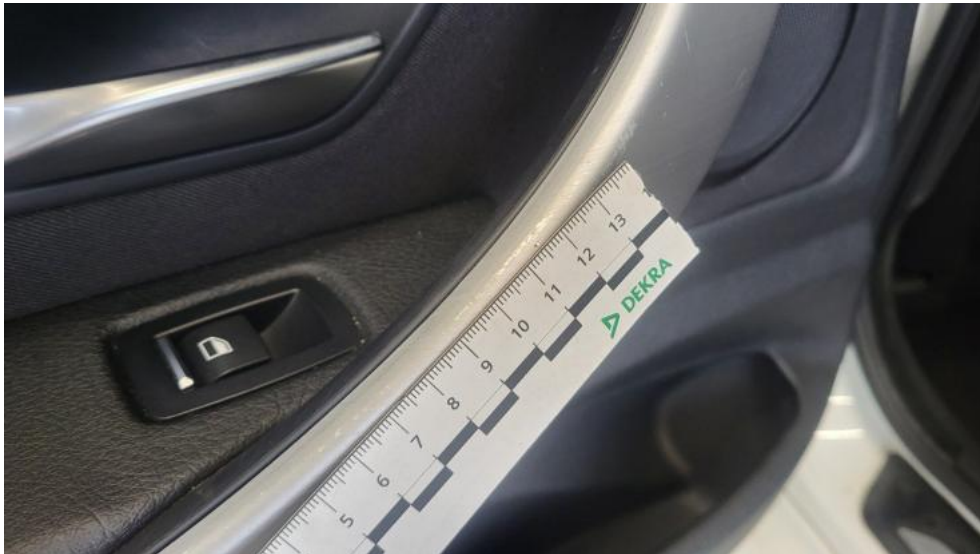
**Photo 83.**

Uchwyt drzwi tyl L - Rysa/odprysk 1

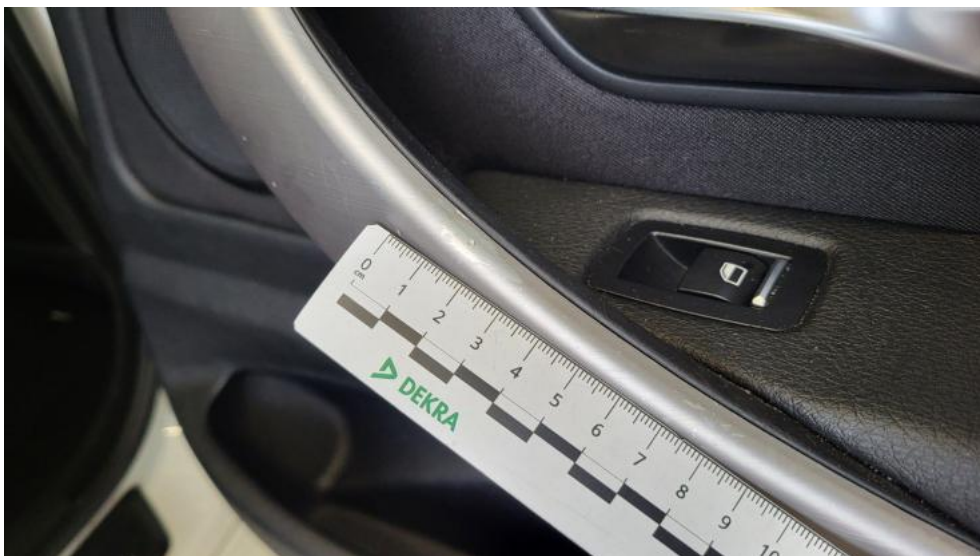
**Photo 84.**

Uchwyt drzwi tyl P - Rysa/odprysk 1

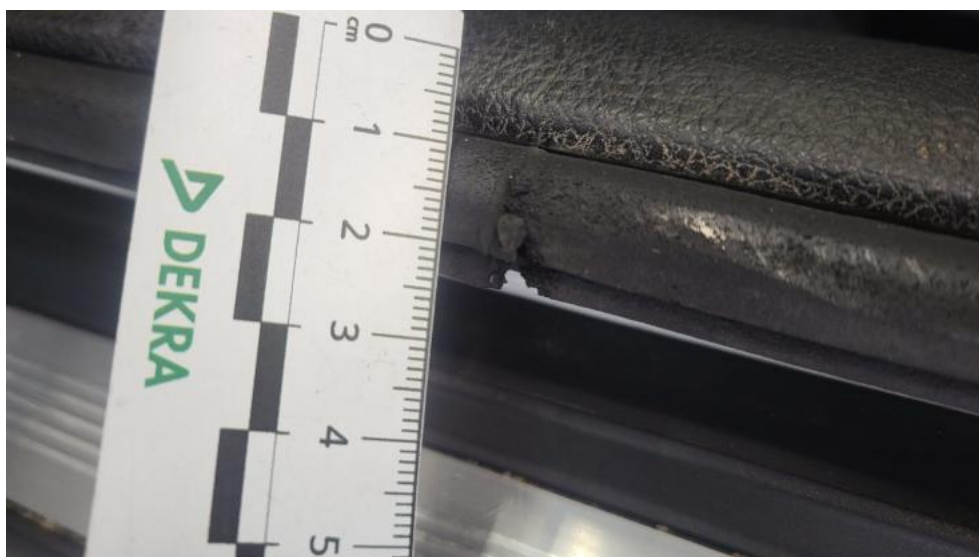
**Photo 85.**

Uszczelka drzwi przednich L - Pęknięcie/rozerwanie 1

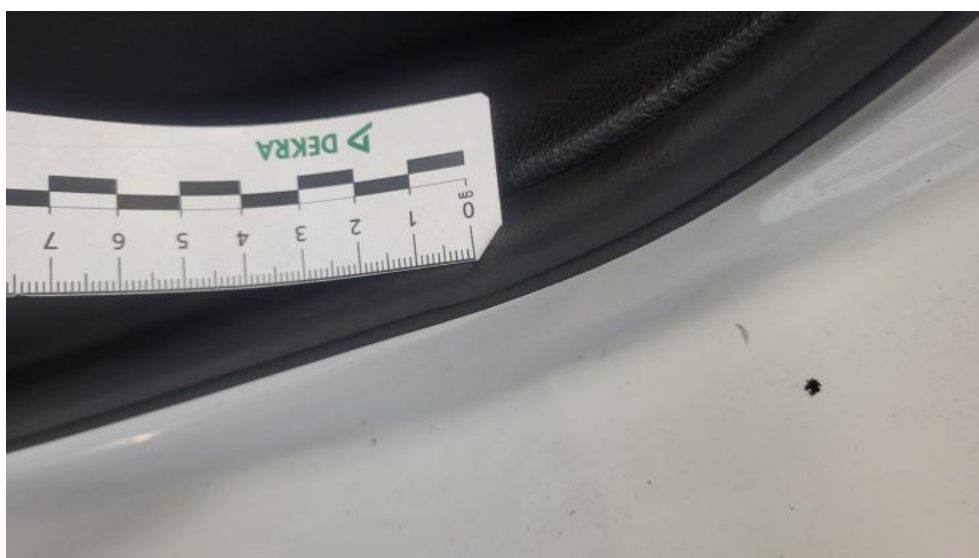
**Photo 86.**

Uszczelka drzwi tylnych L - Pęknięcie/rozerwanie 1

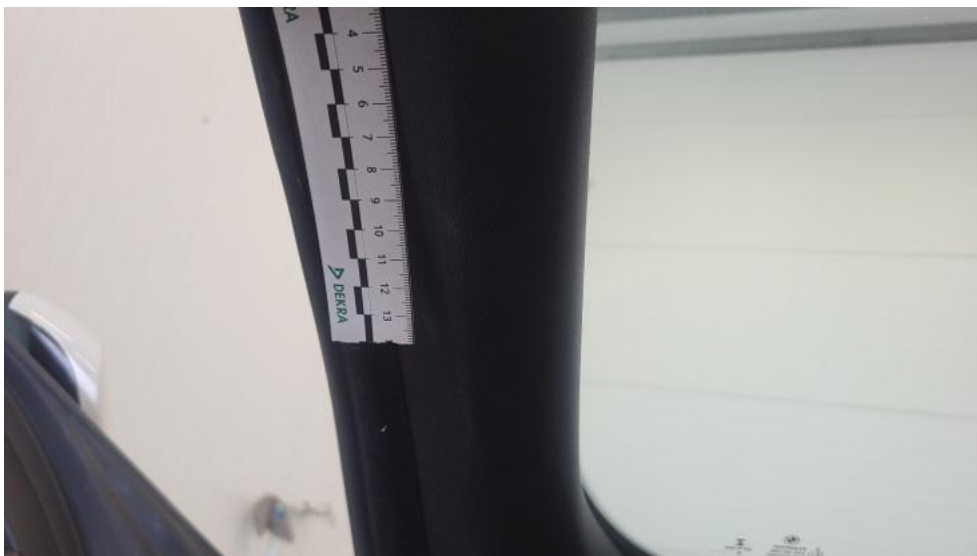
**Photo 87.**

Wykładzina(y) słupka przedniego L - Inne 1
