DEKRA's commission No. : PKOL(W)/LODZ/98915/26/10/22  
commission/ damage No. : 22/018650  
Date of commission: 22-10-2026

| Manufacturer | AUDI |
| Model | A6 Avant [C8] 18-23 |
| Registration /record No. | GD2E936 |

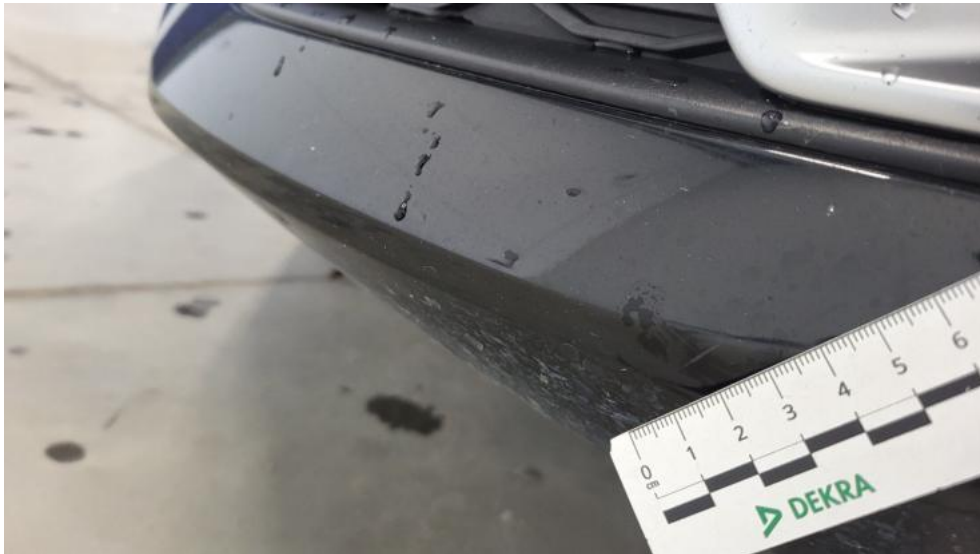
Zderzak - Rysa/odprysk 1

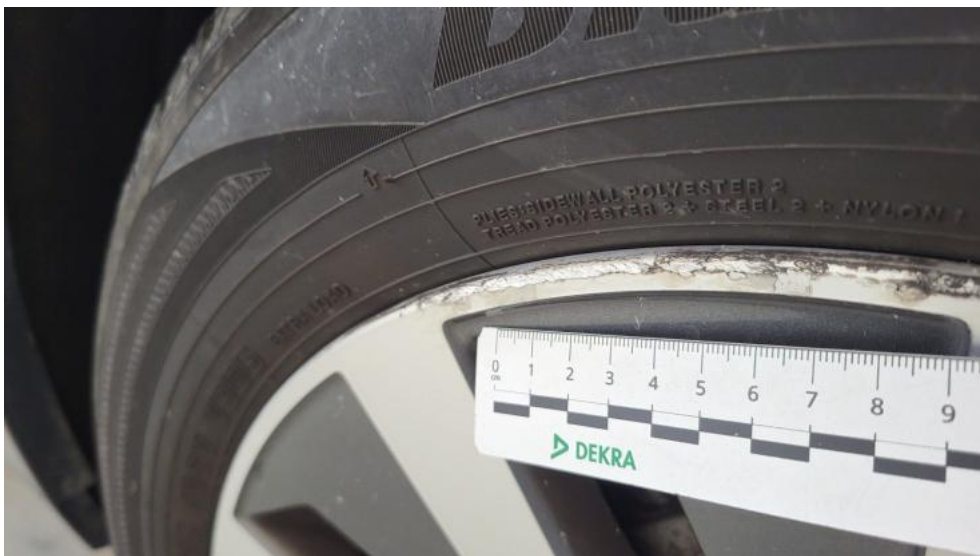
Felga aluminiowa przednia P - Rysa/odprysk 1

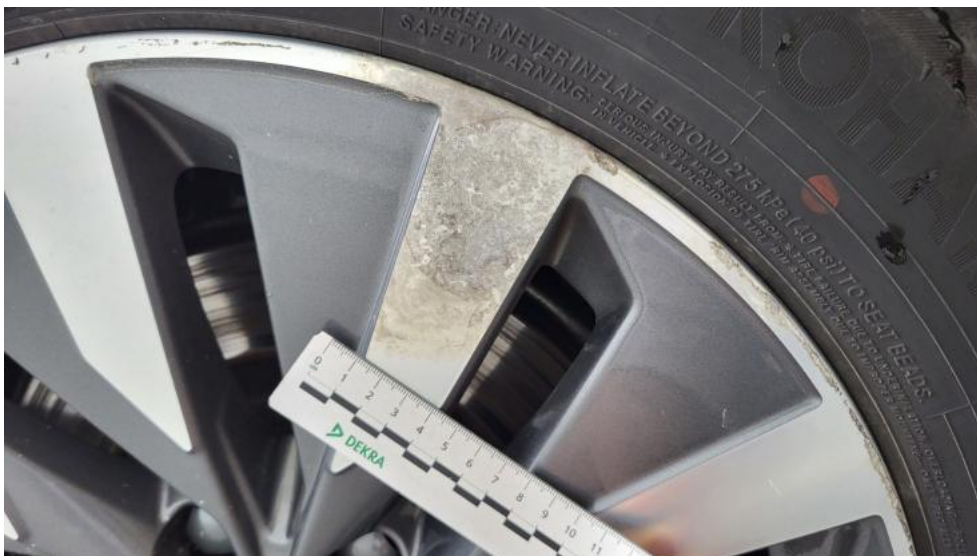
Felga aluminiowa tylna P - Rysa/odprysk 1

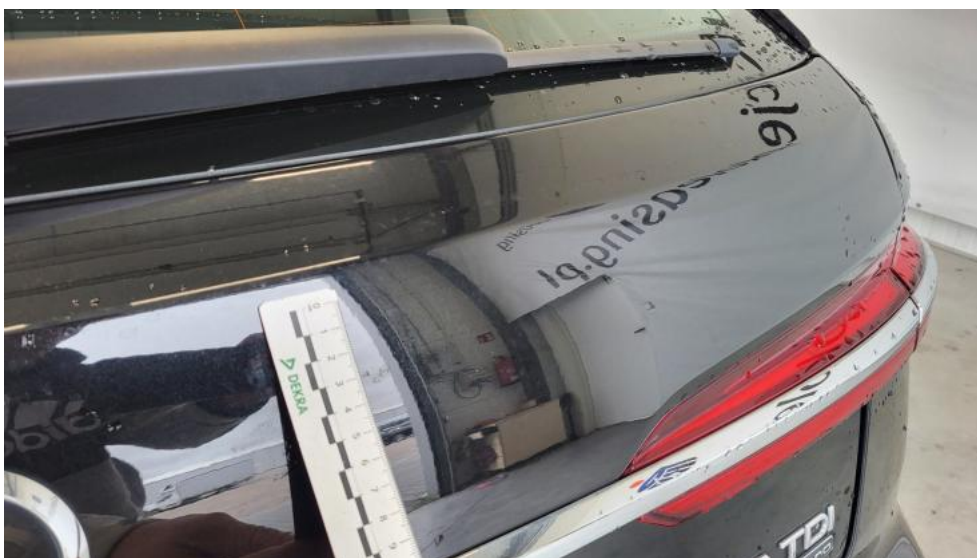
Pokrywy bagażnika - Wgniecenie/odkształcenie 1

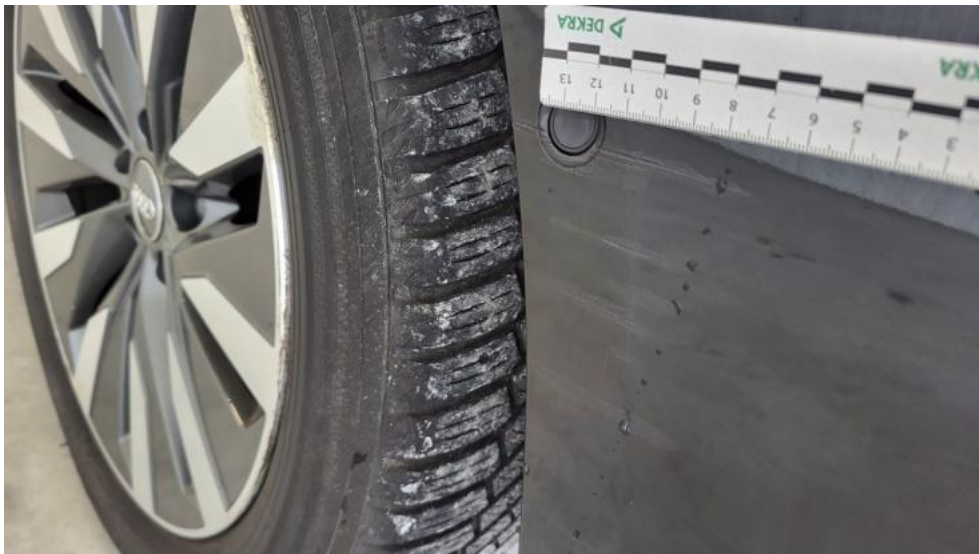
Zderzak tylny - Rysa/odprysk 1

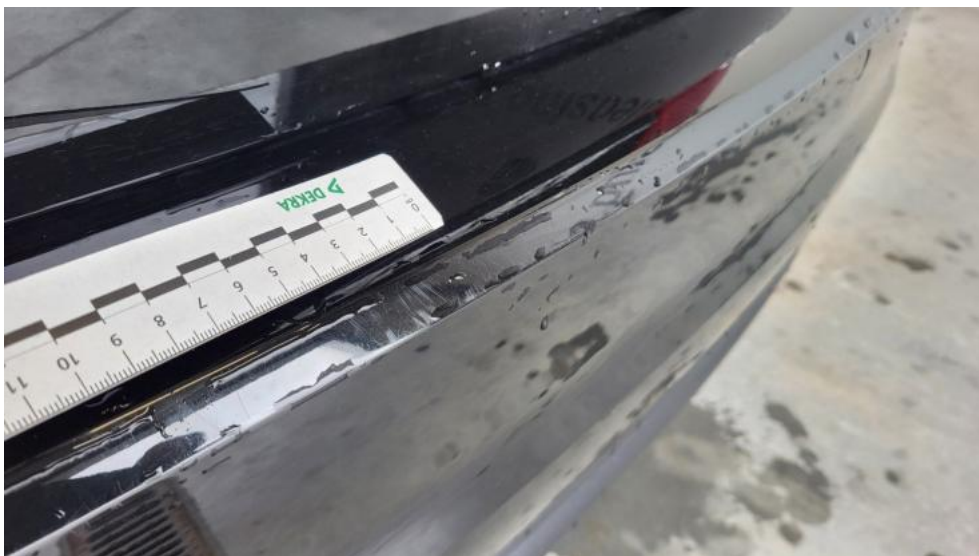
Zderzak tylny - Rysa/odprysk 2

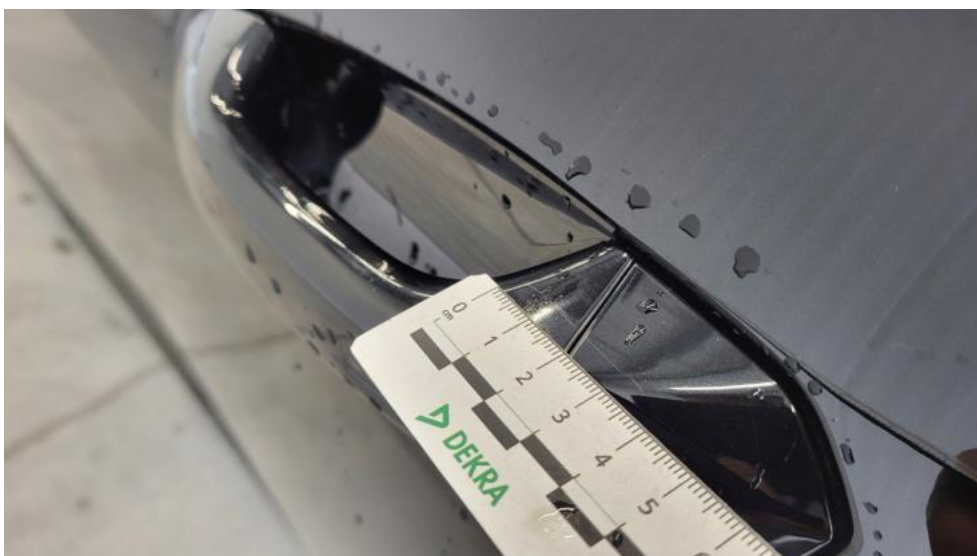
Klamka drzwi tyl L - Rysa/odprysk 1

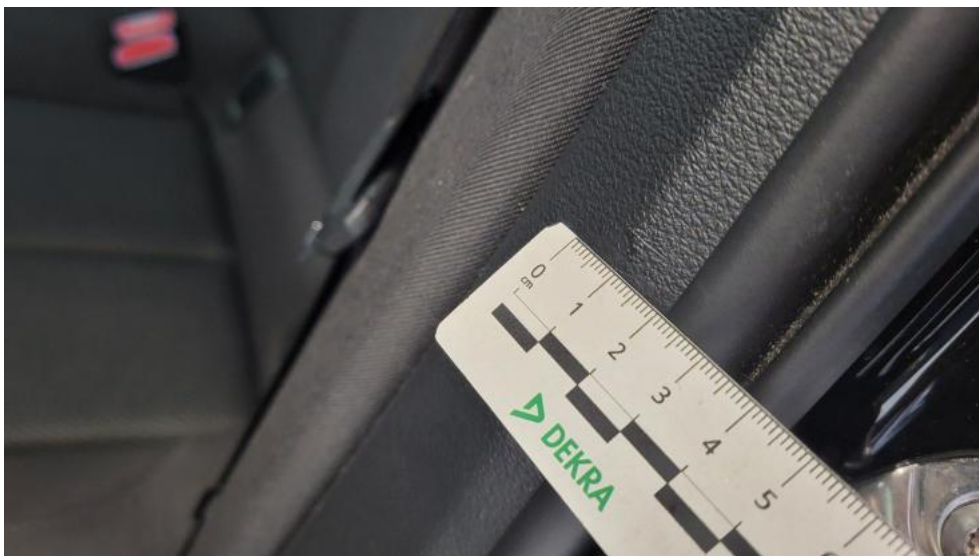
**Photo 68.**  
Wykładzina(y) słupka tylnego L - Rysa/odprysk 1
