DEKRA's commission No. : PKOL(W)/LODZ/79172/25/10/15  
commission/ damage No. : 22/031457  
Date of commission: 15-10-2025

| Manufacturer | VOLVO |
| Model | V40 Cross Country 16-19 |
| Registration /record No. | WZ584FN |

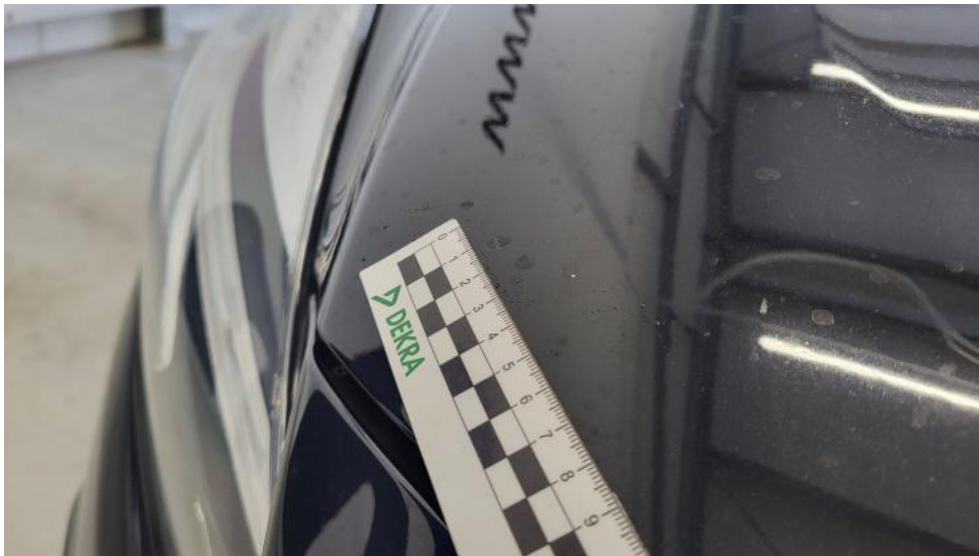
**Photo 39.**

Pokrywa komory silnika - Rysa/odprysk 1

Samochód wymaga polerowania oraz miejscowych uzupełnień lakieru.

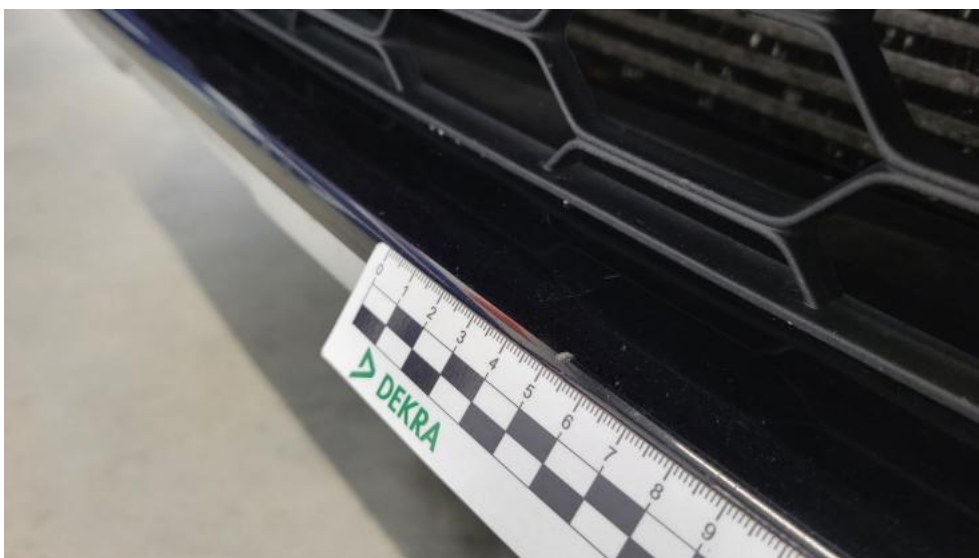
**Photo 40.**

Spoiler zderzaka przedniego - Rysa/odprysk 1

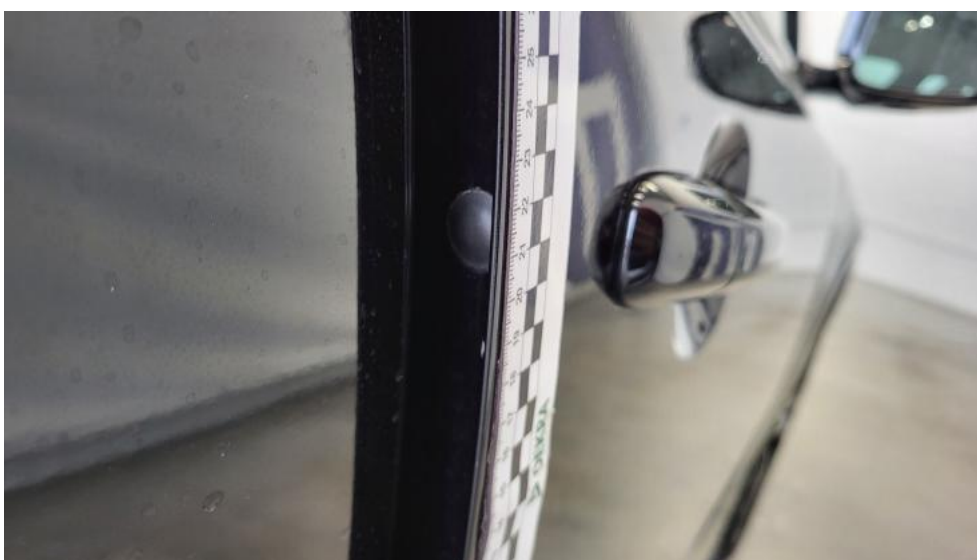
**Photo 42.**

Drzwi przednie P - Rysa/odprysk 1

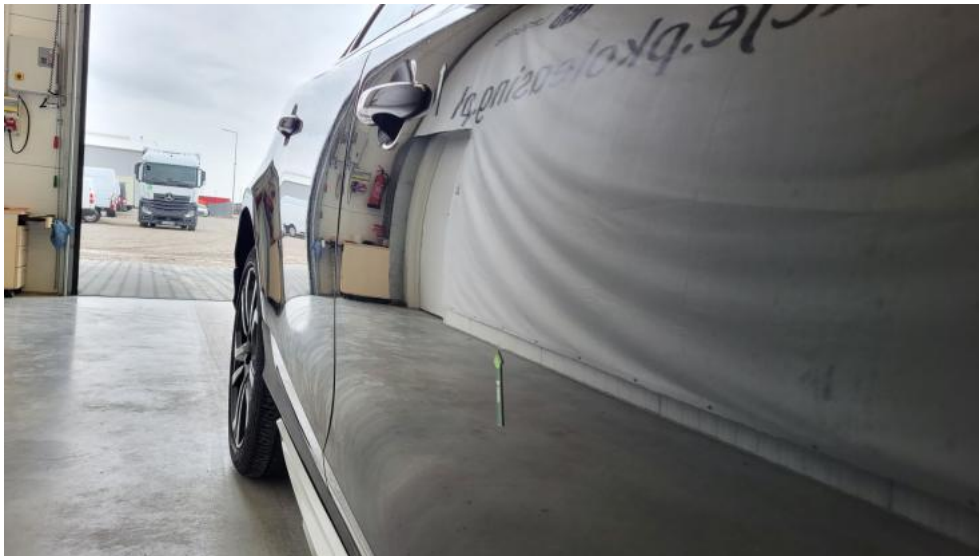
**Photo 43.**

Drzwi przednie P - Wgniecenie/odkształcenie 1

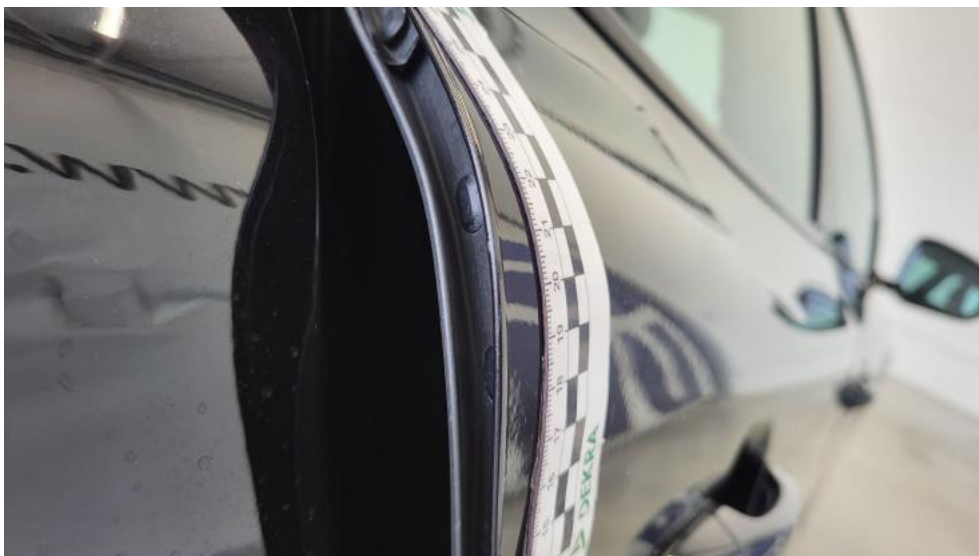
**Photo 44.**

Drzwi tylne P - Rysa/odprysk 1

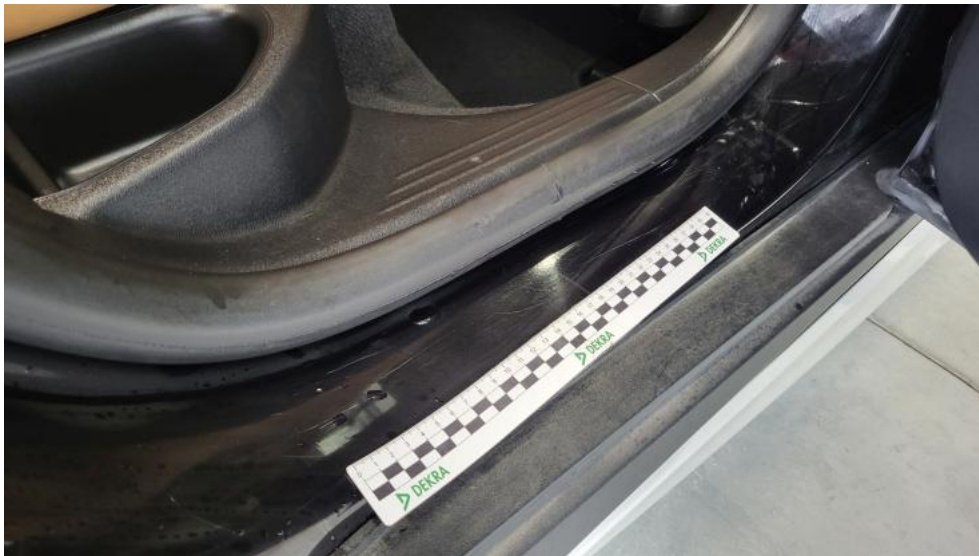
**Photo 45.**

Próg P - Rysa/odprysk 1

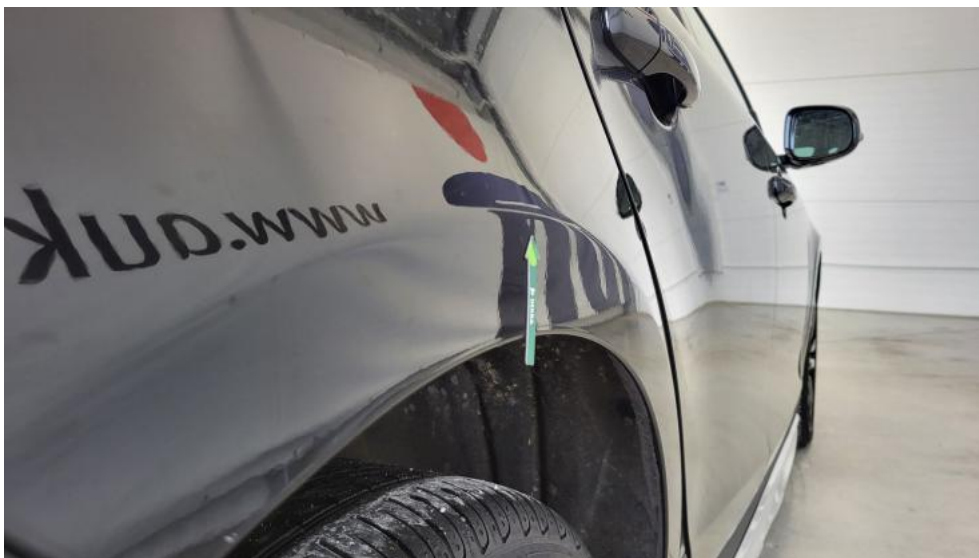
**Photo 46.**

| No. of controlled item | Controlled item | Measured range of thickness of the lacquer coat [ $\mu\text{m}$ ] |
|---|---|---|
| 11 | Right rear fender | 150 - 200 |

Ścianka tylna P / Ścianka boczna P - Wgniecenie/odkształcenie 1

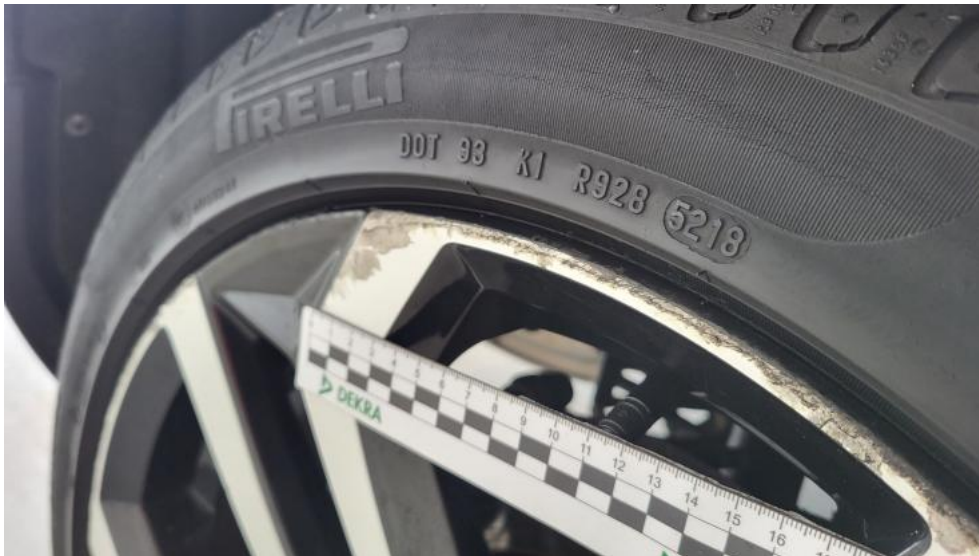
**Photo 47.**

Felga aluminiowa tylna P - Rysa/odprysk 1

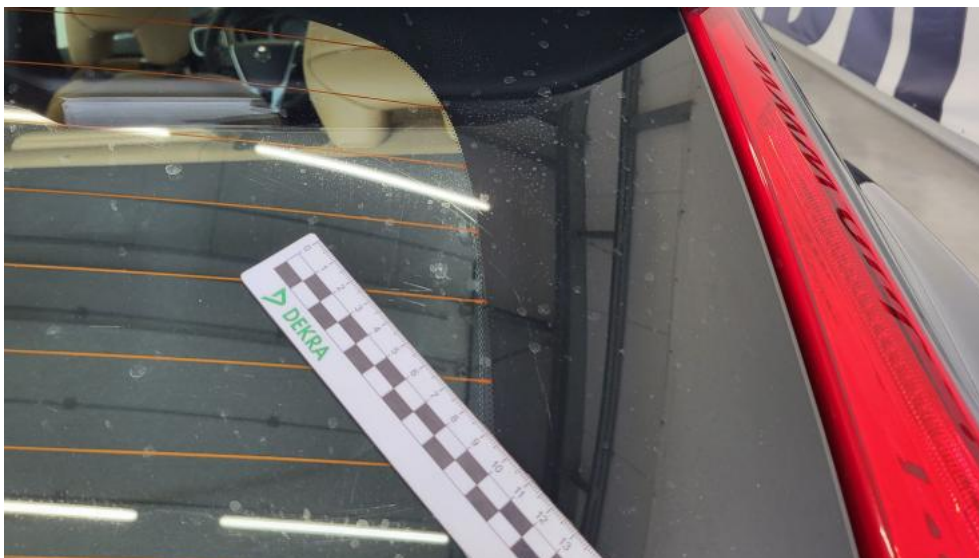
**Photo 48.**

Szyba tylna - Rysa/odprysk 1

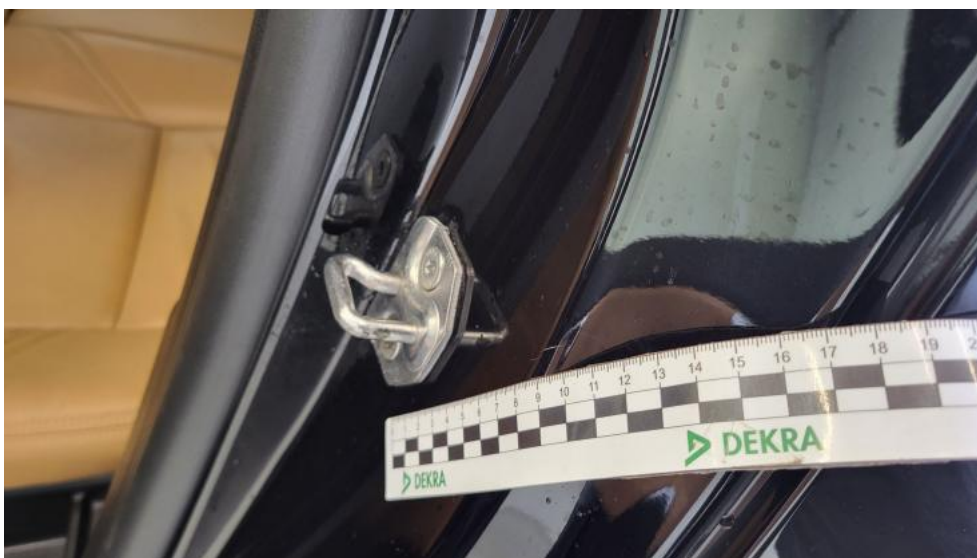
**Photo 52.**

Łotnik tylny L / Ściana boczna L - Rysa/odprysk 1

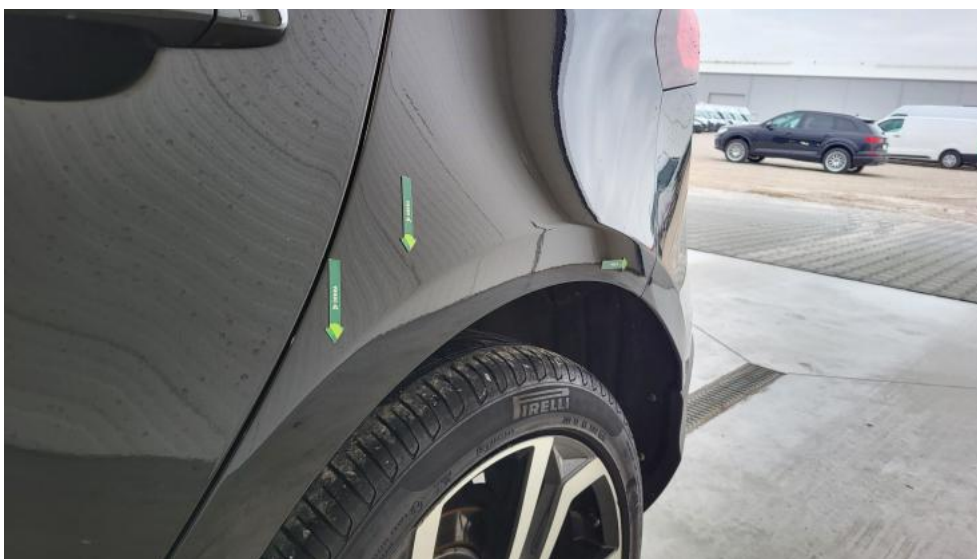
**Photo 53.**

Błotnik tylny L / Ściana boczna L - Wgniecenie/odkształcenie 1

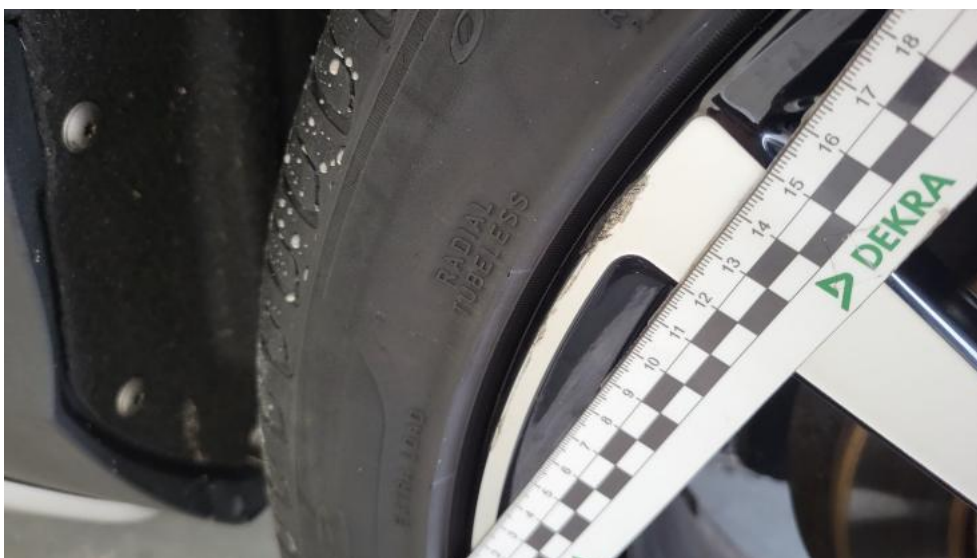
**Photo 54.**

Felga aluminiowa tylna L - Rysa/odprysk 1

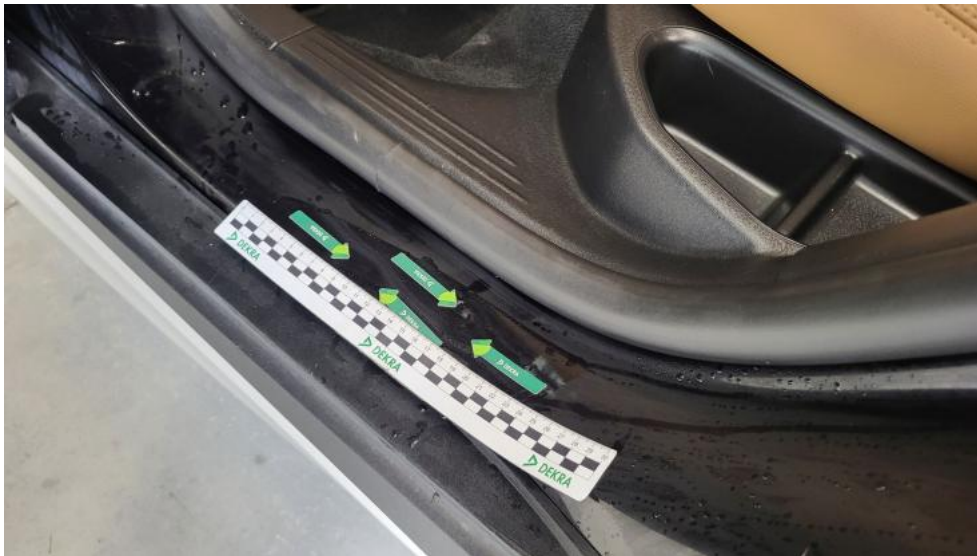
**Photo 59.**

Próg L - Wgniecenie/odkształcenie 1

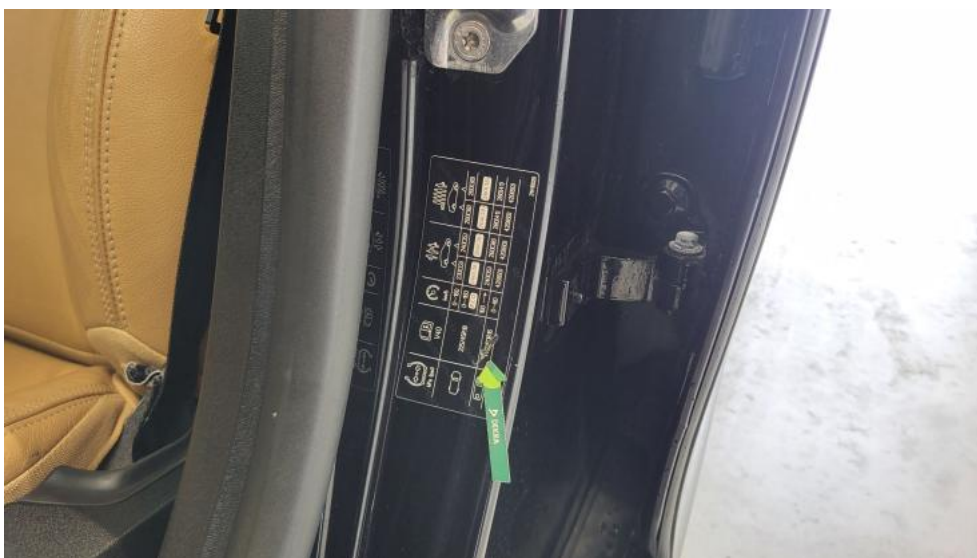
**Photo 60.**

Słupek środkowy L - Wgniecenie/odkształcenie 1

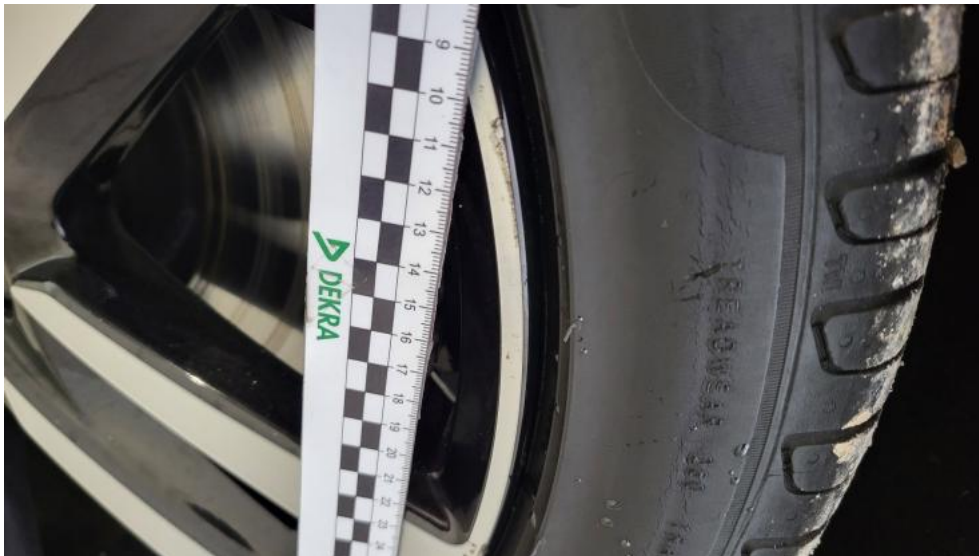
**Photo 61.**

Felga Aluminiowa przednia L - Rysa/odprysk 1

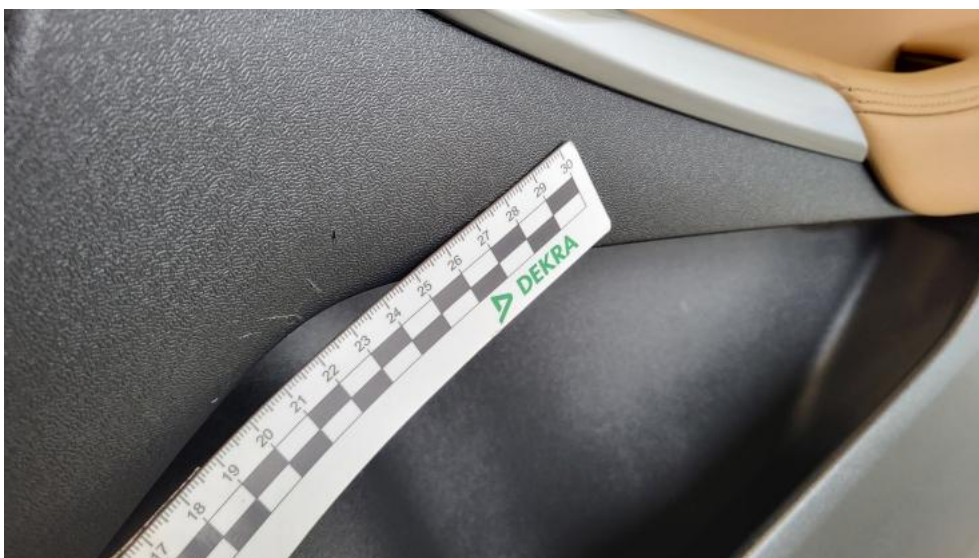
**Photo 62.**

Tapicerka drzwi przednich P - Rysa/odprysk 1

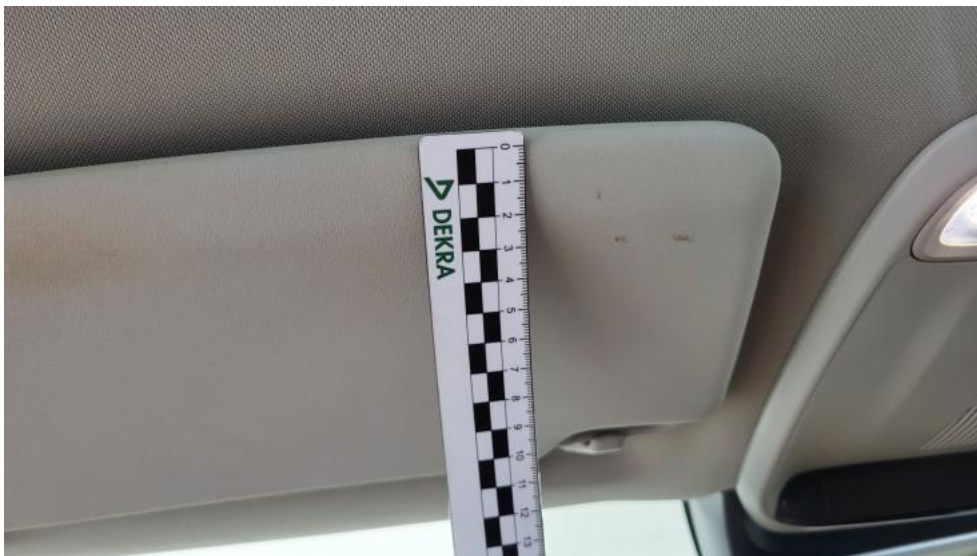
**Photo 63.**

Osłona p/słoneczna lewa - Inne 1

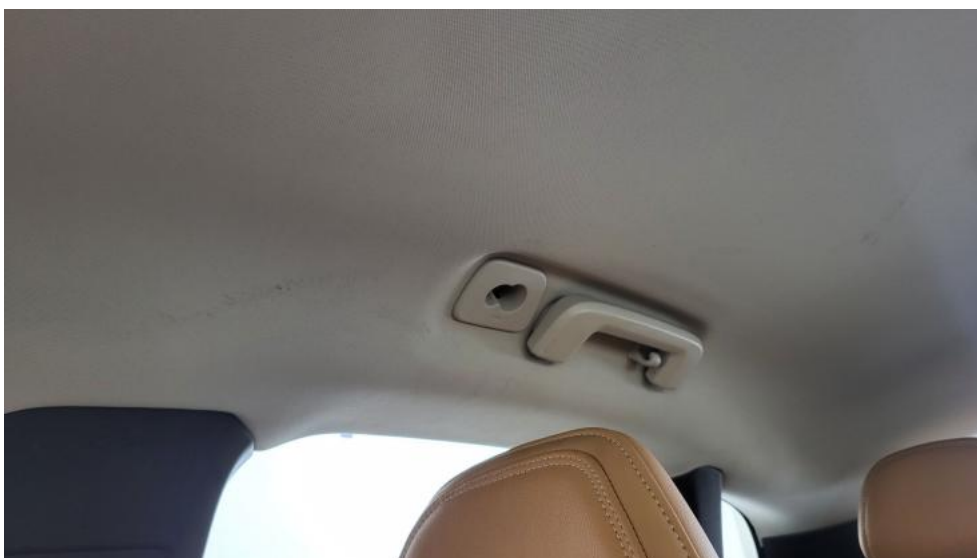
**Photo 64.**

Podsufitka - Inne 1
