DEKRA's commission No. : PKOL(W)/LODZ/92961/25/11/28  
commission/ damage No. : 20/052783  
Date of commission: 28-11-2025

**DEKRA Poland - Headquarters**  
02-673 Warszawa, ul. Konstruktorska 12A

| Manufacturer | FORD |
| Model | Focus Kombi 18-21 |

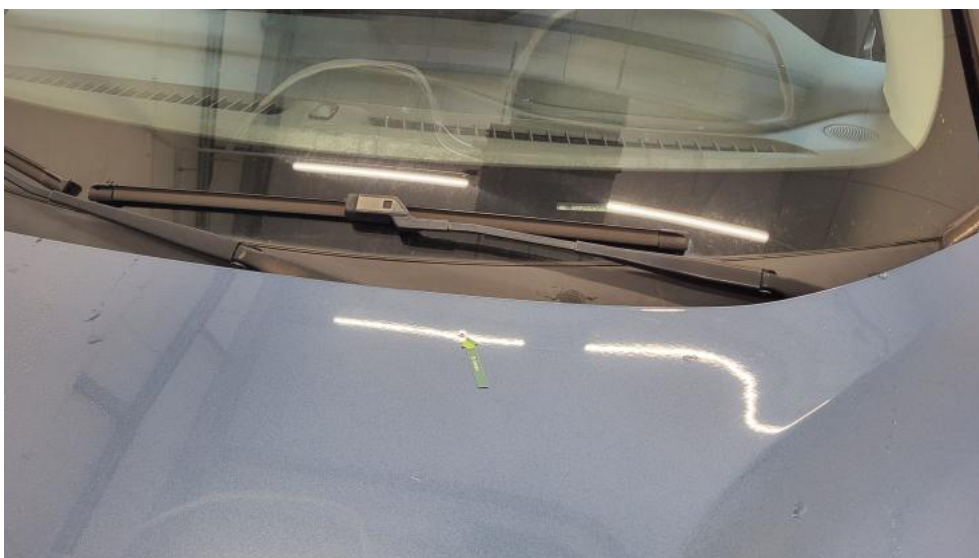
Pokrywa komory silnika - Wgniecenie/odkształcenie 1

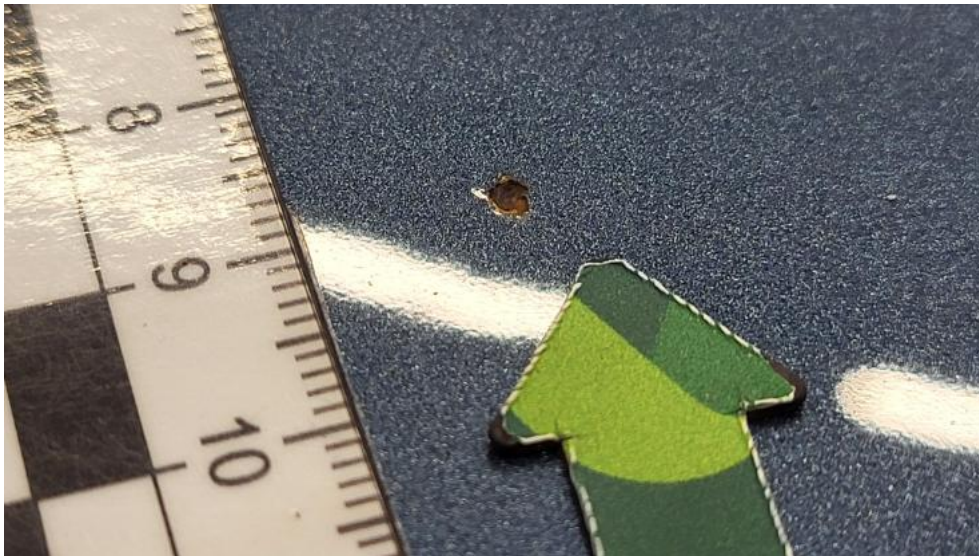
Pokrywa komory silnika - Inne 1

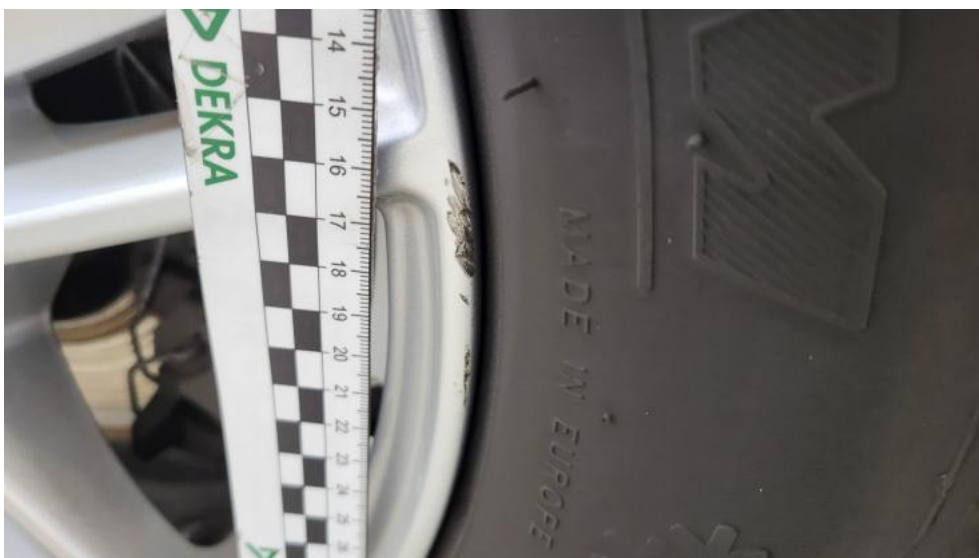
Felga aluminiowa przednia P - Rysa/odprysk 1

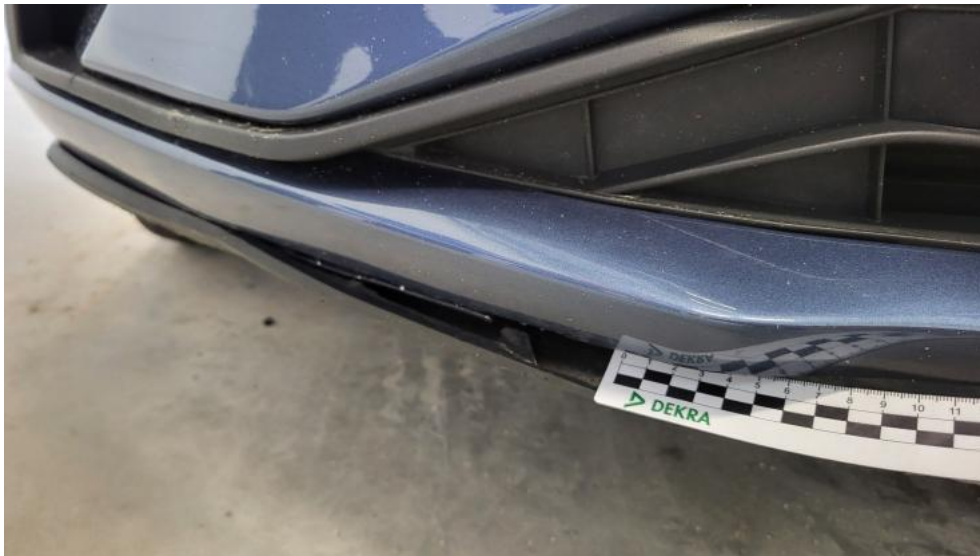
Listwa zderzaka prz P - Inne 1

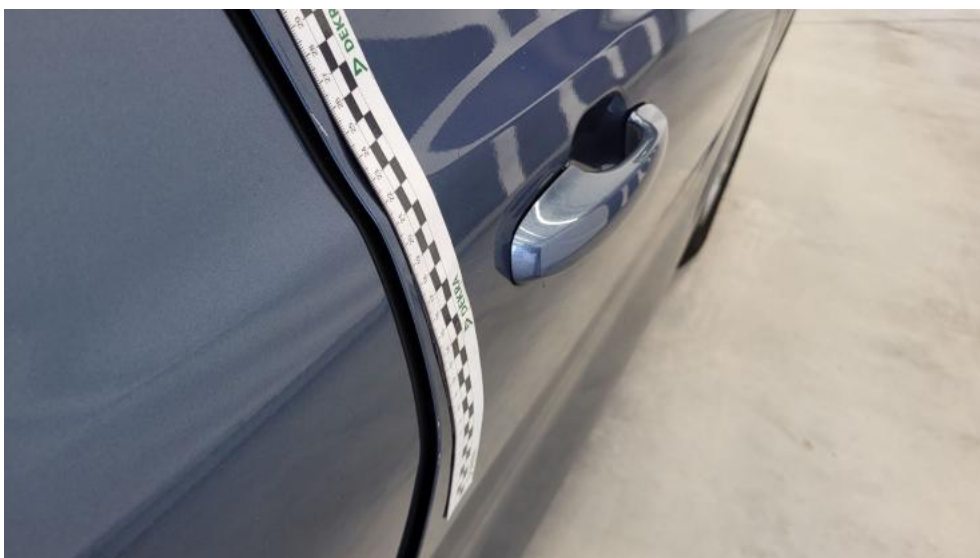
Drzwi przednie P - Rysa/odprysk 1

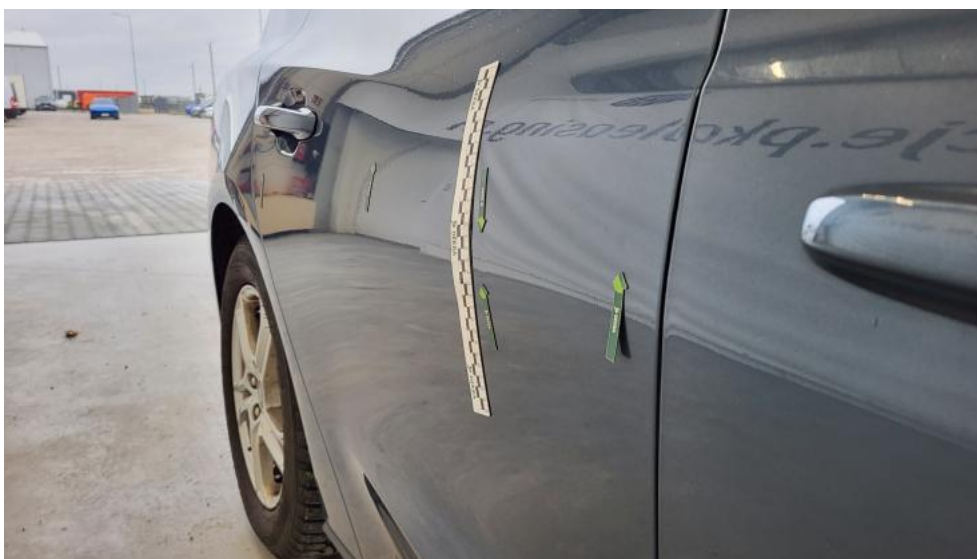
Drzwi tylne P - Wgniecenie/odkształcenie 1

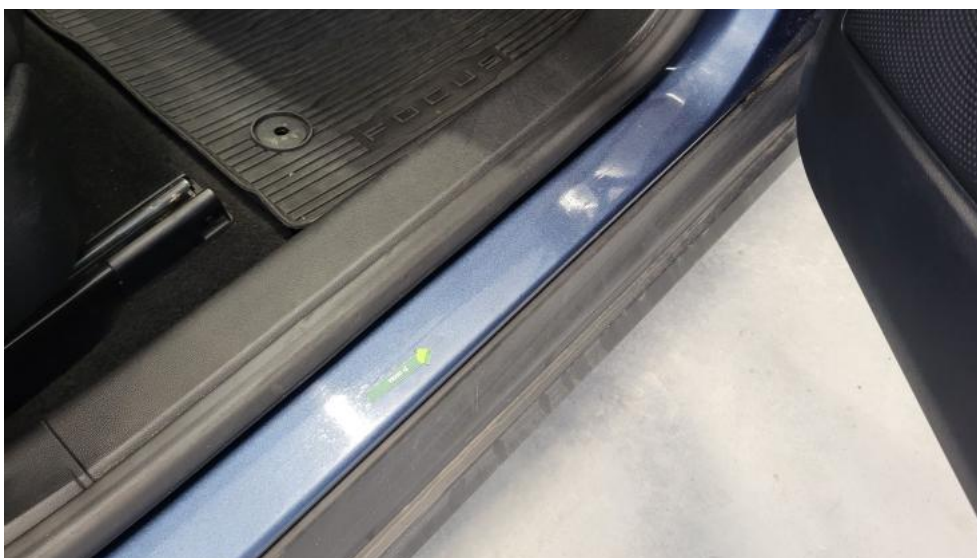
Próg P - Wgniecenie/odkształcenie 1

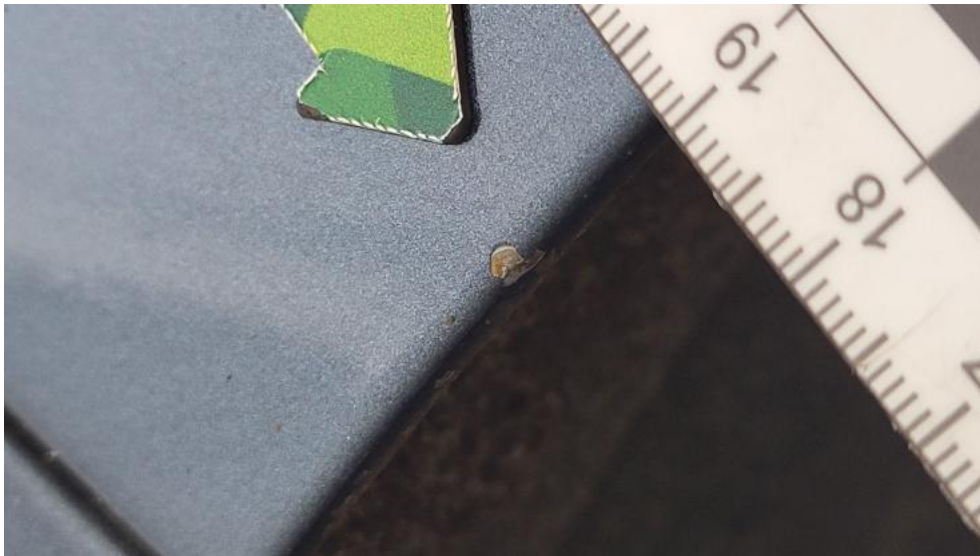
Błotnik tylny P / Ściana boczna P - Inne 1

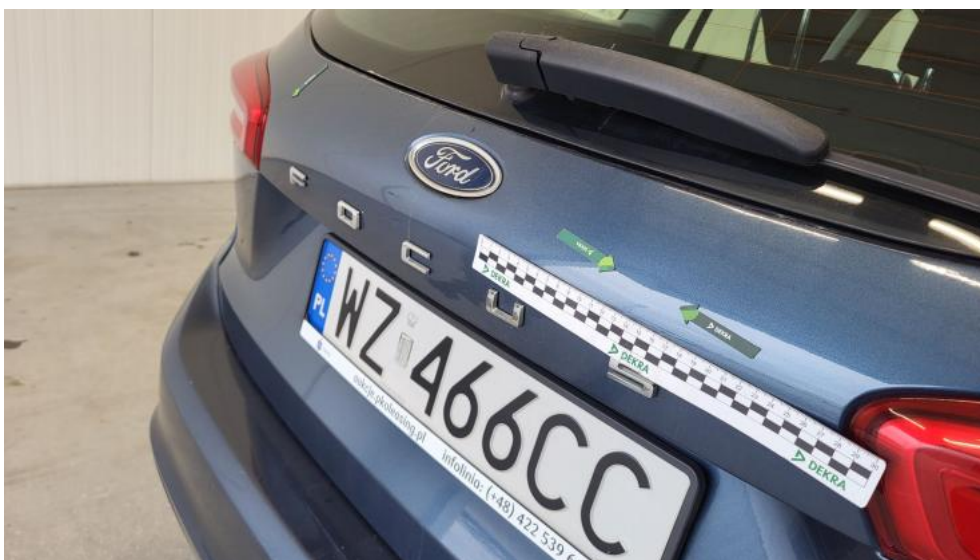
Pokrywy bagażnika - Wgniecenie/odkształcenie 1

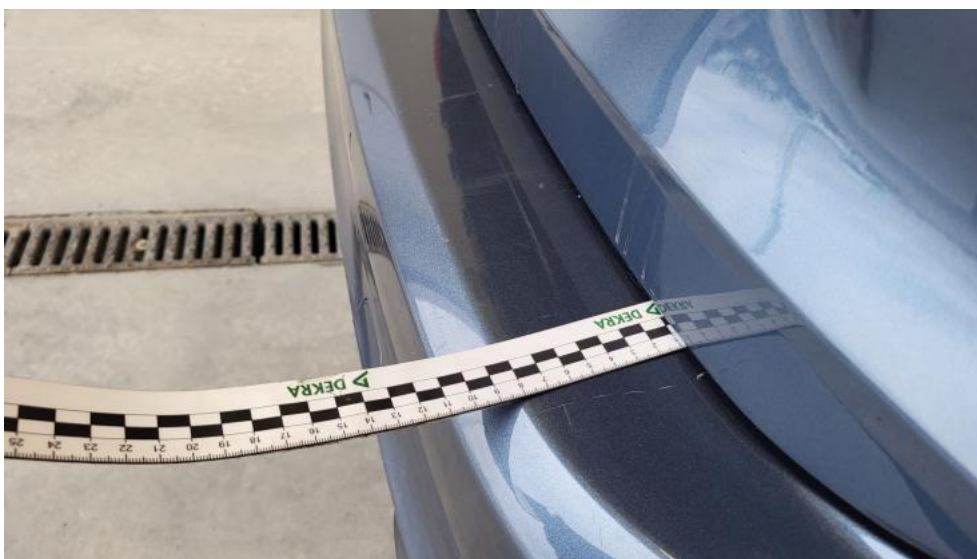
Zderzak tylny - Rysa/odprysk 1

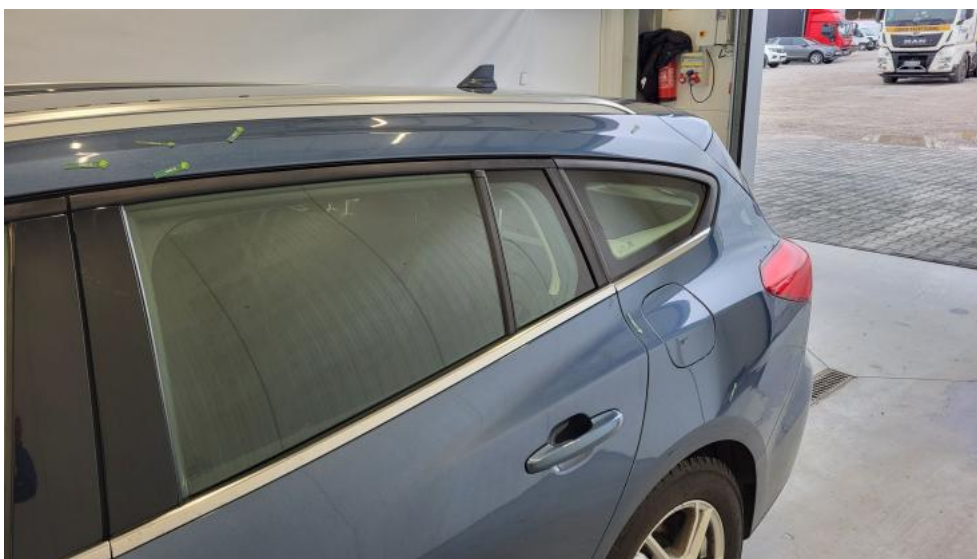
Błotnik tylny L / Ściana boczna L - Wgniecenie/odkształcenie 1

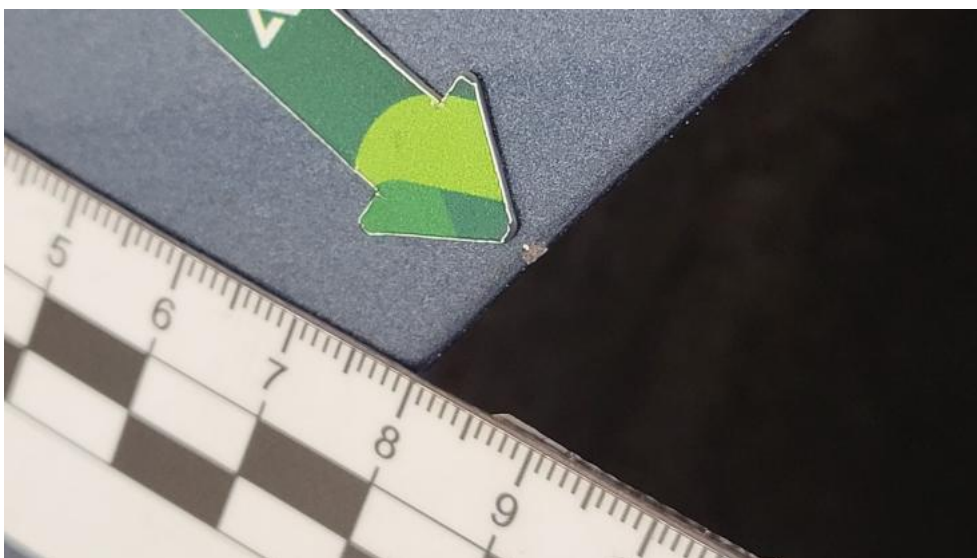
Błotnik tylny L / Ściana boczna L - Inne 1

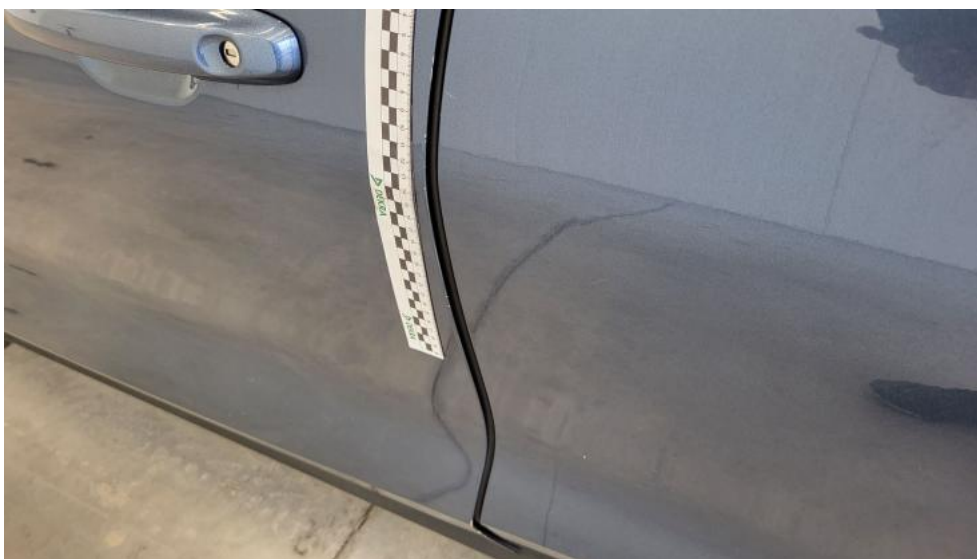
Drzwi przed L - Rysa/odprysk 1

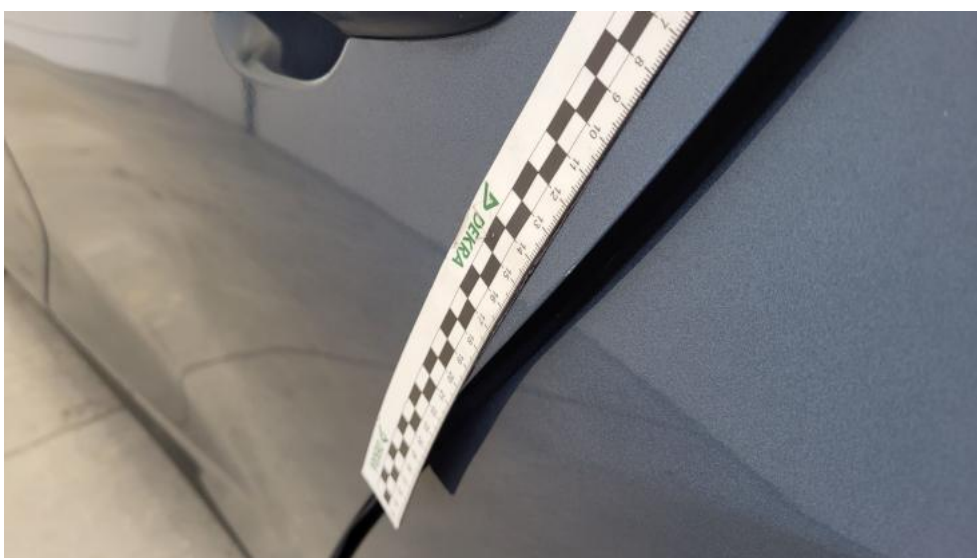
Drzwi tylne L - Rysa/odprysk 1

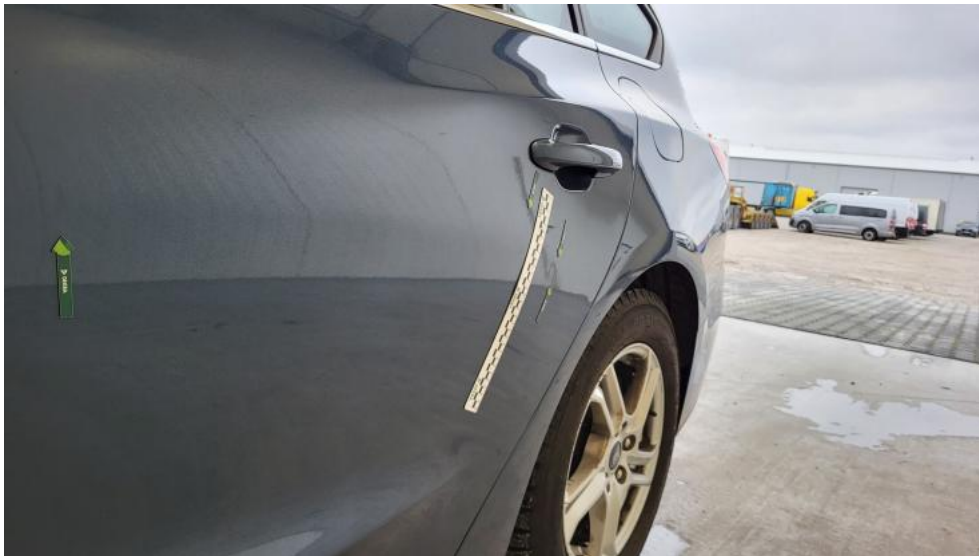
Drzwi tylne L - Wgniecenie/odkształcenie 1

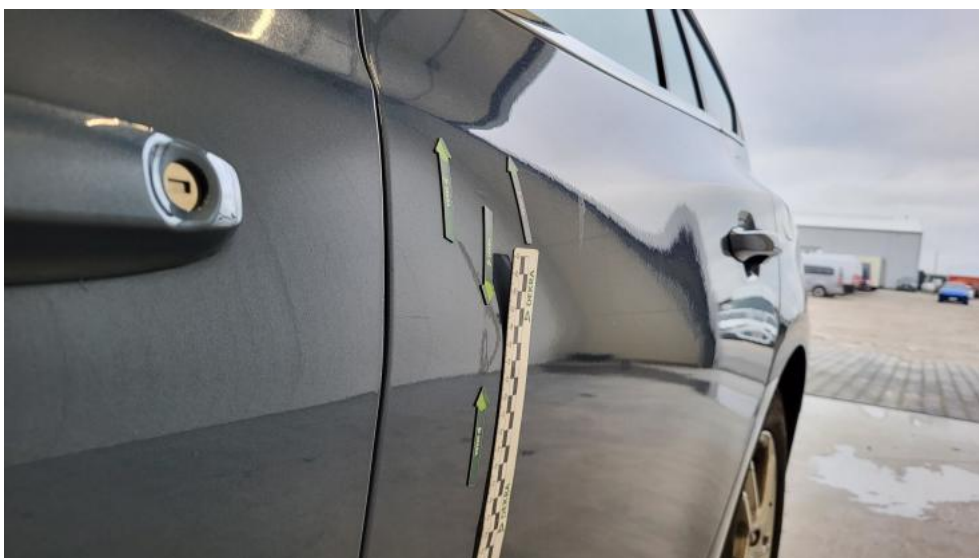
Drzwi tylne L - Wgniecenie/odkształcenie 2

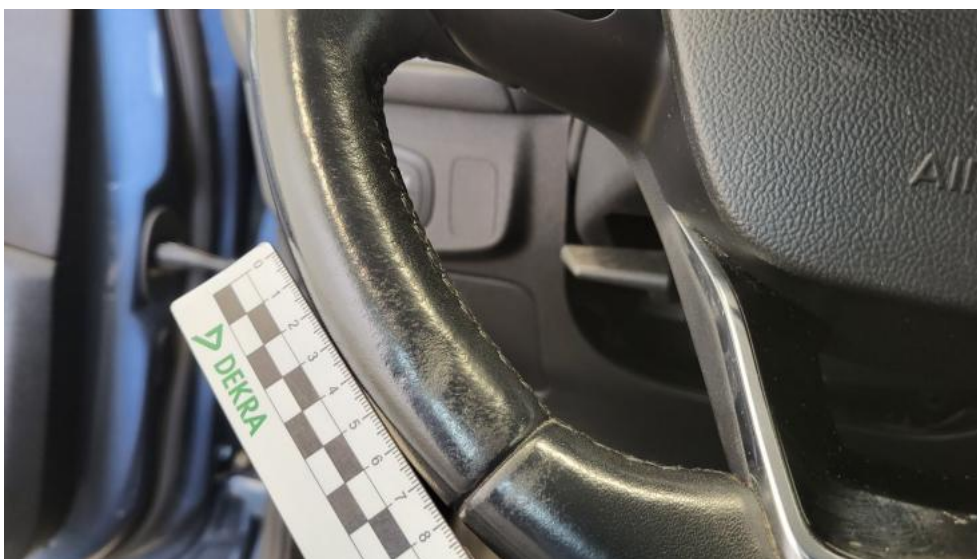
Koło kierownicy - Inne 1

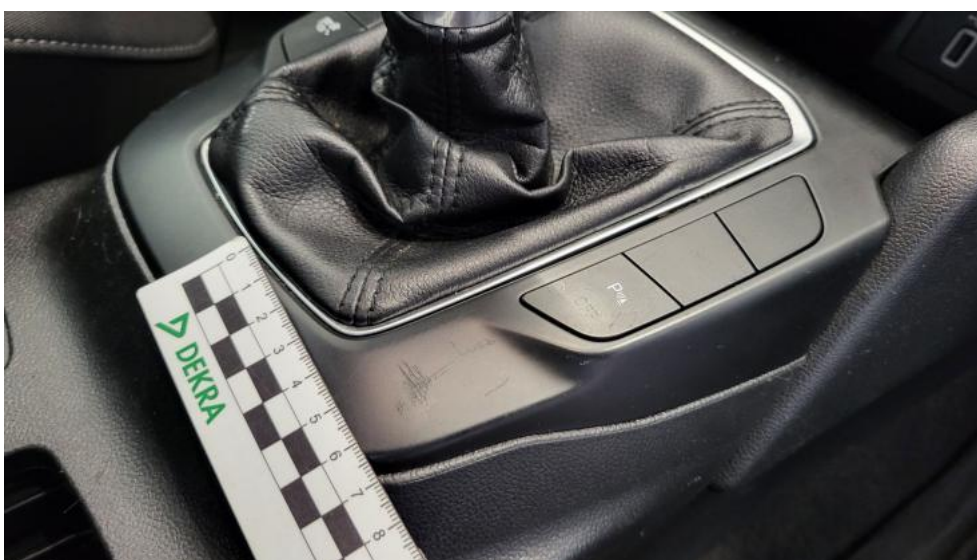
Konsola tunelu śr. - Rysa/odprysk 1

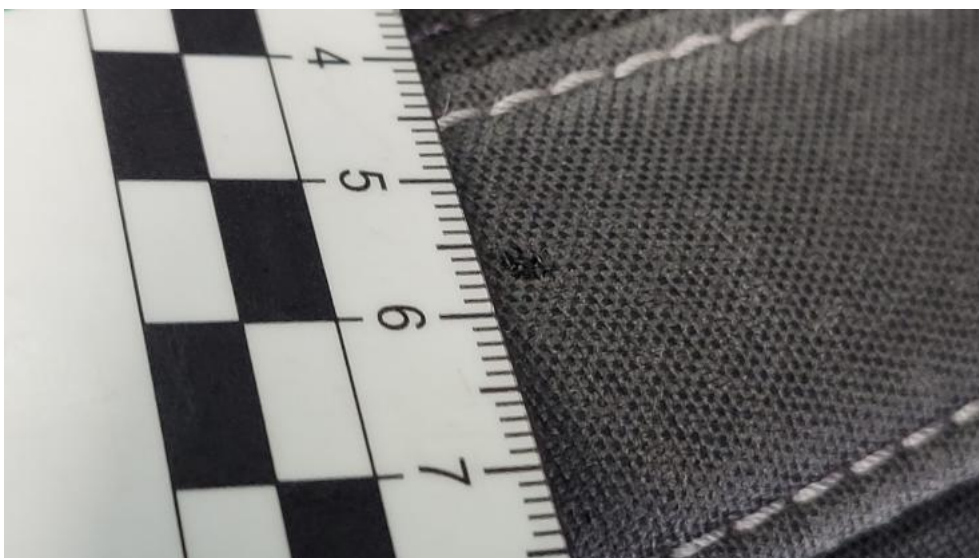
Fotel prz. lew. - Inne 1

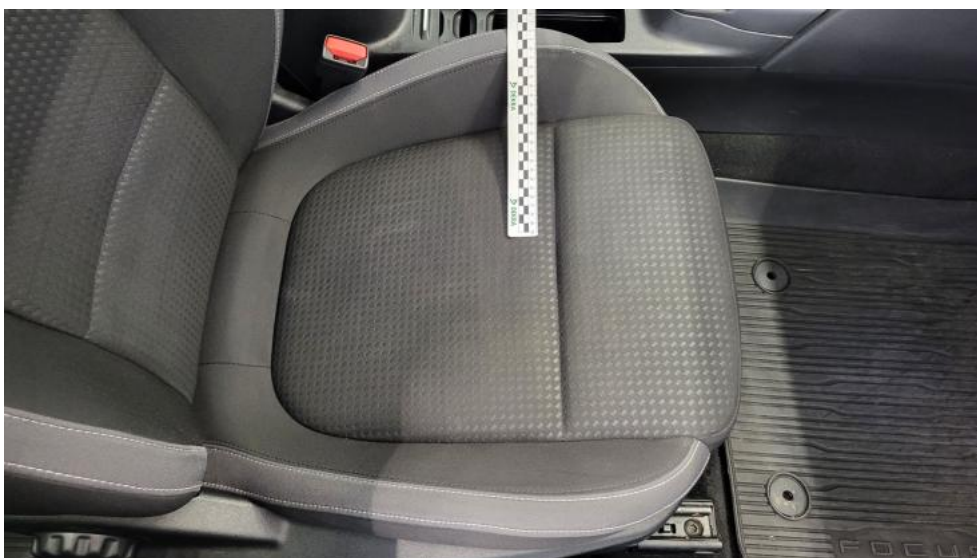
Fotel prz. praw. - Inne 1

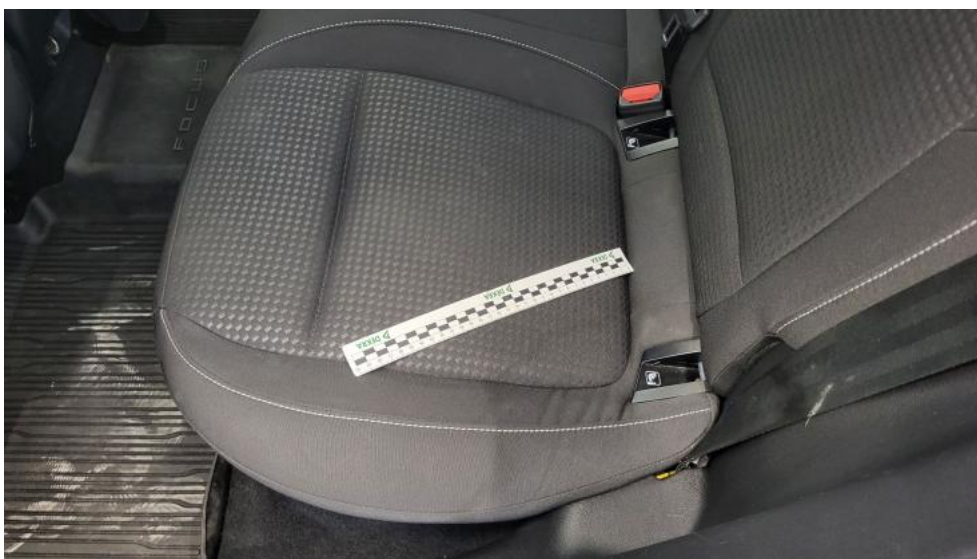
**Photo 63.**  
Kanapa tyl. - Inne 1

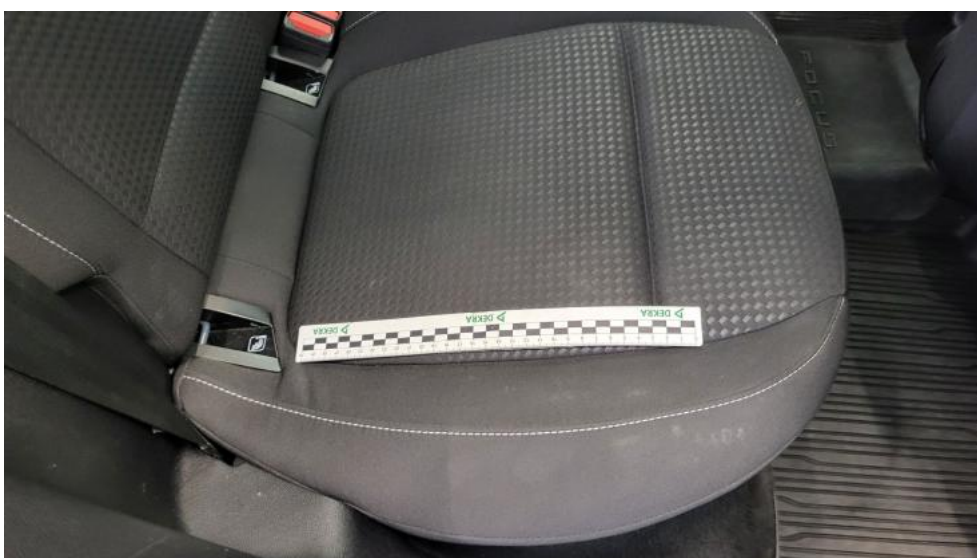
**Photo 64.**  
Kanapa tyl. - Inne 2

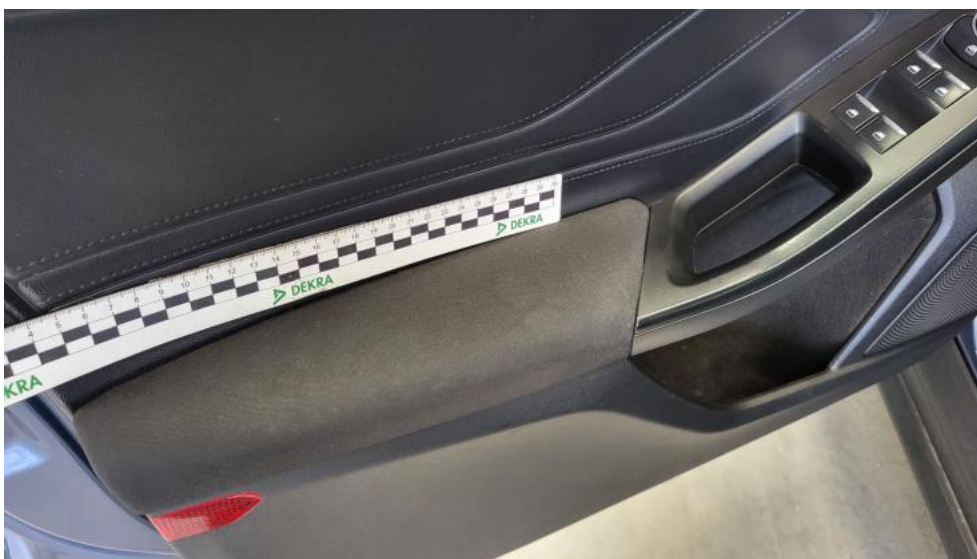
Tapicerka drzwi przednich L - Inne 1

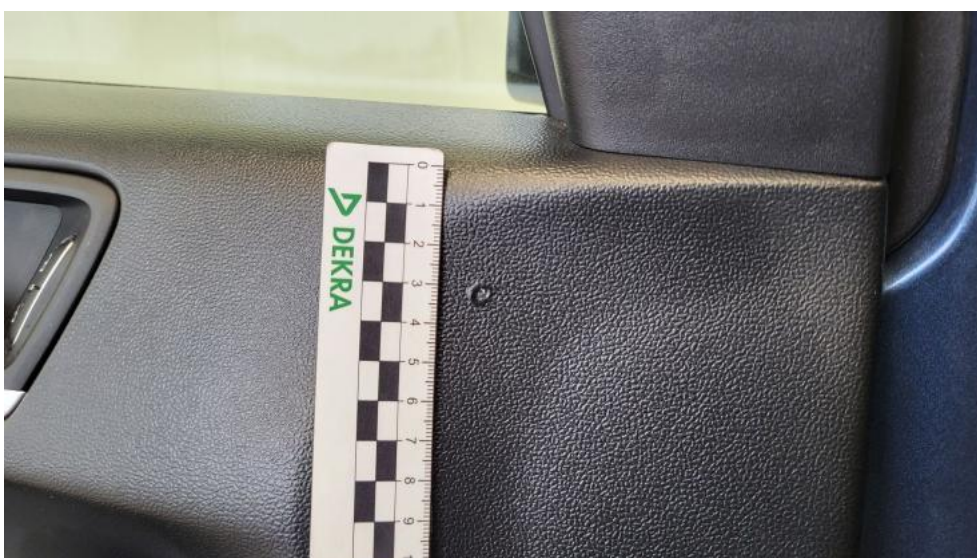
Tapicerka drzwi przednich L - Inne 2

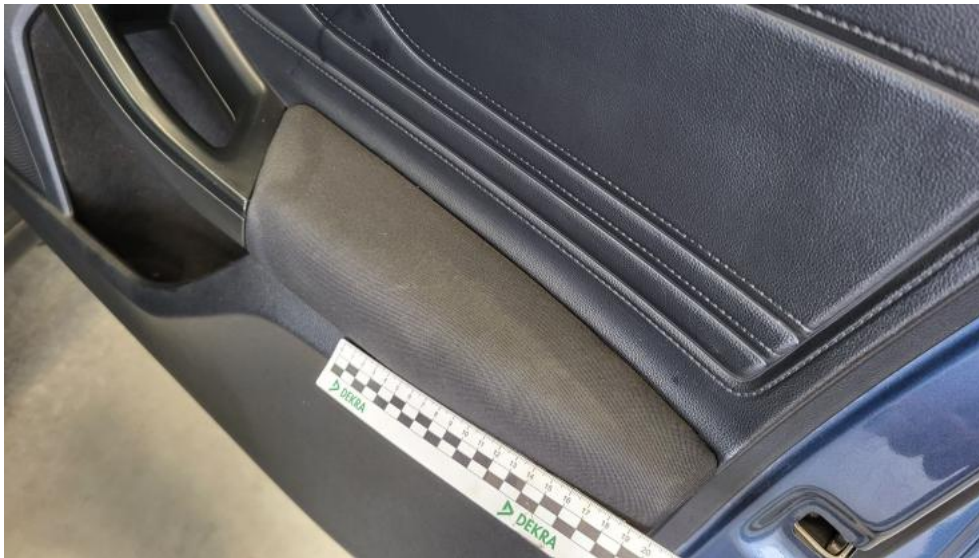
Tapicerka drzwi przednich P - Inne 1

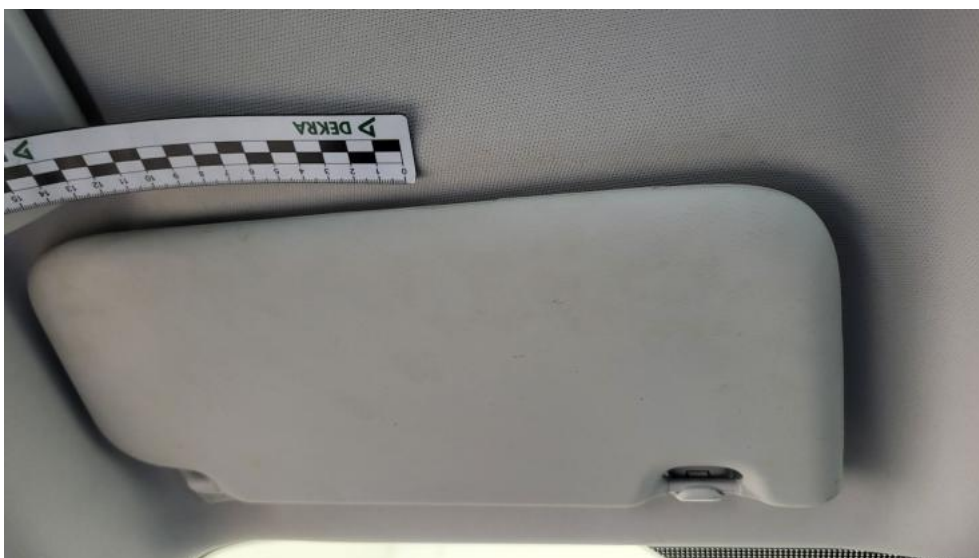
Osłona p/słoneczna lewa - Inne 1

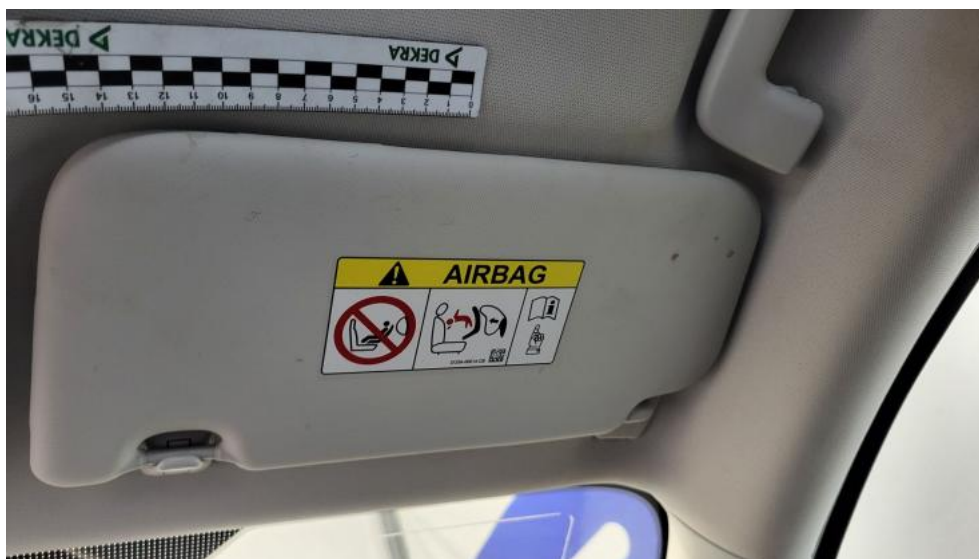
Osłona p/słoneczna prawa - Inne 1

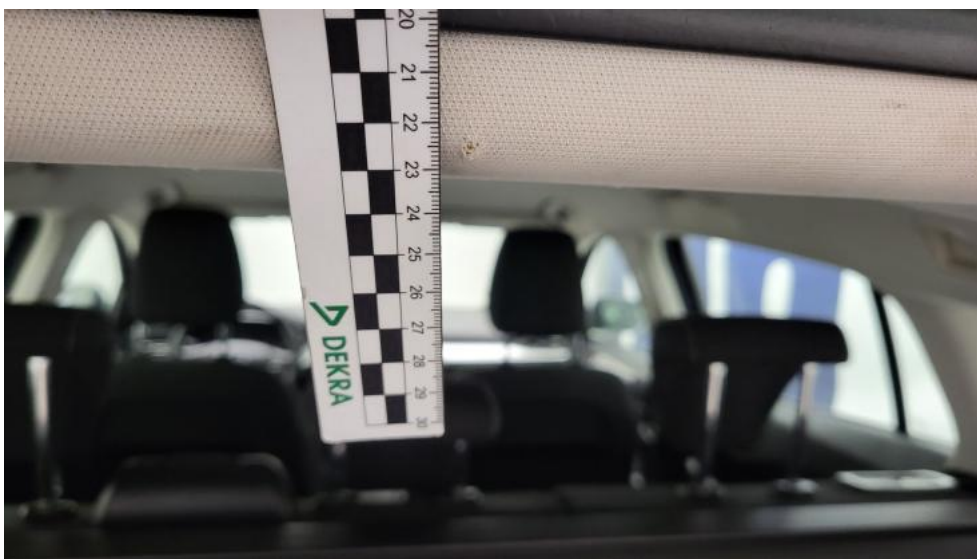
Podsufitka - Pęknięcie/rozerwanie 1

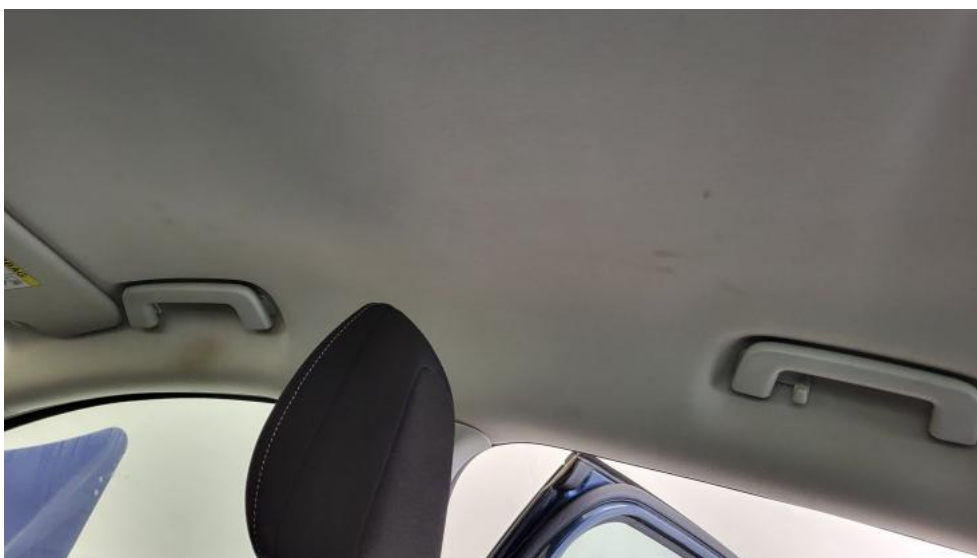
Podsufitka - Inne 1

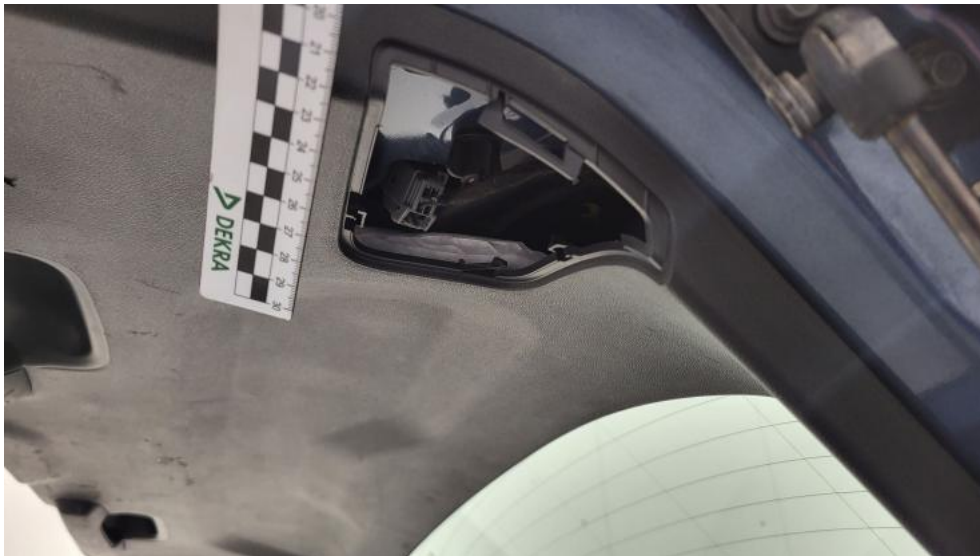
Wykładzina pokrywy tylnej - Inne 1

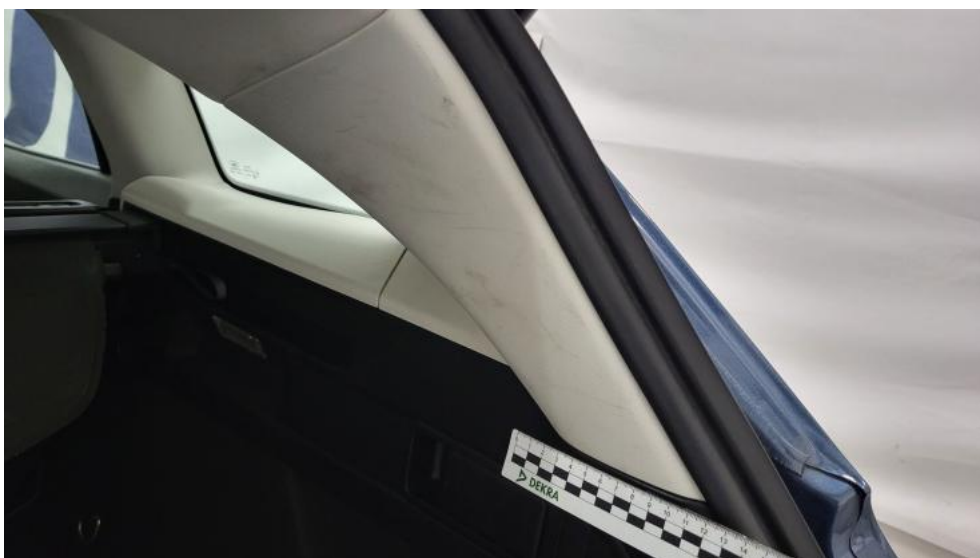
Wykładzina przestrzeni bagażowej - Inne 1
