DEKRA's commission No. : PKOL(W)/LODZ/95836/25/12/05  
commission/ damage No. : 22/023205  
Date of commission: 05-12-2025

**DEKRA Poland - Headquarters**  
02-673 Warszawa, ul. Konstruktorska 12A

| Manufacturer | HYUNDAI |
| Model | i30 Wagon 17-20 |

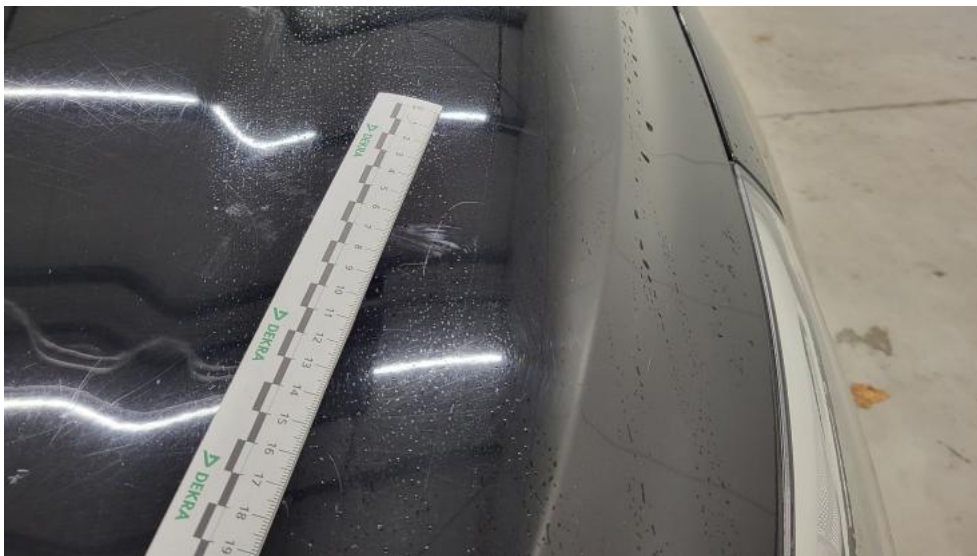
**Photo 37.**

Pokrywa komory silnika - Rysa/odprysk 1

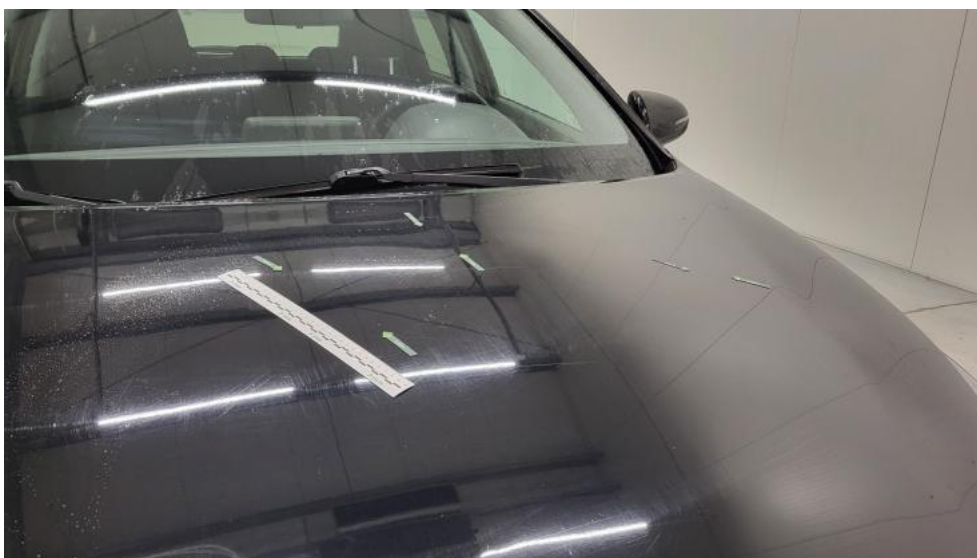
**Photo 38.**

Pokrywa komory silnika - Wgniecenie/odkształcenie 1

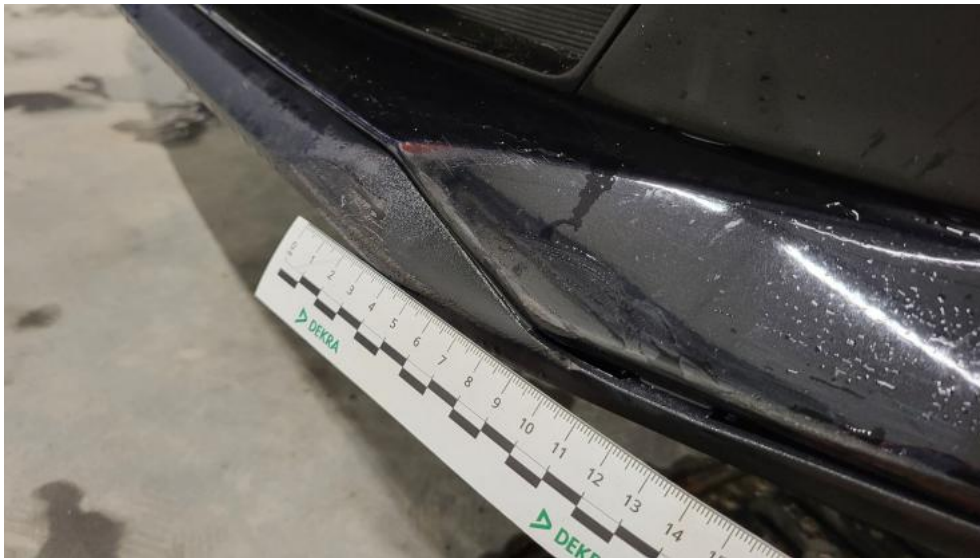
**Photo 39.**

Spoiler zderzaka przedniego - Rysa/odprysk 1

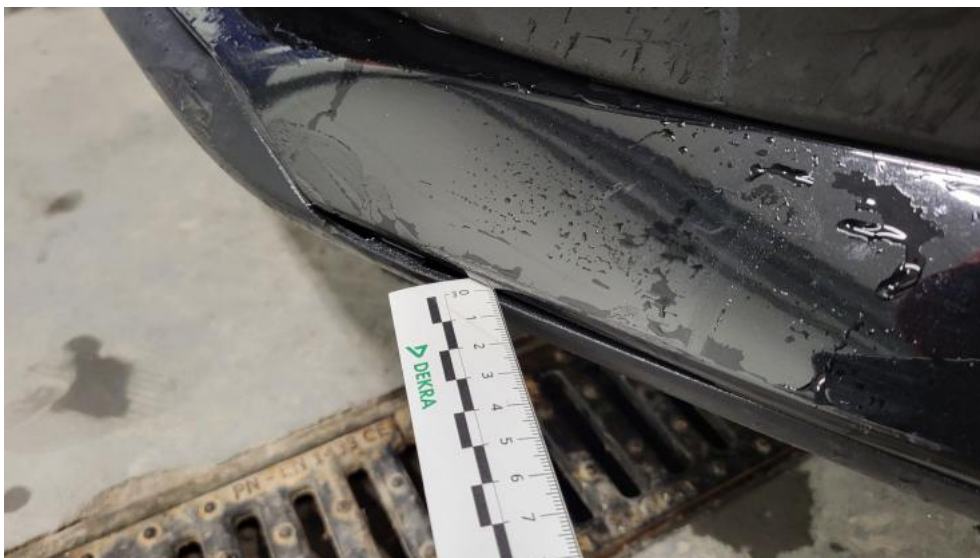
**Photo 40.**

Spoiler zderzaka przedniego - Inne 1

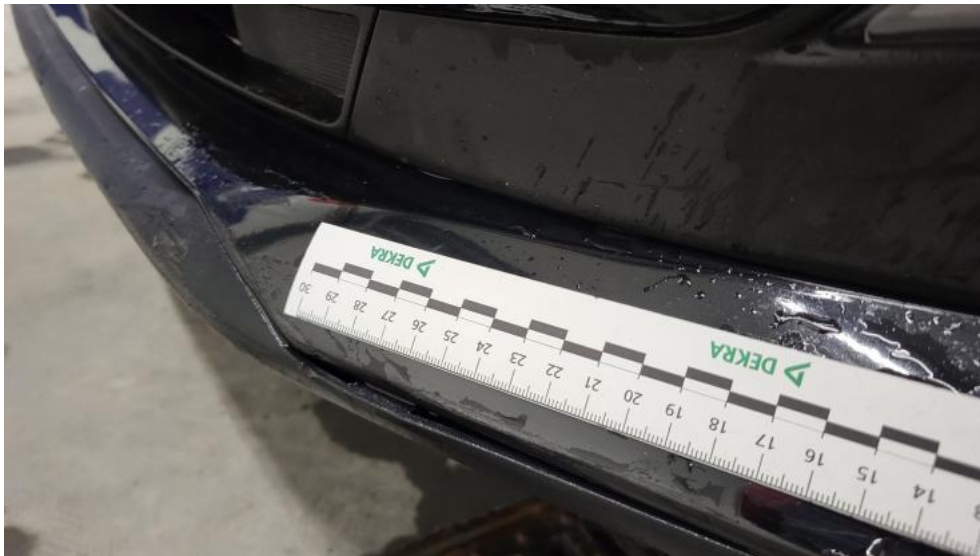
**Photo 41.**

Zderzak - Rysa/odprysk 1

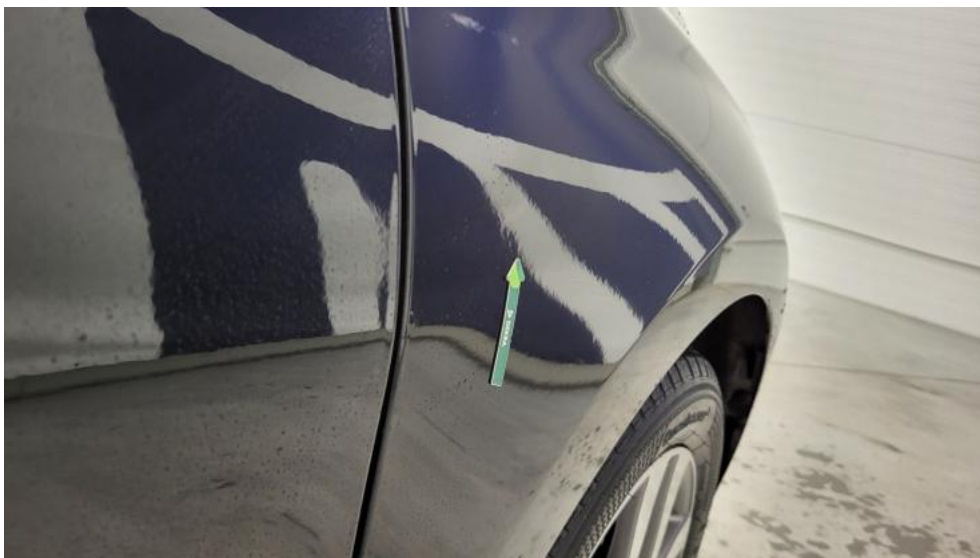
**Photo 42.**

Łotnik przedni P - Wgniecenie/odkształcenie 1

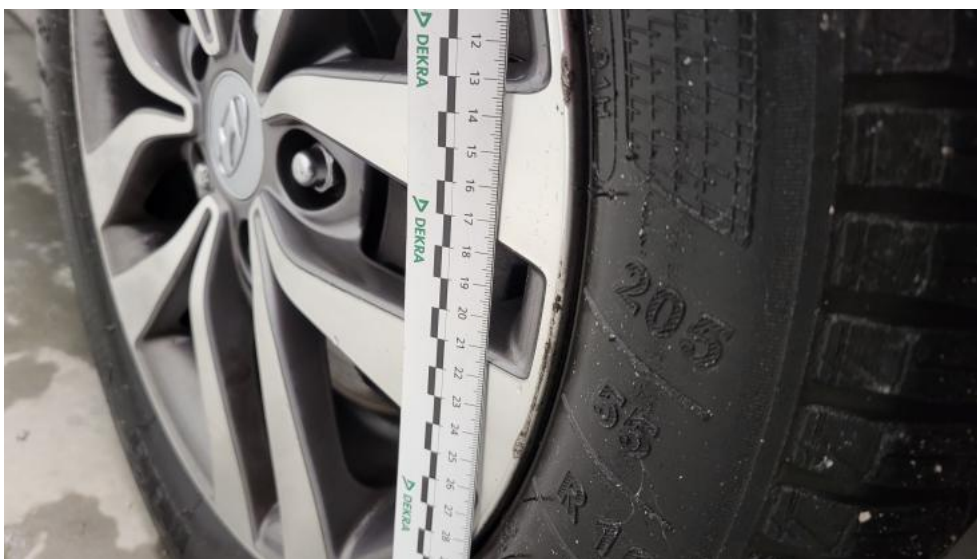
**Photo 43.**

Felga aluminiowa przednia P - Rysa/odprysk 1

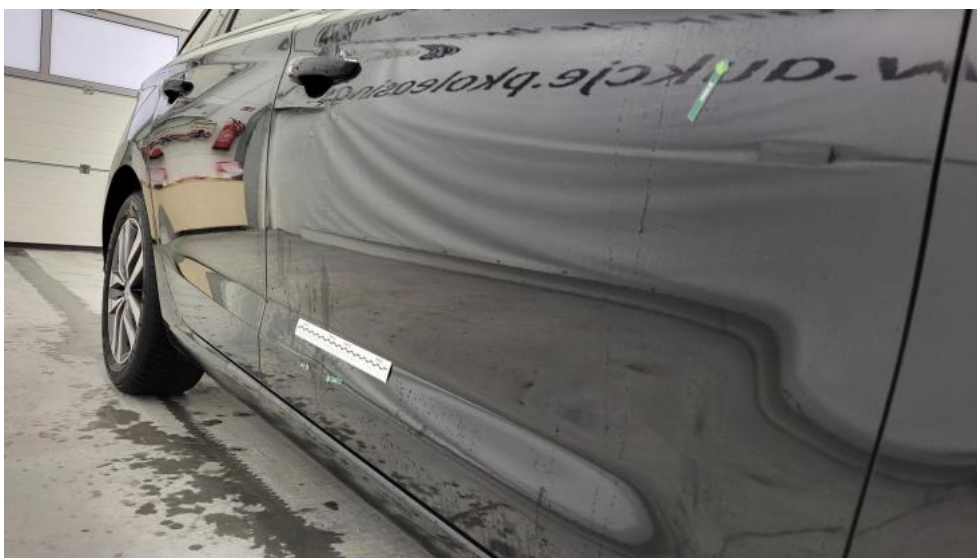
**Photo 44.**

Drzwi przednie P - Wgniecenie/odkształcenie 1

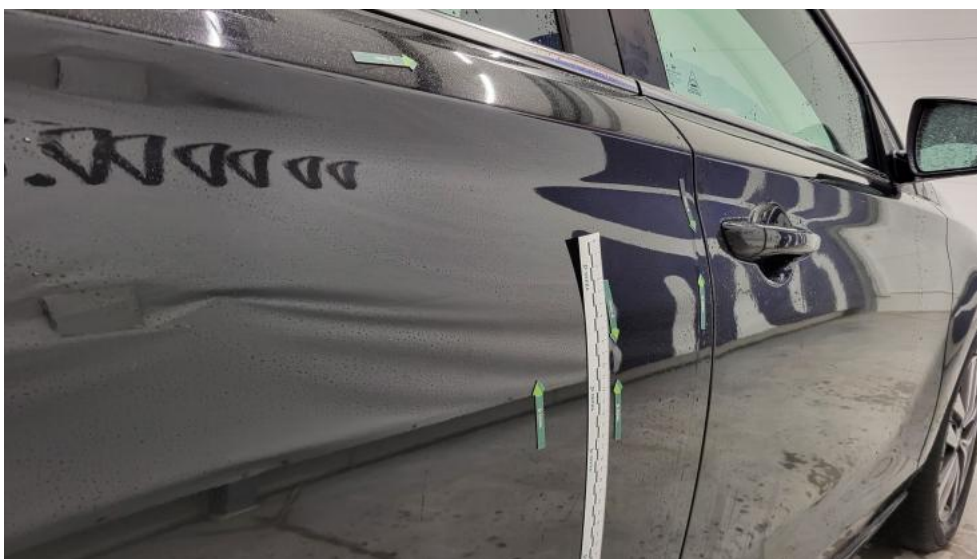
**Photo 45.**

Drzwi tylne P - Wgniecenie/odkształcenie 1

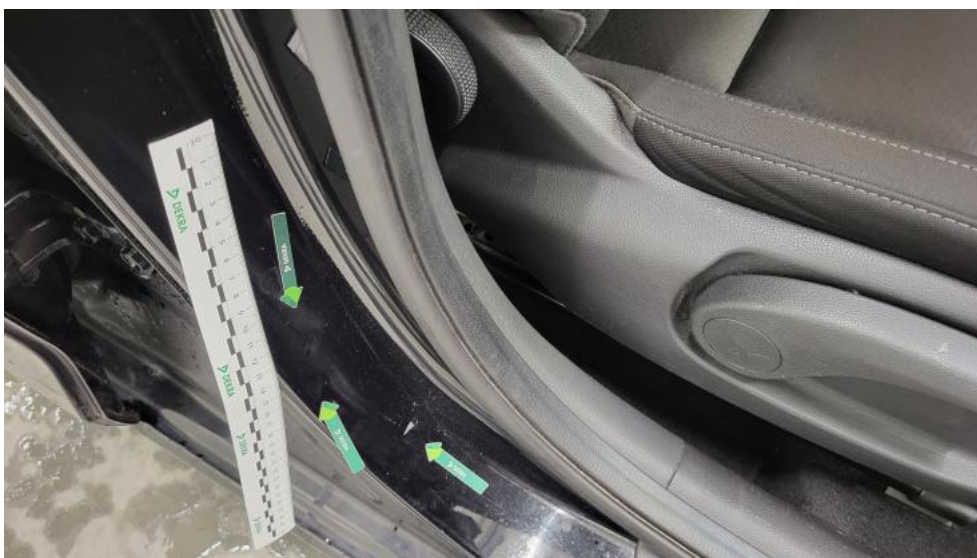
**Photo 46.**

Słupek środkowy P - Wgniecenie/odkształcenie 1

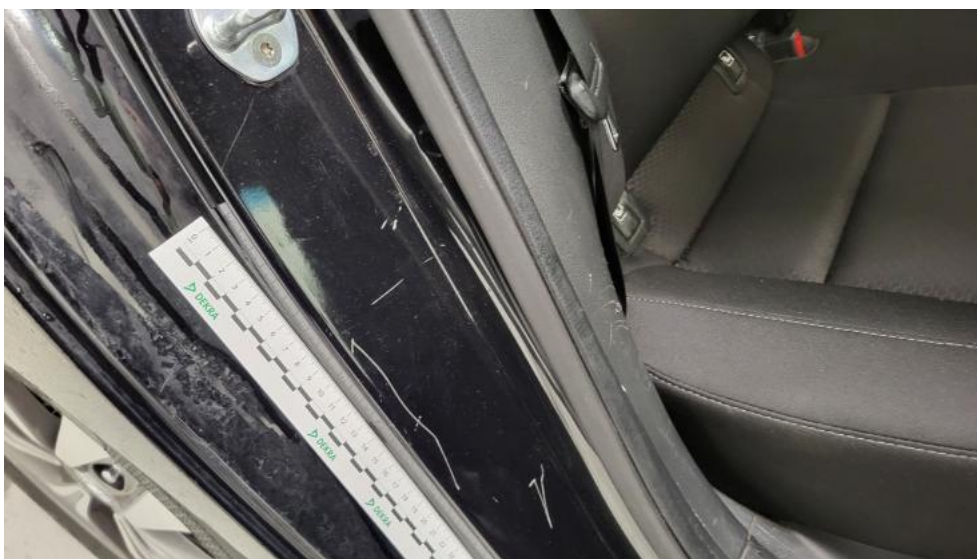
**Photo 47.**

Błotnik tylny P / Ściana boczna P - Rysa/odprysk 1

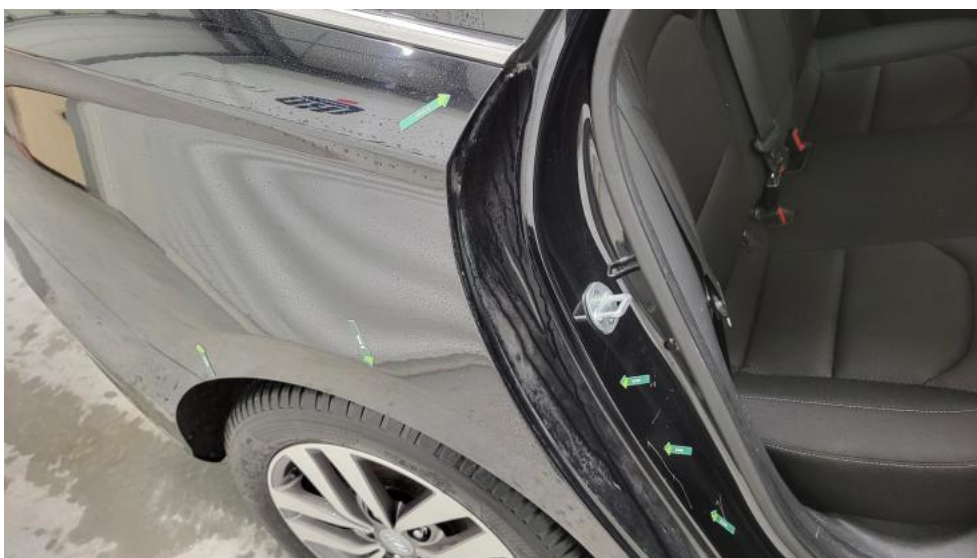
**Photo 48.**

Błotnik tylny P / Ściana boczna P - Wgniecenie/odkształcenie 1

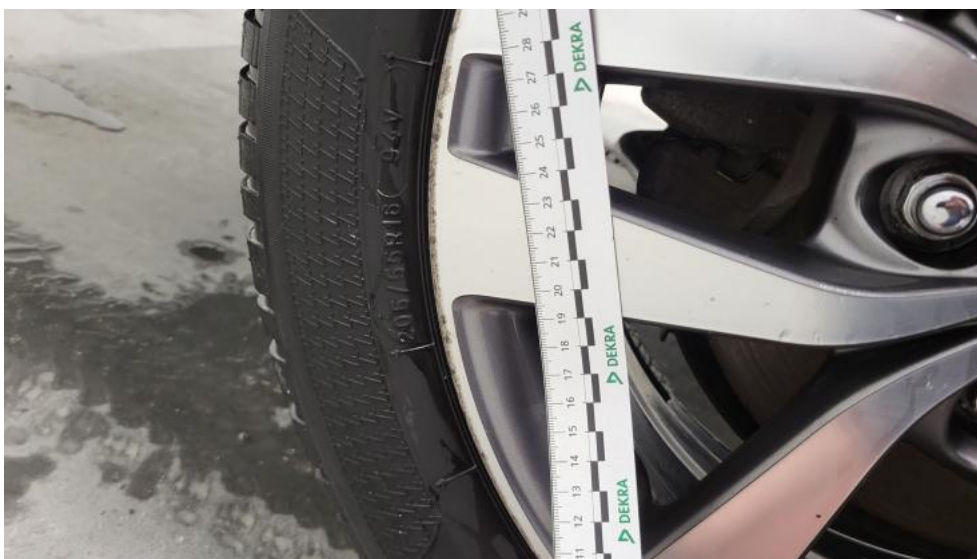
**Photo 49.**

Felga aluminiowa tylna P - Rysa/odprysk 1

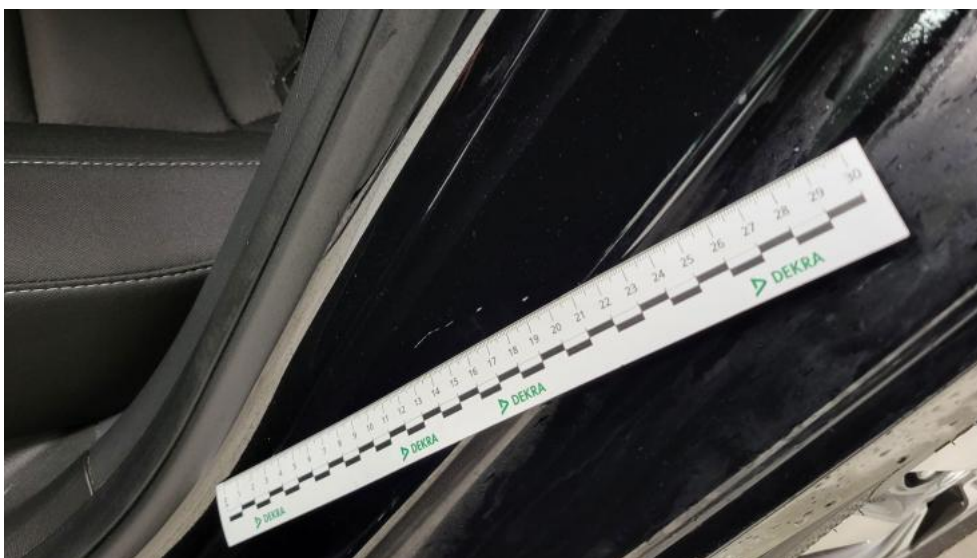
**Photo 50.**

Ścianka tylna L / Ścianka boczna L - Rysa/odprysk 1

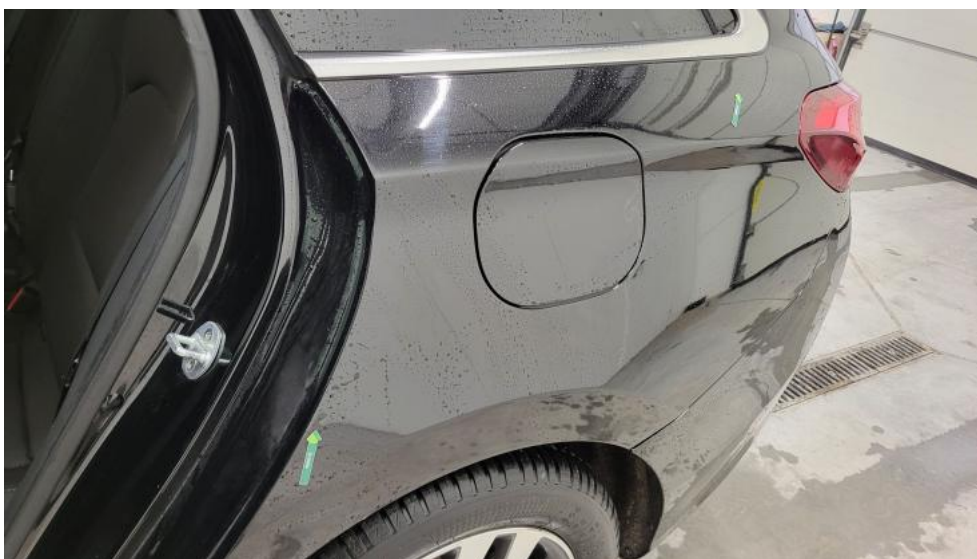
**Photo 51.**

Błotnik tylny L / Ściana boczna L - Wgniecenie/odkształcenie 1

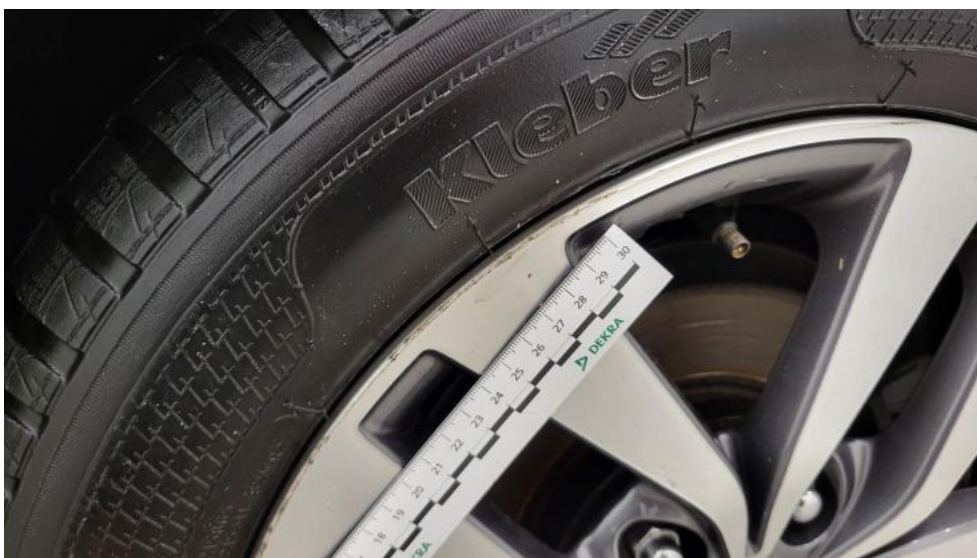
**Photo 52.**

Felga aluminiowa tylna L - Rysa/odprysk 1

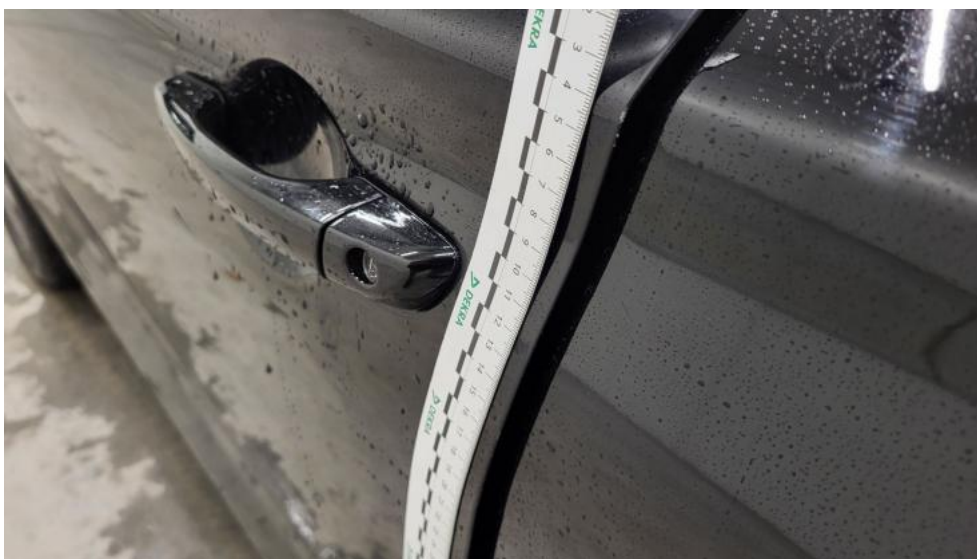
**Photo 53.**

Drzwi przed L - Rysa/odprysk 1

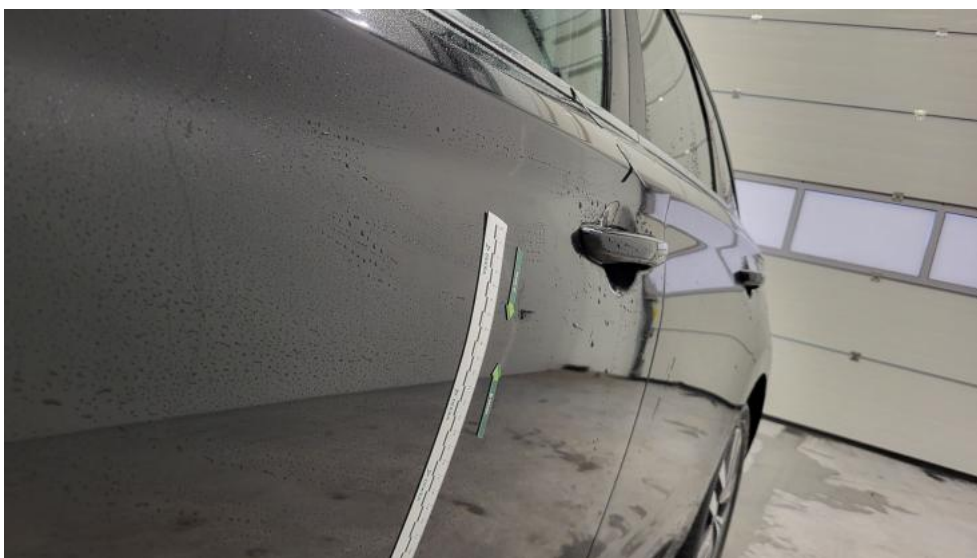
**Photo 54.**

Drzwi przed L - Wgniecenie/odkształcenie 1

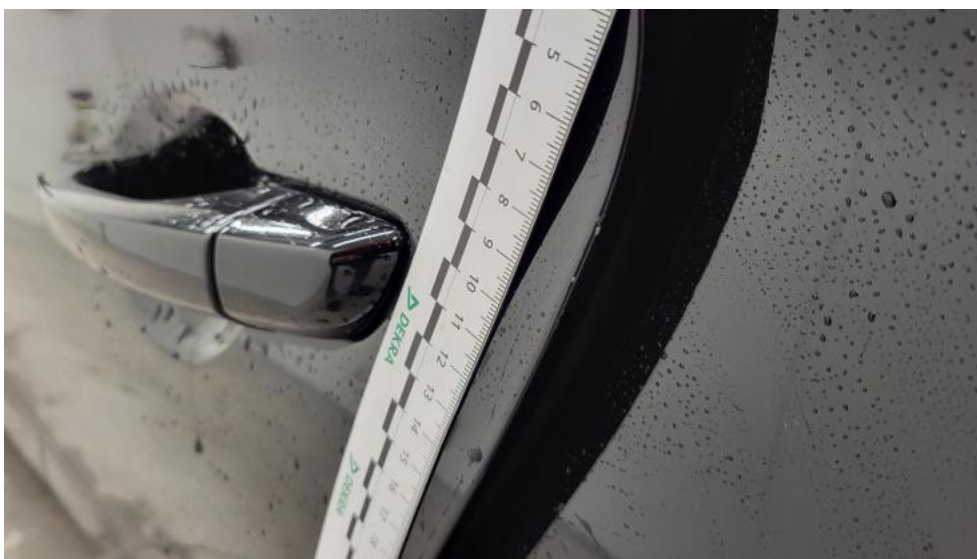
**Photo 55.**

Drzwi tylne L - Rysa/odprysk 1

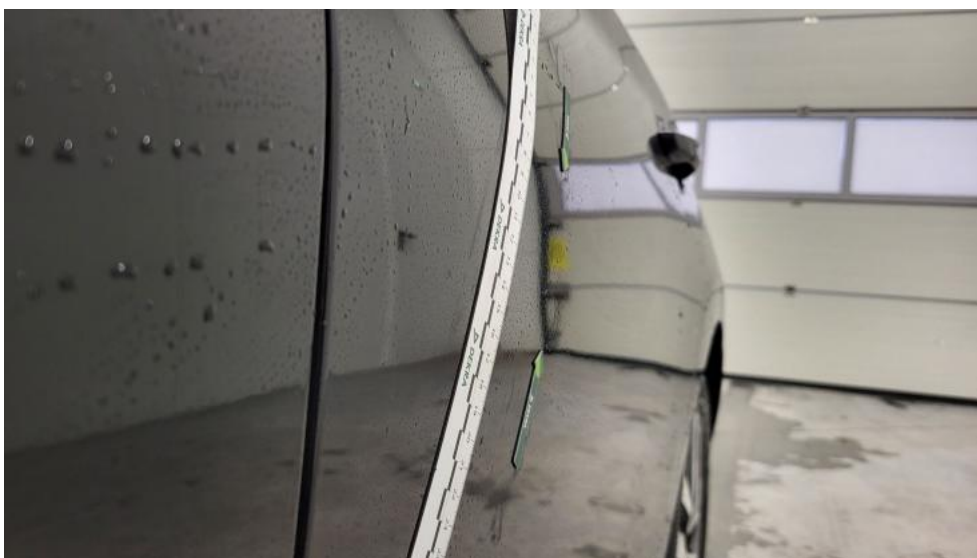
**Photo 56.**

Drzwi tylne L - Wgniecenie/odkształcenie 1

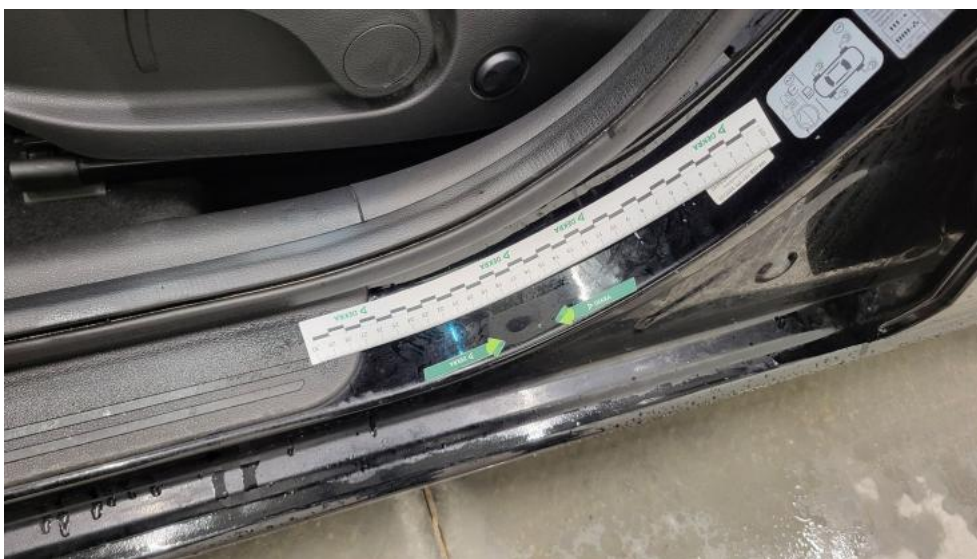
**Photo 57.**

Próg L - Wgniecenie/odkształcenie 1

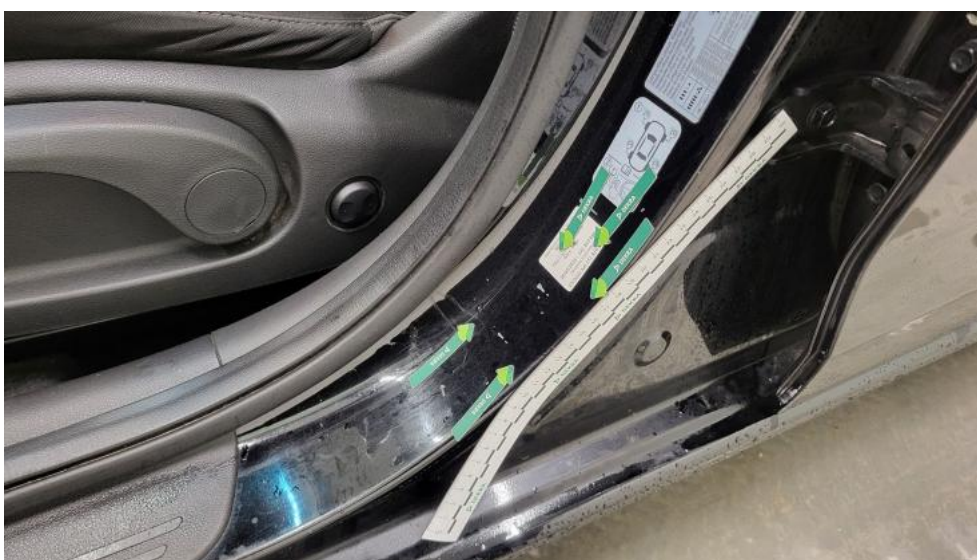
**Photo 58.**

Słupek środkowy L - Wgniecenie/odkształcenie 1

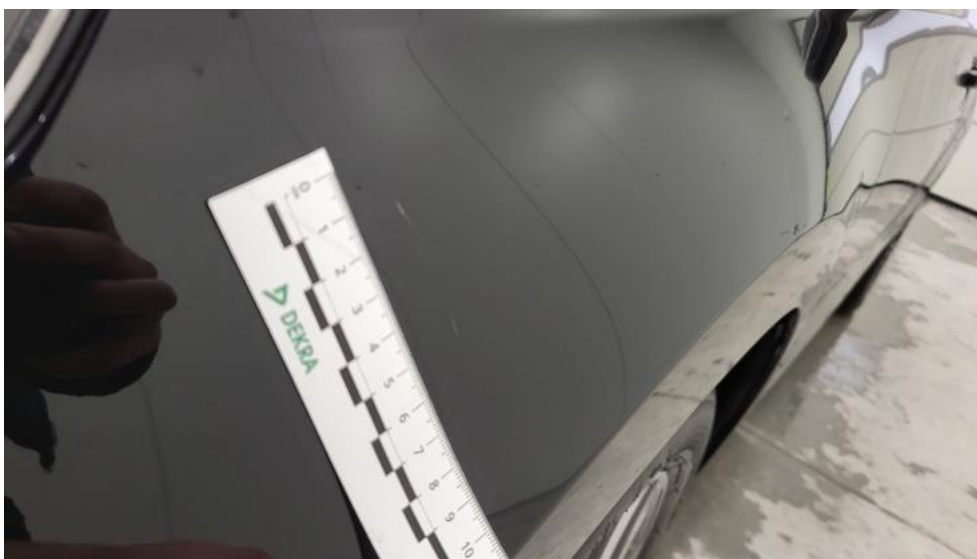
**Photo 59.**

Błotnik przedni L - Rysa/odprysk 1

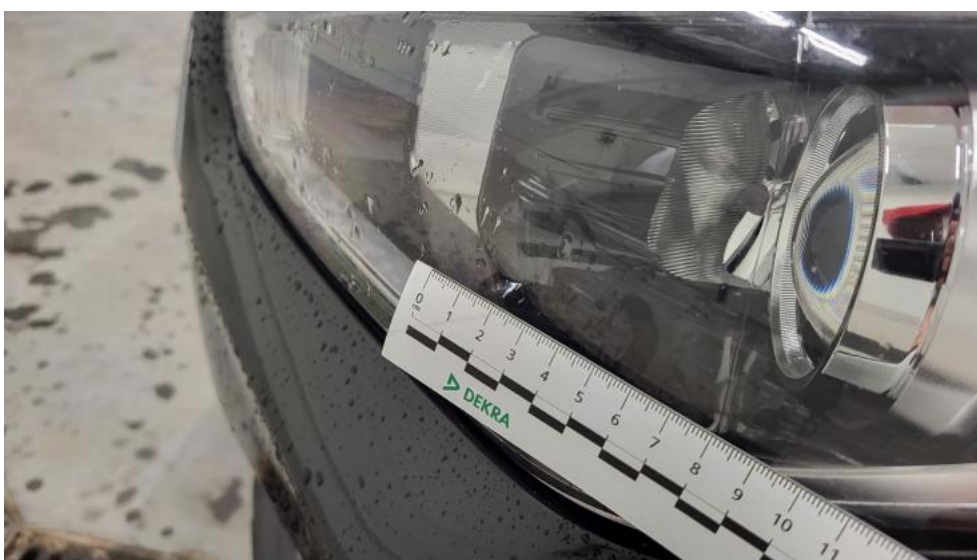
**Photo 60.**

Reflektor L - Rysa/odprysk 1

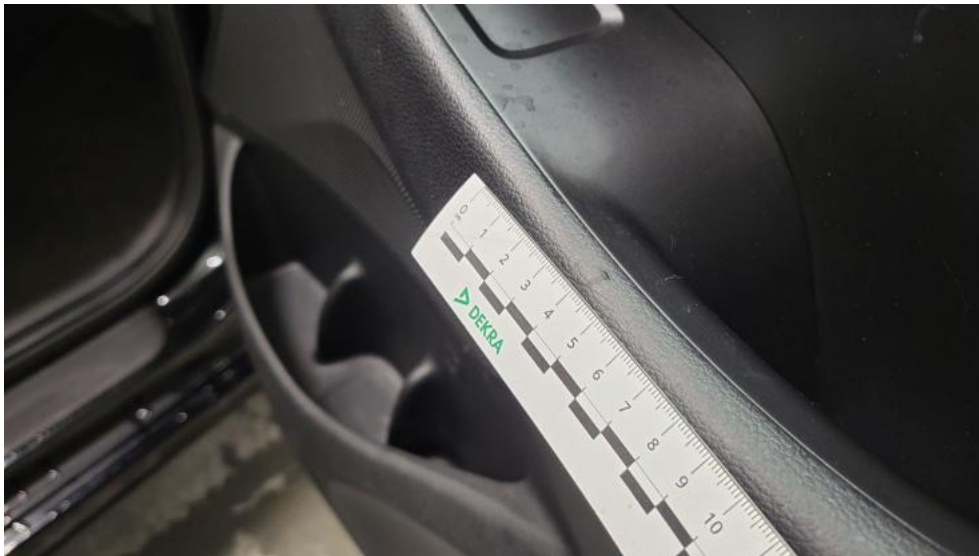
**Photo 61.**

Tapicerka drzwi przednich P - Wgniecenie/odkształcenie 1

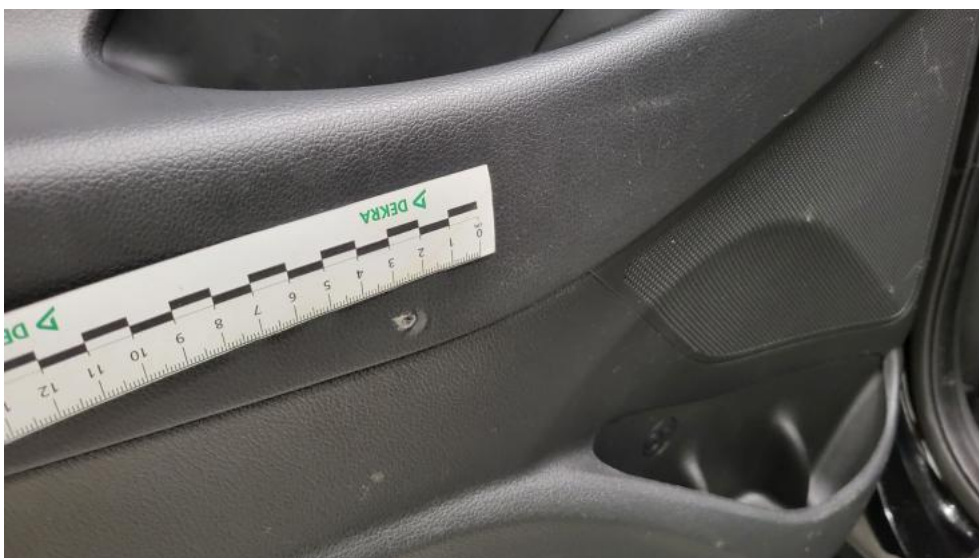
**Photo 62.**

Tapicerka drzwi tylnych L - Pęknięcie/rozerwanie 1

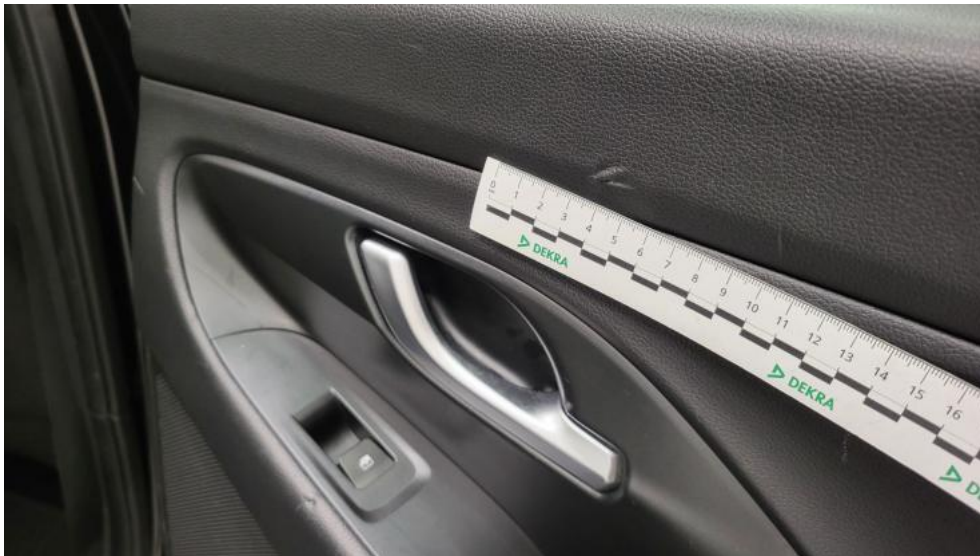
**Photo 63.**

Tapicerka drzwi tylnych P - Pęknięcie/rozerwanie 1

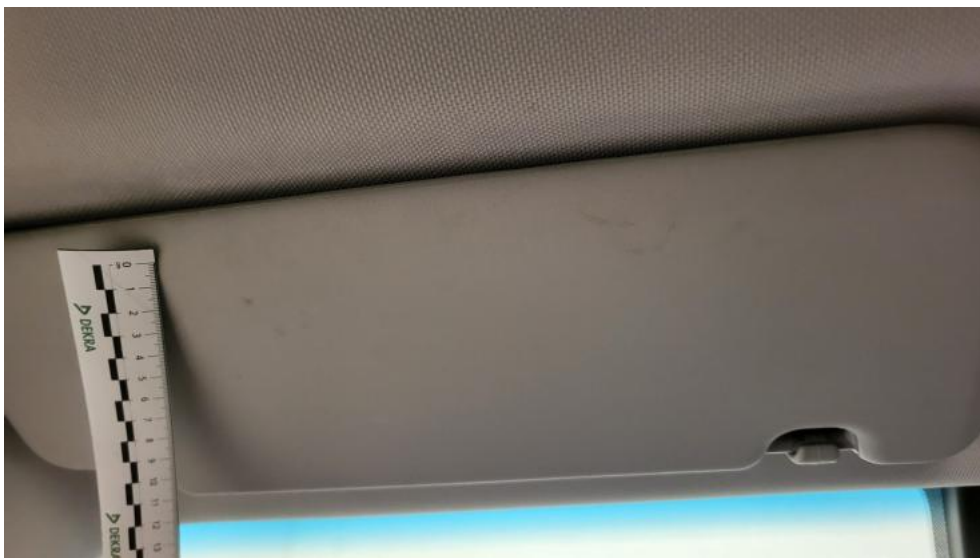
**Photo 64.**

Osłona p/słoneczna lewa - Inne 1

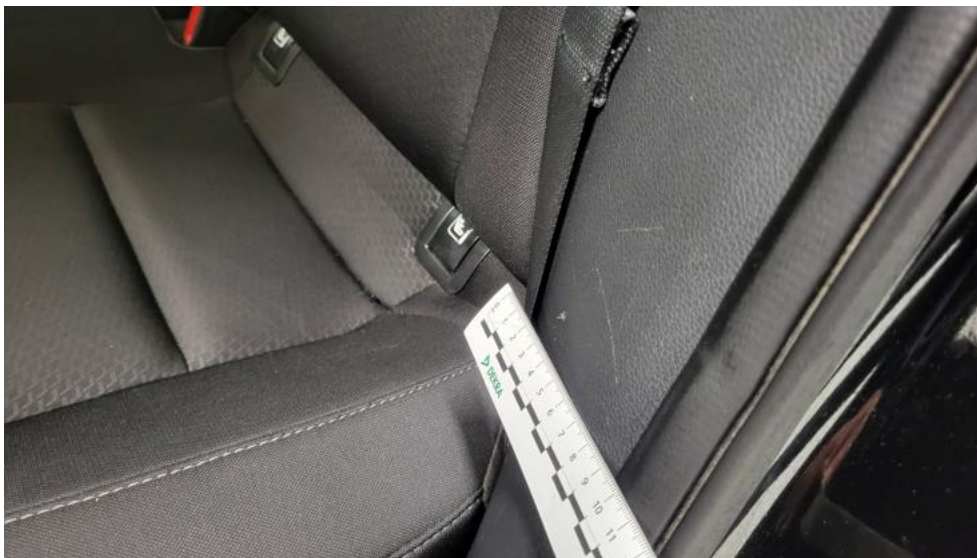
**Photo 65.**

Wykładzina(y) słupka tylnego L - Rysa/odprysk 1

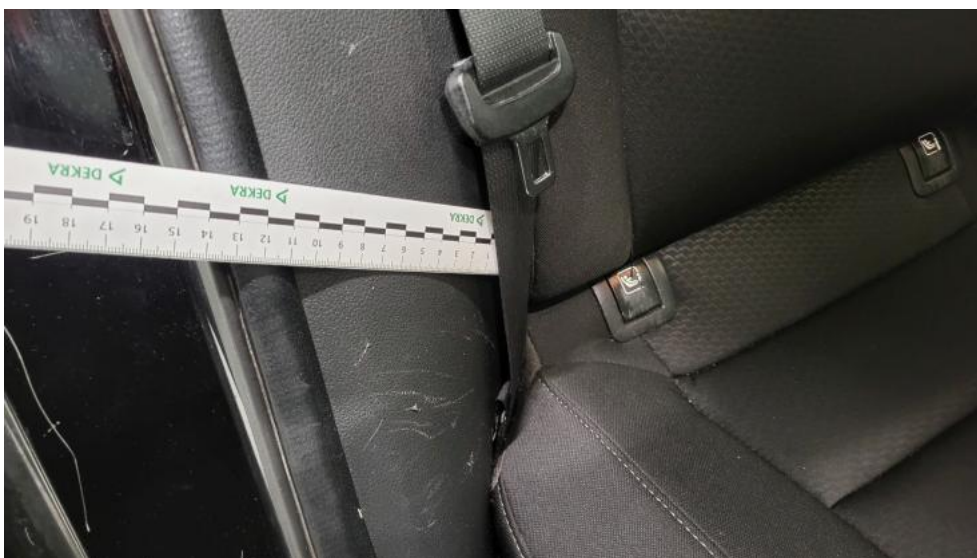
**Photo 66.**

Wykładzina(y) słupka tylnego P - Rysa/odprysk 1

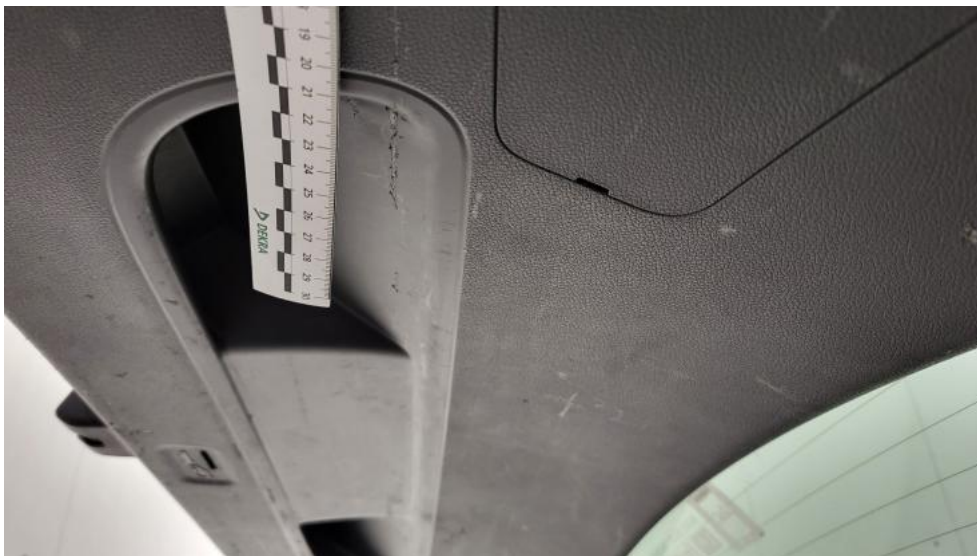
**Photo 67.**

Wykładzina pokrywy tylnej - Rysa/odprysk 1
