DEKRA's commission No. : PKOL(W)/LODZ/76990/25/10/08  
commission/ damage No. : 22/K00181  
Date of commission: 08-10-2025

| Manufacturer | SKODA |
| Type / version | Kamiq 1.5 TSI Style |
| Registration /record No. | WZ112FL |

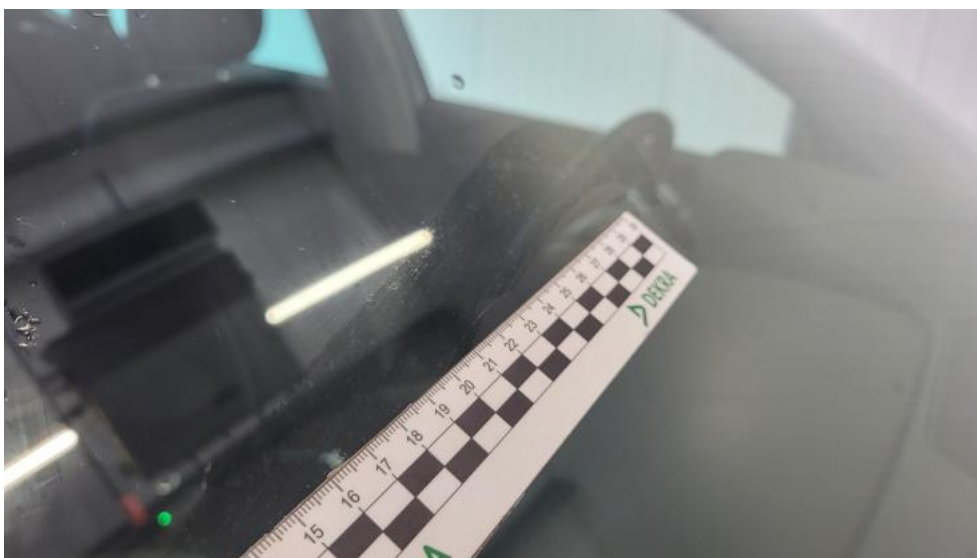
**Photo 38.**

Szyba czołowa - Rysa/odprysk 1

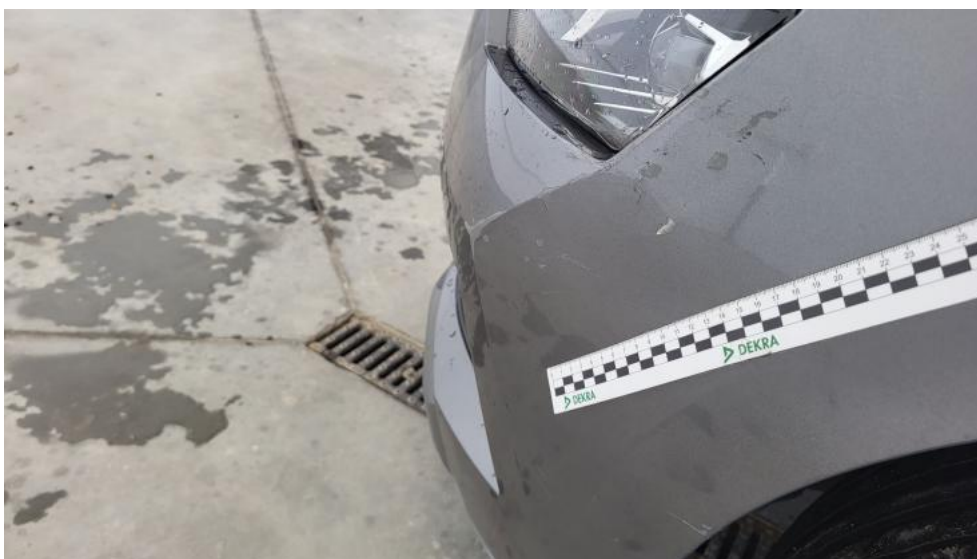
**Photo 39.**

Zderzak - Rysa/odprysk 1

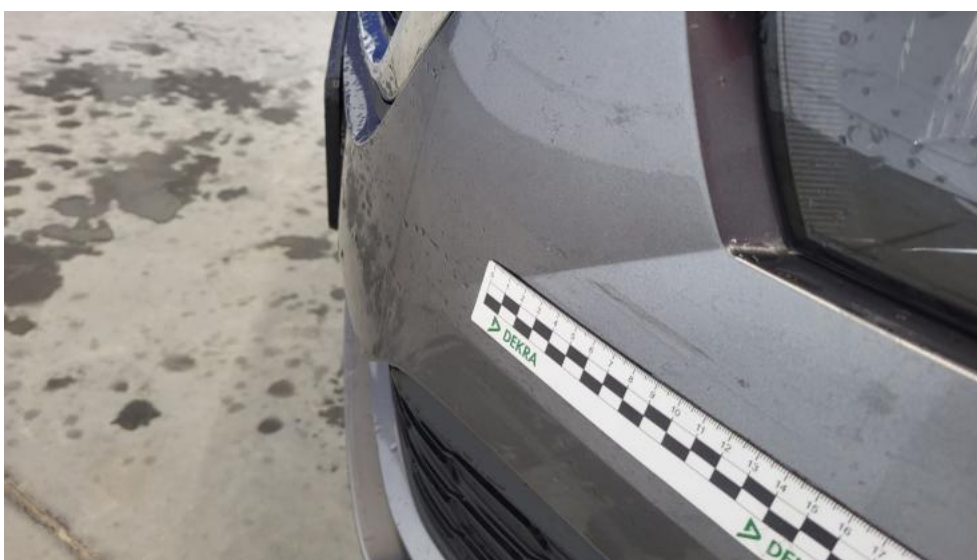
**Photo 40.**

Zderzak - Rysa/odprysk 2

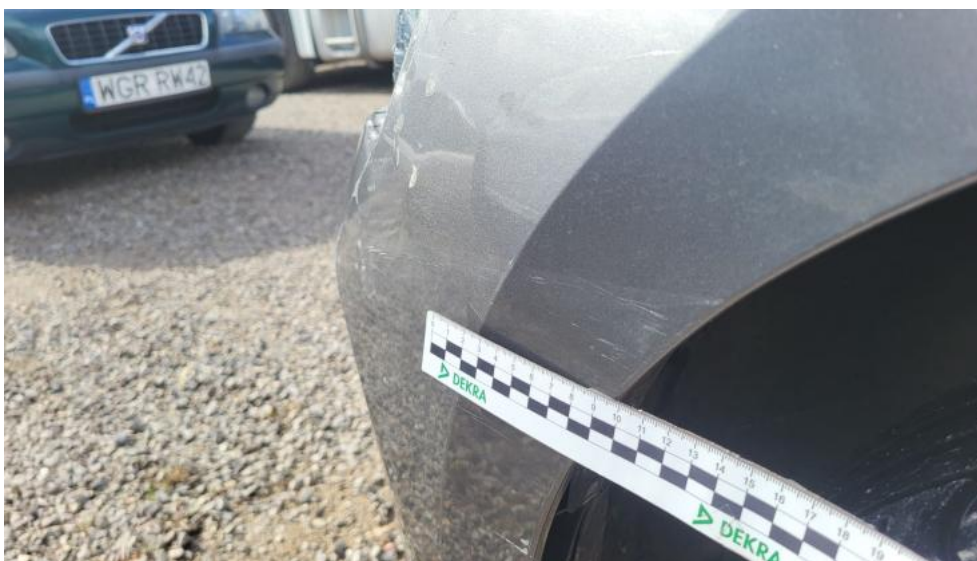
**Photo 41.**

Zderzak - Wgniecenie/odkształcenie 1

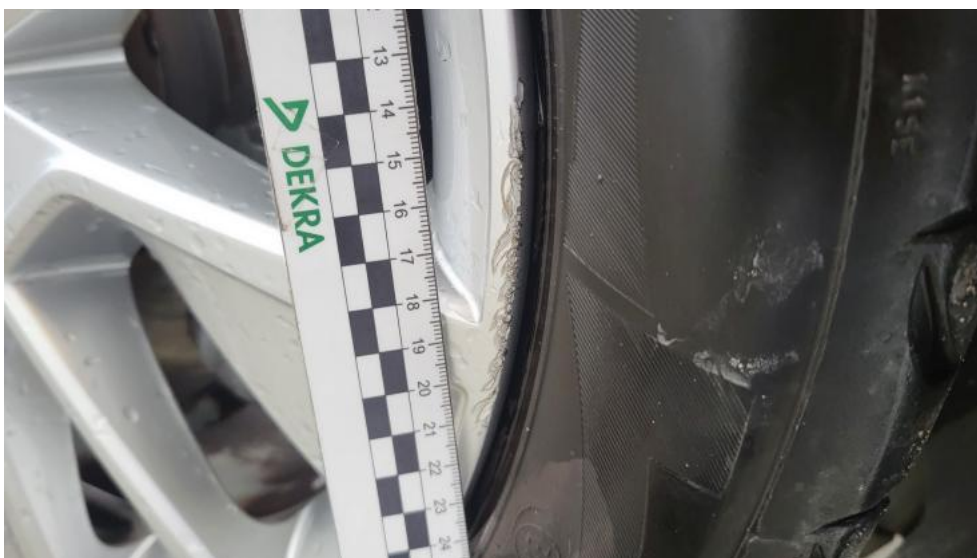
**Photo 42.**

Felga aluminiowa przednia P - Rysa/odprysk 1

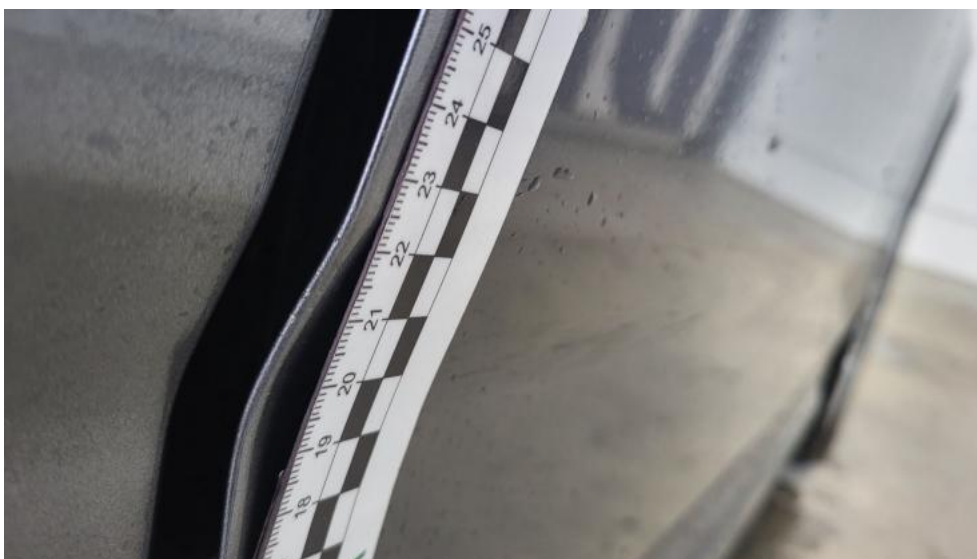
**Photo 43.**

Drzwi przednie P - Rysa/odprysk 1

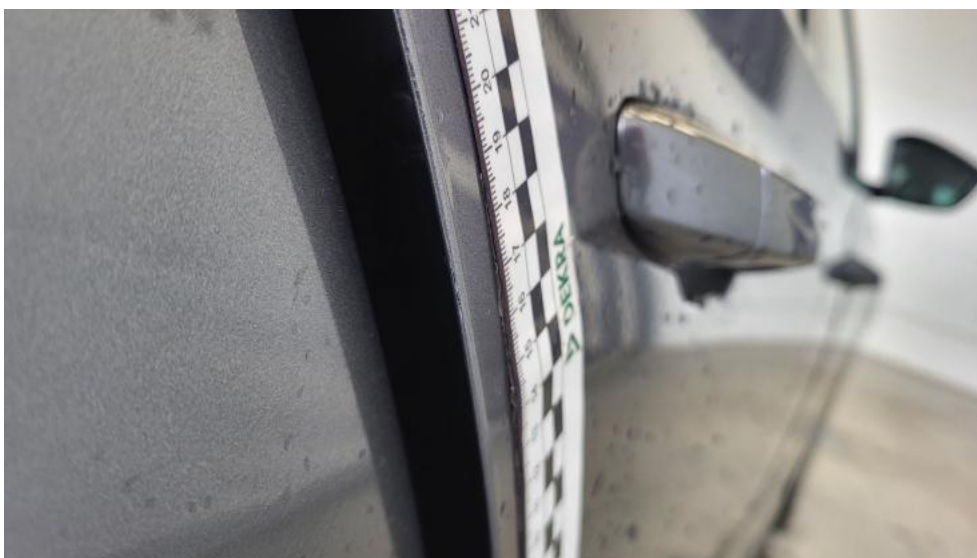
**Photo 44.**

Drzwi tylne P - Rysa/odprysk 1

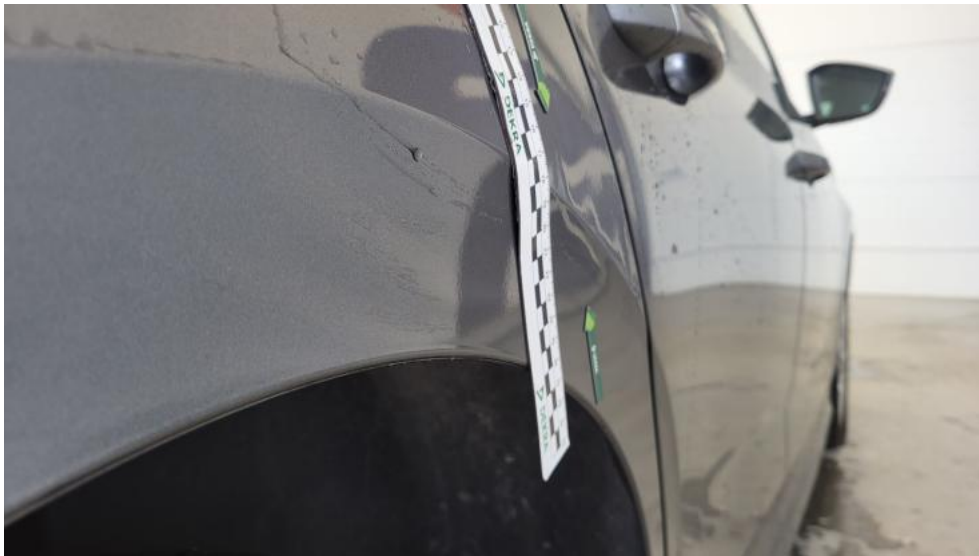
**Photo 45.**

Błotnik tylny P / Ściana boczna P - Wgniecenie/odkształcenie 1

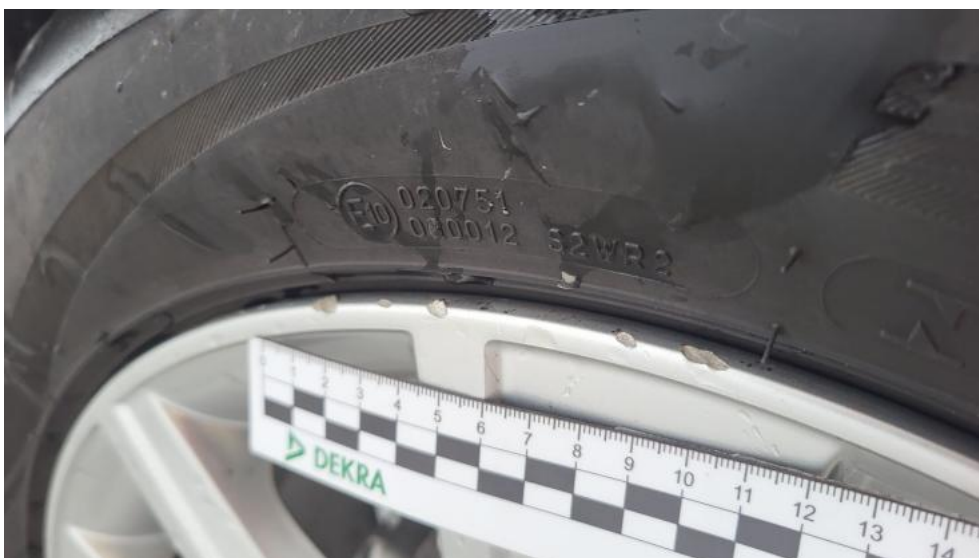
**Photo 46.**

Felga aluminiowa tylna P - Rysa/odprysk 1

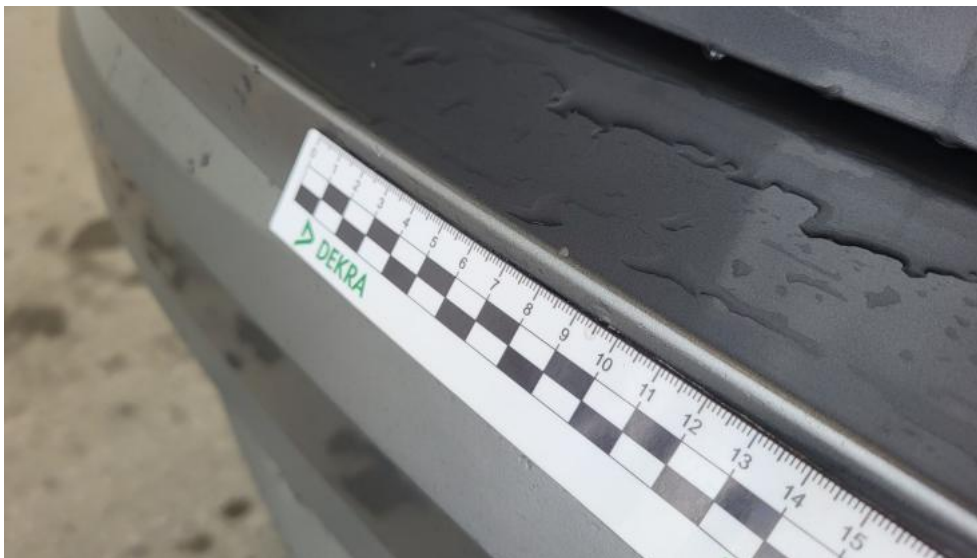
**Photo 47.**

Zderzak tylny - Rysa/odprysk 1

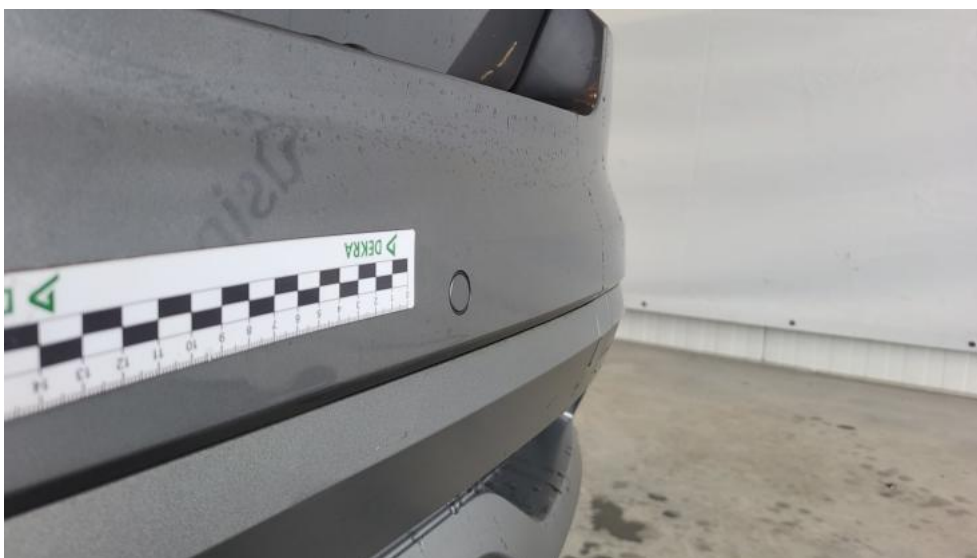
**Photo 48.**

Zderzak tylny - Wgniecenie/odkształcenie 1

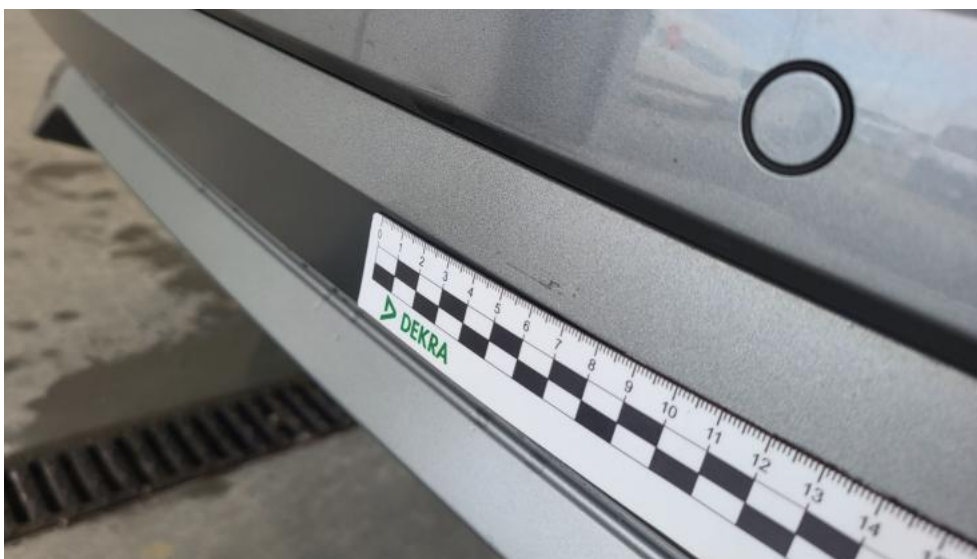
**Photo 49.**

Zderzak tylny cz dolna - Rysa/odprysk 1

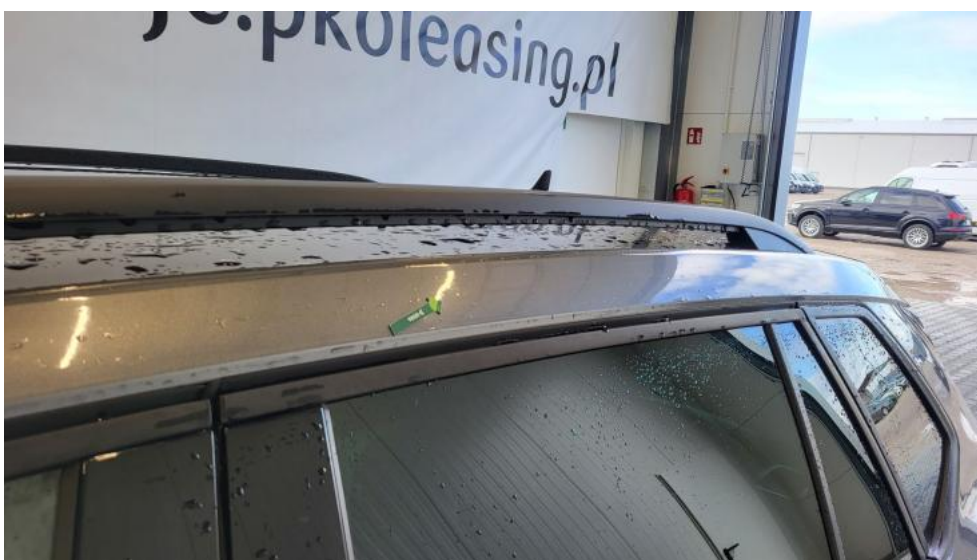
**Photo 50.**

Błotnik tylny L / Ściana boczna L - Wgniecenie/odkształcenie 1

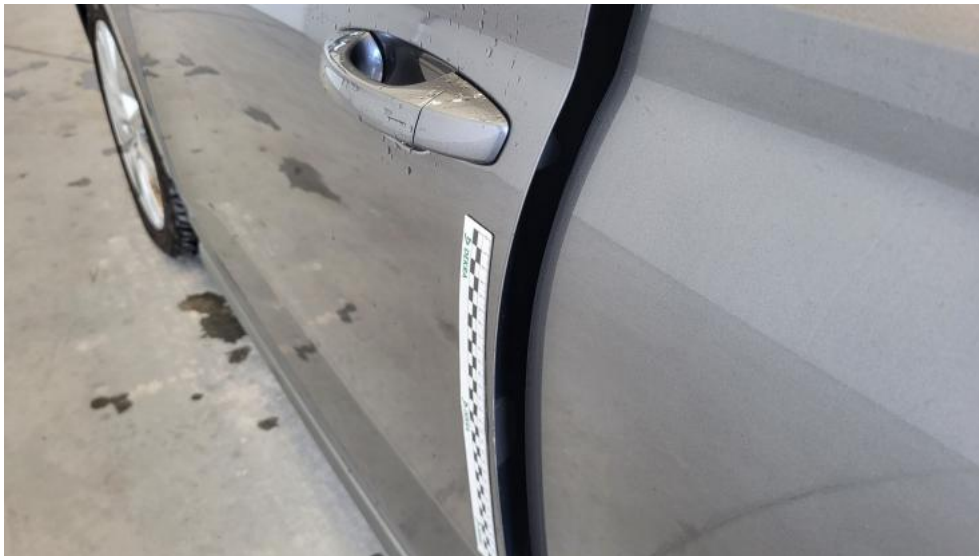
**Photo 51.**

Drzwi przed L - Rysa/odprysk 1

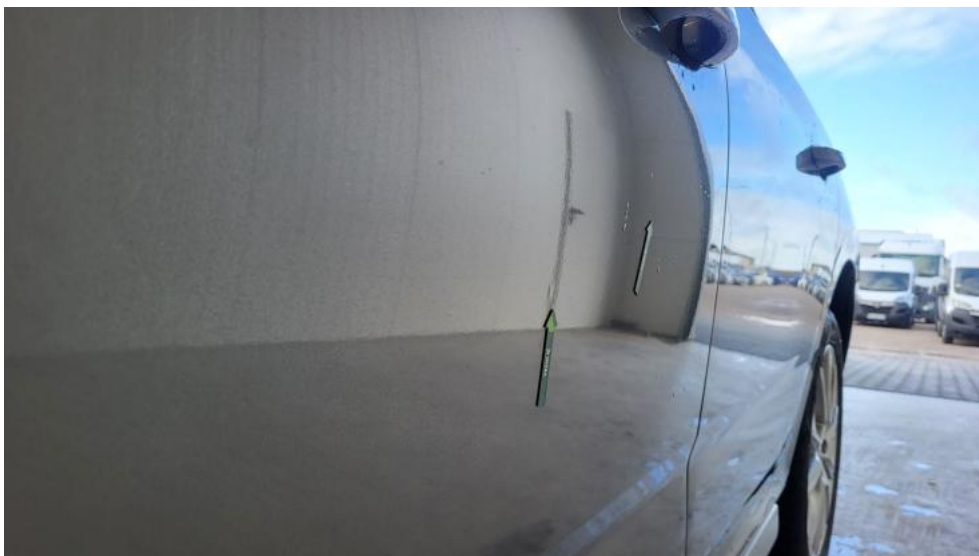
**Photo 52.**

Drzwi przed L - Wgniecenie/odkształcenie 1

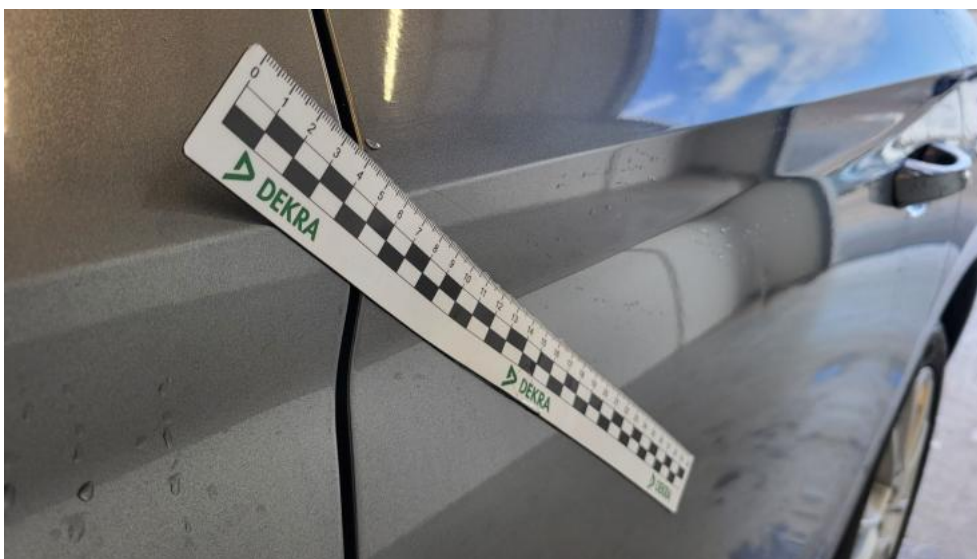
**Photo 53.**

Drzwi tylne L - Rysa/odprysk 1

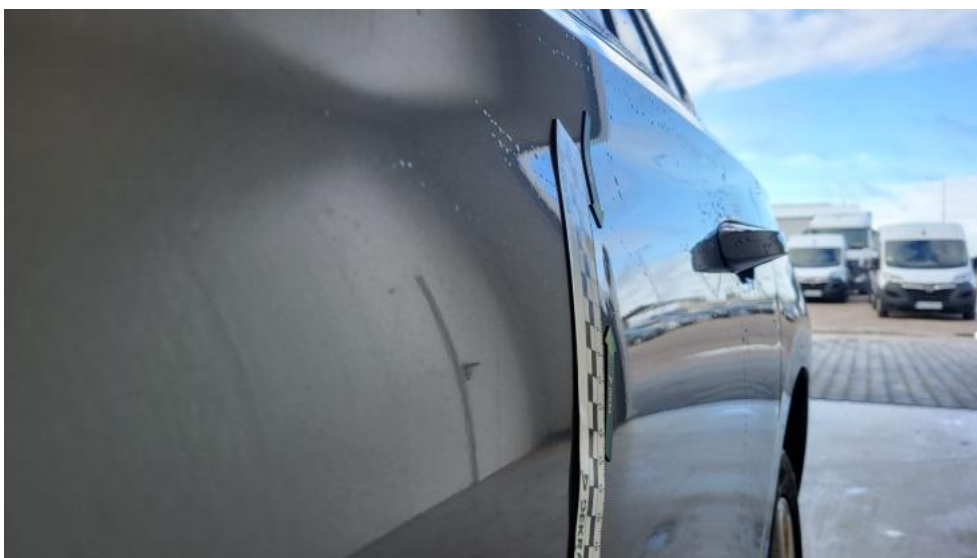
**Photo 54.**

Drzwi tylne L - Wgniecenie/odkształcenie 1

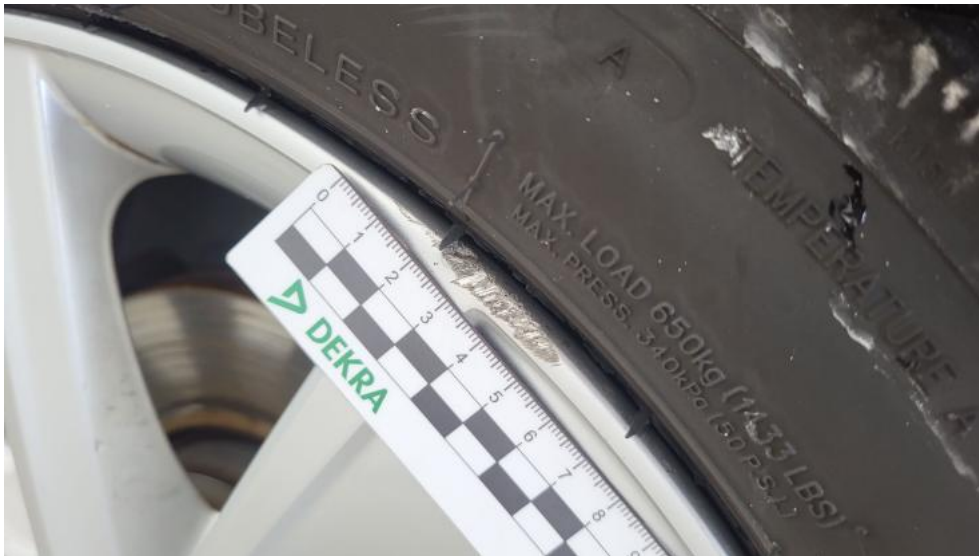
**Photo 55.**

Felga Aluminiowa przednia L - Rysa/odprysk 1

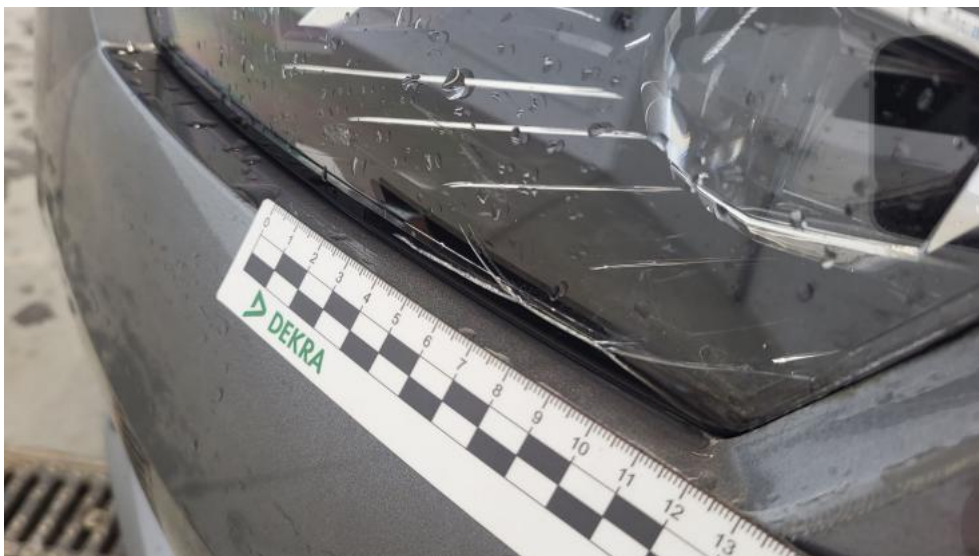
**Photo 56.**

Reflektor L - Pęknięcie/rozerwanie 1

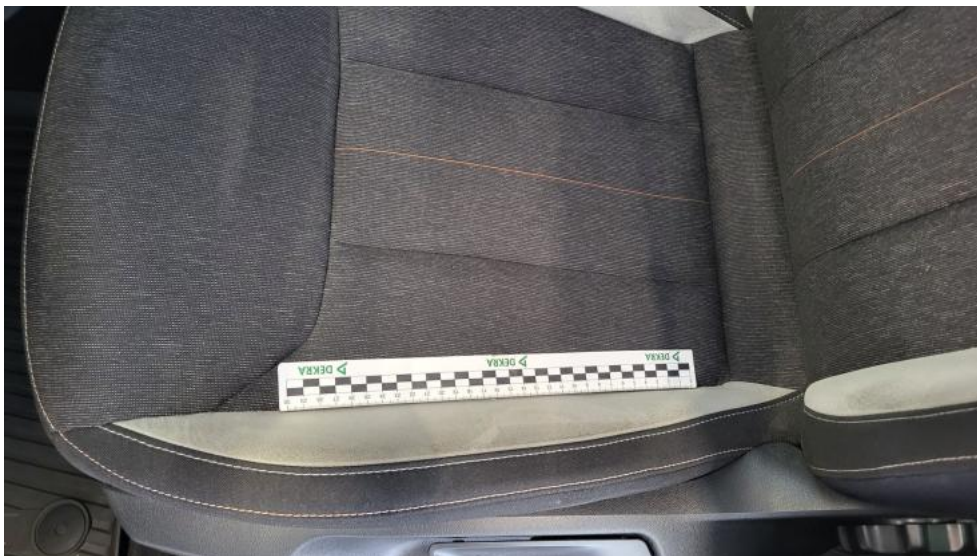
**Photo 57.**

Fotel prz. lew. - Inne 1
