DEKRA's commission No. : PKOL(W)/LODZ/06717/26/01/27  
commission/ damage No. : FLOTA  
Date of commission: 27-01-2026

| Manufacturer | FORD |
| Type / version | Focus 1.0 EcoBoost mHEV ST-Line X |
| Registration /record No. | WZ066FX |

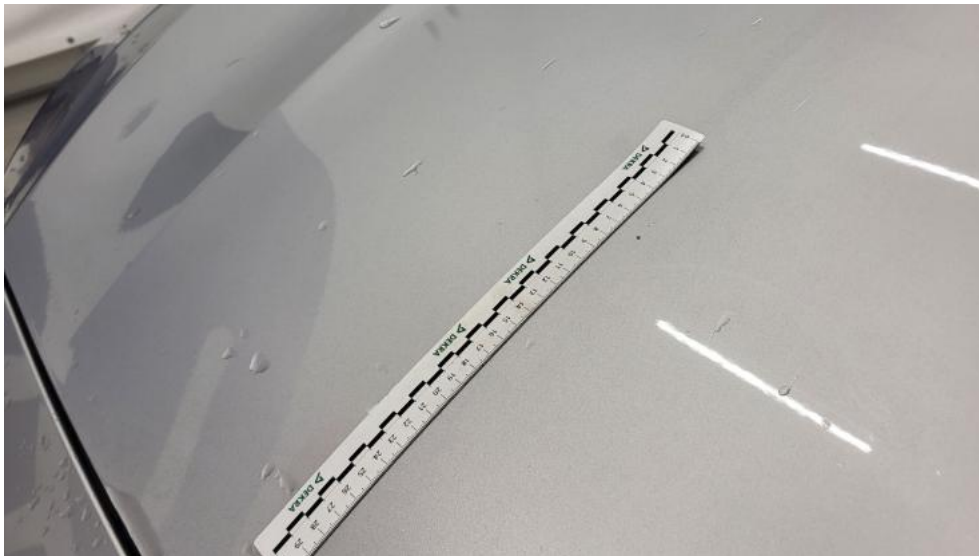
**Photo 39.**

Pokrywa komory silnika - Rysa/odprysk 1

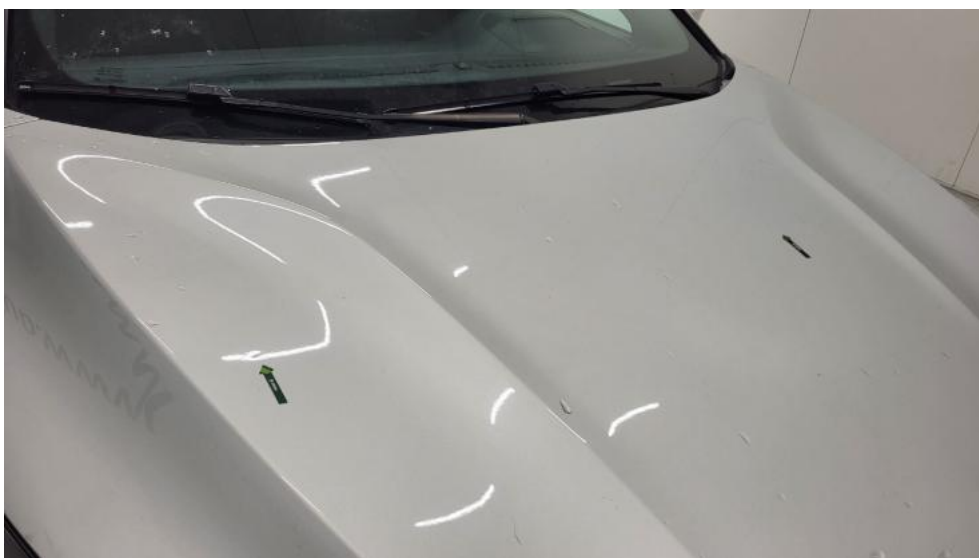
**Photo 40.**

Pokrywa komory silnika - Wgniecenie/odkształcenie 1

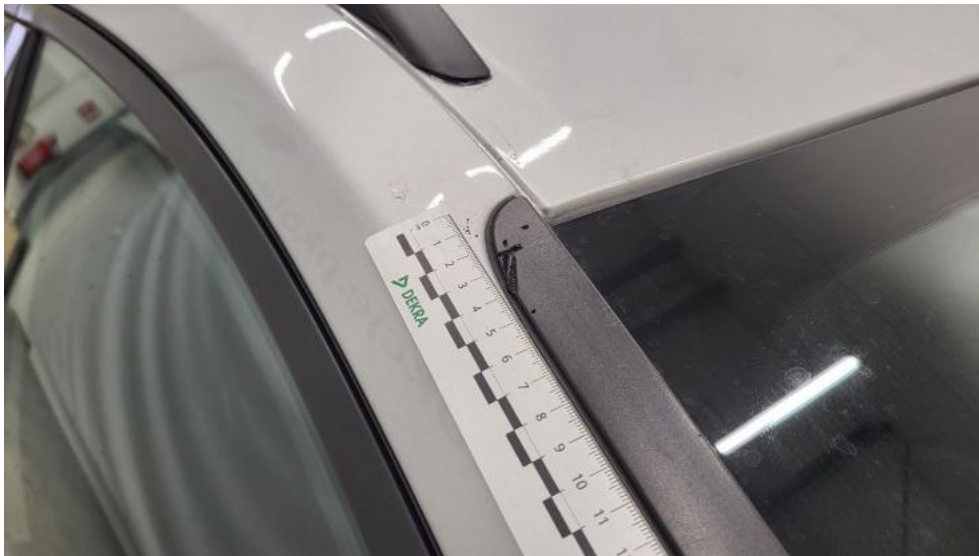
**Photo 43.**

Uszczelka/listwa szyby czołowej - Rysa/odprysk 1

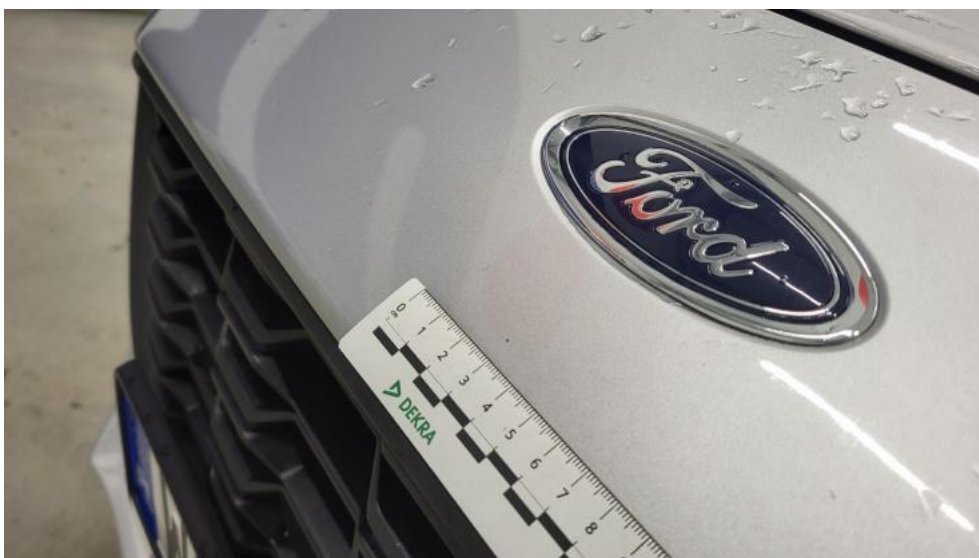
**Photo 44.**

Zderzak - Rysa/odprysk 1

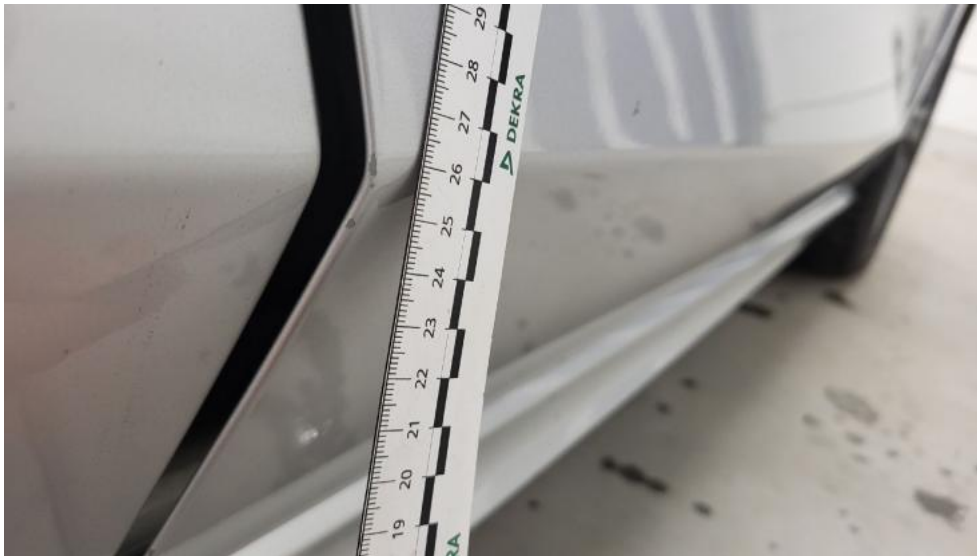
**Photo 45.**

Drzwi przednie P - Rysa/odprysk 1

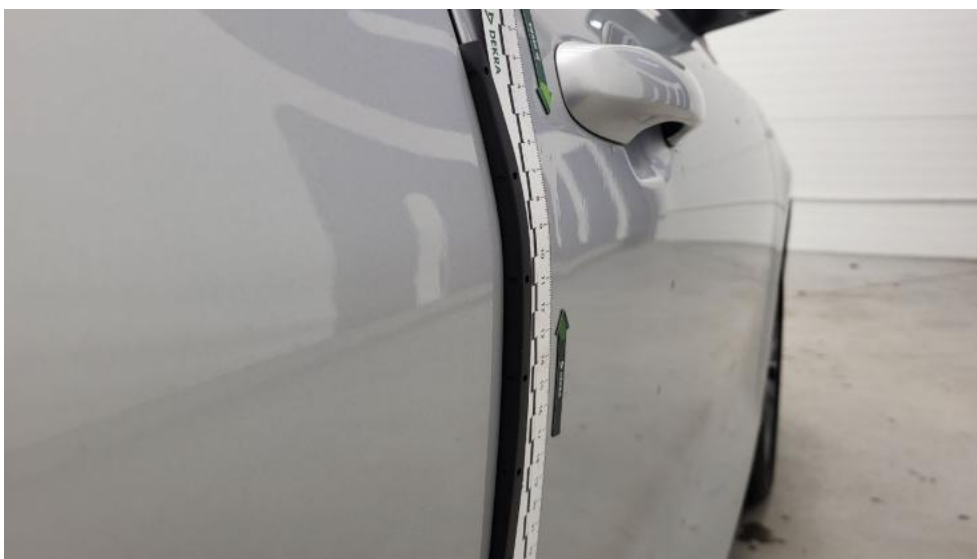
**Photo 47.**

Drzwi przednie P - Wgniecenie/odkształcenie 2

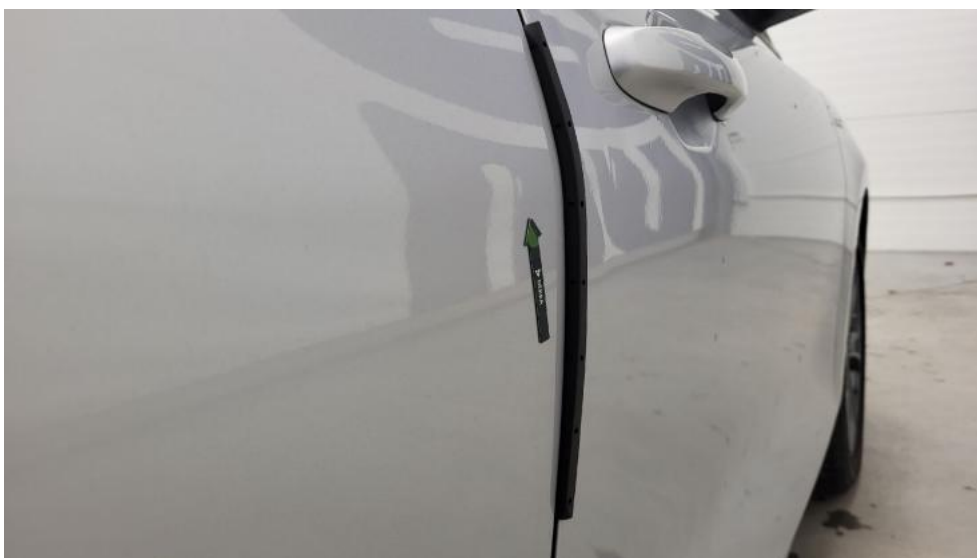
**Photo 48.**

Drzwi tylne P - Wgniecenie/odkształcenie 1

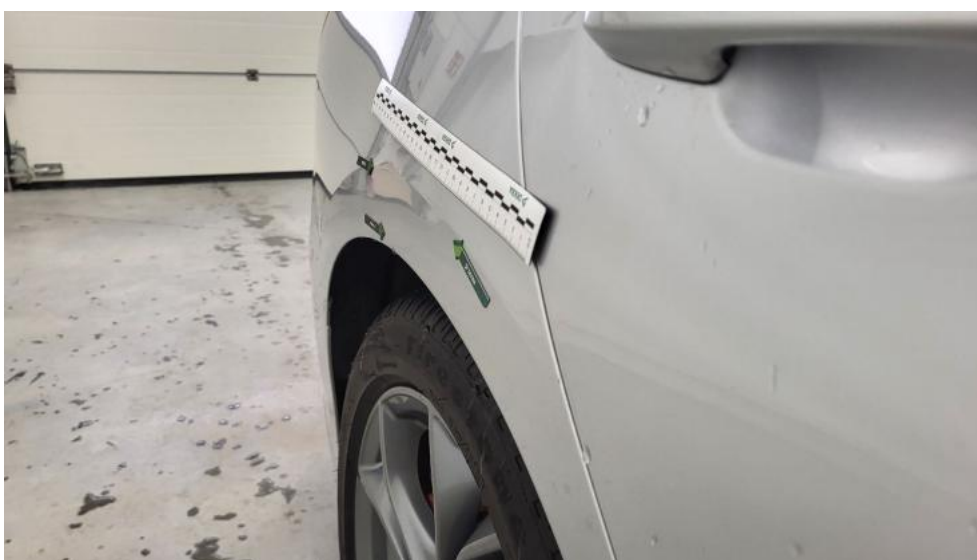
**Photo 50.**

Ścianka tylna P / Ścianka boczna P - Wgniecenie/odkształcenie 1

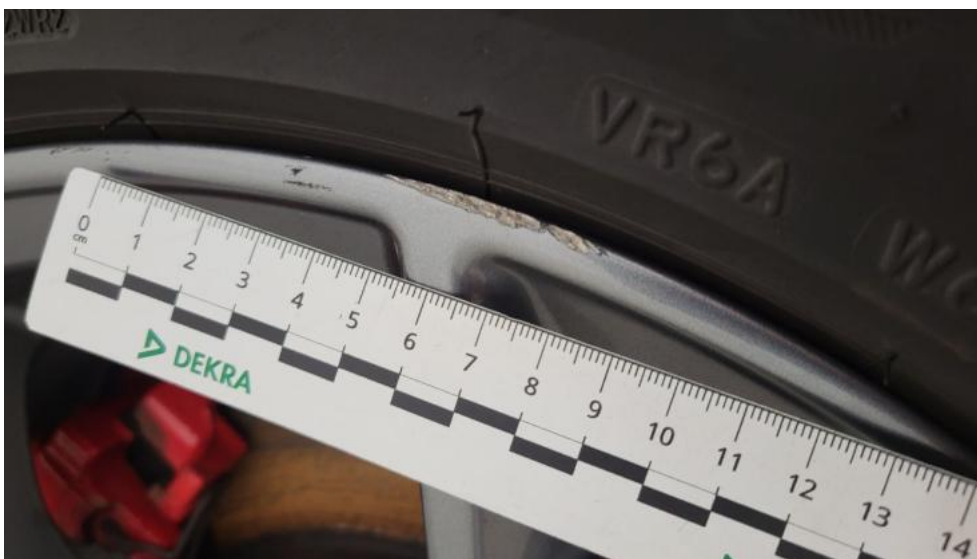
**Photo 51.**

Felga aluminiowa tylna P - Rysa/odprysk 1

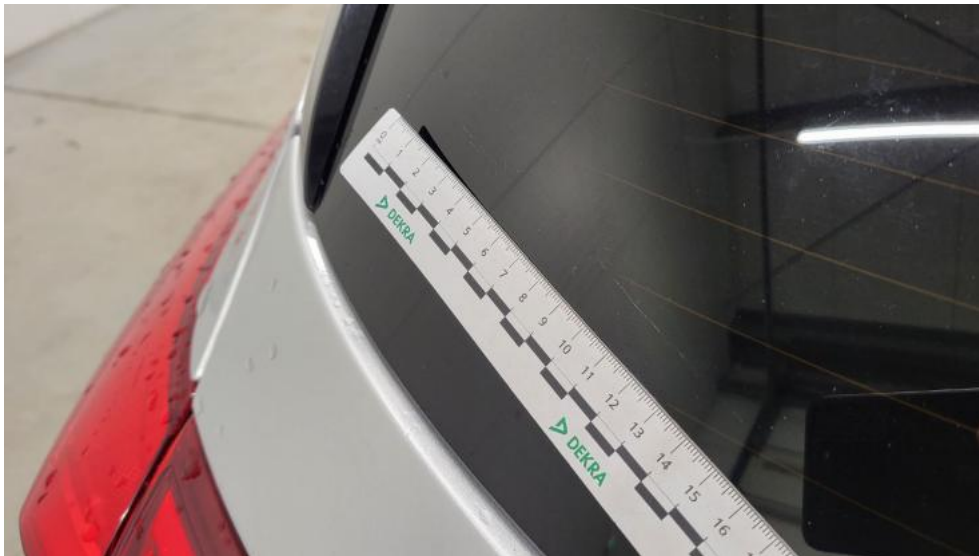
**Photo 53.**

Szyba tylna - Rysa/odprysk 1

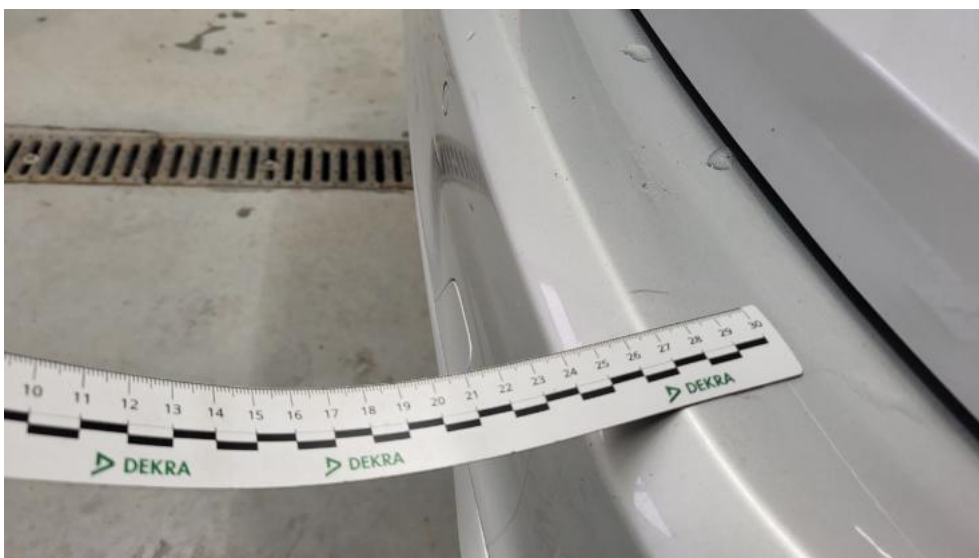
**Photo 54.**

Zderzak tylny - Rysa/odprysk 1

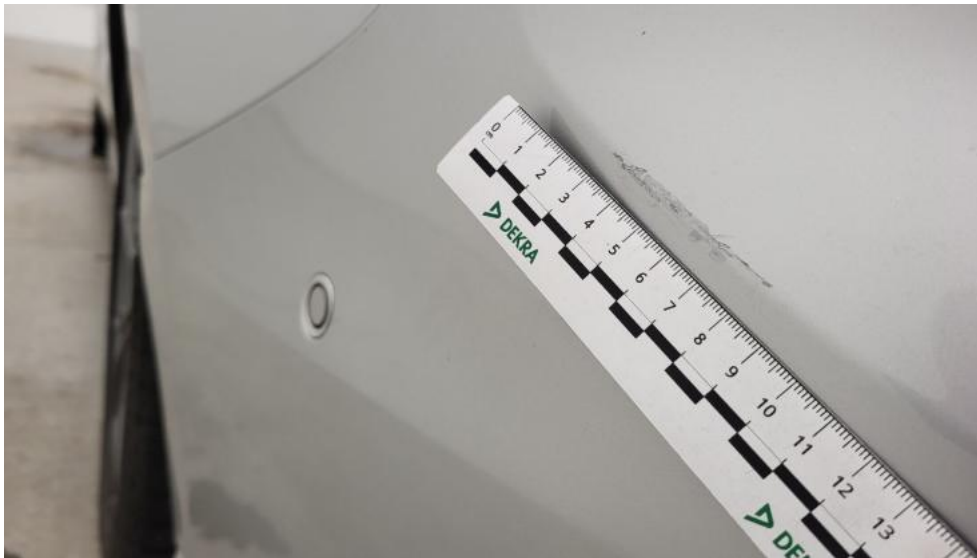
**Photo 55.**

Zderzak tylny - Inne 1

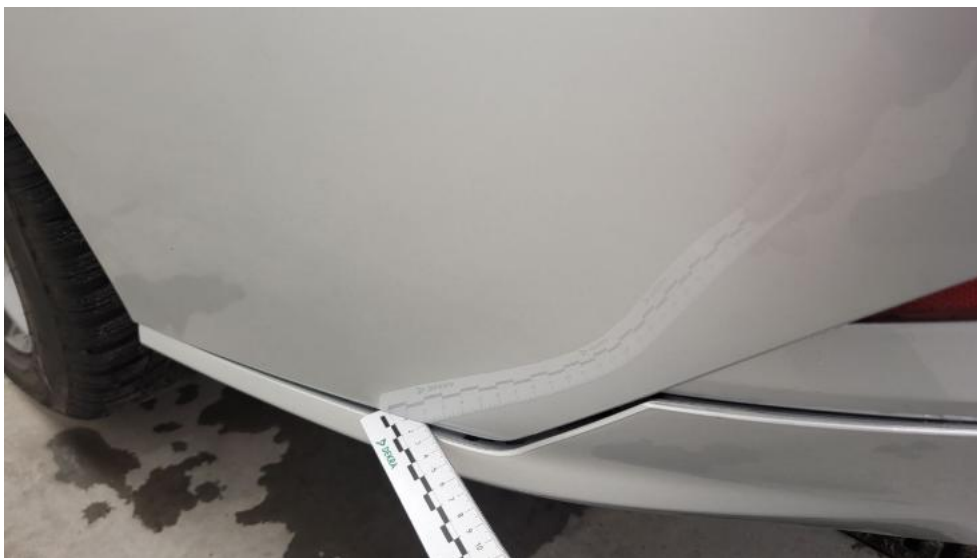
**Photo 56.**

Zderzak tylny cz dolna - Inne 1

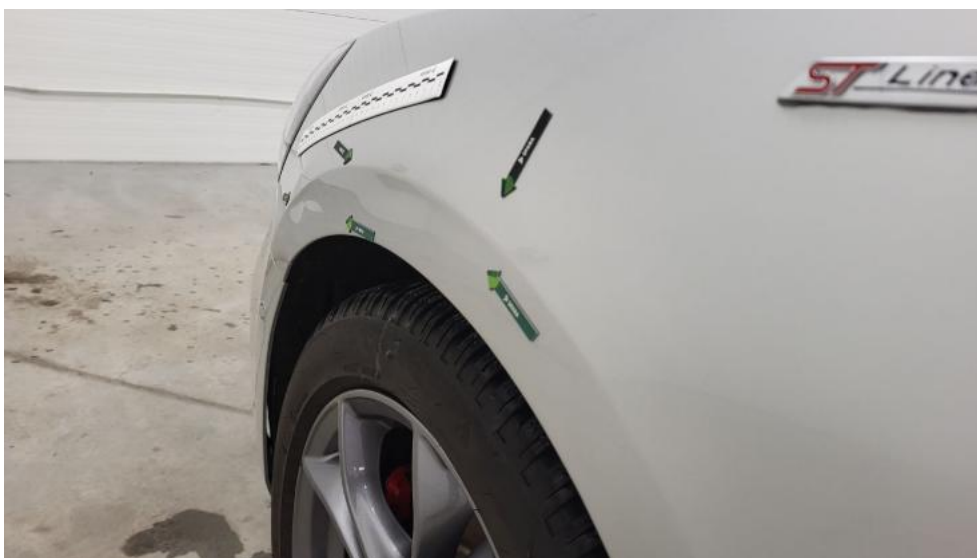
**Photo 66.**

| No. of controlled item | Controlled item | Measured range of thickness of the lacquer coat [ $\mu\text{m}$ ] |
|---|---|---|
| 2 | Front left fender | 150 - 300 |

Ślotnik przedni L - Wgniecenie/odkształcenie 1

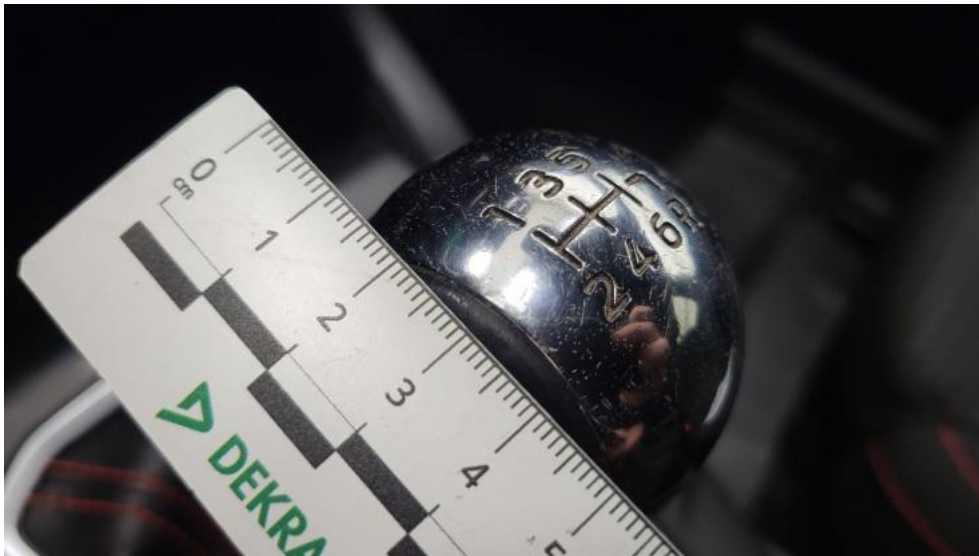
**Photo 67.**

Gałka dźwigni zmiany biegów - Rysa/odprysk 1

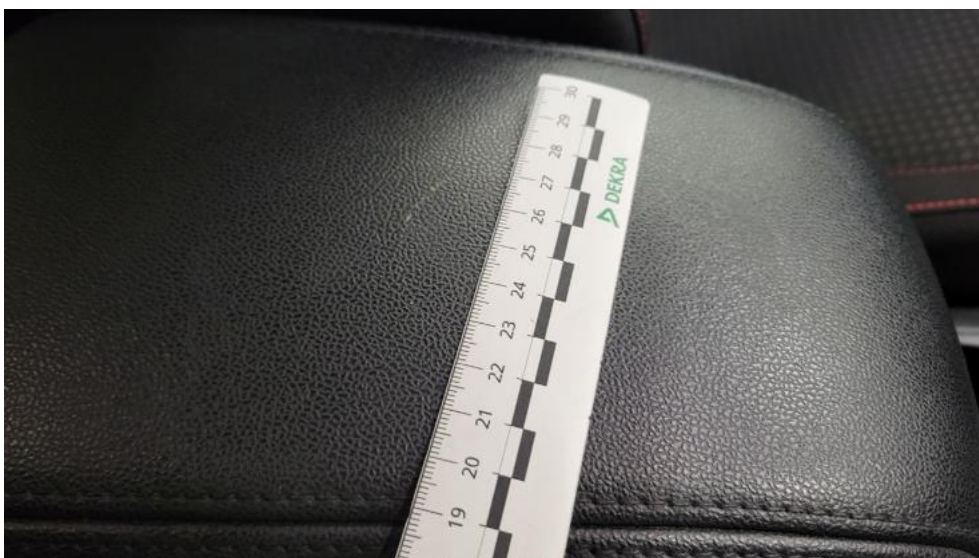
**Photo 68.**

Podłokietnik środkowy przedni - Rysa/odprysk 1

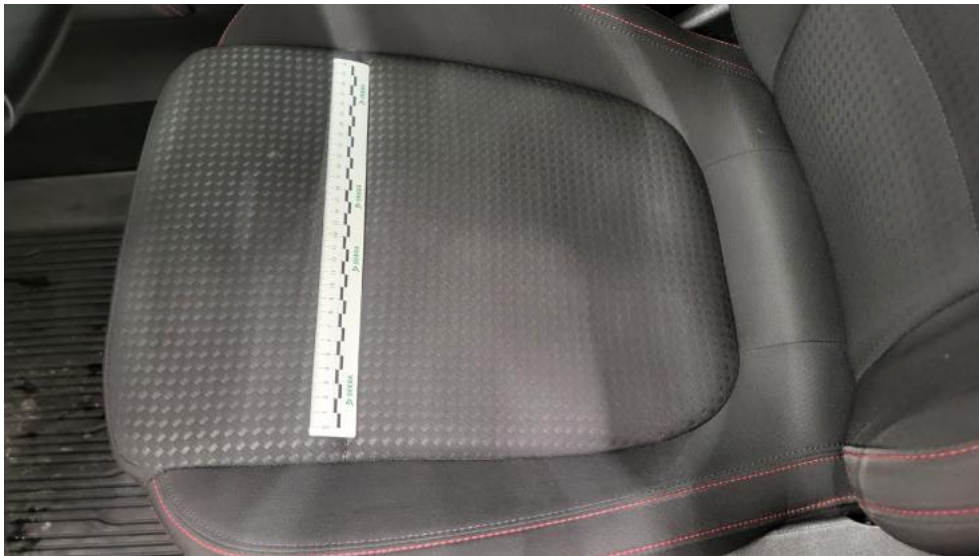
**Photo 69.**

Fotel prz. lew. - Inne 1

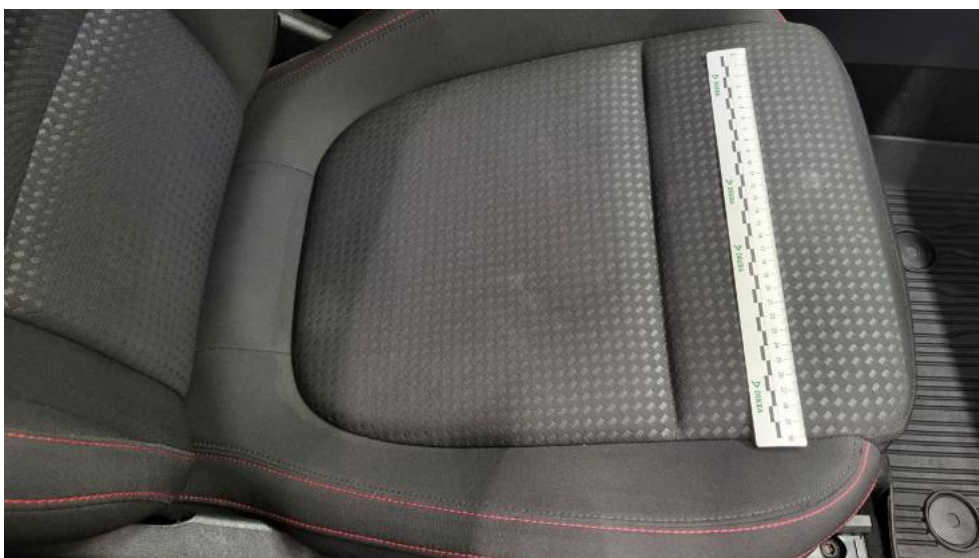
**Photo 70.**

Fotel prz. praw. - Inne 1
