DEKRA's commission No. : PKOL(W)/LODZ/37551/25/05/23  
commission/ damage No. : 21/047934  
Date of commission: 23-05-2025

| Model | Seria 4 Coupe [G22/G82] 20-24 |
| Type / version | M4 Competition M xDrive sport-aut |
| VIN / serial number | WBS41AZ000CL18067 |

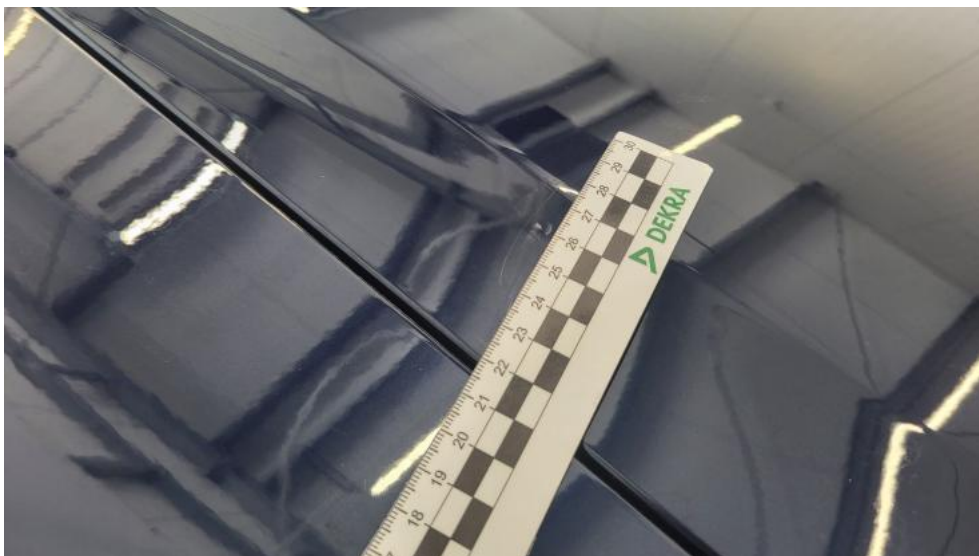
**Photo 42.**

Pokrywa komory silnika - Rysa/odprysk 1

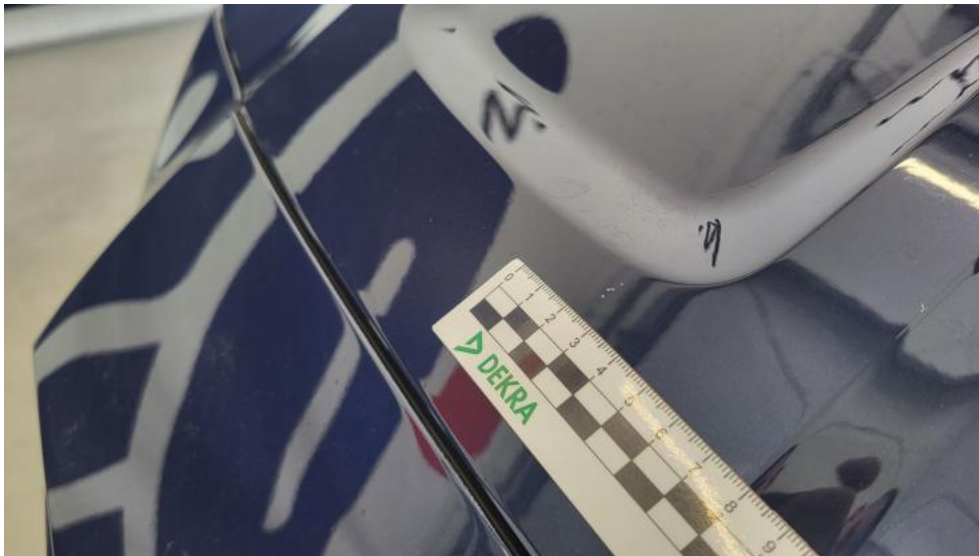
**Photo 43.**

Pokrywa komory silnika - Rysa/odprysk 2

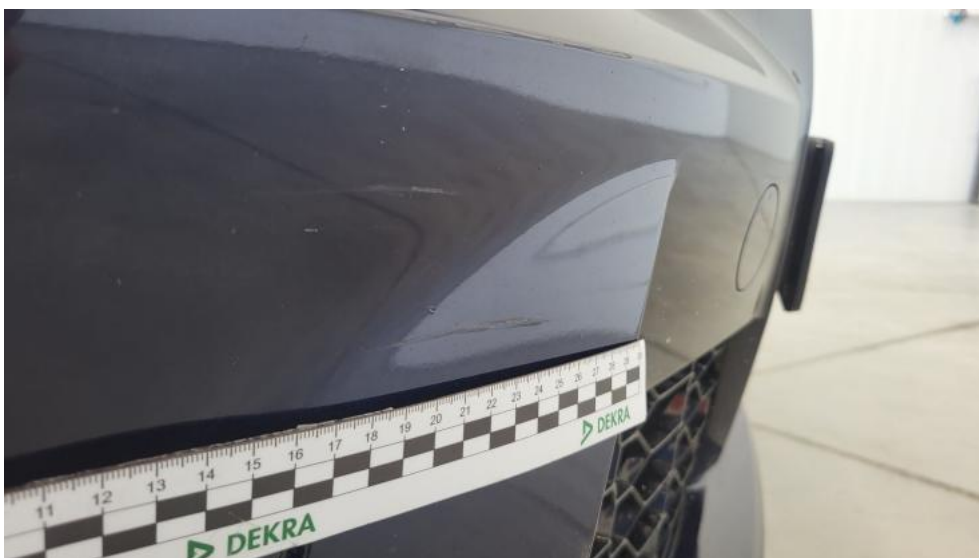
**Photo 44.**

Zderzak - Rysa/odprysk 1

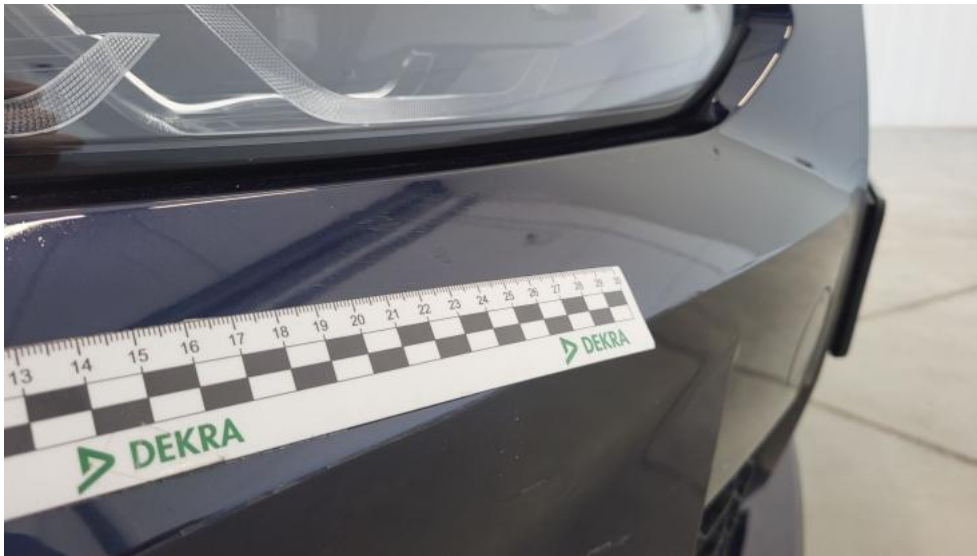
**Photo 45.**

Zderzak - Rysa/odprysk 2

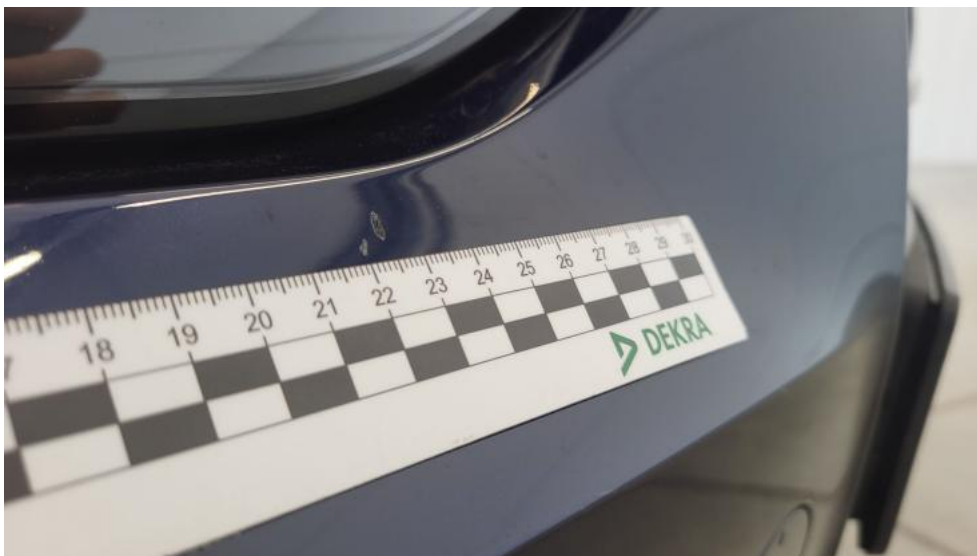
**Photo 46.**

Zderzak() - Rysa/odprysk 3

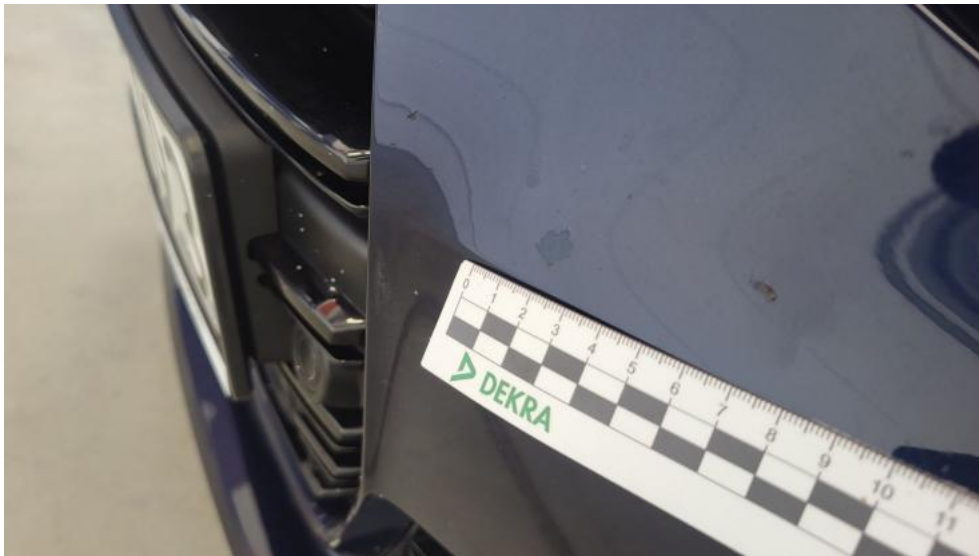
**Photo 47.**  
Zderzak - Inne 1

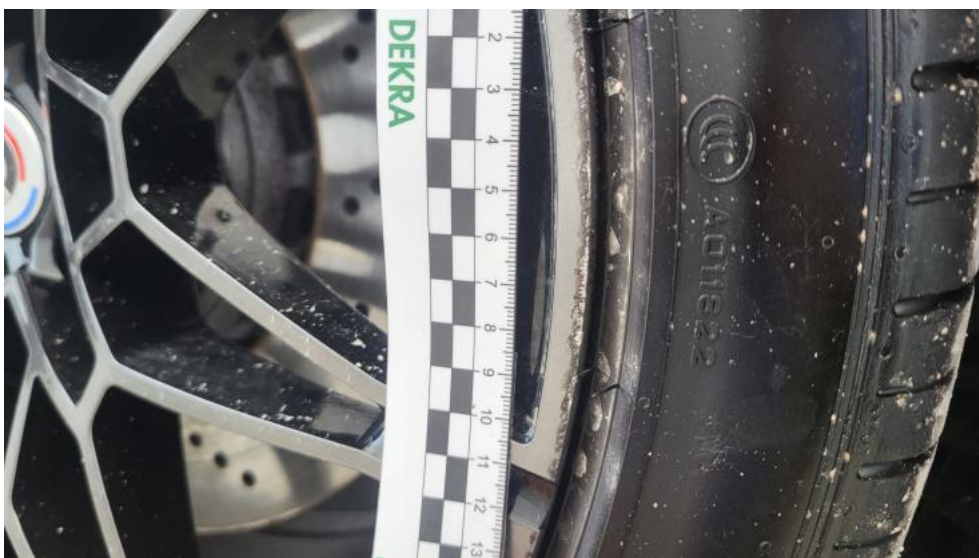
**Photo 48.**  
Felga aluminiowa przednia P - Rysa/odprysk 1

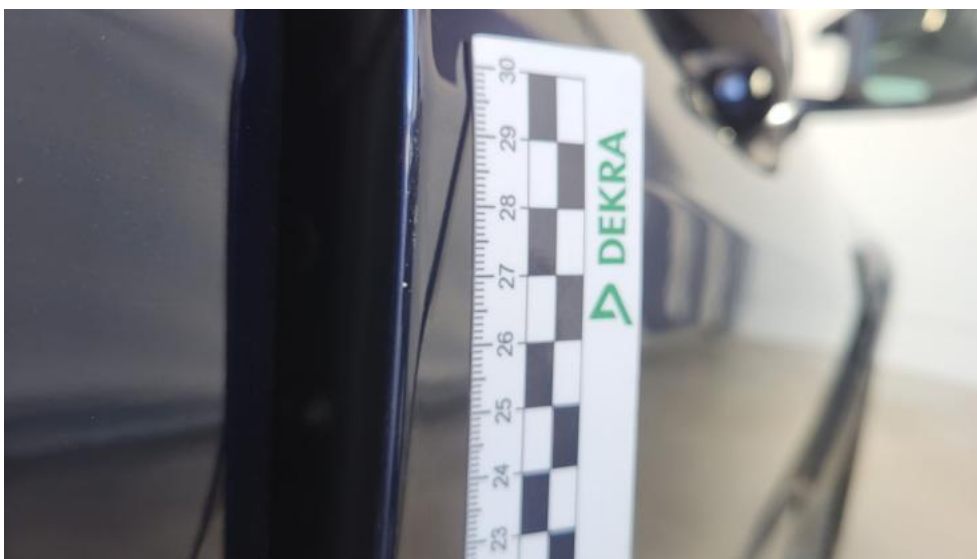
**Photo 49.**

Drzwi przednie P - Rysa/odprysk 1

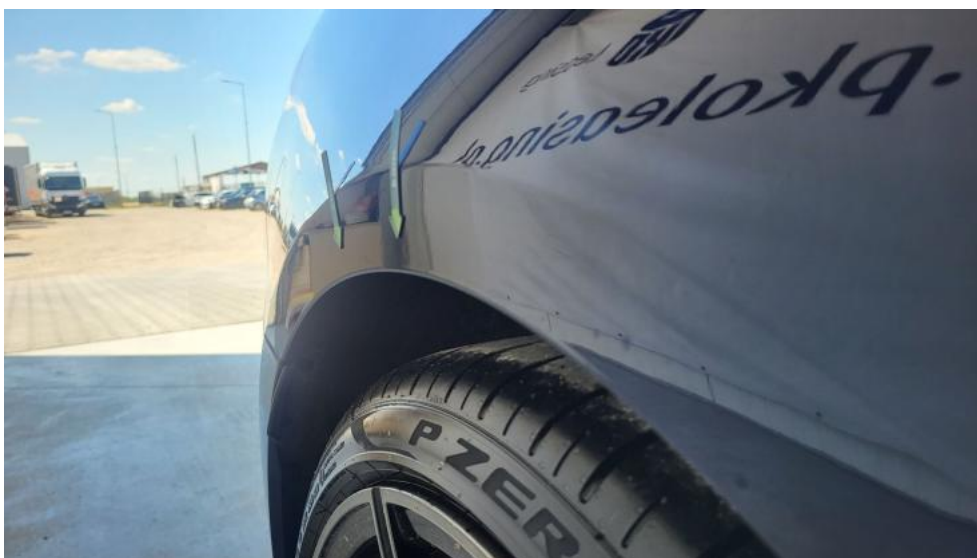
**Photo 50.**

Łotnik tylny P / Ściana boczna P - Wgniecenie/odkształcenie 1

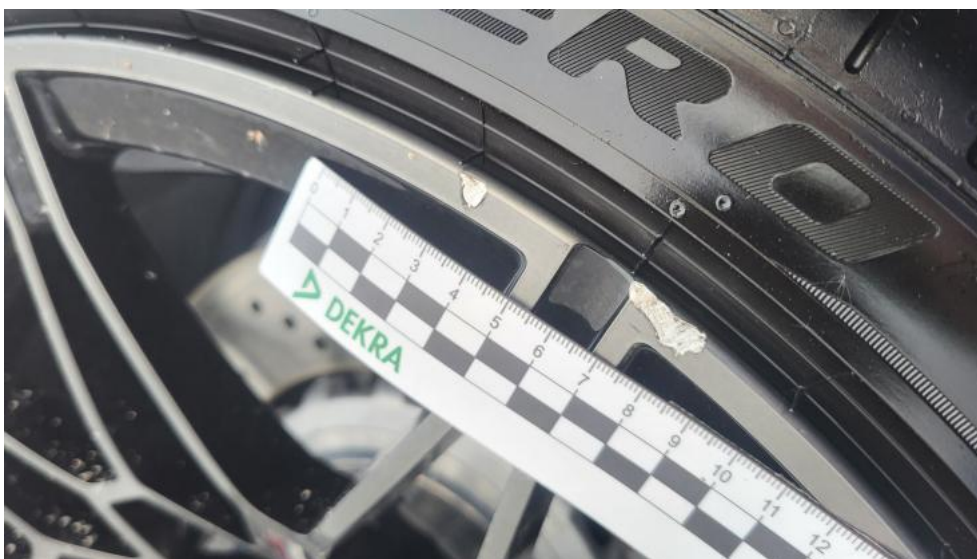
**Photo 51.**

Felga aluminiowa tylna P - Rysa/odprysk 1

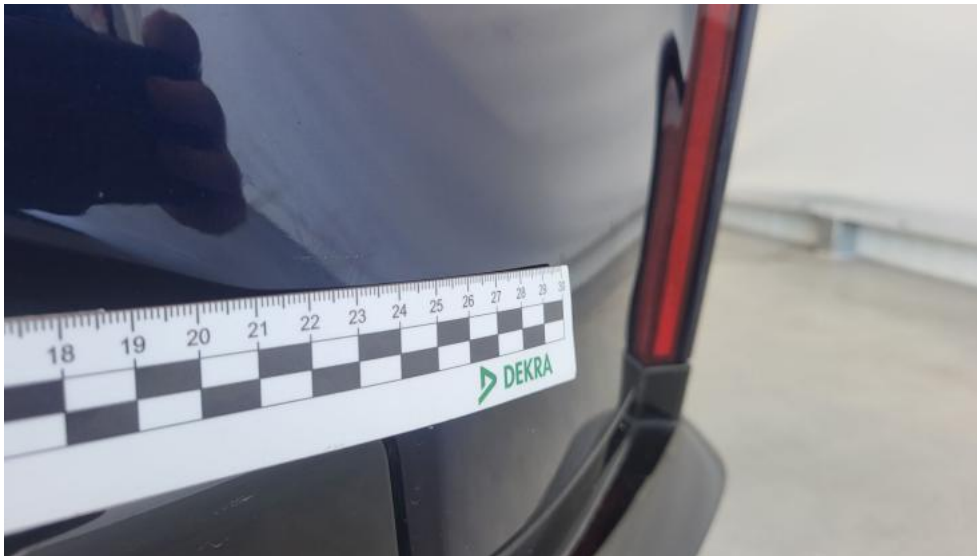
**Photo 53.**

Zderzak tylny - Rysa/odprysk 1

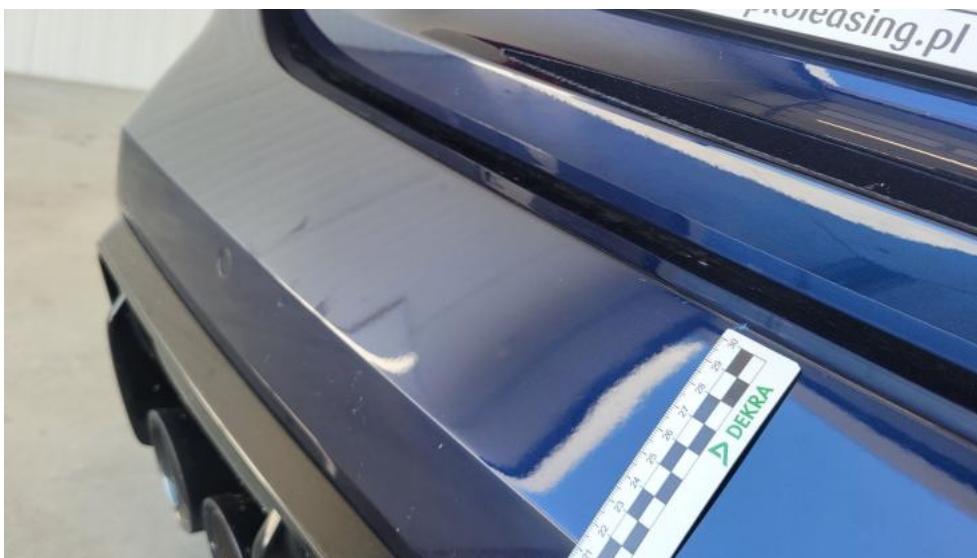
**Photo 54.**

Zderzak tylny - Wgniecenie/odkształcenie 1

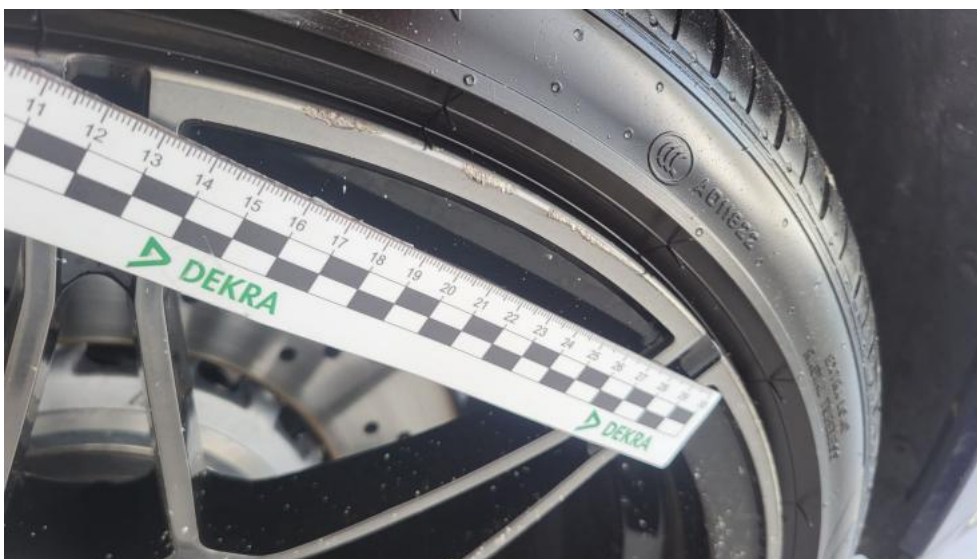
**Photo 55.**

Felga aluminiowa tylna L - Rysa/odprysk 1

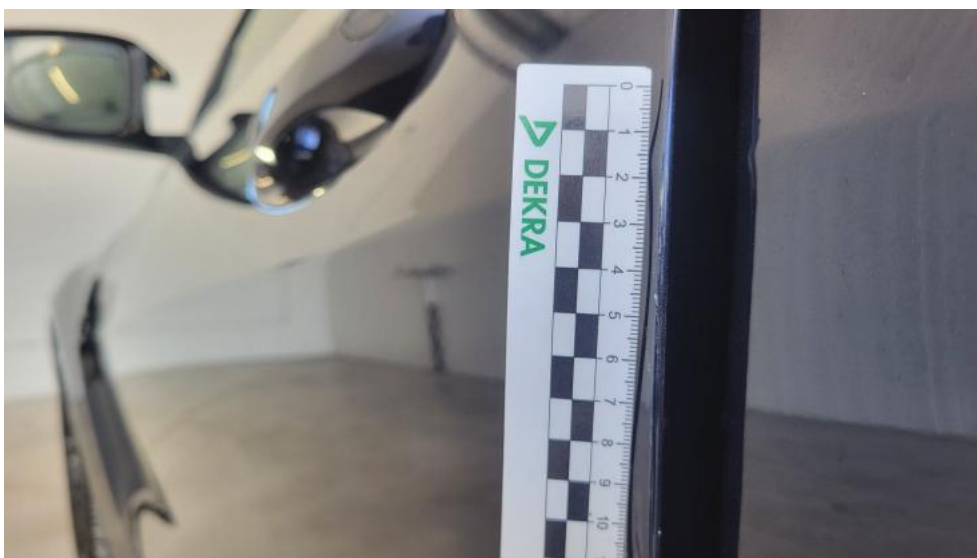
**Photo 56.**

Drzwi przed L - Rysa/odprysk 1

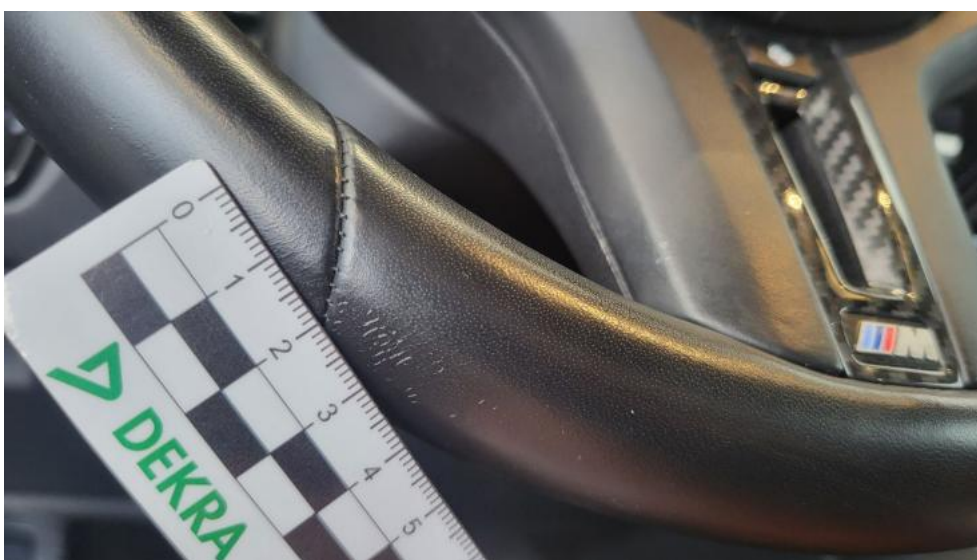
**Photo 58.**

Koło kierownicy - Rysa/odprysk 1

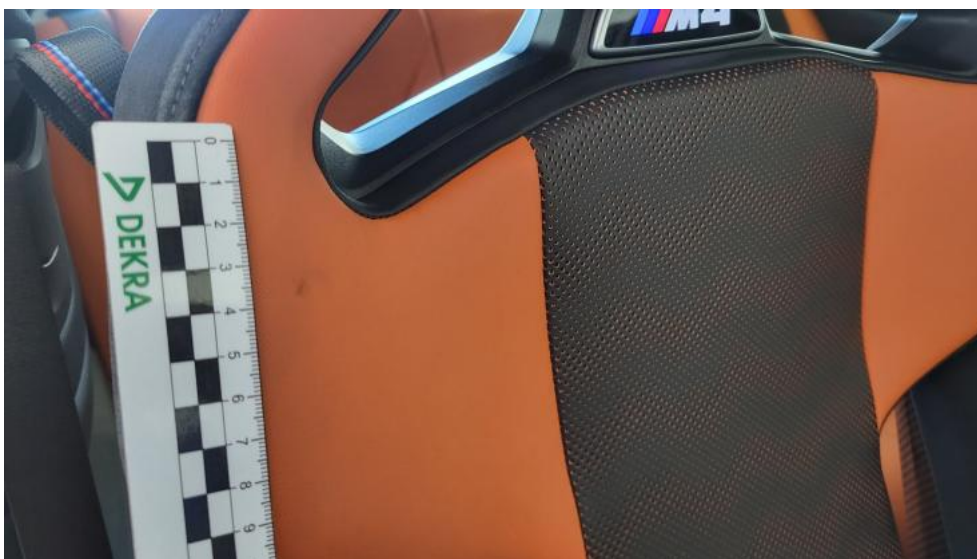
**Photo 59.**

Fotel prz. praw. - Inne 1

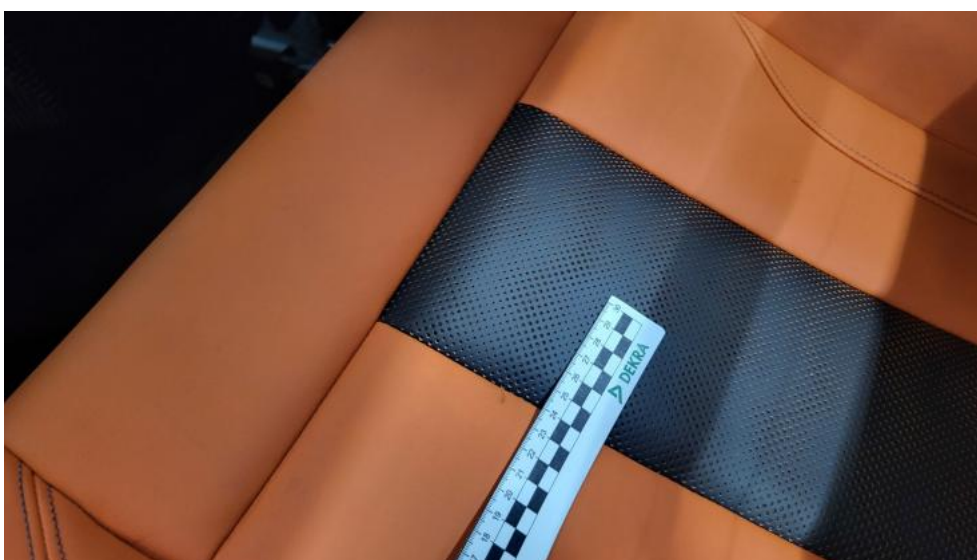
**Photo 60.**

Kanapa tyl. - Inne 1

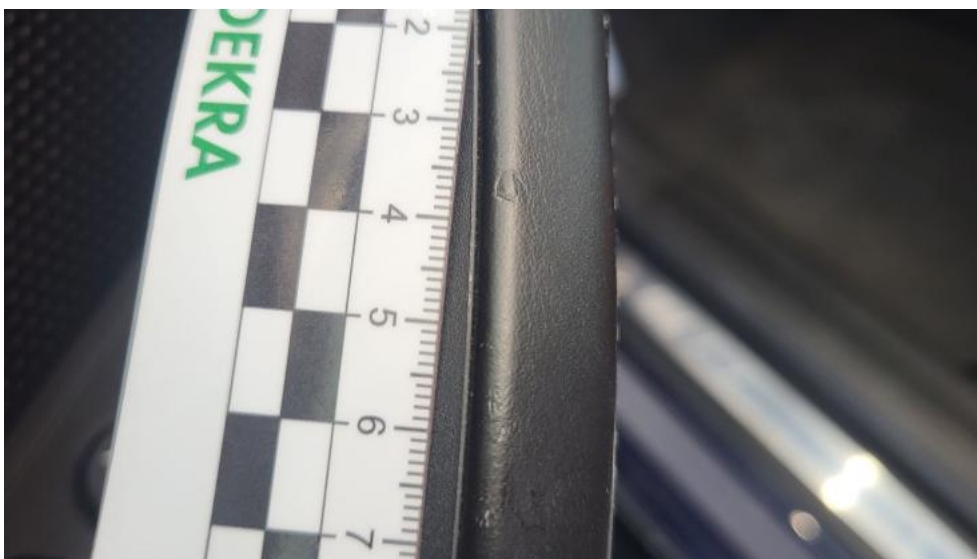
**Photo 61.**

Uchwyt drzwi prze L - Inne 1
