DEKRA's commission No. : PKOL(W)/LODZ/28797/25/04/22  
commission/ damage No. : 19/045563  
Date of commission: 22-04-2025

**Vehicle data**

| Manufacturer | INFINITI |
| Type / version | Q50 2.0t Sport aut |

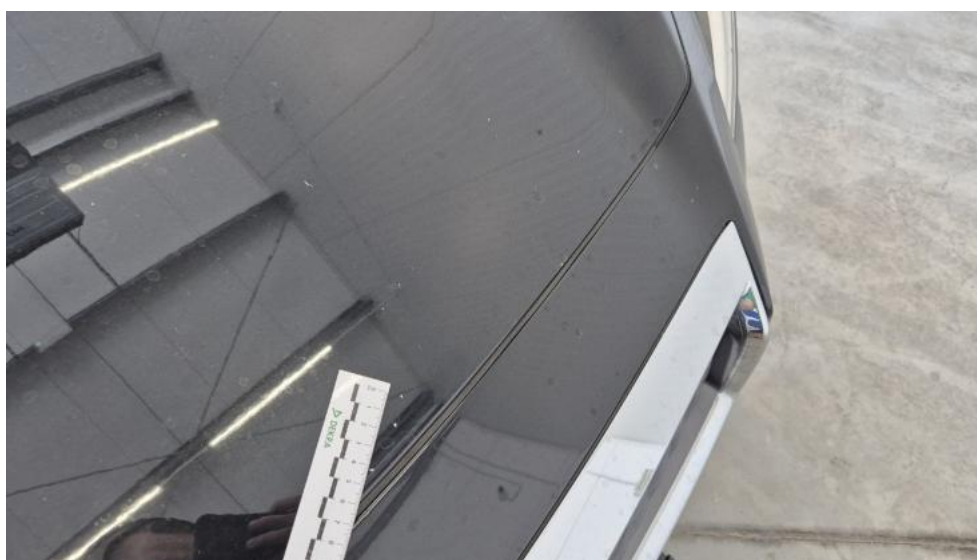
**Photo 34.**

Pokrywa komory silnika - Rysa/odprysk 1

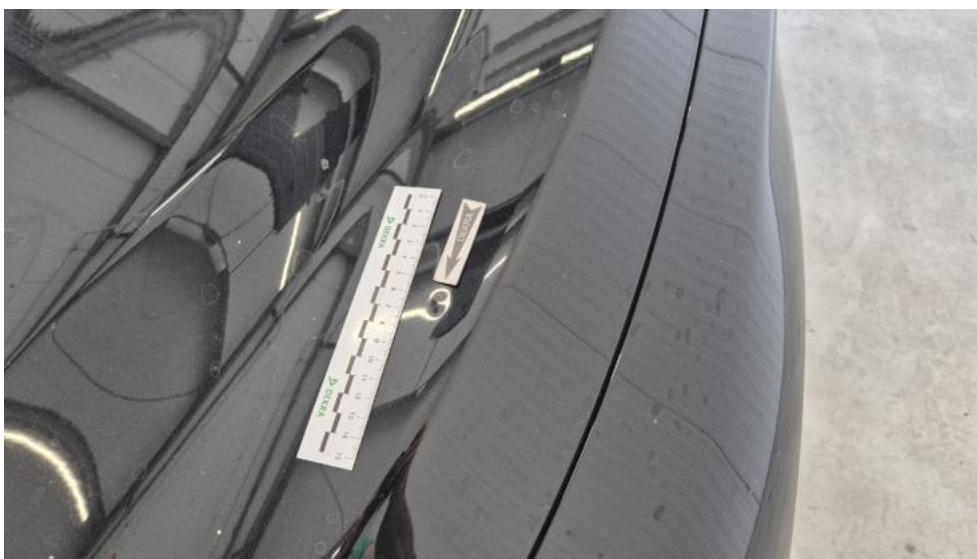
**Photo 35.**

Pokrywa komory silnika - Wgniecenie/odkształcenie 1

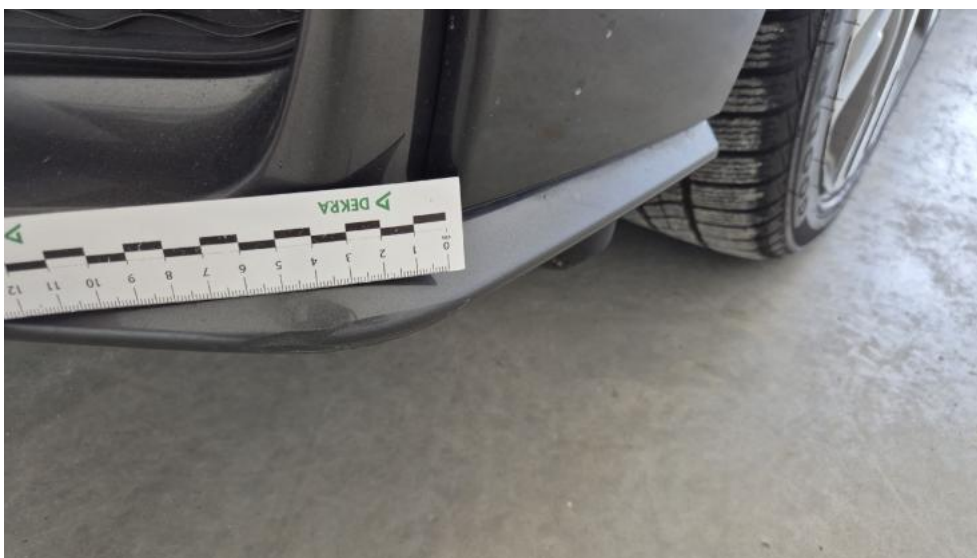
**Photo 36.**

Spoiler zderzaka przedniego - Rysa/odprysk 1

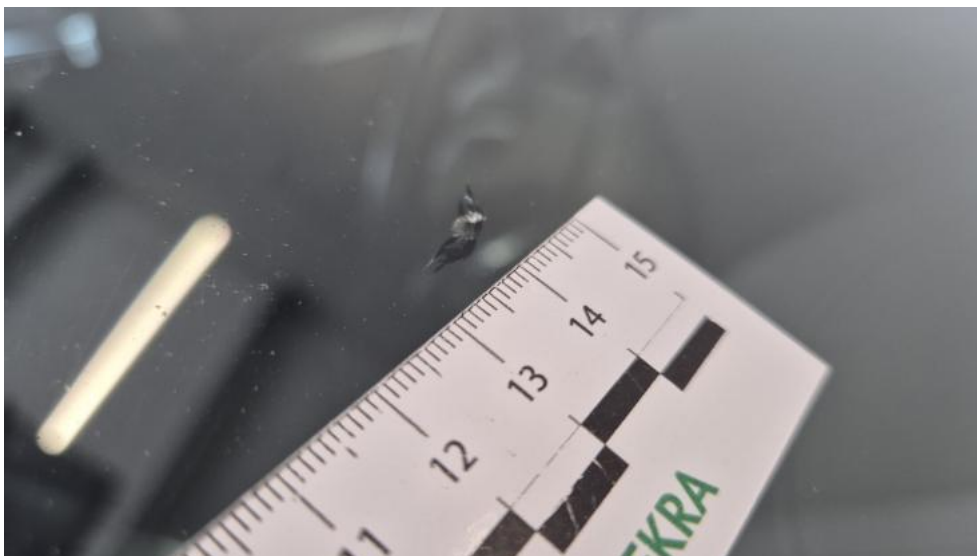
**Photo 38.**

Szyba czołowa - Pęknięcie/rozerwanie 1

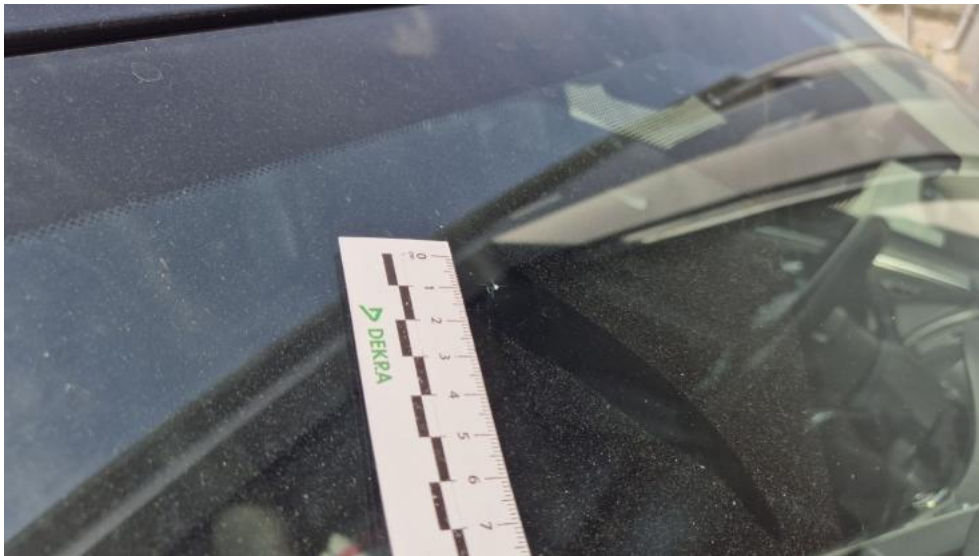
**Photo 39.**

Szyba czołowa - Pęknięcie/rozerwanie 2

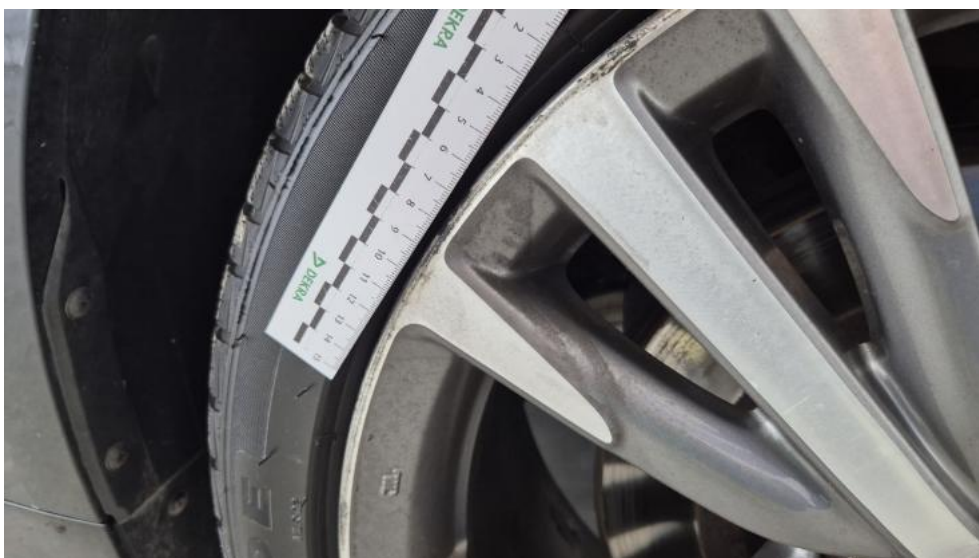
**Photo 40.**

Felga aluminiowa przednia P - Rysa/odprysk 1

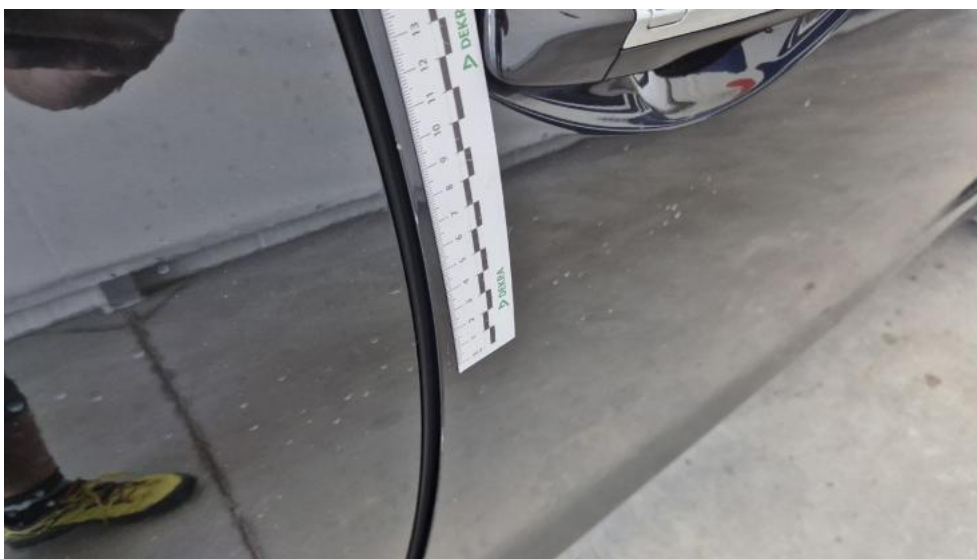
**Photo 41.**

Drzwi przednie P - Rysa/odprysk 1

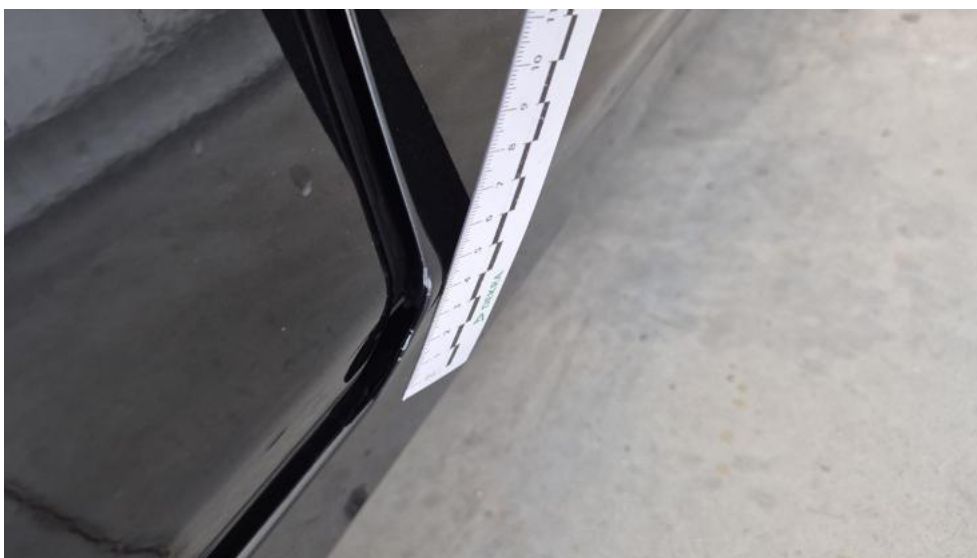
**Photo 42.**

Drzwi przednie P - Rysa/odprysk 2

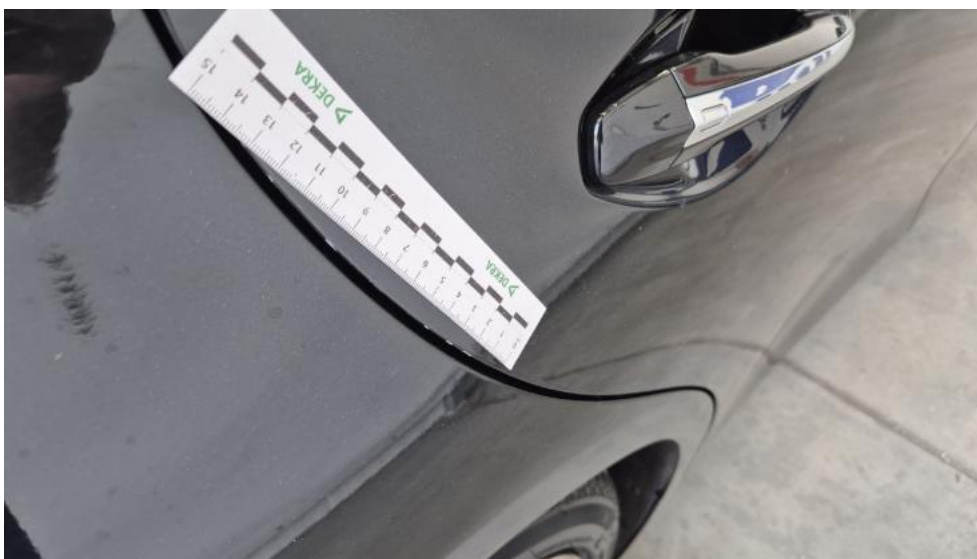
**Photo 43.**

Drzwi tylne P - Rysa/odprysk 1

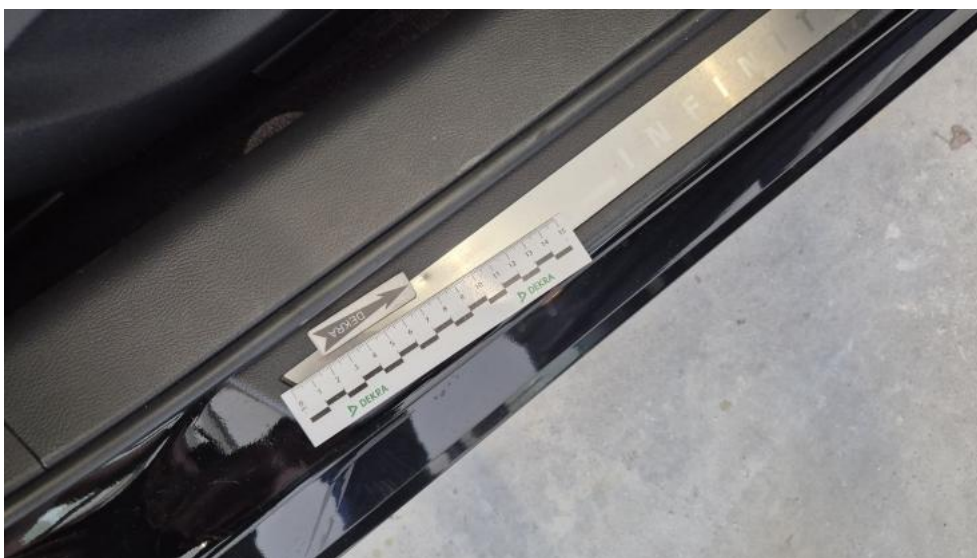
**Photo 44.**

Próg P - Wgniecenie/odkształcenie 1

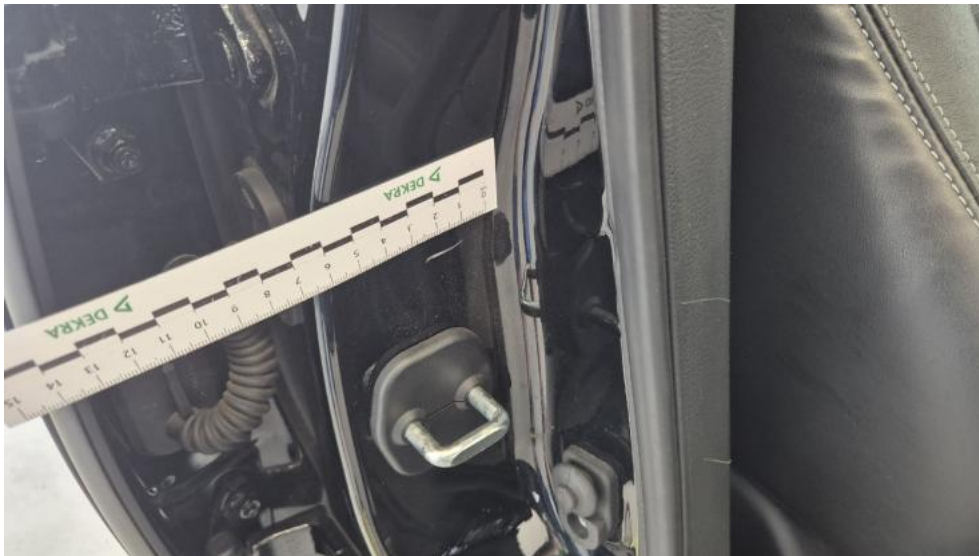
**Photo 45.**

Słupki środkowy P - Rysa/odprysk 1

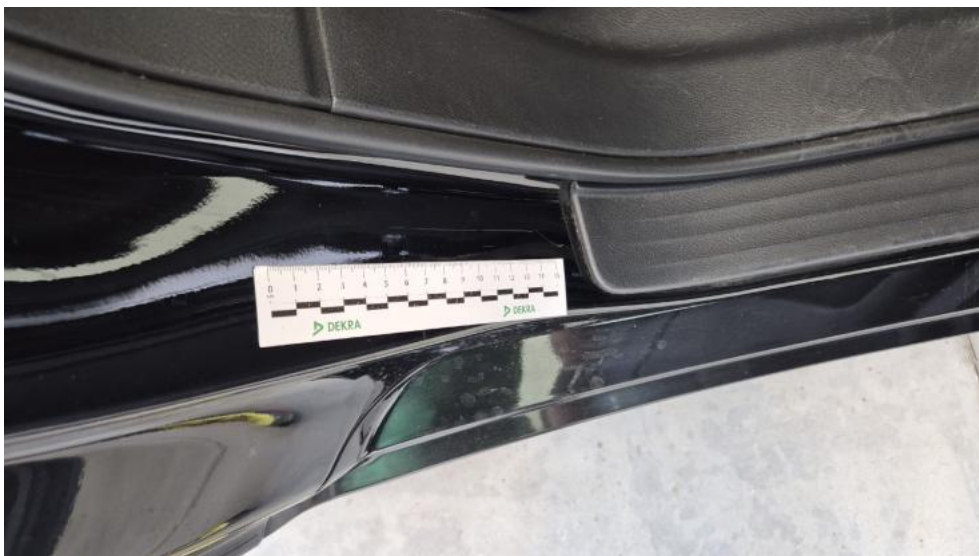
**Photo 46.**

Błotnik tylny P / Ściana boczna P - Rysa/odprysk 1

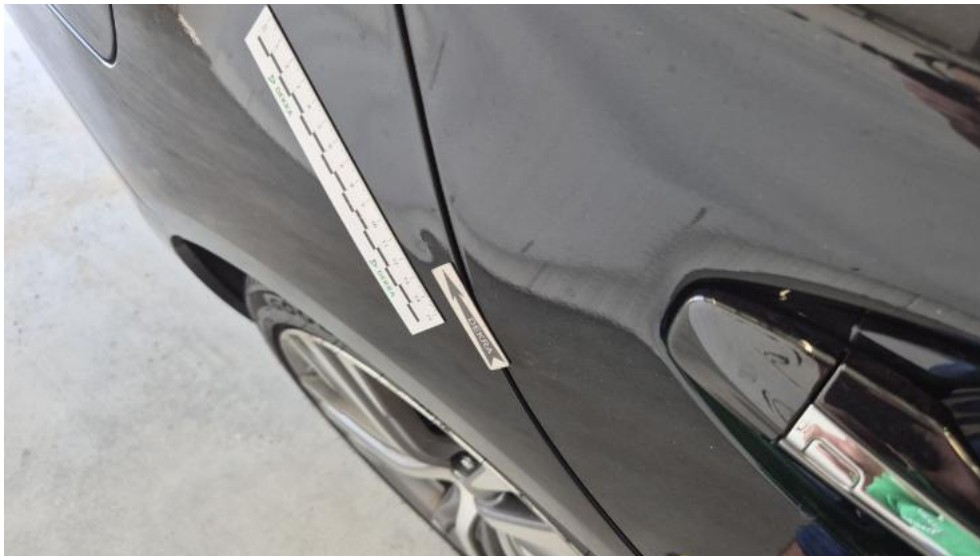
**Photo 47.**

Błotnik tylny P / Ściana boczna P - Wgniecenie/odkształcenie 1

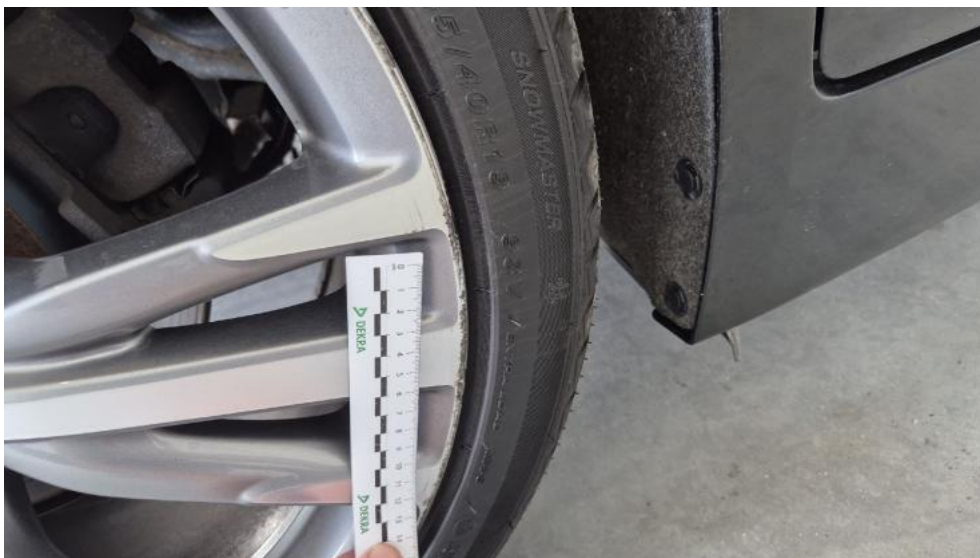
**Photo 48.**

Felga aluminiowa tylna P - Rysa/odprysk 1

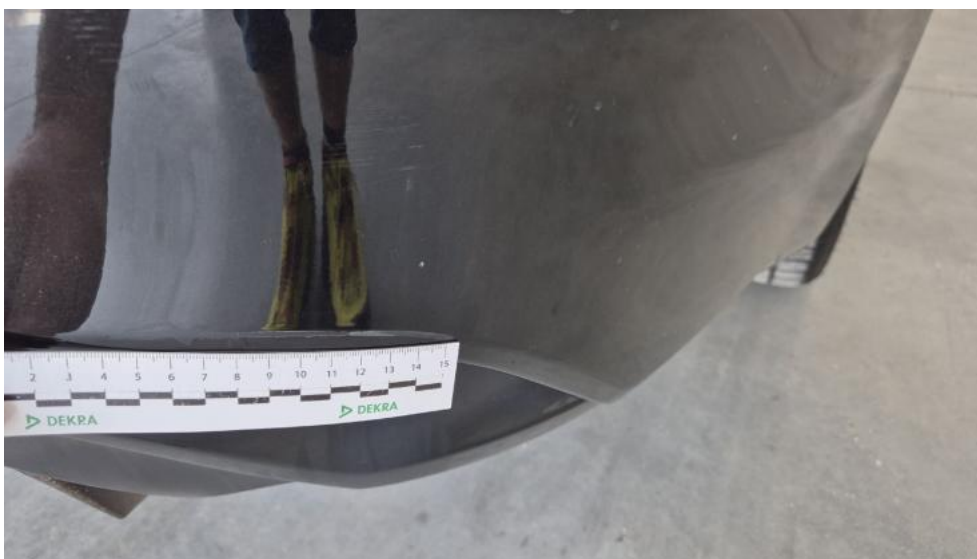
**Photo 49.**

Zderzak tylny - Rysa/odprysk 1

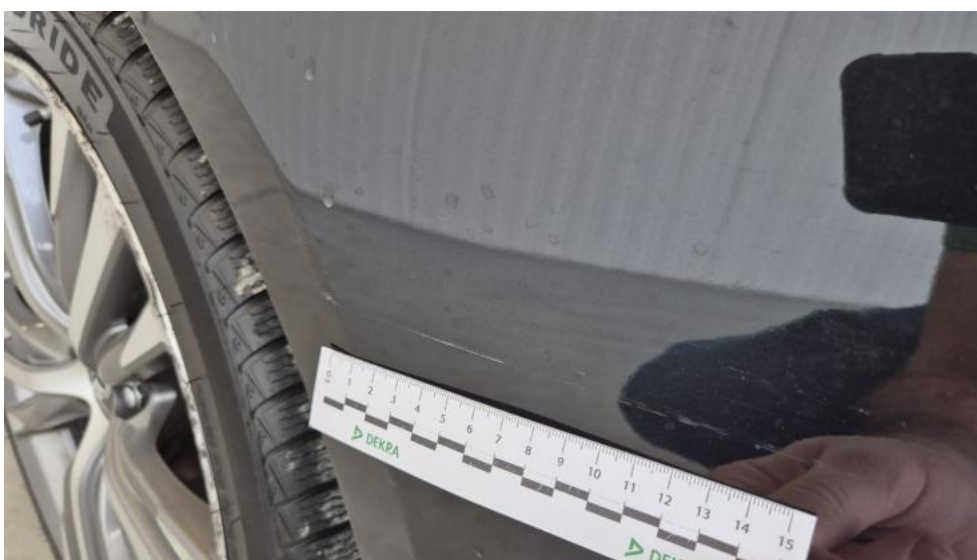
**Photo 50.**

Zderzak tylny - Rysa/odprysk 2

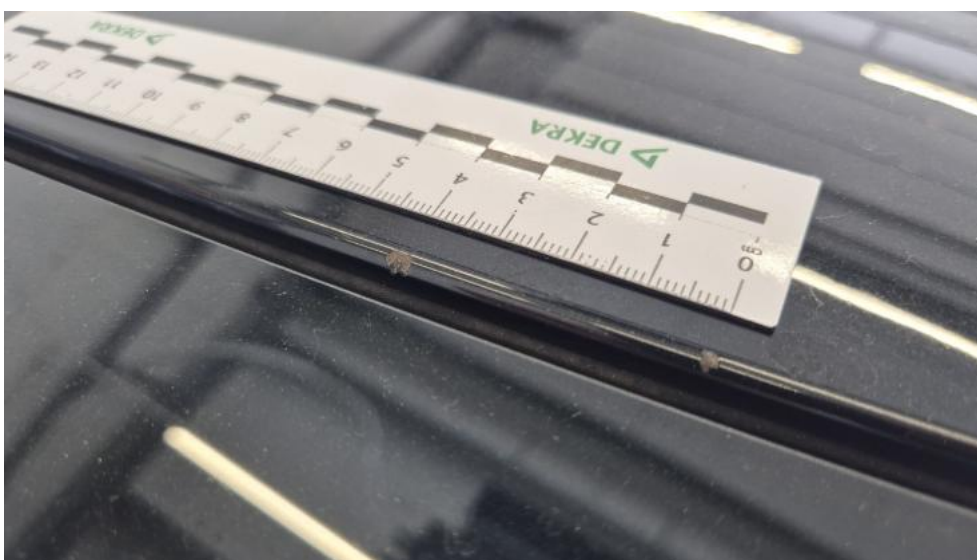
**Photo 52.**

Dach - Inne 1

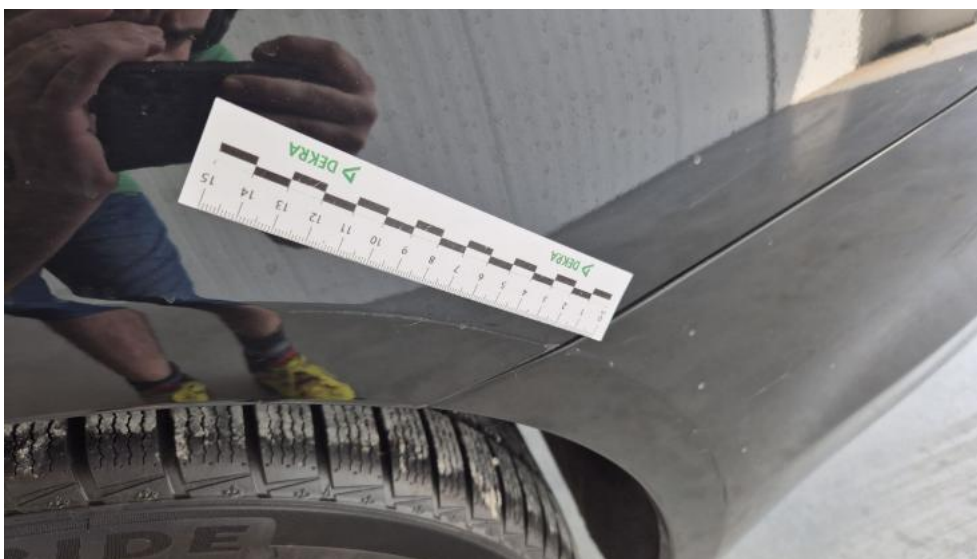
**Photo 53.**

Błotnik tylny L / Ściana boczna L - Rysa/odprysk 1

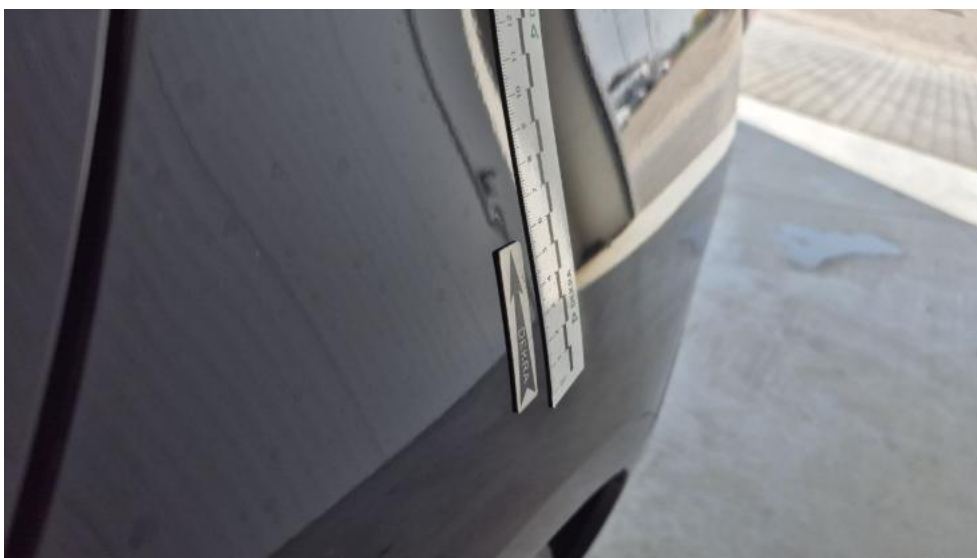
**Photo 54.**

Błotnik tylny L / Ściana boczna L - Wgniecenie/odkształcenie 1

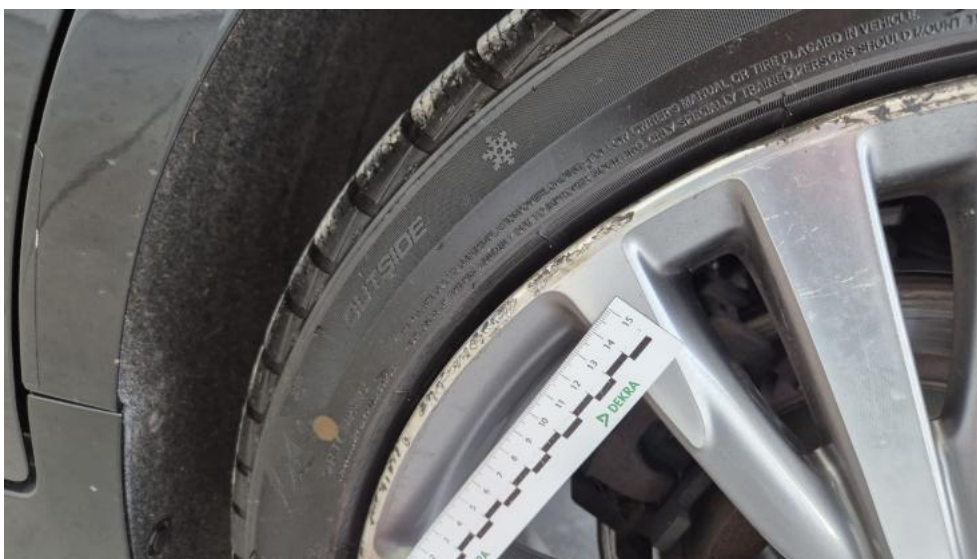
**Photo 55.**

Felga aluminiowa tylna L - Rysa/odprysk 1

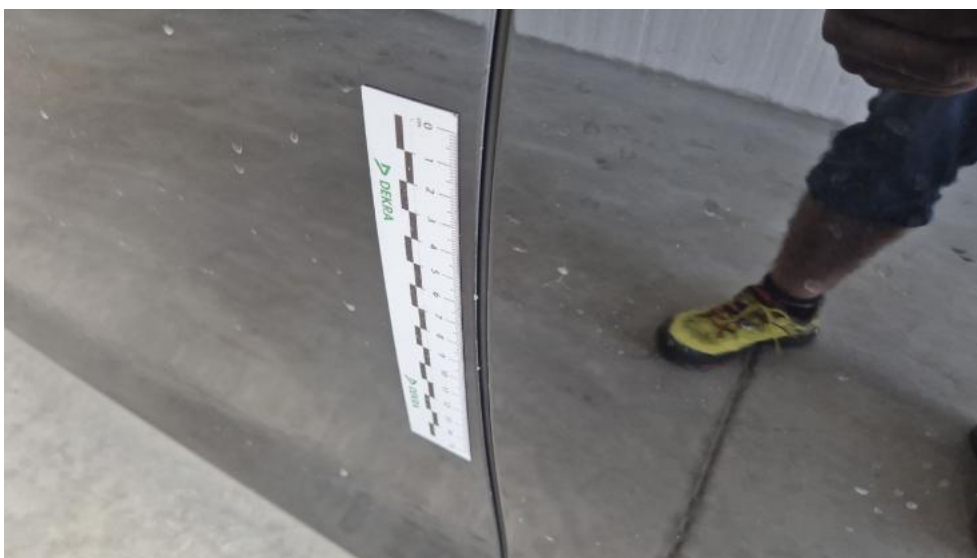
**Photo 56.**

Drzwi przed L - Rysa/odprysk 1

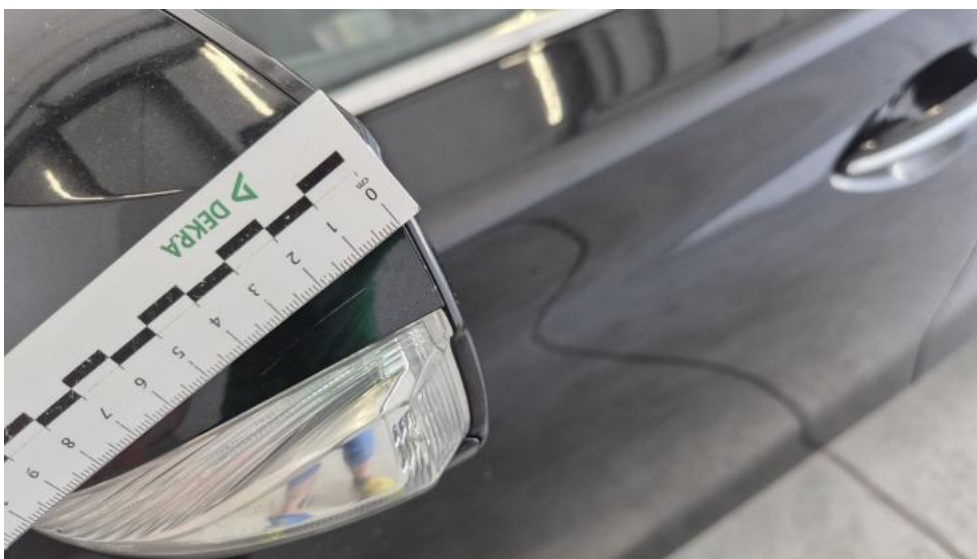
**Photo 57.**

Lusterko zew L - Rysa/odprysk 1

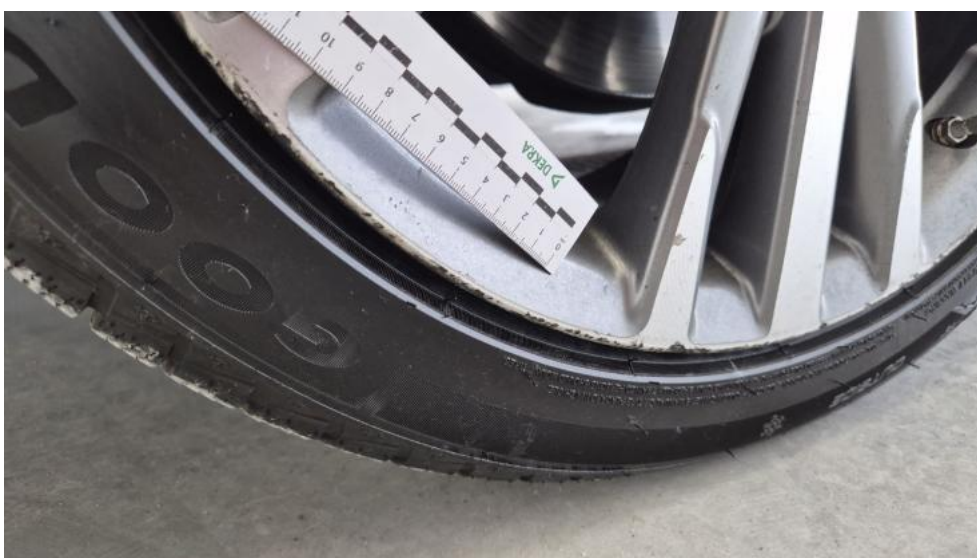
**Photo 58.**

Felga Aluminiowa przednia L - Rysa/odprysk 1

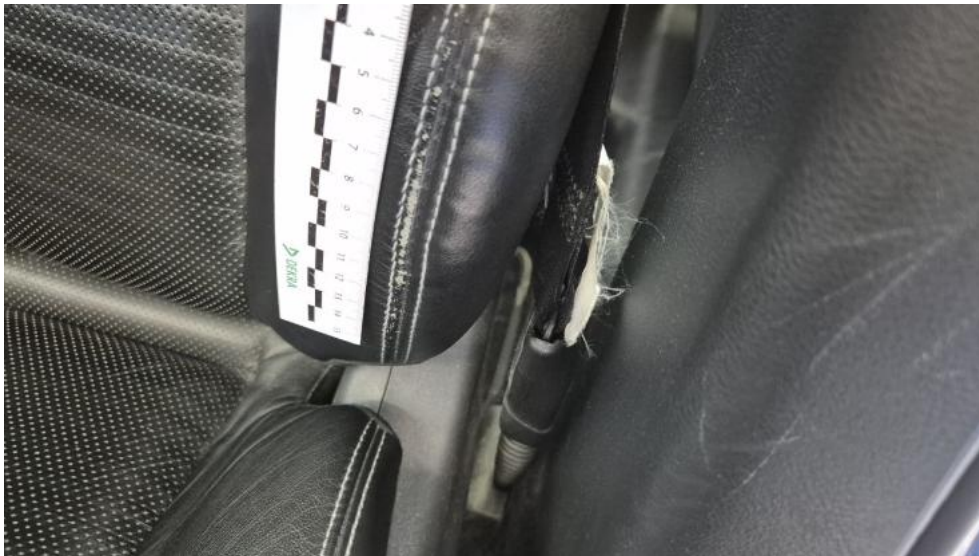
**Photo 59.**

Fotel prz. lew. - Inne 1

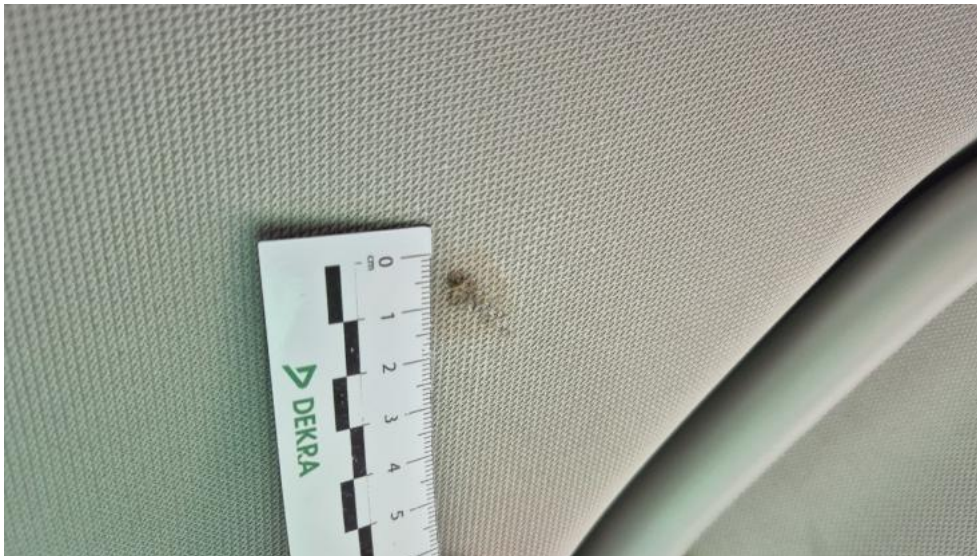
**Photo 61.**

Podsufitka - Inne 1

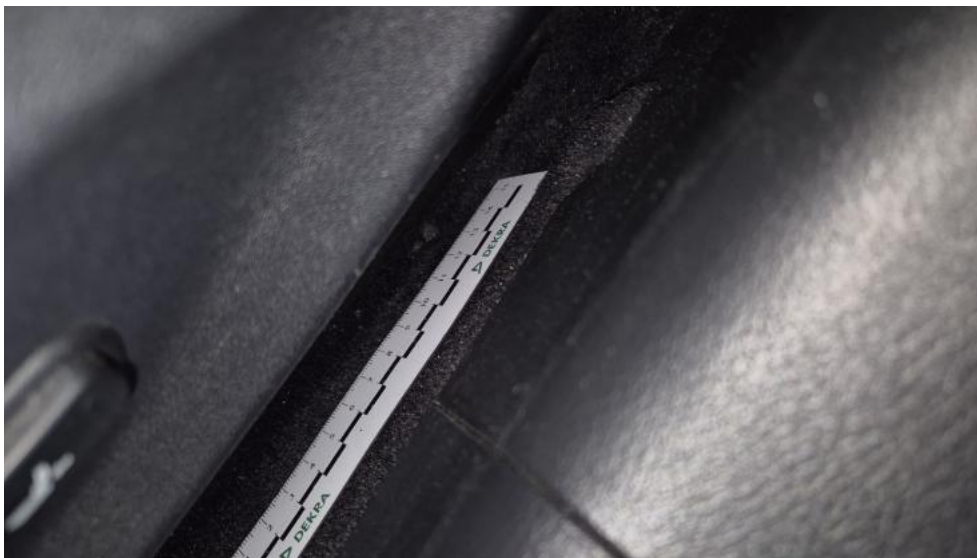
**Photo 63.**

Wykładzina podłogi - Inne 1
