DEKRA's commission No. : PKOL(W)/LODZ/29850/25/04/25  
commission/ damage No. : 24/001255  
Date of commission: 25-04-2025

| Manufacturer | MERCEDES-BENZ |
| Type / version | AMG GLE Coupe 43 4-Matic |
| Registration /record No. | FG3173R |

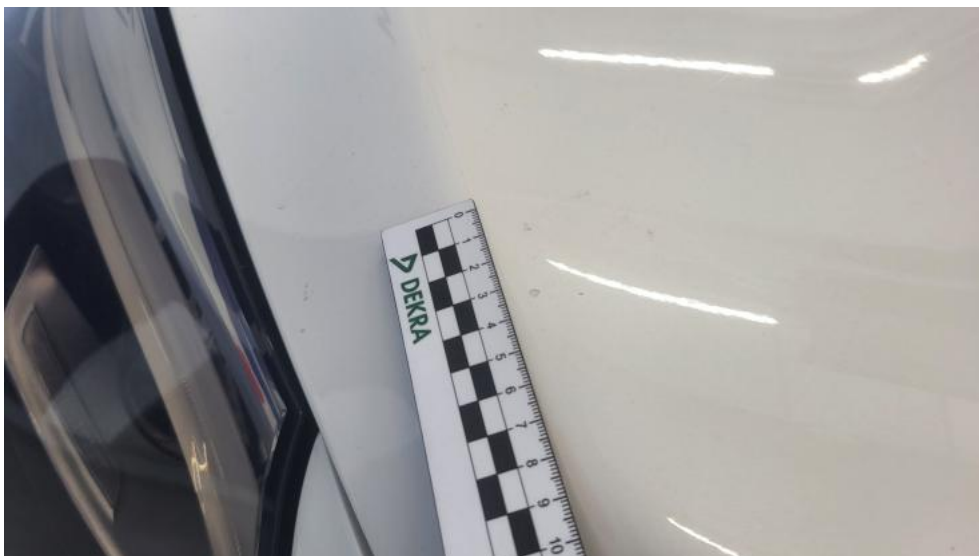
**Photo 42.**

Pokrywa komory silnika - Rysa/odprysk 1

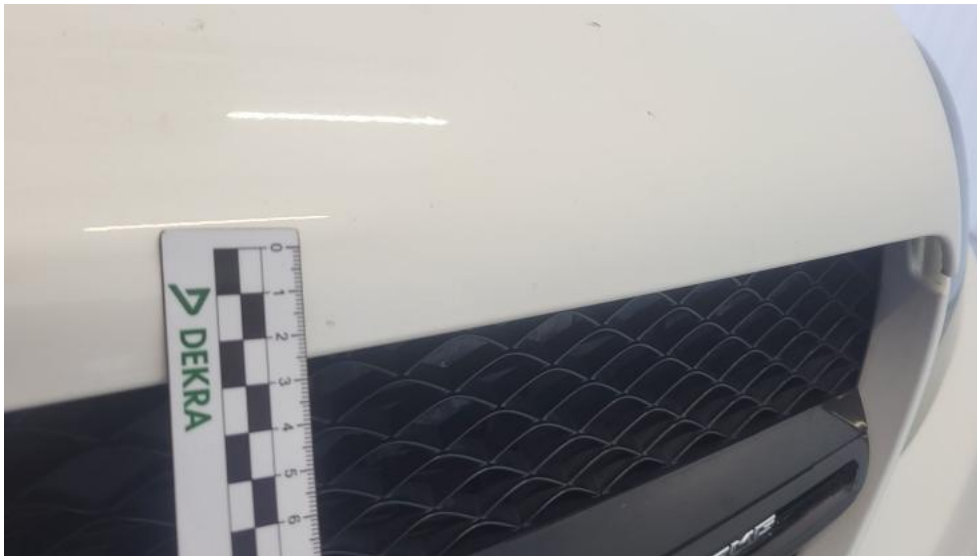
**Photo 43.**

Pokrywa komory silnika - Rysa/odprysk 2

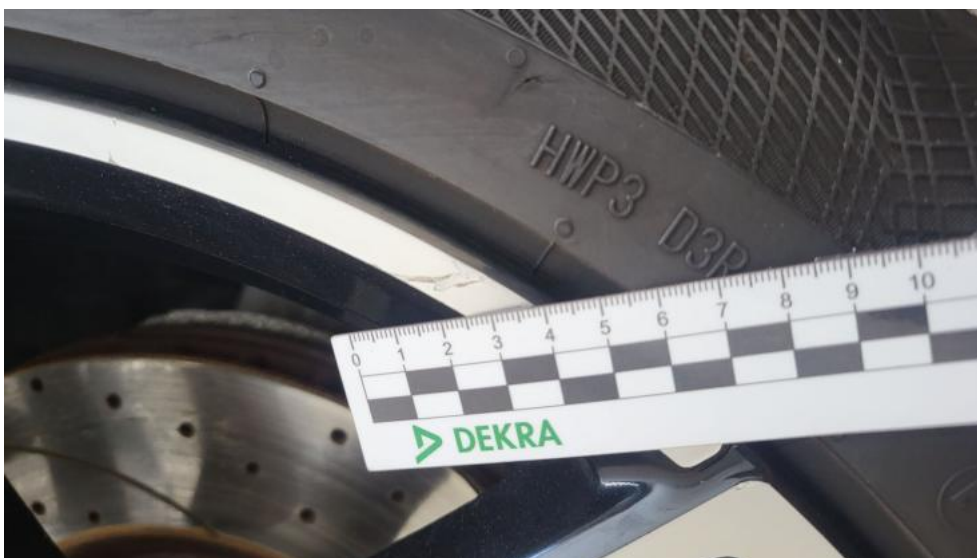
**Photo 44.**

Felga aluminiowa przednia P - Rysa/odprysk 1

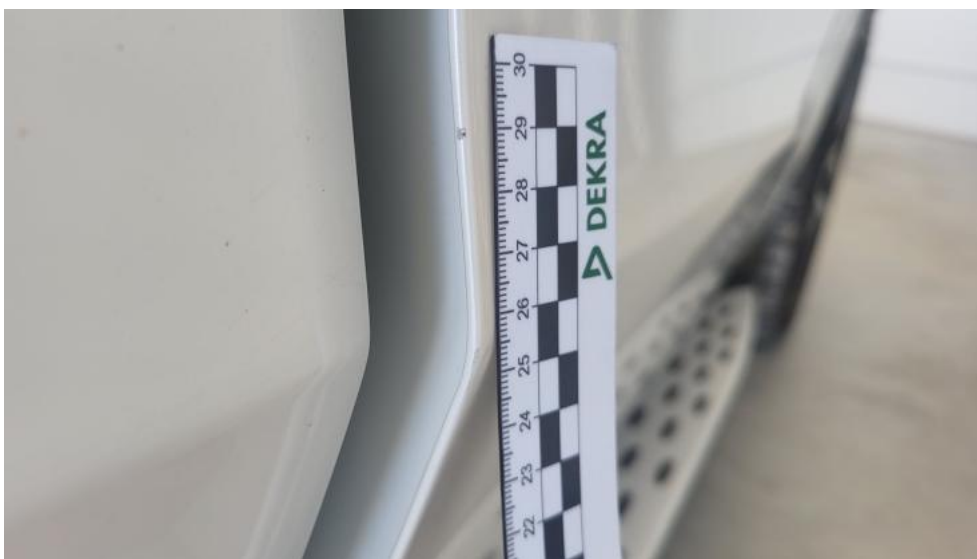
**Photo 45.**

Drzwi przednie P - Rysa/odprysk 1

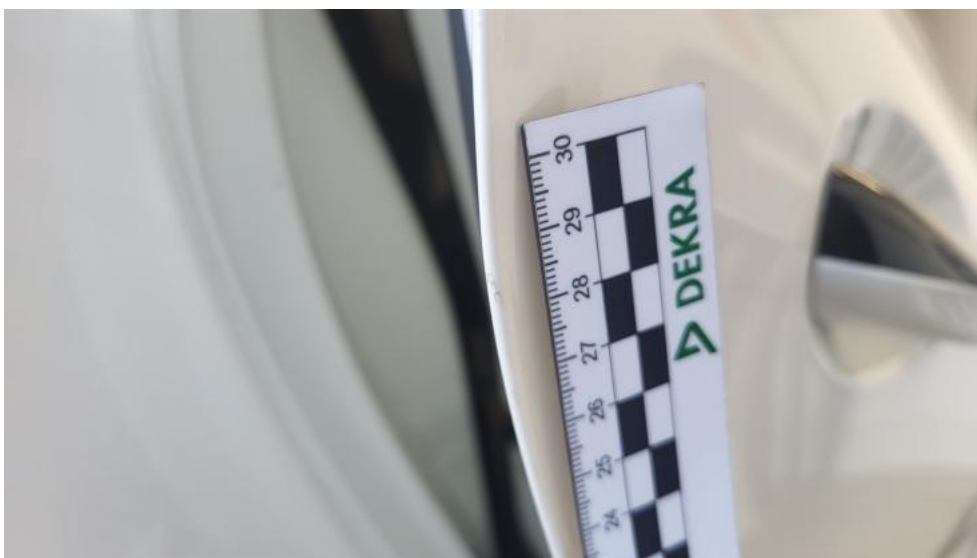
**Photo 46.**

Drzwi tylne P - Rysa/odprysk 1

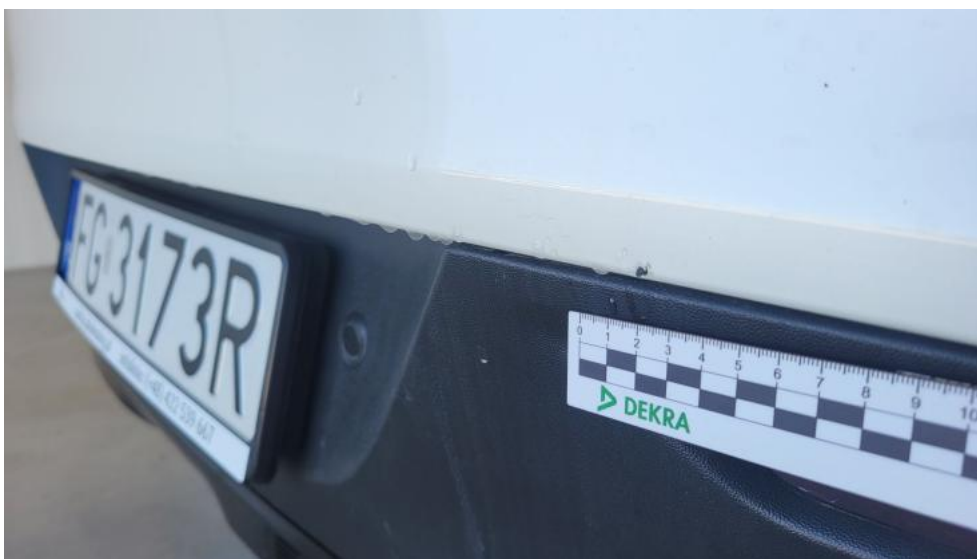
**Photo 47.**

Zderzak tylny - Rysa/odprysk 1

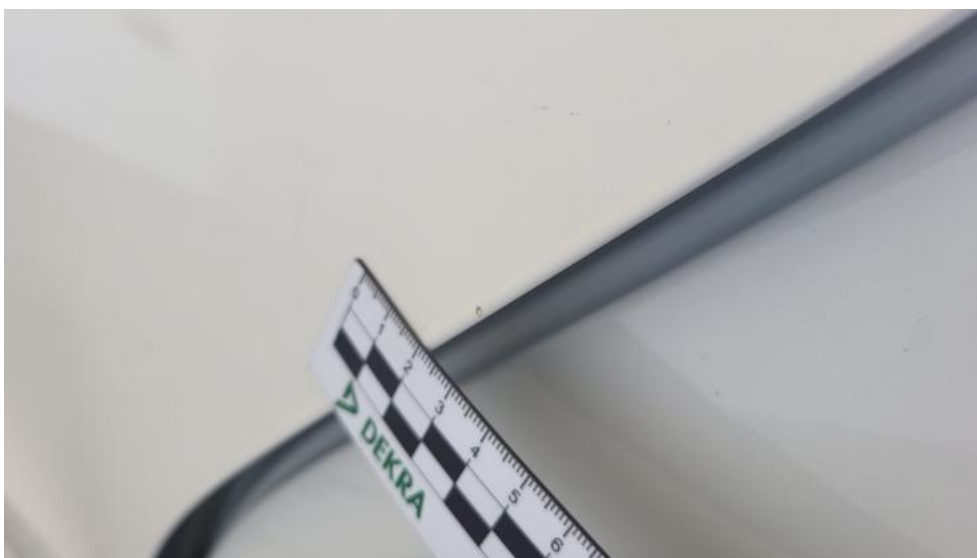
**Photo 48.**

Drzwi tylne L - Rysa/odprysk 1

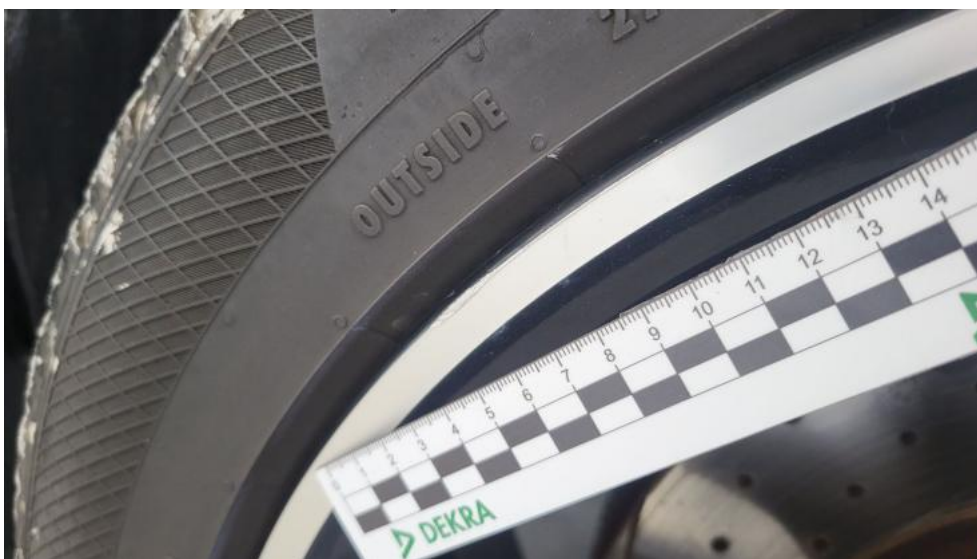
**Photo 49.**

Felga Aluminiowa przednia L - Rysa/odprysk 1

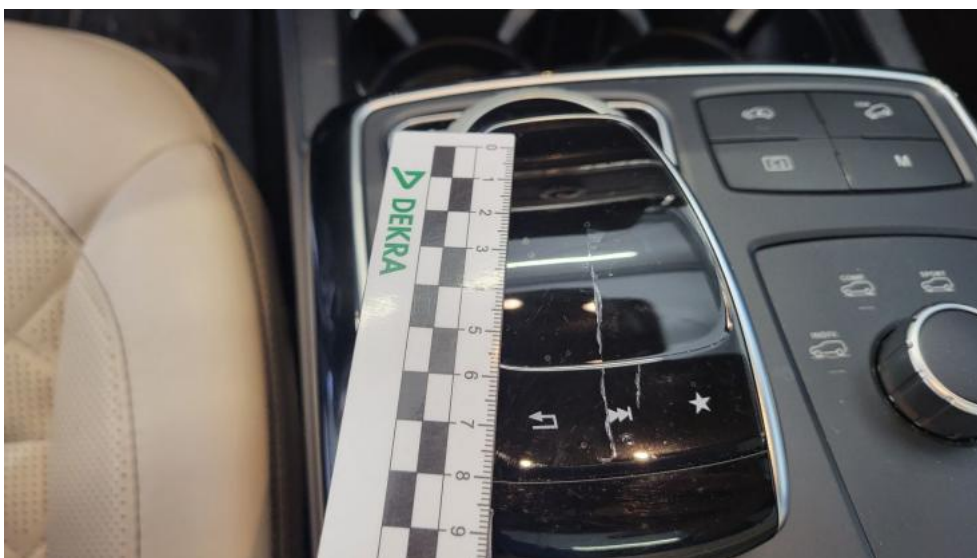
**Photo 50.**

Konsola tunelu śr. - Pęknięcie/rozerwanie 1

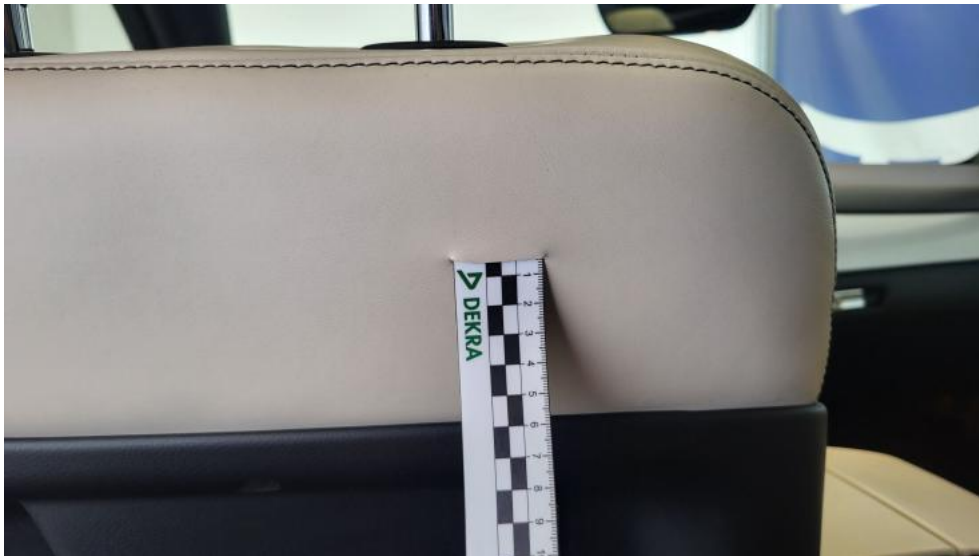
**Photo 51.**

Fotel prz. lew. - Pęknięcie/rozerwanie 1

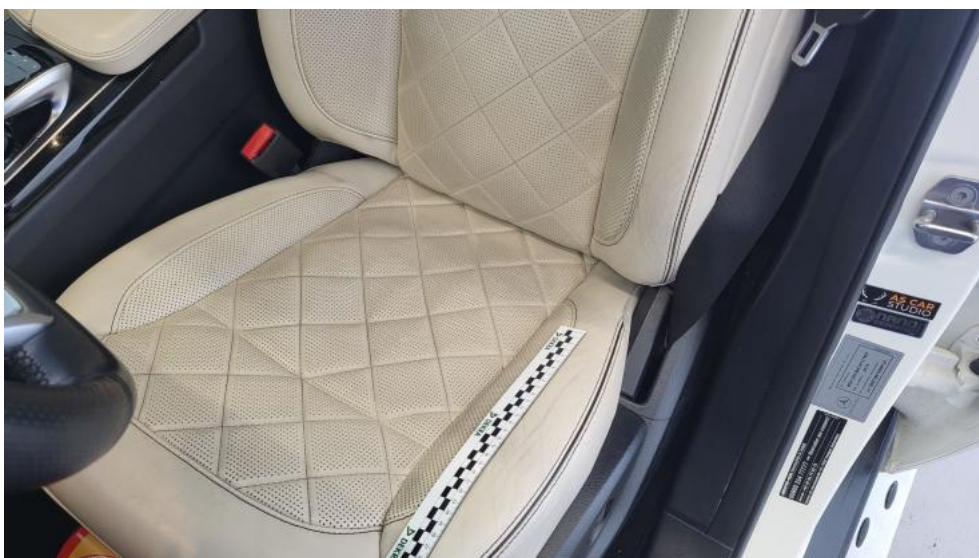
**Photo 52.**

Fotel prz. lew. - Inne 1

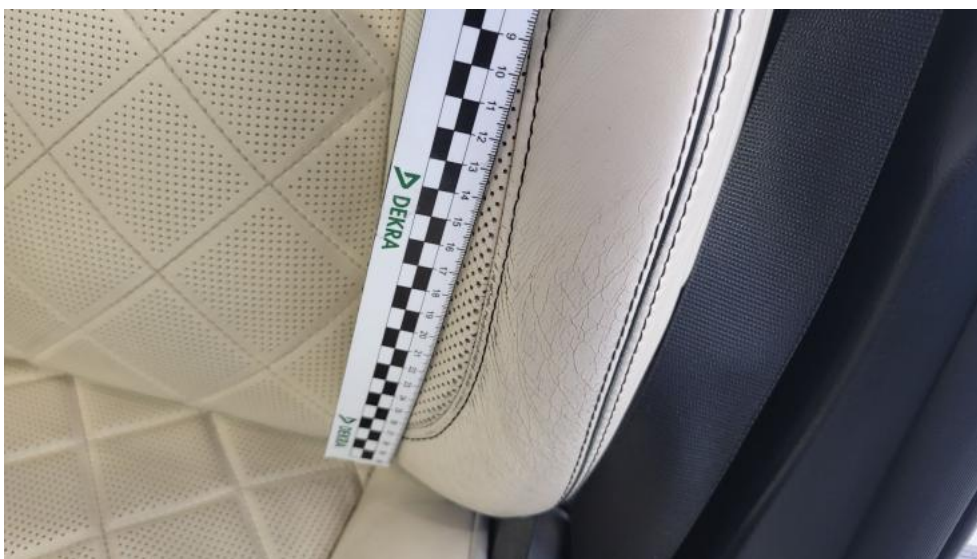
**Photo 53.**

Fotel prz. lew. - Inne 2

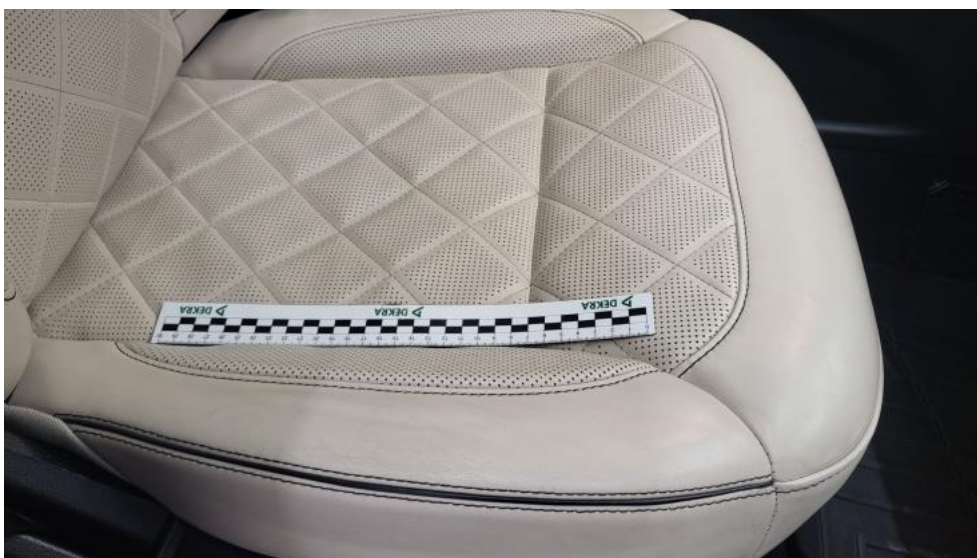
**Photo 54.**

Fotel prz. praw. - Inne 1

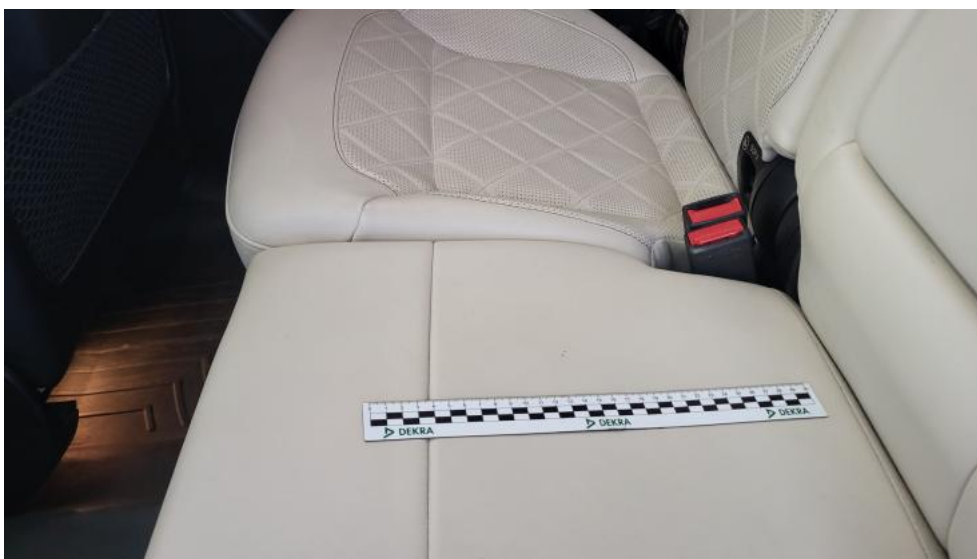
**Photo 55.**

Rysy na samochodzie. Niesprawne przyciski funkcyjne w jednym z kluczyków, grot prawidłowy. Odpryski na szybie czołowej. Brak zaślepek w tylnej kanapie.

Kanapa tyl. - Inne 1

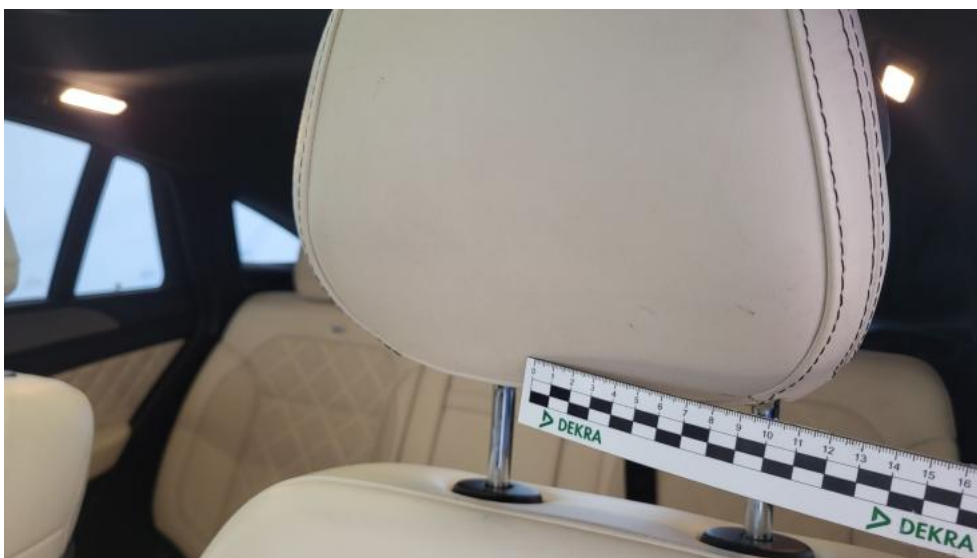
**Photo 56.**

Zaglówek fotela prz. L - Inne 1

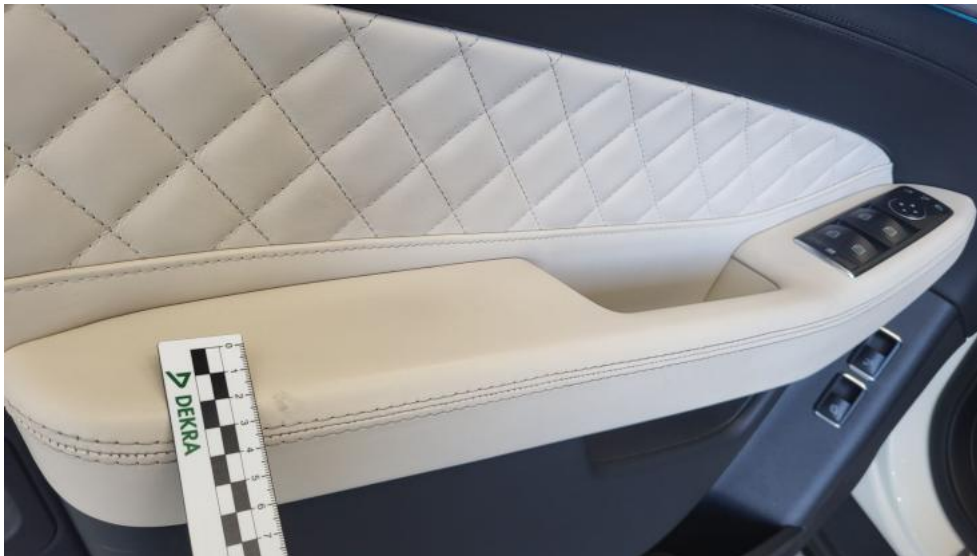
**Photo 57.**

Tapicerka drzwi przednich L - Inne 1

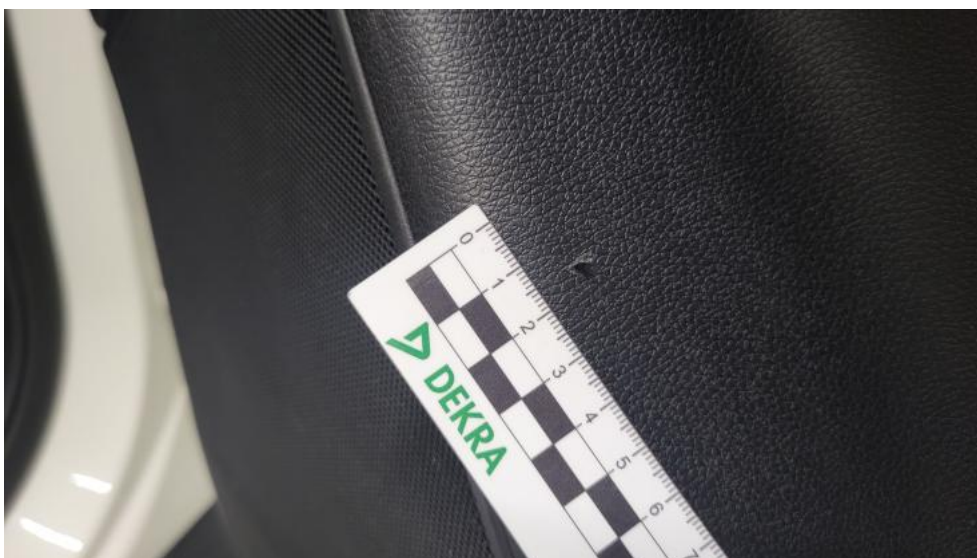
**Photo 58.**

Tapicerka drzwi przednich P - Rysa/odprysk 1

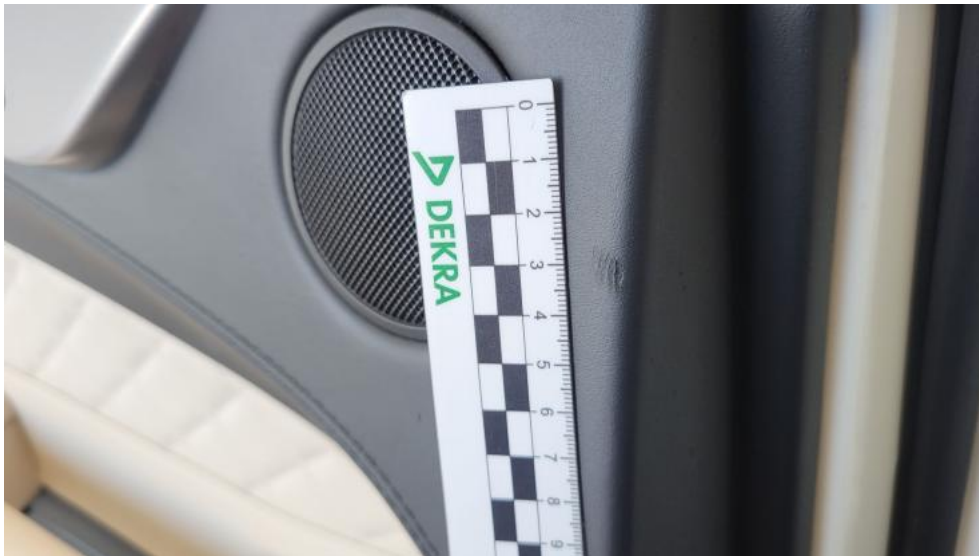
**Photo 59.**

Tapicerka drzwi tylnych L - Rysa/odprysk 1

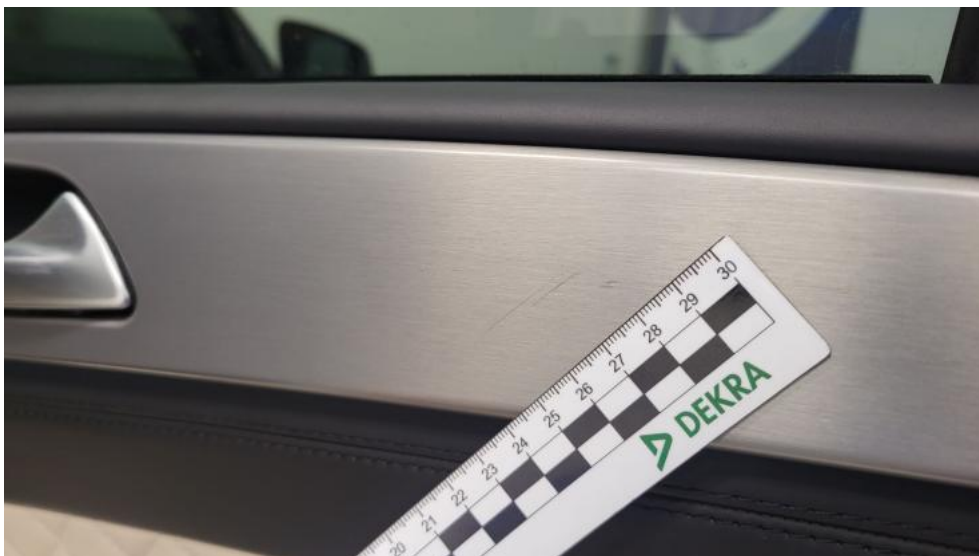
**Photo 60.**

Tapicerka drzwi tylnych P - Rysa/odprysk 1
