DEKRA's commission No. : PKOL(W)/LODZ/19302/25/03/17  
commission/ damage No. : Futura  
Date of commission: 17-03-2025

| Manufacturer | TOYOTA |
| Model | Corolla TS Kombi 22- |
| Registration /record No. | WJ0224L |

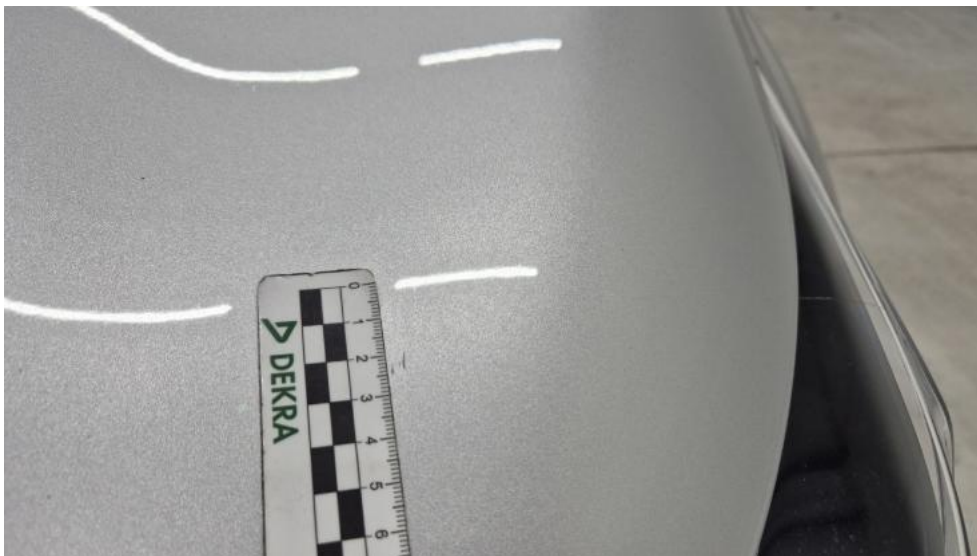
**Photo 37.**

Pokrywa komory silnika - Rysa/odprysk 1

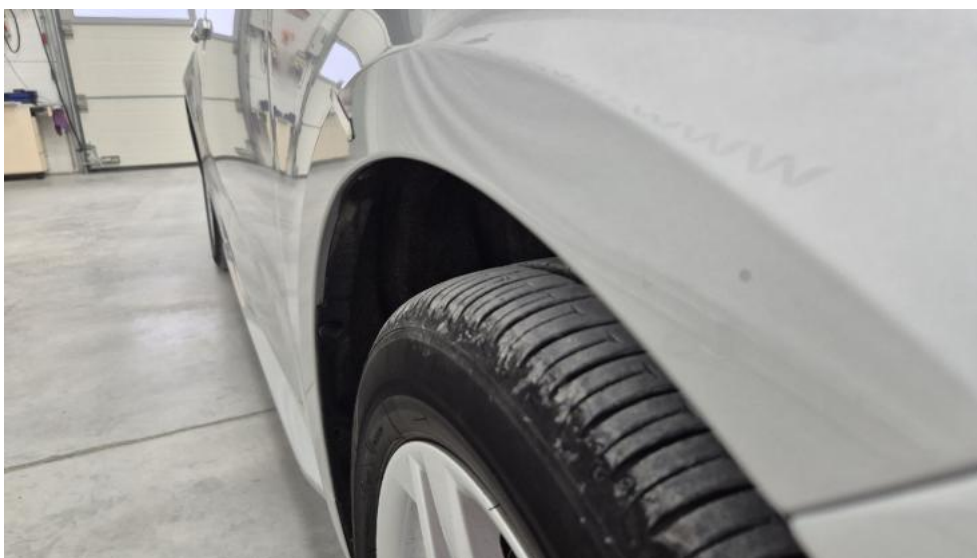
**Photo 38.**

Łotnik przedni P - Wgniecenie/odkształcenie 1

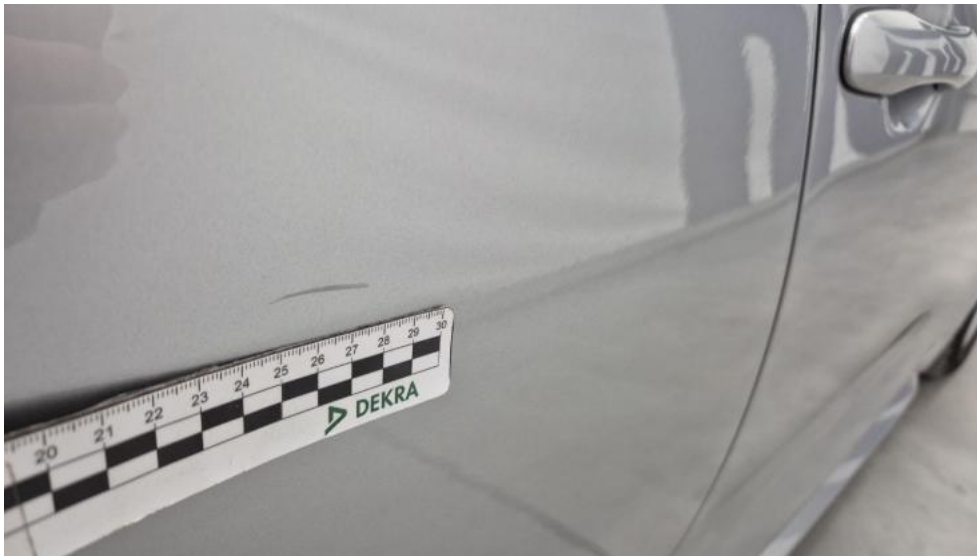
**Photo 39.**

Drzwi tylne P - Rysa/odprysk 1

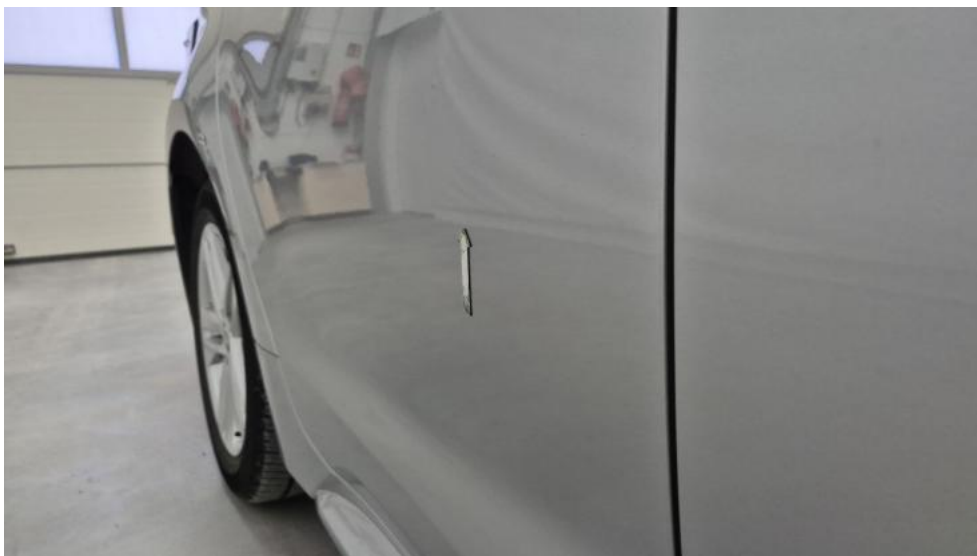
**Photo 40.**

Drzwi tylne P - Wgniecenie/odkształcenie 1

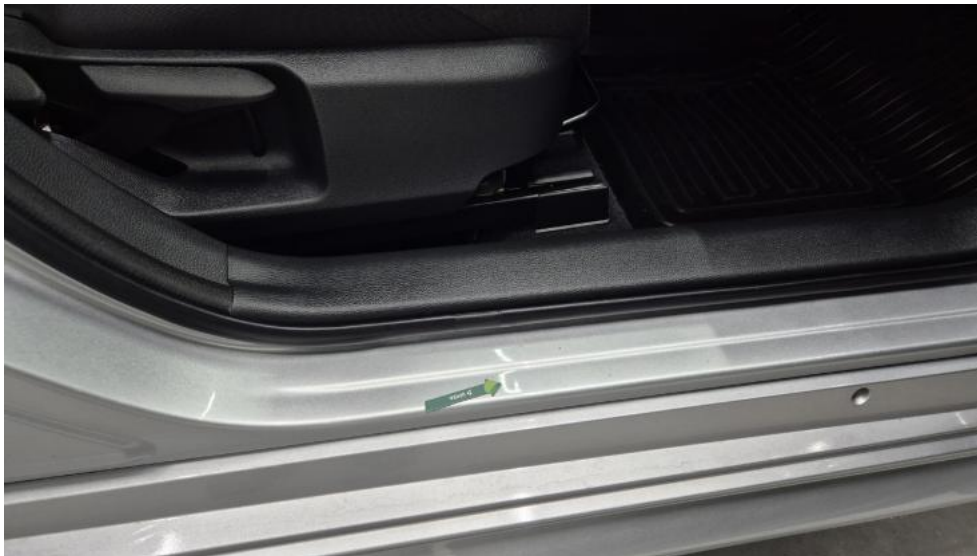
**Photo 41.**

Próg P - Wgniecenie/odkształcenie 1

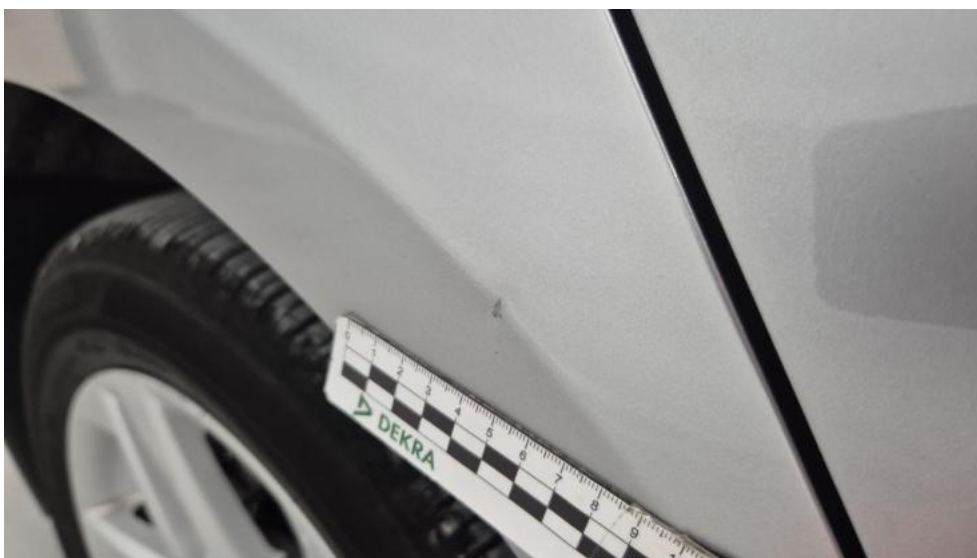
**Photo 42.**

Ścianka tylna P / Ścianka boczna P - Rysa/odprysk 1

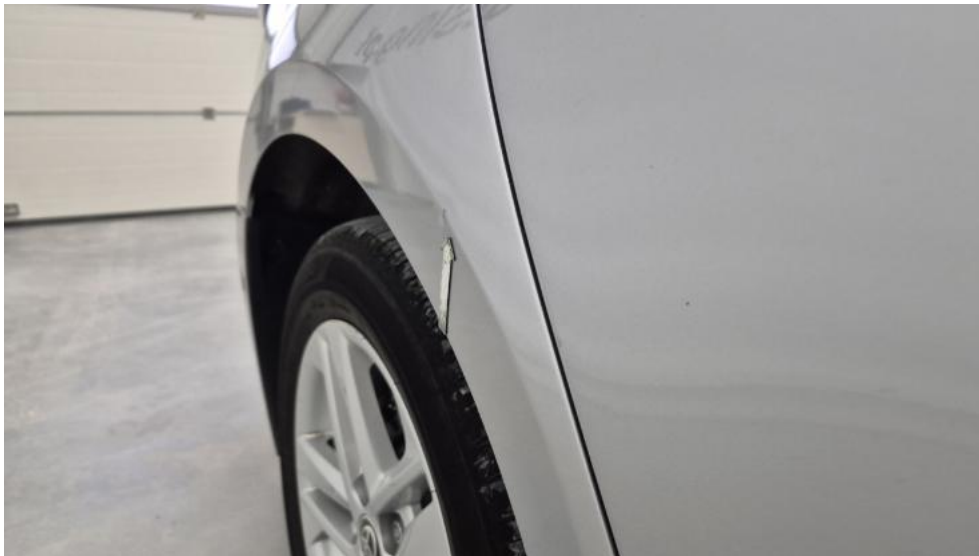
**Photo 43.**

Błotnik tylny P / Ściana boczna P - Wgniecenie/odkształcenie 1

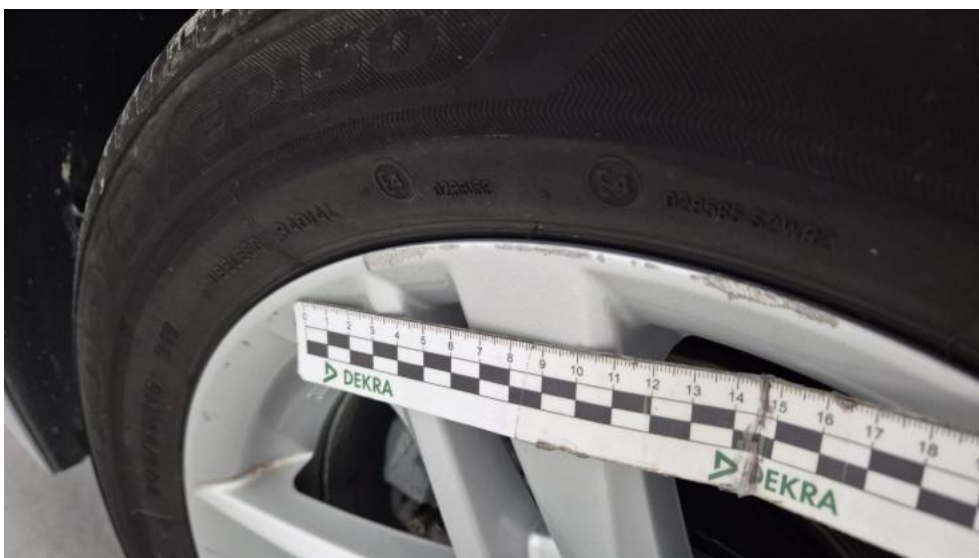
**Photo 44.**

Felga aluminiowa tylna P - Rysa/odprysk 1

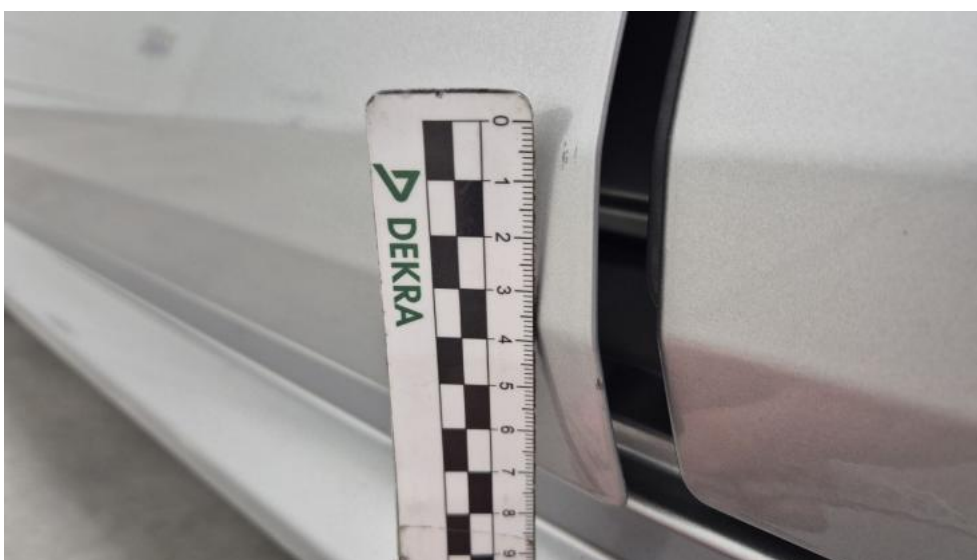
**Photo 46.**

Drzwi przed L - Rysa/odprysk 1

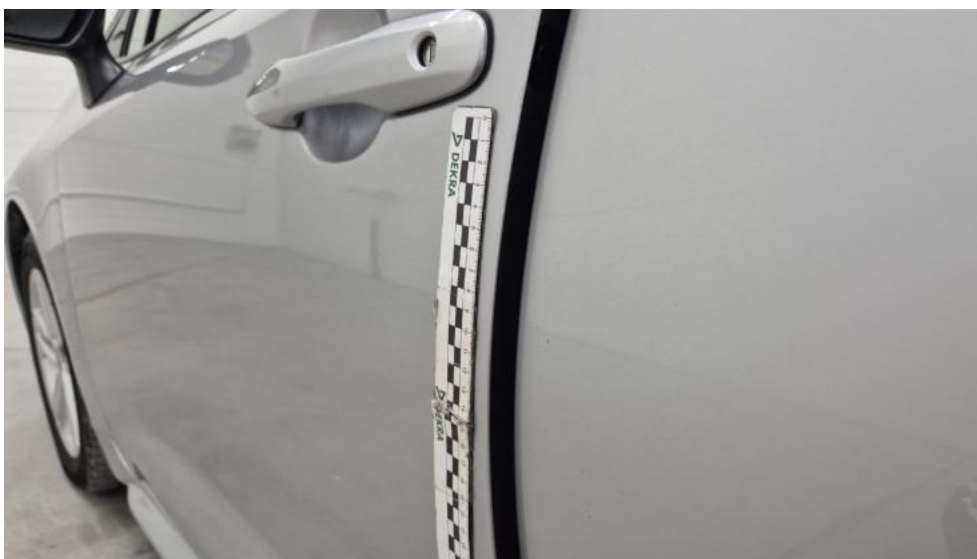
**Photo 47.**

Drzwi przed L - Rysa/odprysk 2

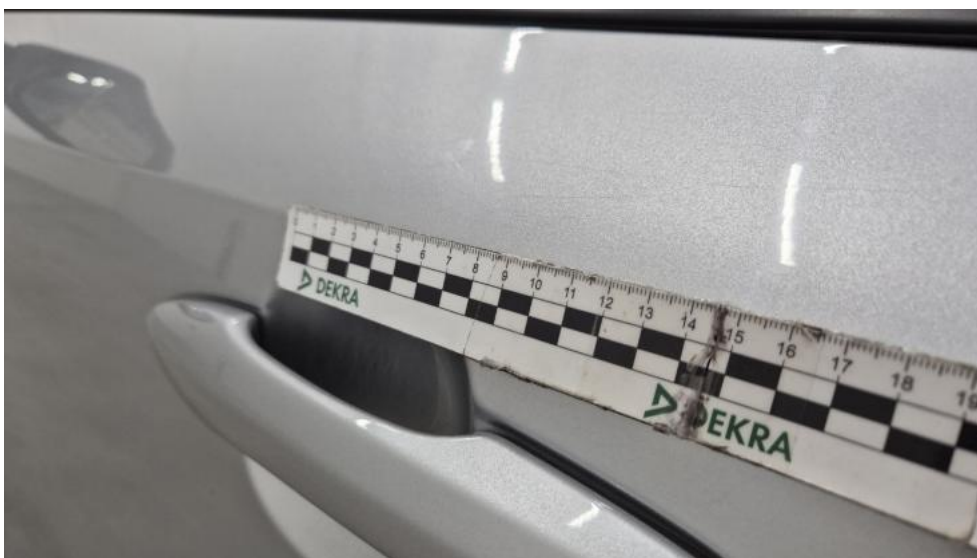
**Photo 48.**

Drzwi przed L() - Rysa/odprysk 3

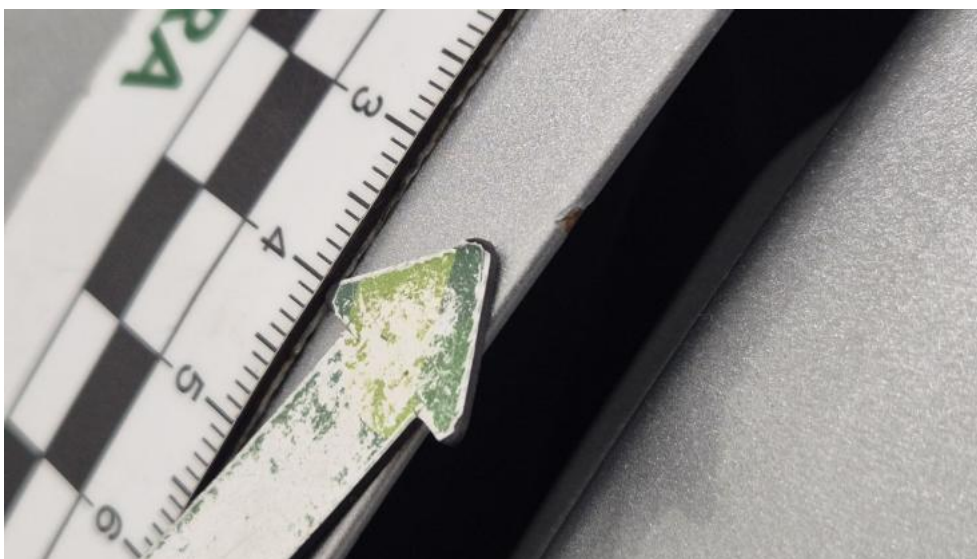
**Photo 49.**

Drzwi przed L - Inne 1

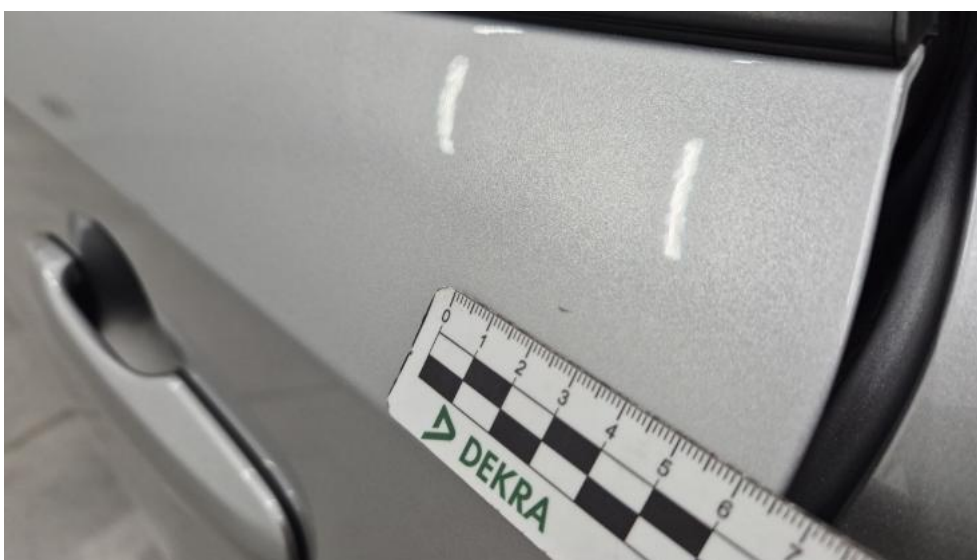
**Photo 50.**

Drzwi tylne L - Rysa/odprysk 1

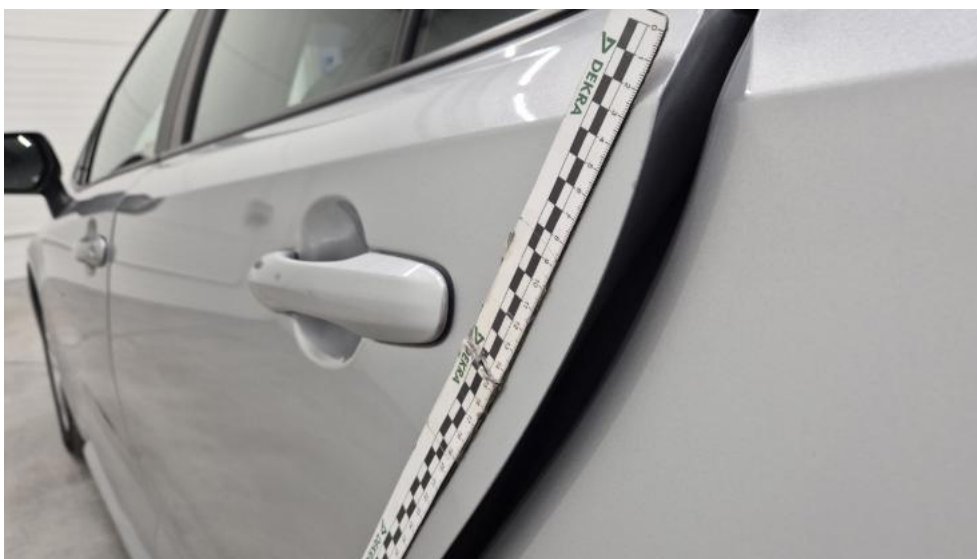
**Photo 51.**

Drzwi tylne L - Rysa/odprysk 2

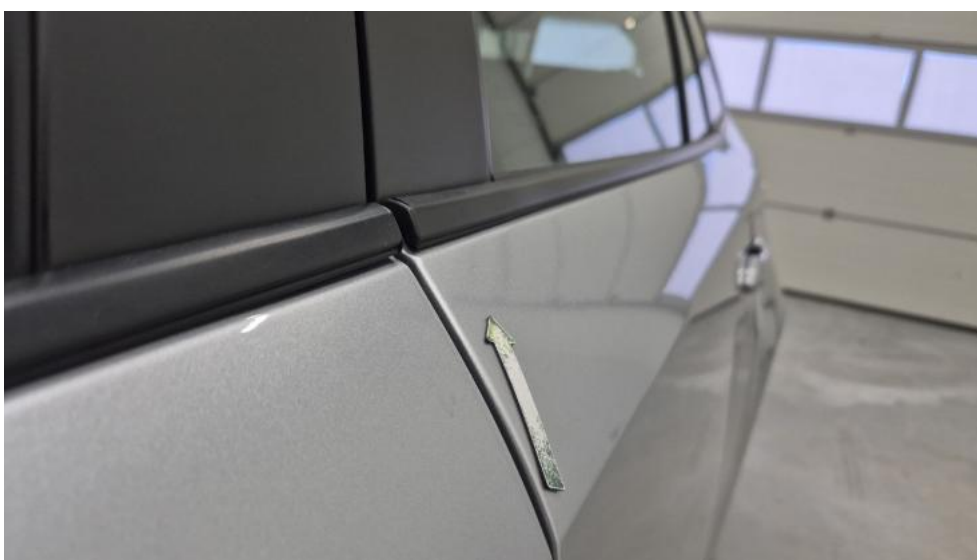
**Photo 52.**

Drzwi tylne L - Wgniecenie/odkształcenie 1

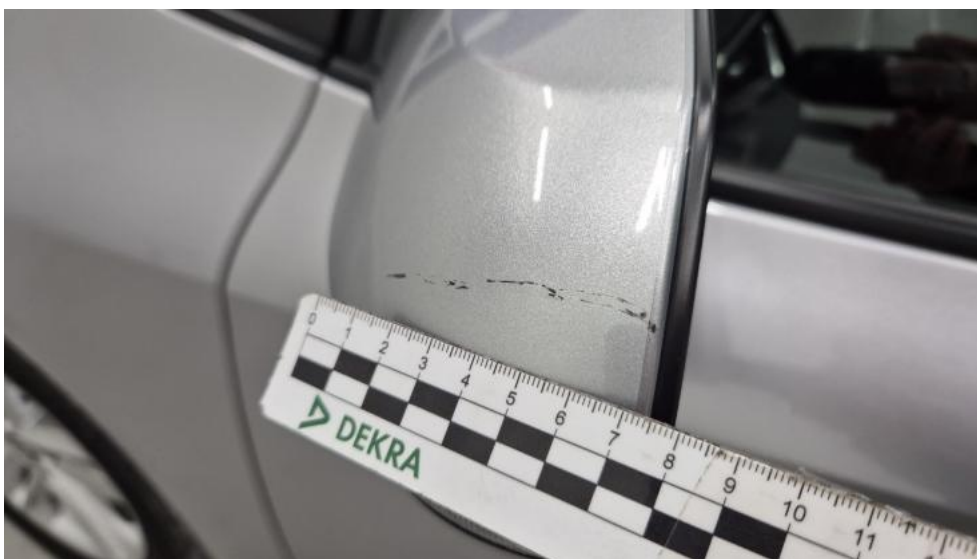
**Photo 53.**

Lusterko zew L - Rysa/odprysk 1

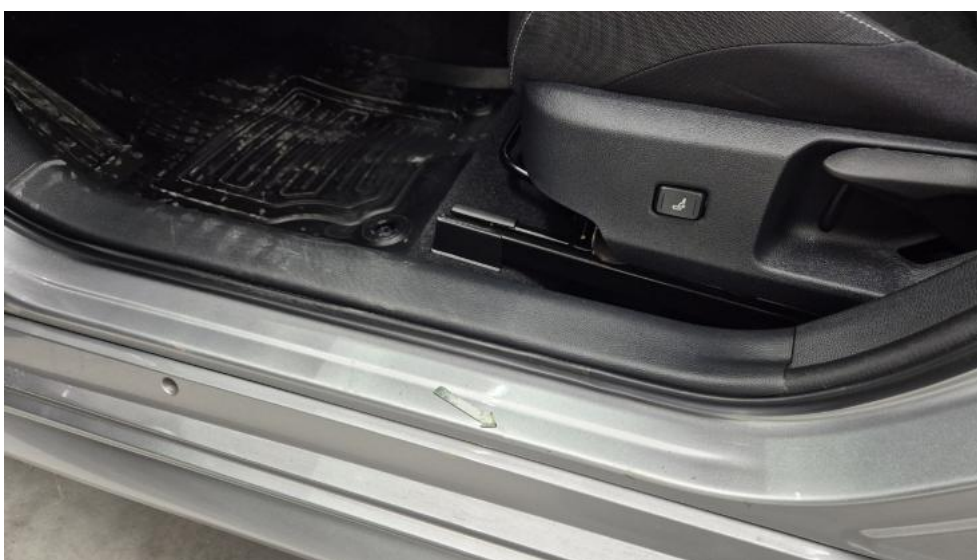
**Photo 54.**

Próg L - Wgniecenie/odkształcenie 1

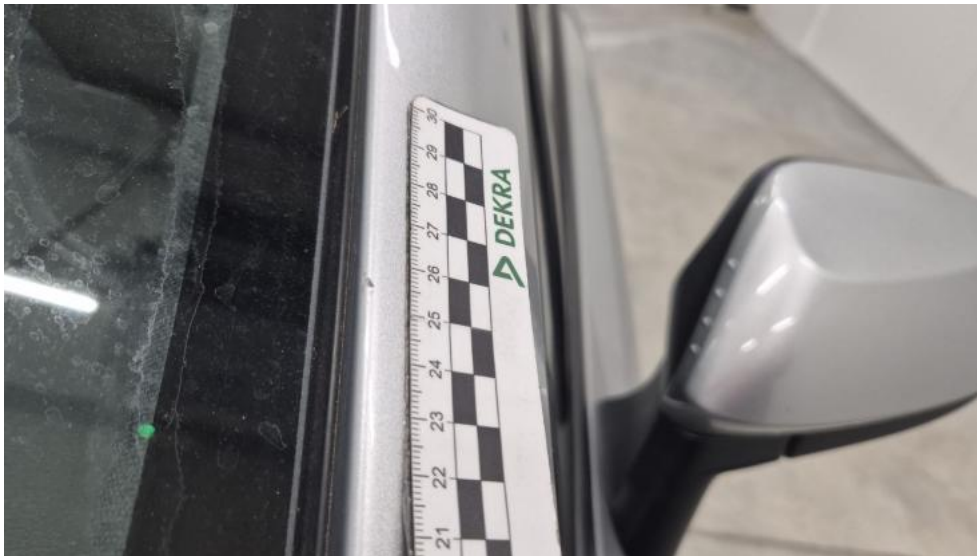
**Photo 55.**

Stupek przedni L - Rysa/odprysk 1

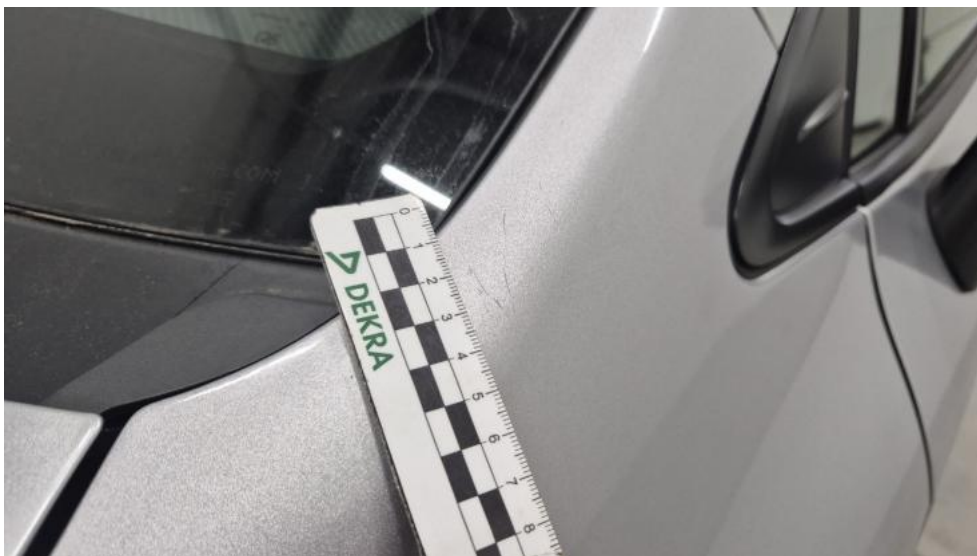
**Photo 56.**

Błotnik przedni L - Rysa/odprysk 1

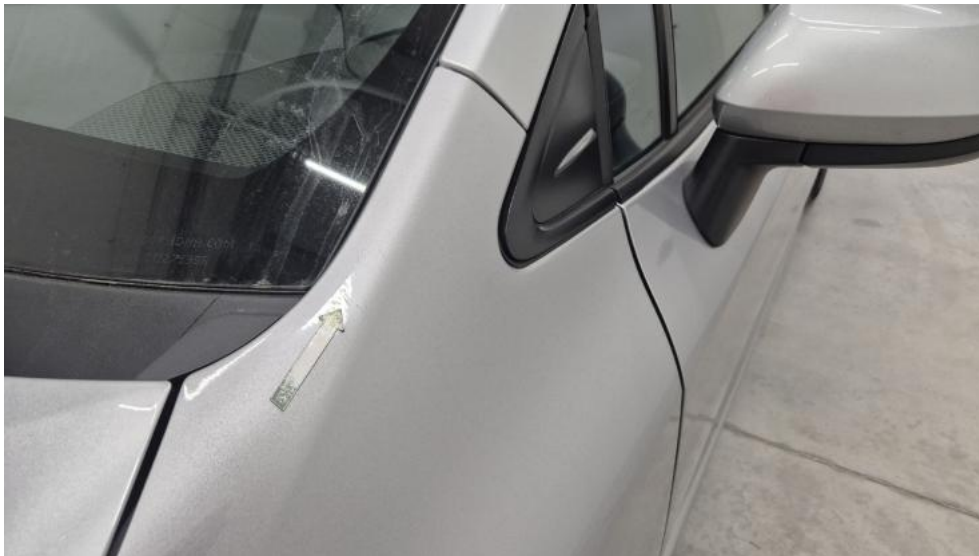
**Photo 57.**

Błotnik przedni L - Wgniecenie/odkształcenie 1

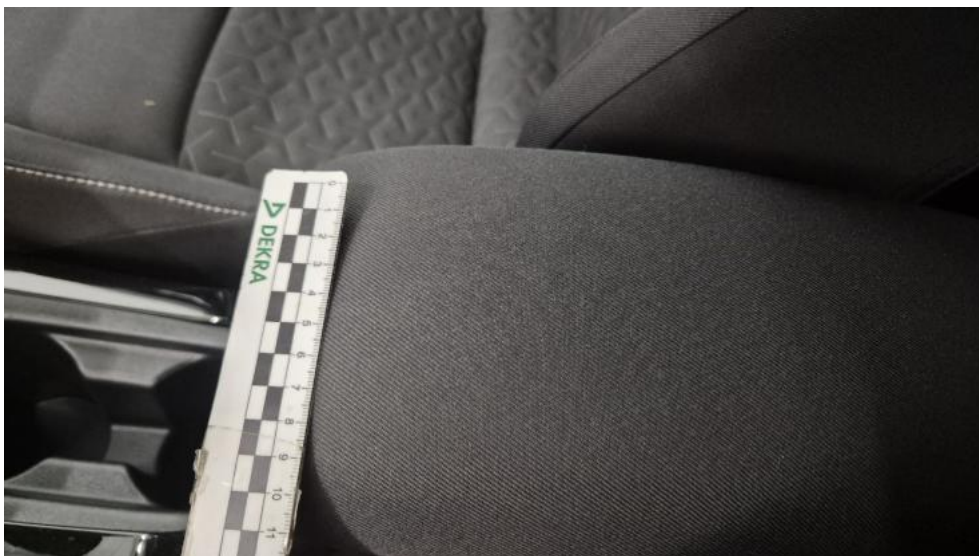
**Photo 58.**

Podłokietnik środkowy przedni - Inne 1

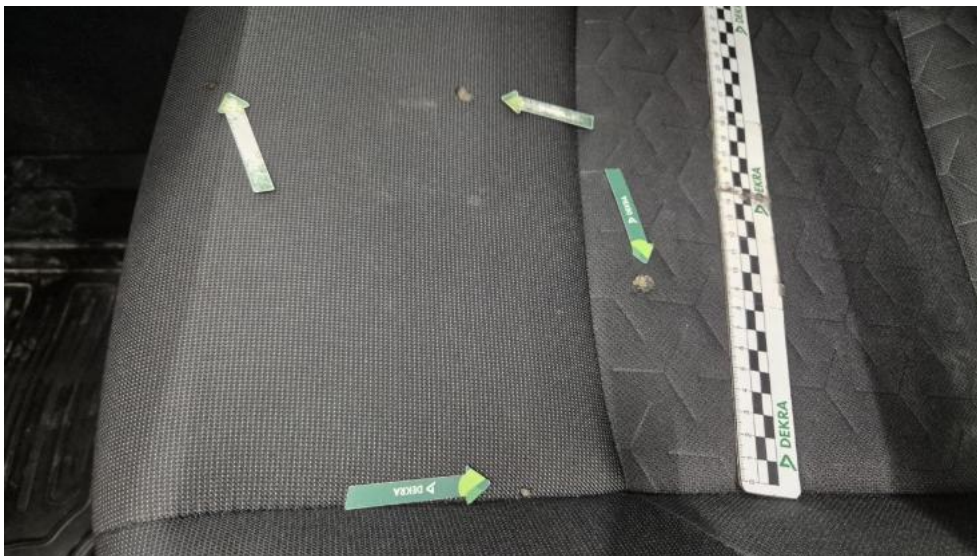
**Photo 59.**

Fotel prz. lew. - Inne 1

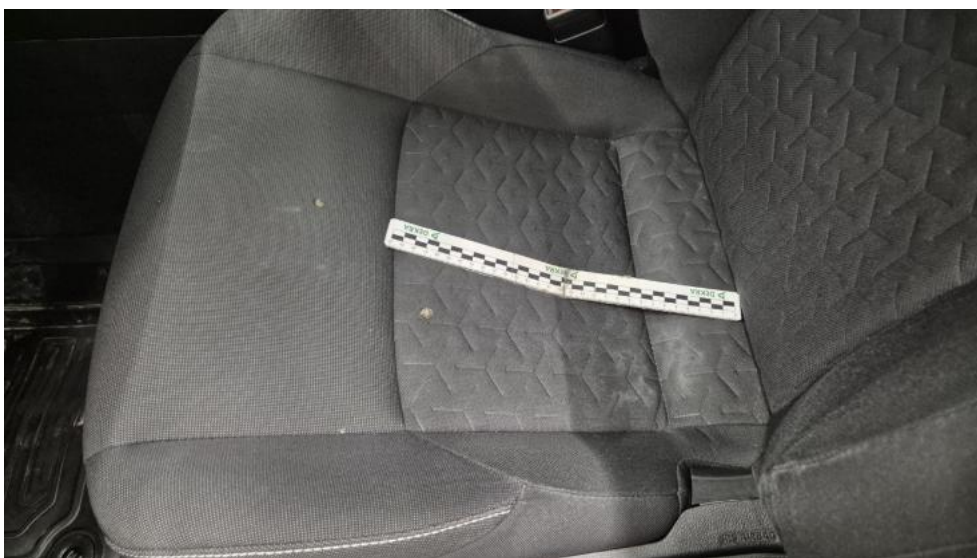
**Photo 60.**

Fotel prz. lew. - Inne 2

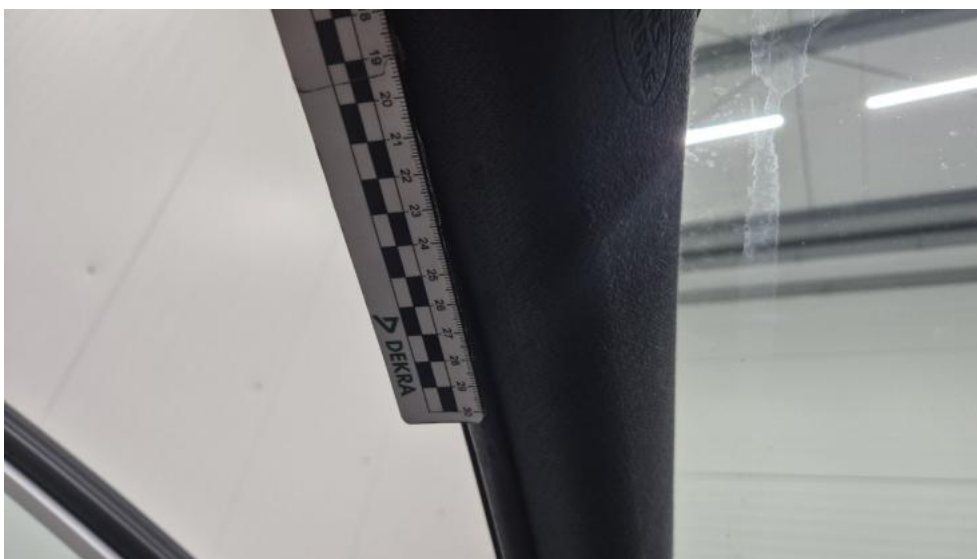
**Photo 61.**

Wykładzina(y) słupka przedniego L - Rysa/odprysk 1
