DEKRA's commission No. : PKOL(W)/LODZ/80270/26/08/27  
commission/ damage No. : 23/014881  
Date of commission: 27-08-2026

**DEKRA Poland - Headquarters**  
02-673 Warszawa, ul. Konstruktorska 12A

| Manufacturer | AUDI |
| Type / version | Q5 45 TFSI mHEV Quattro Sport |

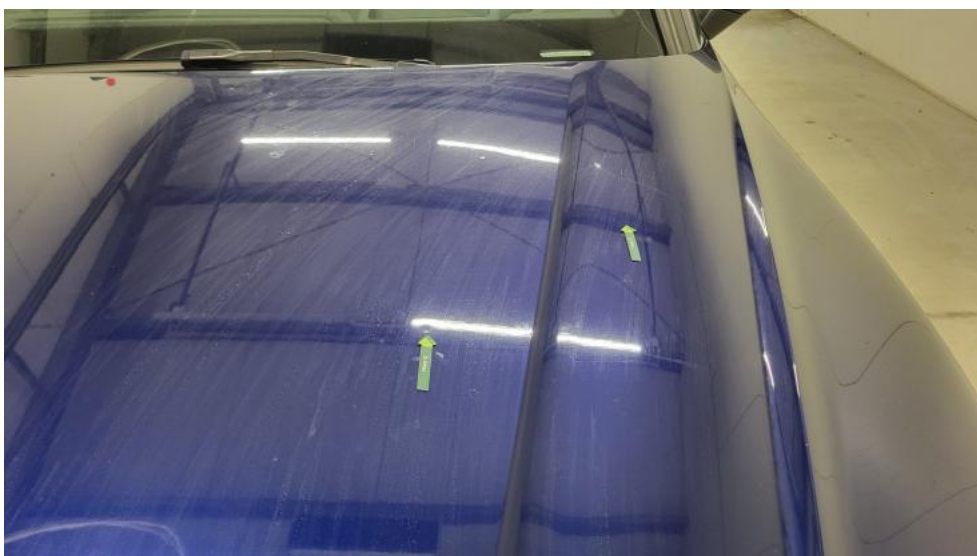
**Photo 42.**

Pokrywa komory silnika - Wgniecenie/odkształcenie 1

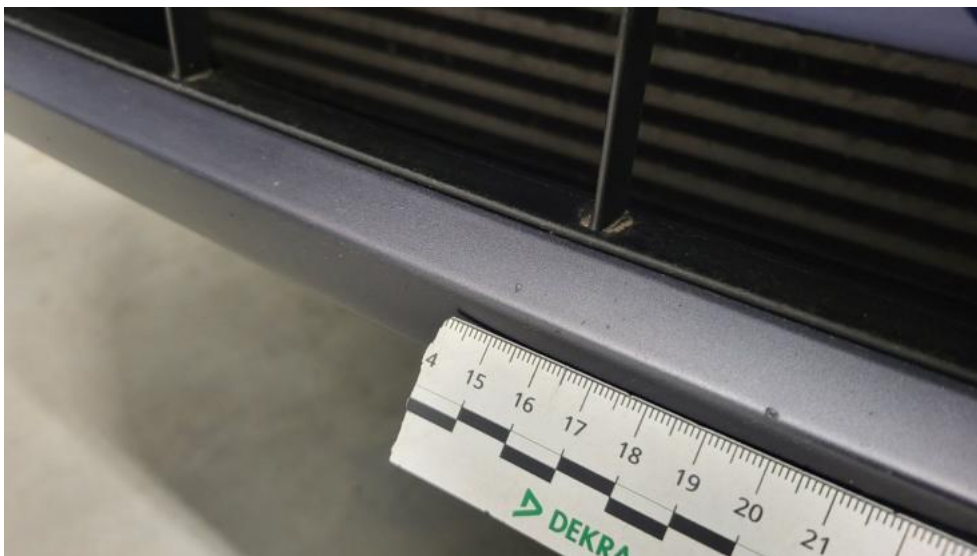
**Photo 43.**

Spoiler zderzaka przedniego - Rysa/odprysk 1

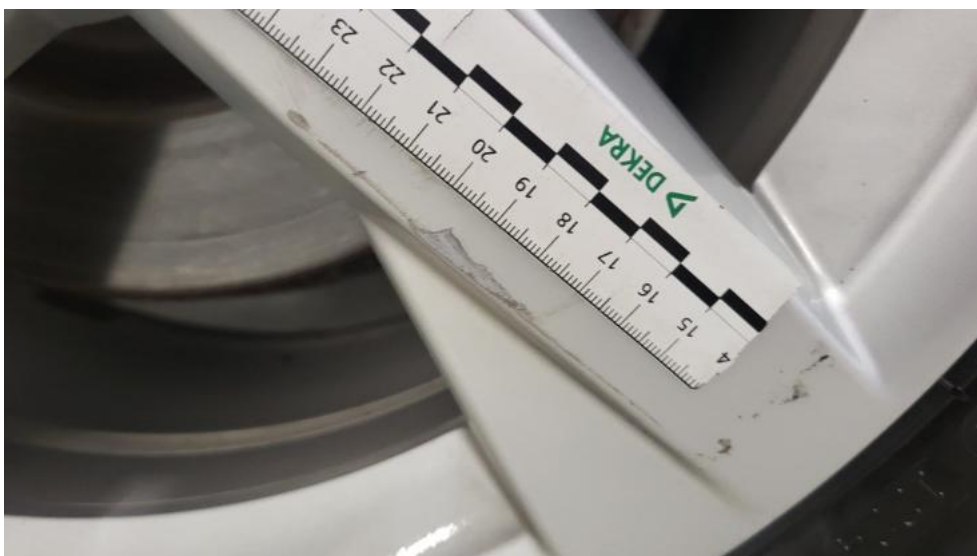
**Photo 44.**

Felga aluminiowa przednia P - Rysa/odprysk 1

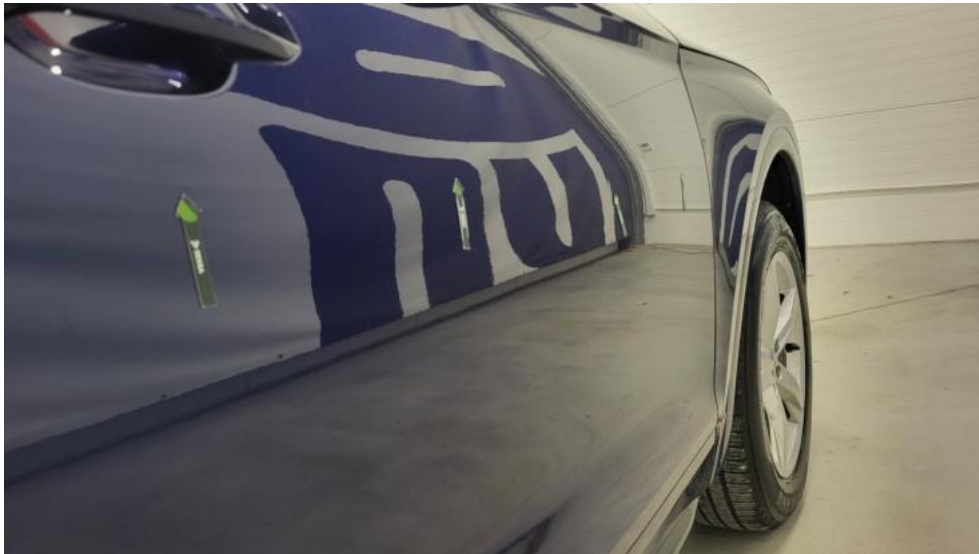
**Photo 45.**

Drzwi przednie P - Wgniecenie/odkształcenie 1

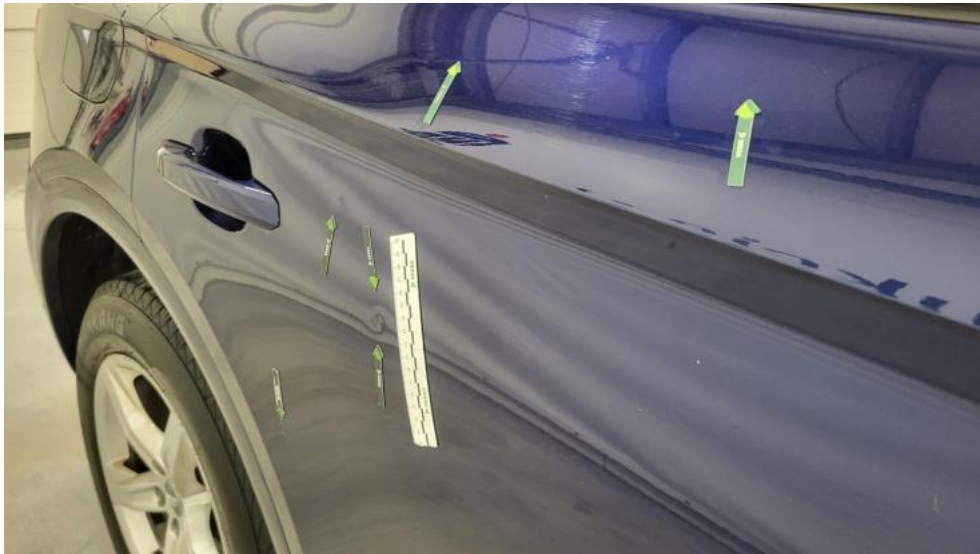
**Photo 47.**

Drzwi tylne P - Wgniecenie/odkształcenie 1

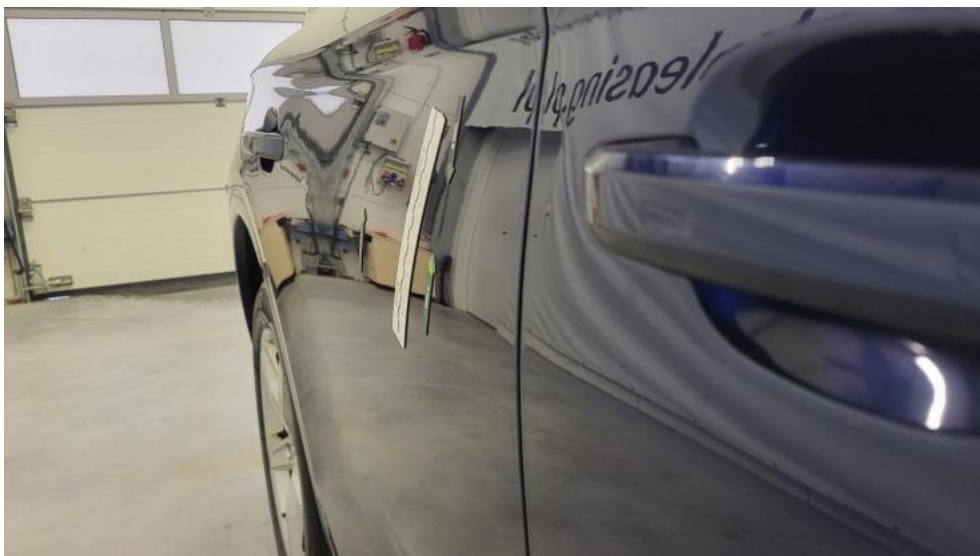
**Photo 48.**

Drzwi tylne P - Wgniecenie/odkształcenie 2

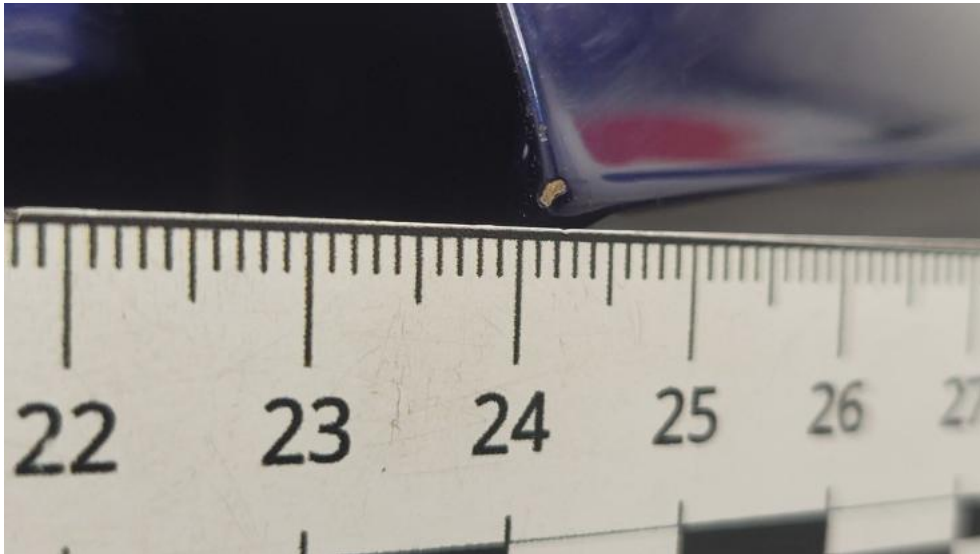
**Photo 49.**

Drzwi tylne P - Inne 1

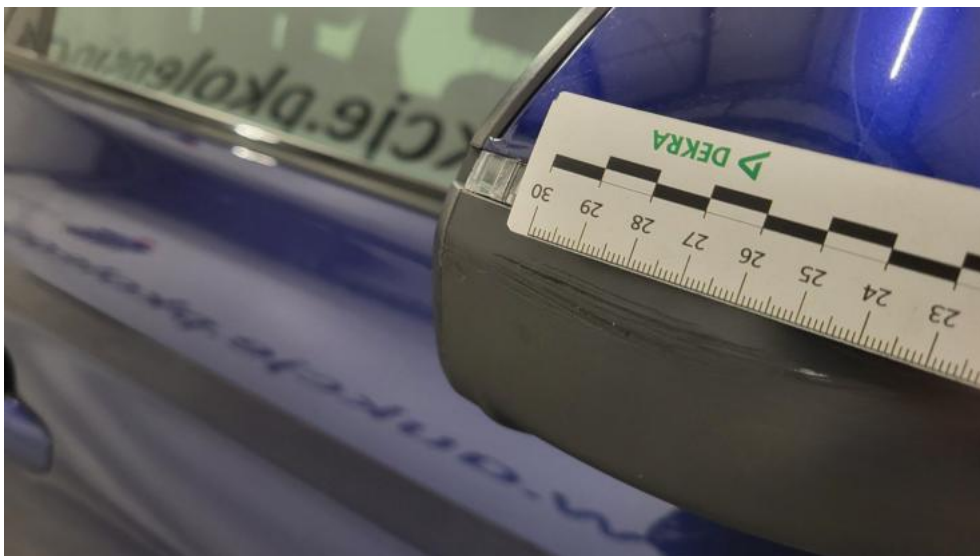
**Photo 50.**

Lusterko zew P - Rysa/odprysk 1

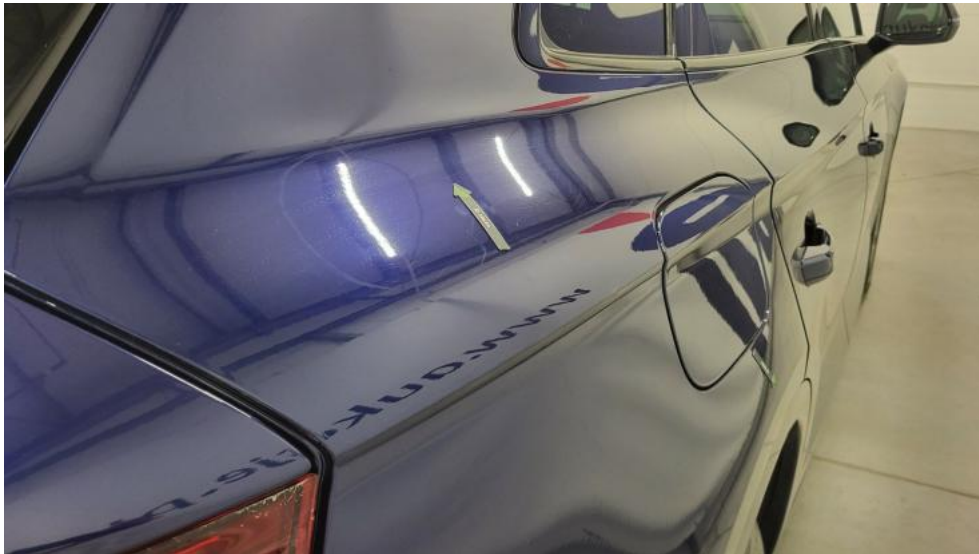
**Photo 51.**

Błotnik tylny P / Ściana boczna P - Wgniecenie/odkształcenie 1

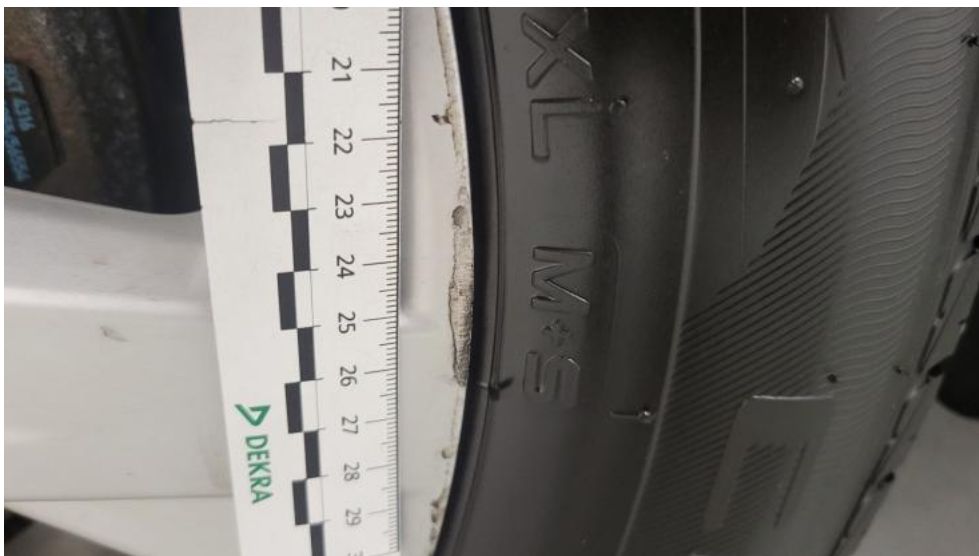
**Photo 52.**

Felga aluminiowa tylna P - Rysa/odprysk 1

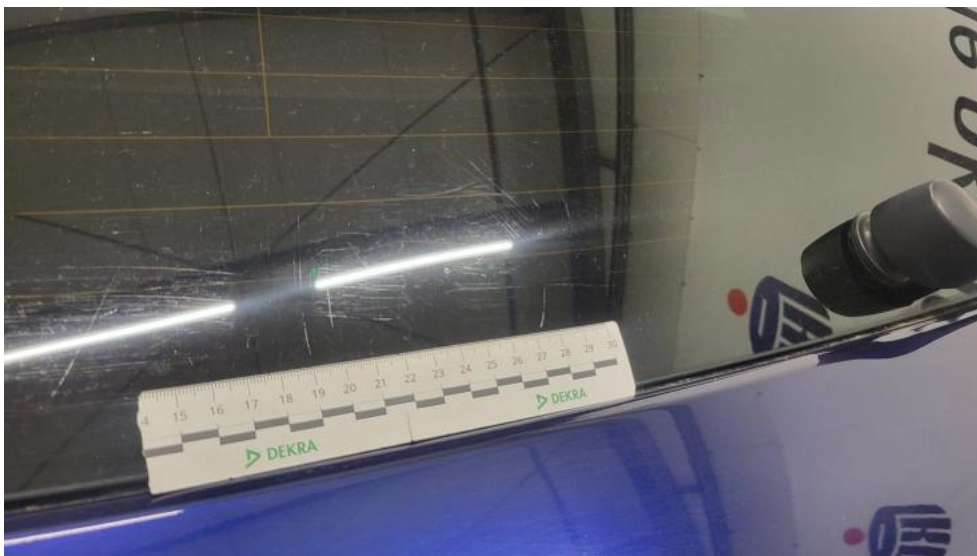
**Photo 53.**

Szyba tylna - Rysa/odprysk 1

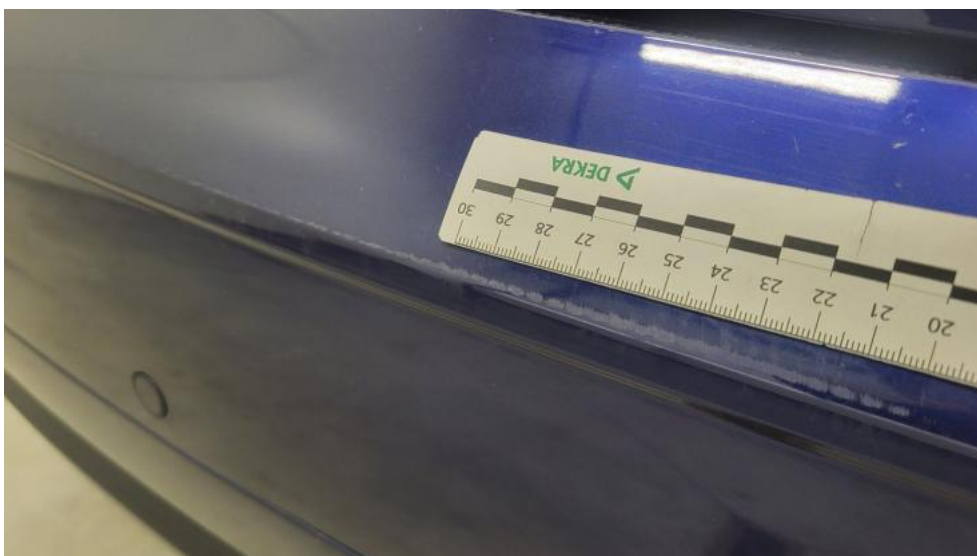
**Photo 54.**

Zderzak tylny - Rysa/odprysk 1

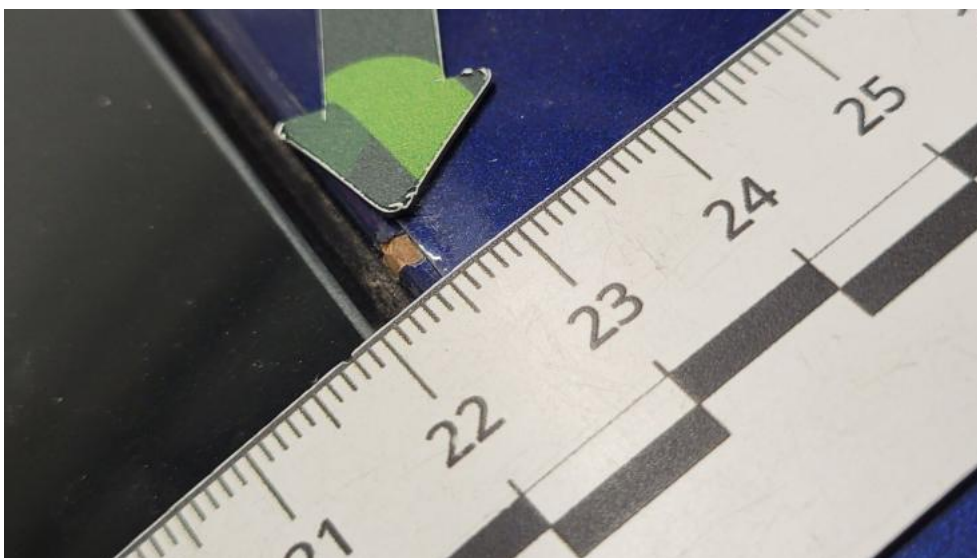
**Photo 56.**

Dach - Inne 1

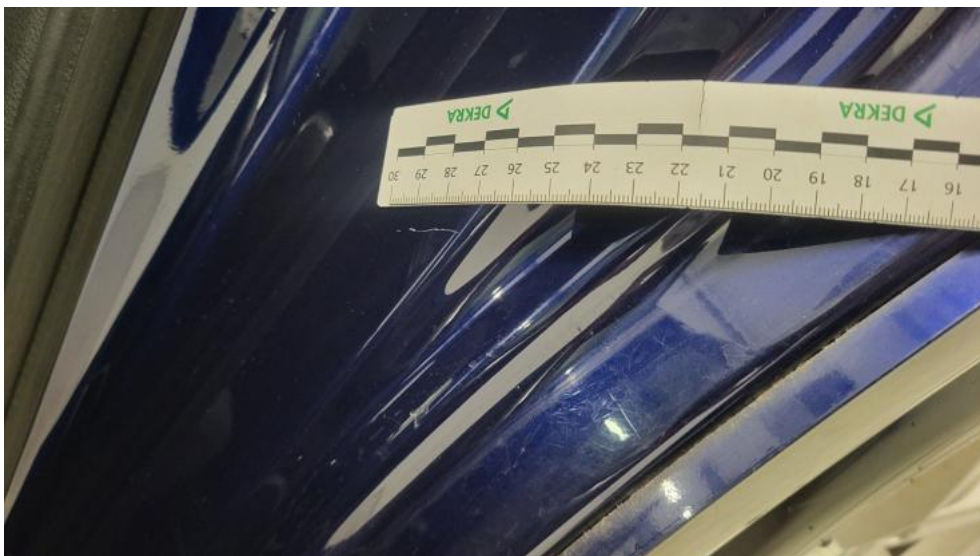
**Photo 58.**

Błotnik tylny L / Ściana boczna L - Rysa/odprysk 1

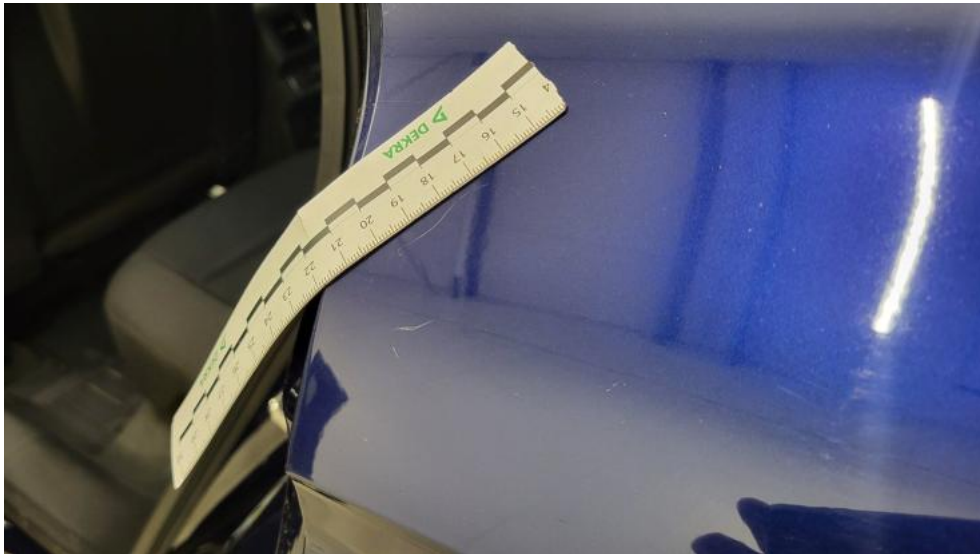
**Photo 59.**

Błotnik tylny L / Ściana boczna L - Rysa/odprysk 2

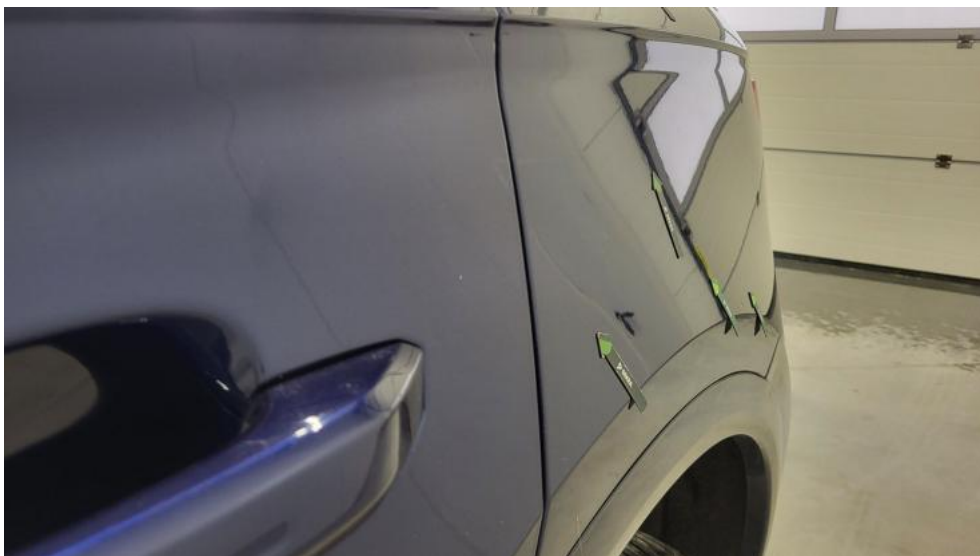
**Photo 60.**

Błotnik tylny L / Ściana boczna L - Wgniecenie/odkształcenie 1

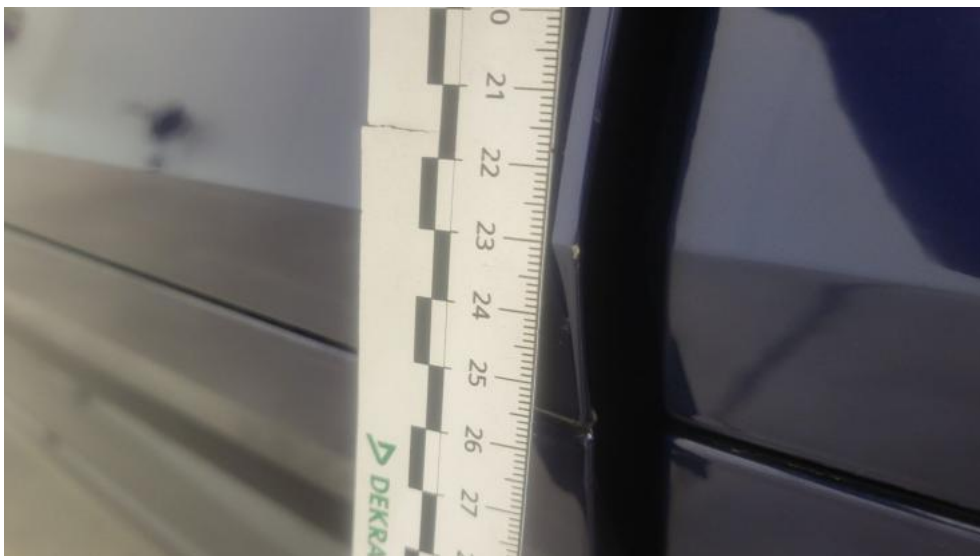
**Photo 62.**

Drzwi przed L - Rysa/odprysk 1

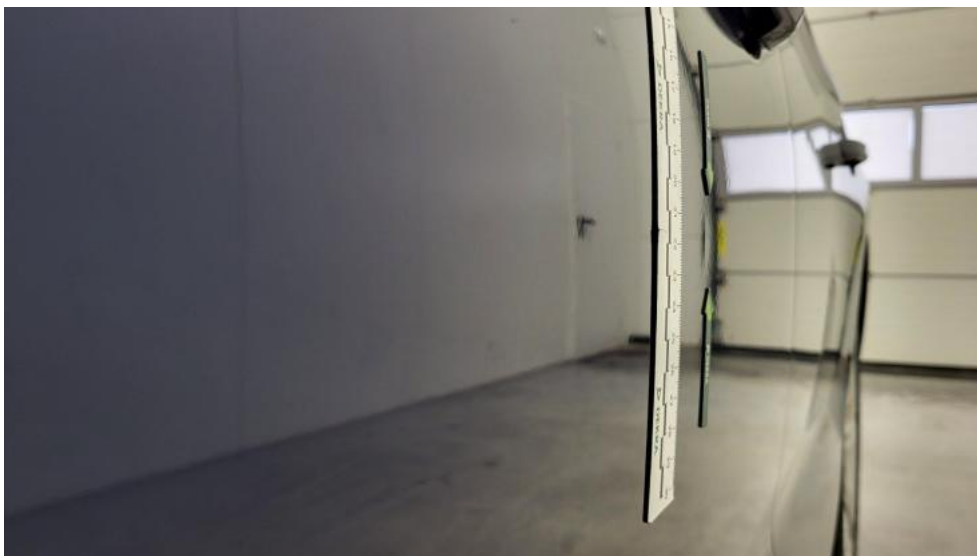
**Photo 63.**

Drzwi przed L - Wgniecenie/odkształcenie 1

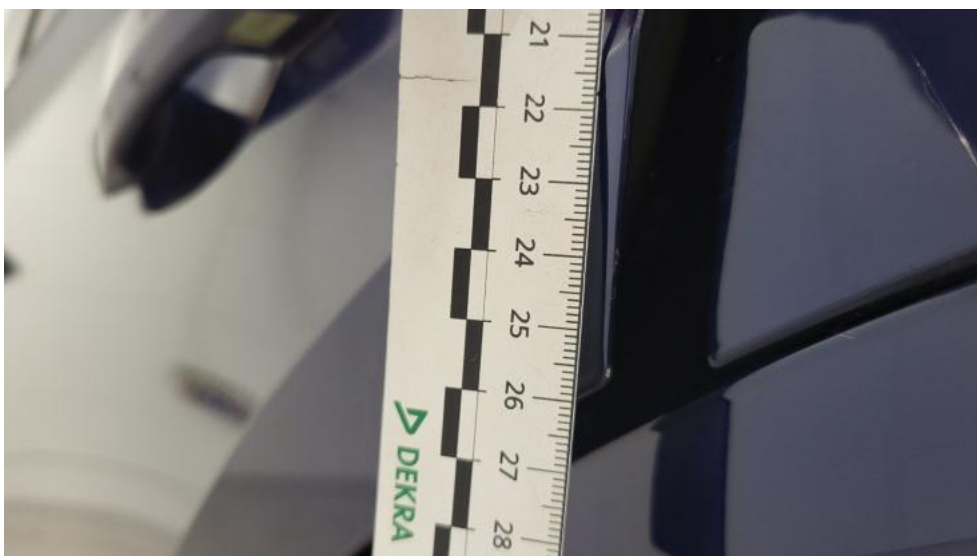
**Photo 64.**

Drzwi tylne L - Rysa/odprysk 1

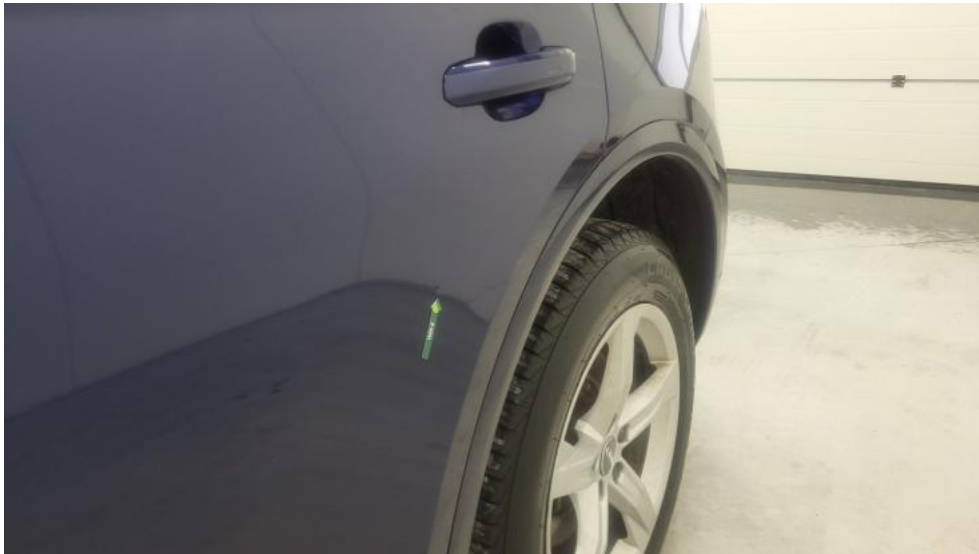
**Photo 65.**

Drzwi tylne L - Wgniecenie/odkształcenie 1

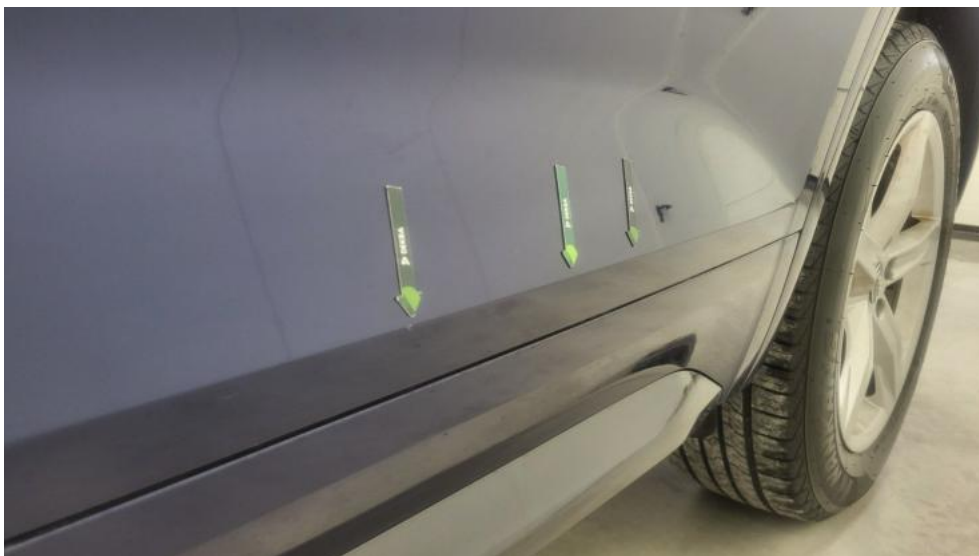
**Photo 66.**

Drzwi tylne L - Wgniecenie/odkształcenie 2

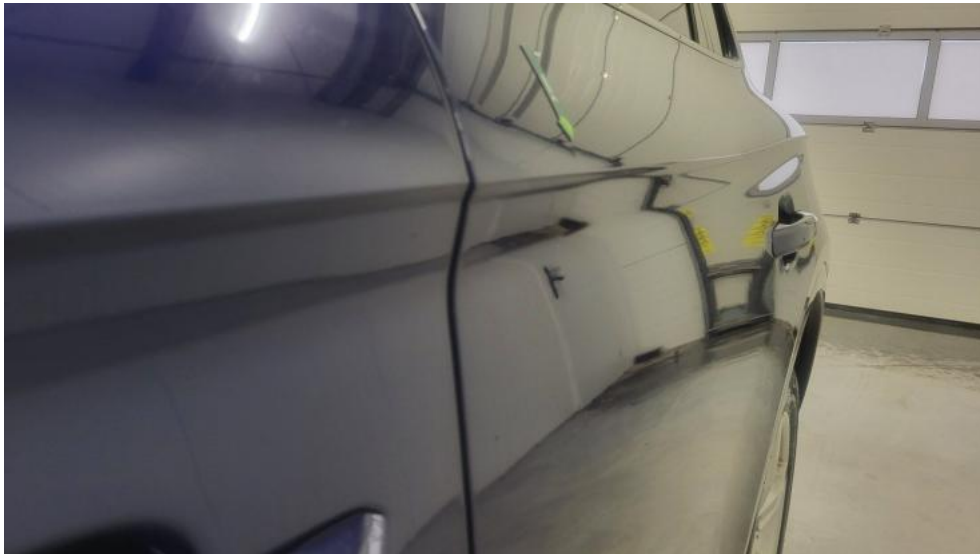
**Photo 67.**

Drzwi tylne L() - Wgniecenie/odkształcenie 3

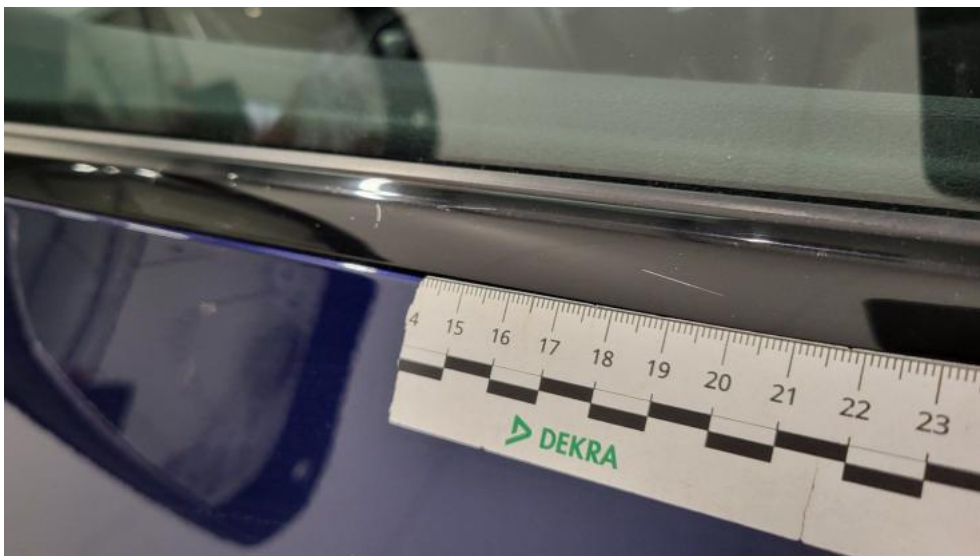
**Photo 68.**

Listwa drzwi przednich L - Rysa/odprysk 1

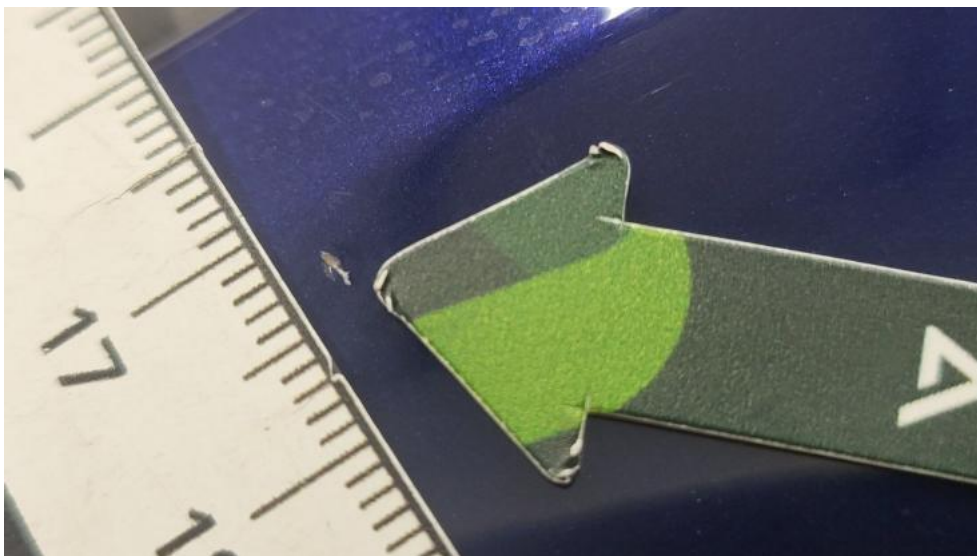
**Photo 71.**

Słupek przedni L - Inne 1

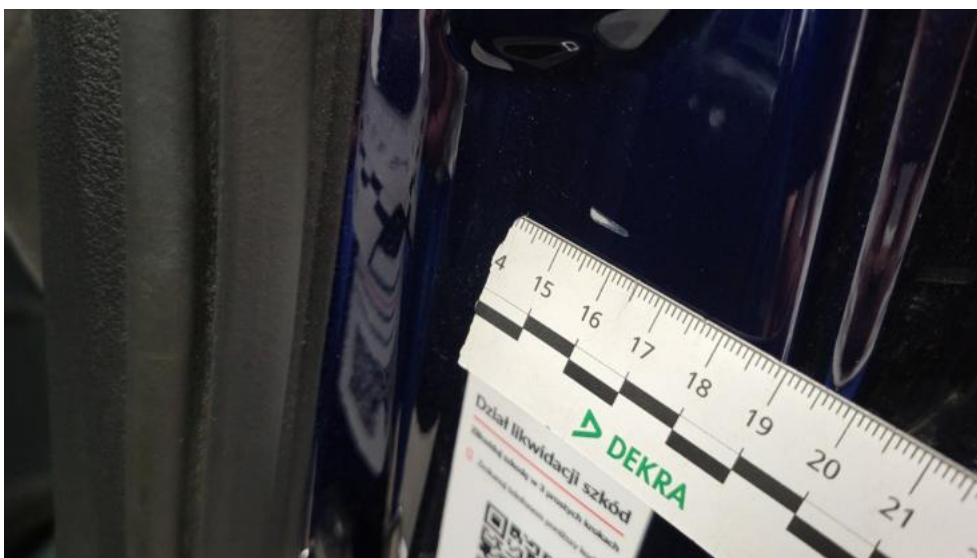
**Photo 72.**

Słupek środkowy L - Rysa/odprysk 1

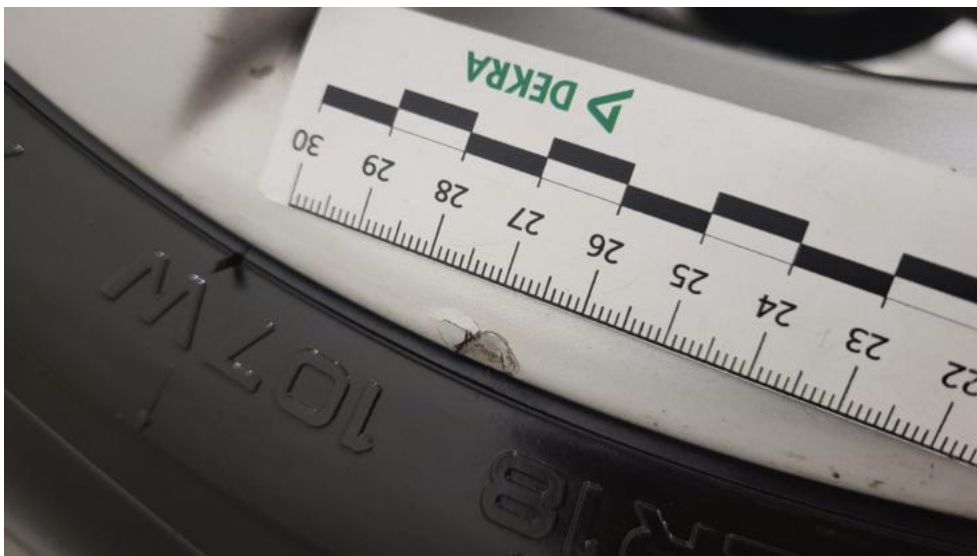
**Photo 73.**

Felga Aluminiowa przednia L - Rysa/odprysk 1

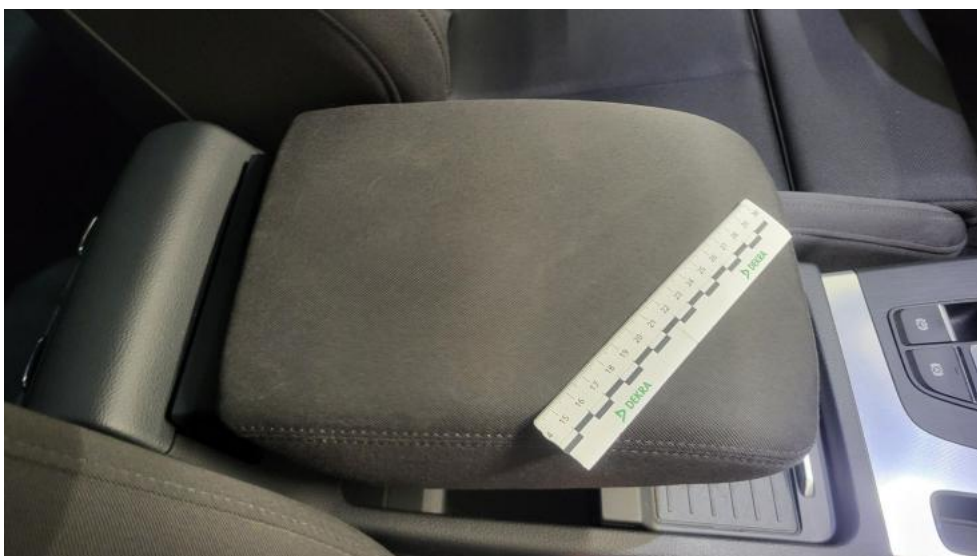
**Photo 74.**

Podłokietnik środkowy przedni - Inne 1

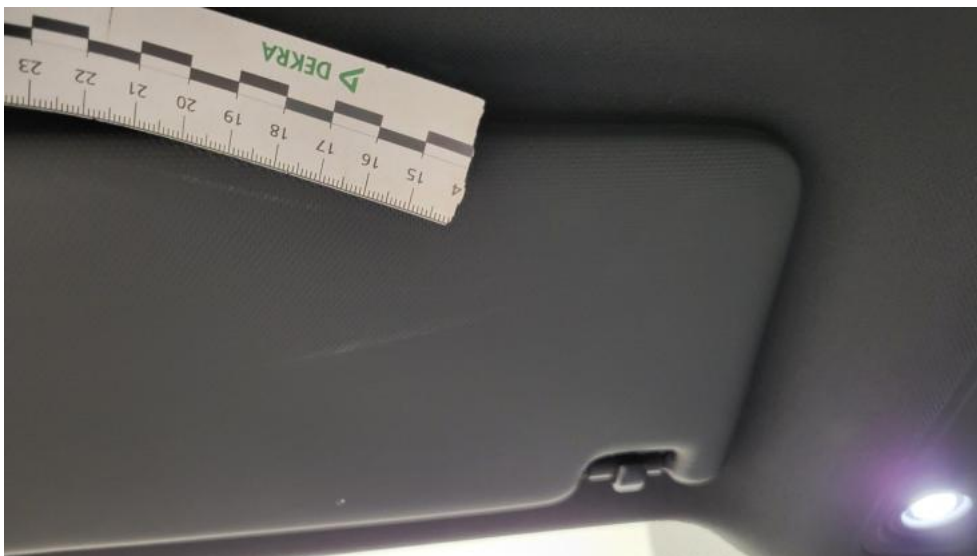
**Photo 75.**

Osłona p/słoneczna lewa - Inne 1
