DEKRA's commission No. : PKOL(W)/LODZ/10549/25/02/11  
 commission/ damage No. : 22/033999  
 Date of commission: 11-02-2025

Group of objects (Eurotax)	cars
EC code (Eurotax)	0150372
Manufacturer	BMW
Model	Seria 2 Gran Coupe [F44] 19-
Type / version	220i xDrive Sport Line aut
Body type	sedan
Number of doors / seats	4/5
Curb weight [kg]	1520
Gross vehicle weight [kg]	2060
Wheelbase 1/2	2670
Engine type	spark ignition
Pollution reduction system	GPF
Engine capacity [ccm]	1998
Engine Power [hp/kW]	178/131
Gearbox	automatic
Registration /record No.	PY15691
VIN / serial number	WBA51AL0807L78754
Date of first registration	21-11-2022
Date of next. tech. test	21-11-2025
Year of manufacture	2022 (year has been verified with the manufacturer's base)
Readout [km]	54 974 (read)
Body color / type of coating	white/double-layered, metallized

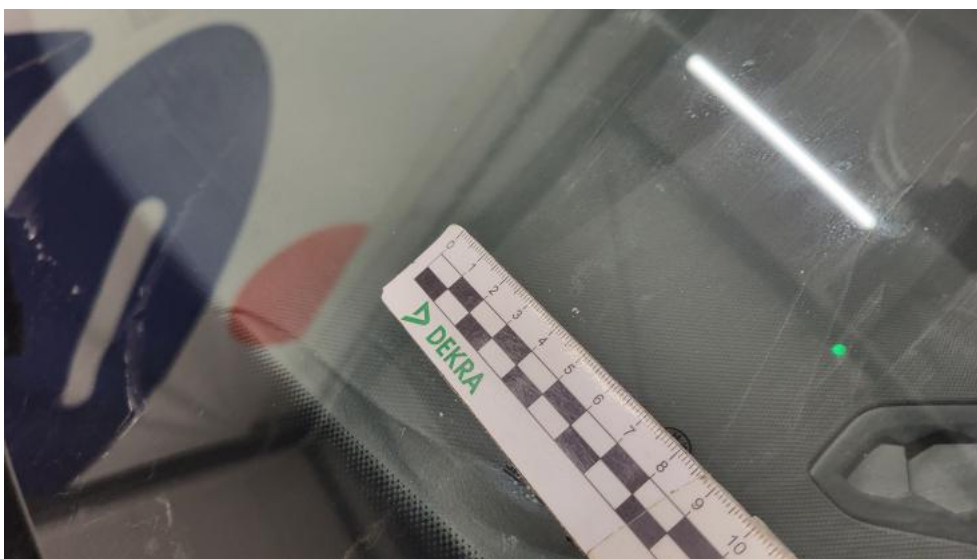
**Photo 39.**  
Szyba czołowa - Rysa/odprysk 1

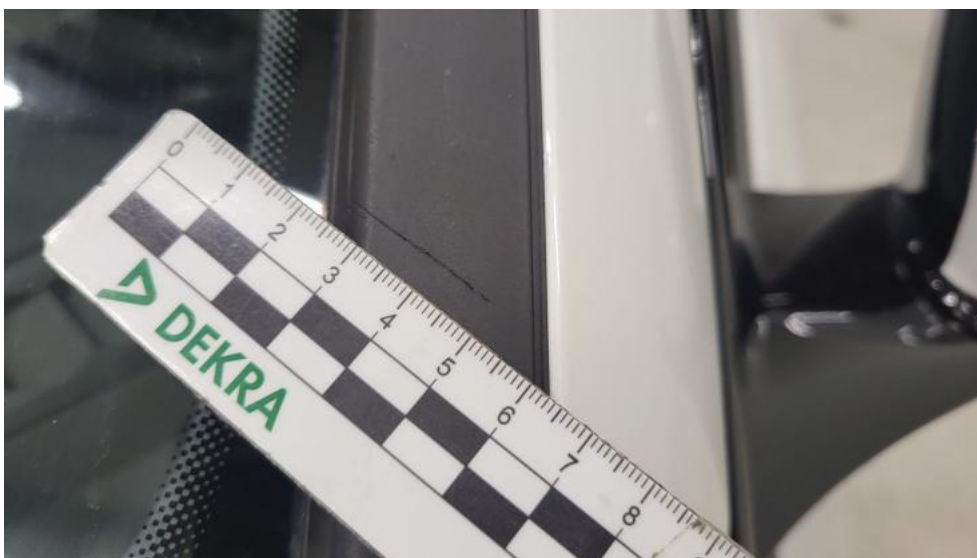
**Photo 40.**  
Uszczelka/listwa szyby czołowej - Rysa/odprysk 1

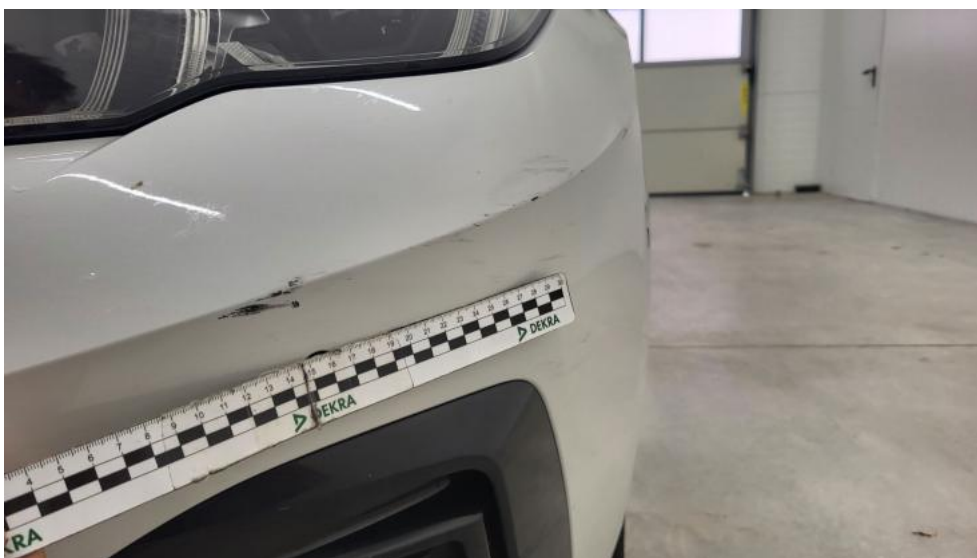
**Photo 42.**  
Zderzak - Rysa/odprysk 2

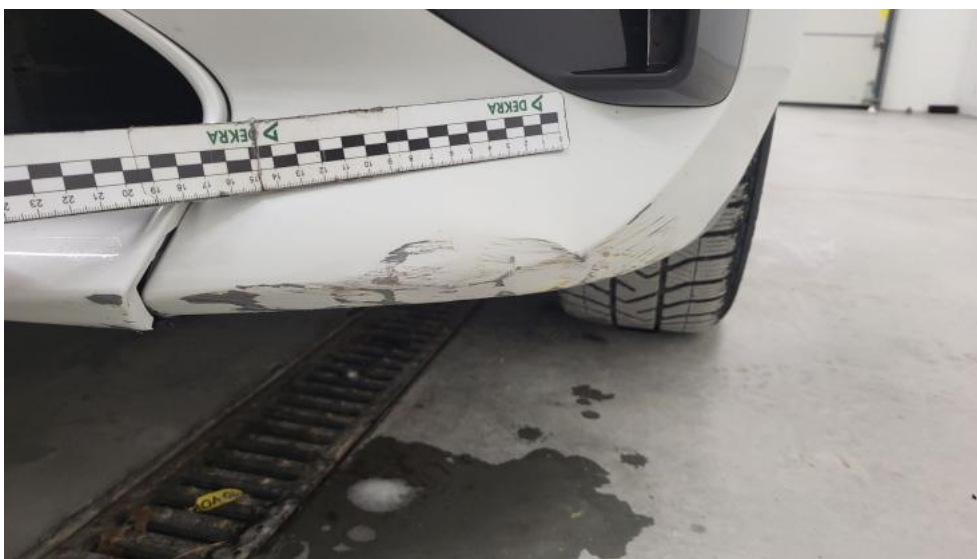
**Photo 43.**  
Zderzak() - Rysa/odprysk 3

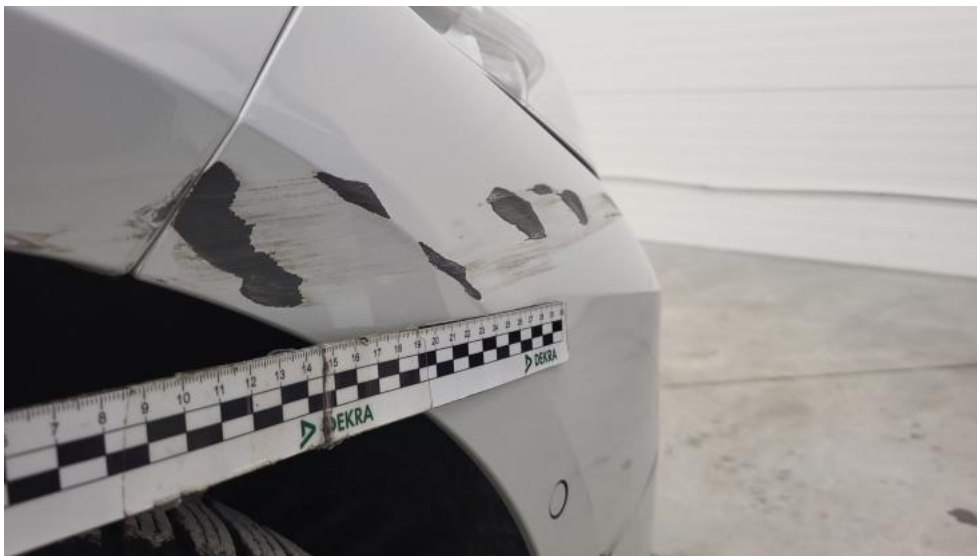
**Photo 45.**  
Zderzak - Wgniecenie/odkształcenie 2

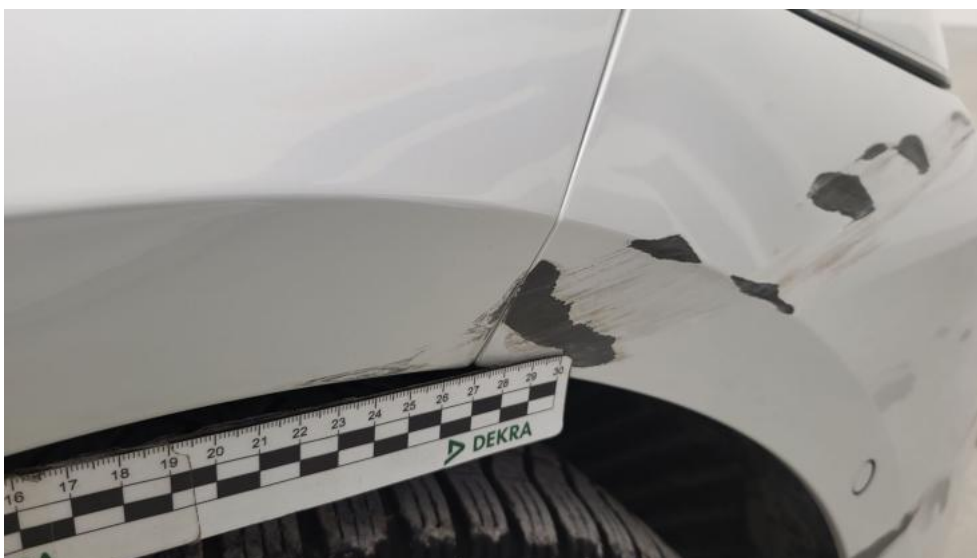
**Photo 48.**

Błotnik przedni P - Rysa/odprysk 2

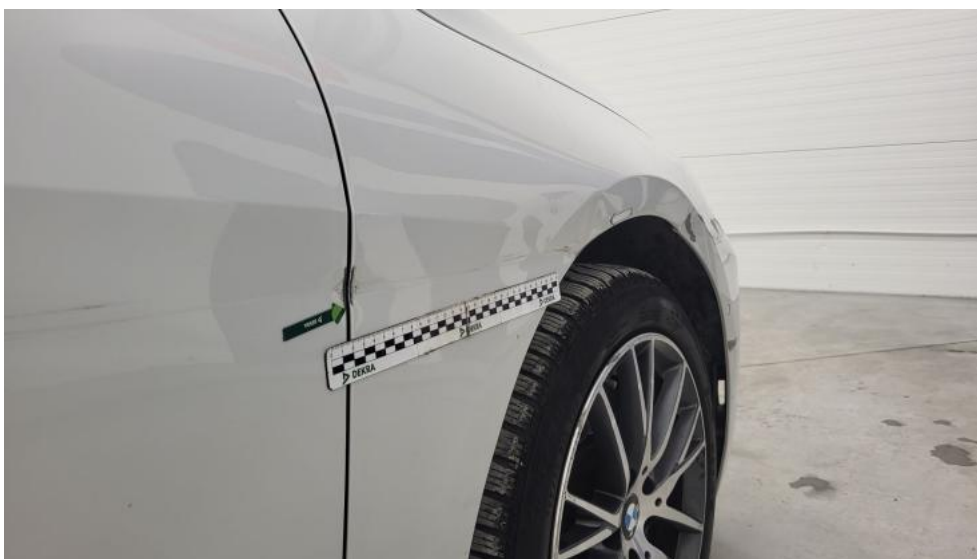
**Photo 49.**  
Błotnik przedni P - Wgniecenie/odkształcenie 1

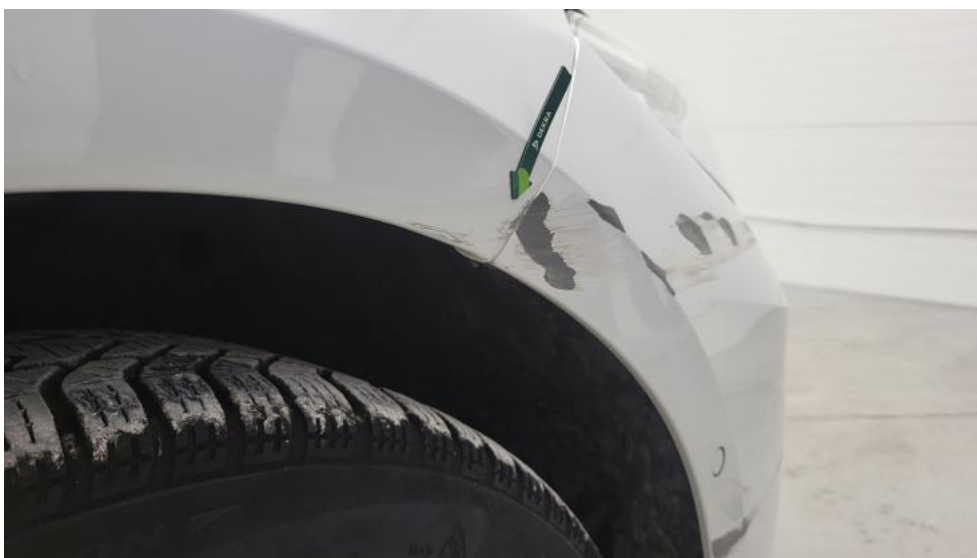
**Photo 50.**  
Błotnik przedni P - Wgniecenie/odkształcenie 2

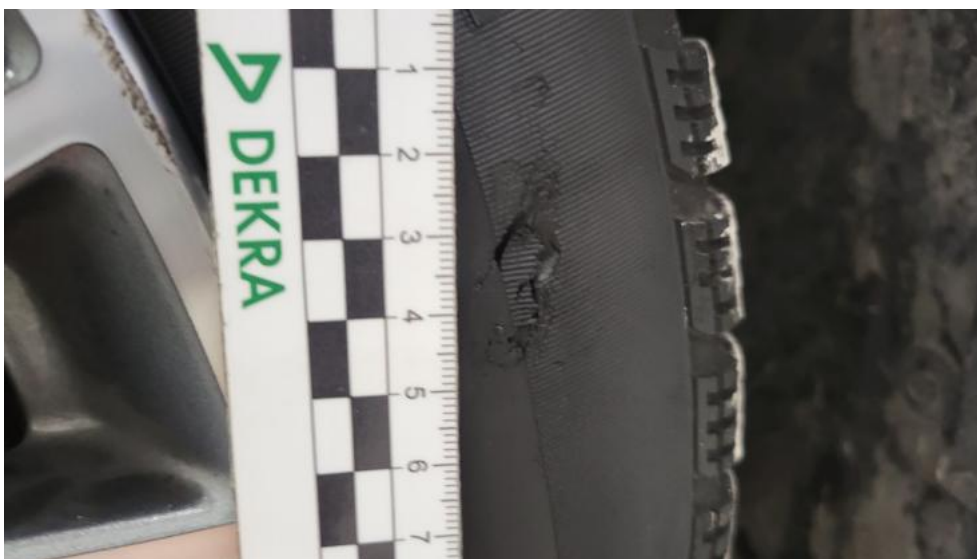
**Photo 53.**  
Opona przednia P - Pęknięcie/rozerwanie 1

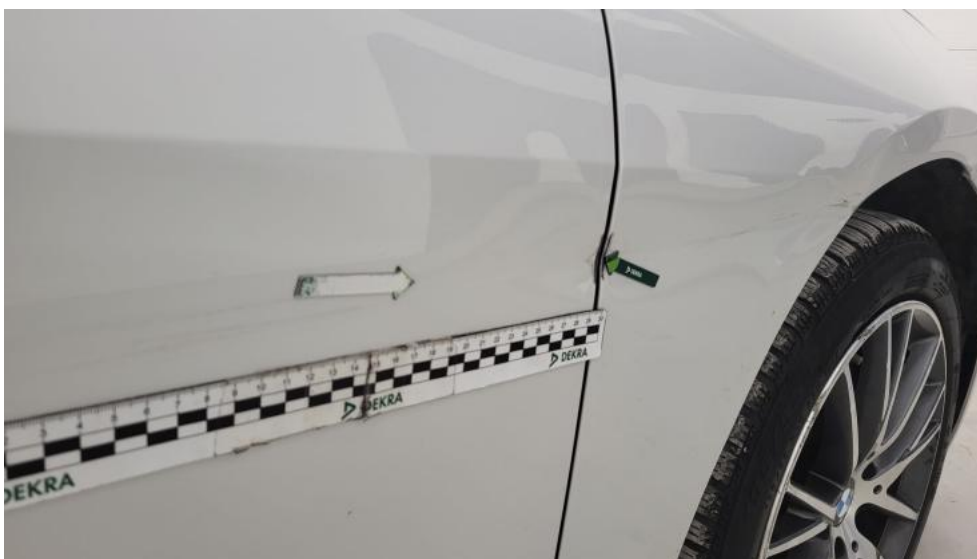
**Photo 55.**  
Drzwi przednie P - Wgniecenie/odkształcenie 1

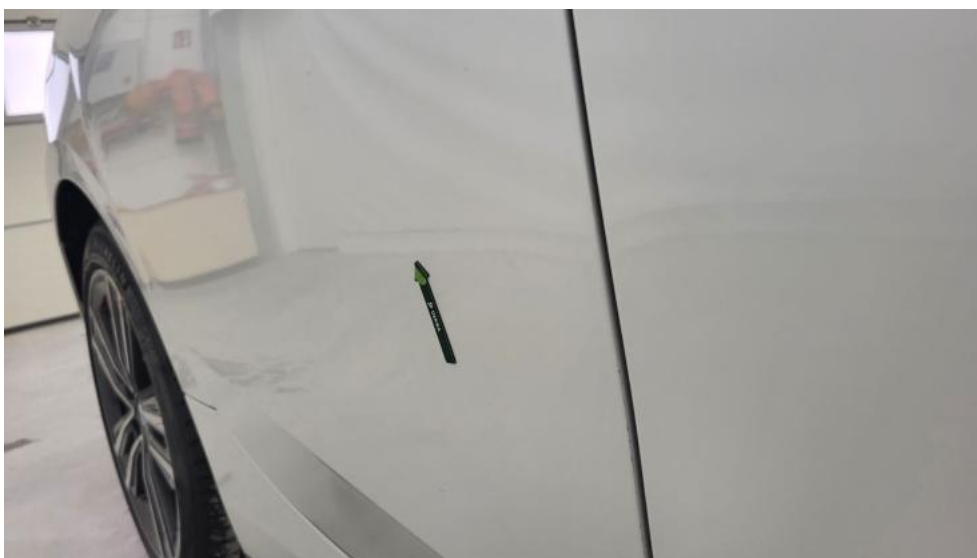
**Photo 56.**  
Drzwi tylne P - Wgniecenie/odkształcenie 1

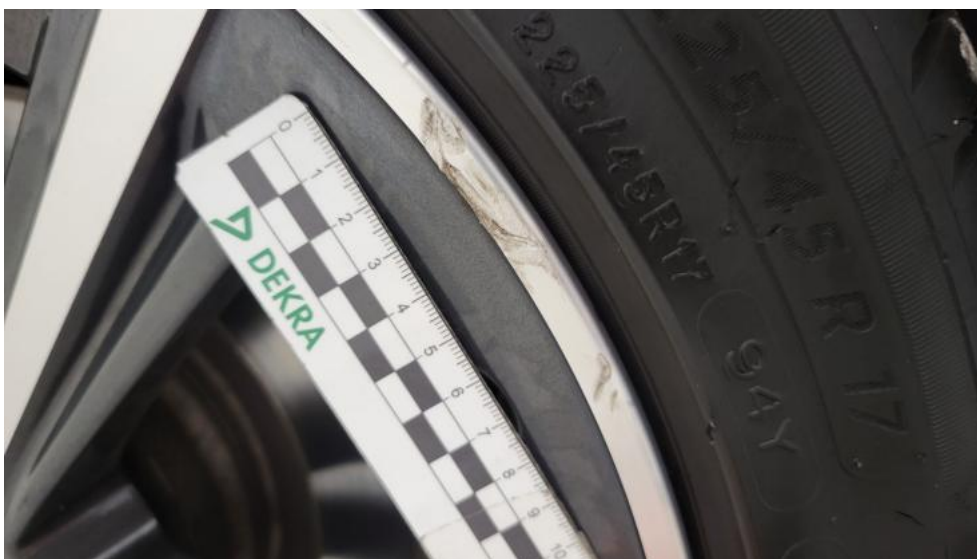
**Photo 57.**  
Felga aluminiowa tylna P - Rysa/odprysk 1

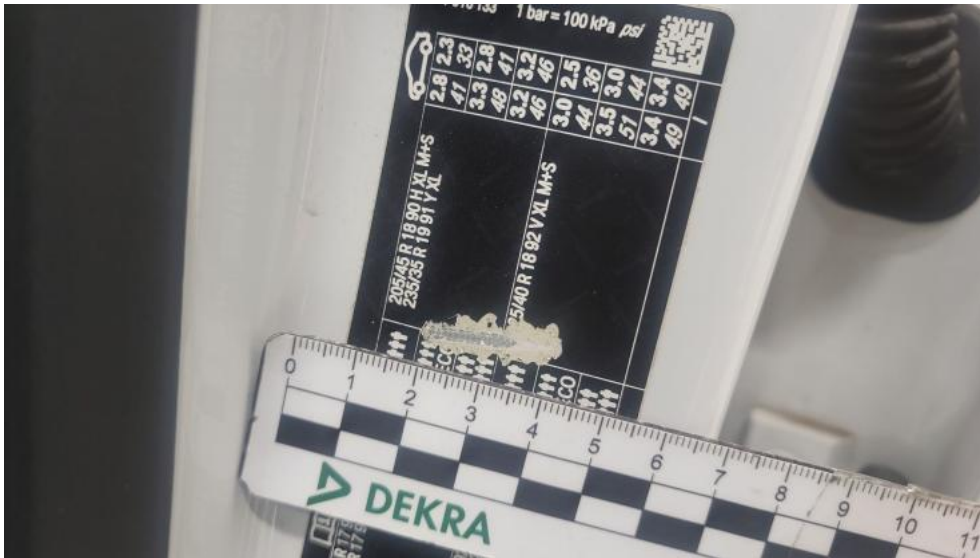
**Photo 61.**  
Stupek środkowy L - Rysa/odprysk 1

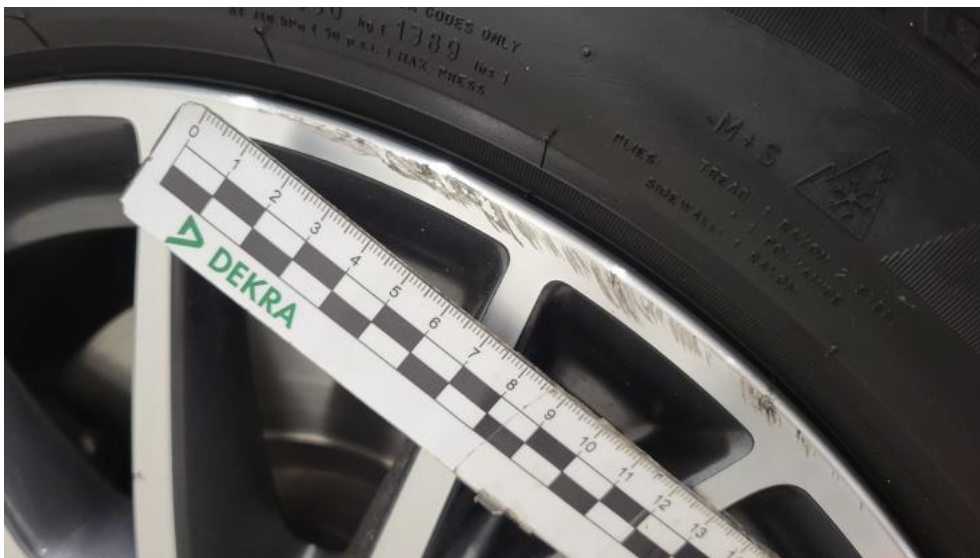
**Photo 62.**  
Felga Aluminiowa przednia L - Rysa/odprysk 1

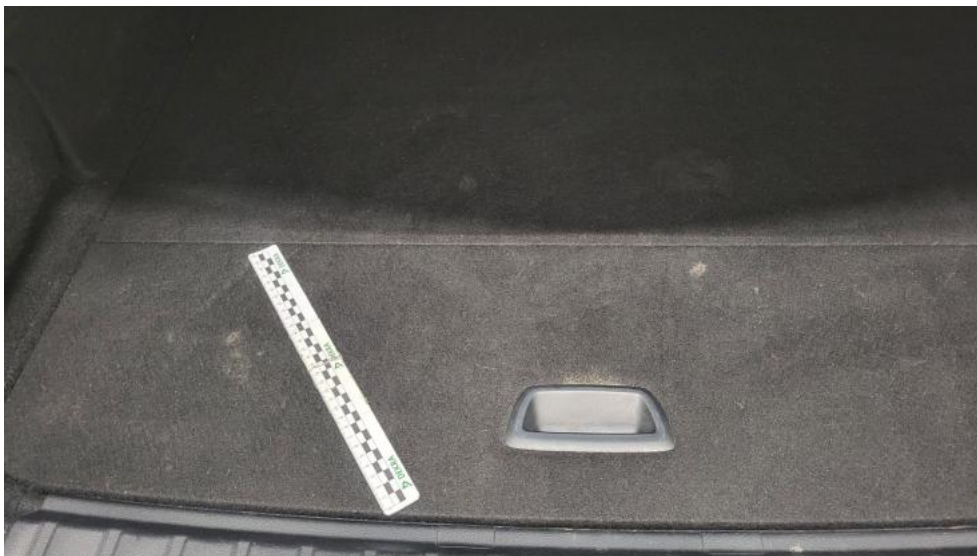
**Photo 63.**

Wykładzina podłogi bagażnika - Inne 1
