DEKRA's commission No. : PKOL(W)/LODZ/29698/26/04/03
commission/ damage No. : 24/039361
Date of commission: 03-04-2026

Group of objects (Eurotax)	jeeps
EC code (Eurotax)	0147744
Manufacturer	CUPRA
Model	Formentor 20-24
Type / version	Formentor 1.5 TSI DSG
Body type	hatchback
Number of doors / seats	5/5
Curb weight [kg]	1418
Gross vehicle weight [kg]	1980
Wheelbase 1/2	2679
Engine type	spark ignition
Pollution reduction system	GPF
Engine capacity [ccm]	1498
Engine Power [hp/kW]	150/110
Gearbox	automatic
Registration /record No.	WZ876JJ
VIN / serial number	VSSZZZKM2RR023840
Date of first registration	13-09-2023
Date of next. tech. test	13-09-2026
Year of manufacture	2023 (year has been verified with the manufacturer's base)
Readout [km]	61 055 (read)
Body color / type of coating	grafitowy/double-layered, metallized

Measurement of thickness of the vehicle lacquer coating

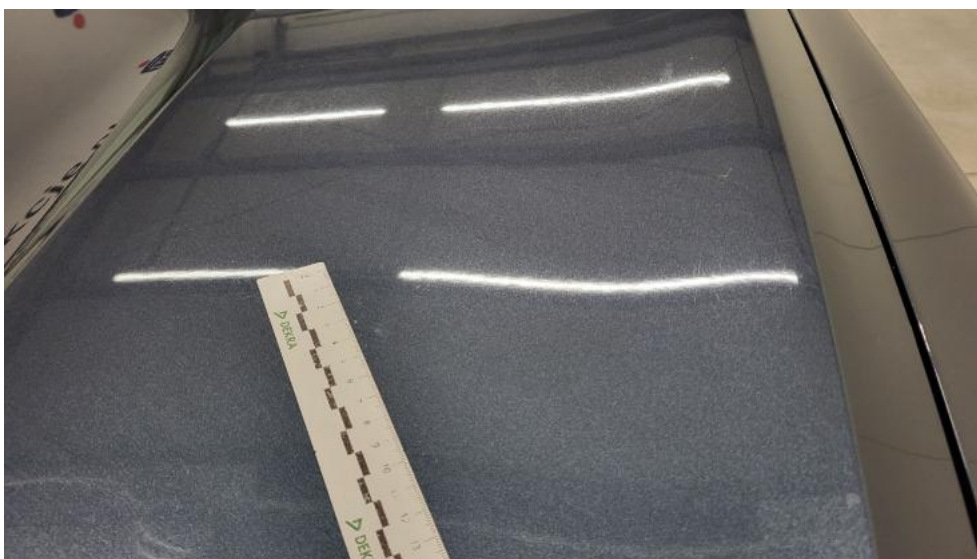
Photo 39.
Pokrywa komory silnika - Rysa/odprysk 1

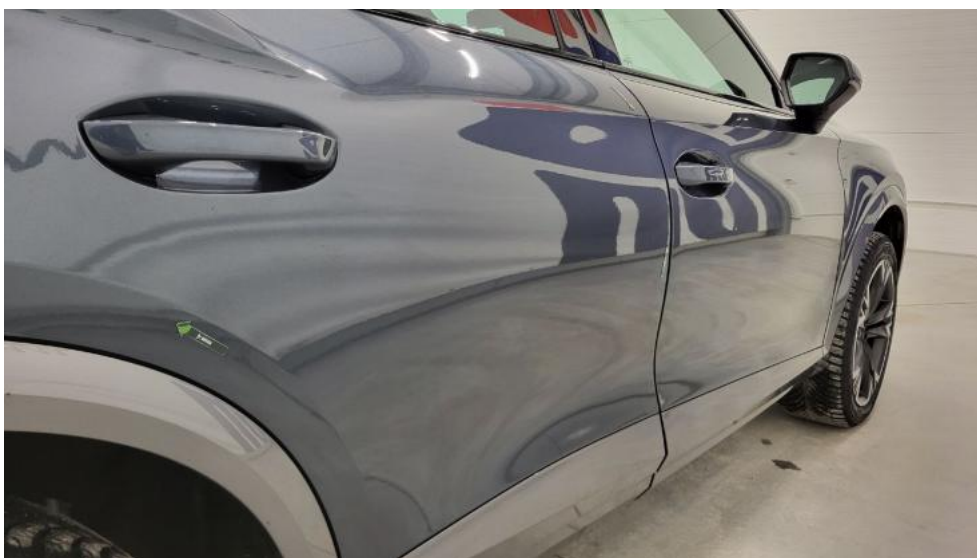
Photo 48.
Drzwi tylne P - Wgniecenie/odkształcenie 1

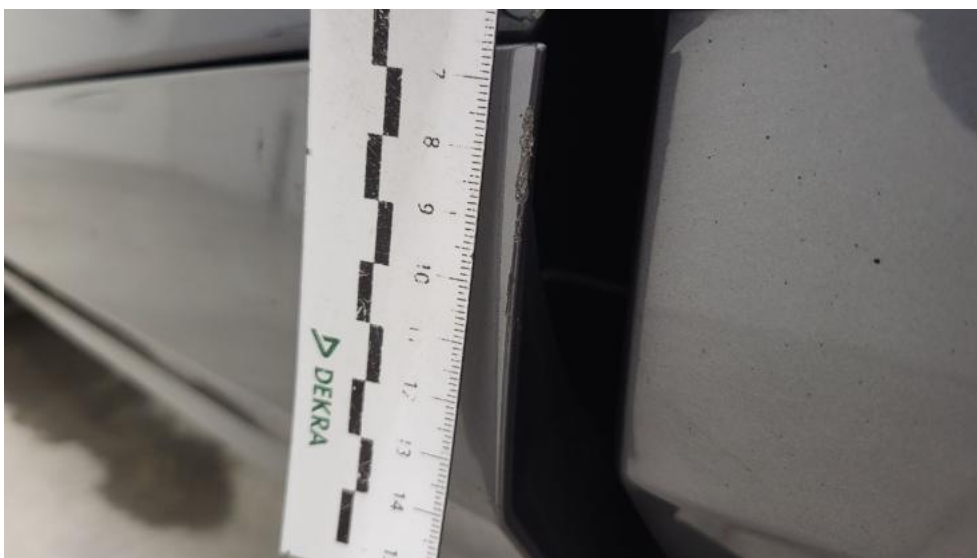
Photo 56.
Listwa drzwi przednich L - Rysa/odprysk 1

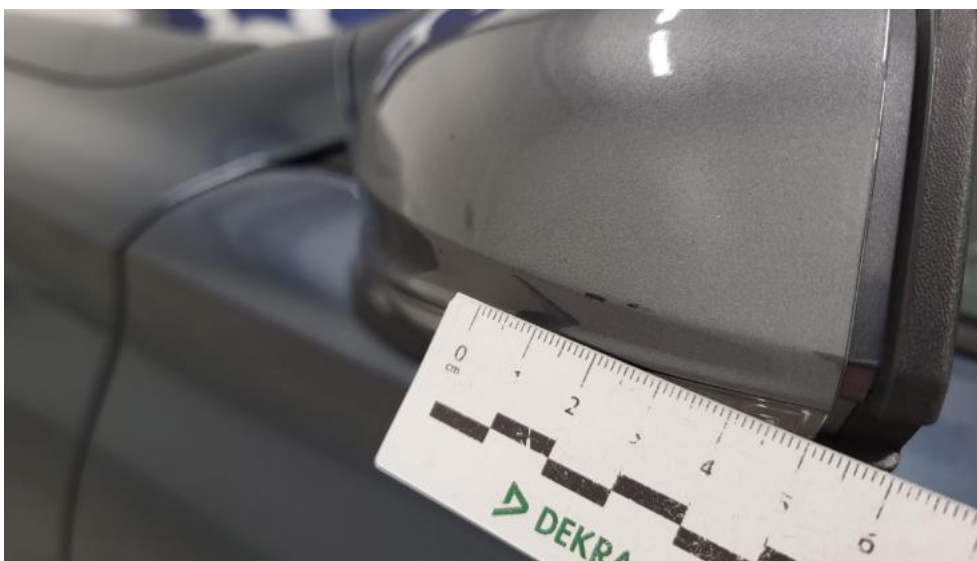
Photo 57.

Lusterko zew L - Rysa/odprysk 1

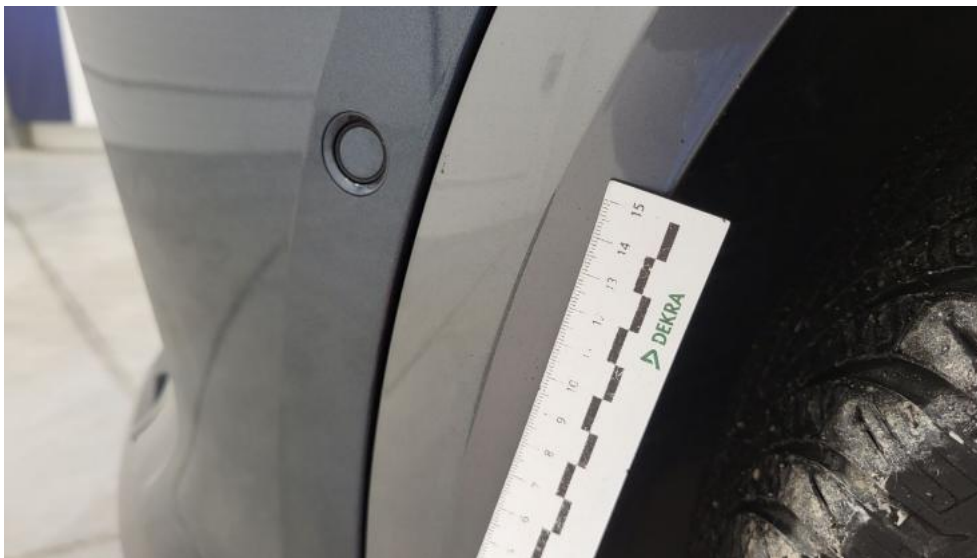
Photo 61.
Listwa błotnika przedniego L - Rysa/odprysk 1

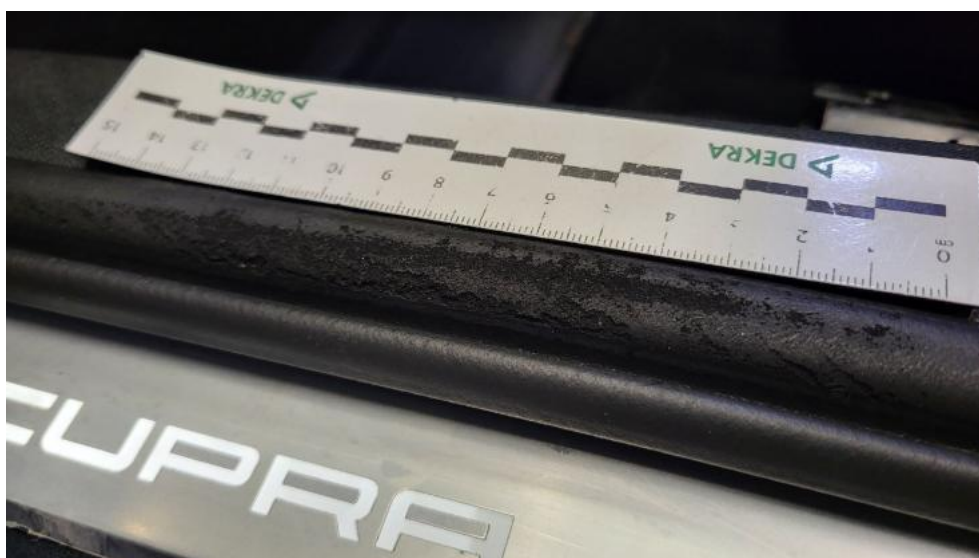
Photo 64.
Uszczelka drzwi przednich L - Rysa/odprysk 1

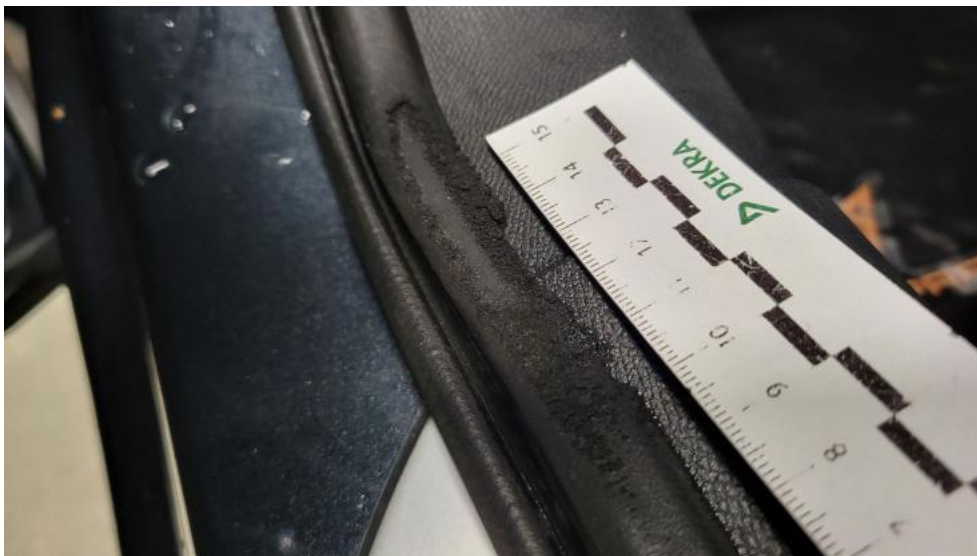
Photo 65.

Uszczelka drzwi przednich L - Pęknięcie/rozerwanie 1

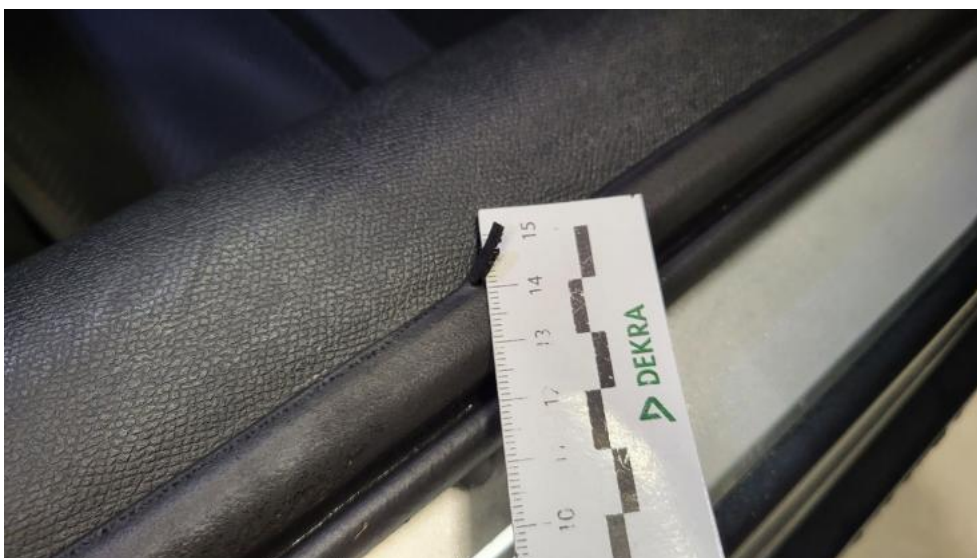
Photo 66.

Uszczelka drzwi przednich P - Pęknięcie/rozerwanie 1

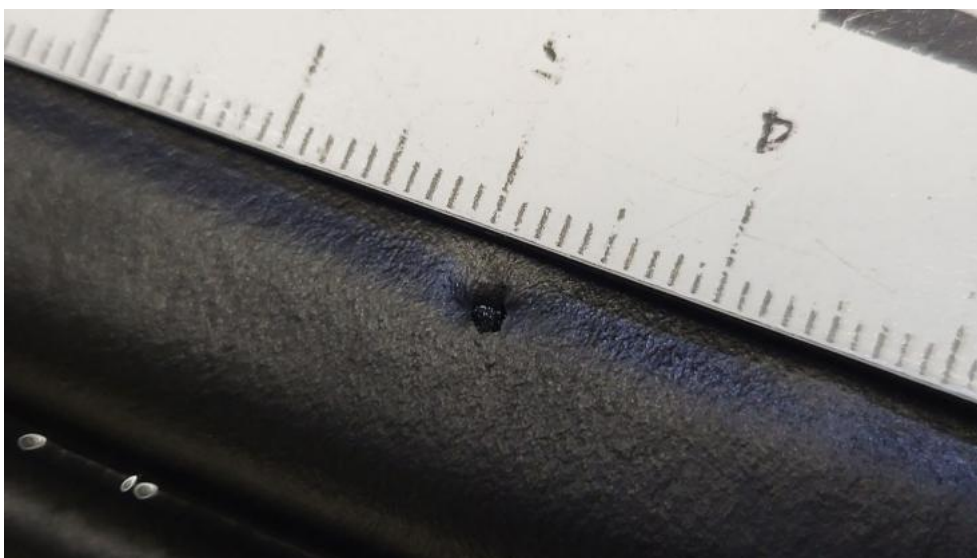
Photo 68.

Uszczelka drzwi tylnych L - Pęknięcie/rozerwanie 1
