DEKRA's commission No. : PKOL(W)/LODZ/05215/26/01/21  
commission/ damage No. : 24/042905  
Date of commission: 21-01-2026

**Vehicle data**

| Model | Proace City Verso 19-24 |
| Type / version | Proace City Verso Long 1.5 D-4D Business Aut. |

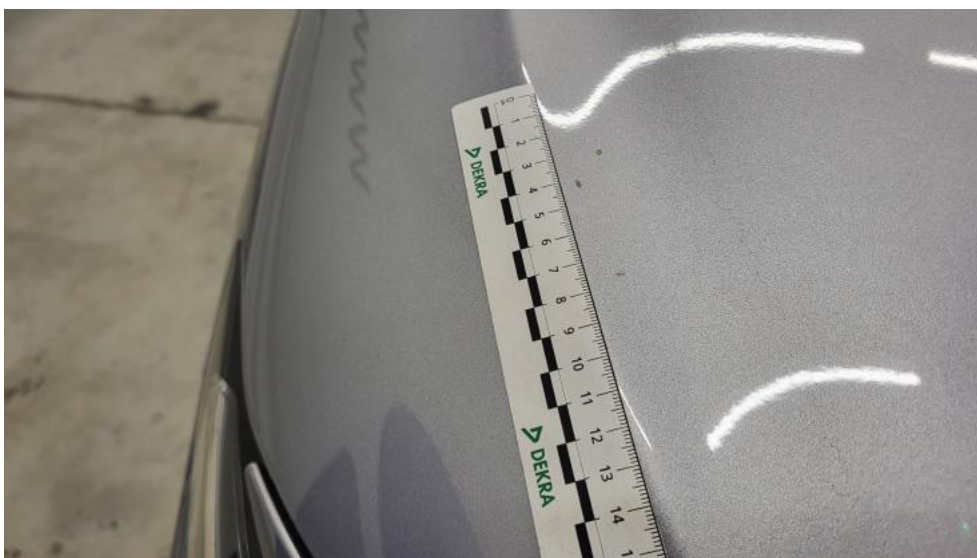
**Photo 32.**

Pokrywa komory silnika - Rysa/odprysk 1

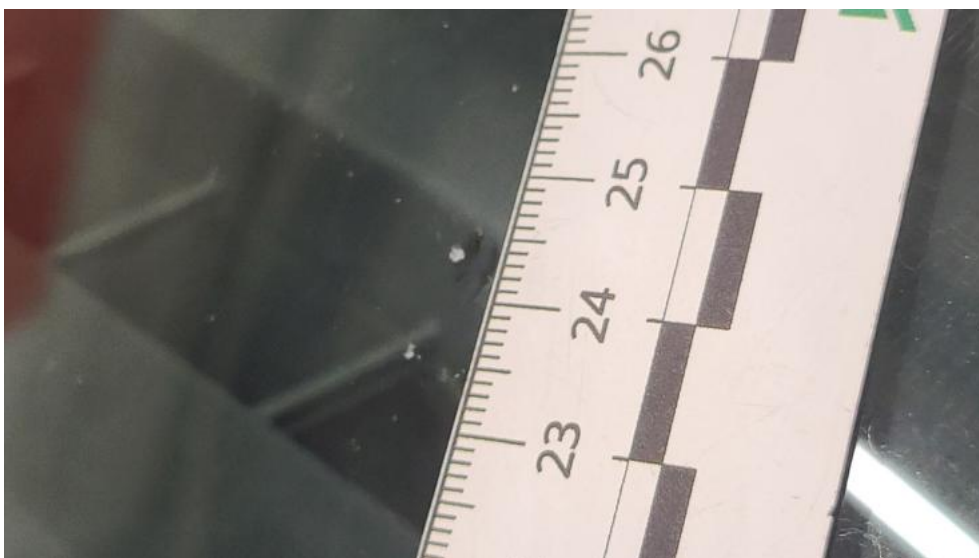
**Photo 34.**

Szyba czołowa - Pęknięcie/rozerwanie 1

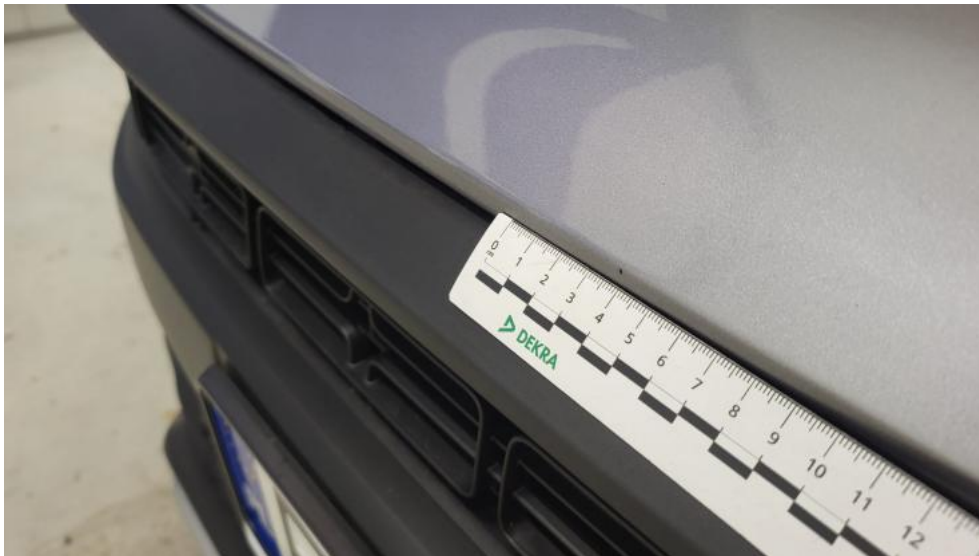
**Photo 35.**

Zderzak - Rysa/odprysk 1

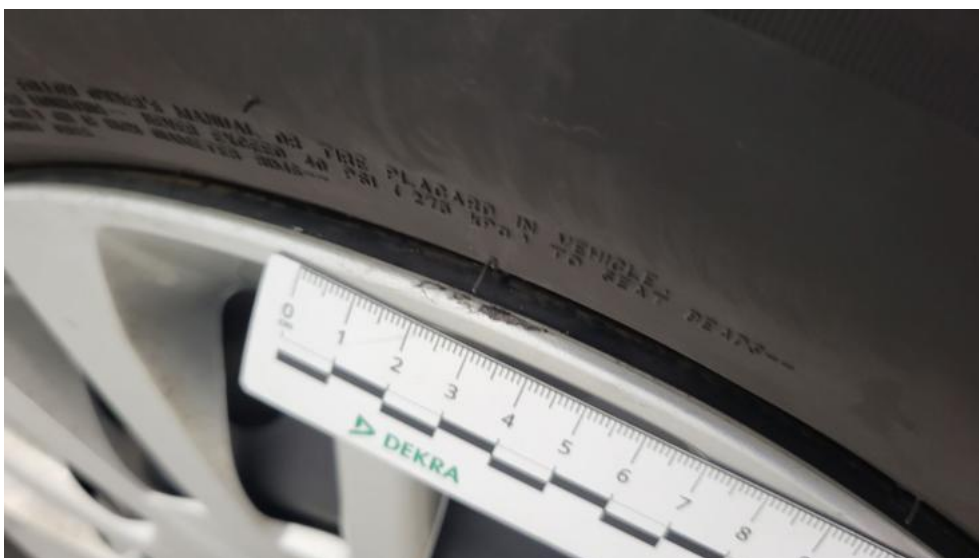
**Photo 36.**

Kołpak przedni P - Rysa/odprysk 1

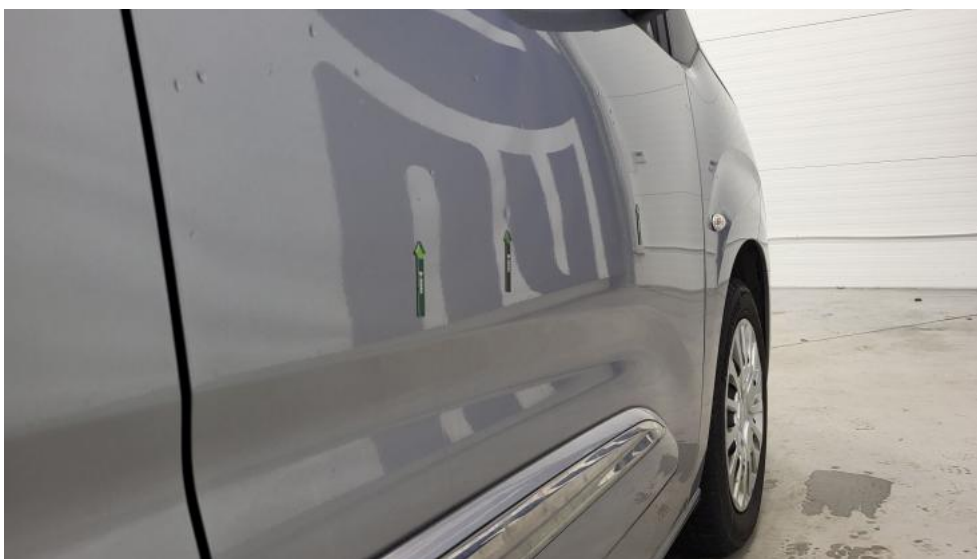
**Photo 37.**

Drzwi przednie P - Wgniecenie/odkształcenie 1

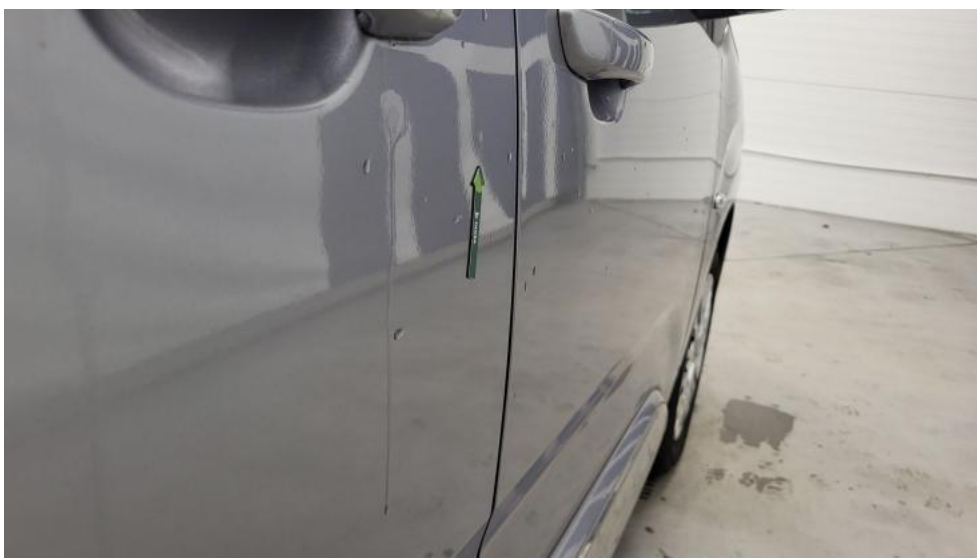
**Photo 38.**

Drzwi tylne P - Wgniecenie/odkształcenie 1

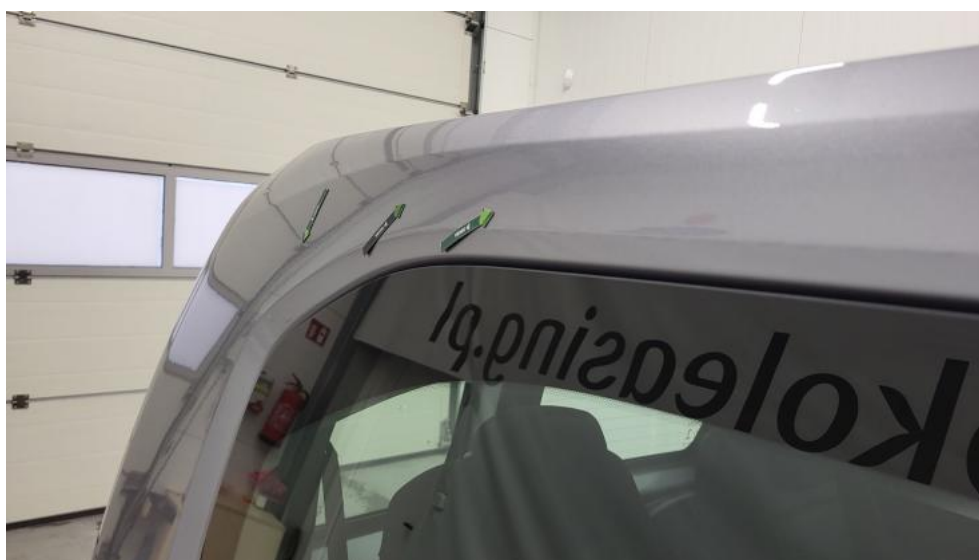
**Photo 40.**

Ścianka tylna P / Ścianka boczna P - Wgniecenie/odkształcenie 1

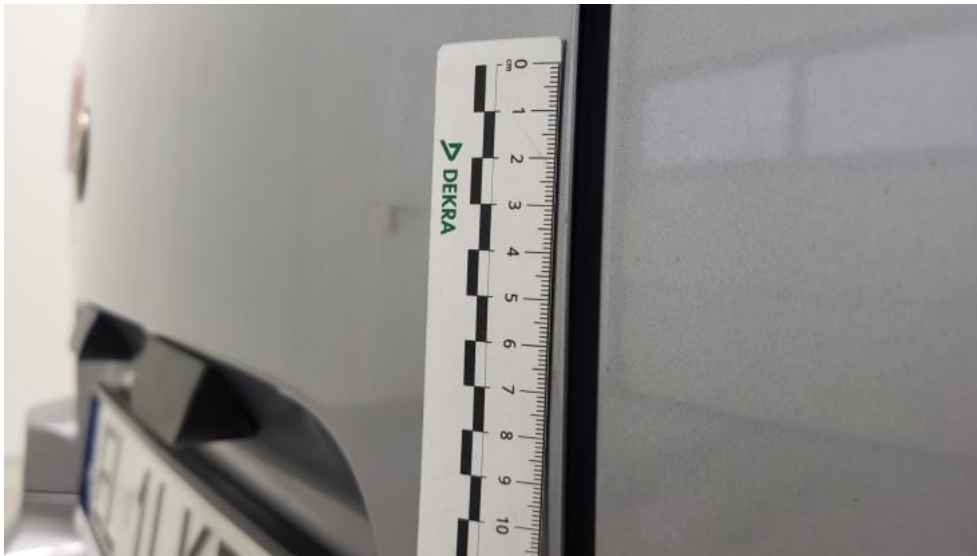
**Photo 41.**

Pokrywy bagażnika - Rysa/odprysk 1

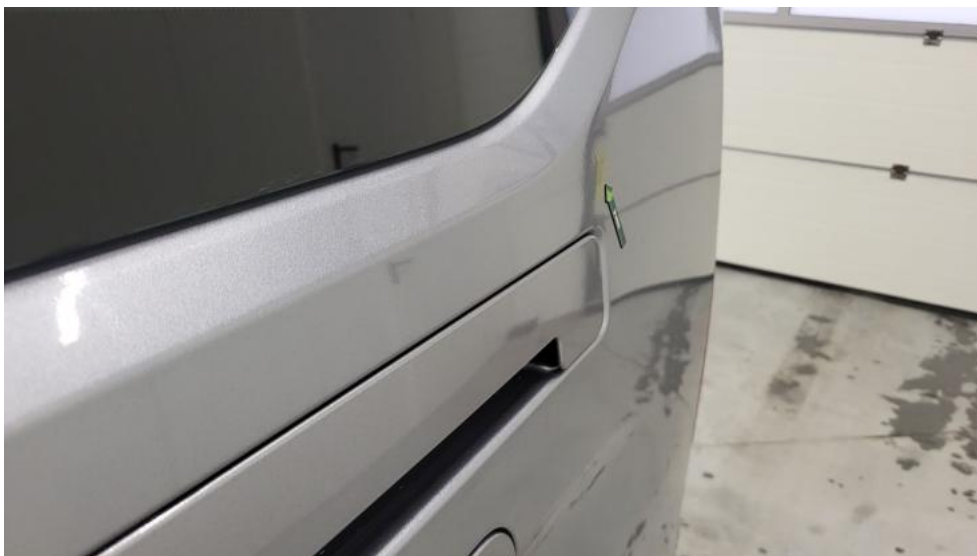
**Photo 42.**

Ścianka tylna L / Ścianka boczna L - Wgniecenie/odkształcenie 1

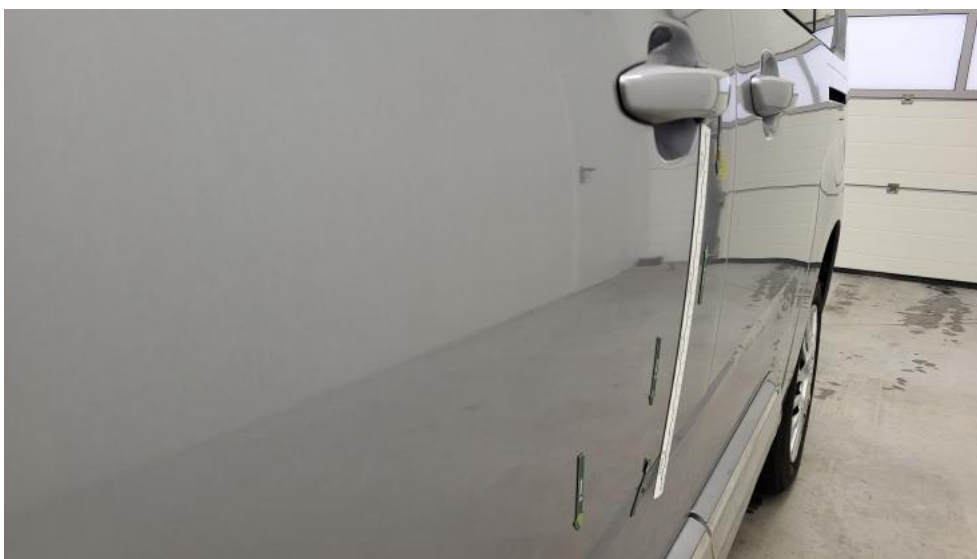
**Photo 43.**

Drzwi przed L - Wgniecenie/odkształcenie 1

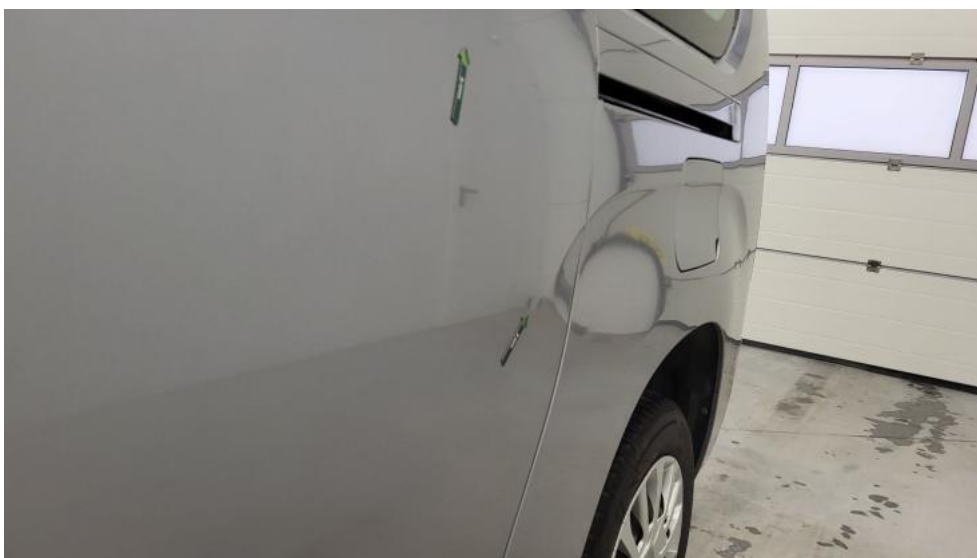
**Photo 44.**

Drzwi tylne L - Wgniecenie/odkształcenie 1

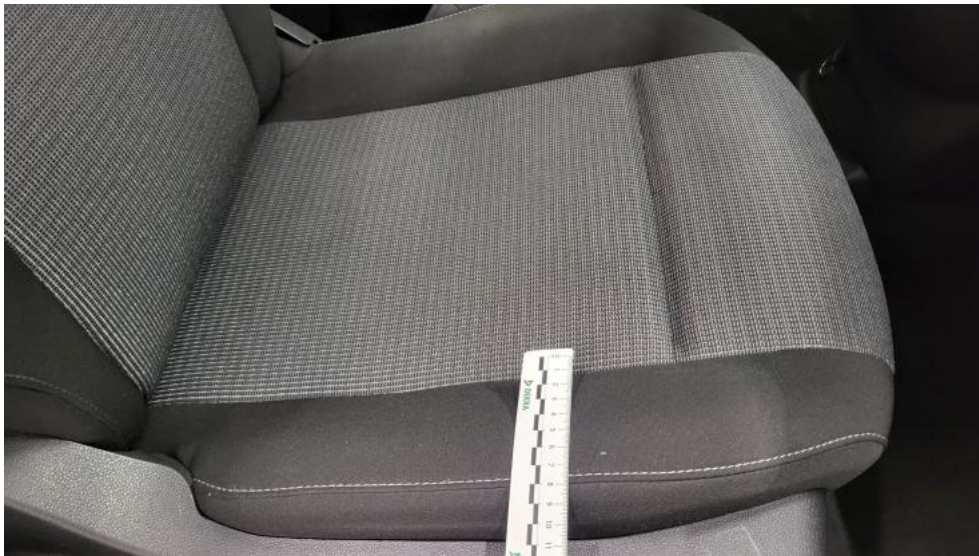
**Photo 45.**

Fotel prz. praw. - Inne 1

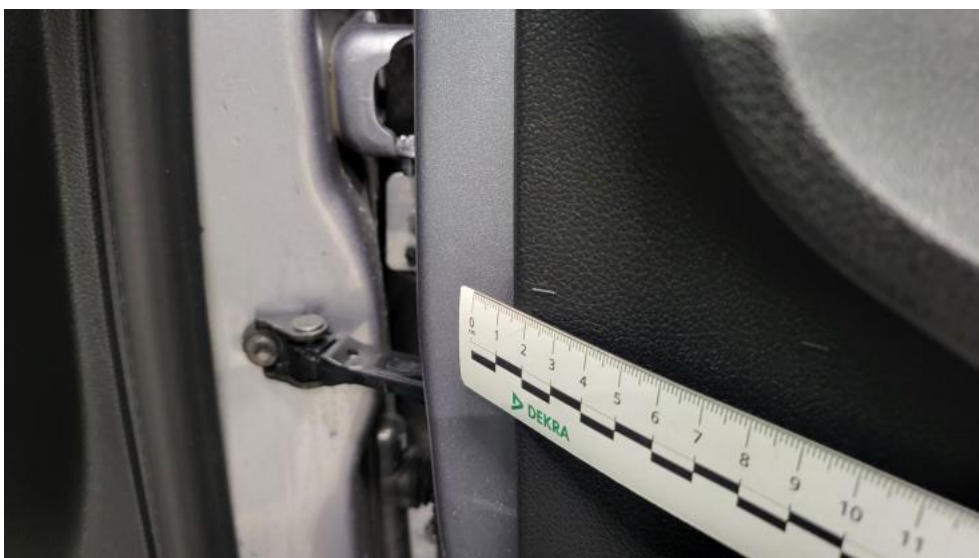
**Photo 46.**

Tapicerka drzwi przednich P - Rysa/odprysk 1

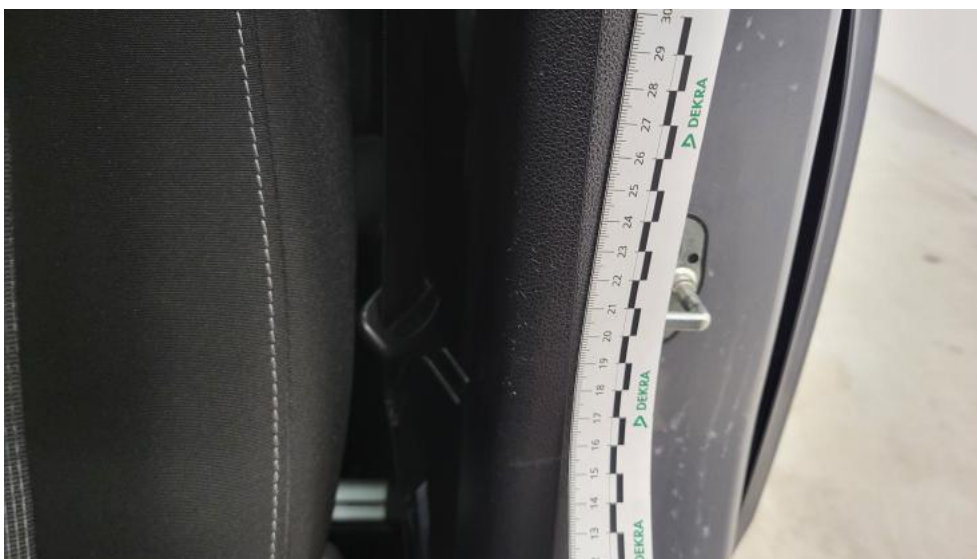
**Photo 47.**

Wykładzina(y) słupka środkowego L - Rysa/odprysk 1
