DEKRA's commission No. : PKOL(W)/LODZ/17543/26/02/26  
commission/ damage No. : 24/017657  
Date of commission: 26-02-2026

**DEKRA Poland - Headquarters**  
02-673 Warszawa, ul. Konstruktorska 12A

PKO Leasing SA  
Świętokrzyska 36  
00-116 Warszawa

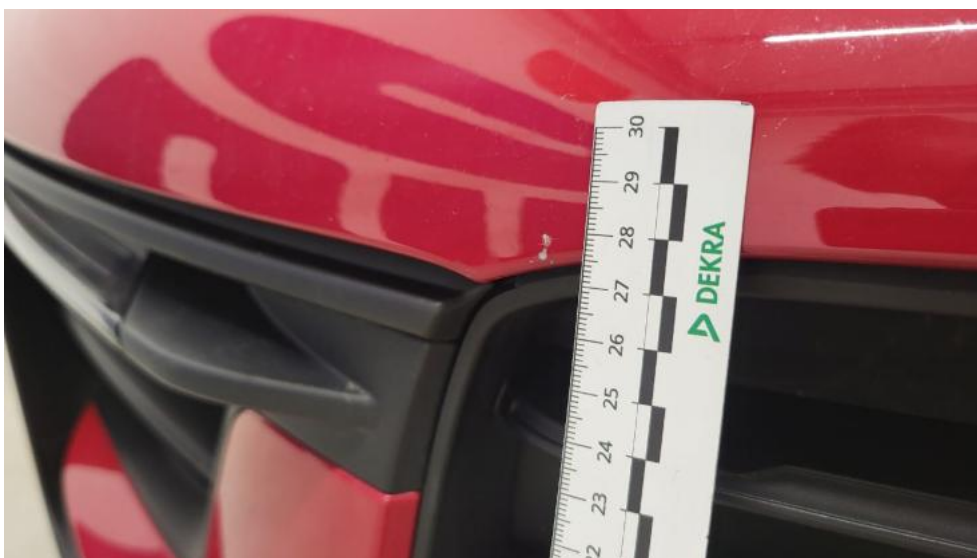
**Photo 44.**  
Pokrywa komory silnika - Rysa/odprysk 1

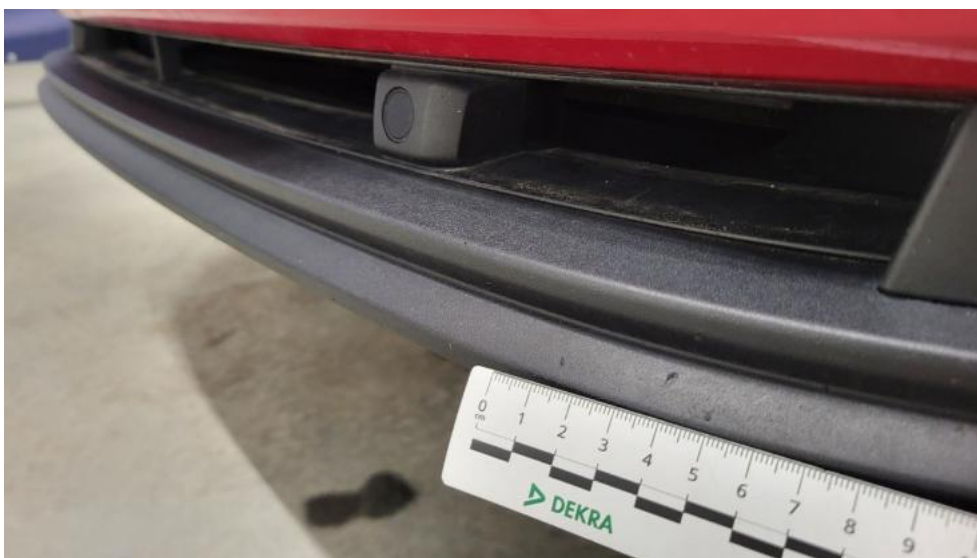
**Photo 46.**

Spoiler zderzaka przedniego - Rysa/odprysk 1

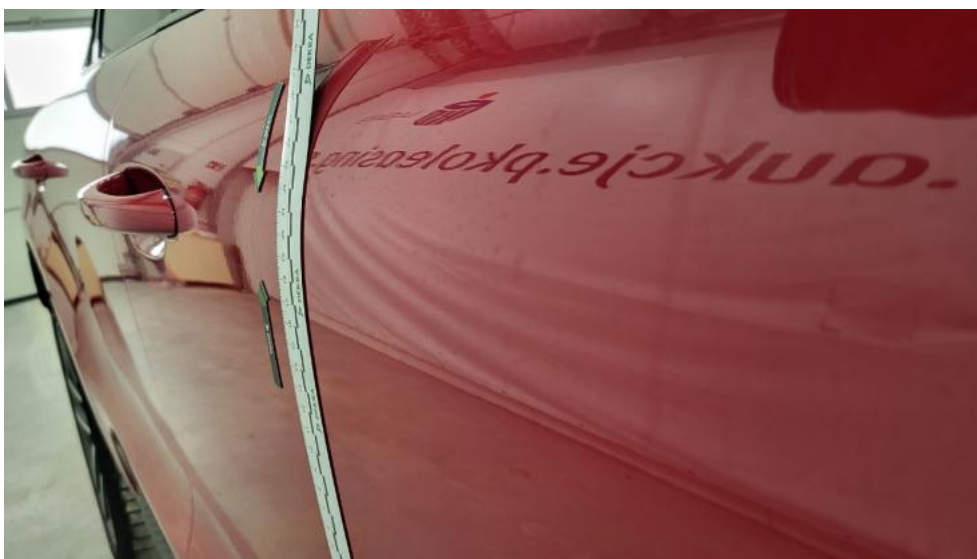
**Photo 49.**  
Drzwi przednie P - Wgniecenie/odkształcenie 1

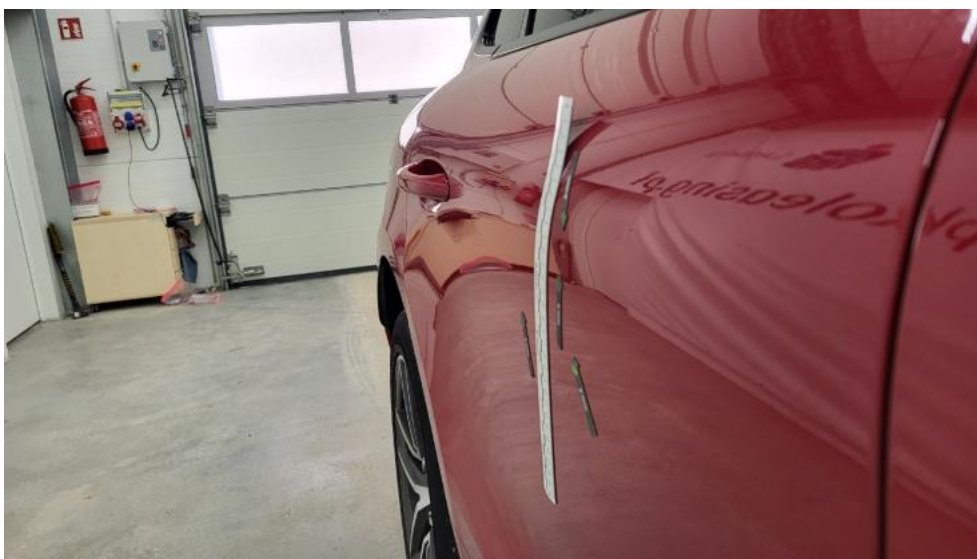
**Photo 51.**  
Drzwi tylne P - Wgniecenie/odkształcenie 1

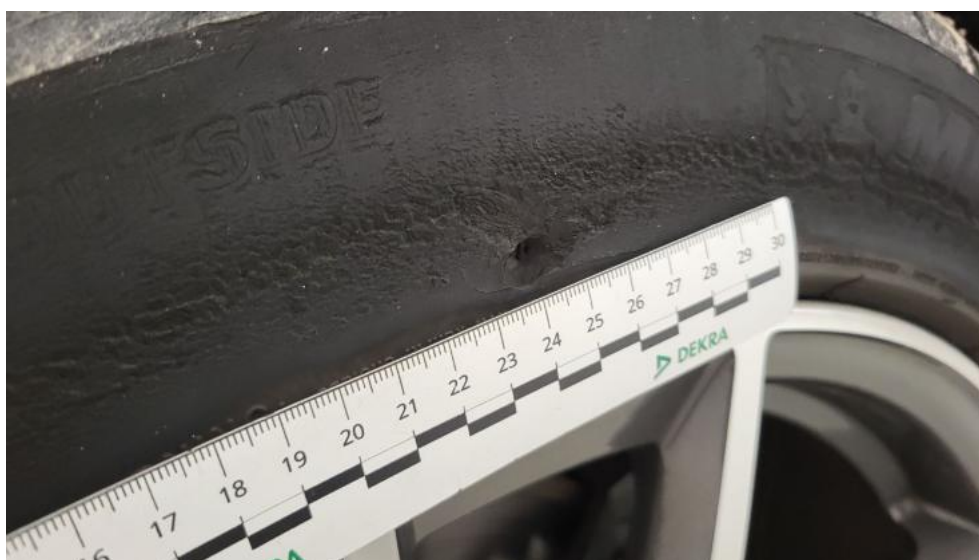
**Photo 54.**  
Opona tylna P - Pęknięcie/rozerwanie 1

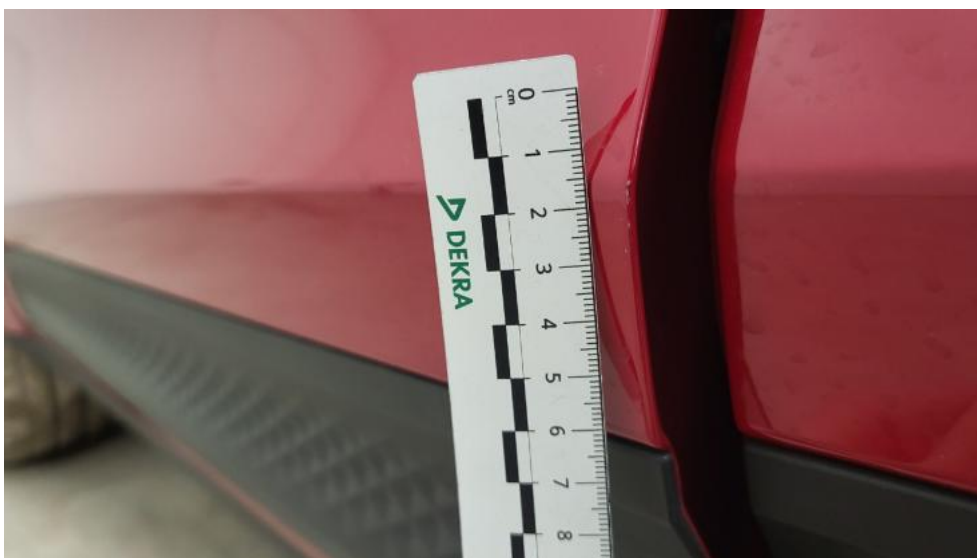
**Photo 60.**  
Drzwi przed L - Rysa/odprysk 1

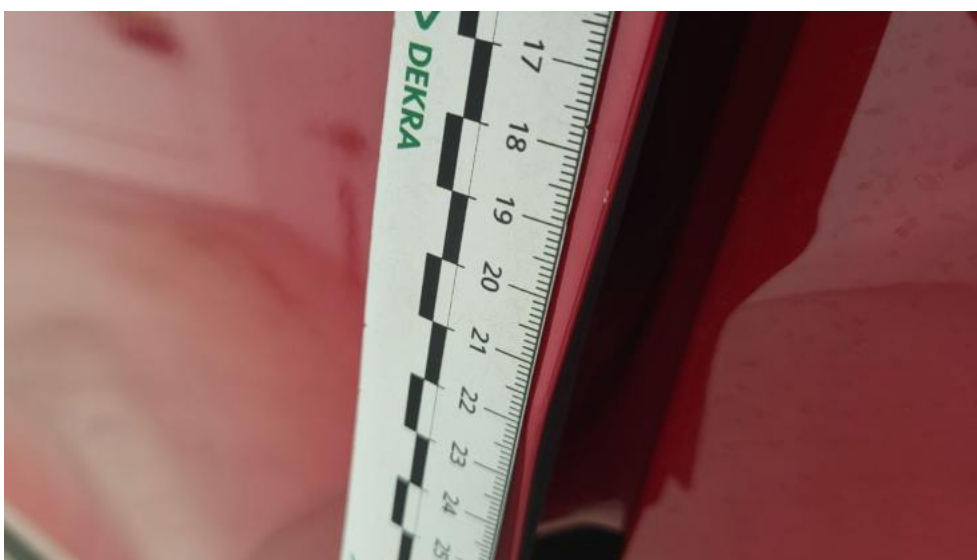
**Photo 62.**

Drzwi tylne L - Rysa/odprysk 1

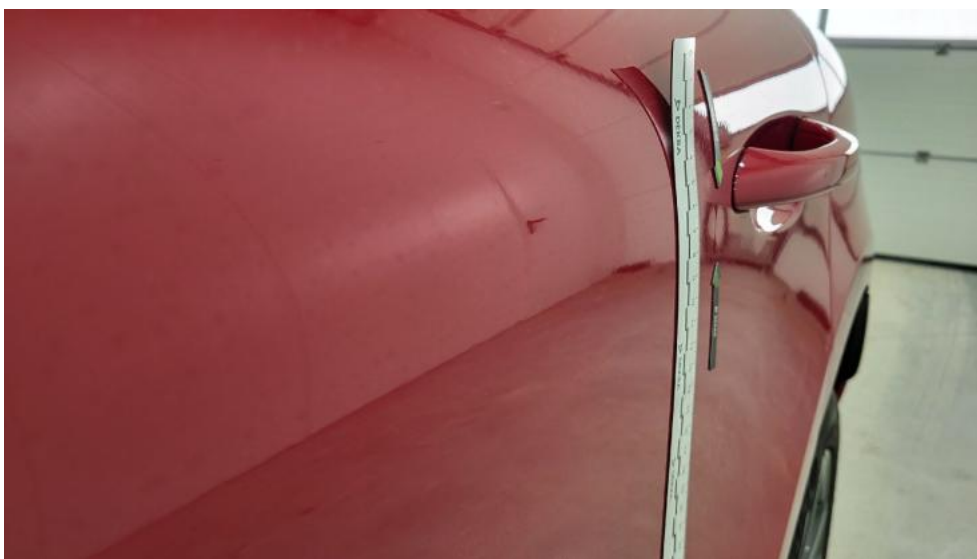
**Photo 63.**  
Drzwi tylne L - Wgniecenie/odkształcenie 1

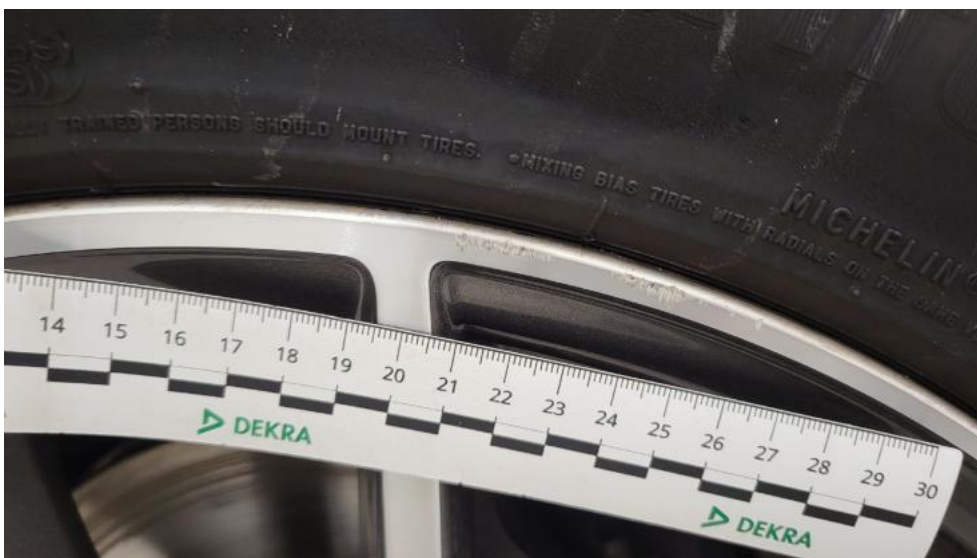
**Photo 64.**  
Felga Aluminiowa przednia L - Rysa/odprysk 1

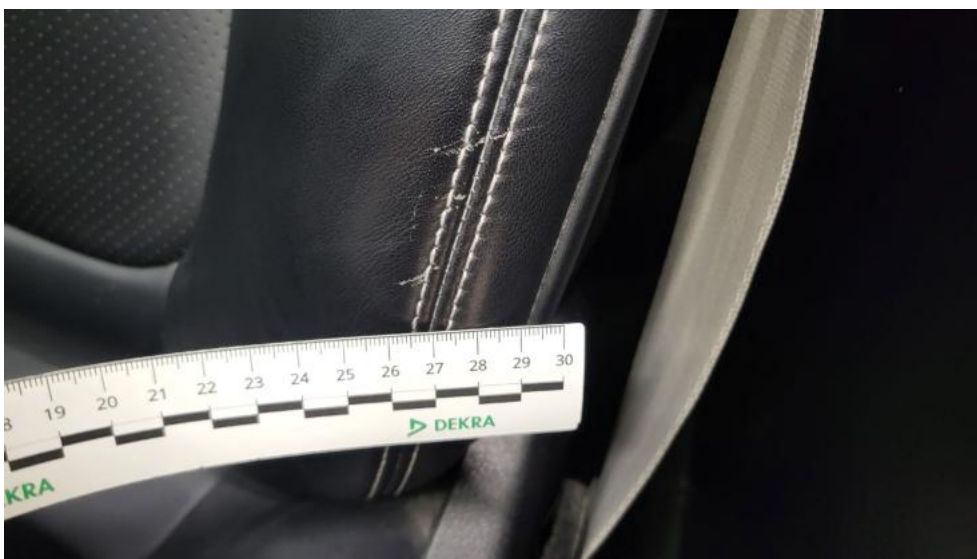
**Photo 65.**

Fotel prz. lew. - Rysa/odprysk 1

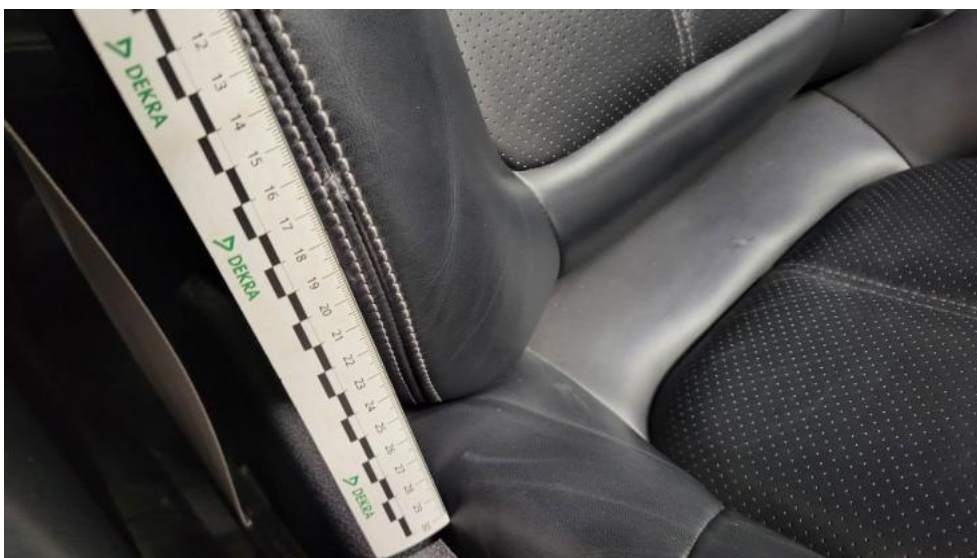
**Photo 66.**

Fotel prz. praw. - Rysa/odprysk 1

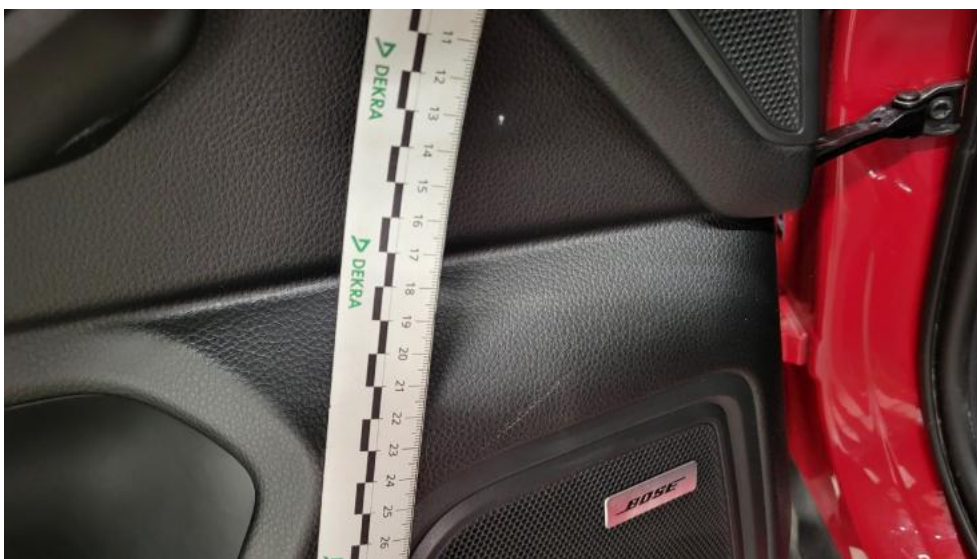
**Photo 67.**  
Tapicerka drzwi tylnych L - Inne 1

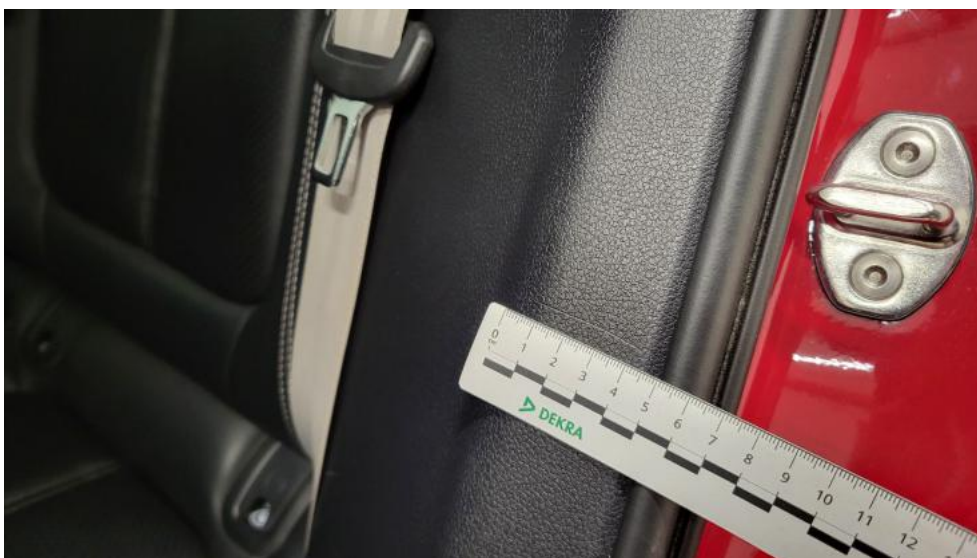
**Photo 68.**  
Wykładzina(y) słupka tylnego L - Rysa/odprysk 1
