DEKRA's commission No. : PKOL(W)/LODZ/84131/24/10/30
 commission/ damage No. : 00472/LF/23
 Date of commission: 30-10-2024

Vehicle data

Measurement of thickness of the vehicle lacquer coating

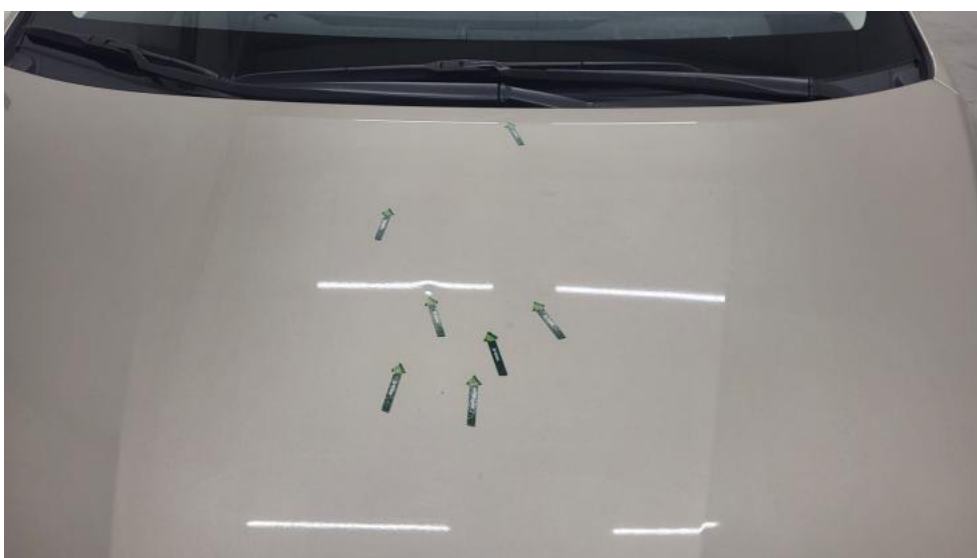
Photo 40.
Pokrywa komory silnika - Wgniecenie/odkształcenie 2

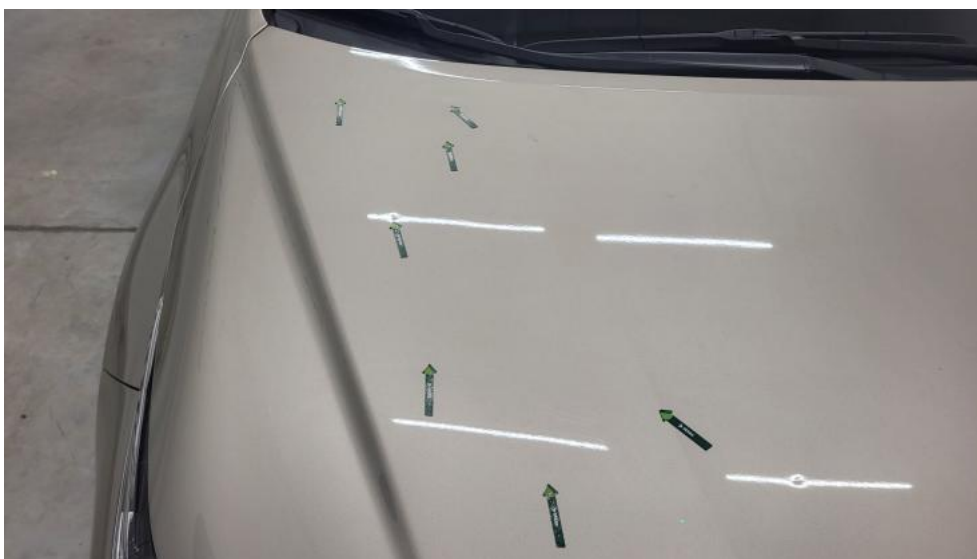
Photo 41.
Pokrywa komory silnika() - Wgniecenie/odkształcenie 3

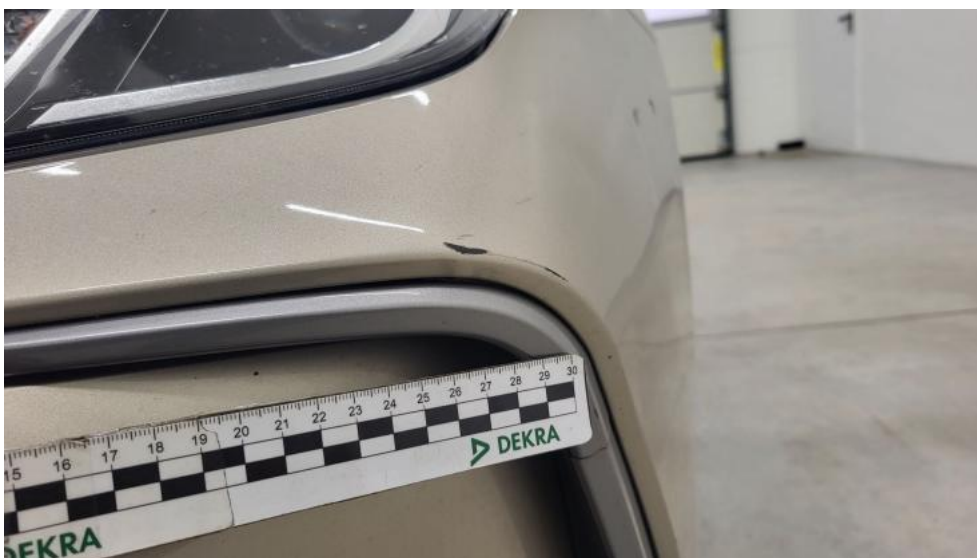
Photo 42.
Zderzak - Rysa/odprysk 1

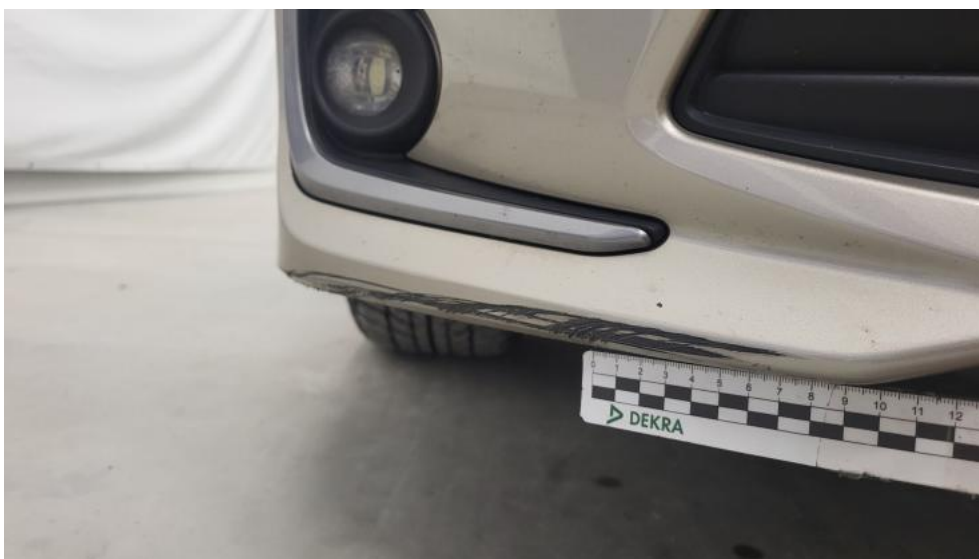
Photo 43.
Zderzak - Rysa/odprysk 2

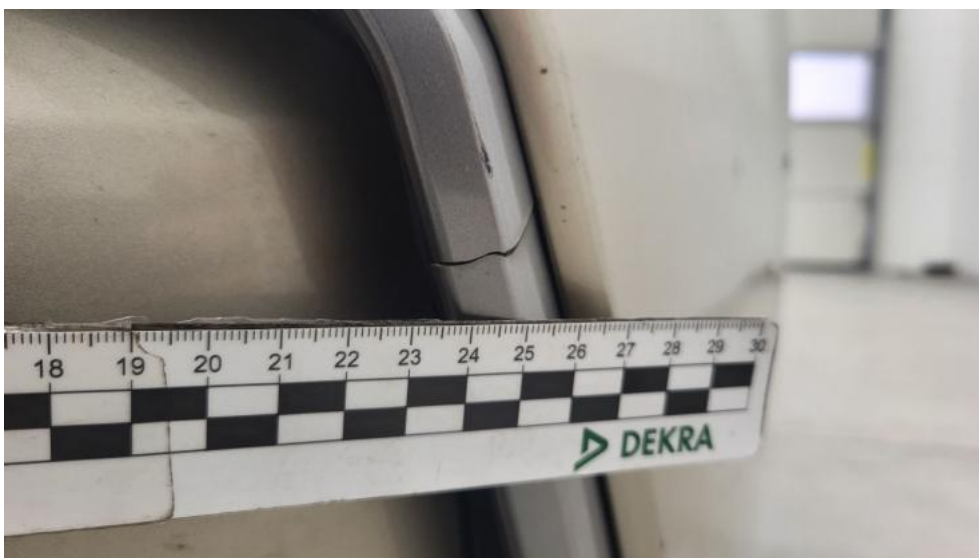
Photo 44.
Zderzak - Pęknięcie/rozerwanie 1

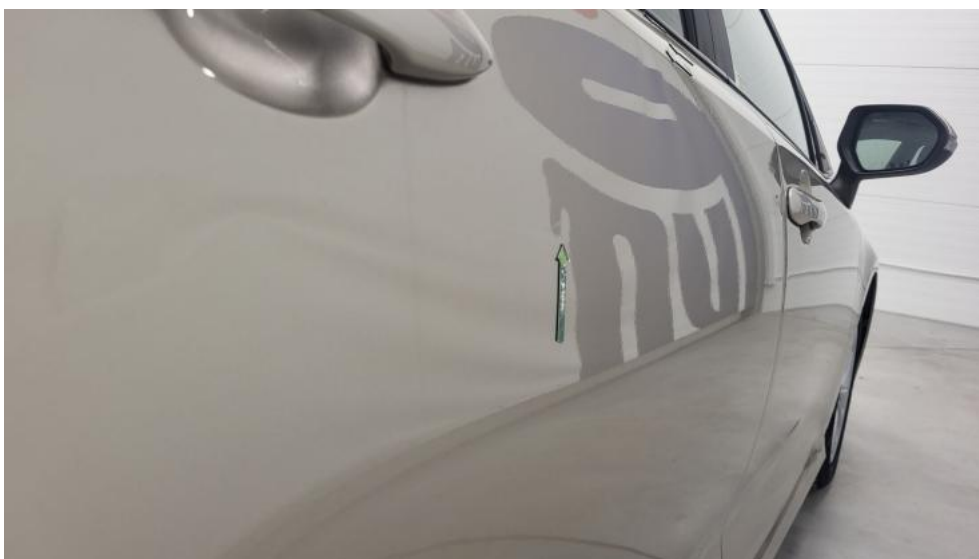
Photo 51.
Drzwi tylne P - Wgniecenie/odkształcenie 1

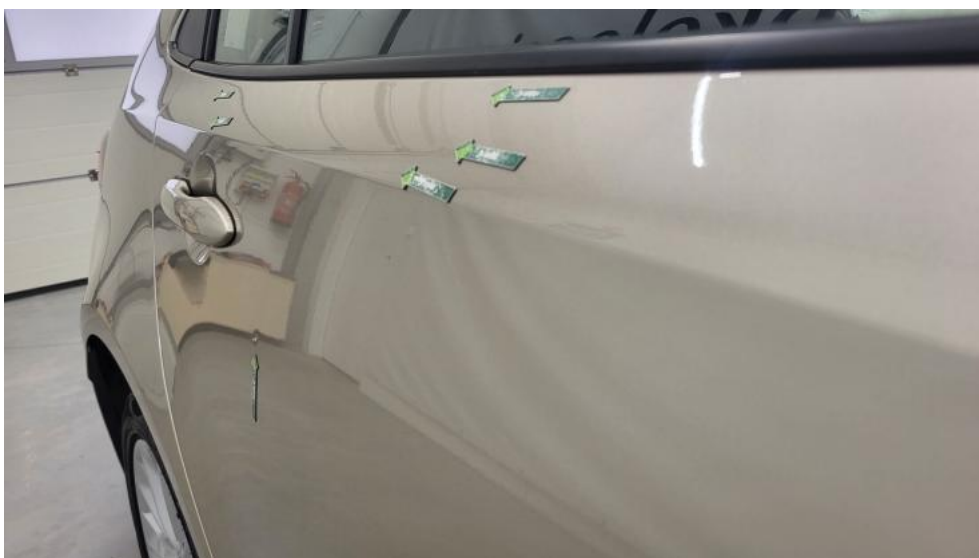
Photo 52.
Drzwi tylne P - Wgniecenie/odkształcenie 2

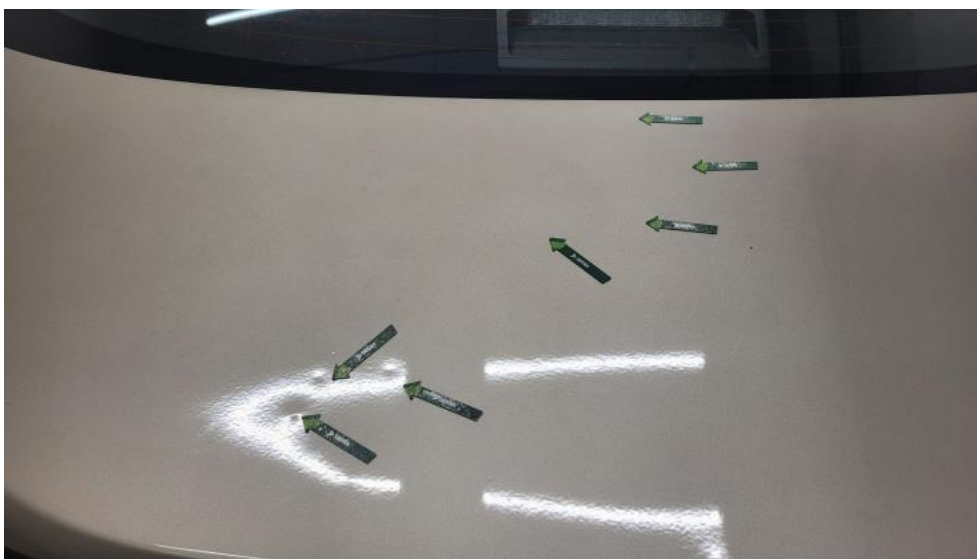
Photo 61.
Pokrywy bagażnika - Wgniecenie/odkształcenie 1

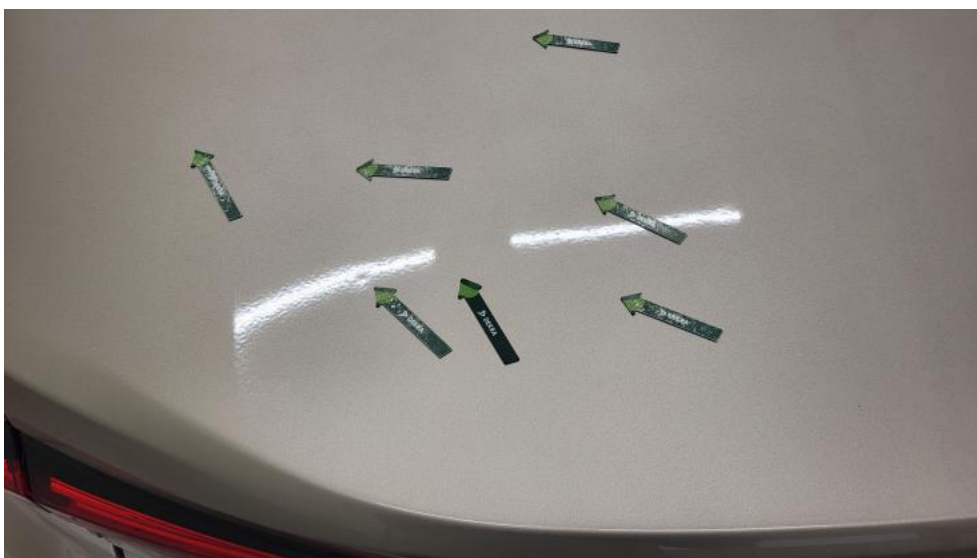
Photo 62.
Pokrywy bagażnika - Wgniecenie/odkształcenie 2

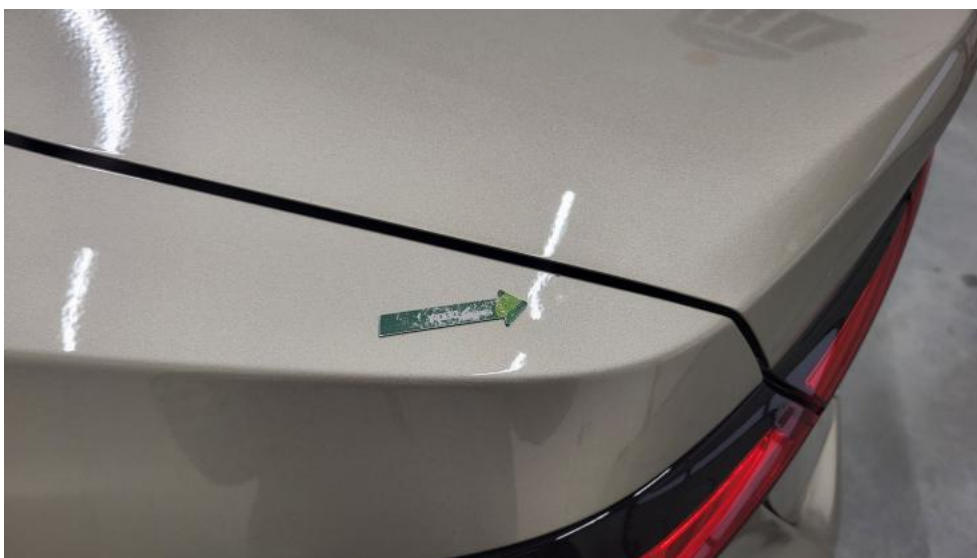
Photo 72.
Błotnik tylny L / Ściana boczna L - Wgniecenie/odkształcenie 1

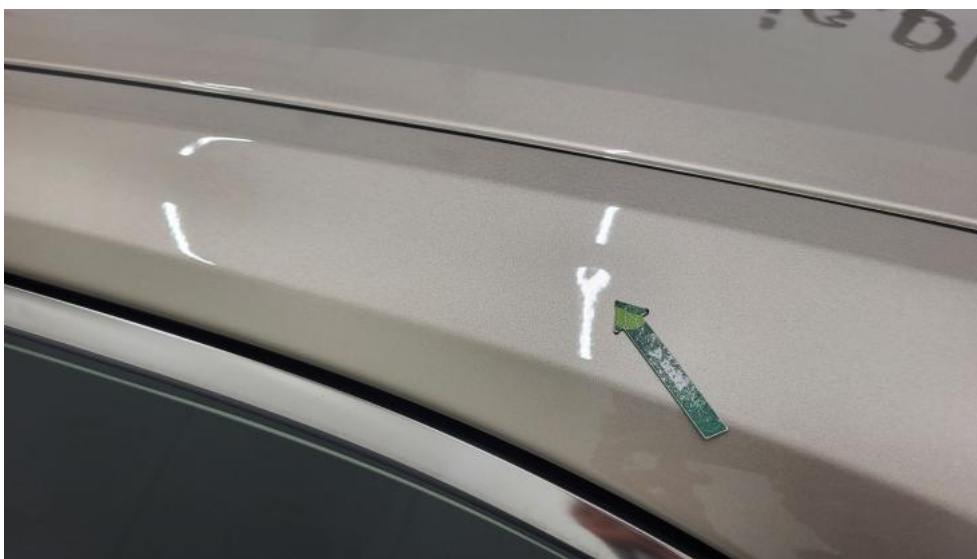
Photo 73.
Błotnik tylny L / Ściana boczna L - Wgniecenie/odkształcenie 2

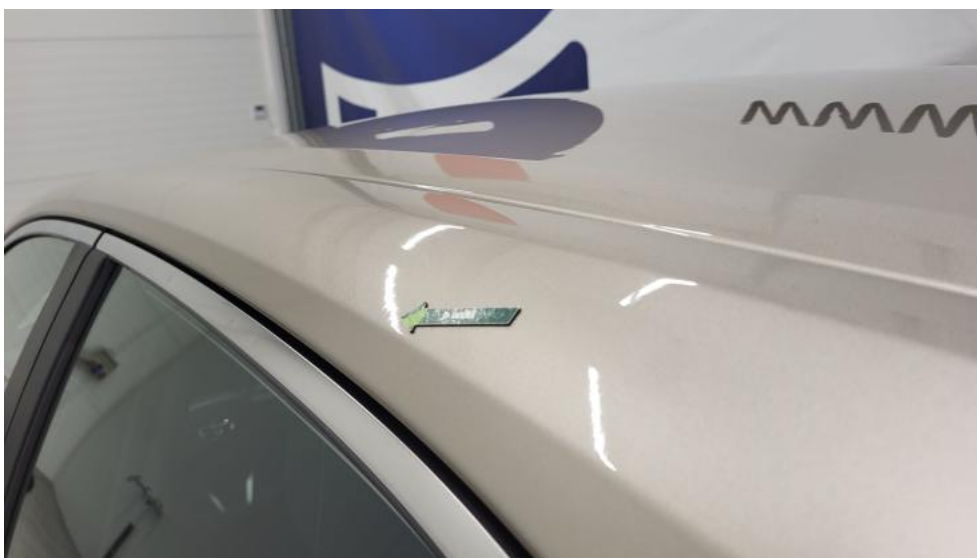
Photo 74.
Błotnik tylny L / Ściana boczna L() - Wgniecenie/odkształcenie 3

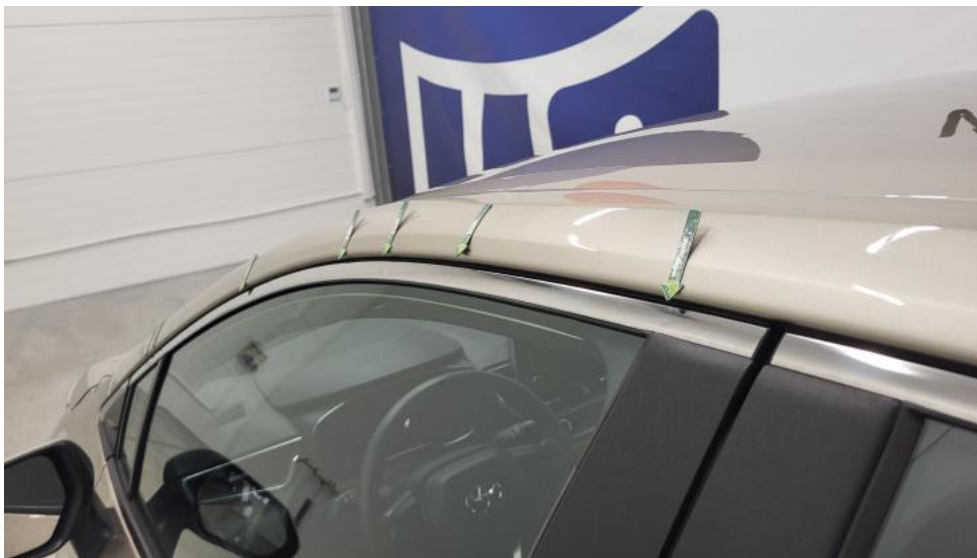
Photo 77.
Drzwi przed L - Wgniecenie/odkształcenie 2

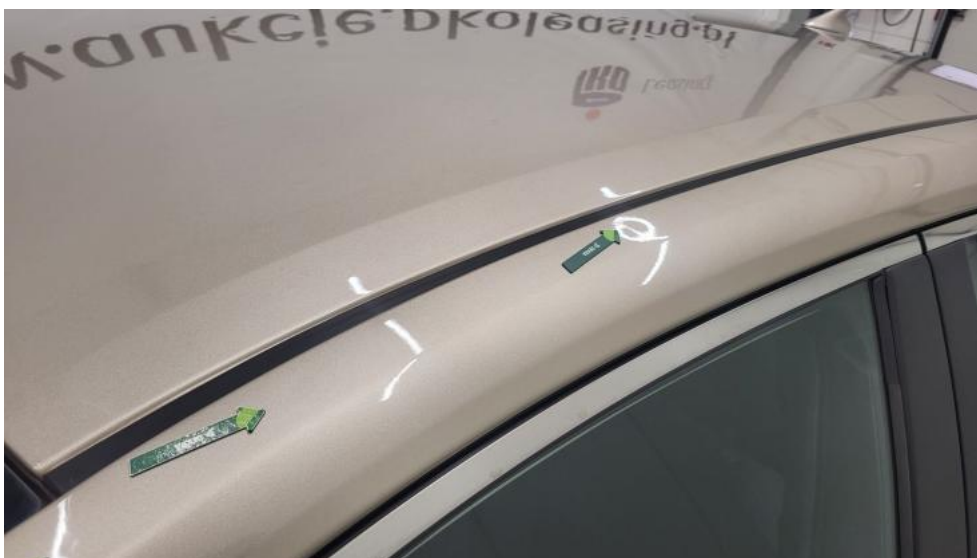
Photo 80.

Stupek przedni L - Wgniecenie/odkształcenie 1
