DEKRA's commission No. : PKOL(W)/LODZ/74711/24/09/27
commission/ damage No. : 22/025248
Date of commission: 27-09-2024

Vehicle data

Measurement of thickness of the vehicle lacquer coating

PHOTOGRAPHIC DOCUMENTATION

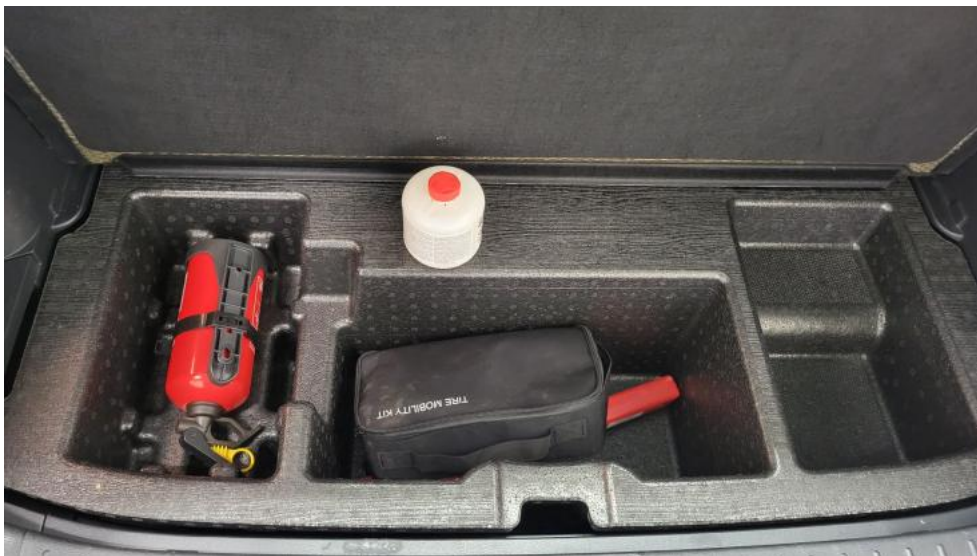
Photo 35.
Zestaw naprawczy koła

Wymagany przegląd. Rysy na samochodzie. Dostarczono ksero dowodu rejestracyjnego. Brak kompresora zestawu naprawczego koła. Brak płynu zestawu naprawczego.

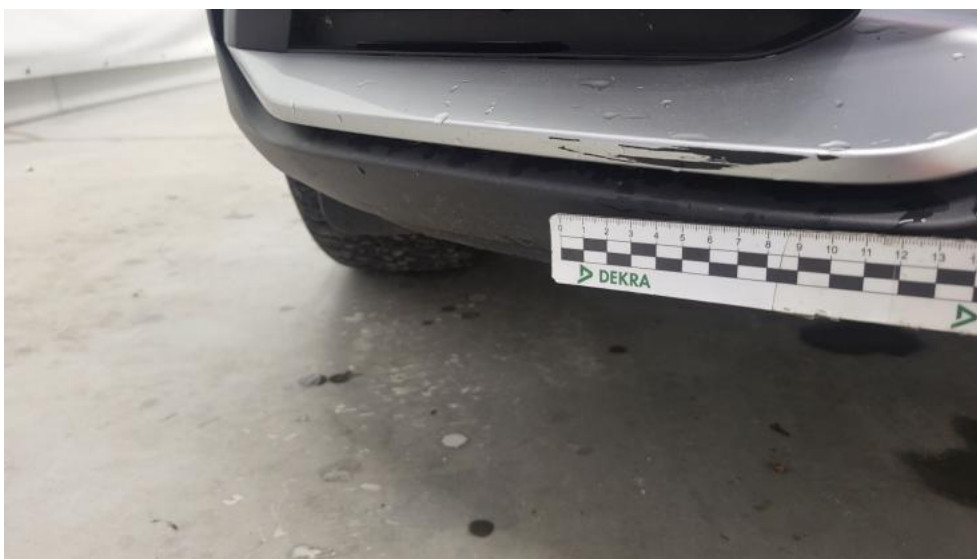
Photo 37.
Zderzak - Rysa/odprysk 1

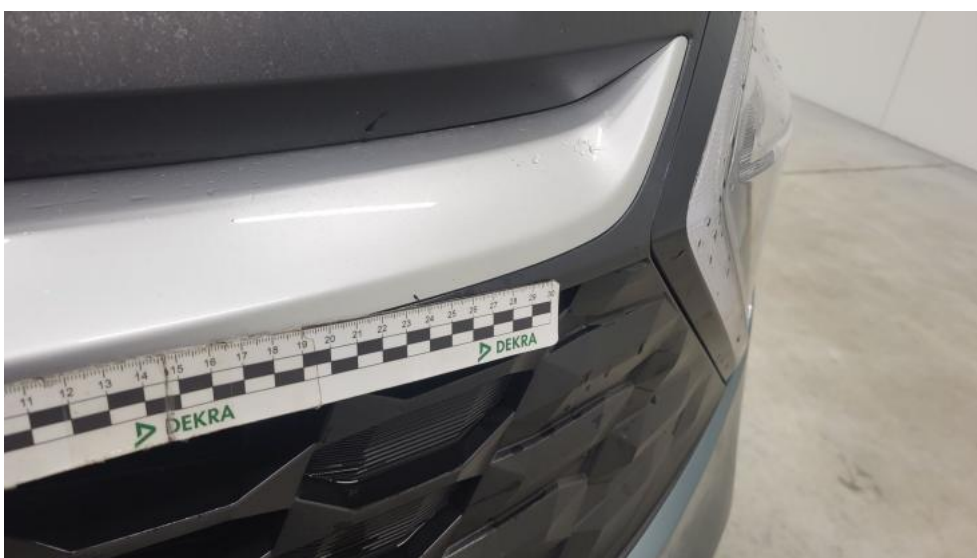
Photo 38.
Zderzak - Rysa/odprysk 2

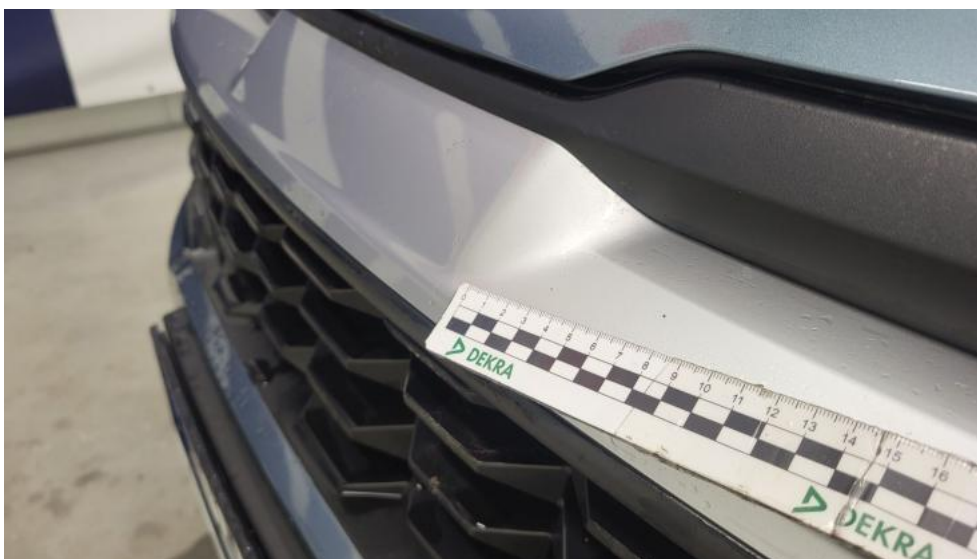
Photo 39.
Zderzak() - Rysa/odprysk 3

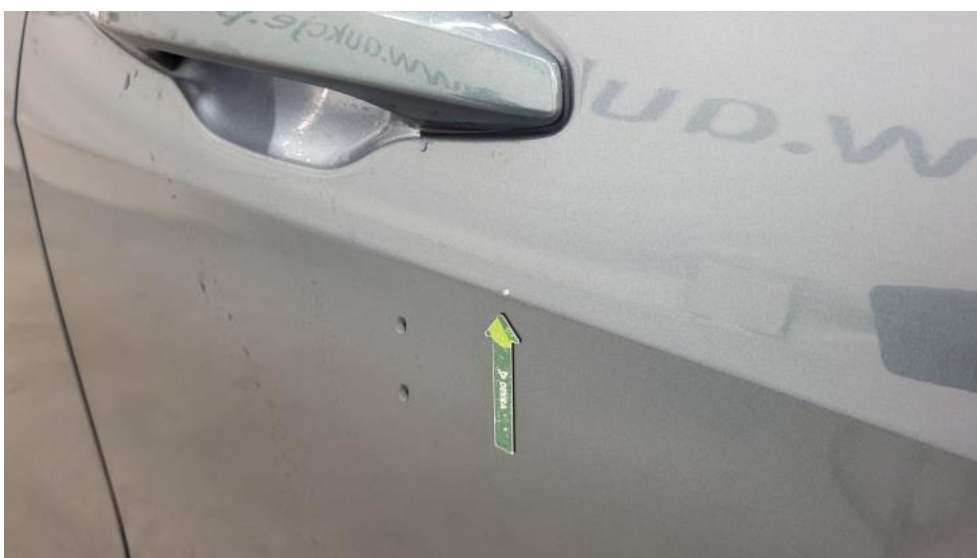
Photo 40.
Drzwi przednie P - Rysa/odprysk 1

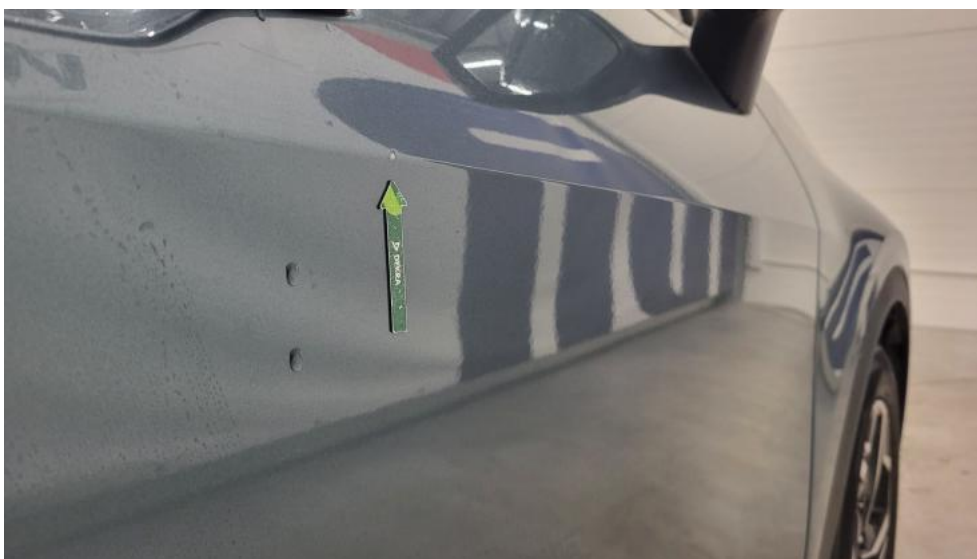
Photo 41.
Drzwi przednie P - Wgniecenie/odkształcenie 1

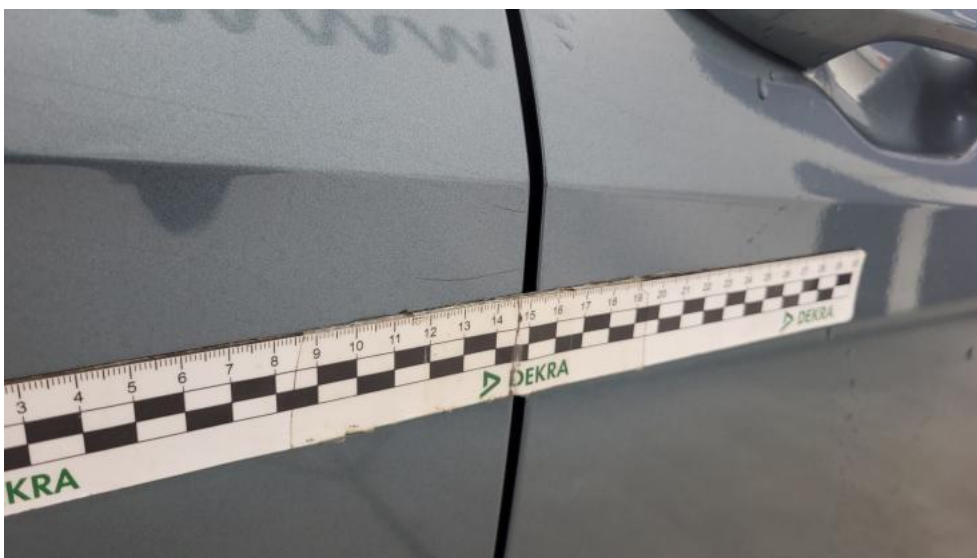
Photo 42.
Drzwi tylne P - Rysa/odprysk 1

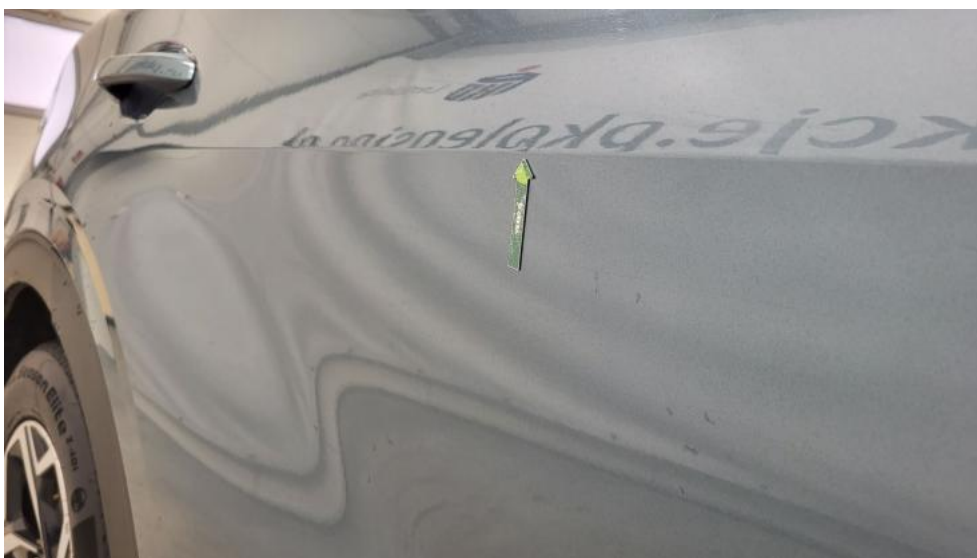
Photo 44.

Drzwi tylne P - Wgniecenie/odkształcenie 1

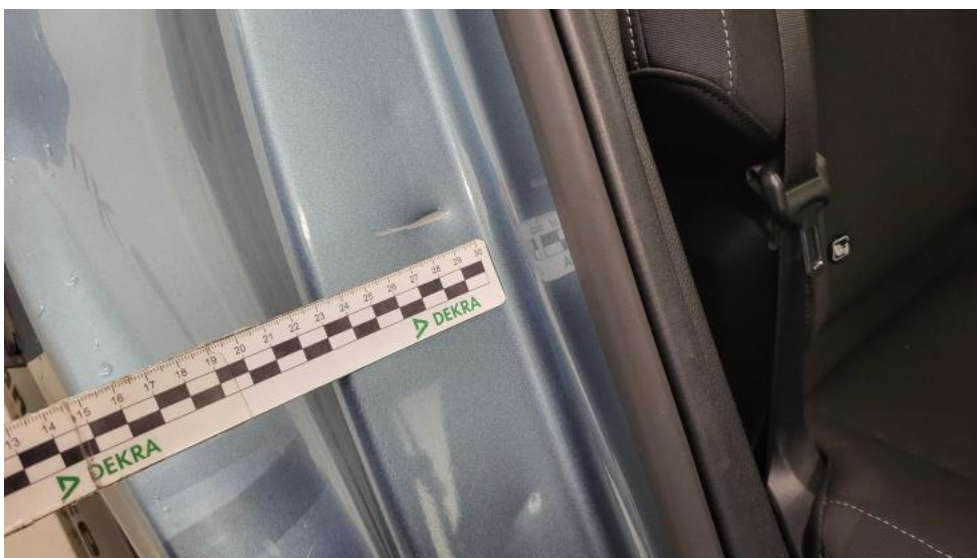
Photo 46.
Błotnik tylny P / Ściana boczna P - Rysa/odprysk 1

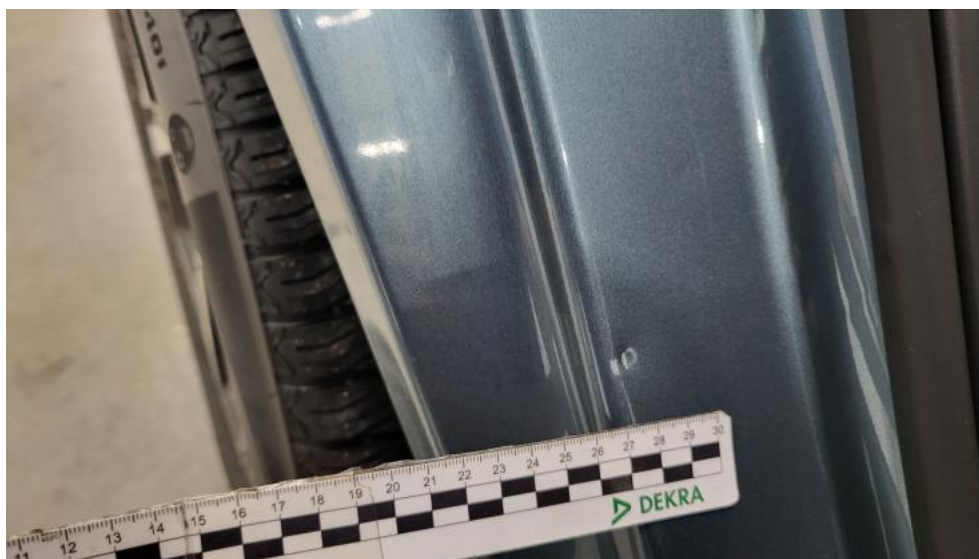
Photo 47.

Błotnik tylny P / Ściana boczna P - Rysa/odprysk 2

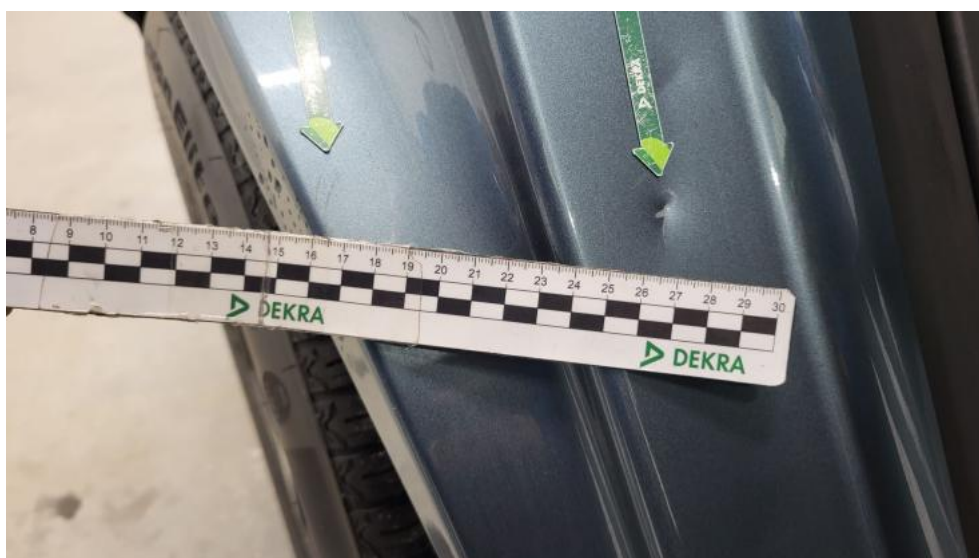
Photo 48.

Błotnik tylny P / Ściana boczna P() - Rysa/odprysk 3

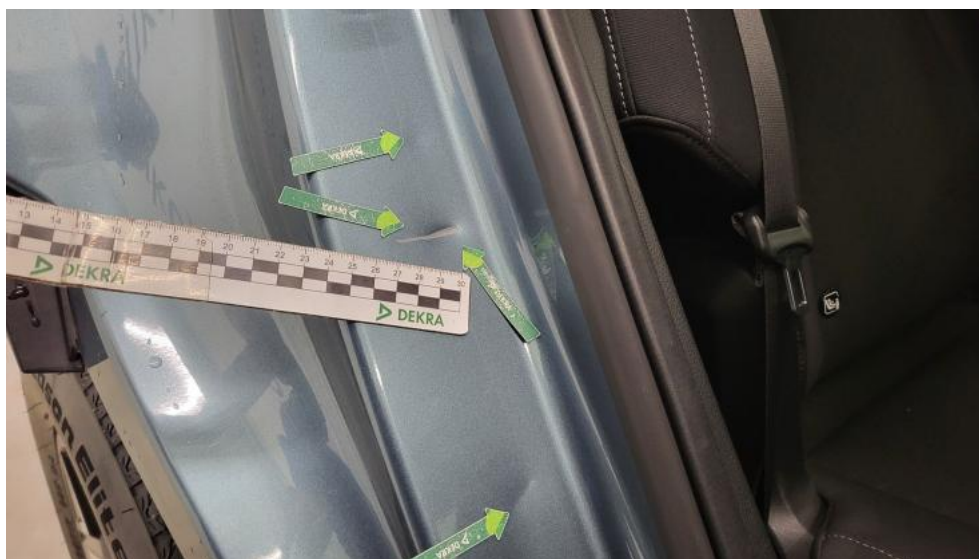
Photo 49.
Błotnik tylny P / Ściana boczna P - Wgniecenie/odkształcenie 1

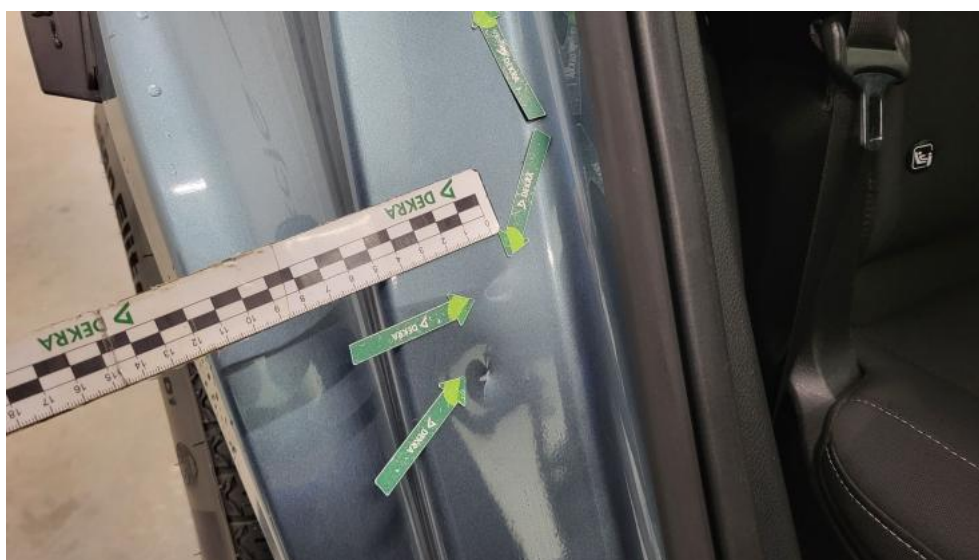
Photo 50.
Błotnik tylny P / Ściana boczna P - Wgniecenie/odkształcenie 2

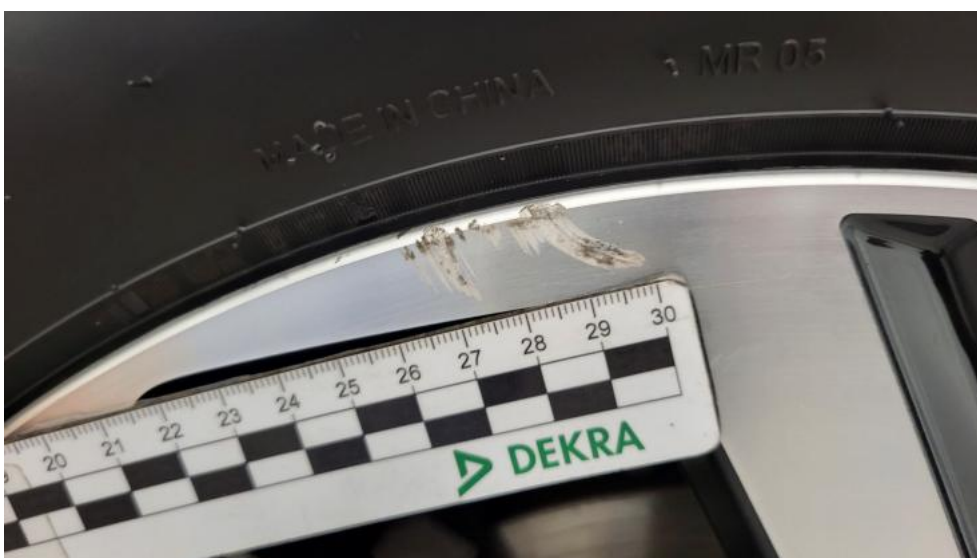
Photo 52.
Felga aluminiowa tylna P - Rysa/odprysk 1

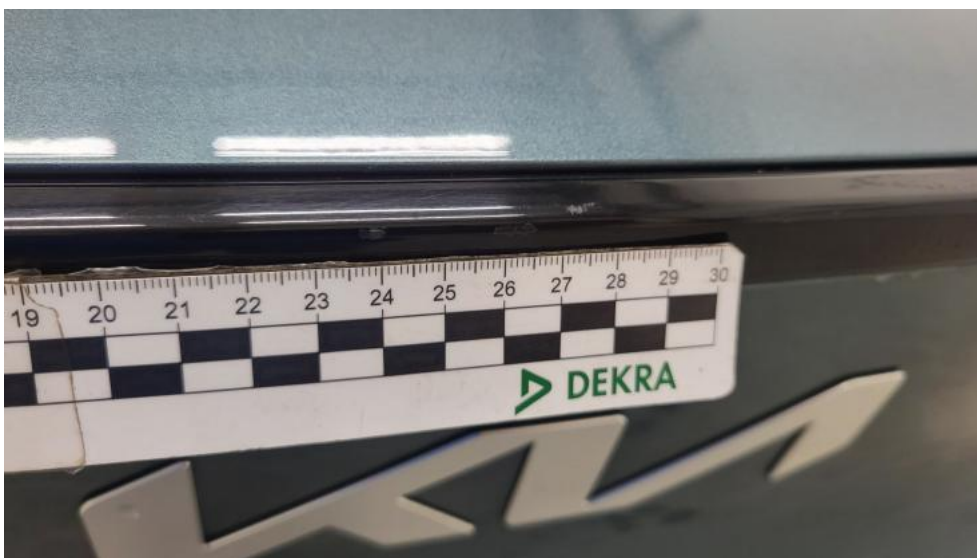
Photo 54.

Pokrywy bagażnika - Rysa/odprysk 1

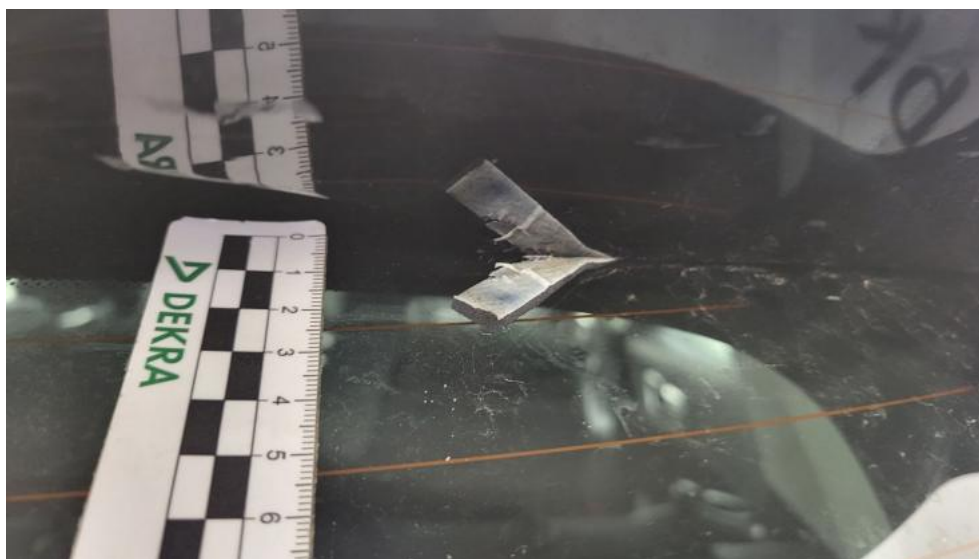
Photo 55.
Pokrywy bagażnika - Inne 1

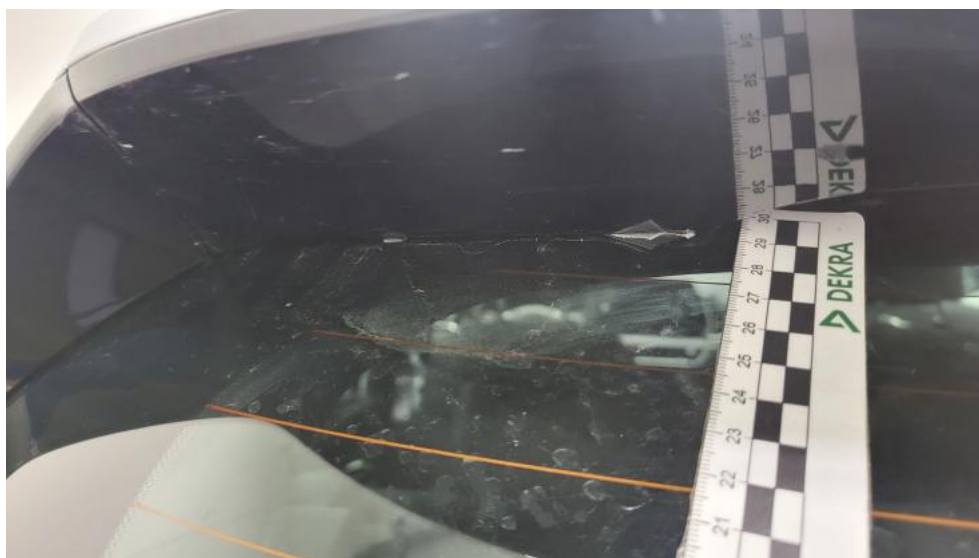
Photo 56.
Pokrywy bagażnika - Inne 2

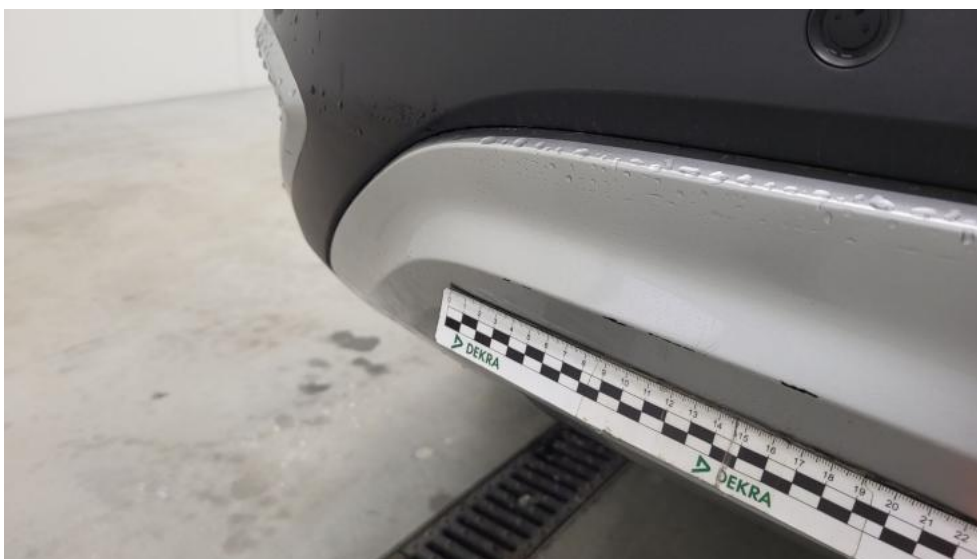
Photo 57.
Zderzak tylny - Rysa/odprysk 1

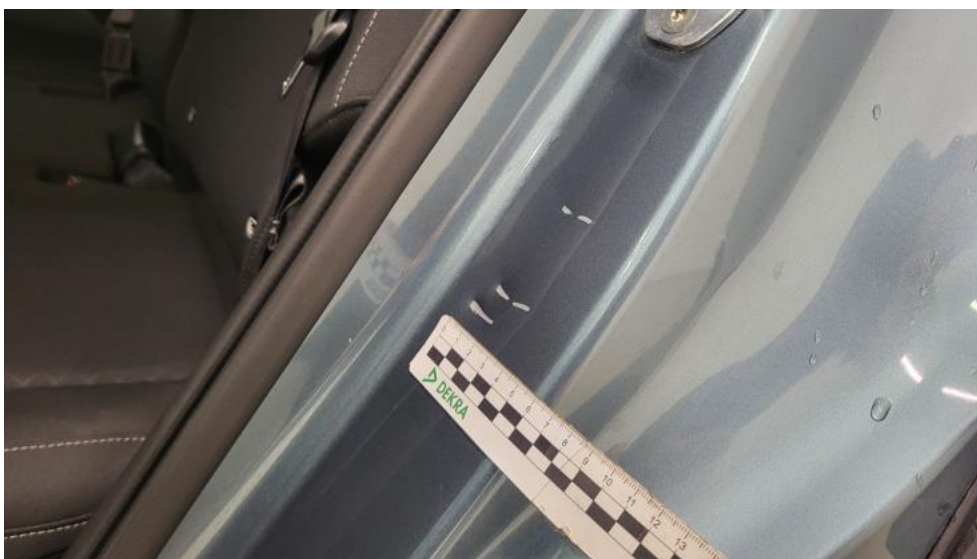
Photo 59.
Błotnik tylny L / Ściana boczna L - Rysa/odprysk 1

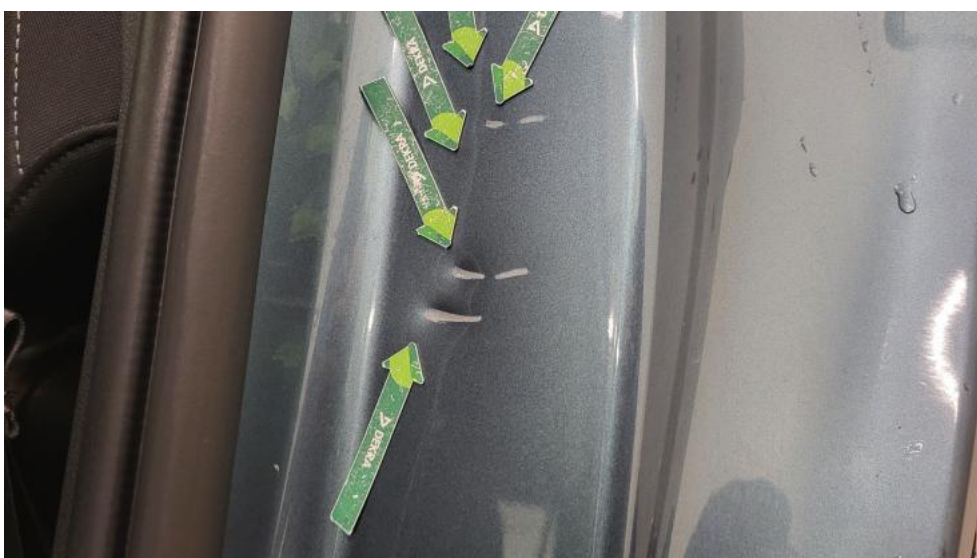
Photo 60.
Błotnik tylny L / Ściana boczna L - Wgniecenie/odkształcenie 1

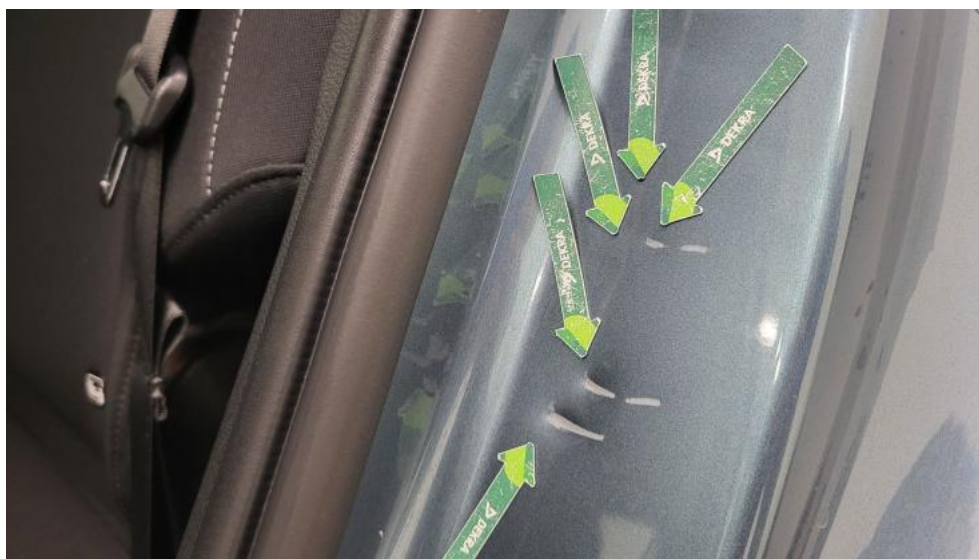
Photo 61.
Błotnik tylny L / Ściana boczna L - Wgniecenie/odkształcenie 2

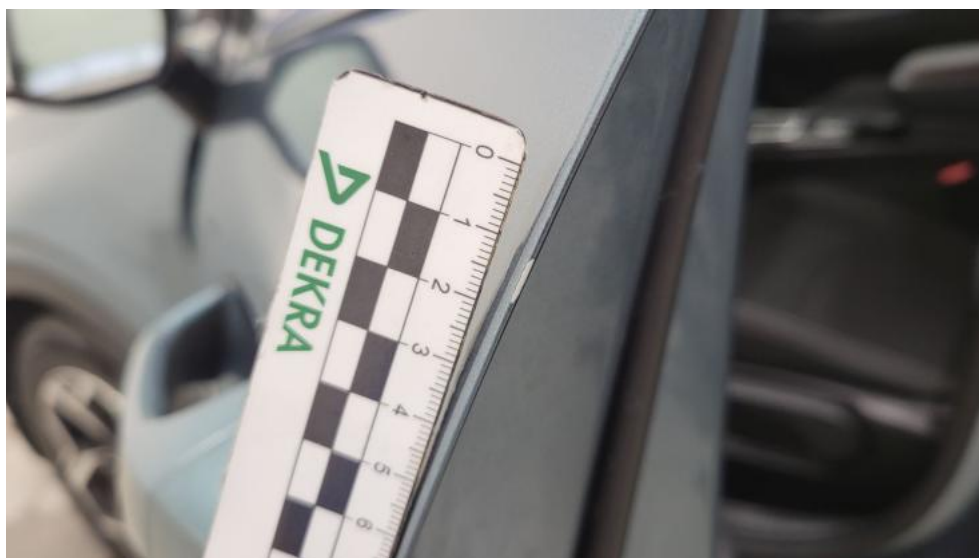
Photo 62.
Drzwi przed L - Rysa/odprysk 1

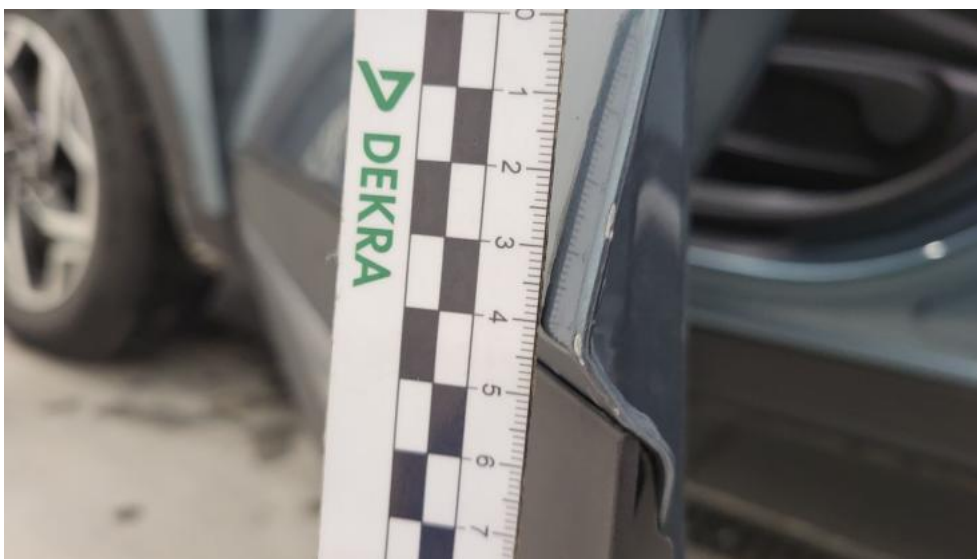
Photo 63.

Drzwi przed L - Rysa/odprysk 2

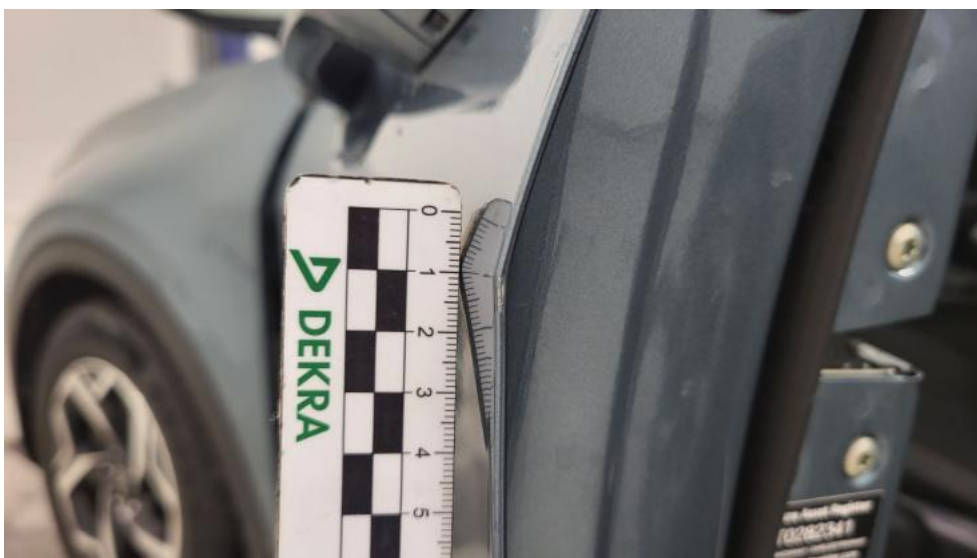
Photo 64.

Drzwi przed L() - Rysa/odprysk 3

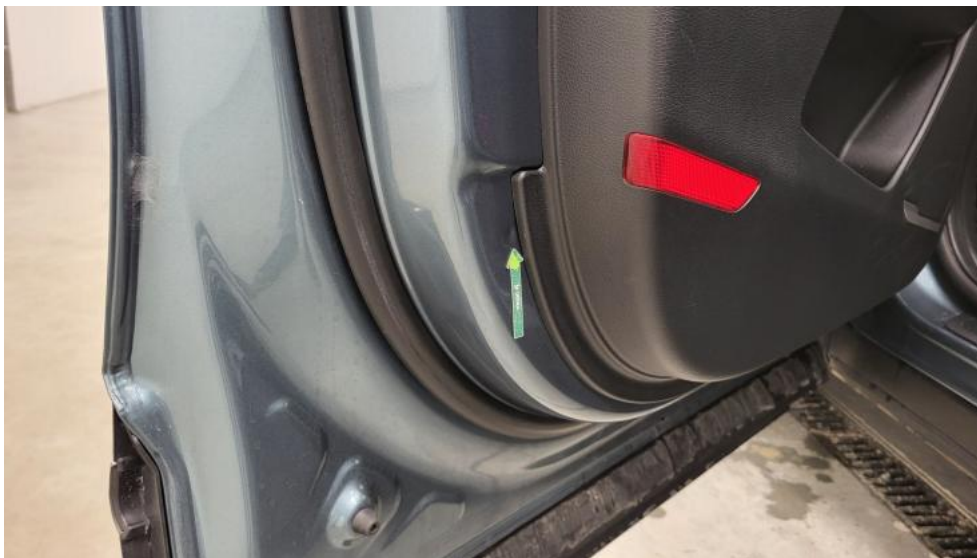
Photo 65.
Drzwi przed L - Wgniecenie/odkształcenie 1

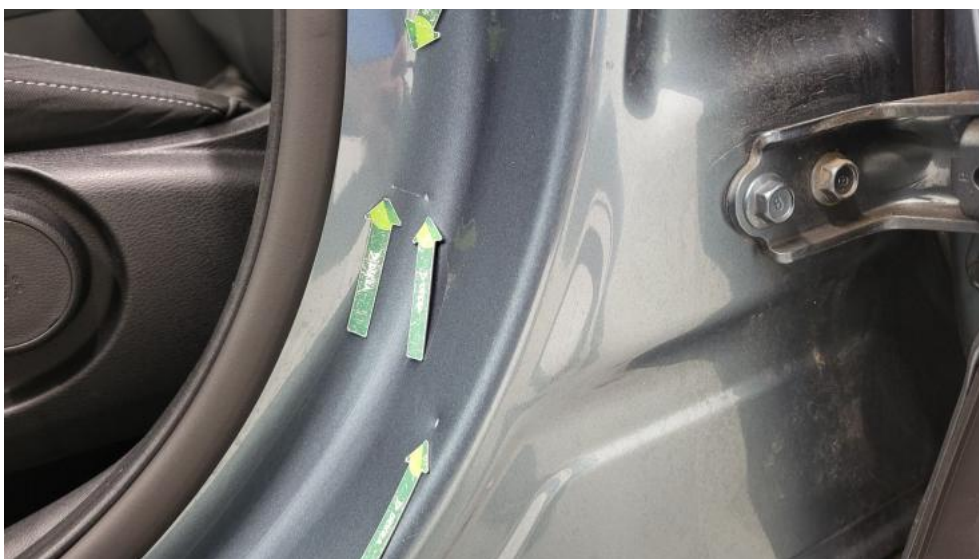
Photo 69.
Słupek środkowy L - Wgniecenie/odkształcenie 1

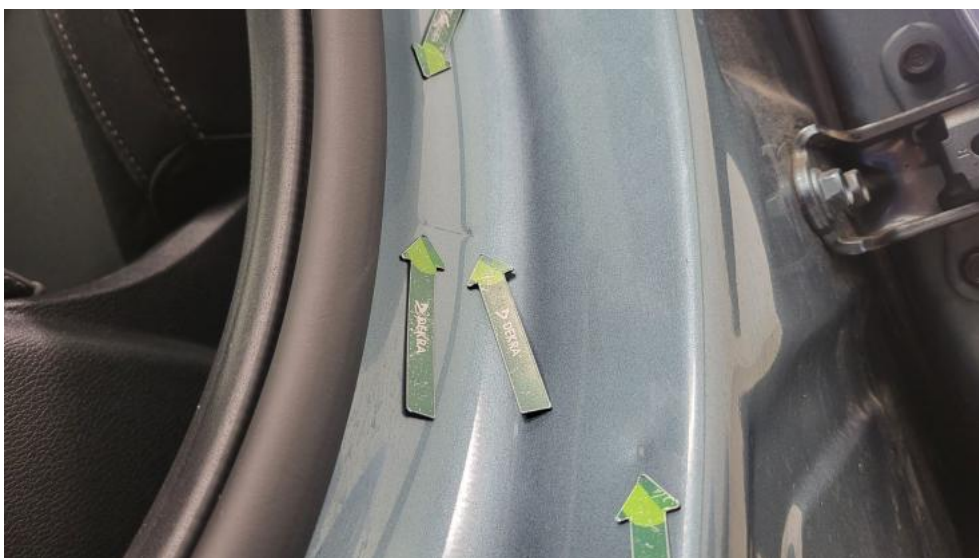
Photo 70.
Słupek środkowy L - Wgniecenie/odkształcenie 2

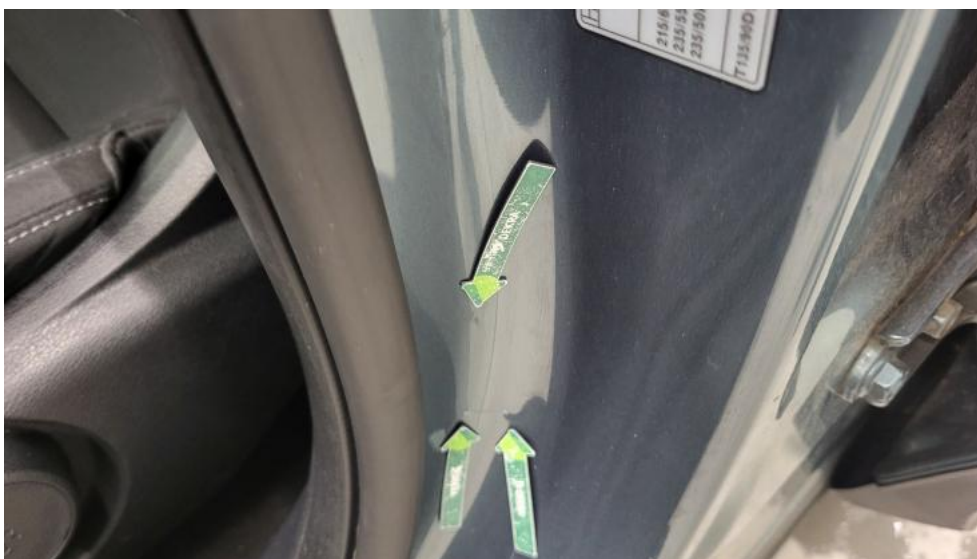
Photo 71.

Stupek środkowy L() - Wgniecenie/odkształcenie 3
