DEKRA's commission No. : PKOL(W)/LODZ/73936/24/09/25
 commission/ damage No. : 22/014825
 Date of commission: 25-09-2024

Vehicle data

| Model | X7 [G07] 18-22 |
| Type / version | X7 xDrive40d mHEV sport-aut |

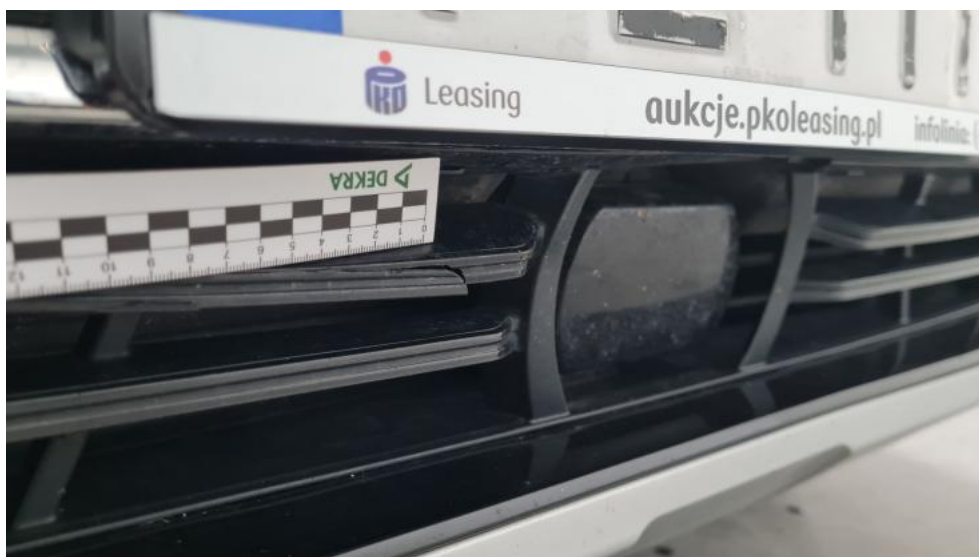
Photo 41.
Kratka zderzaka prz. - Pęknięcie/rozerwanie 1

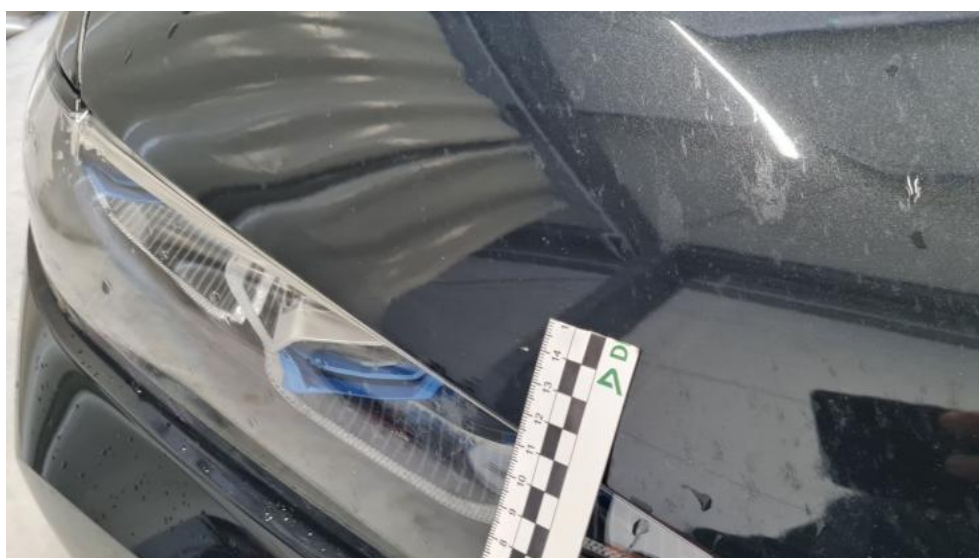
Photo 42.
Pokrywa komory silnika - Rysa/odprysk 1

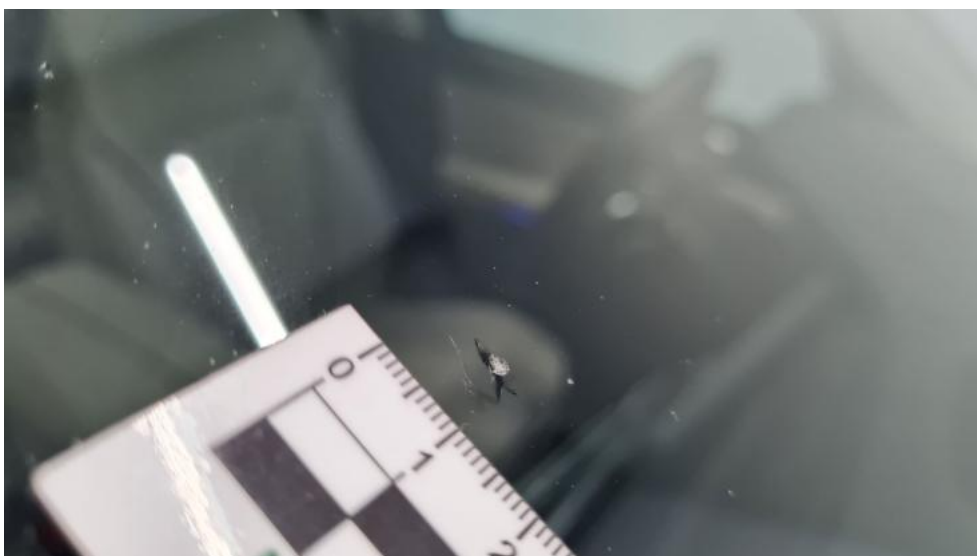
Photo 44.

Szyba czołowa - Pęknięcie/rozerwanie 1

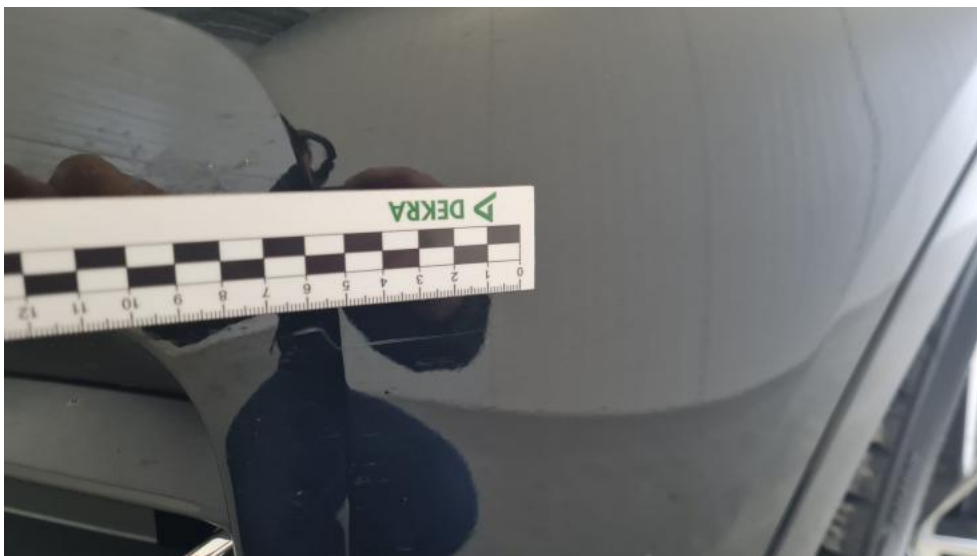
Photo 45.
Zderzak - Rysa/odprysk 1

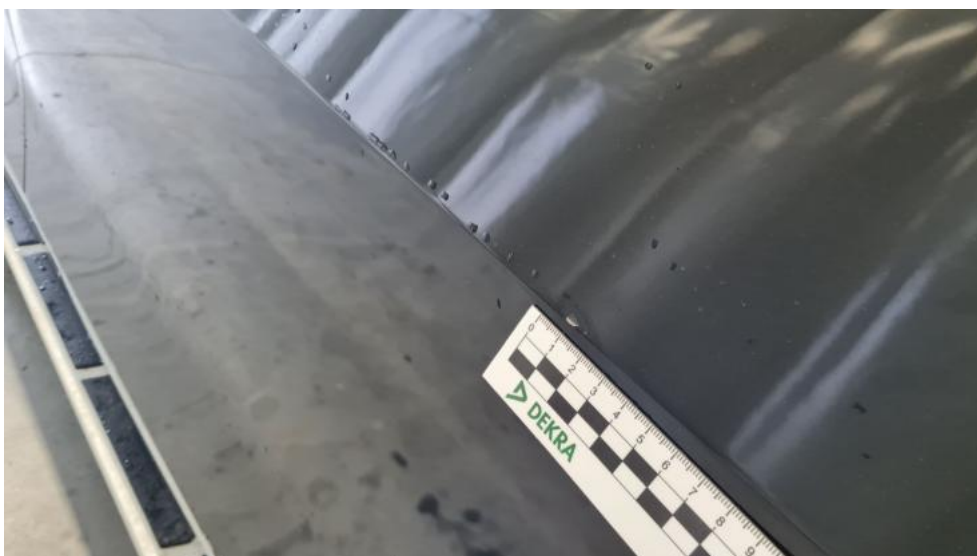
Photo 46.
Drzwi przednie P - Rysa/odprysk 1

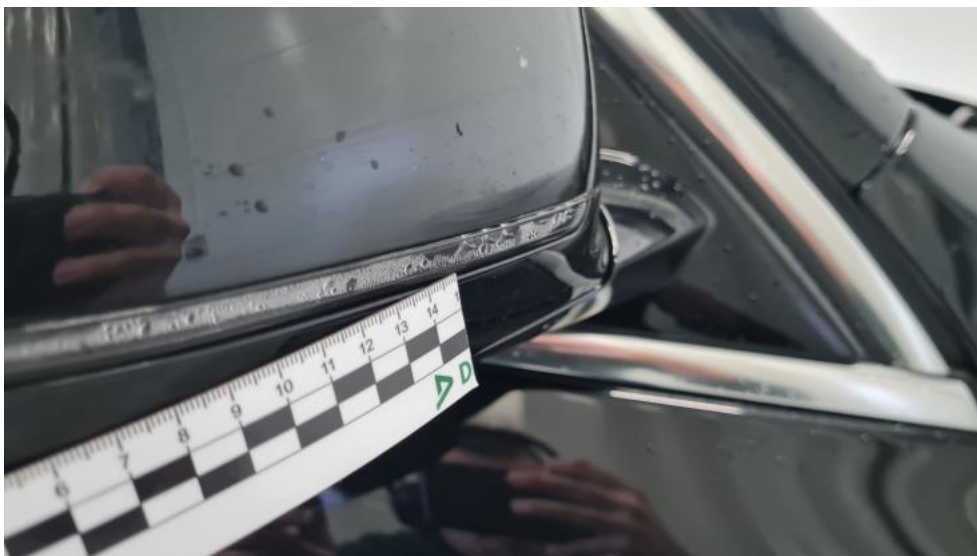
Photo 47.
Lusterko zew P - Inne 1

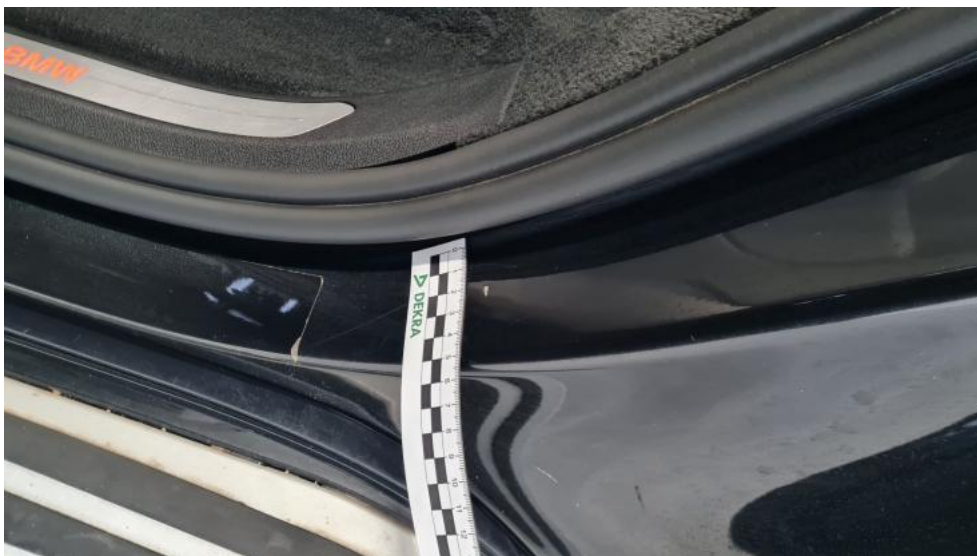
Photo 49.
Błotnik tylny L / Ściana boczna L - Rysa/odprysk 1

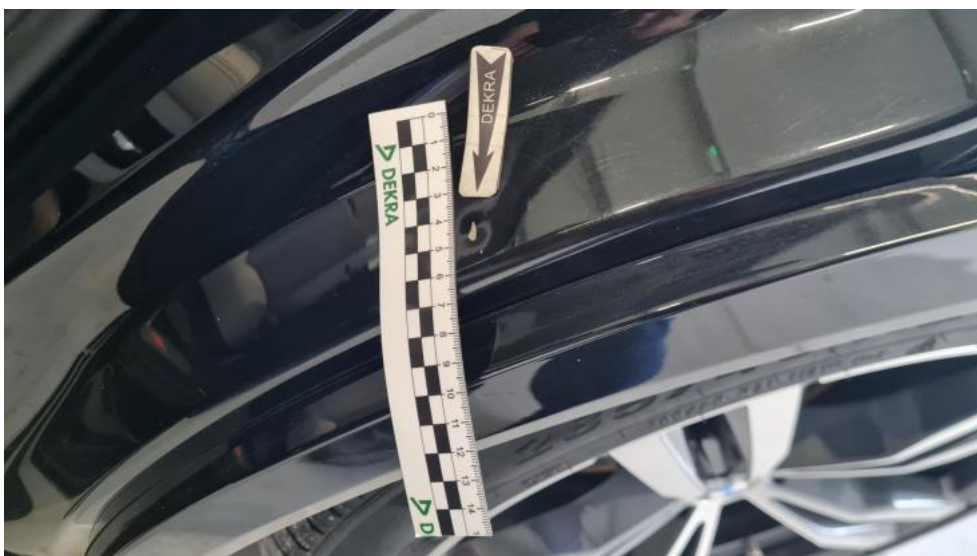
Photo 50.
Błotnik tylny L / Ściana boczna L - Wgniecenie/odkształcenie 1

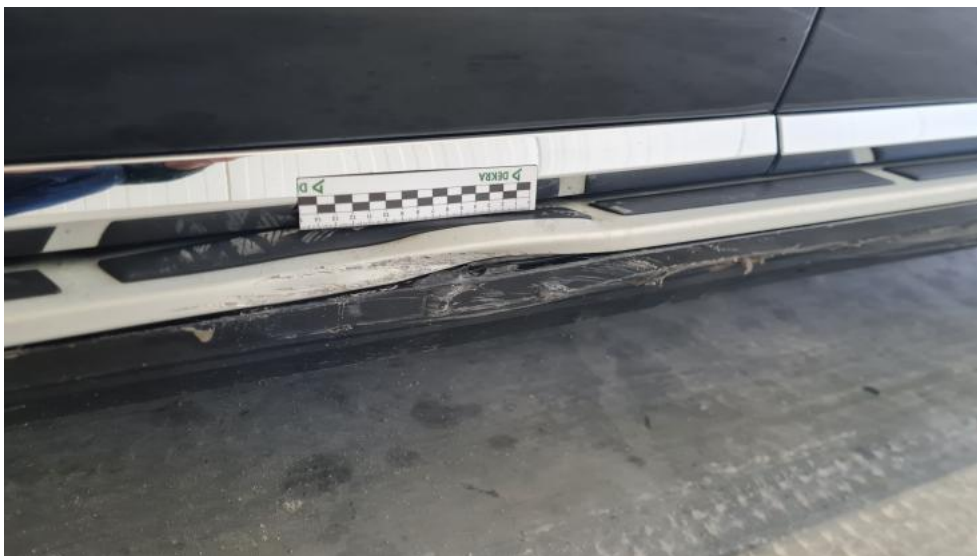
Photo 53.
Próg L - Wgniecenie/odkształcenie 1

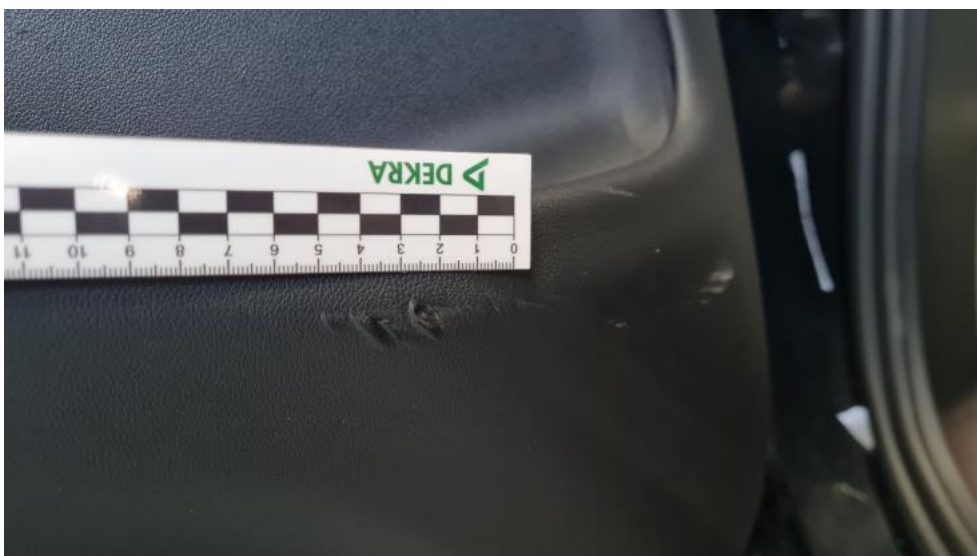
Photo 54.
Tapicerka drzwi tylnych L - Pęknięcie/rozerwanie 1

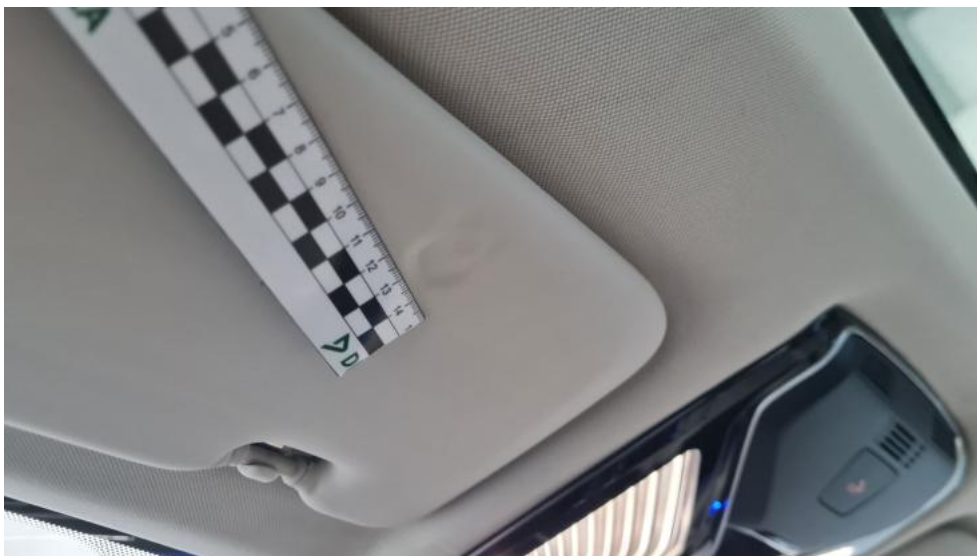
Photo 55.

Osłona p/słoneczna lewa - Wgniecenie/odkształcenie 1
