DEKRA's commission No. : PKOL(W)/LODZ/73944/25/09/30  
commission/ damage No. : PS22/01044  
Date of commission: 30-09-2025

**DEKRA Poland - Headquarters**  
02-673 Warszawa, ul. Konstruktorska 12A

PKO Leasing SA  
Świętokrzyska 36  
00-116 Warszawa

| Type / version | Stelvio 2.9 V6 Bi-Turbo Quadrifoglio Q4 aut |

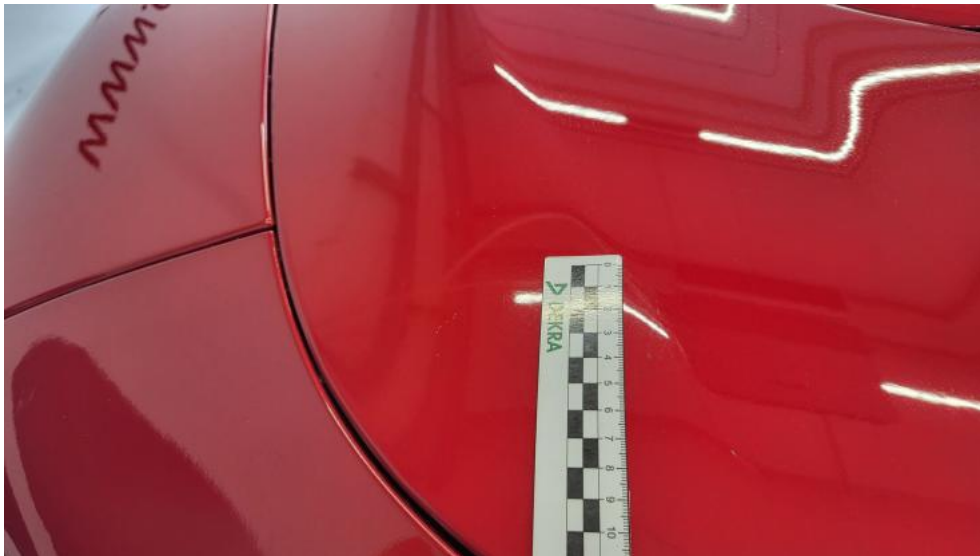
**Photo 43.**

Pokrywa komory silnika - Rysa/odprysk 1

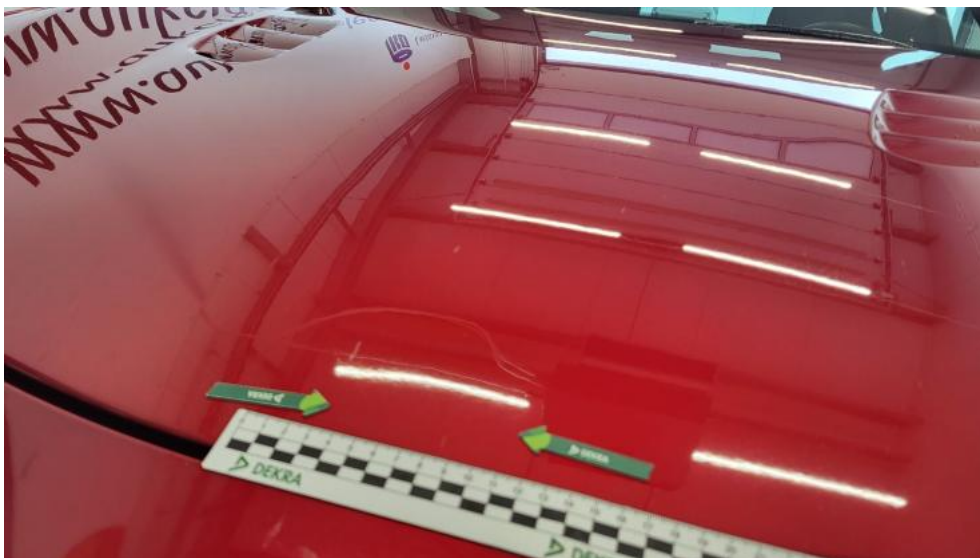
**Photo 44.**

Pokrywa komory silnika - Wgniecenie/odkształcenie 1

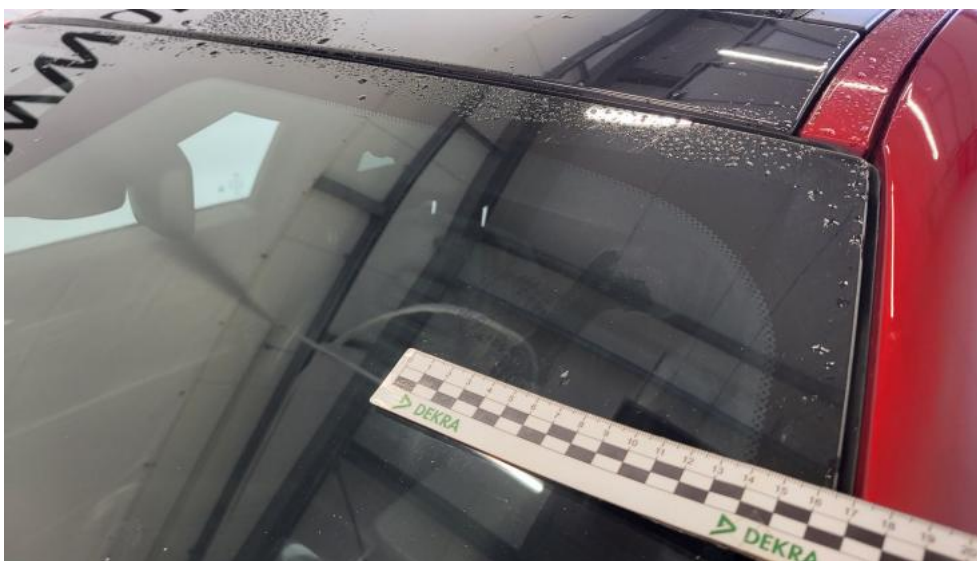
**Photo 45.**

Rysy na samochodzie. Odpryski na szybie czołowej.

Szyba czołowa - zdjęcie poglądowe 1

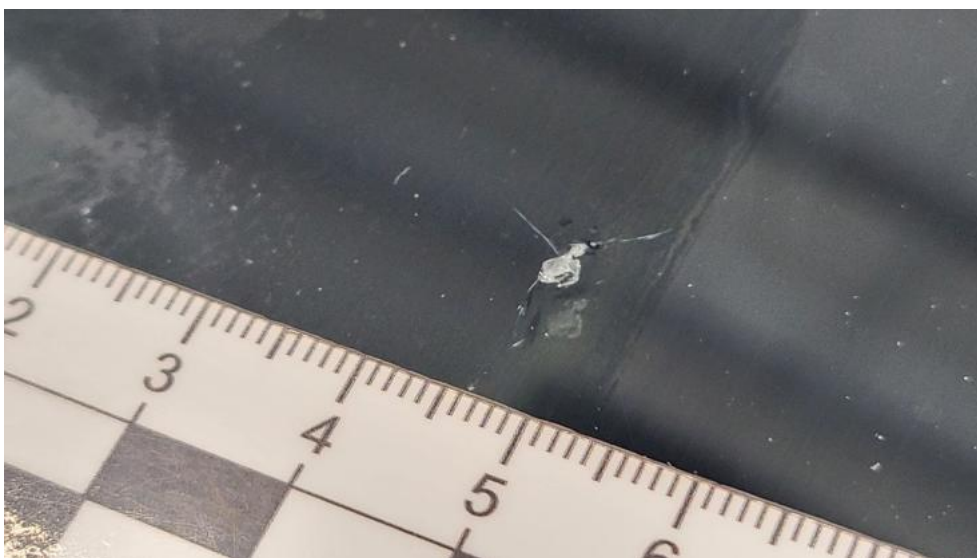
**Photo 46.**

Szyba czołowa - Pęknięcie/rozerwanie 1

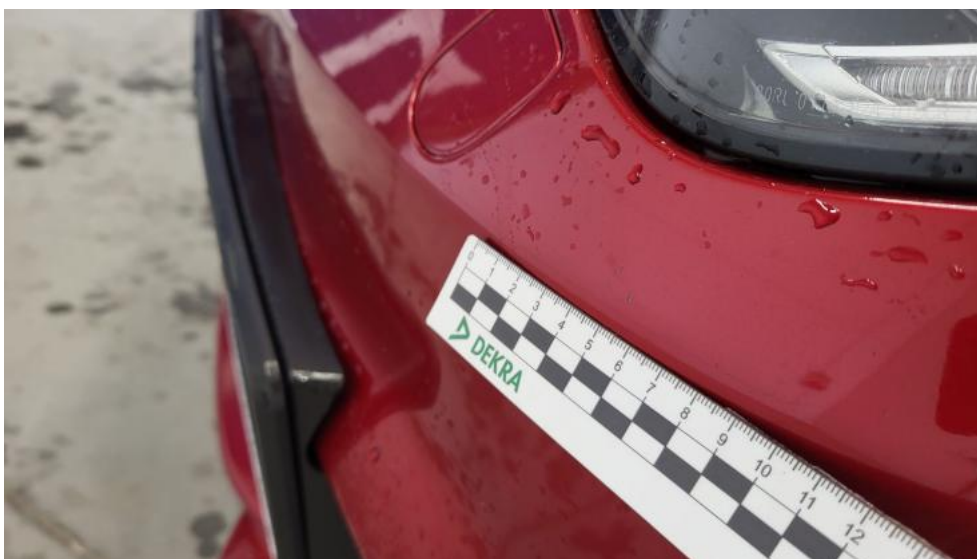
**Photo 47.**

Zderzak - Rysa/odprysk 1

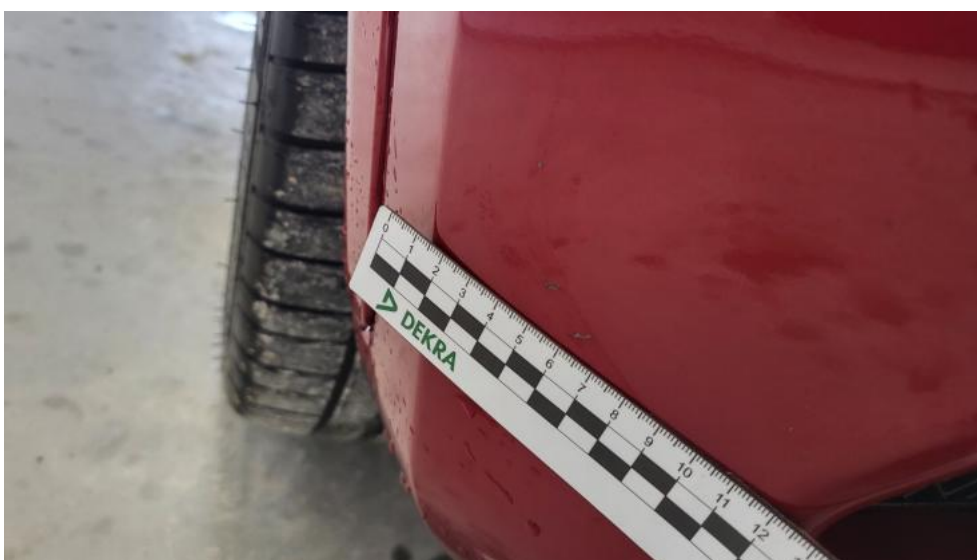
**Photo 48.**

Zderzak - Rysa/odprysk 2

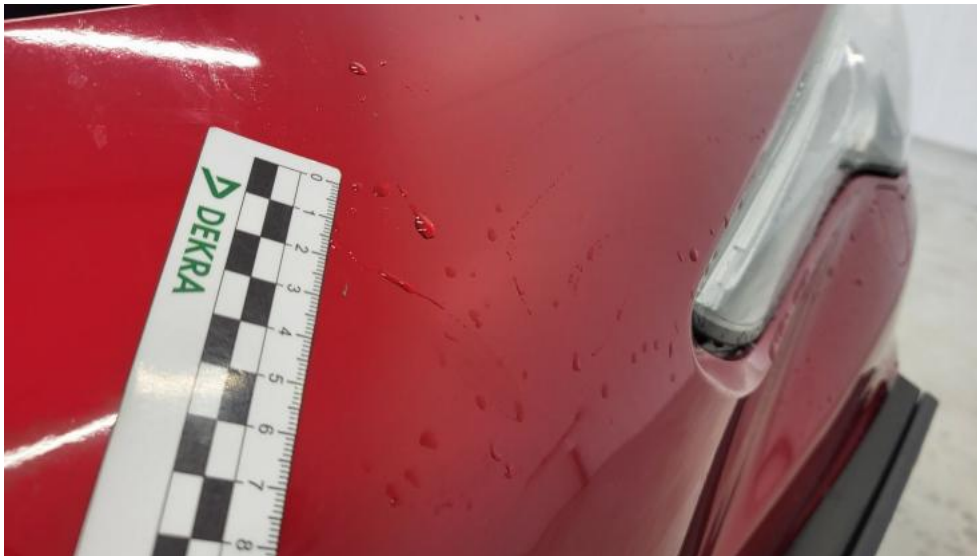
**Photo 49.**

Zderzak() - Rysa/odprysk 3

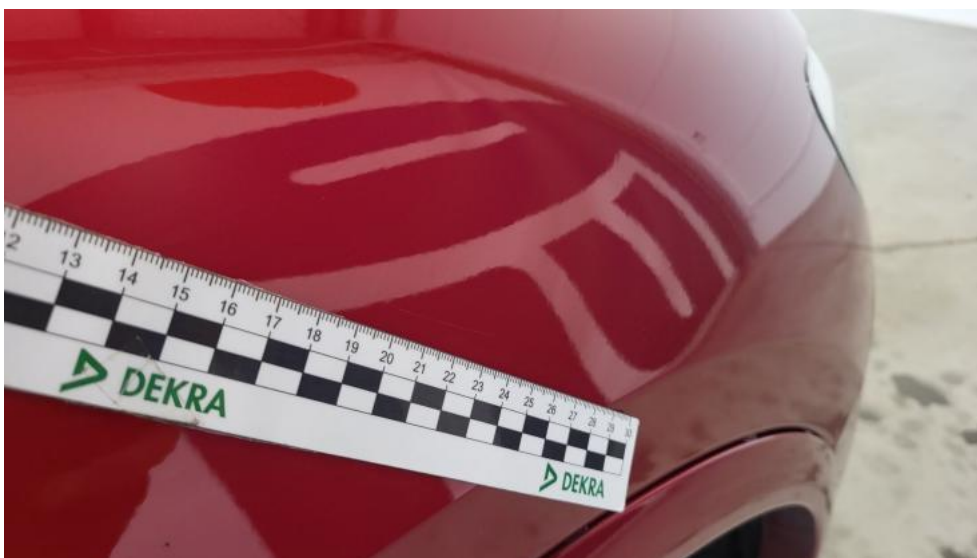
**Photo 50.**

Błotnik przedni P - Rysa/odprysk 1

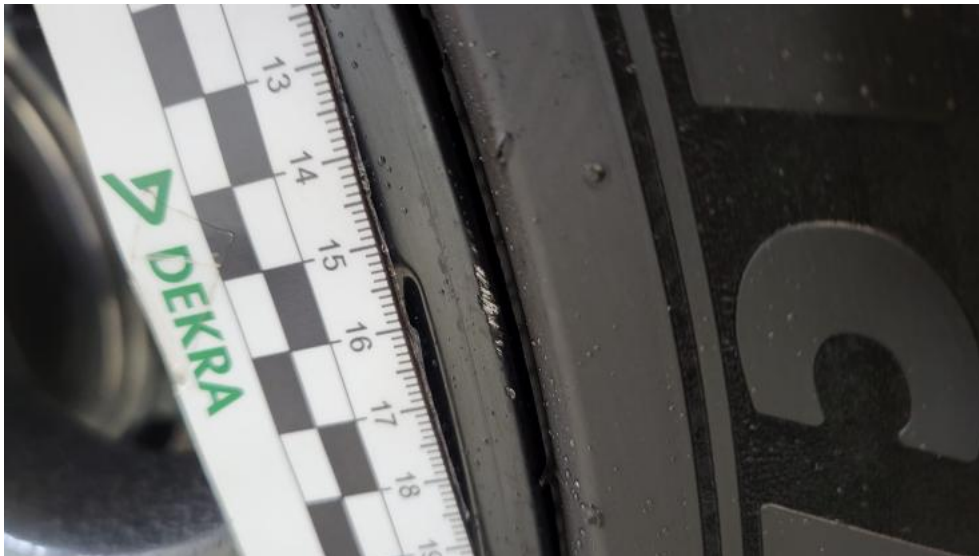
**Photo 51.**

Felga aluminiowa przednia P - Rysa/odprysk 1

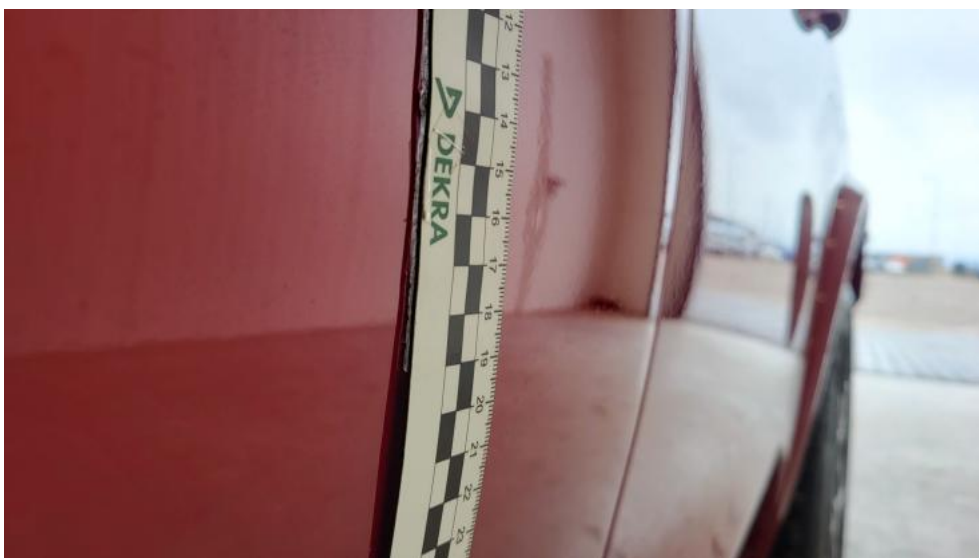
**Photo 52.**

Drzwi przednie P - Wgniecenie/odkształcenie 1

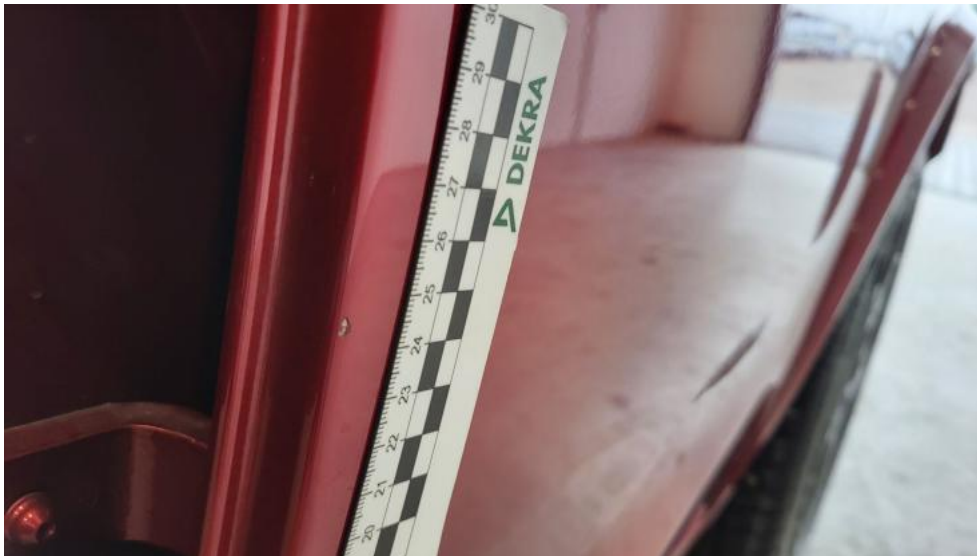
**Photo 53.**

Drzwi tylne P - Rysa/odprysk 1

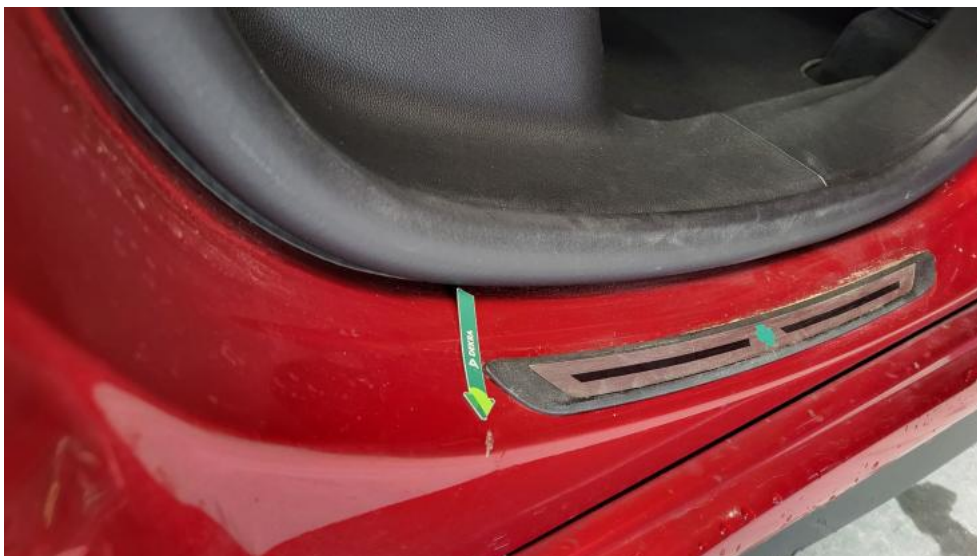
**Photo 54.**

Próg P - Wgniecenie/odkształcenie 1

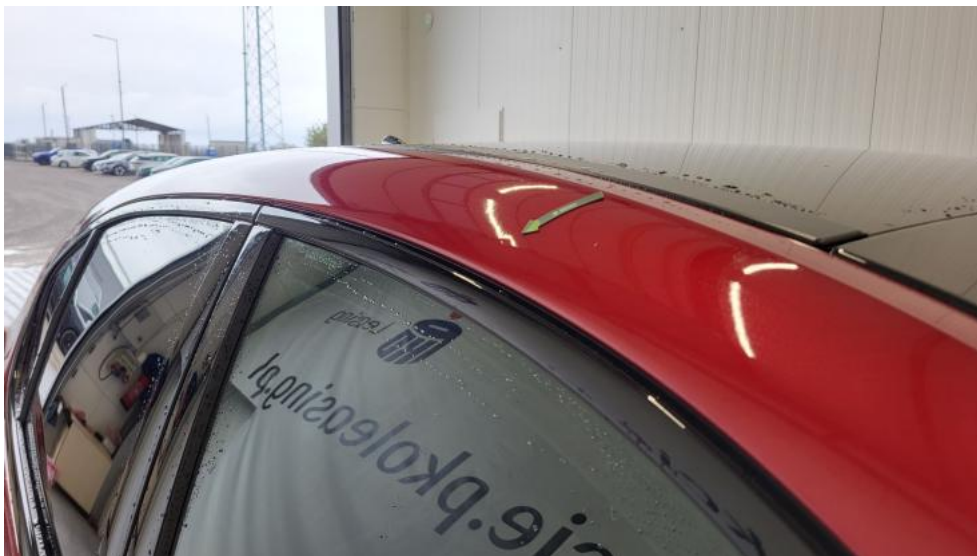
**Photo 55.**

Słupek przedni P - Wgniecenie/odkształcenie 1

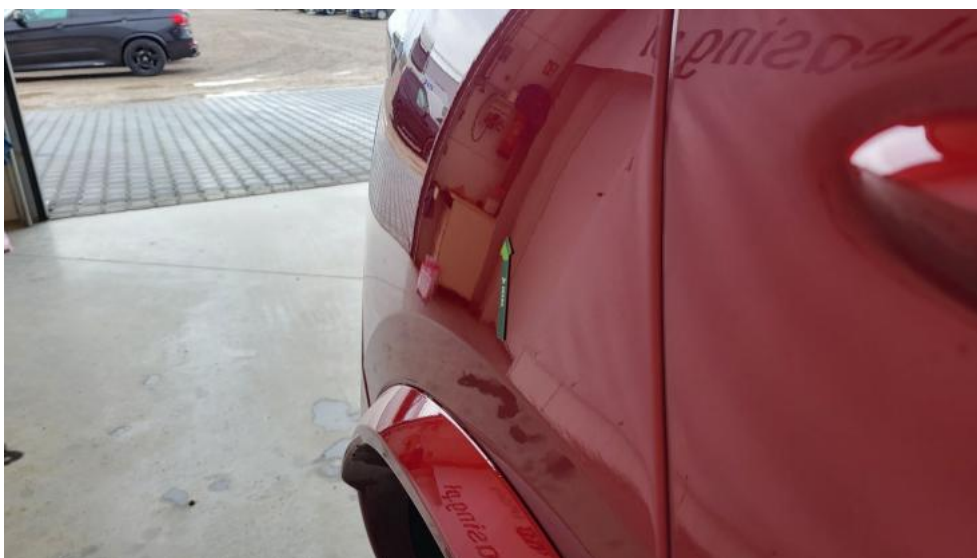
**Photo 56.**

Ścianka tylna P / Ścianka boczna P - Wgniecenie/odkształcenie 1

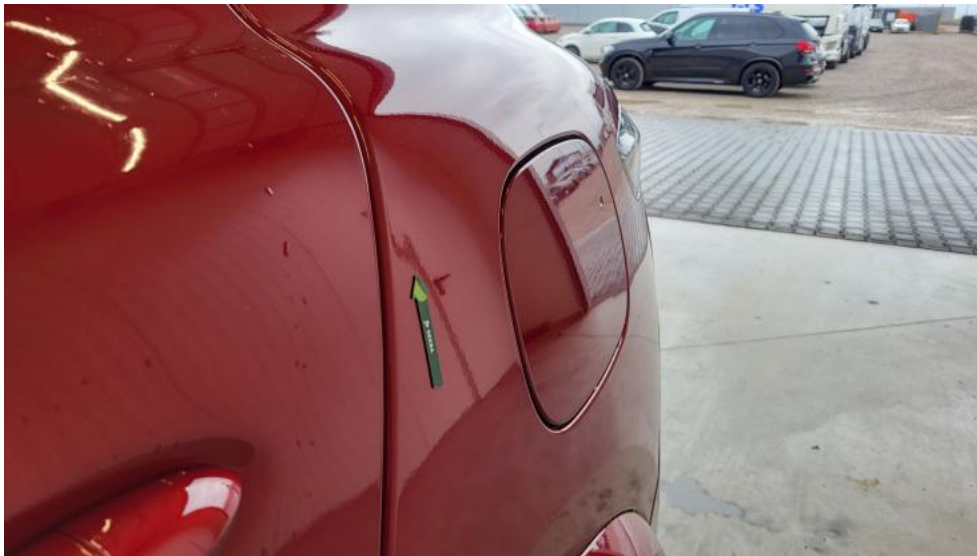
**Photo 59.**

Błotnik tylny L / Ściana boczna L - Wgniecenie/odkształcenie 1

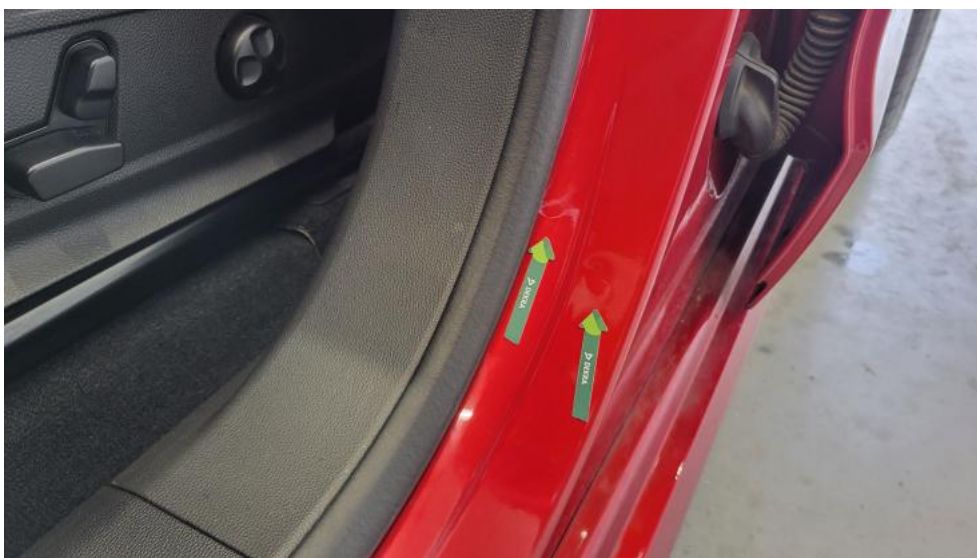
**Photo 60.**

Próg L - Wgniecenie/odkształcenie 1

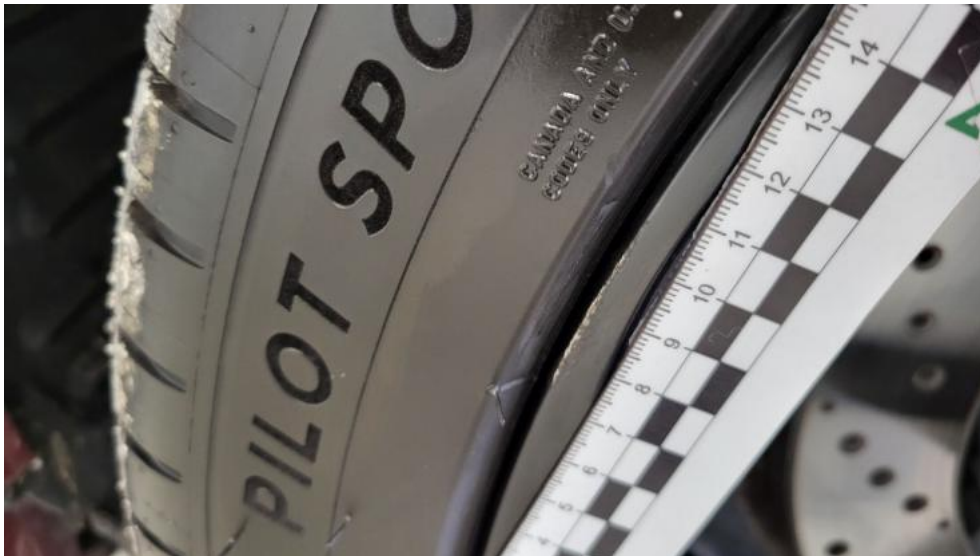
**Photo 61.**

Felga Aluminiowa przednia L - Rysa/odprysk 1

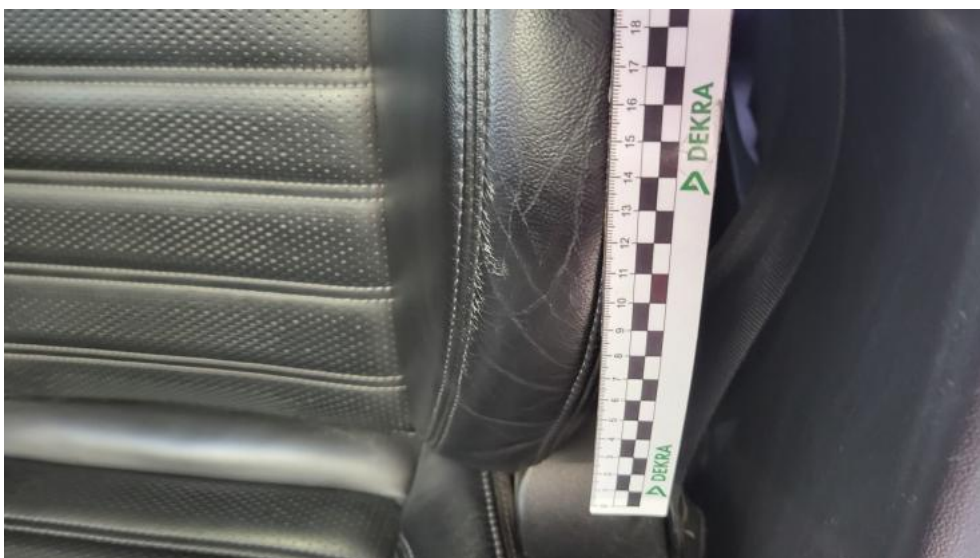
**Photo 62.**

Fotel prz. lew. - Inne 1

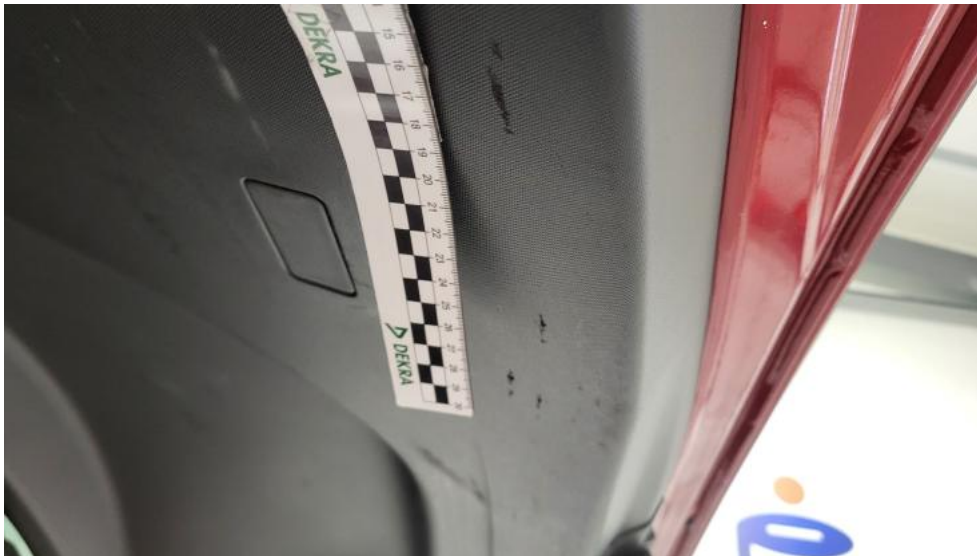
**Photo 63.**

Wykładzina pokrywy tylnej - Rysa/odprysk 1
