DEKRA's commission No. : PKOL(W)/LODZ/55913/26/06/17  
commission/ damage No. : PS24/04529  
Date of commission: 17-06-2026

PKO Leasing SA  
Świętokrzyska 36  
00-116 Warszawa

| Model | CX-60 22- |
| Type / version | CX-60 3.3 D mHEV Homura AWD aut |

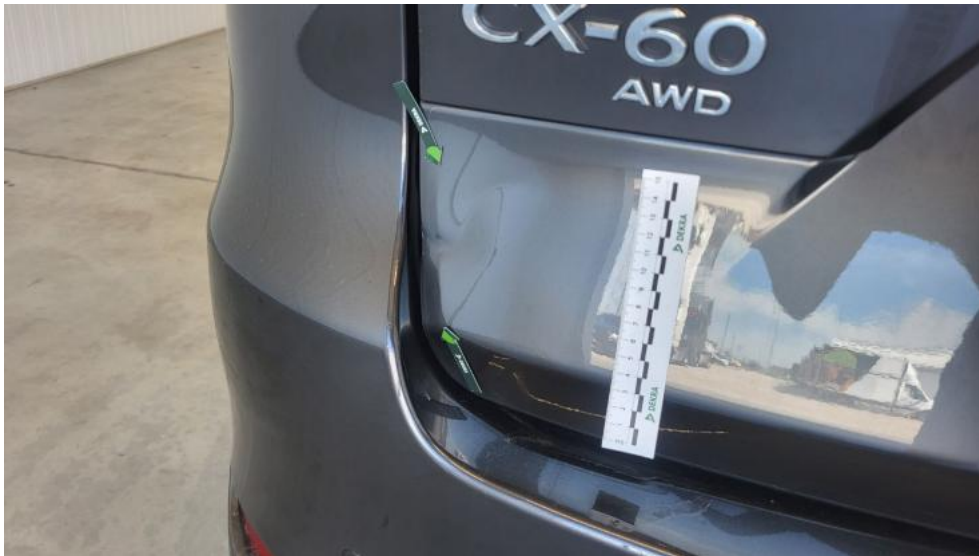
**Photo 49.**

Pokrywy bagażnika - Wgniecenie/odkształcenie 1

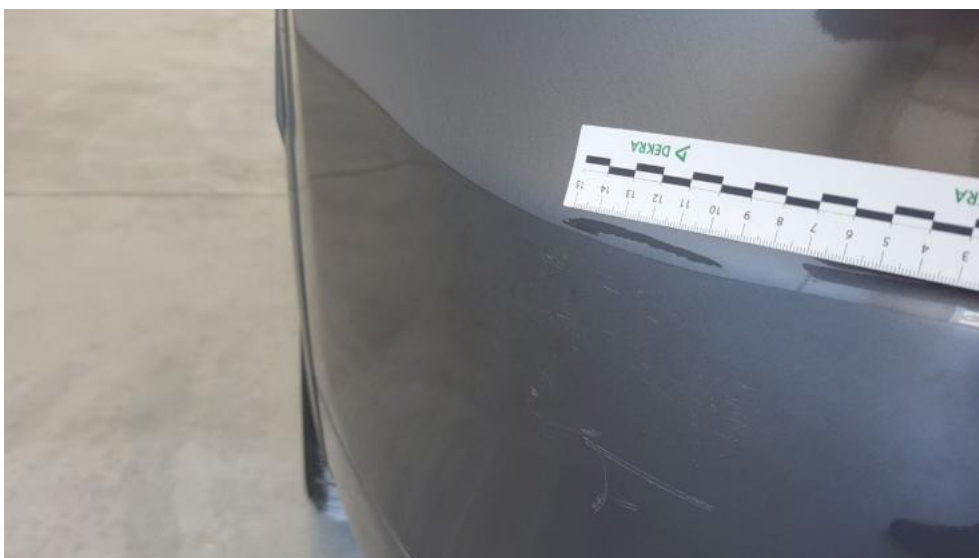
**Photo 50.**

Zderzak tylny - Rysa/odprysk 1

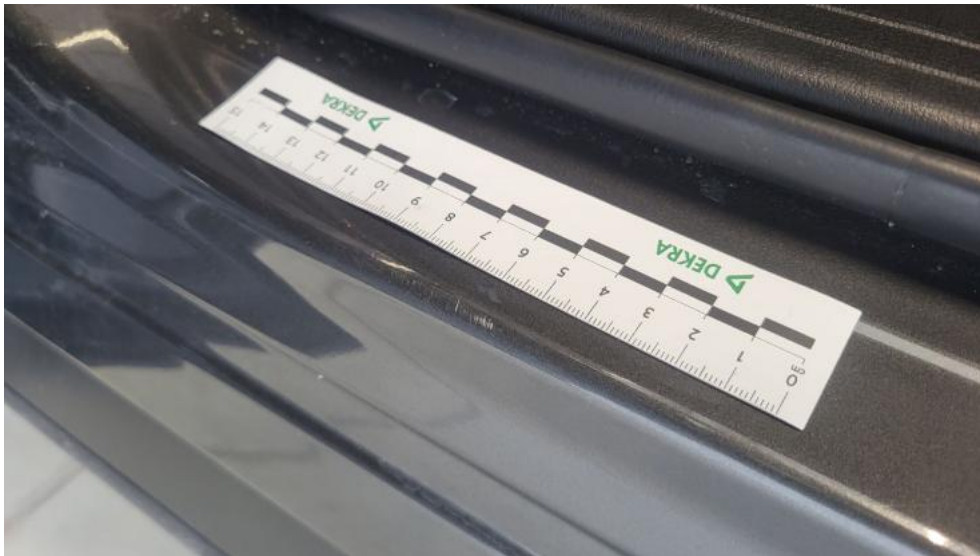
**Photo 55.**

Próg L - Rysa/odprysk 1

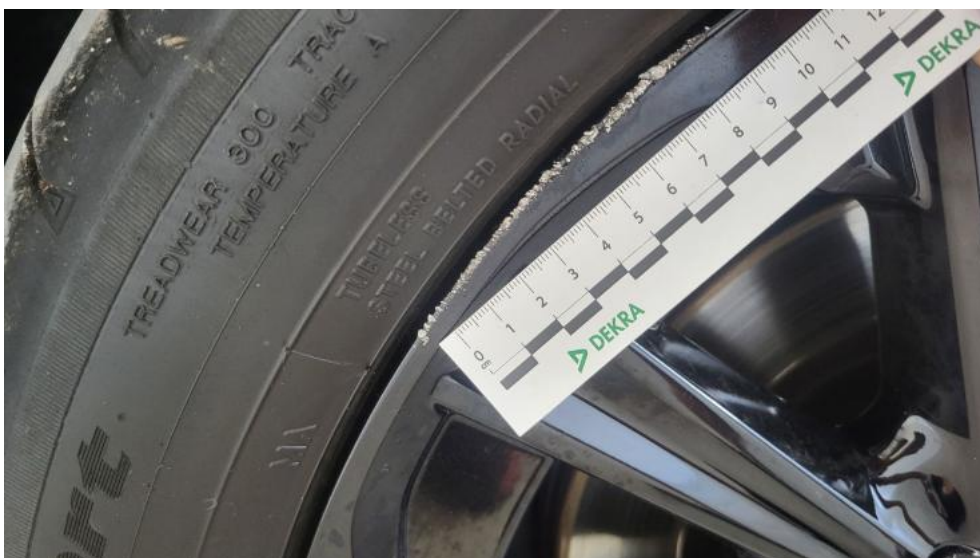
**Photo 56.**

Felga Aluminiowa przednia L - Rysa/odprysk 1

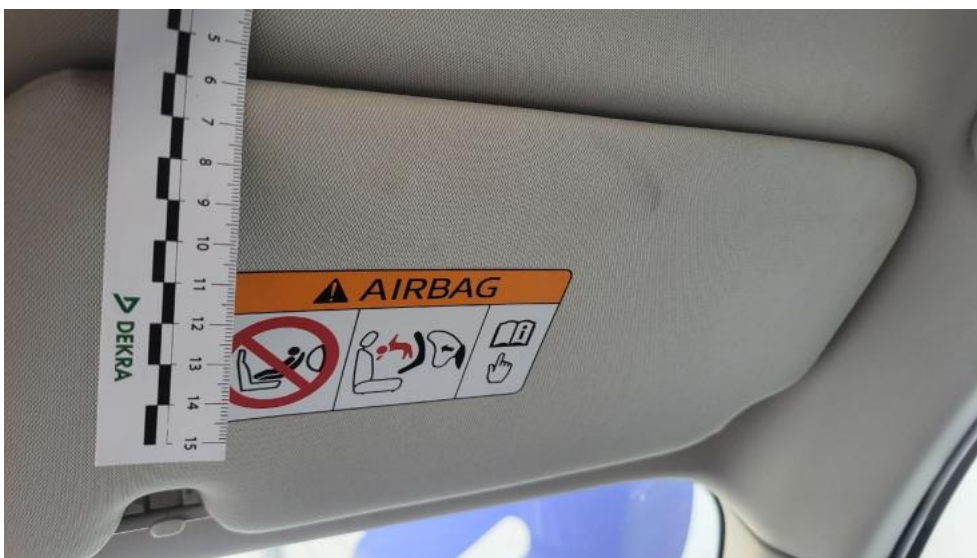
**Photo 58.**

Osłona p/słoneczna prawa - Inne 1
