DEKRA's commission No. : PKOL(W)/LODZ/39434/25/05/30  
commission/ damage No. : 24/000257  
Date of commission: 30-05-2025

**Vehicle data**

| Manufacturer | BMW |
| Model | Seria 5 Touring [G31] 17-20 |

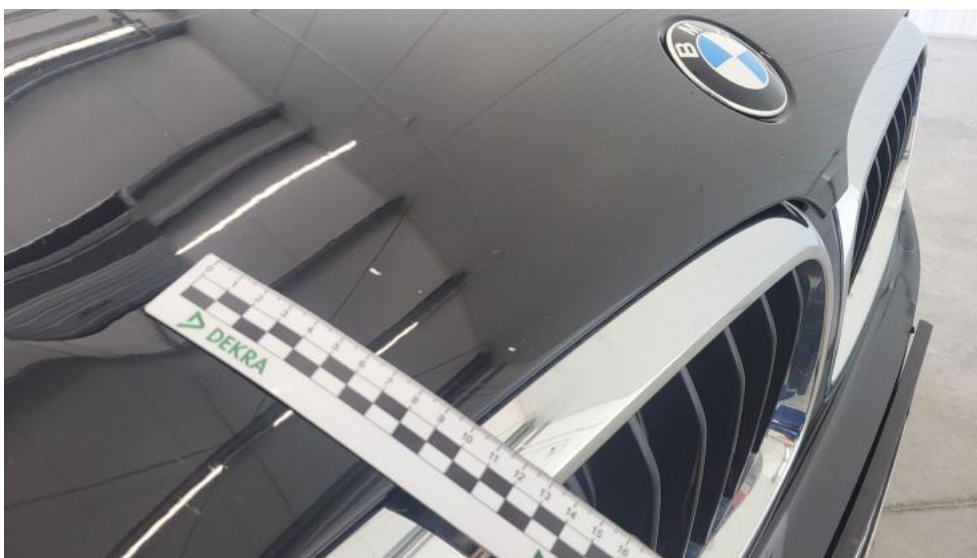
**Photo 40.**

Pokrywa komory silnika - Rysa/odprysk 1

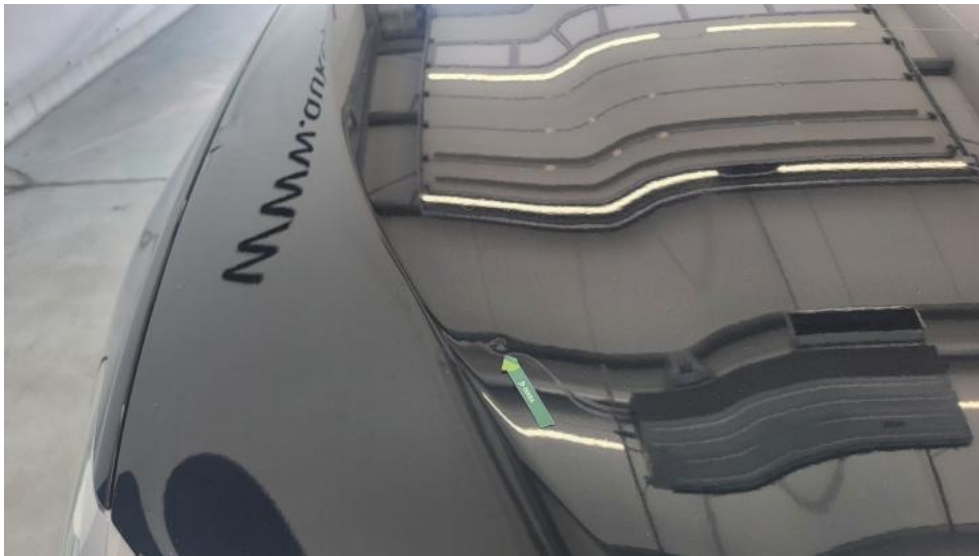
**Photo 41.**

Pokrywa komory silnika - Wgniecenie/odkształcenie 1

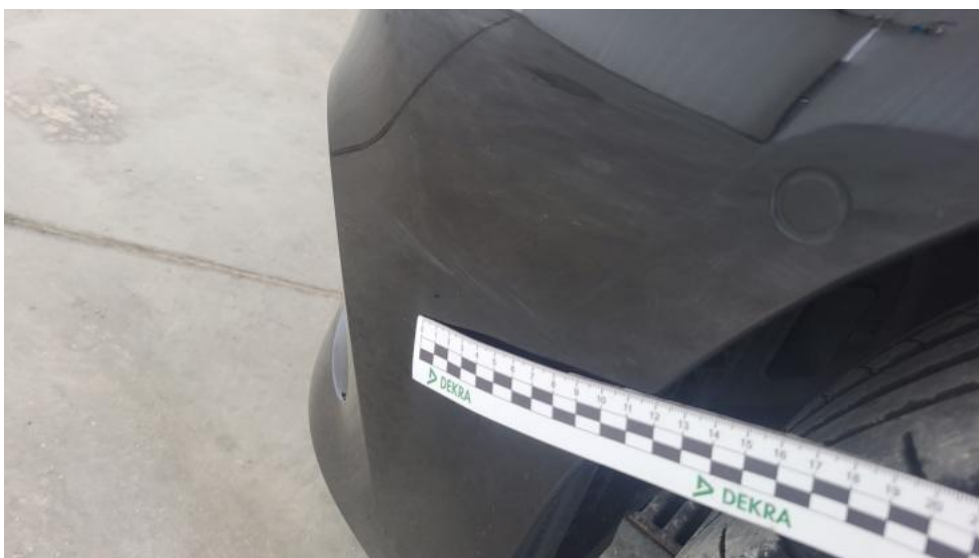
**Photo 42.**

Zderzak - Rysa/odprysk 1

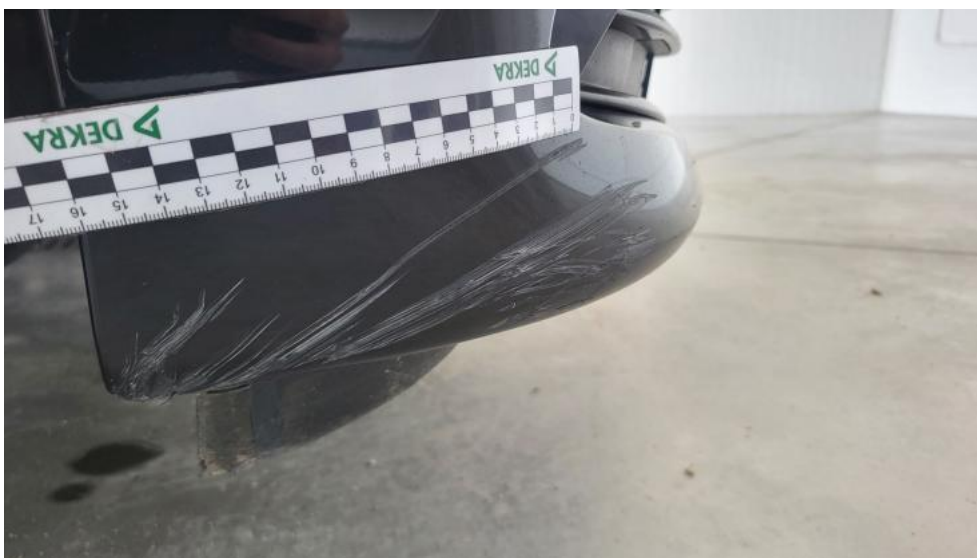
**Photo 44.**

Zderzak() - Rysa/odprysk 3

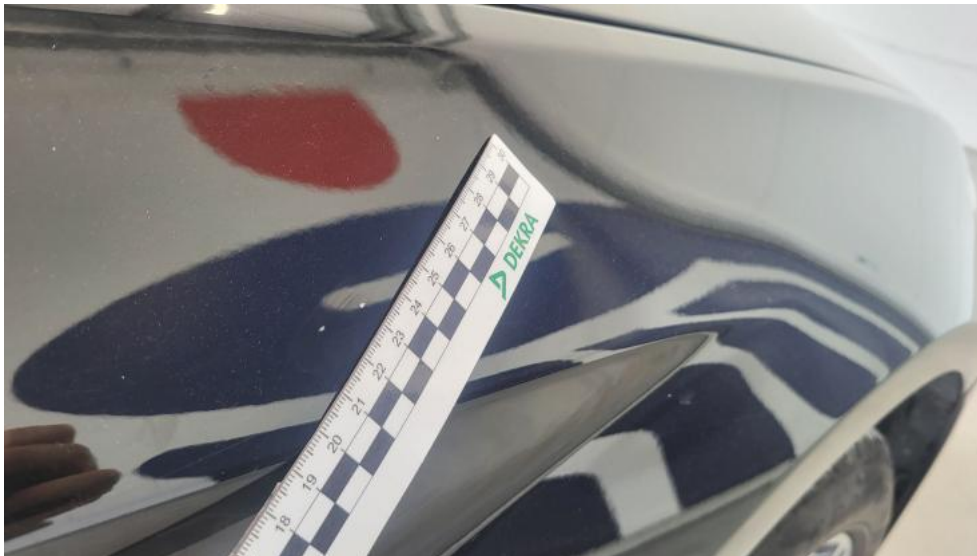
**Photo 45.**

Błotnik przedni P - Rysa/odprysk 1

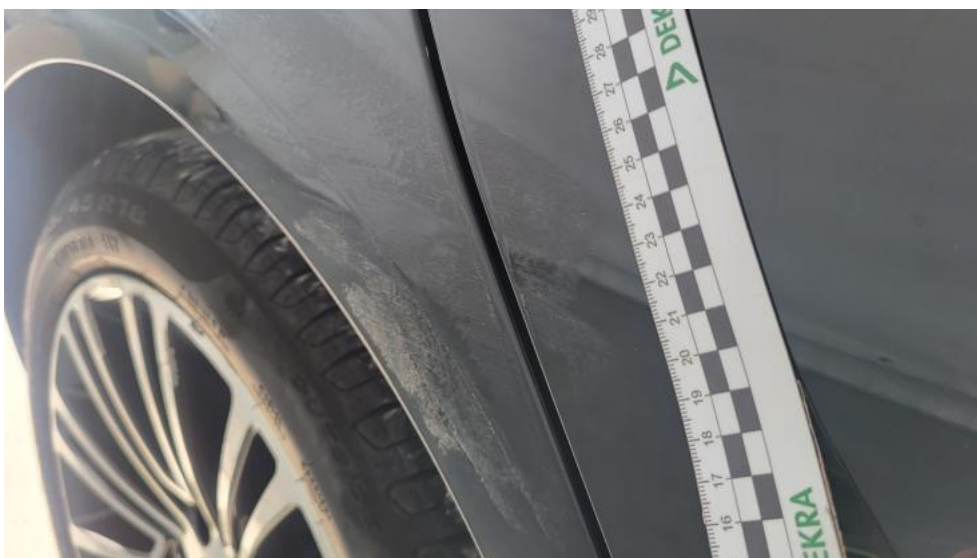
**Photo 46.**

Drzwi tylne P - Rysa/odprysk 1

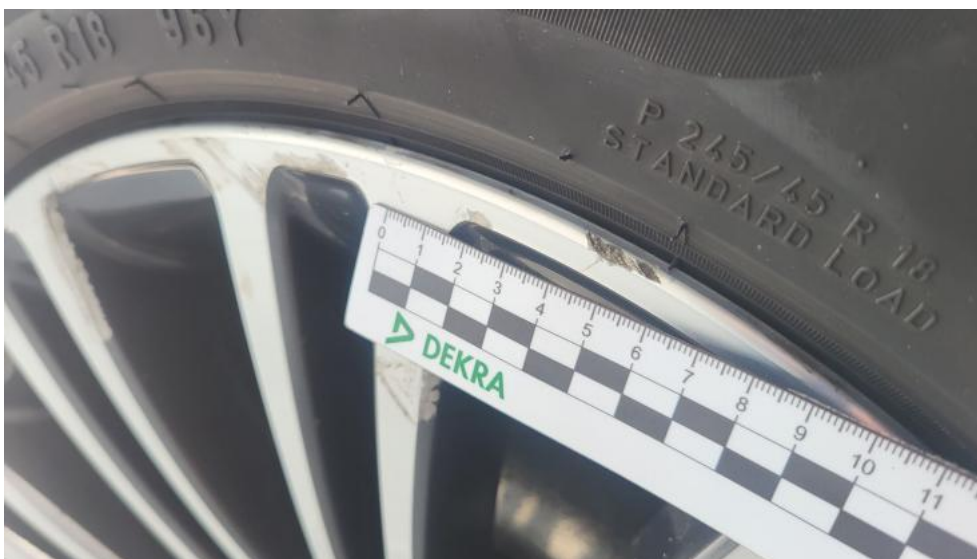
**Photo 51.**

Felga aluminiowa tylna P - Rysa/odprysk 1

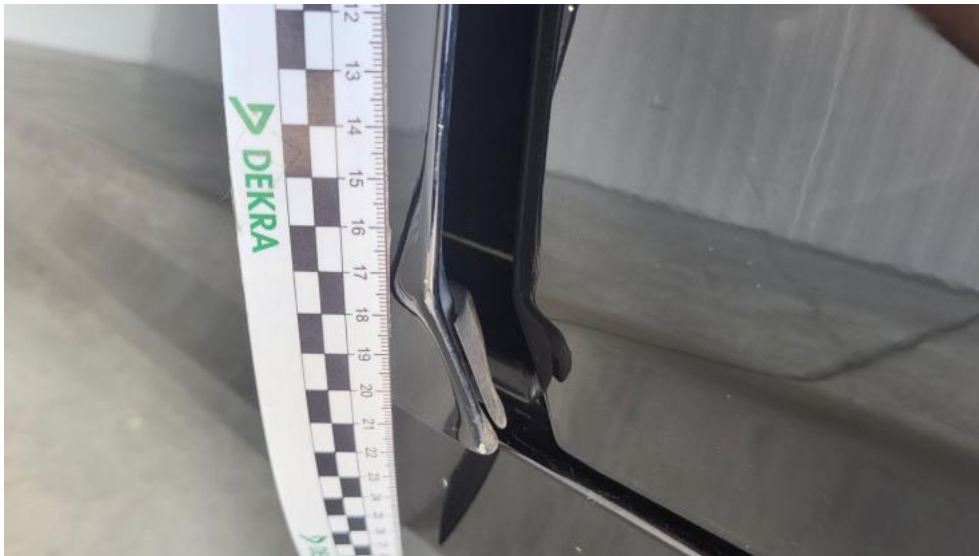
**Photo 57.**

Drzwi przed L - Rysa/odprysk 1

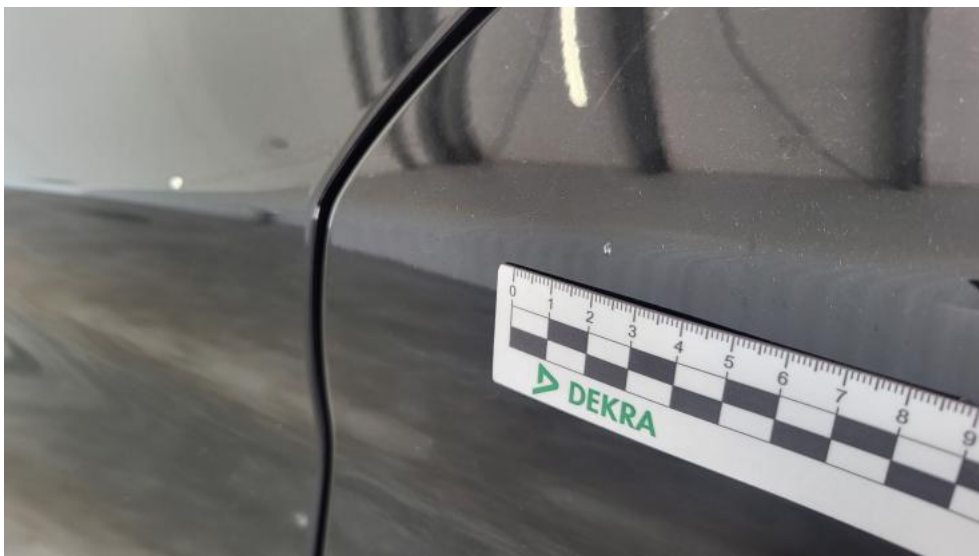
**Photo 58.**

Drzwi przed L - Rysa/odprysk 2

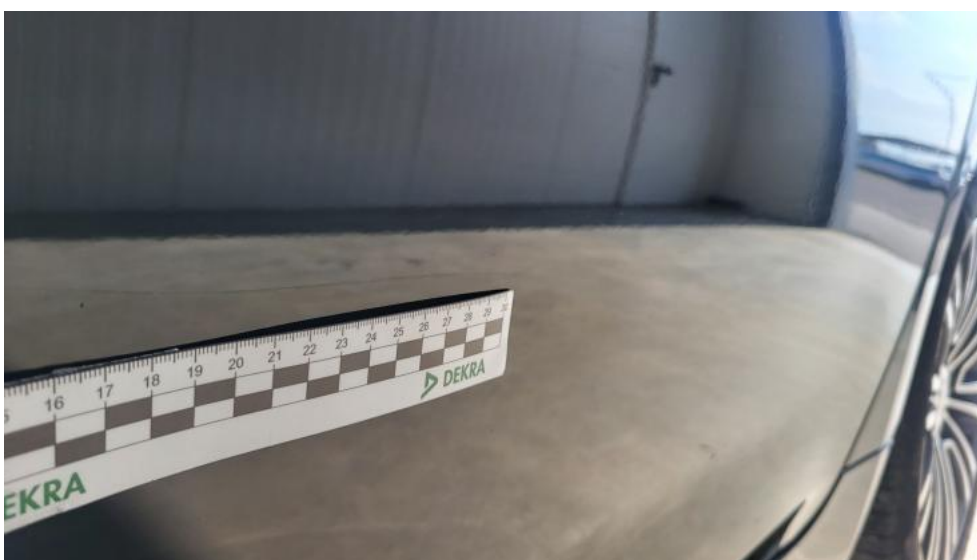
**Photo 60.**

Drzwi tylne L - Rysa/odprysk 2

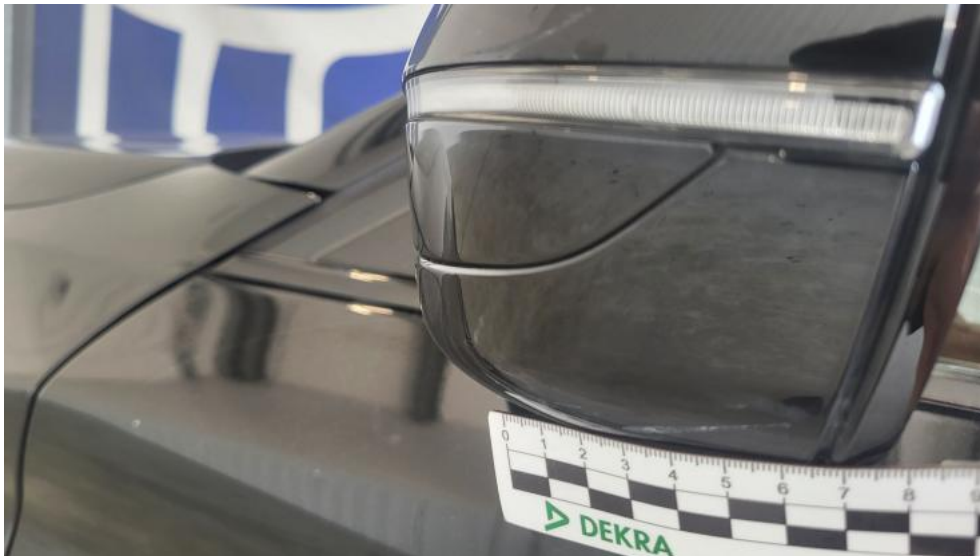
**Photo 61.**

Lusterko zew L - Rysa/odprysk 1

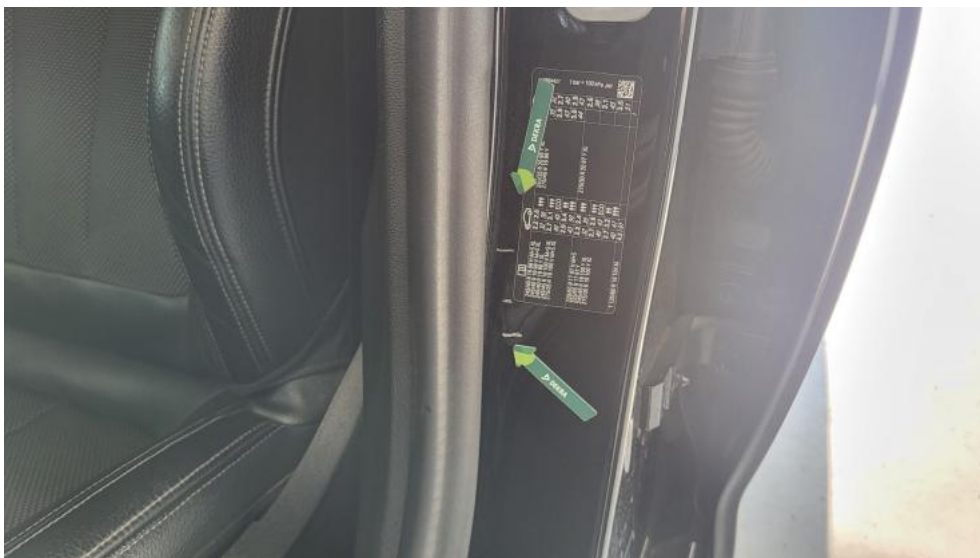
**Photo 62.**

Słupek środkowy L - Wgniecenie/odkształcenie 1

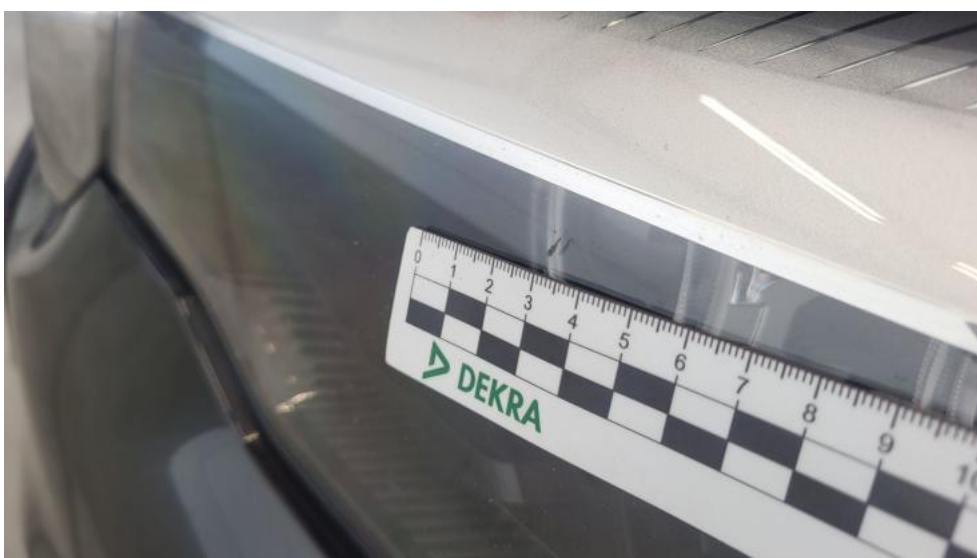
**Photo 64.**

Reflektor L - Rysa/odprysk 1

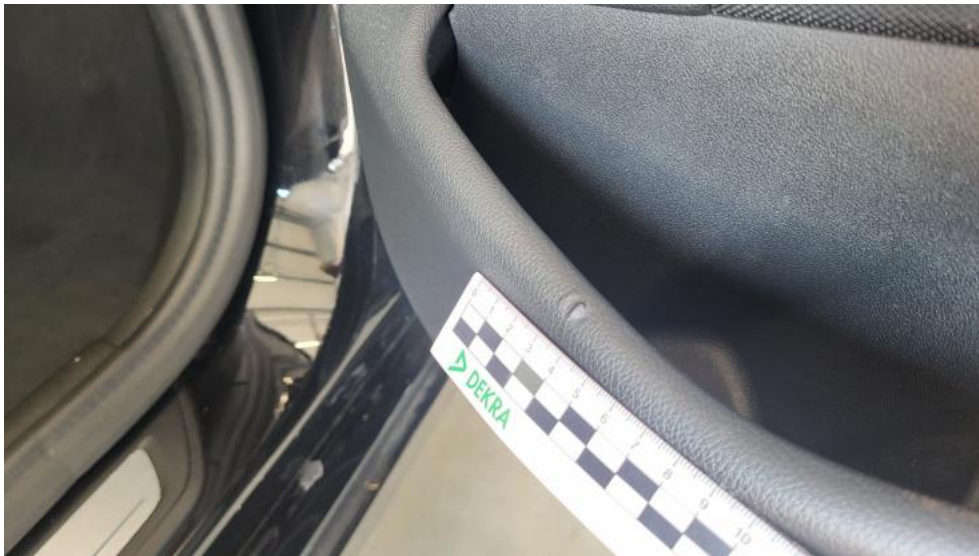
**Photo 65.**

Tapicerka drzwi przednich P - Wgniecenie/odkształcenie 1

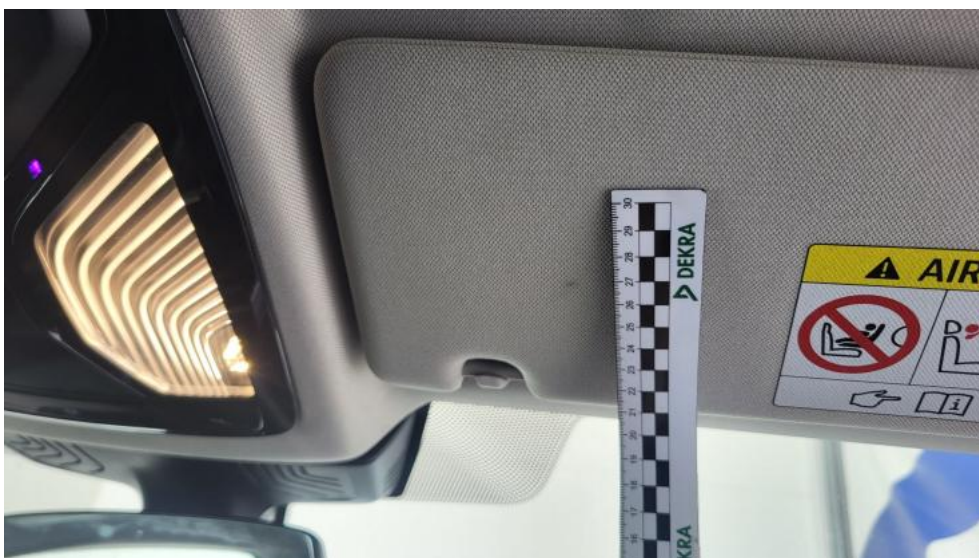
**Photo 66.**

Osłona p/słoneczna prawa - Inne 1

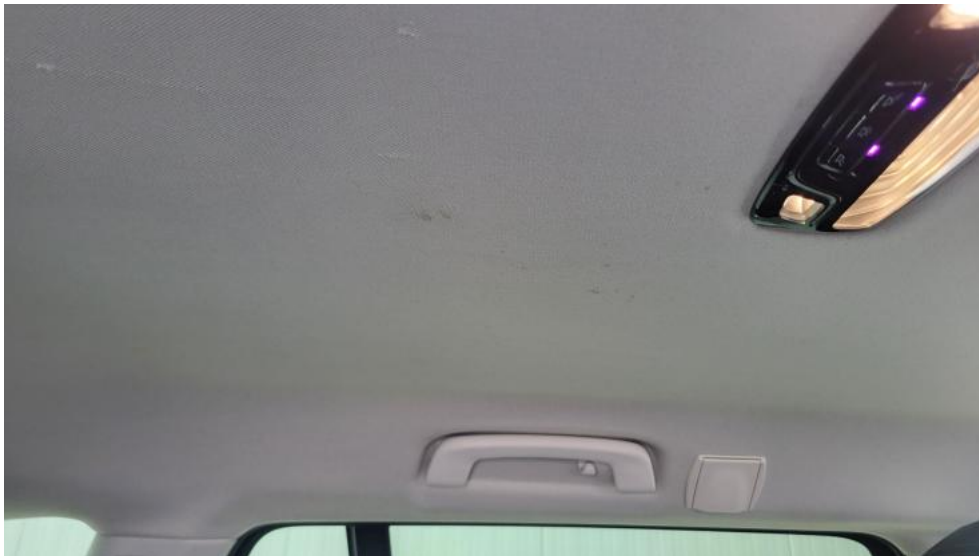
**Photo 67.**

Podsufitka - Inne 1

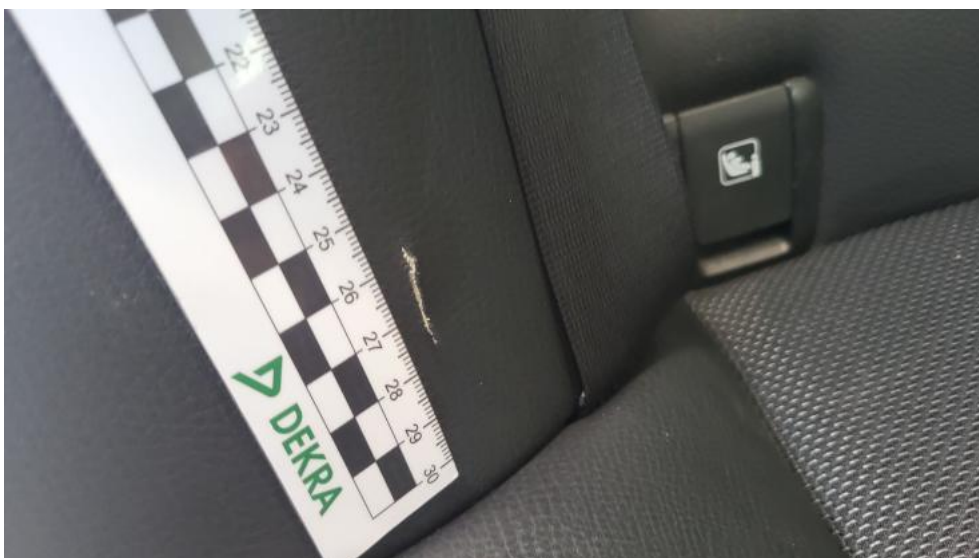
**Photo 68.**

Wykładzina(y) słupka tylnego P - Pęknięcie/rozerwanie 1
