DEKRA's commission No. : PKOL(W)/LODZ/02576/25/01/13
commission/ damage No. : PS21/04310
Date of commission: 13-01-2025

Vehicle data

Measurement of thickness of the vehicle lacquer coating

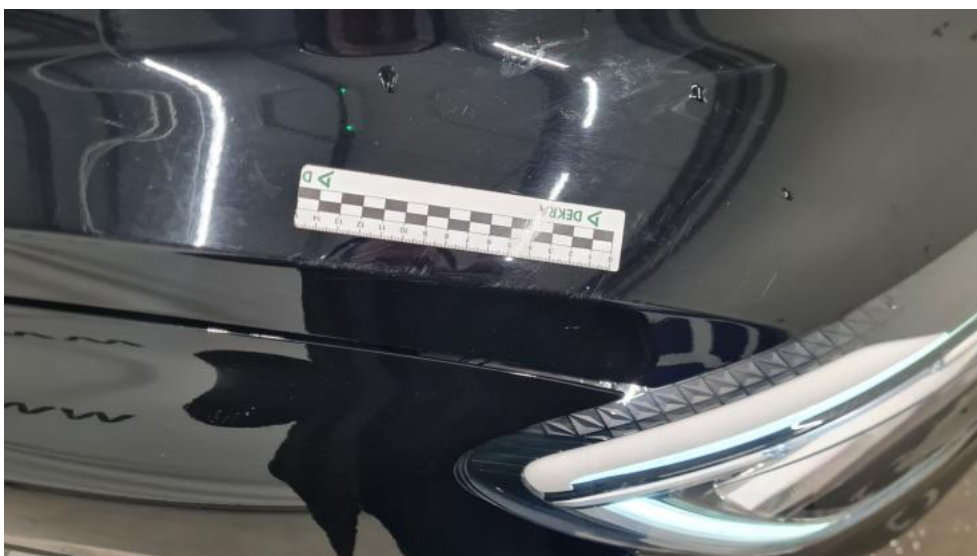
Photo 38.
Pokrywa komory silnika - Rysa/odprysk 1

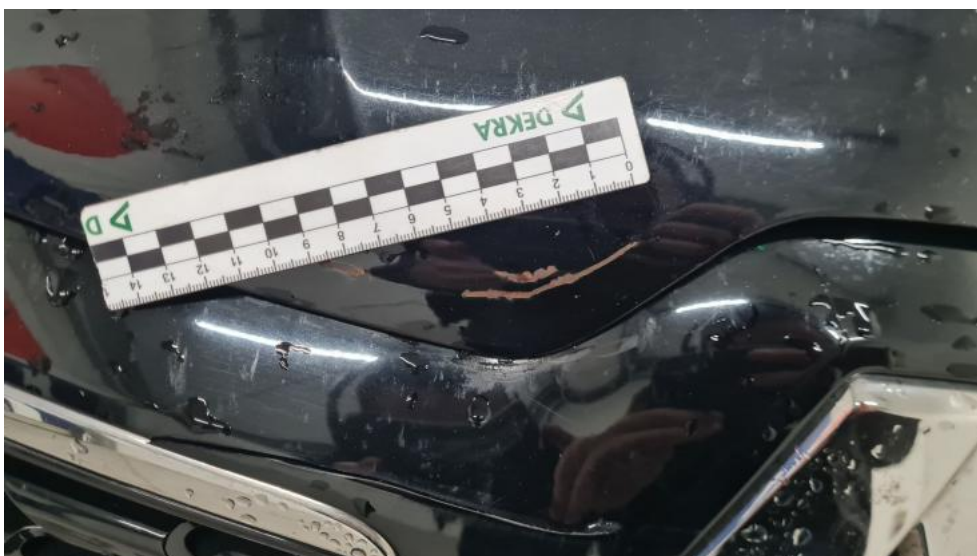
Photo 42.
Pokrywa komory silnika - Inne 1

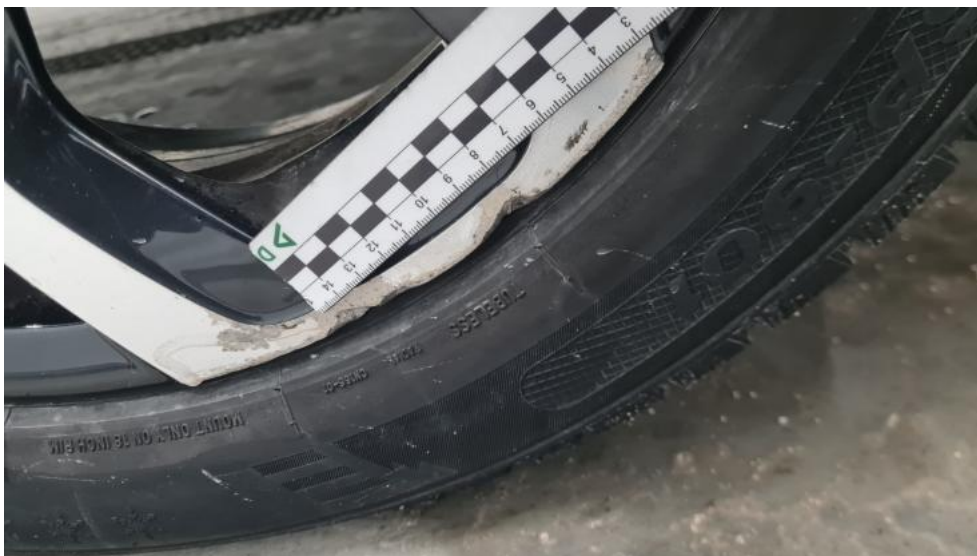
Photo 45.
Felga aluminiowa przednia P - Rysa/odprysk 1

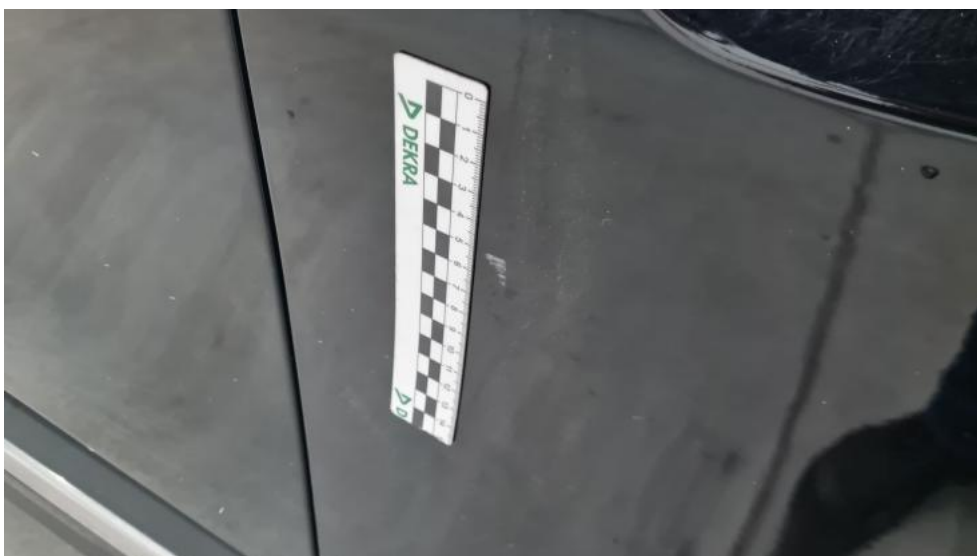
Photo 46.
Drzwi przednie P - Rysa/odprysk 1

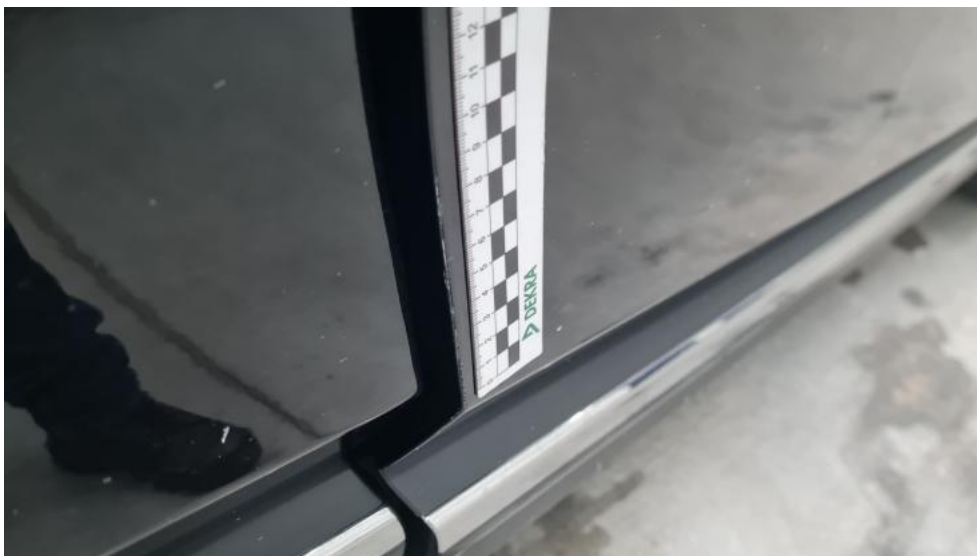
Photo 47.
Drzwi przednie P - Rysa/odprysk 2

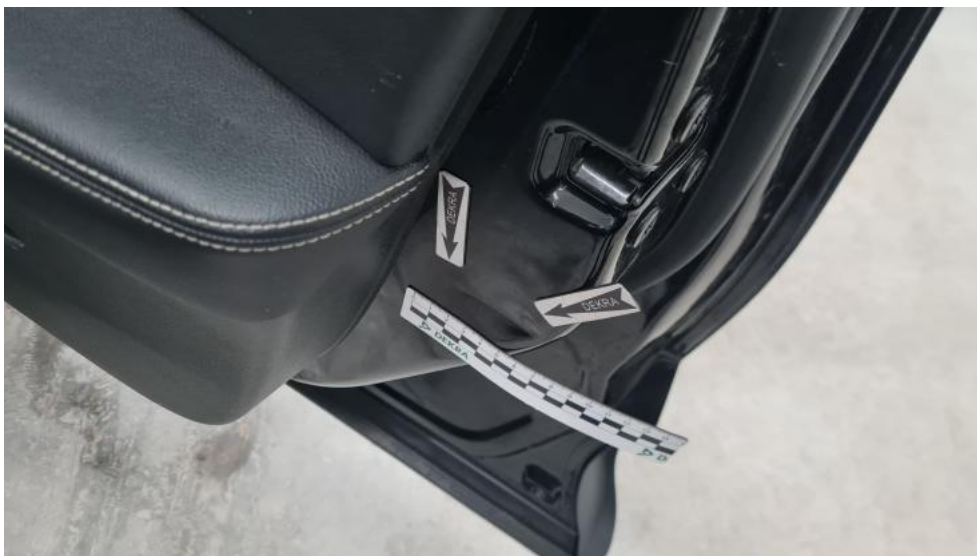
Photo 49.
Drzwi przednie P - Wgniecenie/odkształcenie 2

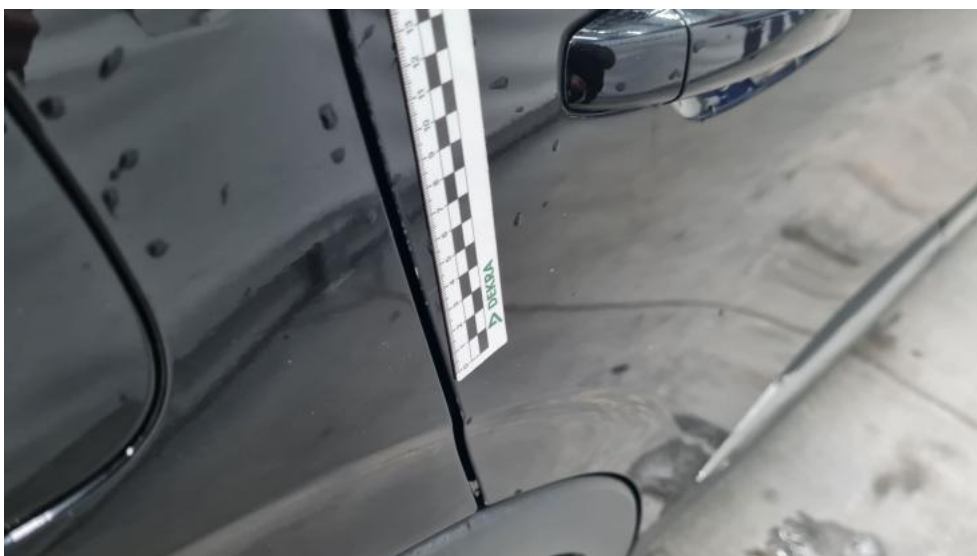
Photo 50.
Drzwi tylne P - Rysa/odprysk 1

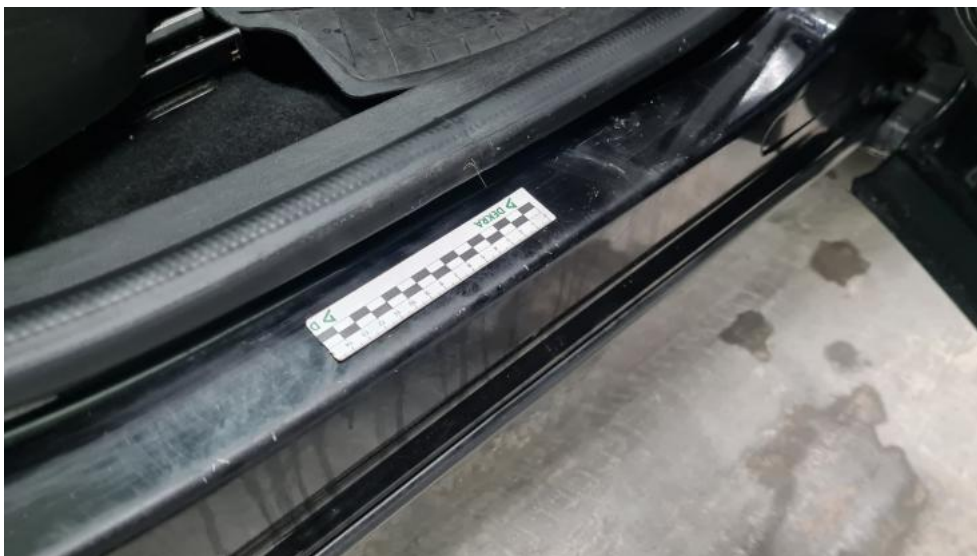
Photo 51.
Próg P - Rysa/odprysk 1

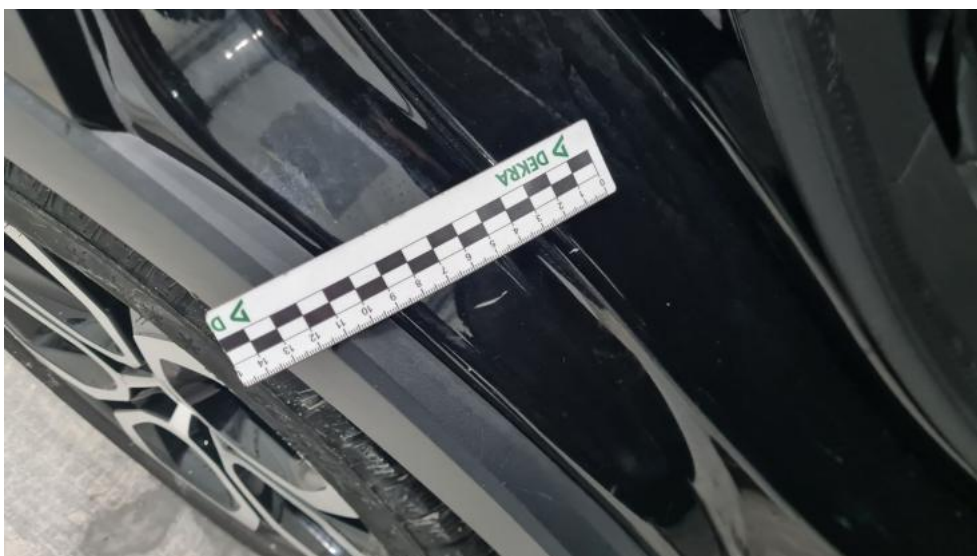
Photo 52.
Błotnik tylny P / Ściana boczna P - Rysa/odprysk 1

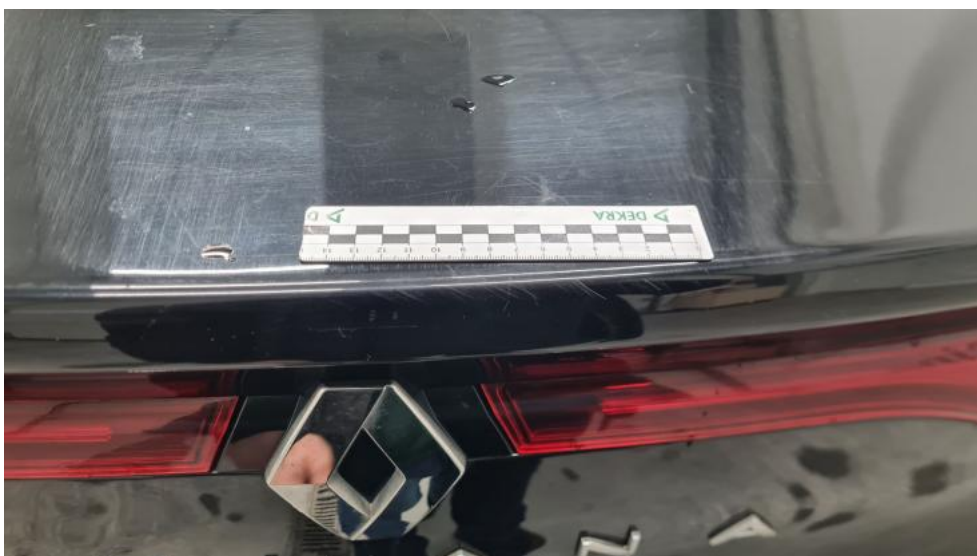
Photo 56.
Pokrywy bagażnika - Rysa/odprysk 1

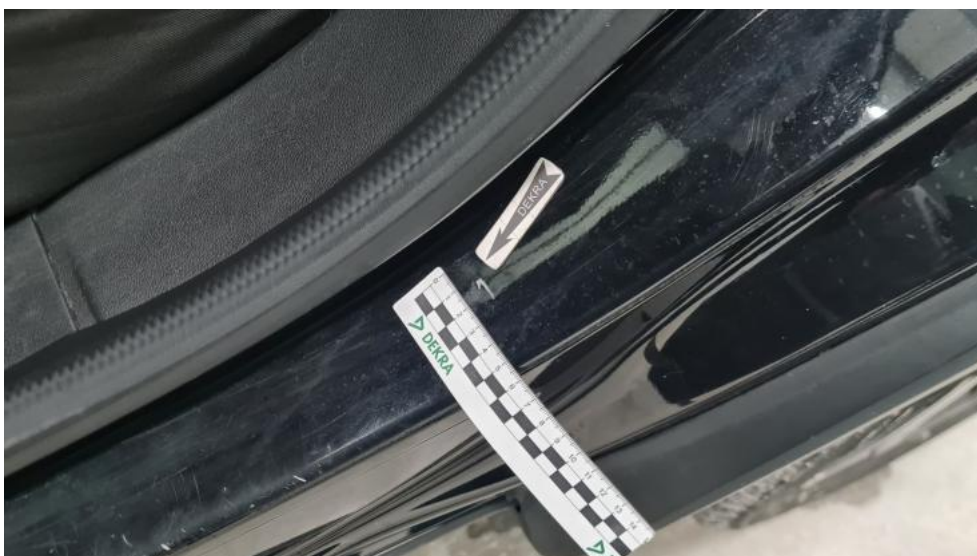
Photo 62.
Błotnik tylny L / Ściana boczna L - Wgniecenie/odkształcenie 1

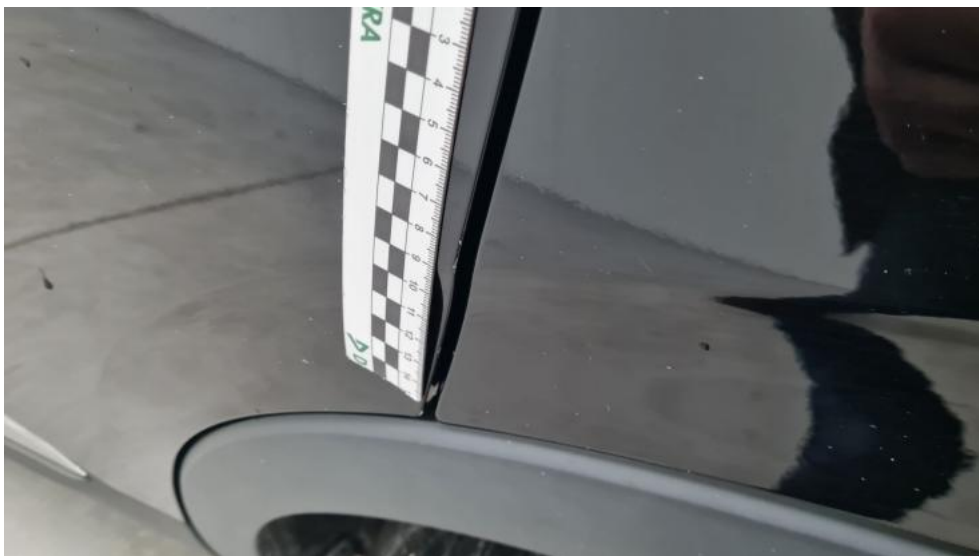
Photo 65.
Drzwi tylne L - Rysa/odprysk 1

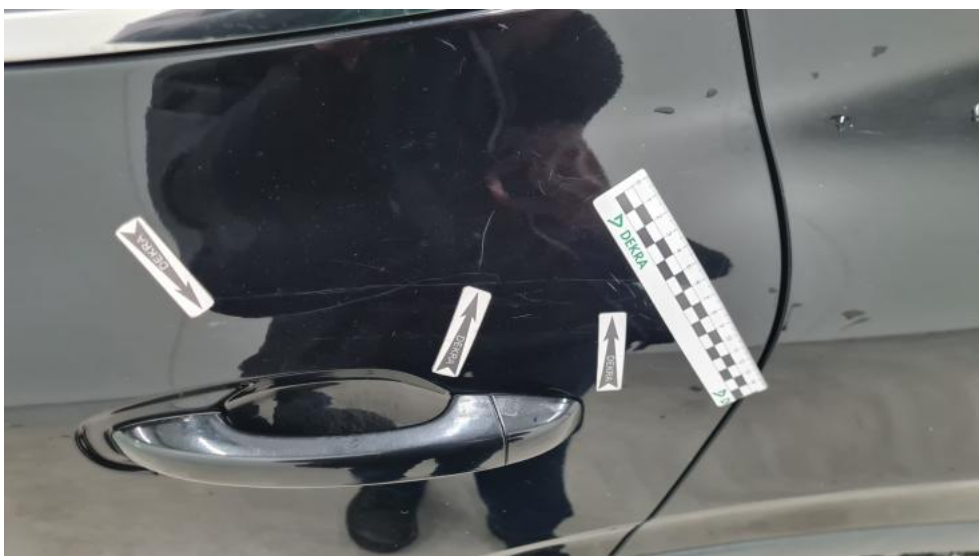
Photo 66.
Drzwi tylne L - Rysa/odprysk 2

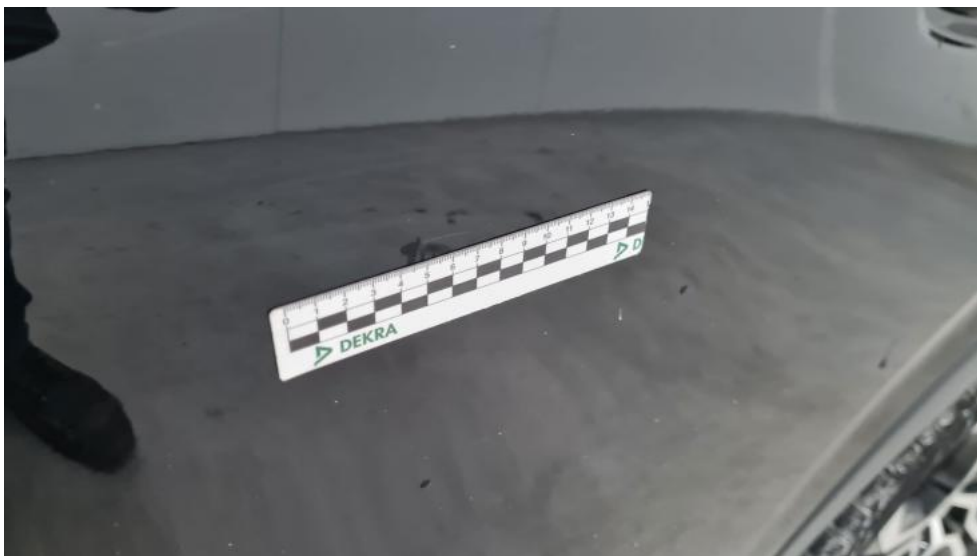
Photo 67.
Drzwi tylne L() - Rysa/odprysk 3

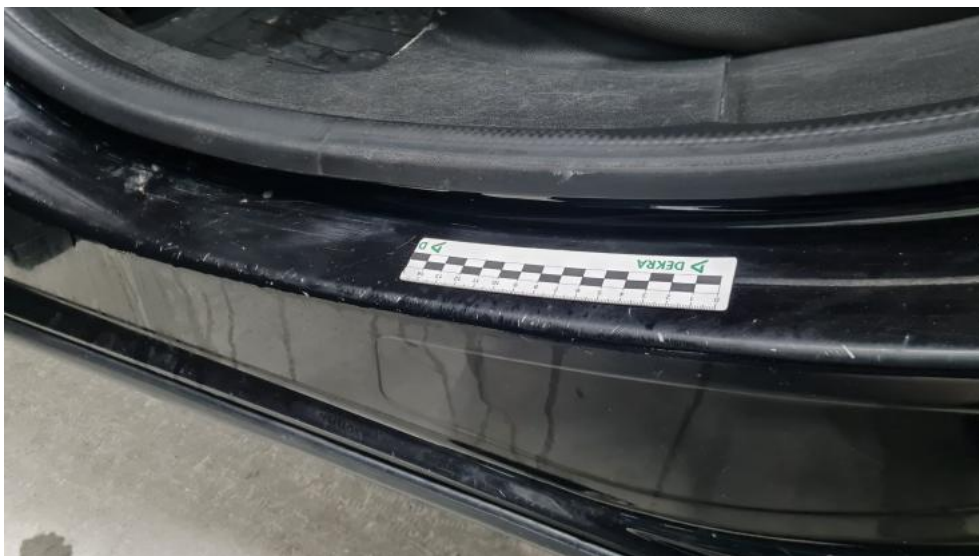
Photo 69.
Próg L - Rysa/odprysk 1

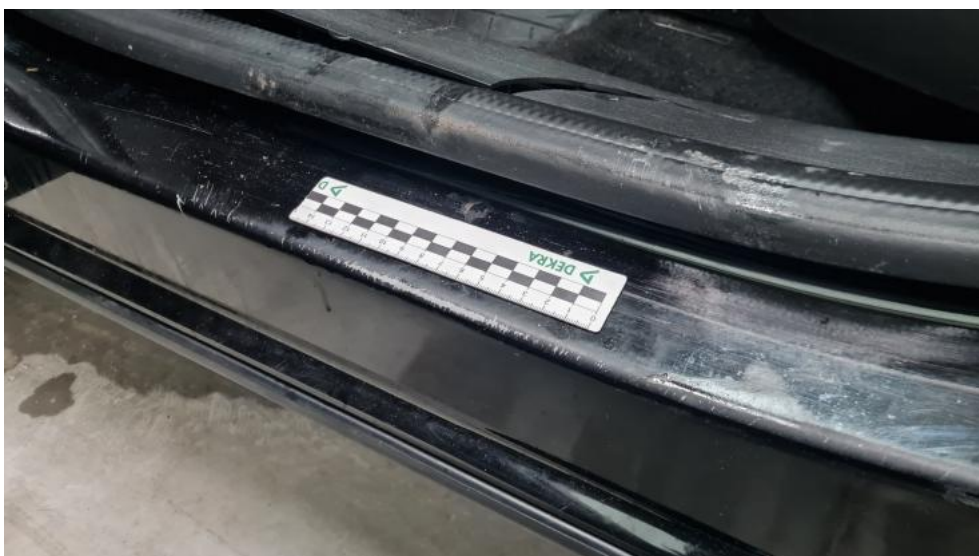
Photo 70.
Próg L - Rysa/odprysk 2

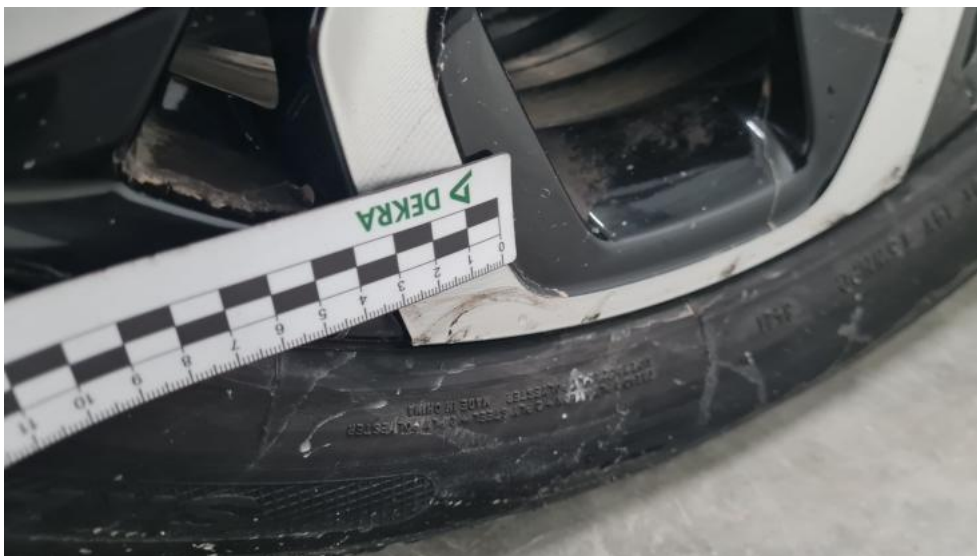
Photo 73.
Felga Aluminiowa przednia L - Rysa/odprysk 1
