DEKRA's commission No. : PKOL(W)/LODZ/02591/25/01/13
 commission/ damage No. : 06321/EO/22
 Date of commission: 13-01-2025

Vehicle data

Measurement of thickness of the vehicle lacquer coating

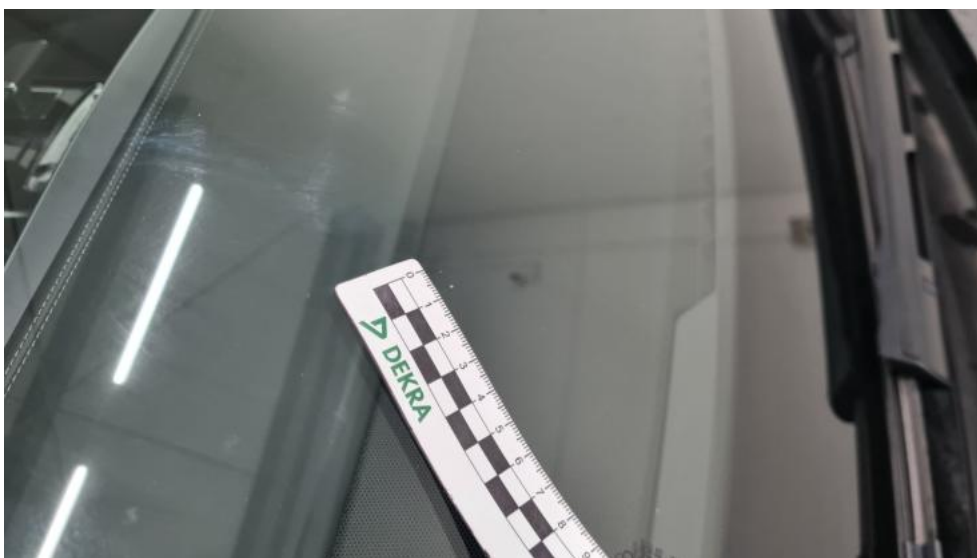
Photo 36.
Szyba czołowa - Rysa/odprysk 1
