DEKRA's commission No. : PKOL(W)/LODZ/101889/25/12/22
commission/ damage No. : 24/051974
Date of commission: 22-12-2025

PKO Leasing SA
Świętokrzyska 36
00-116 Warszawa

Group of objects (Eurotax)	cars
EC code (Eurotax)	0130775
Manufacturer	FORD
Model	Focus Kombi 18-21
Type / version	Focus 1.5 EcoBlue Trend Edition
Body type	KOM
Number of doors / seats	5/5
Curb weight [kg]	1320
Gross vehicle weight [kg]	1955
Wheelbase 1/2	2650
Engine type	Automatic ignition
Pollution reduction system	DPF
Engine capacity [ccm]	1498
Engine Power [hp/kW]	120/88
Gearbox	manual 6- gear
Registration /record No.	DLU8003E
VIN / serial number	WF0PXXGCHPLA64986
Date of first registration	29-09-2020
Date of next. tech. test	18-09-2026
Year of manufacture	2020 (year has been verified with the manufacturer's base)
Readout [km]	111 651 (read)
Body color / type of coating	gray/double-layered, metallized

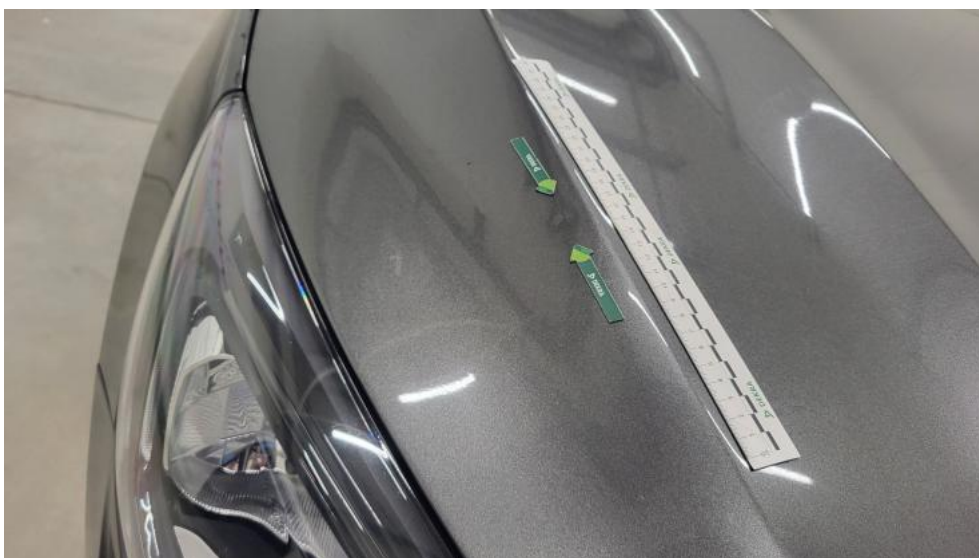
Photo 38.
Pokrywa komory silnika - Wgniecenie/odkształcenie 1

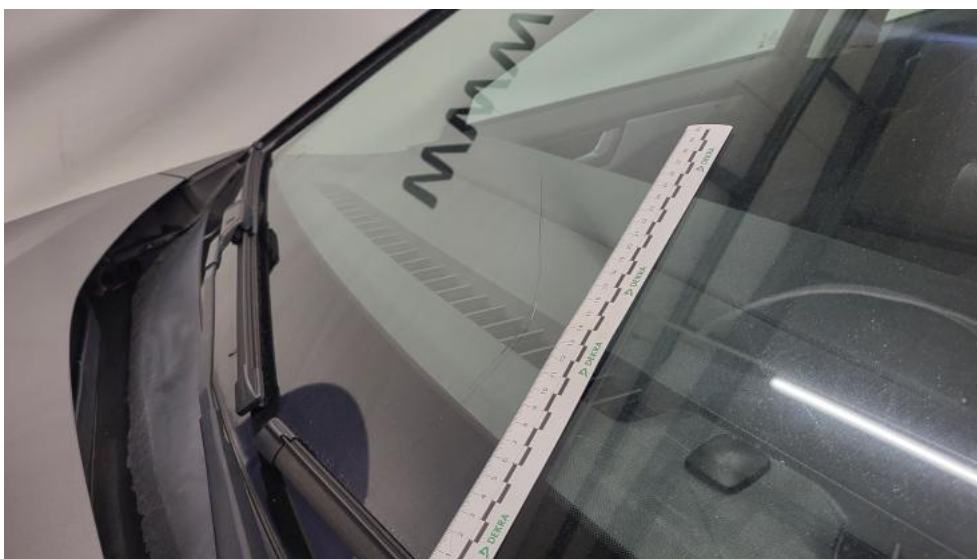
Photo 39.

Szyba czołowa - Pęknięcie/rozerwanie 1

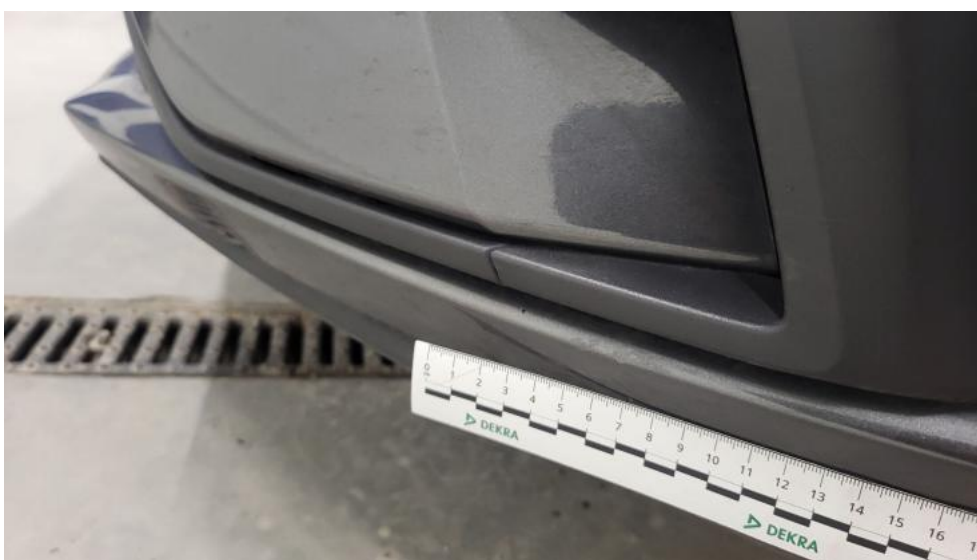
Photo 40.

Zderzak - Rysa/odprysk 1

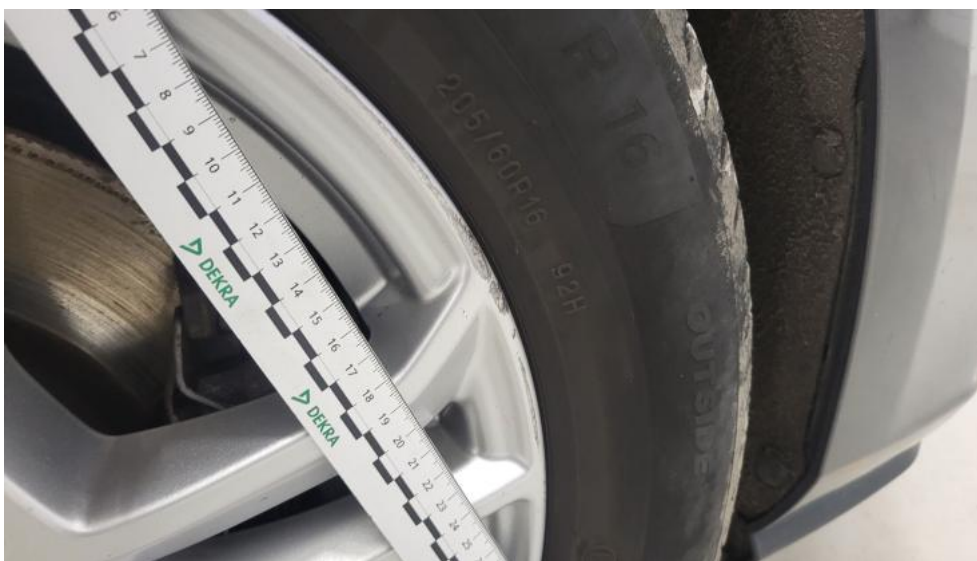
Photo 41.
Felga aluminiowa przednia P - Rysa/odprysk 1

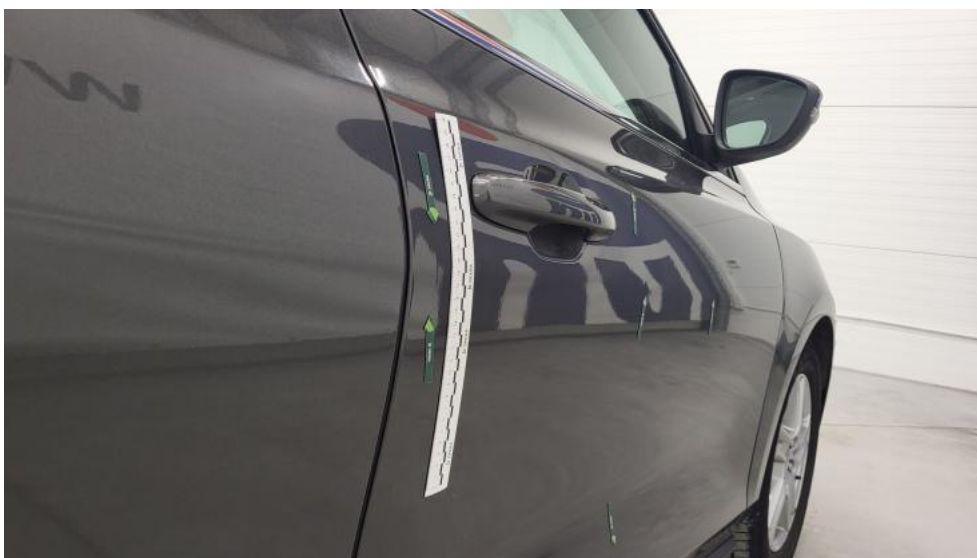
Photo 42.
Drzwi przednie P - Wgniecenie/odkształcenie 1

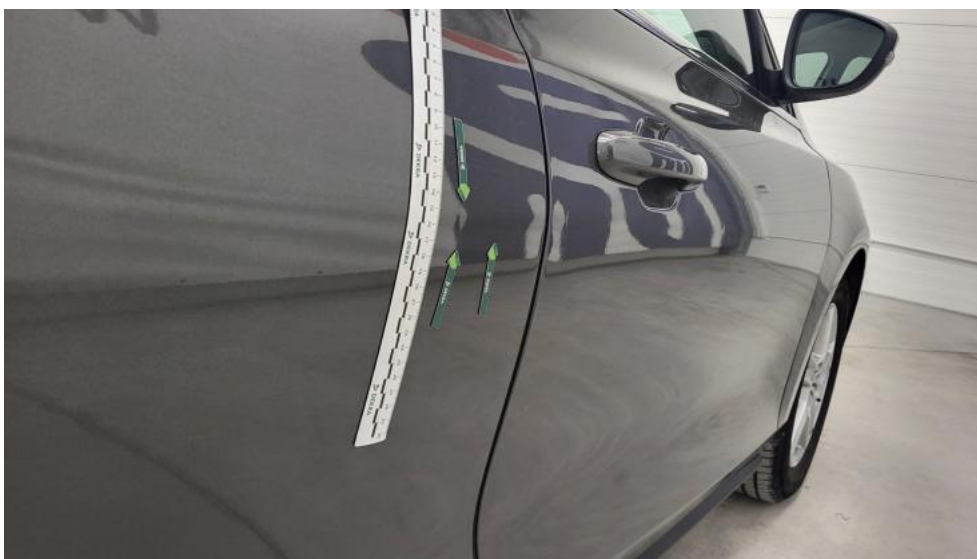
Photo 43.
Drzwi tylne P - Wgniecenie/odkształcenie 1

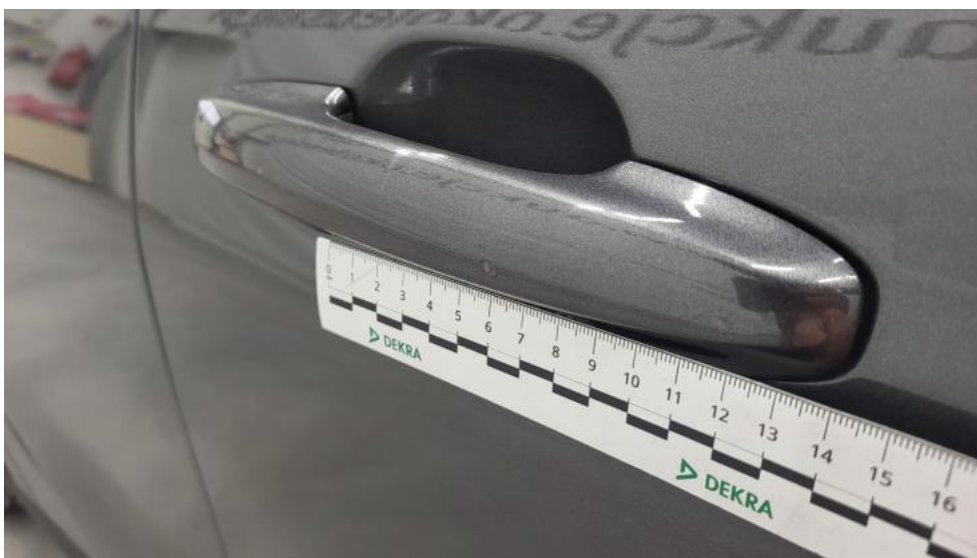
Photo 44.
Klamka drzwi prz P - Rysa/odprysk 1

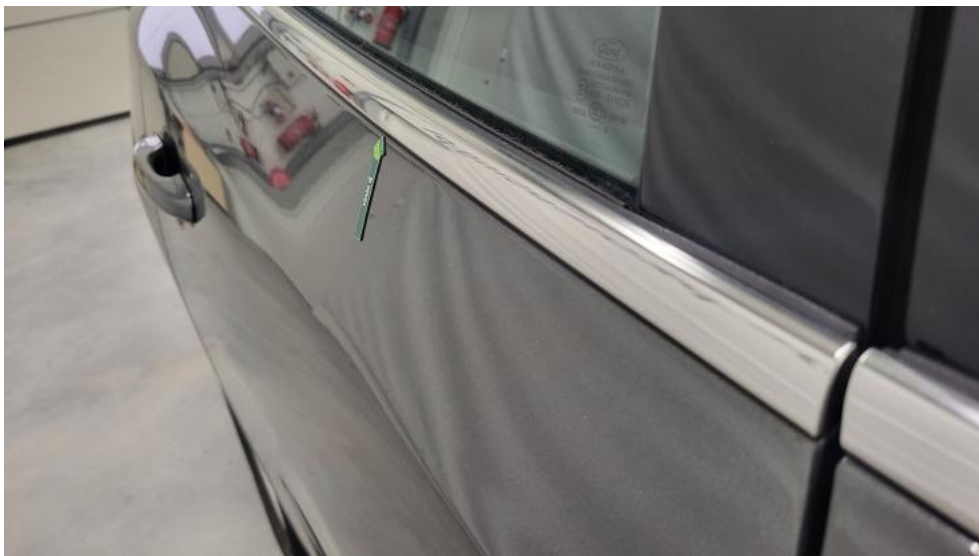
Photo 45.
Listwa drzwi tylnych P - Wgniecenie/odkształcenie 1

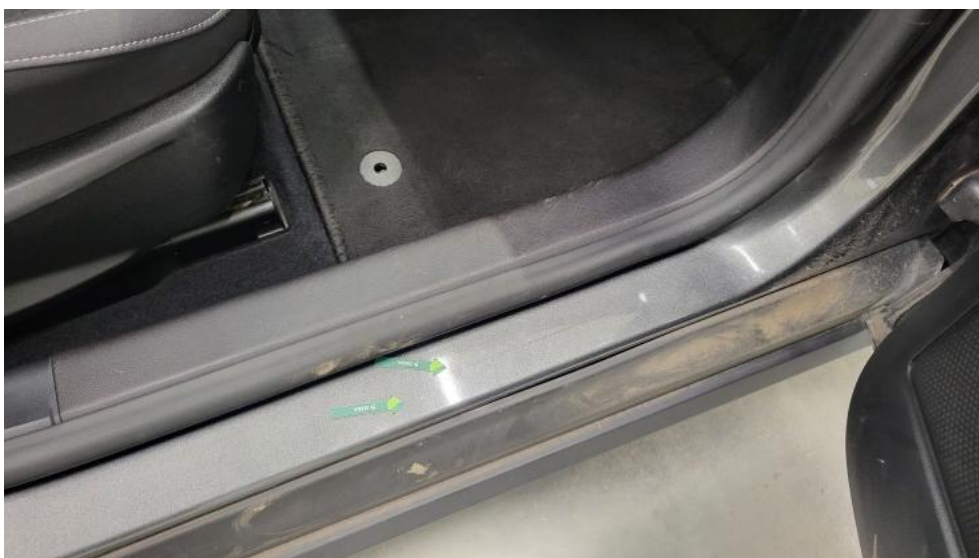
Photo 46.
Próg P - Wgniecenie/odkształcenie 1

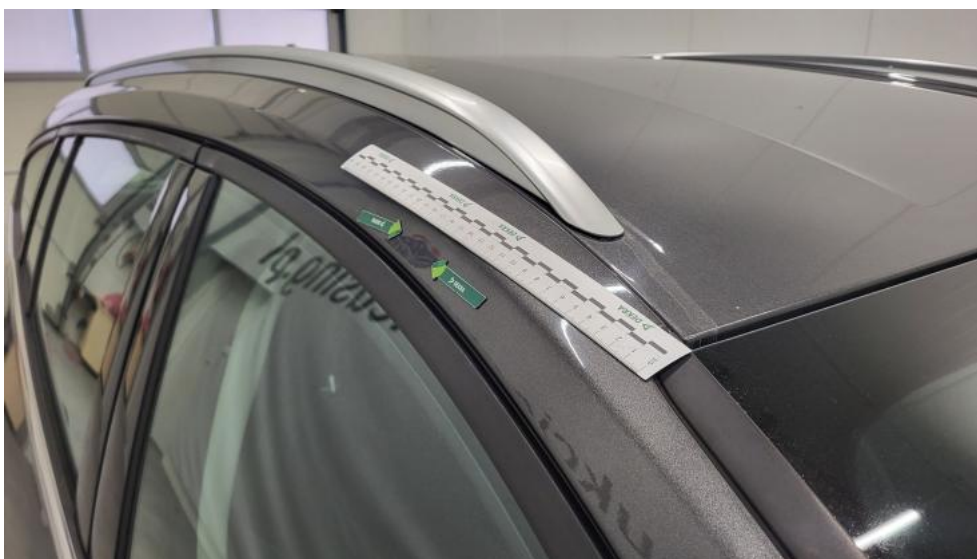
Photo 47.
Stupek przedni P - Wgniecenie/odkształcenie 1

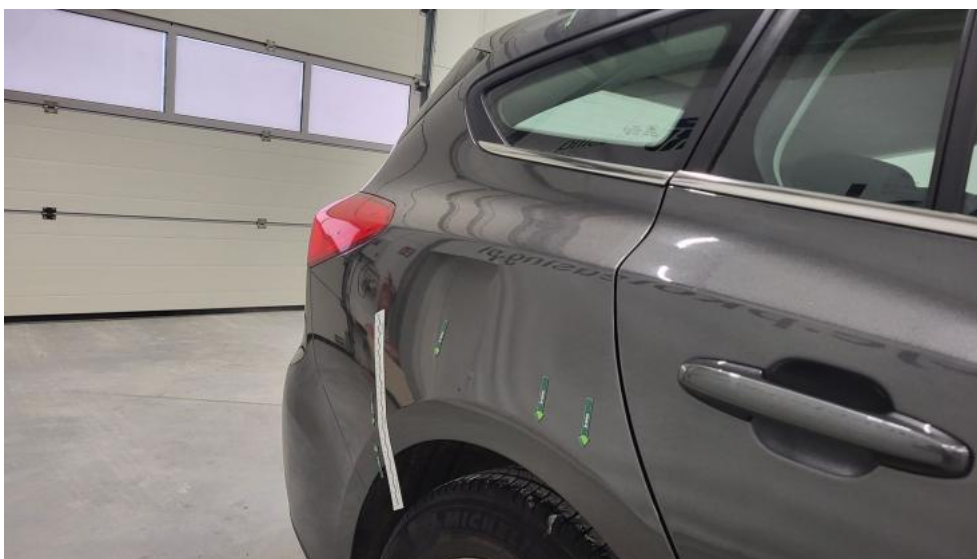
Photo 49.
Błotnik tylny P / Ściana boczna P - Wgniecenie/odkształcenie 1

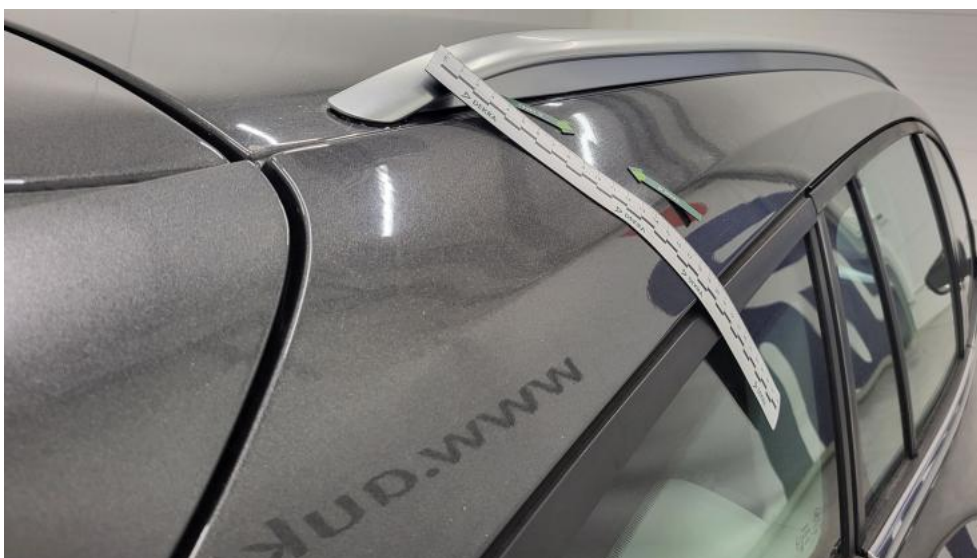
Photo 50.
Błotnik tylny P / Ściana boczna P - Wgniecenie/odkształcenie 2

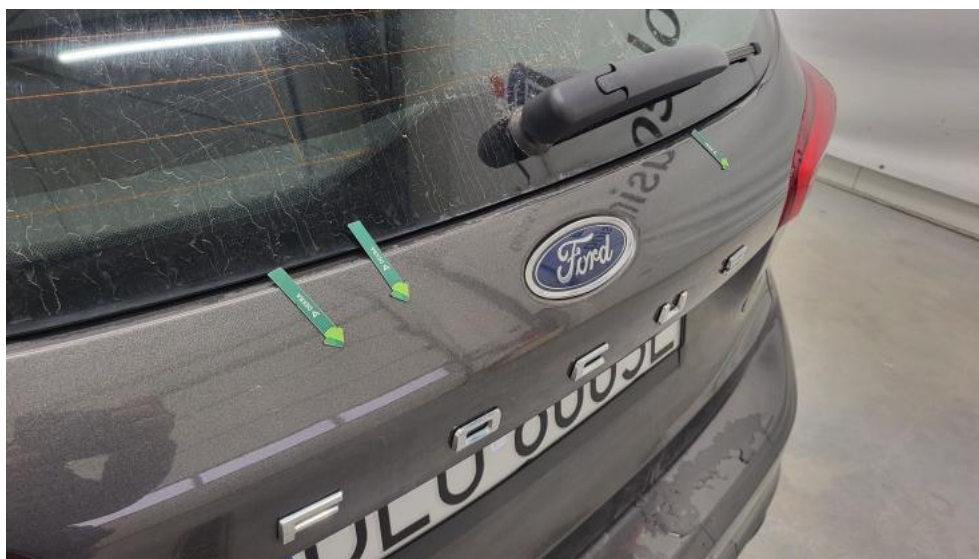
Photo 51.
Pokrywy bagażnika - Wgniecenie/odkształcenie 1

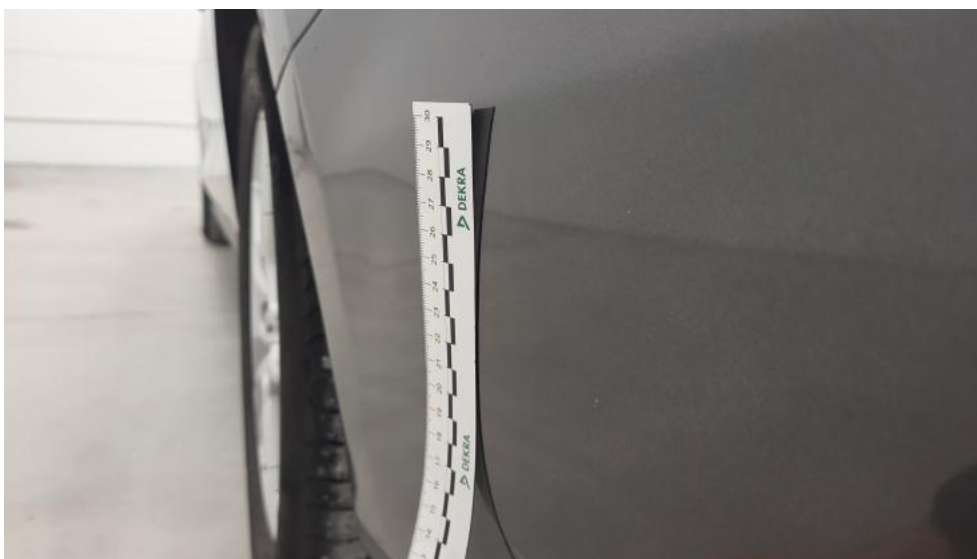
Photo 53.
Zderzak tylny - Wgniecenie/odkształcenie 1

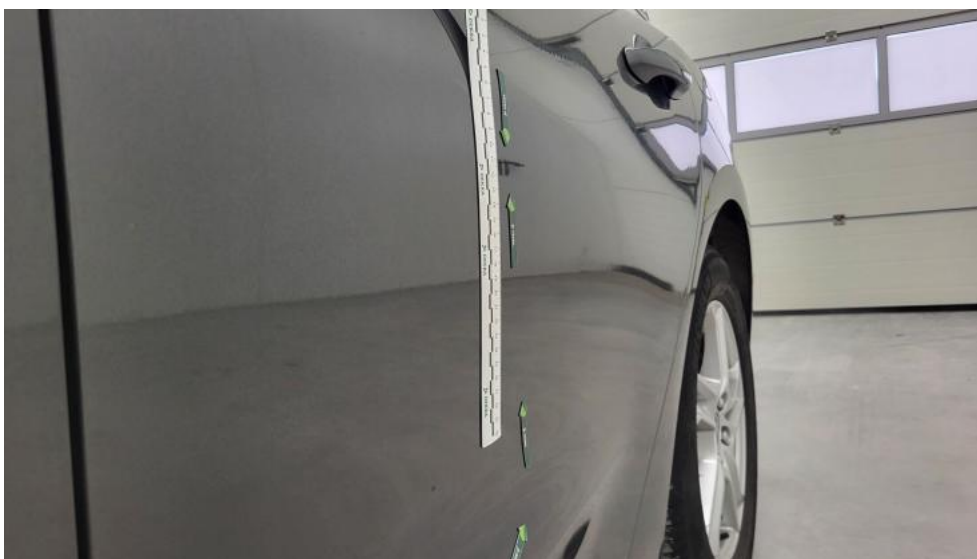
Photo 55.
Drzwi tylne L - Wgniecenie/odkształcenie 1

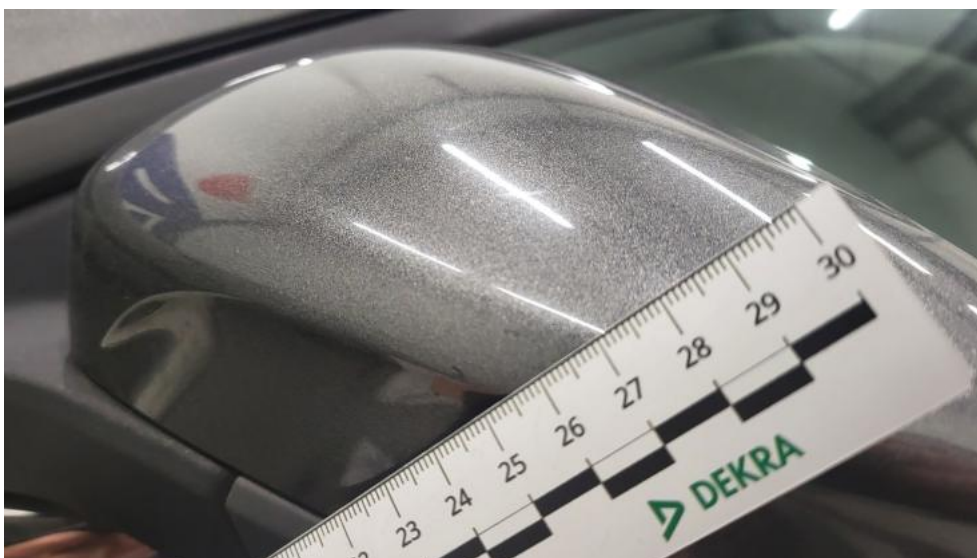
Photo 56.
Lusterko zew L - Rysa/odprysk 1

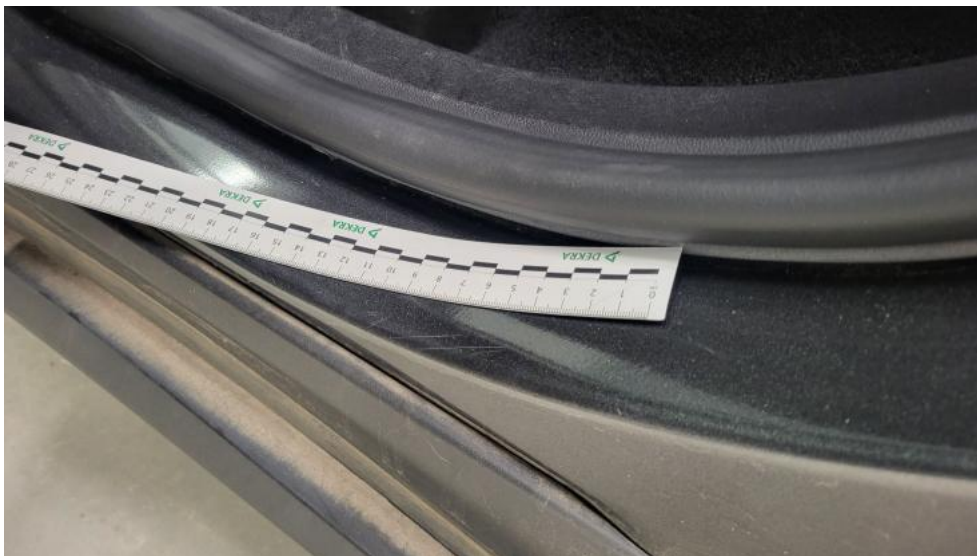
Photo 57.
Próg L - Rysa/odprysk 1

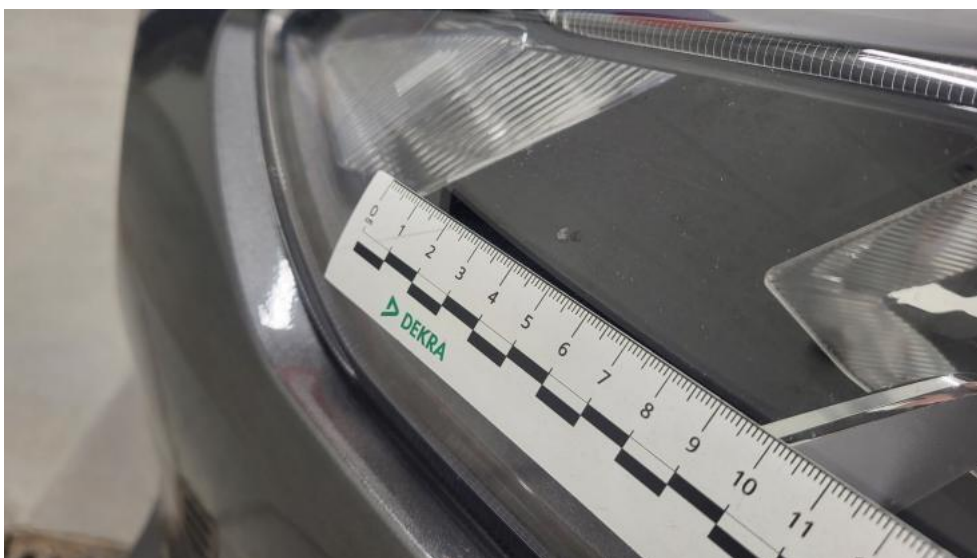
Photo 58.
Reflektor L - Rysa/odprysk 1

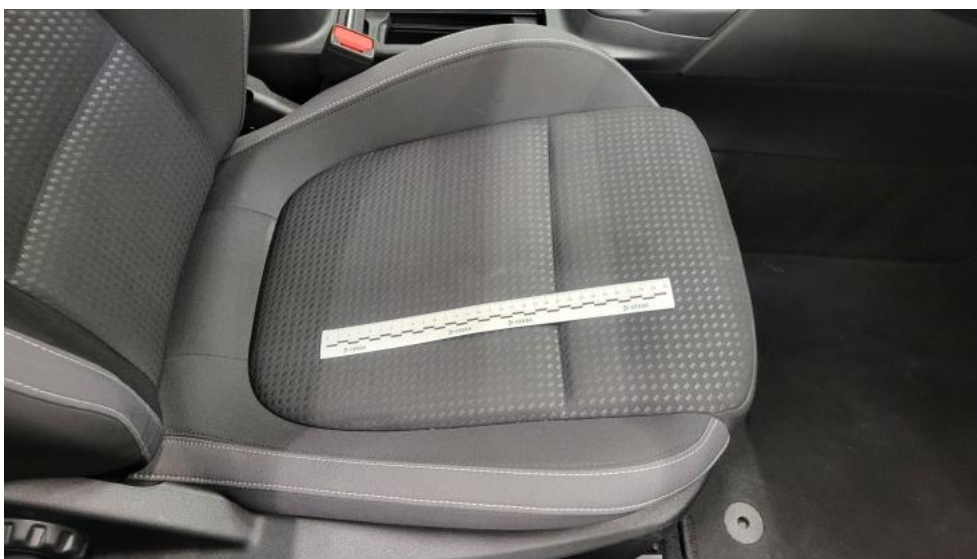
Photo 61.
Fotel prz. praw. - Inne 1

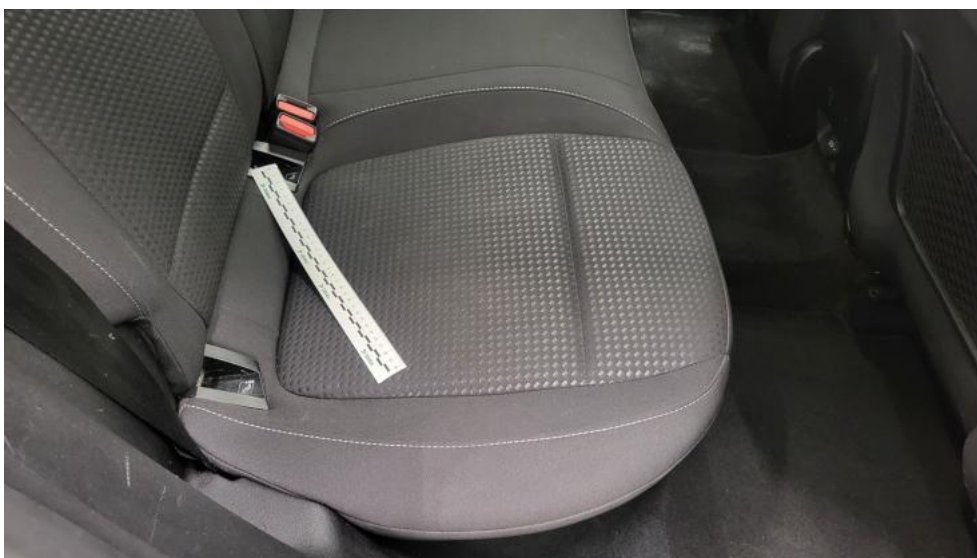
Rysy na samochodzie. Brak zaślepek w tylnej kanapie. Widoczne wady lakiernicze.

Photo 62.
Kanapa tyl. - Inne 1

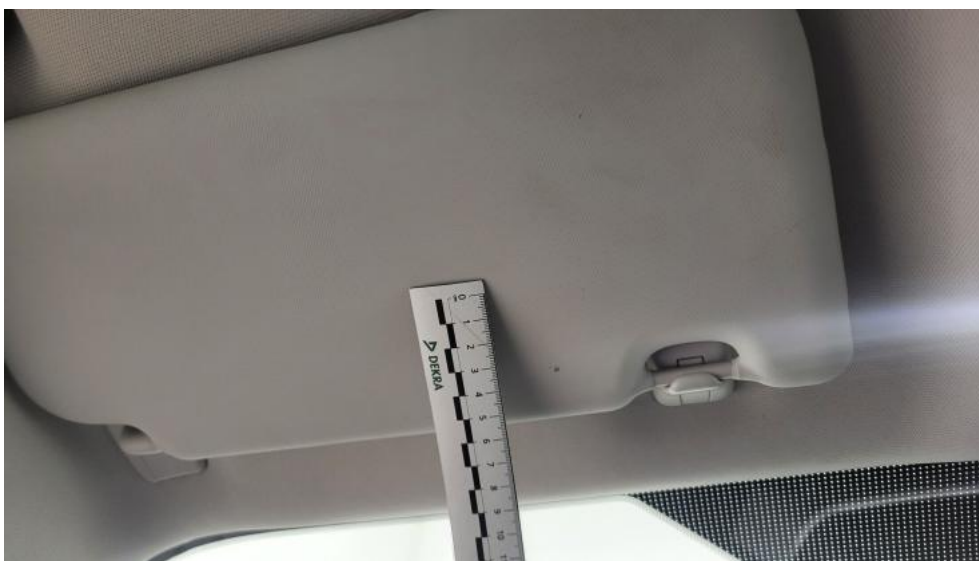
Photo 63.
Osłona p/słoneczna lewa - Inne 1

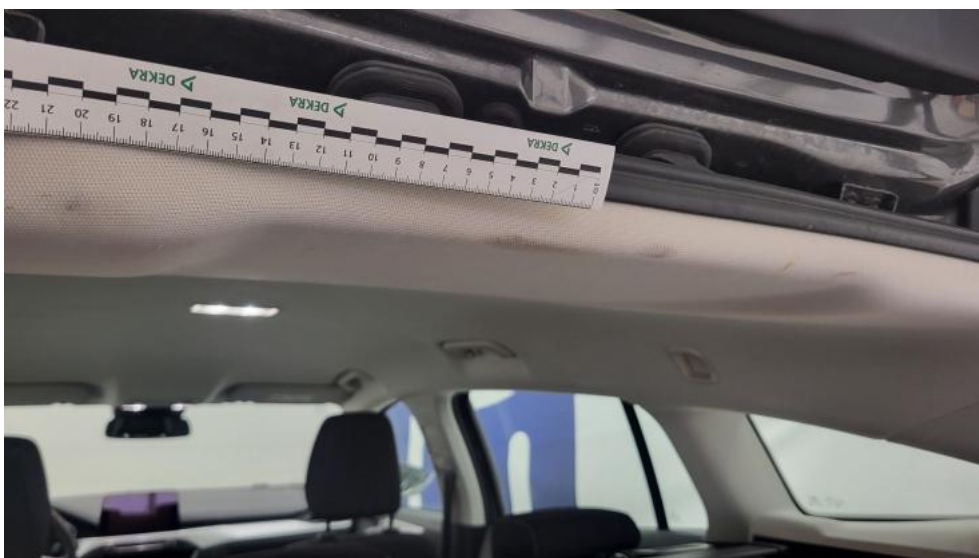
Photo 64.
Podsufitka - Inne 1

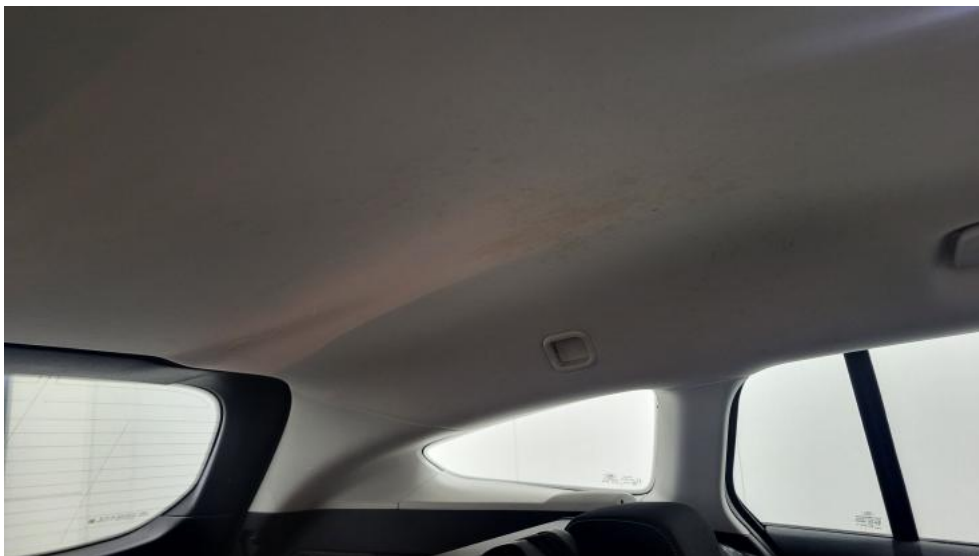
Photo 65.
Podsufitka - Inne 2

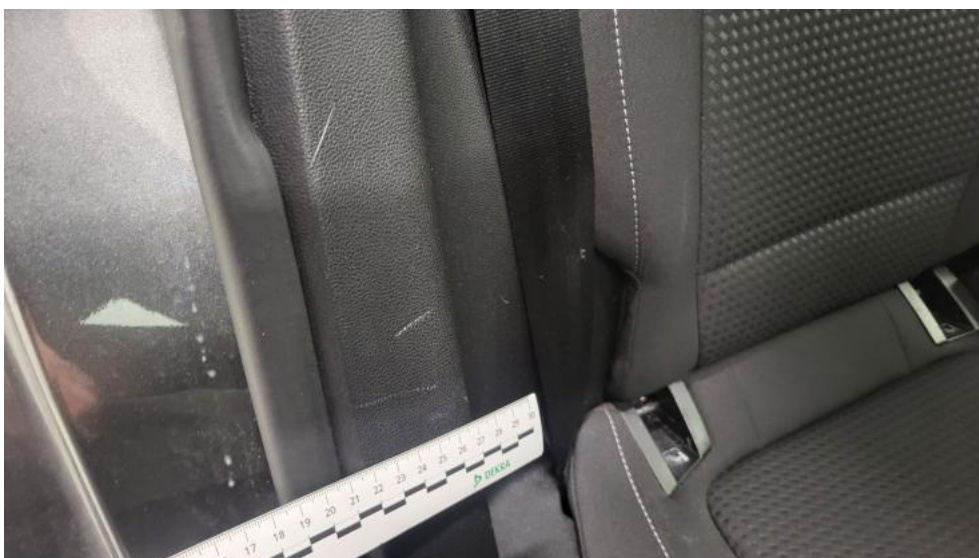
Photo 66.
Wykładzina(y) słupka tylnego P - Rysa/odprysk 1

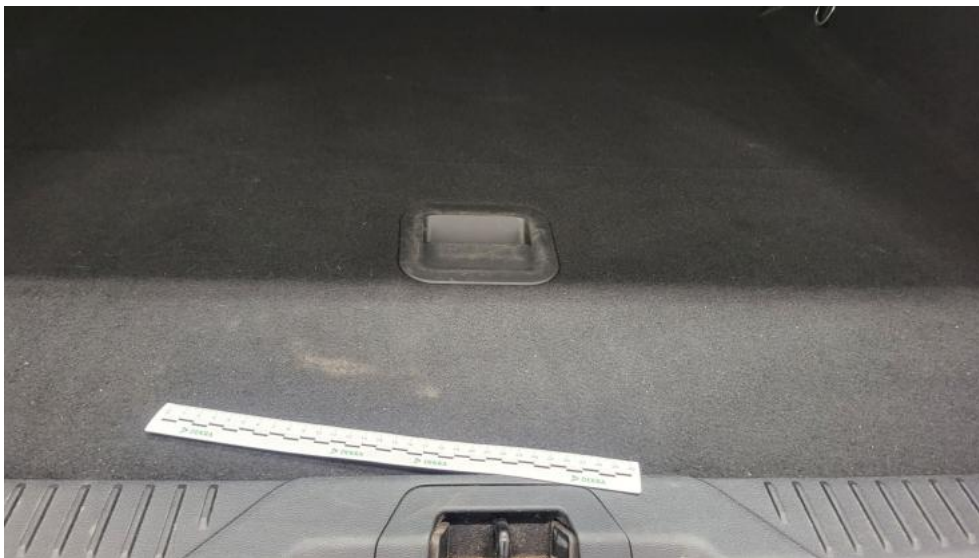
Photo 67.

Wykładzina podłogi bagażnika - Inne 1
