DEKRA's commission No. : PKOL(W)/LODZ/02715/26/01/13  
commission/ damage No. : 23/046091  
Date of commission: 13-01-2026

**DEKRA Poland - Headquarters**  
02-673 Warszawa, ul. Konstruktorska 12A

| Model | Corolla TS Kombi 18-22 |
| Type / version | Corolla 1.8 Hybrid GPF Comfort |

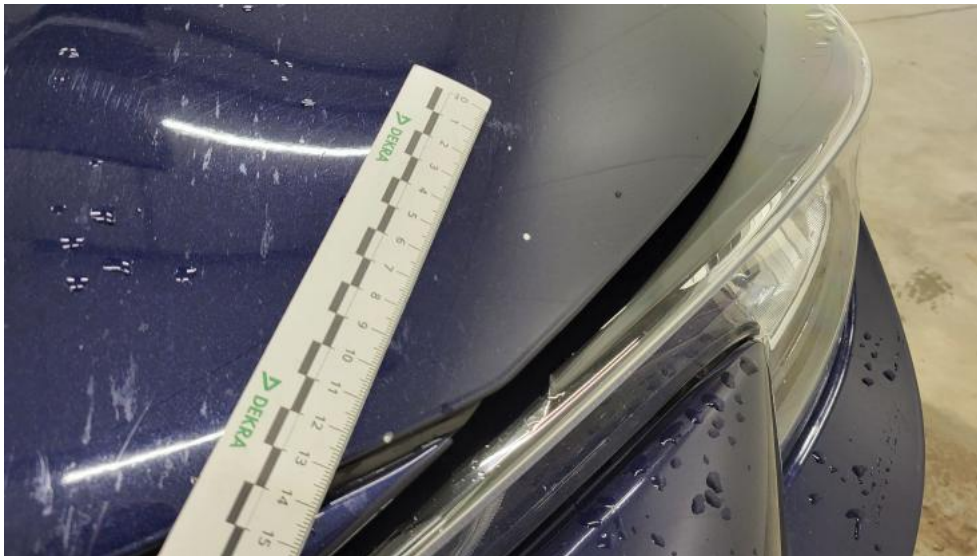
**Photo 39.**

Rysy na samochodzie. Odpryski na szybie czołowej.

Pokrywa komory silnika - Rysa/odprysk 1

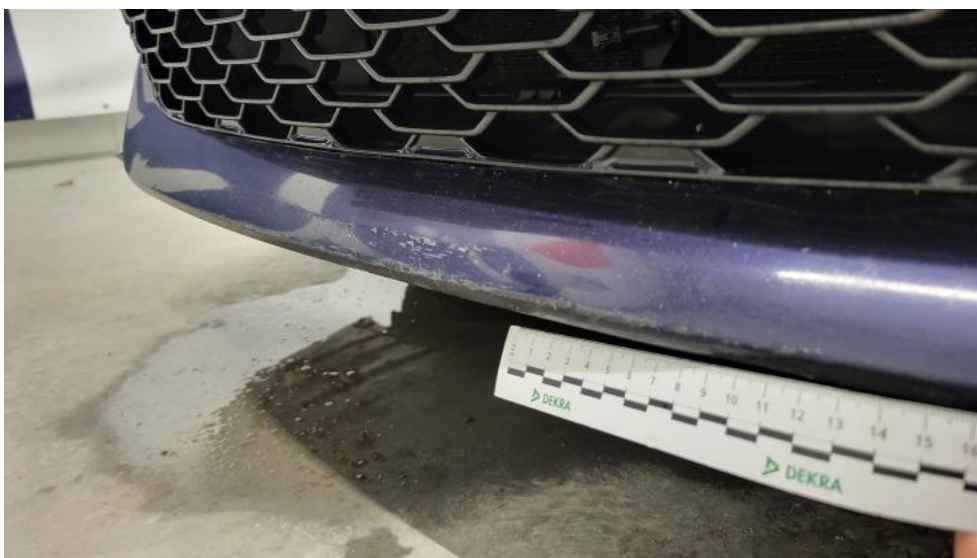
**Photo 40.**

Spoiler zderzaka przedniego - Rysa/odprysk 1

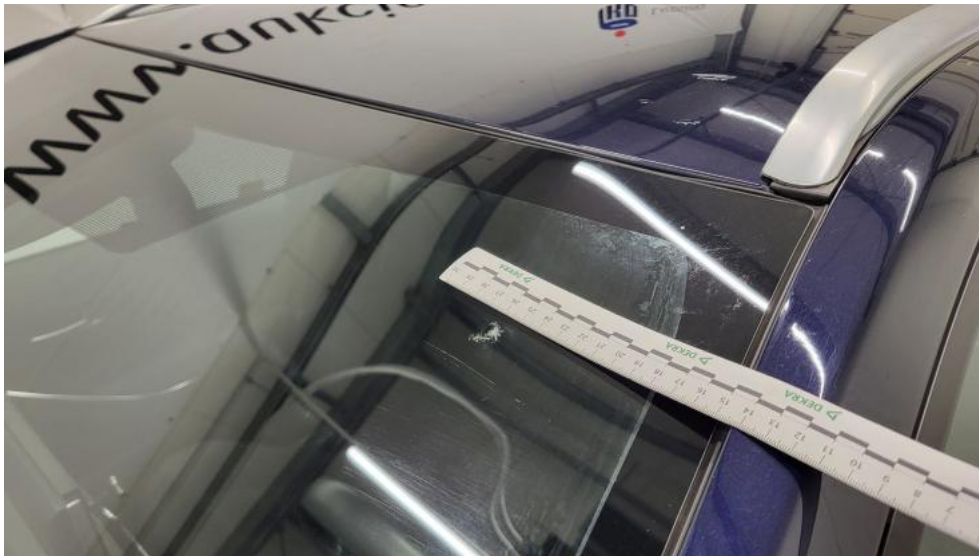
**Photo 41.**

Szyba czołowa - zdjęcie poglądowe 1

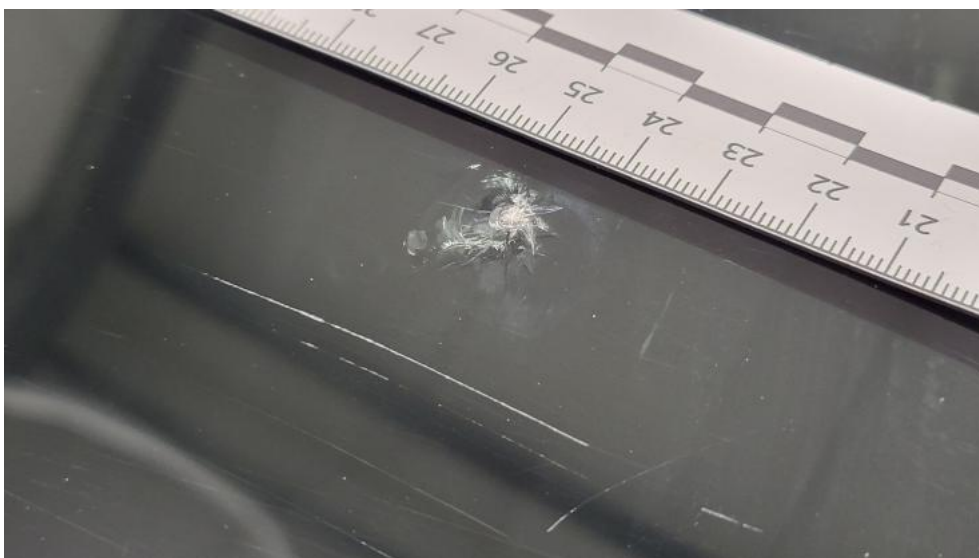
**Photo 42.**

Szyba czołowa - Pęknięcie/rozerwanie 1

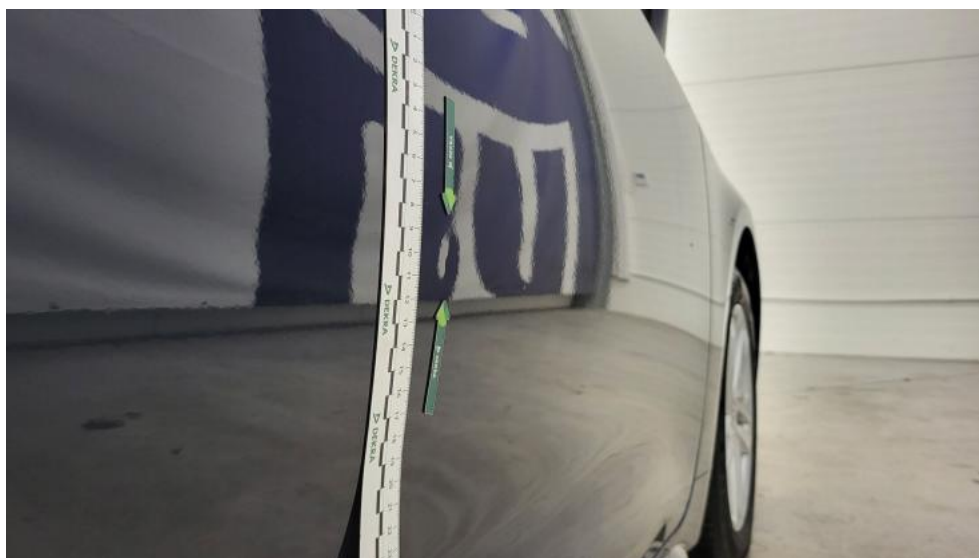
**Photo 46.**

Drzwi przednie P - Wgniecenie/odkształcenie 1

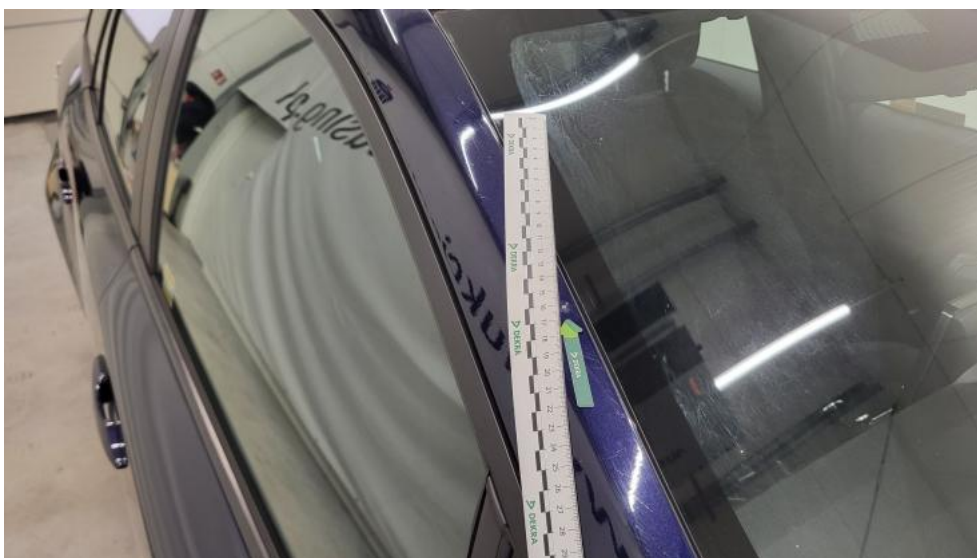
**Photo 48.**

Słupek przedni P - zdjęcie poglądowe 1

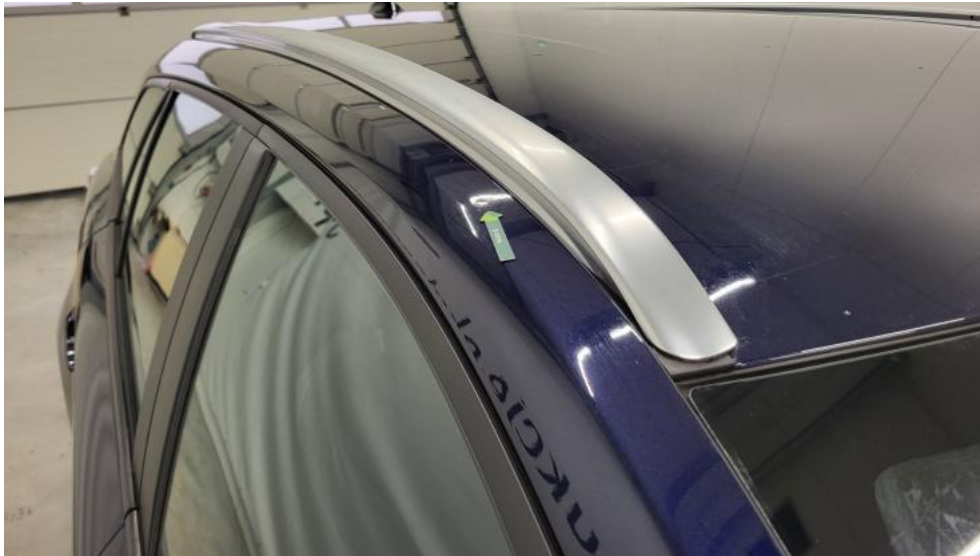
**Photo 49.**

Słupek przedni P - Wgniecenie/odkształcenie 1

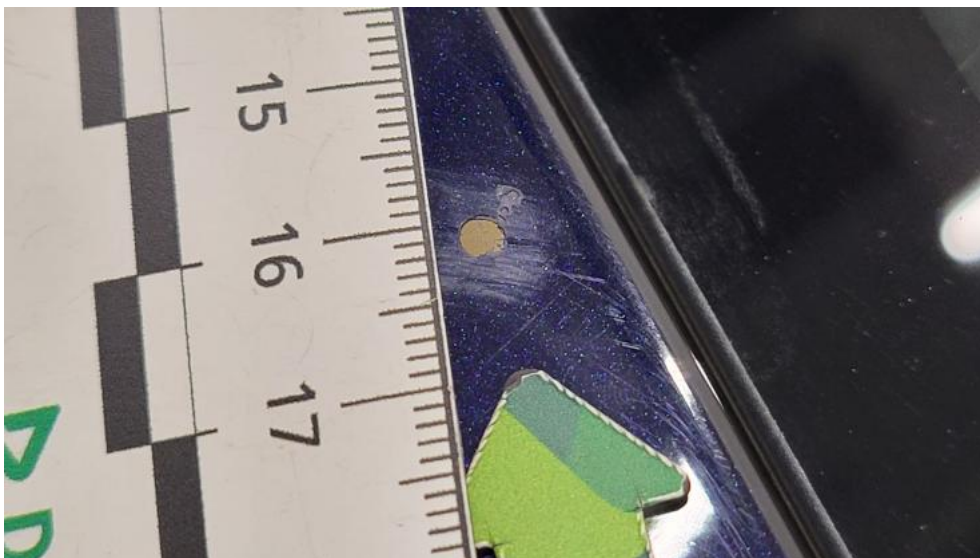
**Photo 50.**

Słupek przedni P - Inne 1

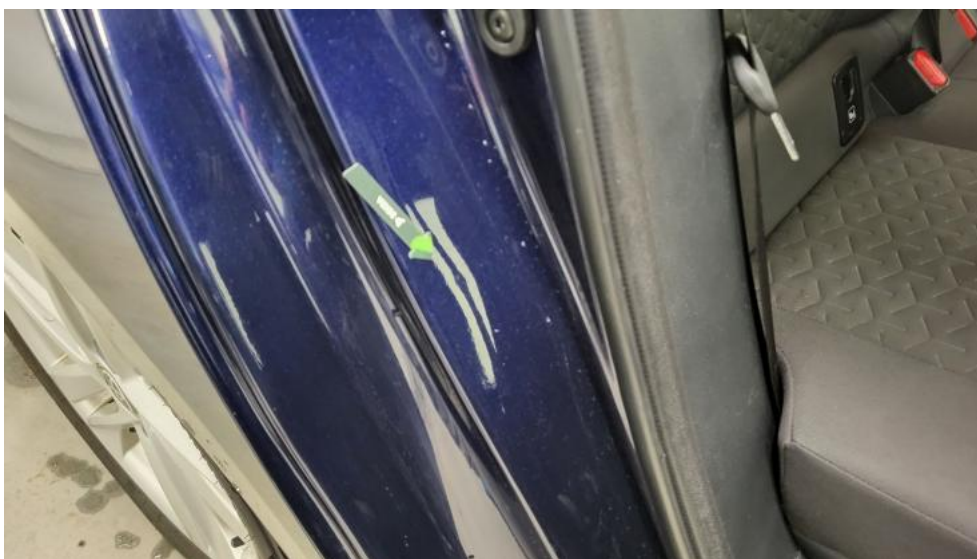
**Photo 51.**

Błotnik tylny P / Ściana boczna P - Wgniecenie/odkształcenie 1

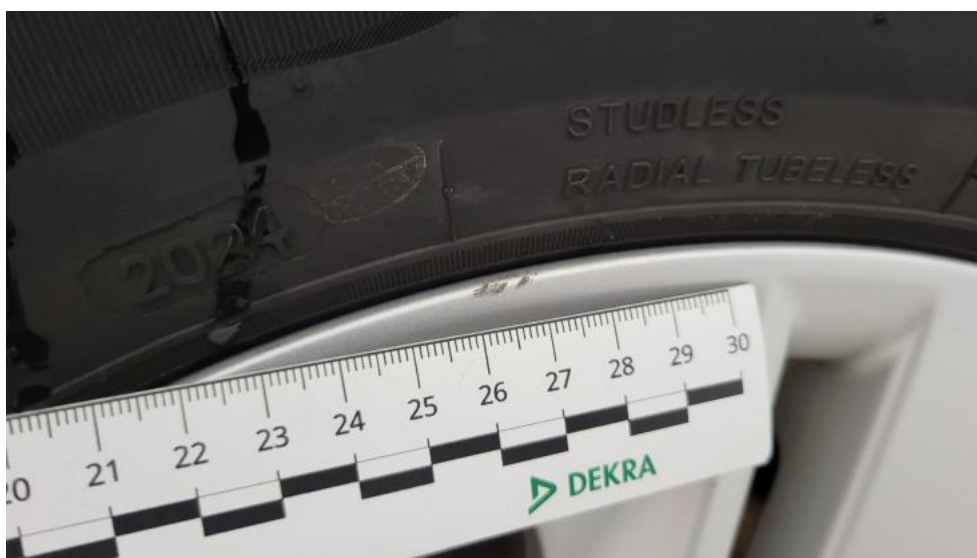
**Photo 52.**

Felga aluminiowa tylna P - Rysa/odprysk 1

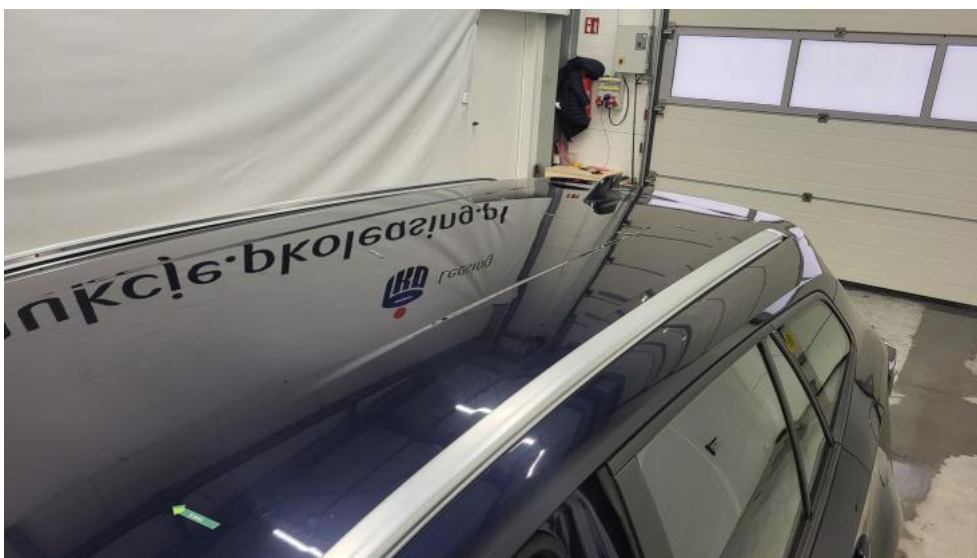
**Photo 56.**

Dach - zdjęcie poglądowe 1

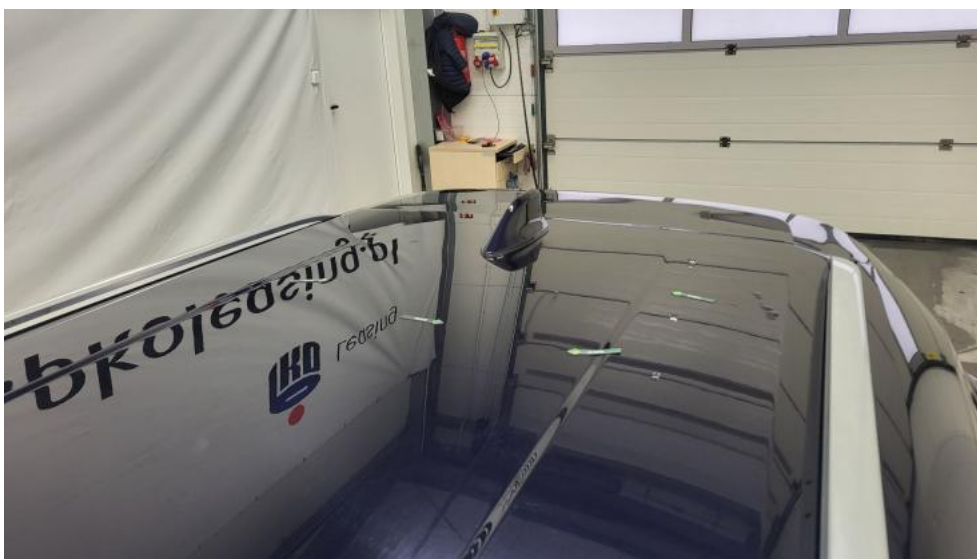
**Photo 57.**

Dach - Wgniecenie/odkształcenie 1

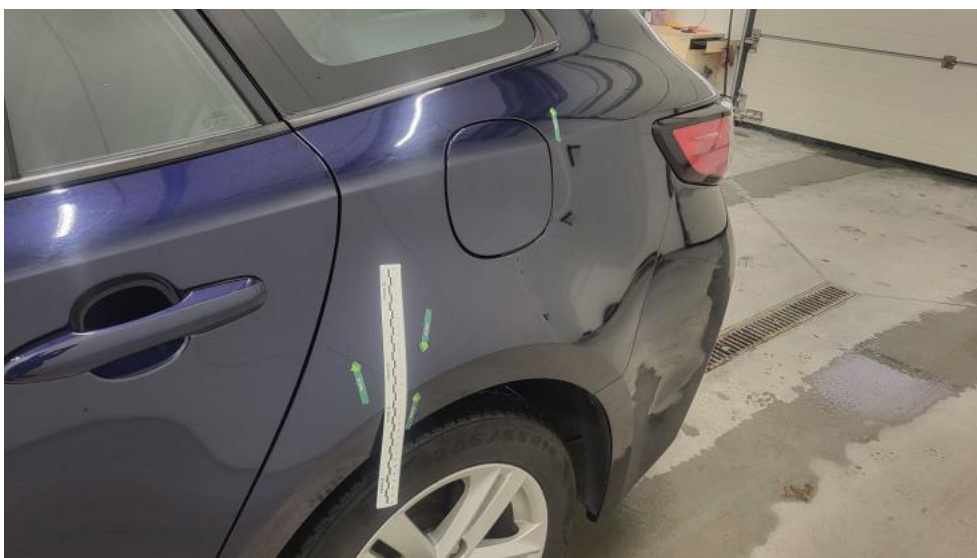
**Photo 58.**

Łotnik tylny L / Ściana boczna L - zdjęcie poglądowe 1

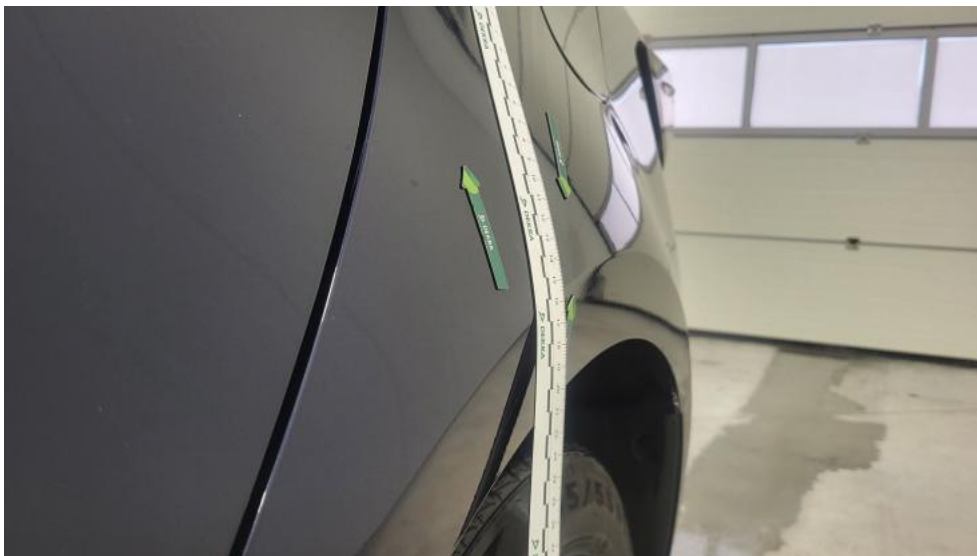
**Photo 59.**

Błotnik tylny L / Ściana boczna L - Wgniecenie/odkształcenie 1

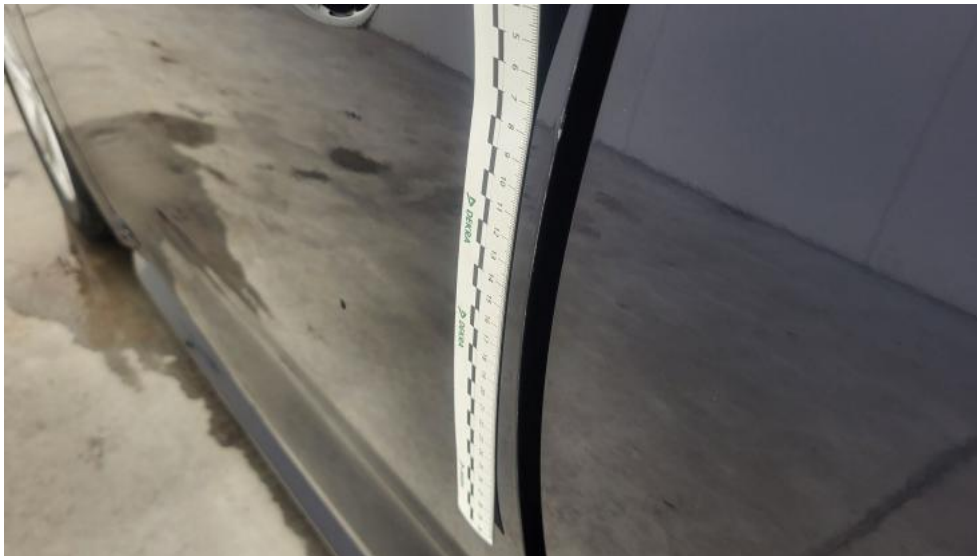
**Photo 61.**

Drzwi przed L - Rysa/odprysk 1

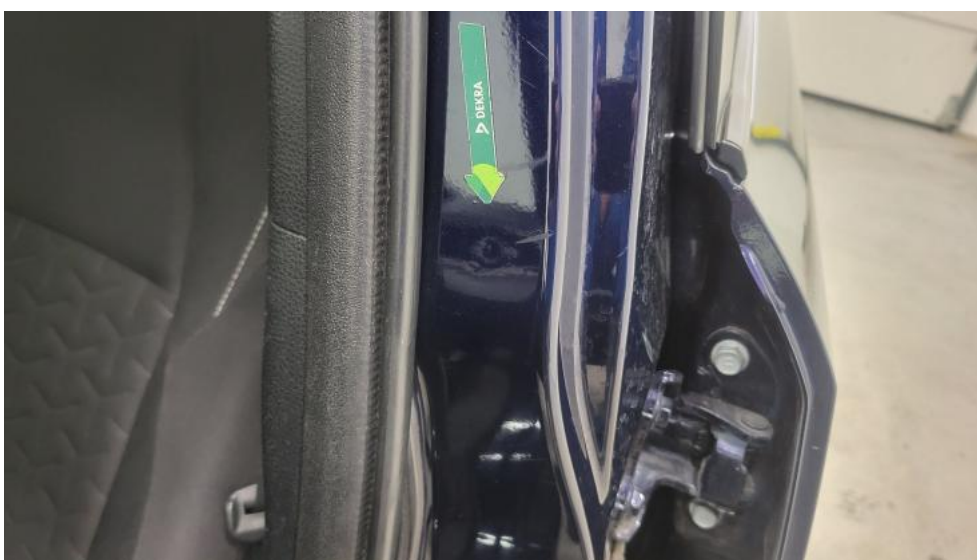
**Photo 64.**

Słupek środkowy L - Wgniecenie/odkształcenie 1

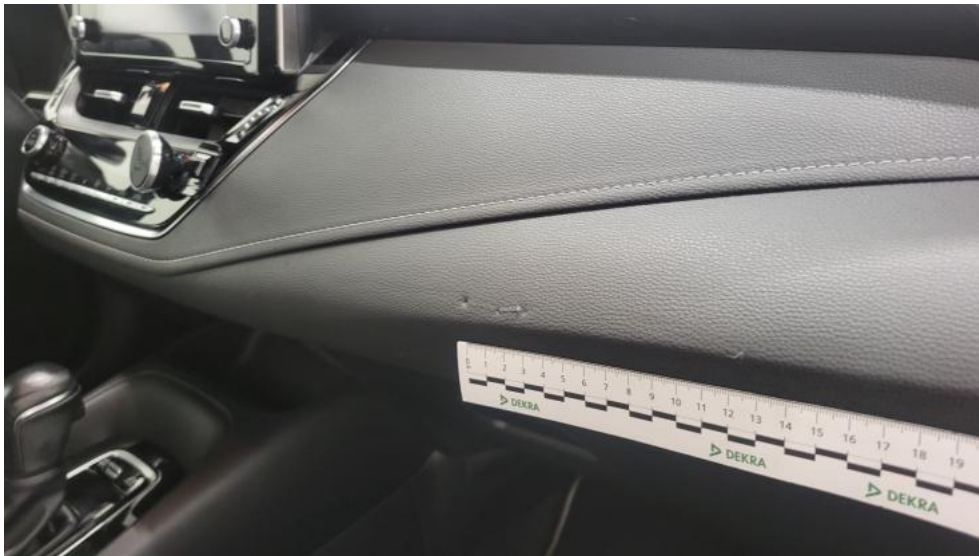
**Photo 65.**

Deska rozdzielcza - zdjęcie poglądowe 1

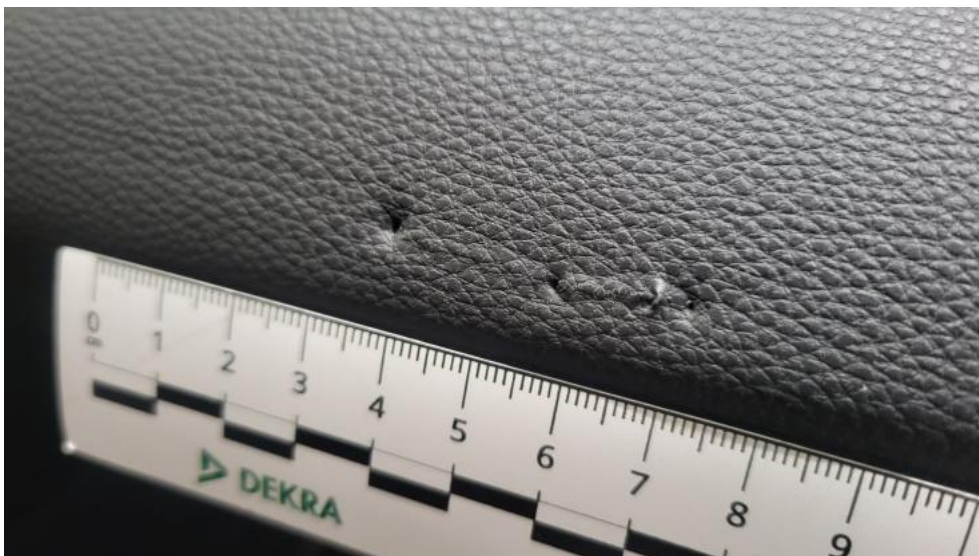
**Photo 66.**

Deska rozdzielcza - Pęknięcie/rozerwanie 1

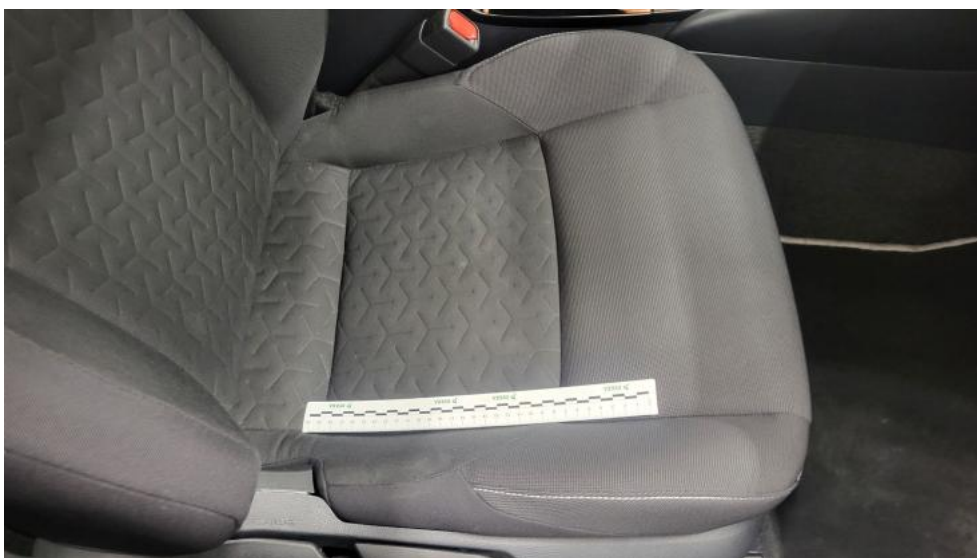
**Photo 68.**

Fotel prz. praw. - Inne 1
