DEKRA's commission No. : PKOL(W)/LODZ/70508/25/09/18  
commission/ damage No. :  
Date of commission: 18-09-2025

| Manufacturer | BMW |
| Model | Seria 5 [G30/F90] 16-20 |
| Registration /record No. | DW2CY27 |

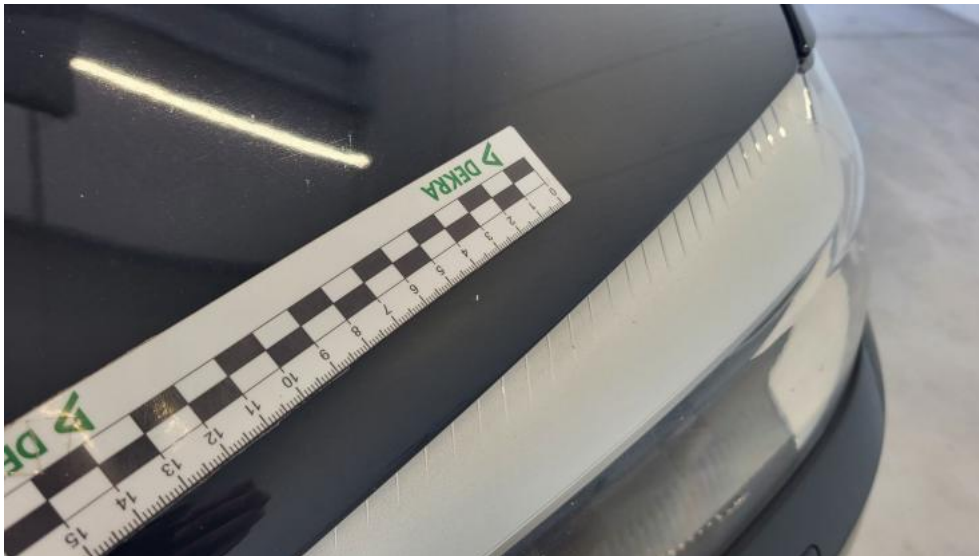
**Photo 39.**

Pokrywa komory silnika - Rysa/odprysk 1

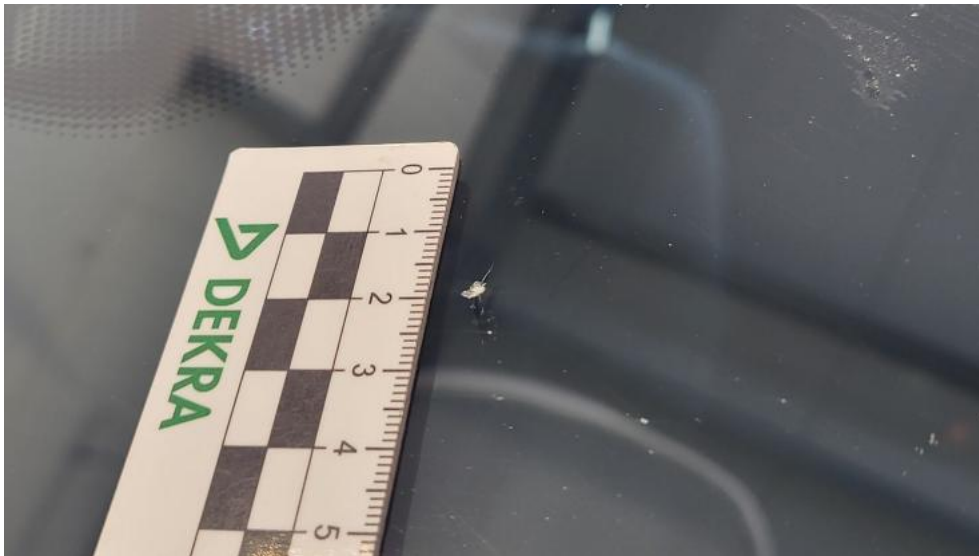
**Photo 41.**

Szyba czołowa - Pęknięcie/rozerwanie 1

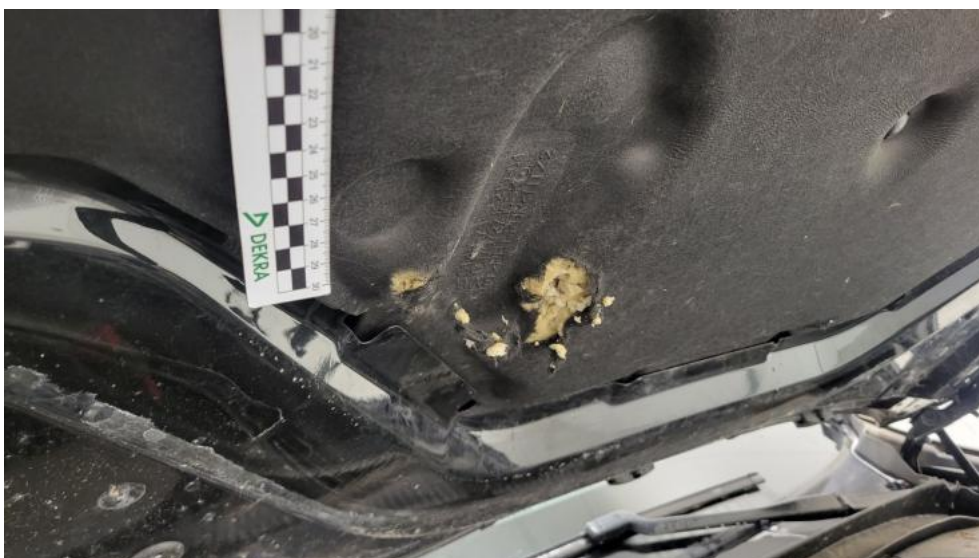
**Photo 42.**

Wykładzina pokrywy komory silnika - Pęknięcie/rozerwanie 1

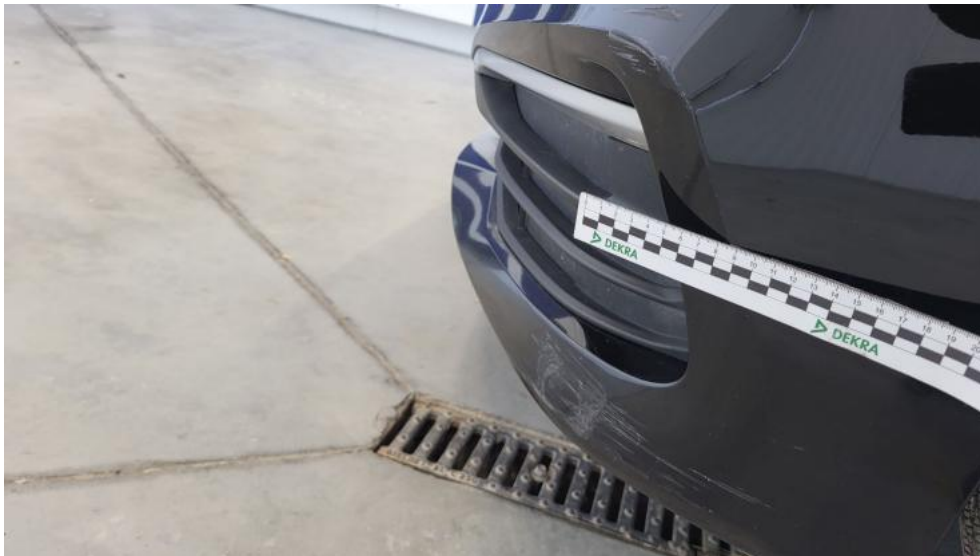
**Photo 43.**

Zderzak - Rysa/odprysk 1

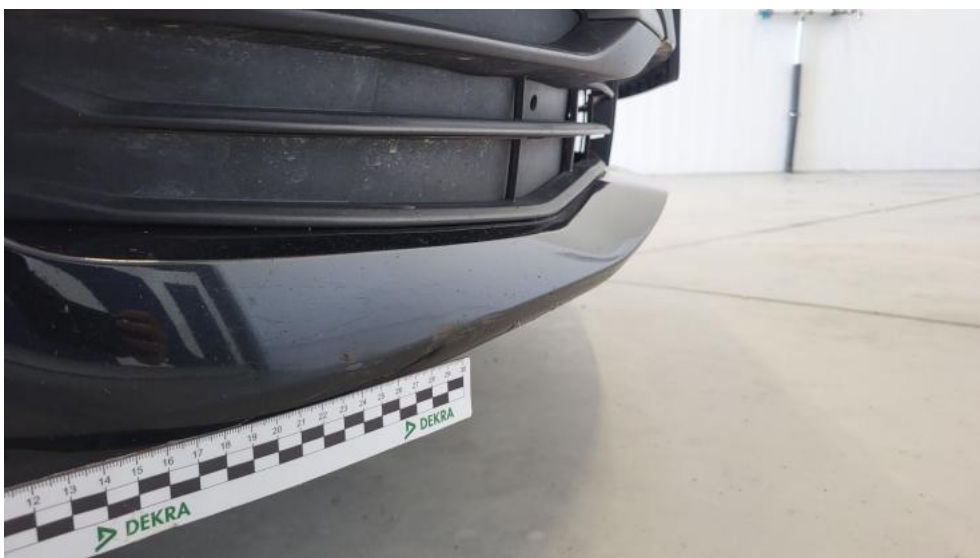
**Photo 44.**

Zderzak - Rysa/odprysk 2

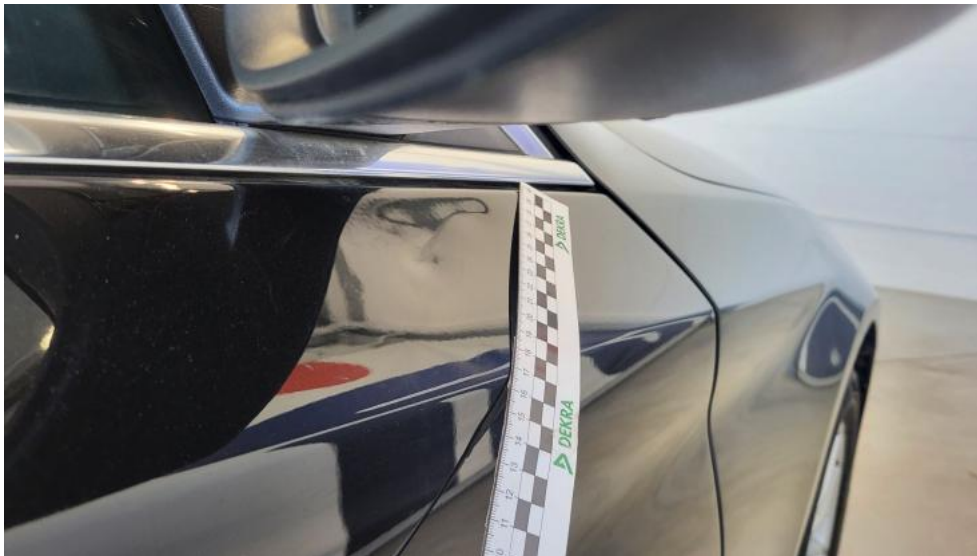
**Photo 45.**

Drzwi przednie P - Wgniecenie/odkształcenie 1

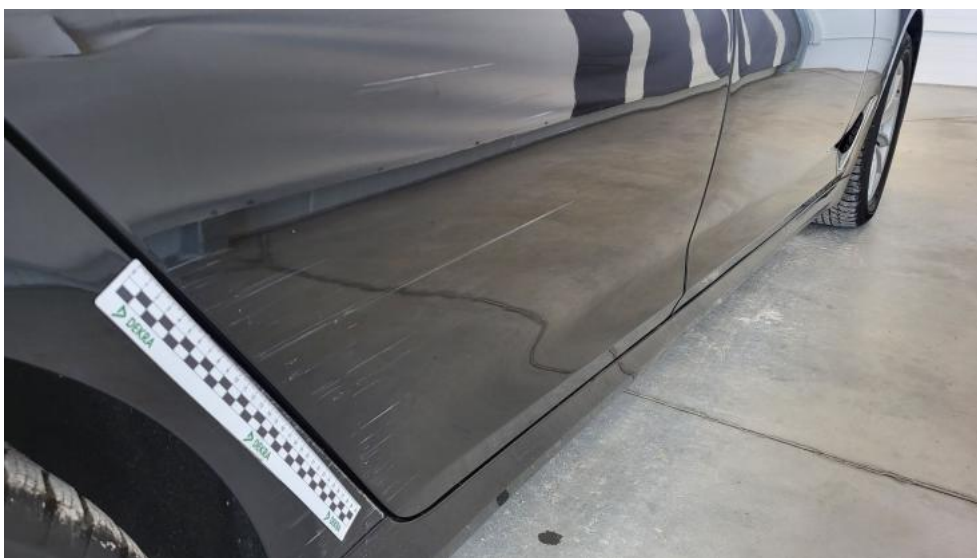
**Photo 46.**

Drzwi tylne P - Rysa/odprysk 1

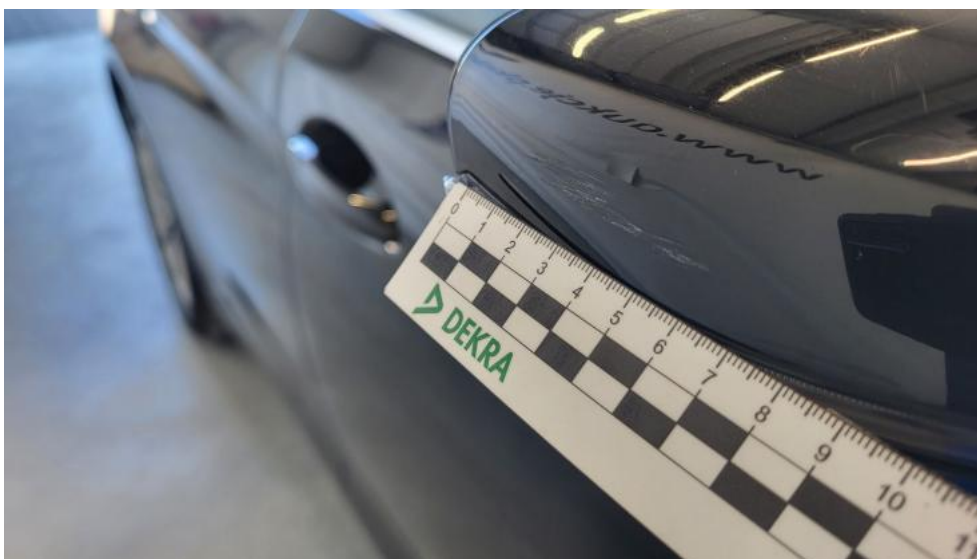
**Photo 47.**

Lusterko zew P - Rysa/odprysk 1

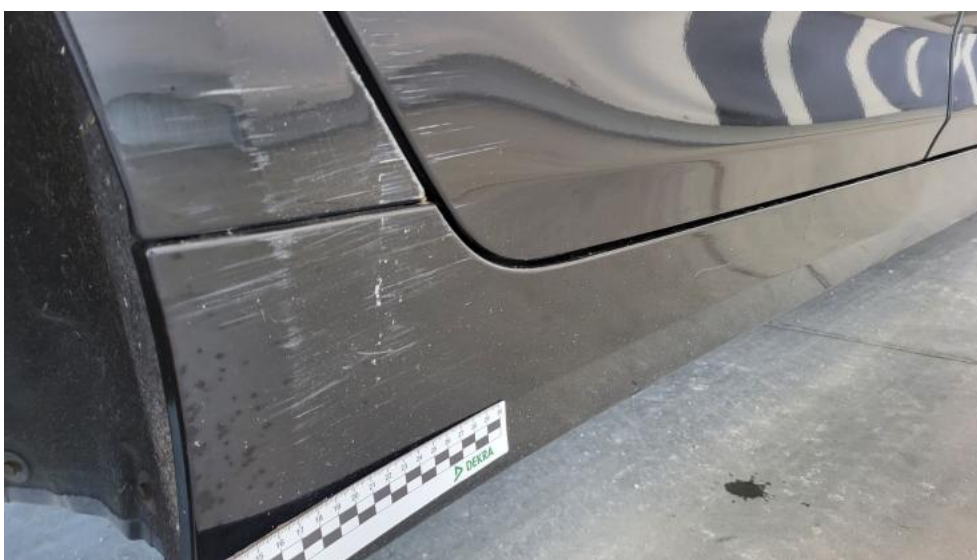
**Photo 48.**

Próg P - Rysa/odprysk 1

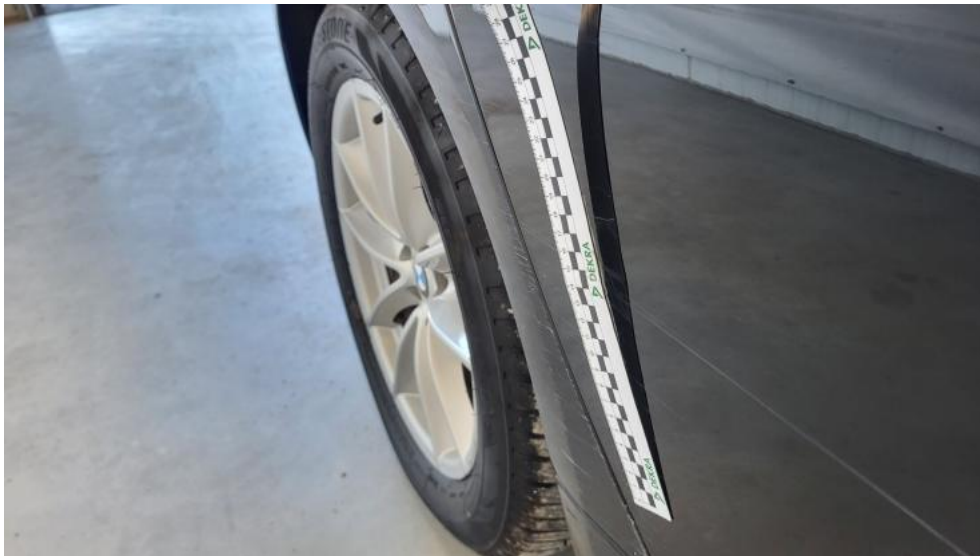
**Photo 49.**

Błotnik tylny P / Ściana boczna P - Rysa/odprysk 1

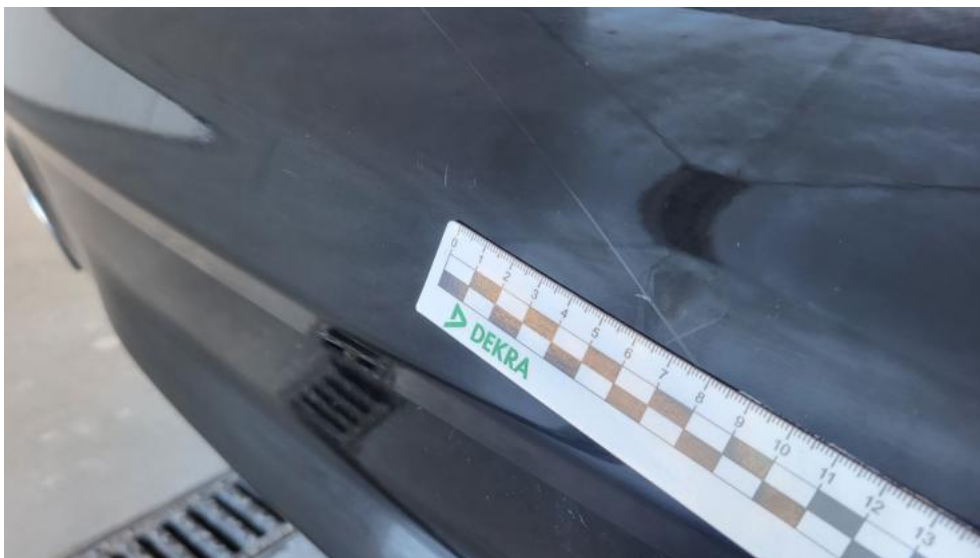
**Photo 50.**

Zderzak tylny - Rysa/odprysk 1

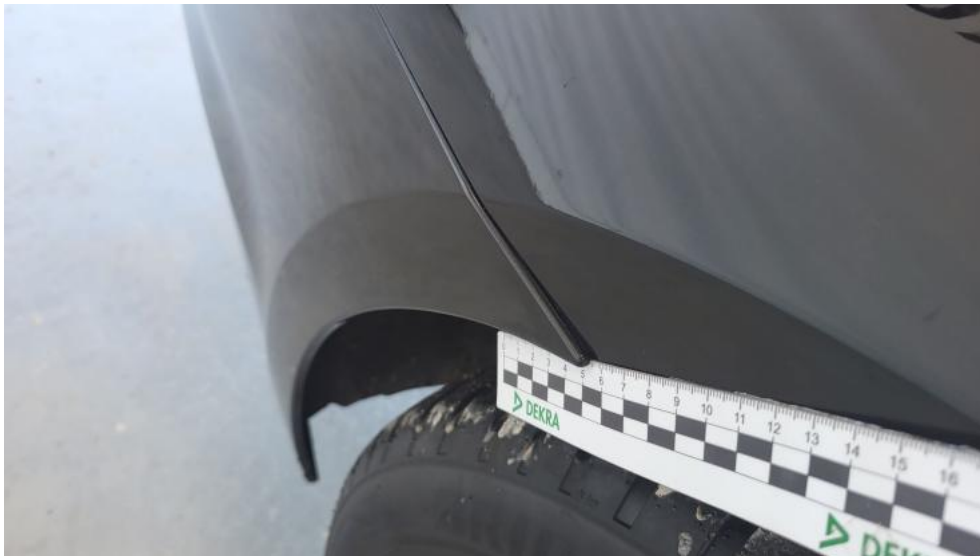
**Photo 51.**

Zderzak tylny - Inne 1

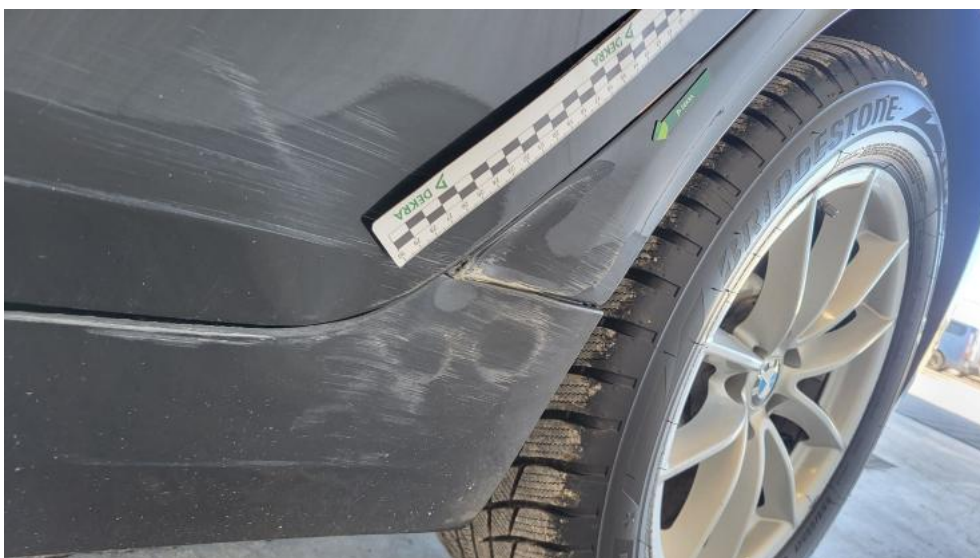
**Photo 52.**

Ścianka tylna L / Ścianka boczna L - Wgniecenie/odkształcenie 1

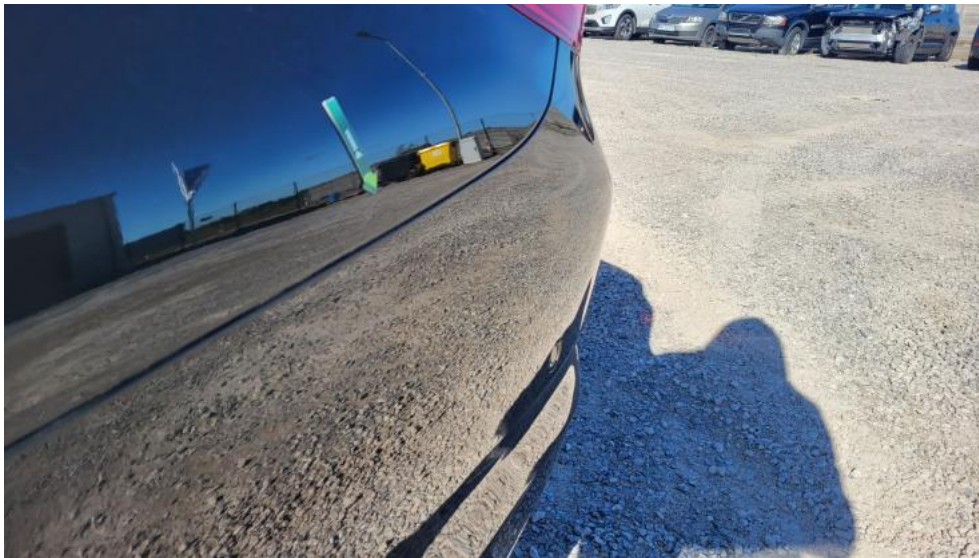
**Photo 53.**

Błotnik tylny L / Ściana boczna L - Wgniecenie/odkształcenie 2

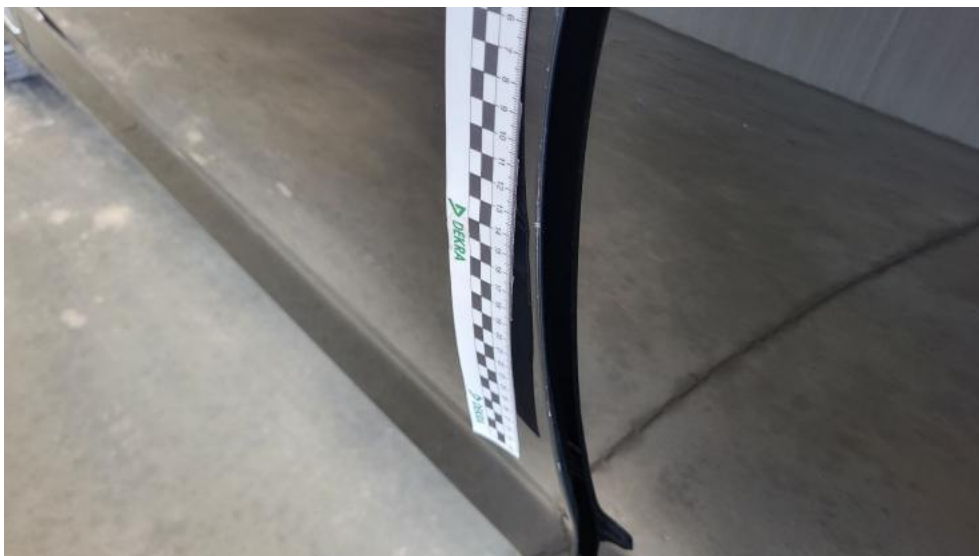
**Photo 54.**

Drzwi przed L - Rysa/odprysk 1

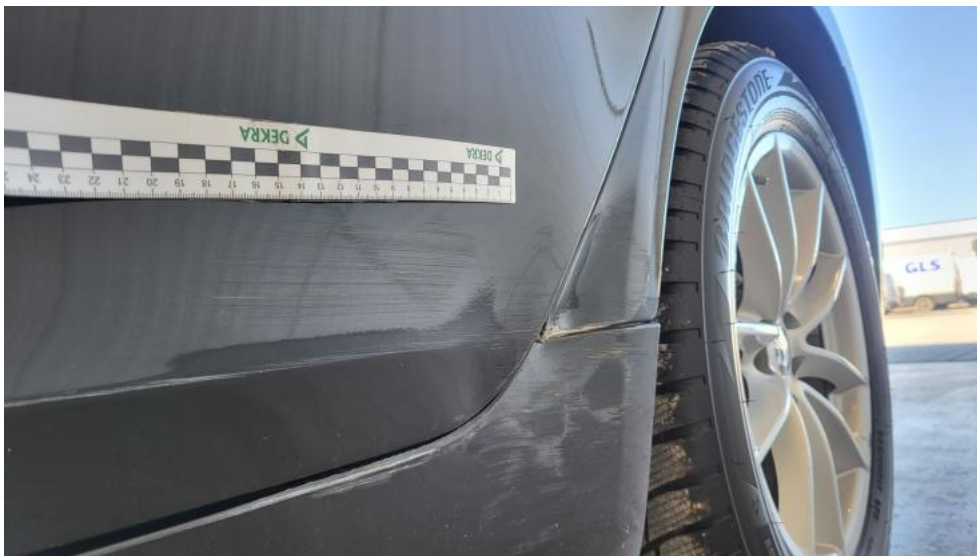
**Photo 55.**

Drzwi tylne L - Wgniecenie/odkształcenie 1

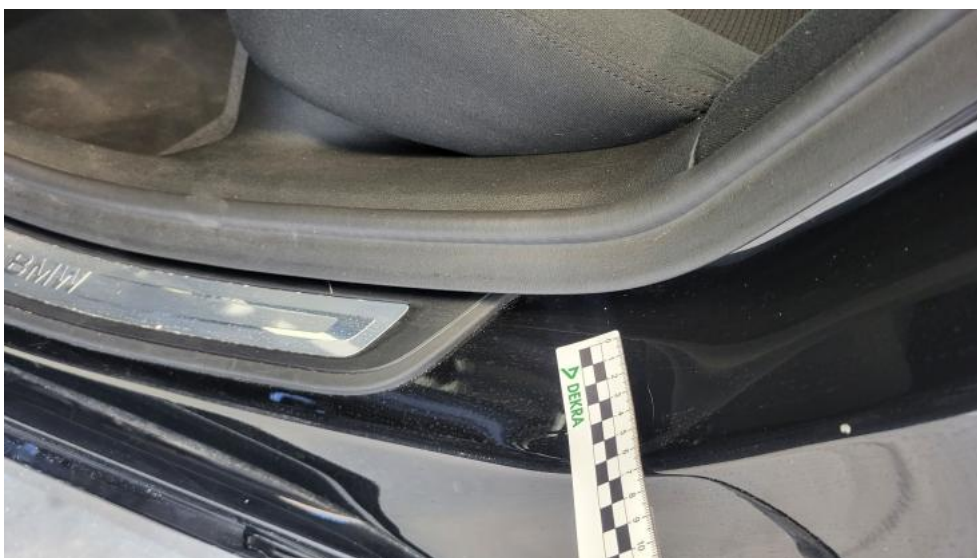
**Photo 56.**

Próg L - Rysa/odprysk 1

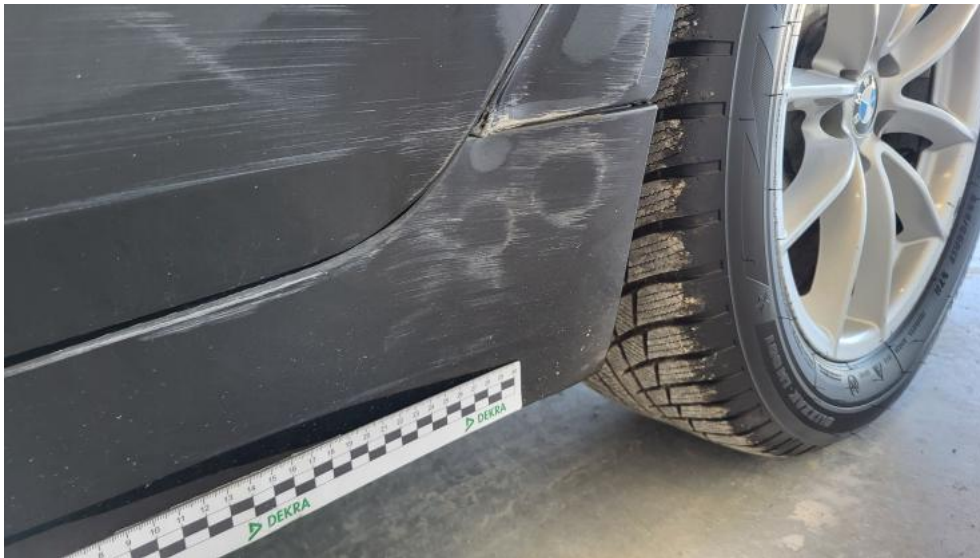
**Photo 57.**  
Próg L - Rysa/odprysk 2

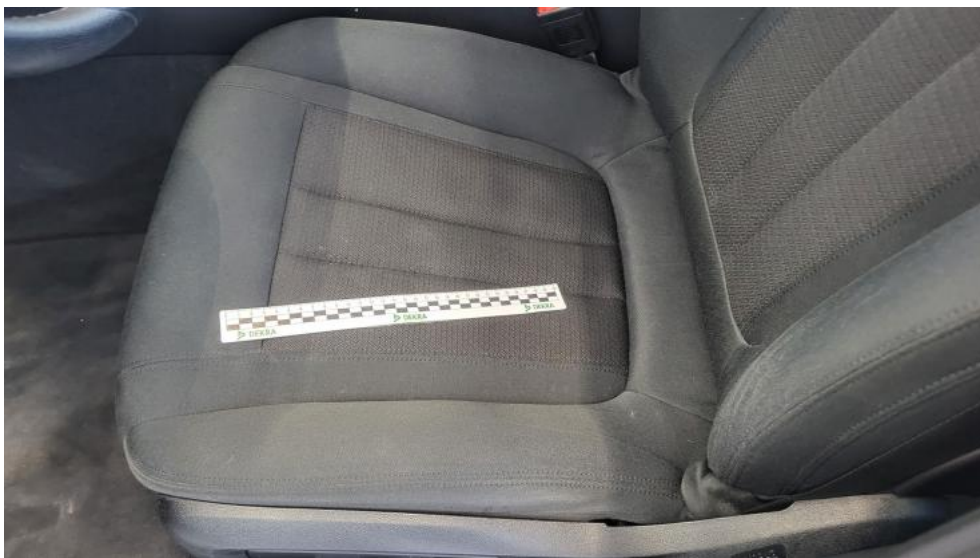
**Photo 58.**  
Fotel prz. lew. - Inne 1

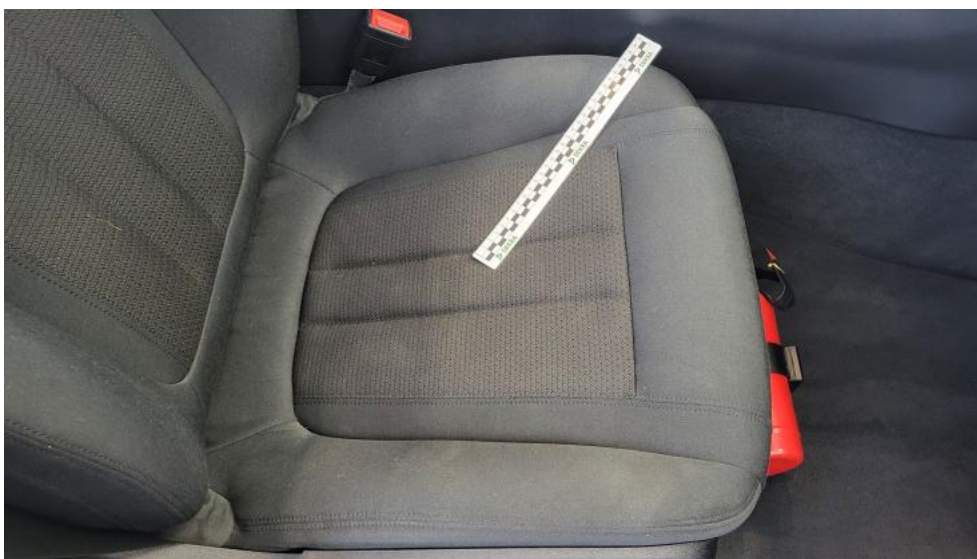
**Photo 59.**

Fotel prz. praw. - Inne 1

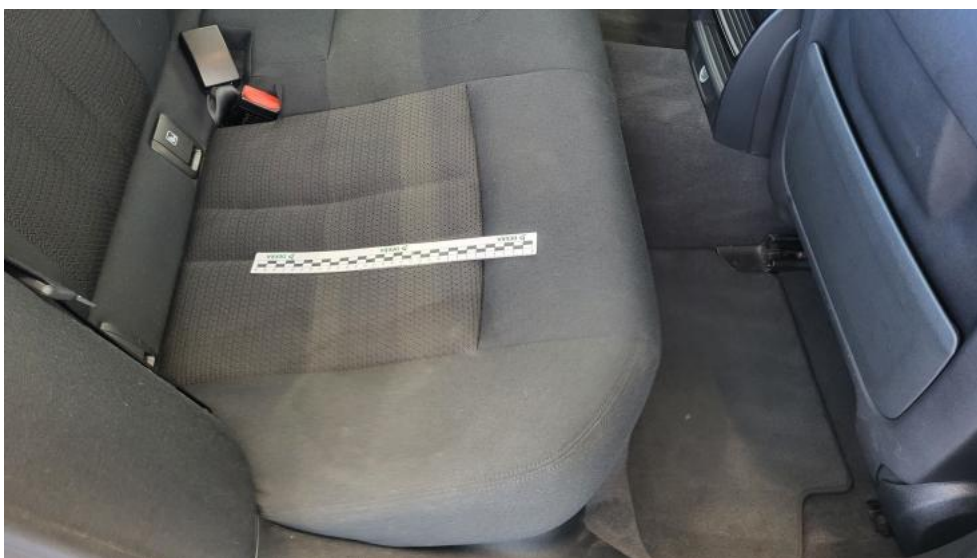
**Photo 60.**

Kanapa tyl. - Inne 1

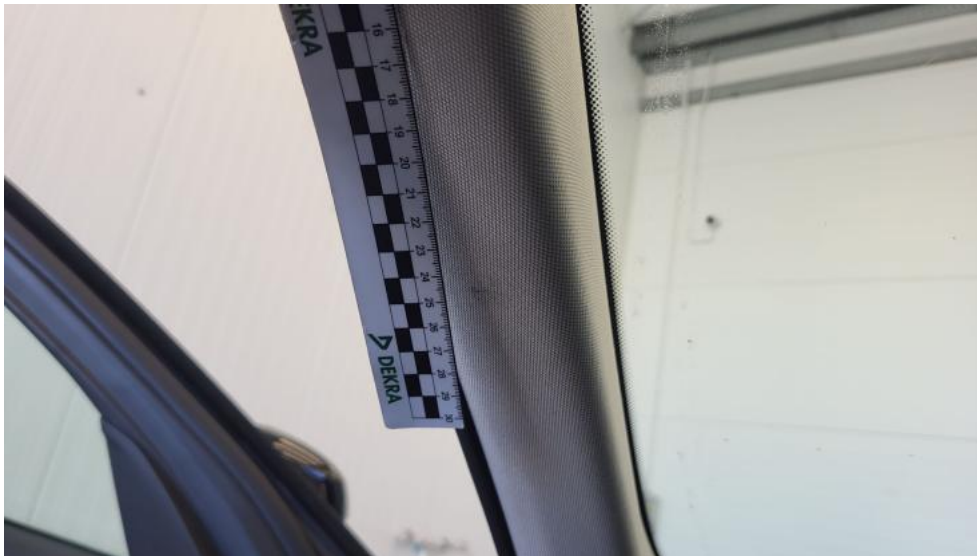
**Photo 61.**

Wykładzina(y) słupka przedniego L - Inne 1

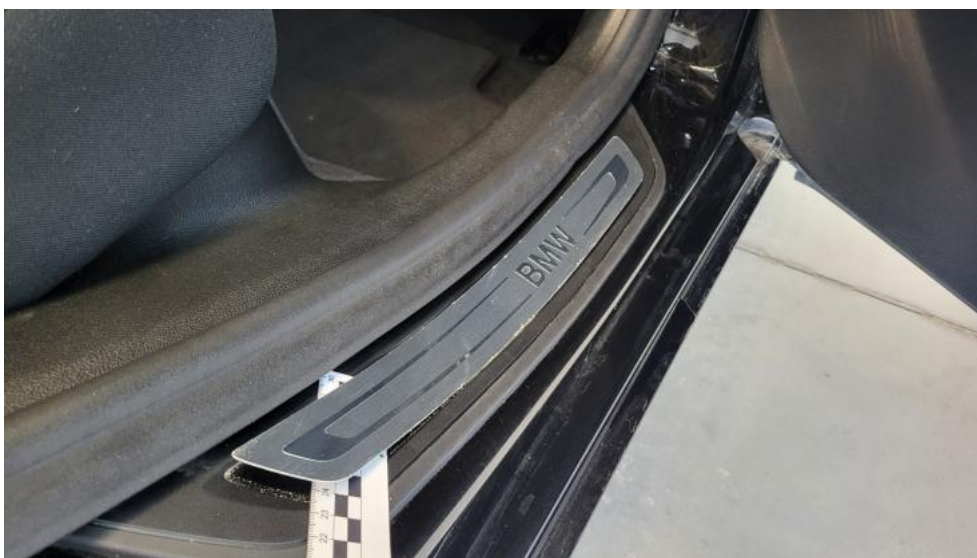
**Photo 62.**

Listwy progowe praw. - Inne 1
