DEKRA's commission No. : PKOL(W)/LODZ/66323/25/09/05  
commission/ damage No. : 22/006216  
Date of commission: 05-09-2025

| Manufacturer | JEEP |
| Model | Wrangler 18-23 |
| VIN / serial number | 1C4HJXFNXMW851608 |

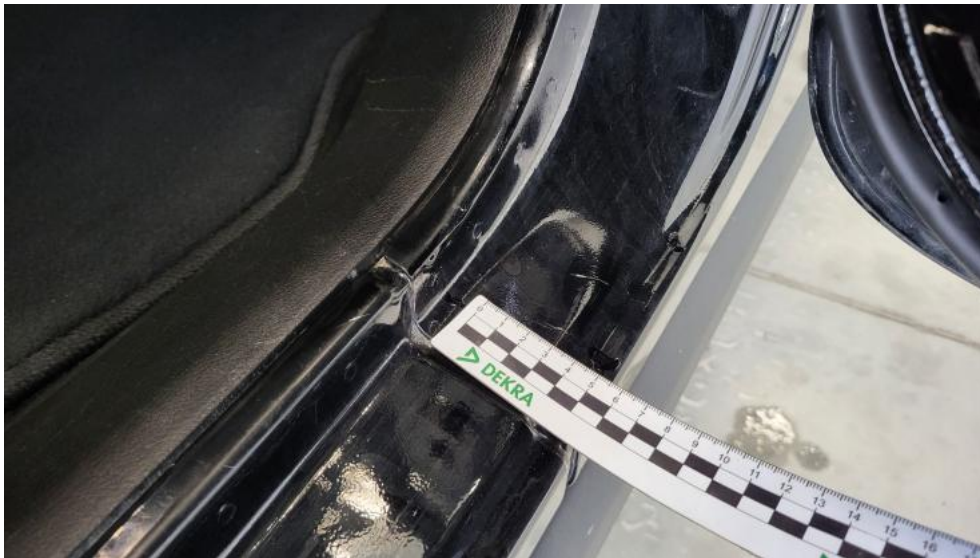
**Photo 45.**

Próg P - Rysa/odprysk 1

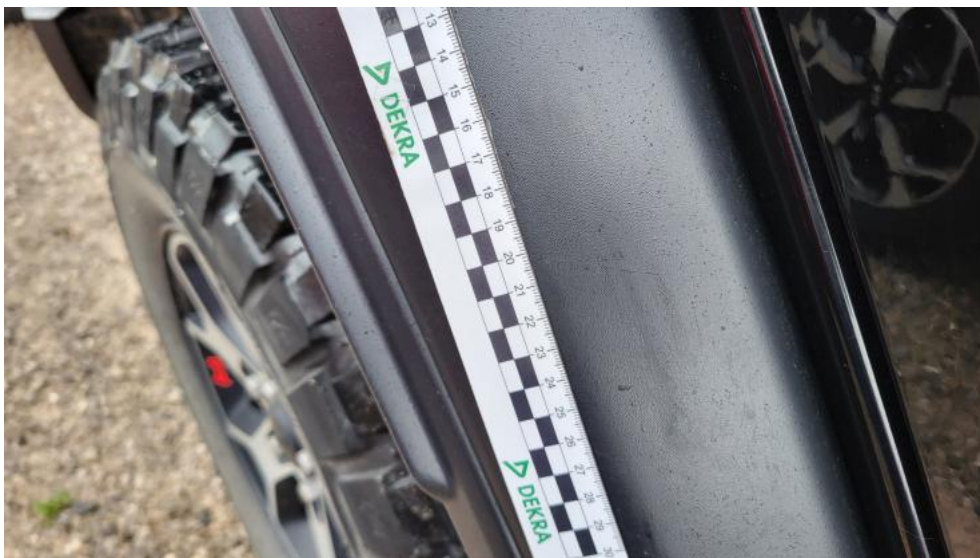
**Photo 46.**

Nadkole tylne P - Rysa/odprysk 1

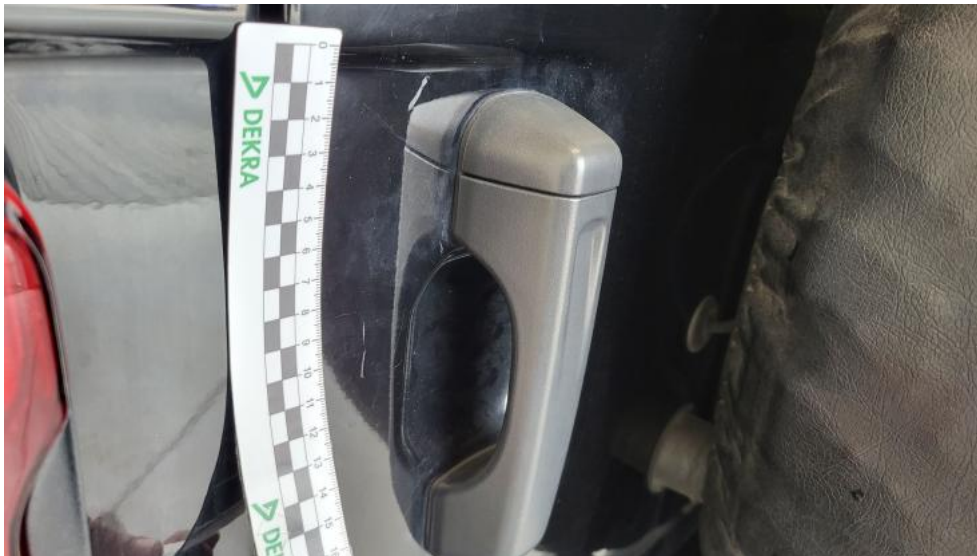
**Photo 47.**

Pokrywy bagażnika - Rysa/odprysk 1

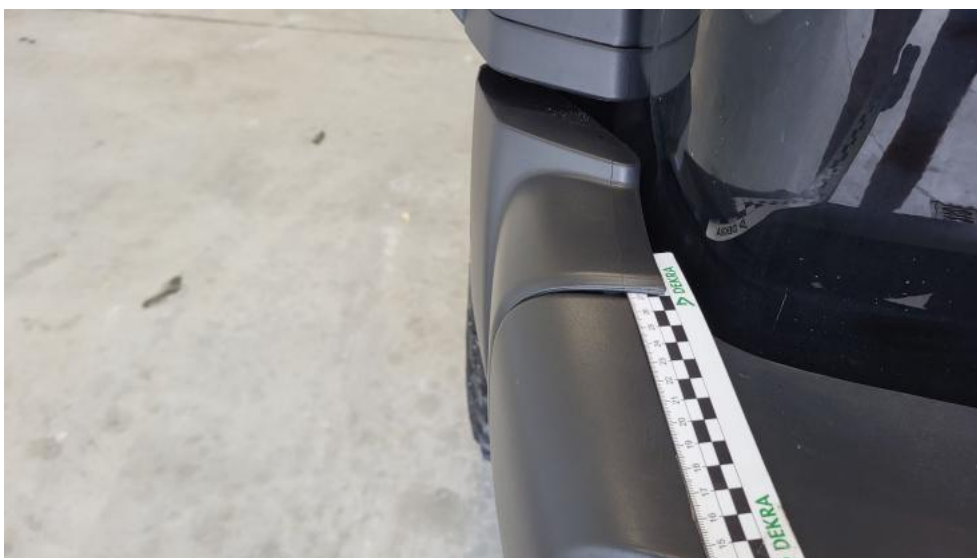
**Photo 48.**

Zderzak tylny cz L - Inne 1

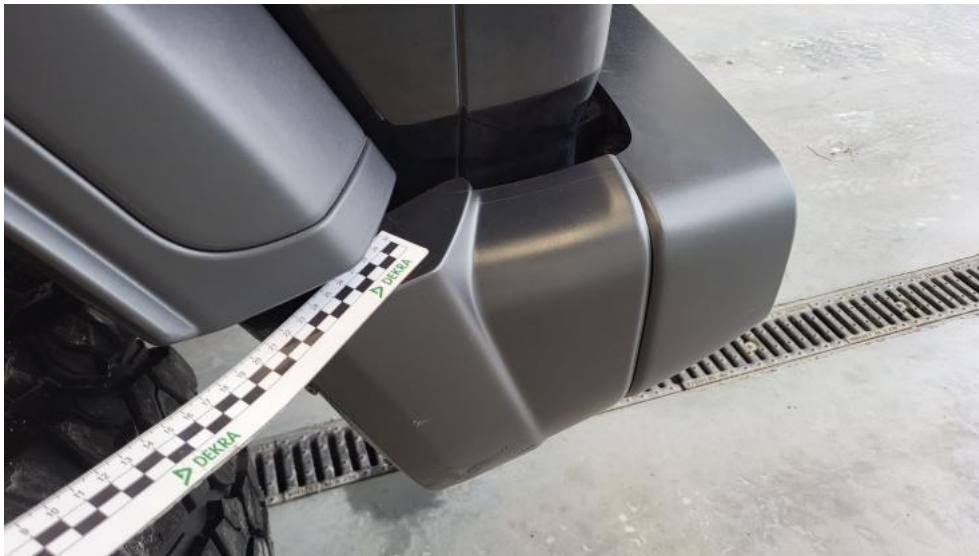
**Photo 49.**

Zderzak tylny cz L - Inne 2

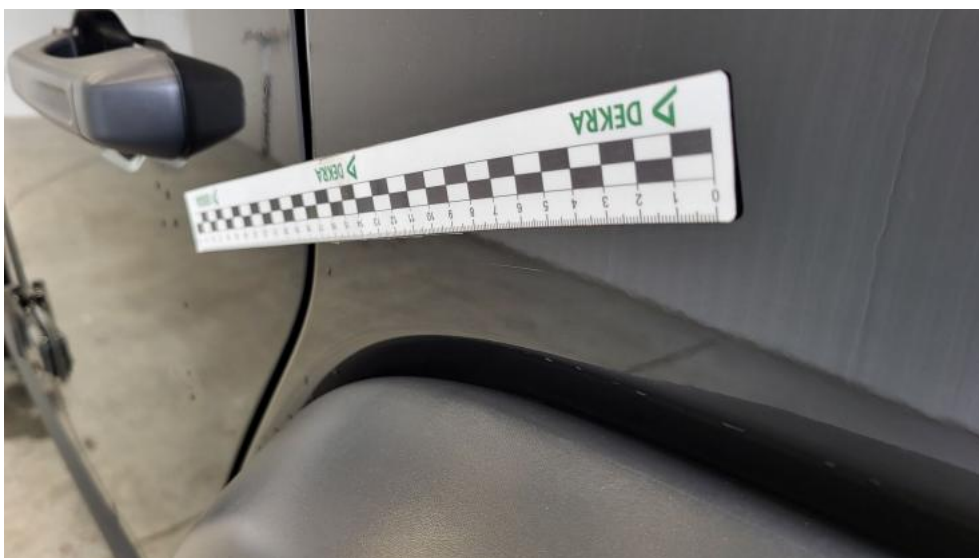
**Photo 50.**

Błotnik tylny L / Ściana boczna L - Rysa/odprysk 1

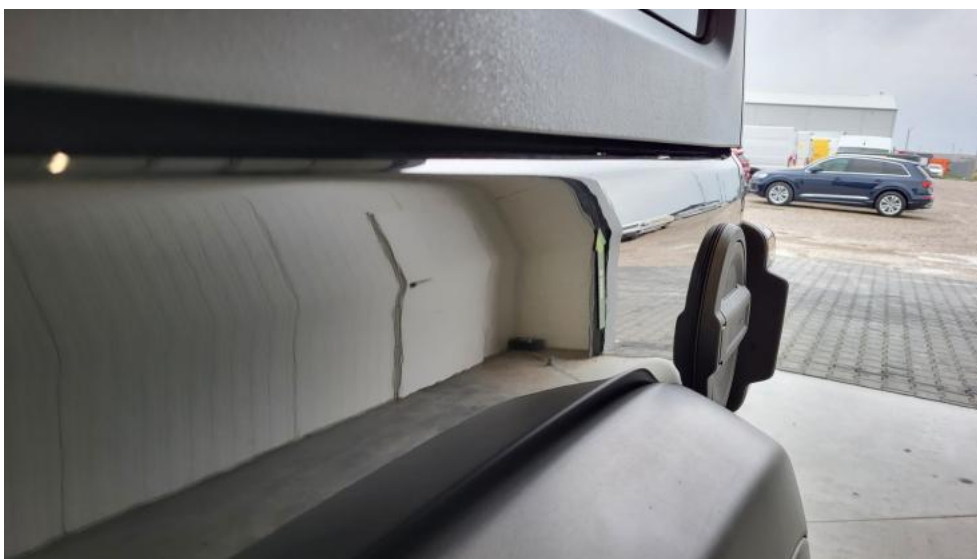
**Photo 51.**

Błotnik tylny L / Ściana boczna L - Wgniecenie/odkształcenie 1

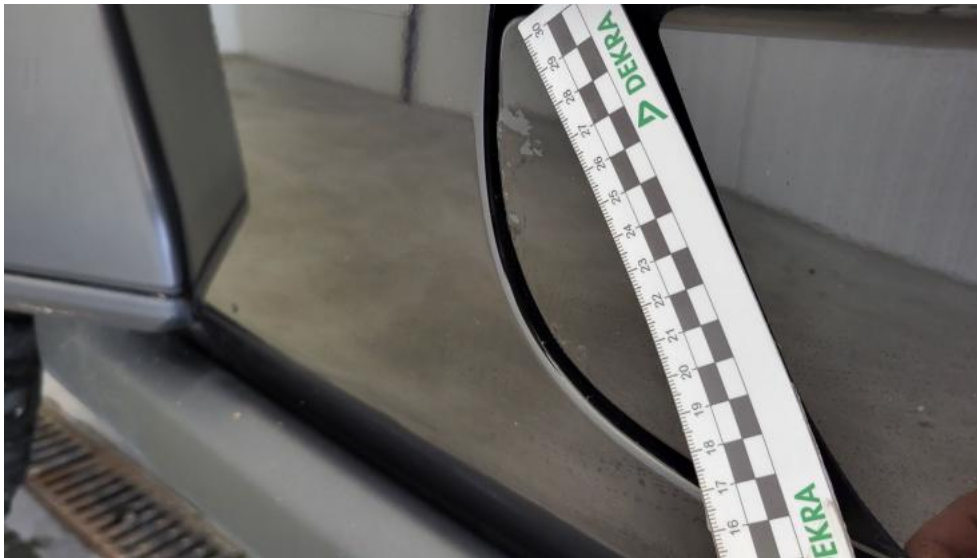
**Photo 53.**

Drzwi przed L - Inne 1

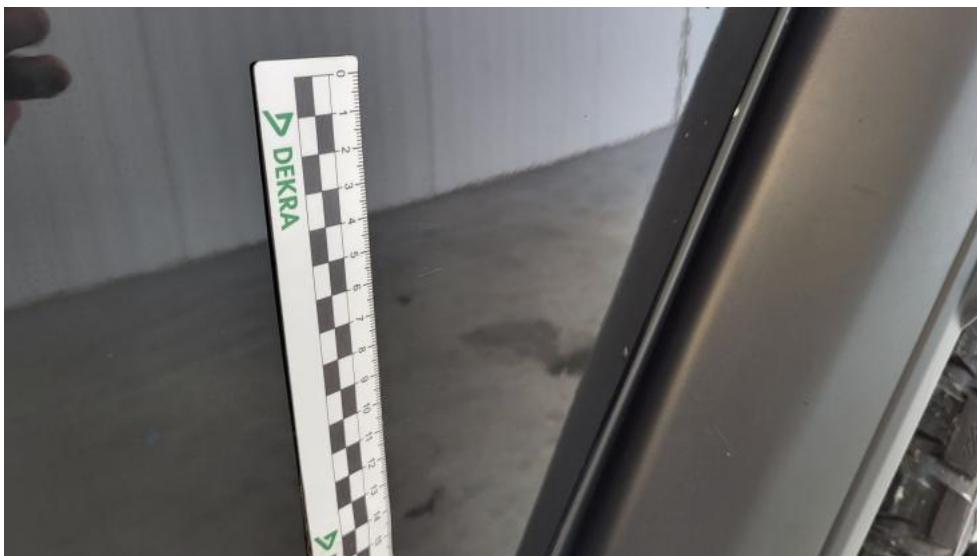
**Photo 54.**

Drzwi tylne L - Rysa/odprysk 1

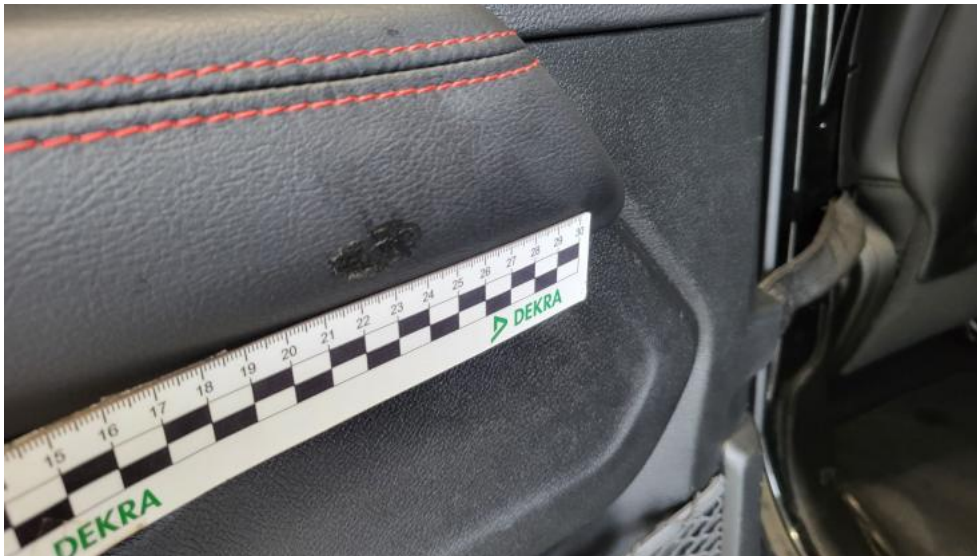
**Photo 57.**

Tapicerka drzwi tylnych L - Inne 1
