DEKRA's commission No. : PKOL(W)/LODZ/49317/24/06/27  
commission/ damage No. : 22/022627  
Date of commission: 27-06-2024

| Manufacturer | BMW |
| Model | Seria 3 [G20] 18-22 |
| Type / version | 330e aut |

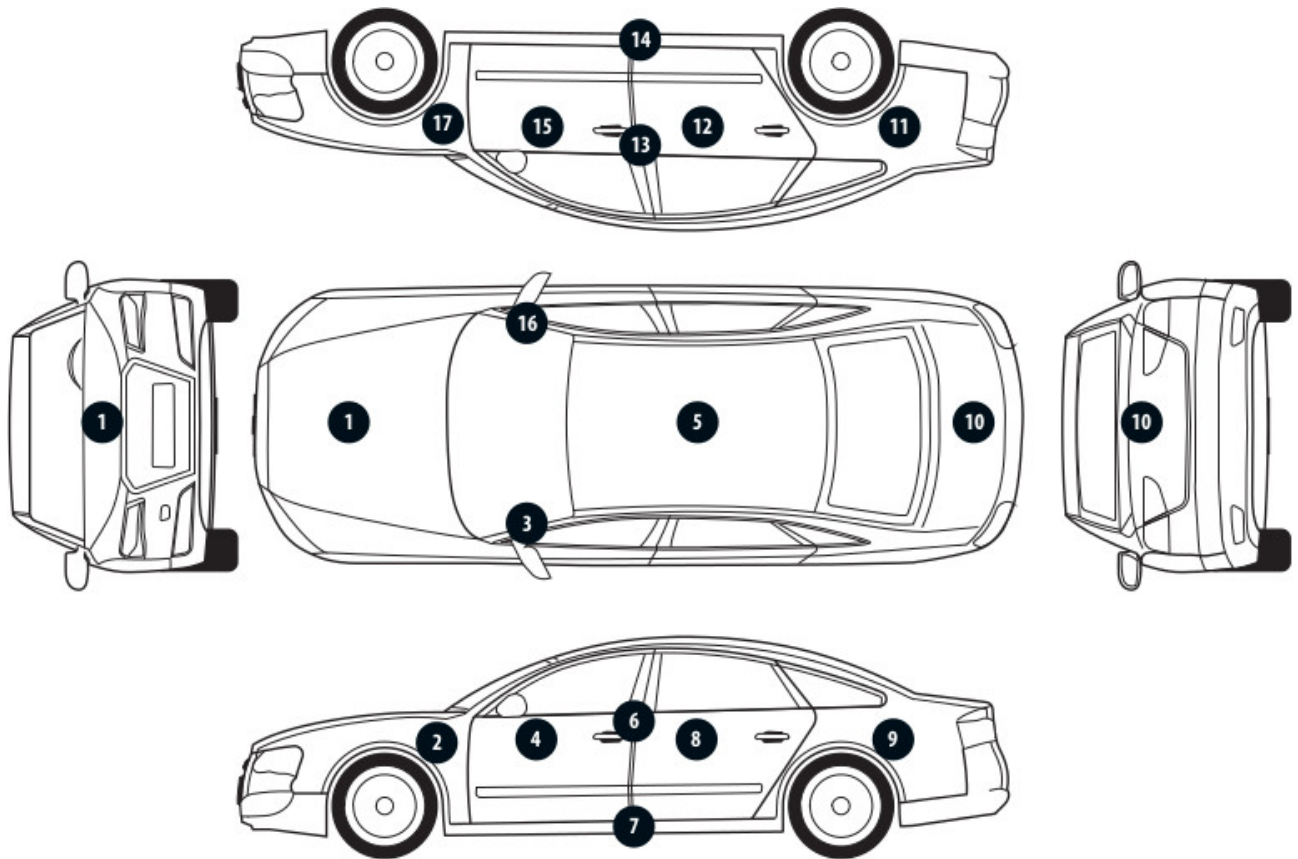
Measurement of thickness of the vehicle lacquer coating

| No. of controlled item | Controlled item | Measured range of thickness of the lacquer coat [ $\mu\text{m}$ ] |
|---|---|---|
| 1 | Front cover | 150 - 300 |
| 2 | Front left fender | 150 - 300 |
| 3 | Left front pillar | 150 - 300 |
| 16 | Right front pillar | 150 - 300 |
| 17 | Front right fender | 150 - 300 |

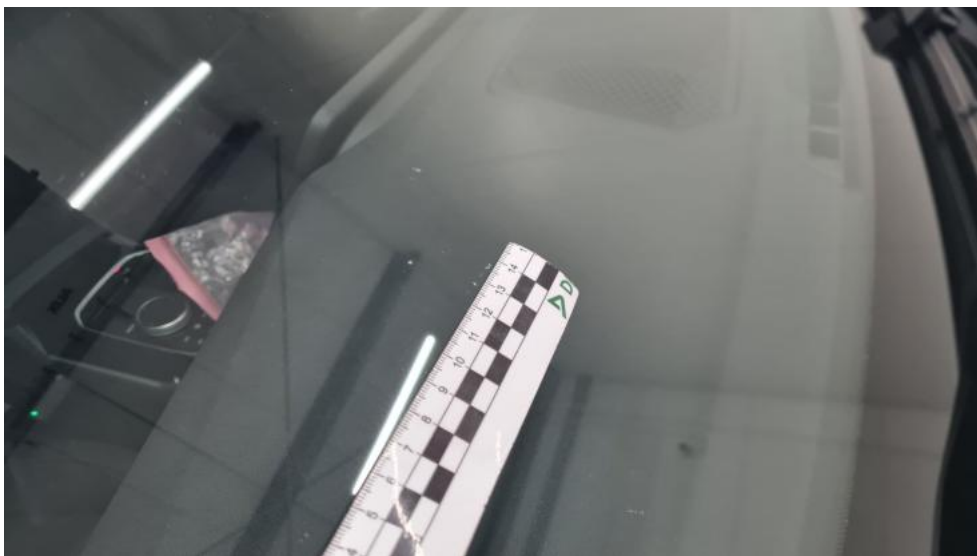
**Photo 39.**

Szyba czołowa - Rysa/odprysk 1

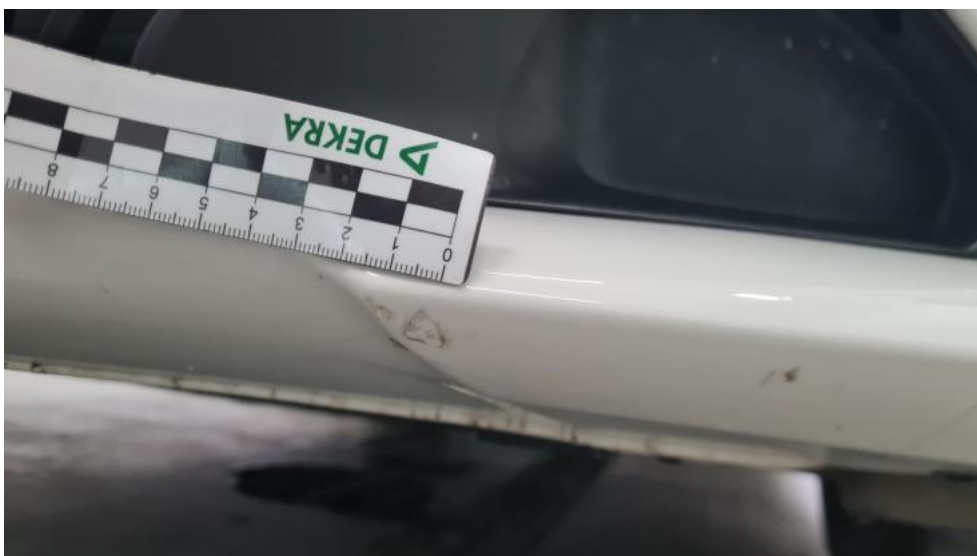
**Photo 40.**

Zderzak - Rysa/odprysk 1

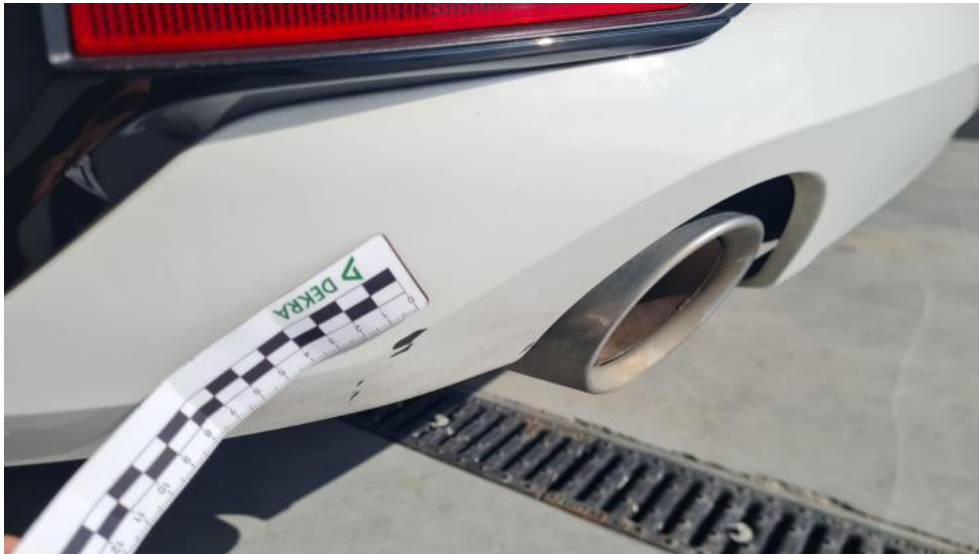
**Photo 41.**

Zderzak tylny - Rysa/odprysk 1

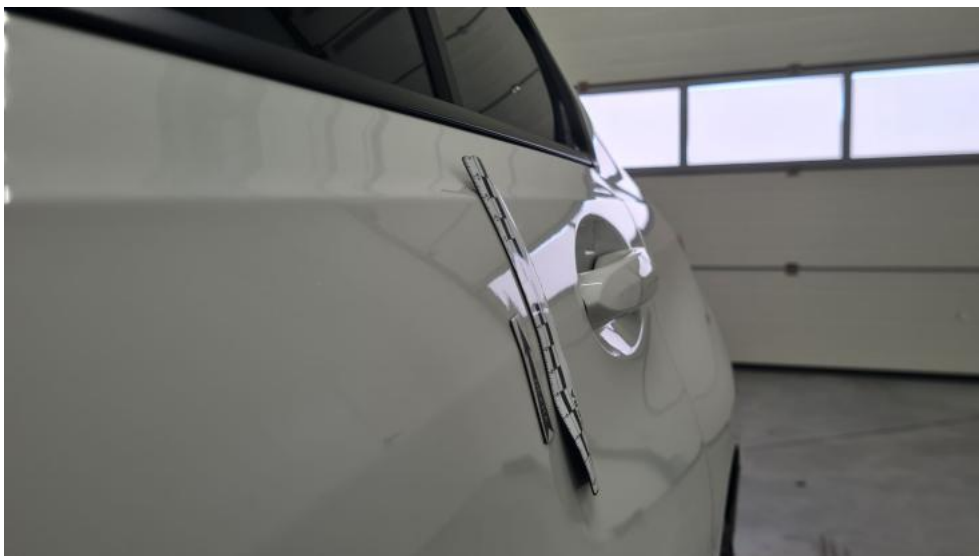
**Photo 42.**

Drzwi tylne L - Wgniecenie/odkształcenie 1

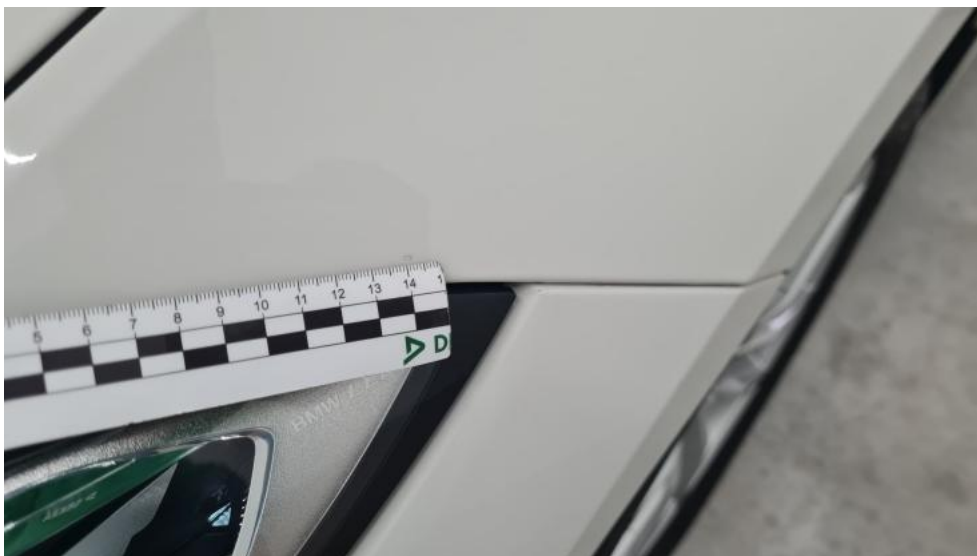
**Photo 43.**

Błotnik przedni L - Rysa/odprysk 1
