DEKRA's commission No. : PKOL(W)/LODZ/56231/26/06/18  
 commission/ damage No. : 23/018054  
 Date of commission: 18-06-2026

**Vehicle data**

Measurement of thickness of the vehicle lacquer coating

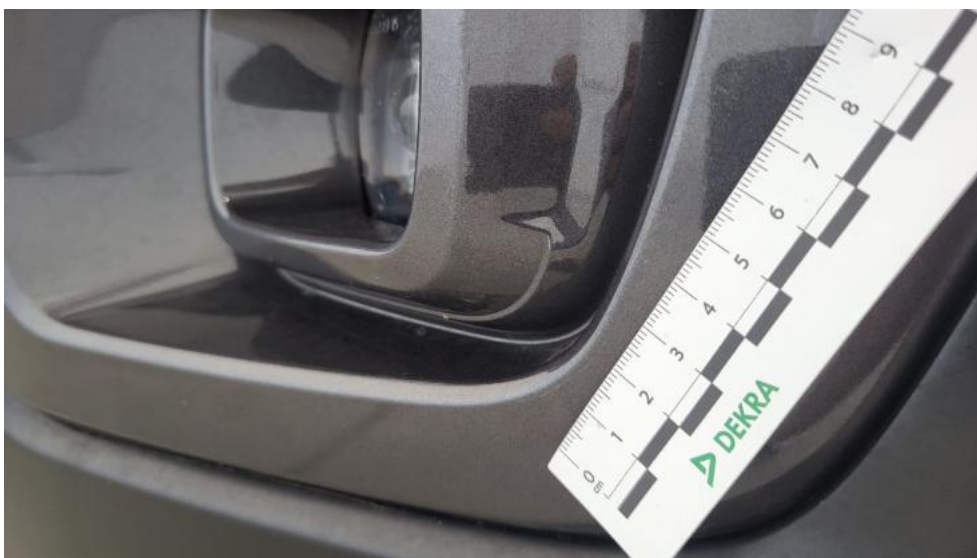
**Photo 38.**  
Kratka/zaślepka halogenu L - Rysa/odprysk 1

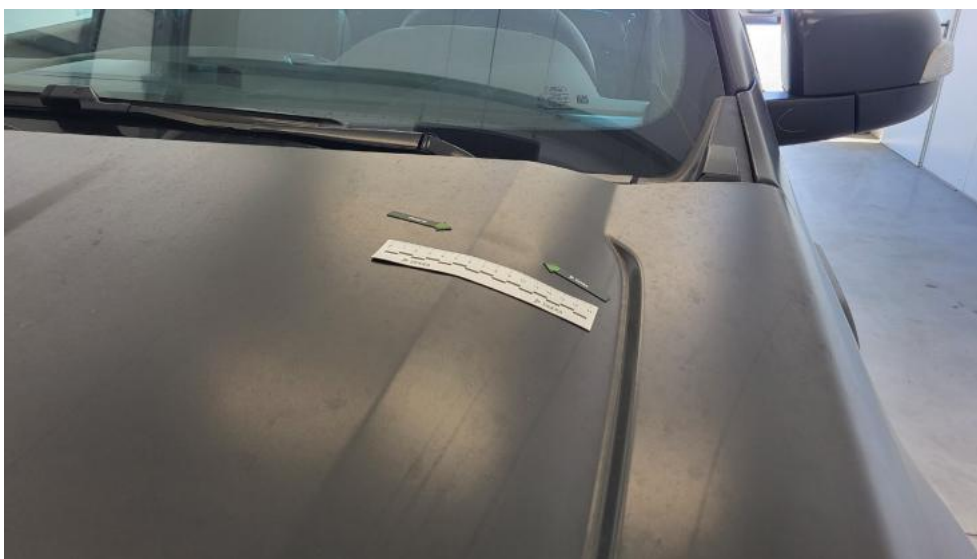
**Photo 39.**  
Pokrywa komory silnika - Wgniecenie/odkształcenie 1

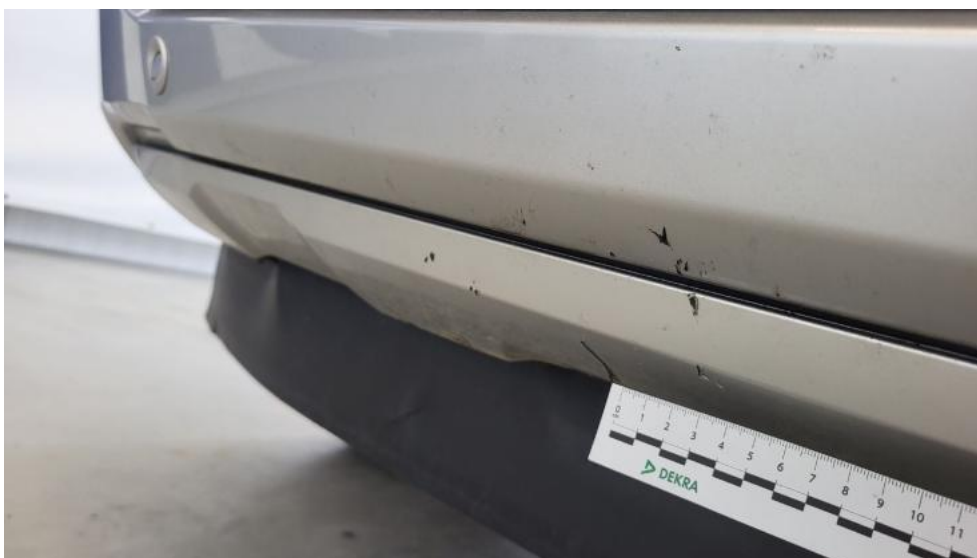
**Photo 40.**  
Spoiler zderzaka przedniego - Rysa/odprysk 1

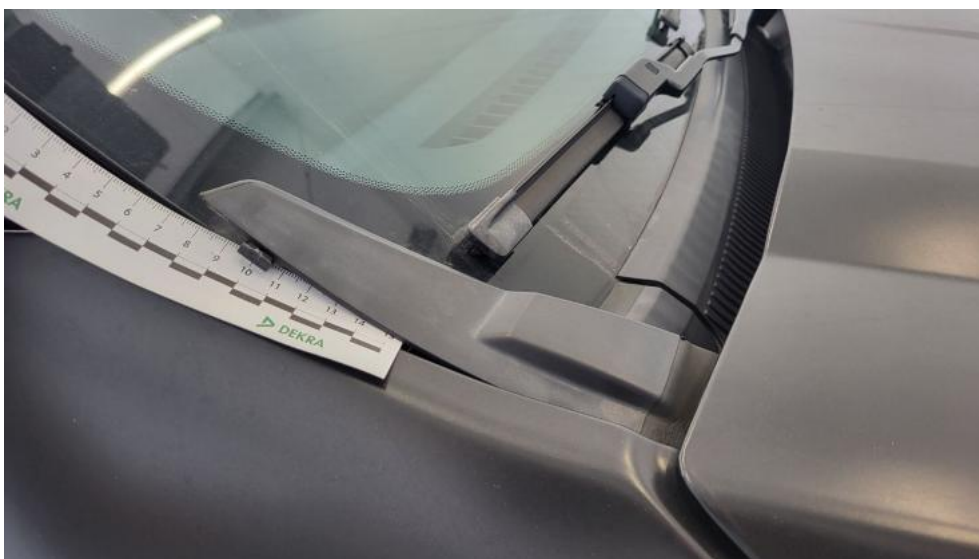
**Photo 41.**

Uszczelka/listwa szyby czołowej - Inne 1

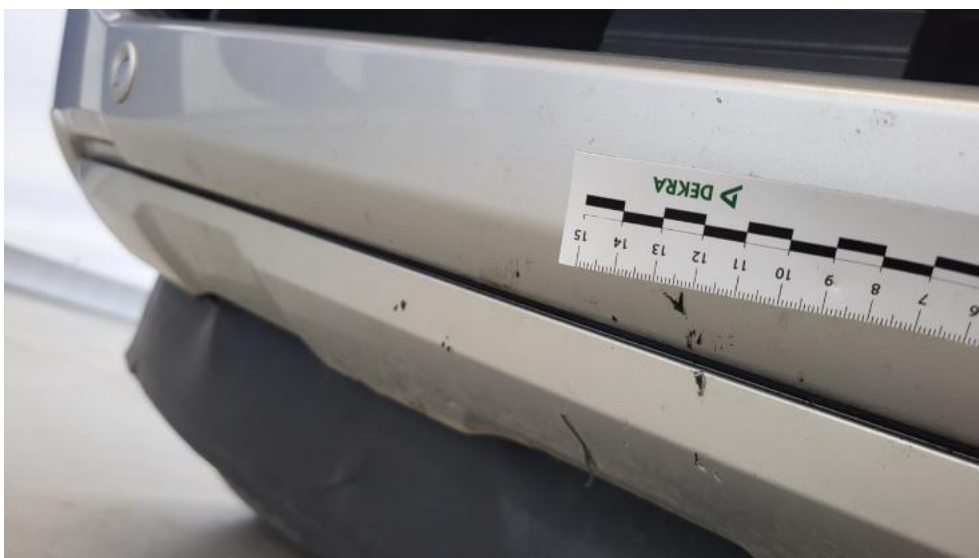
**Photo 42.**

Zderzak przedni cz dolna - Rysa/odprysk 1

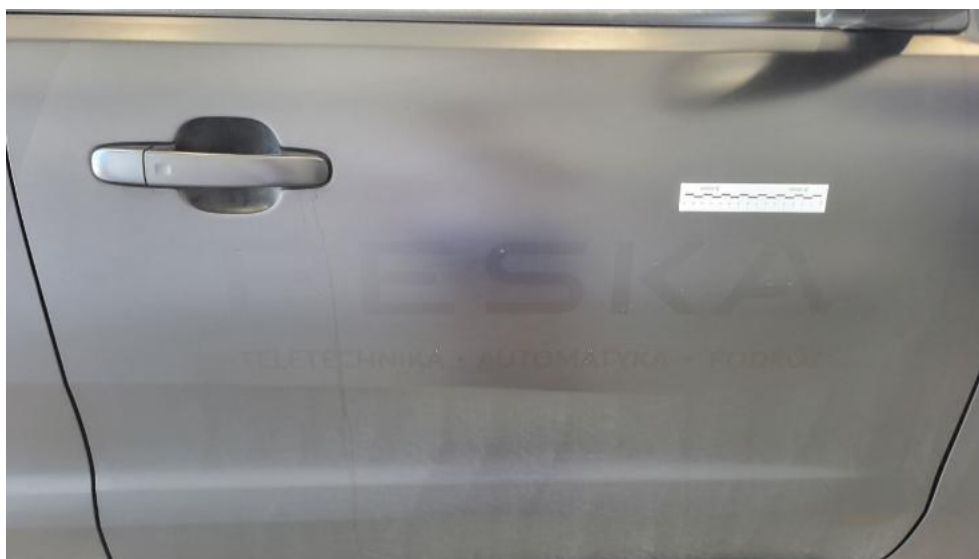
**Photo 43.**

Drzwi przednie P - Inne 1

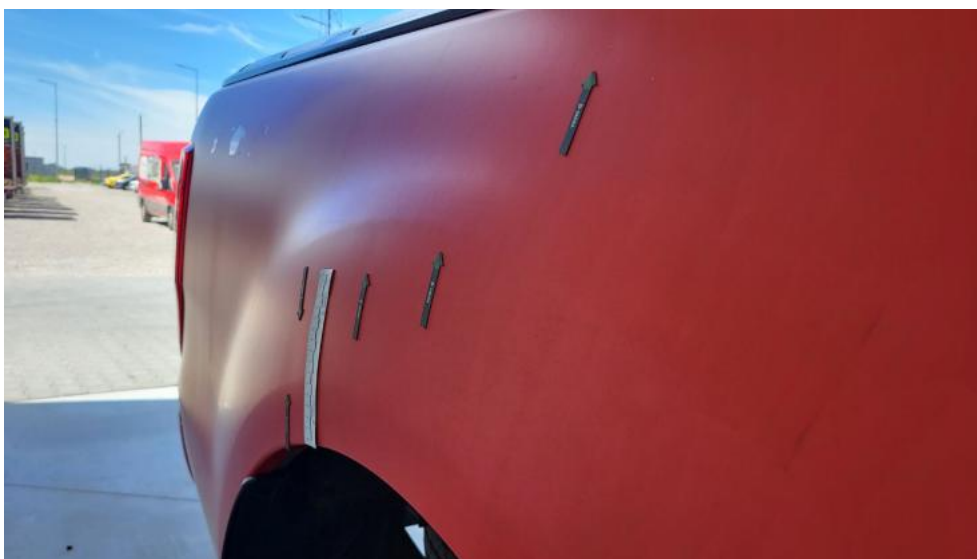
**Photo 45.**  
Błotnik tylny P / Ściana boczna P - Wgniecenie/odkształcenie 1

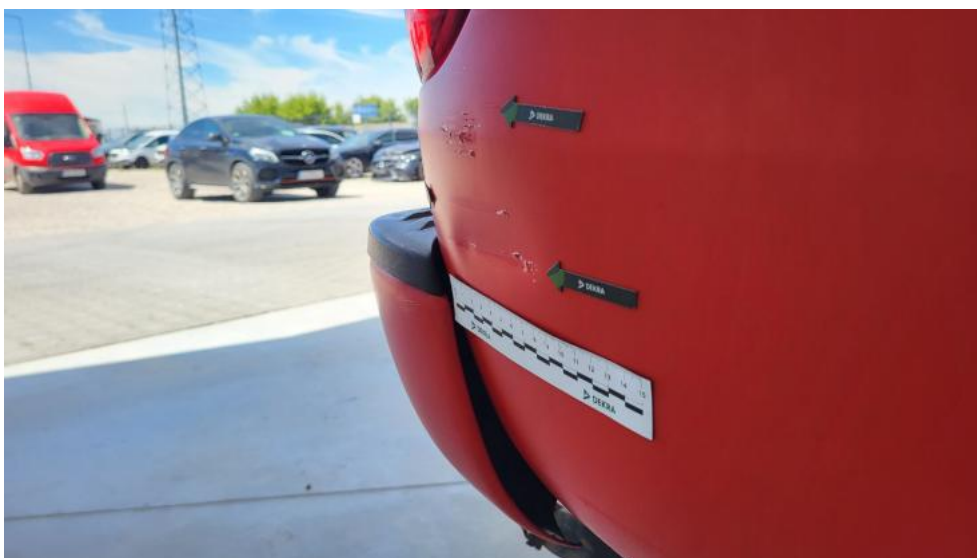
**Photo 46.**  
Błotnik tylny P / Ściana boczna P - Wgniecenie/odkształcenie 2

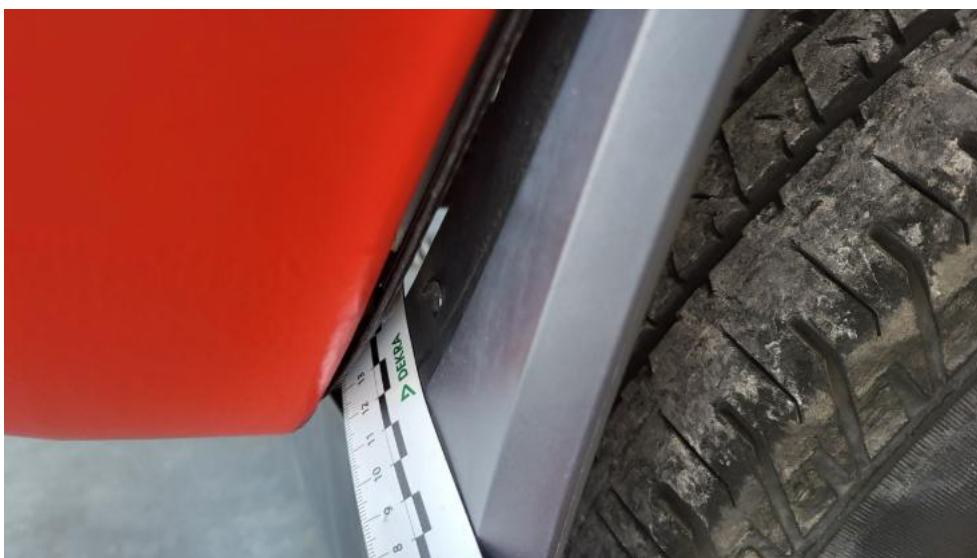
**Photo 48.**  
Nadkole tylne P - Inne 1

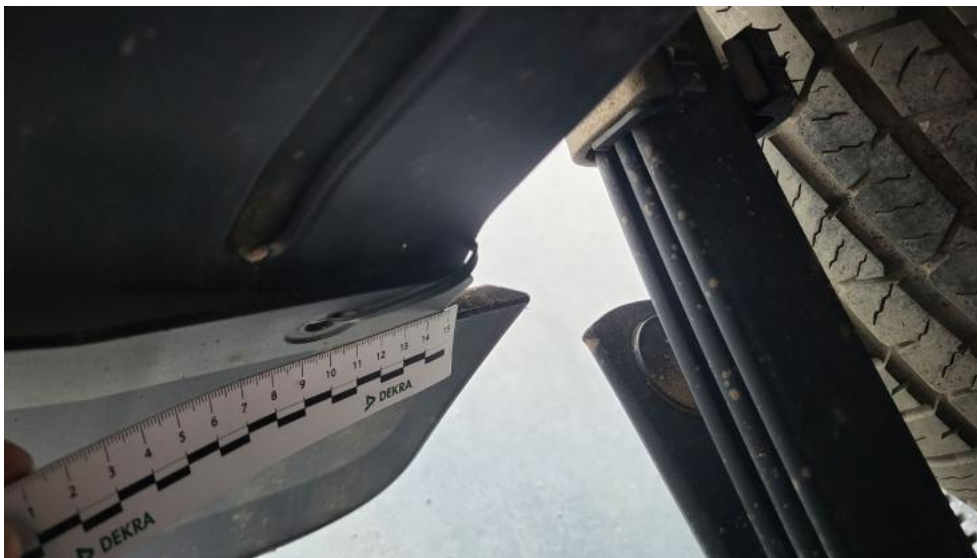
**Photo 49.**  
Nadkole tylne P - Inne 2

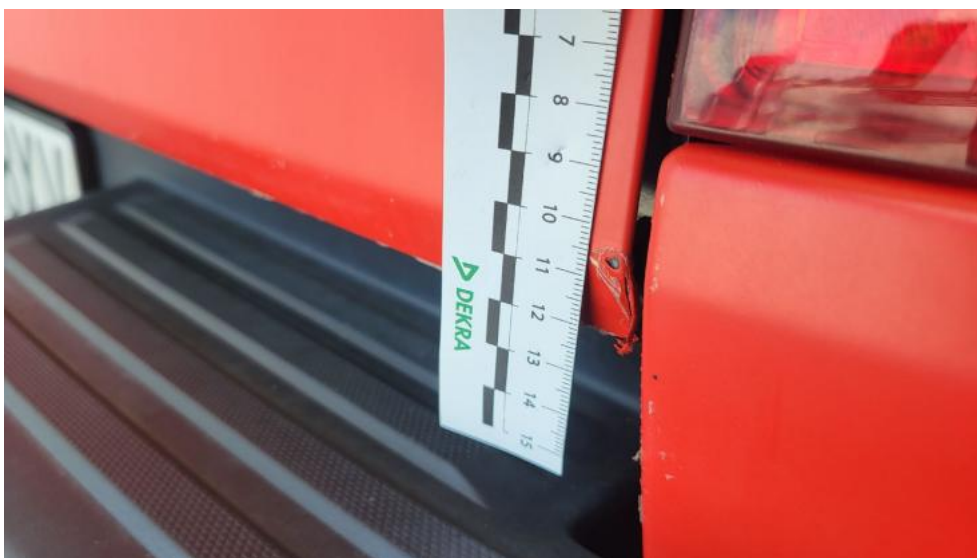
**Photo 50.**  
Pokrywy bagażnika - Rysa/odprysk 1

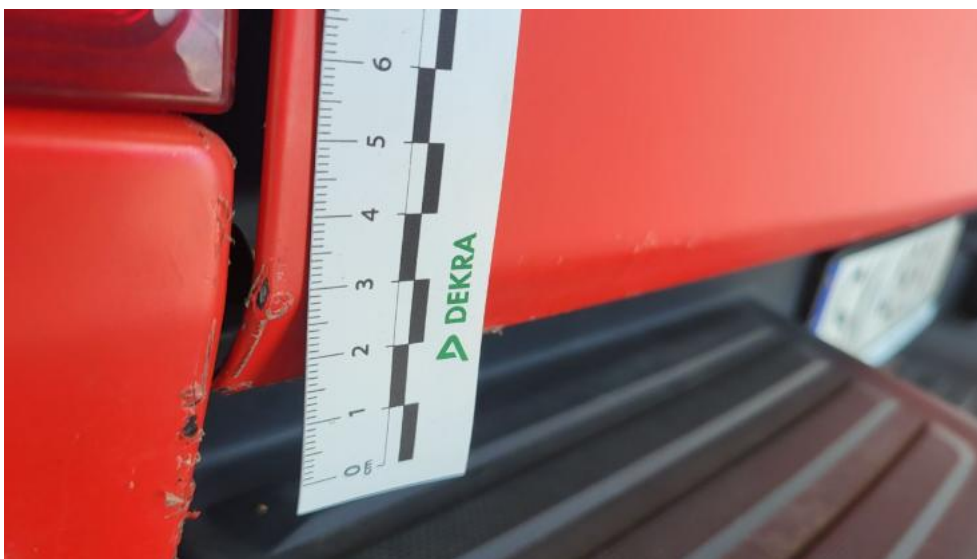
**Photo 51.**  
Pokrywy bagażnika - Rysa/odprysk 2

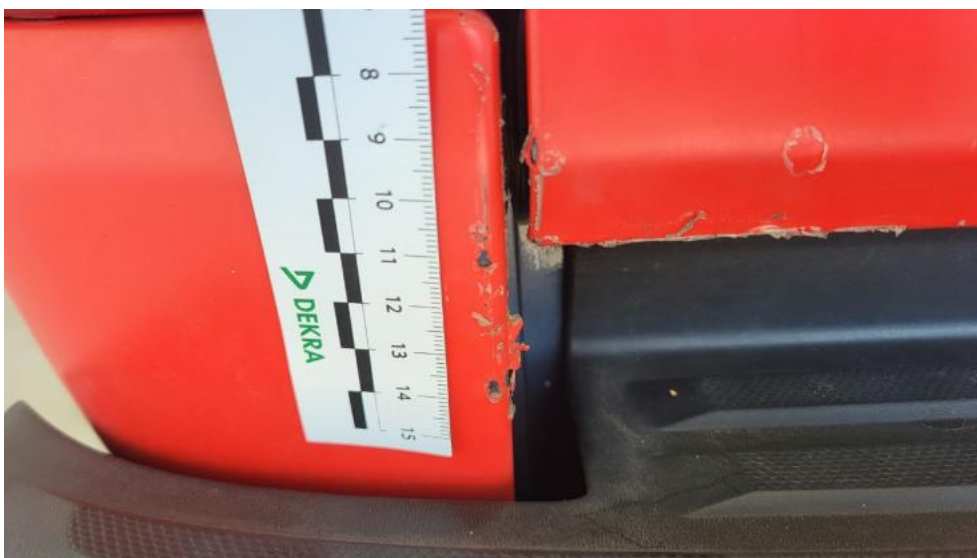
**Photo 52.**  
Błotnik tylny L / Ściana boczna L - Rysa/odprysk 1

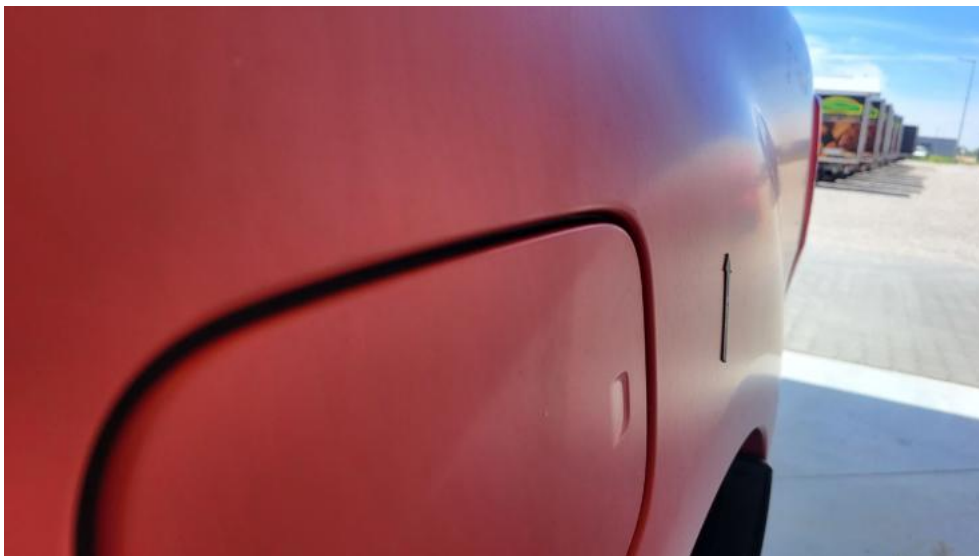
**Photo 53.**  
Błotnik tylny L / Ściana boczna L - Wgniecenie/odkształcenie 1

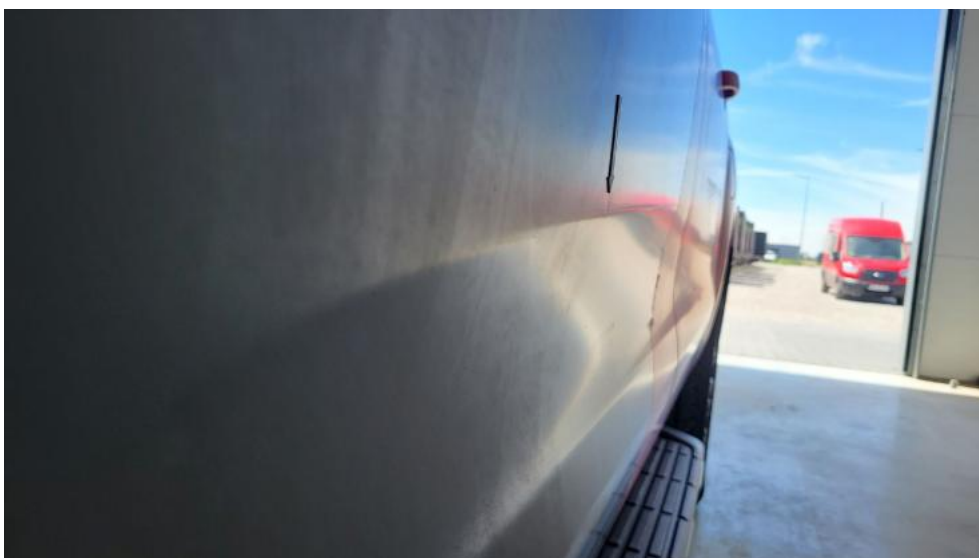
**Photo 54.**  
Drzwi przed L - Wgniecenie/odkształcenie 1

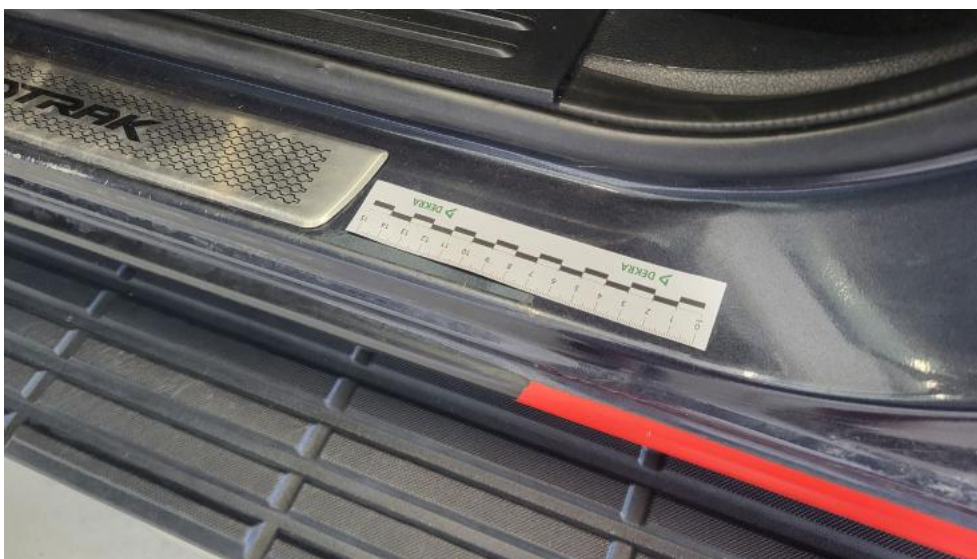
**Photo 55.**  
Próg L - Rysa/odprysk 1

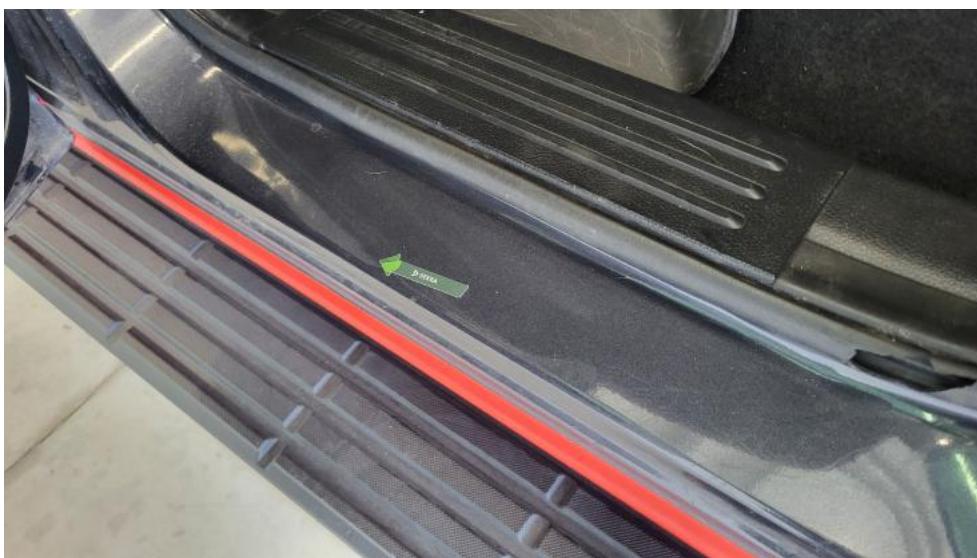
**Photo 56.**  
Próg L - Wgniecenie/odkształcenie 1

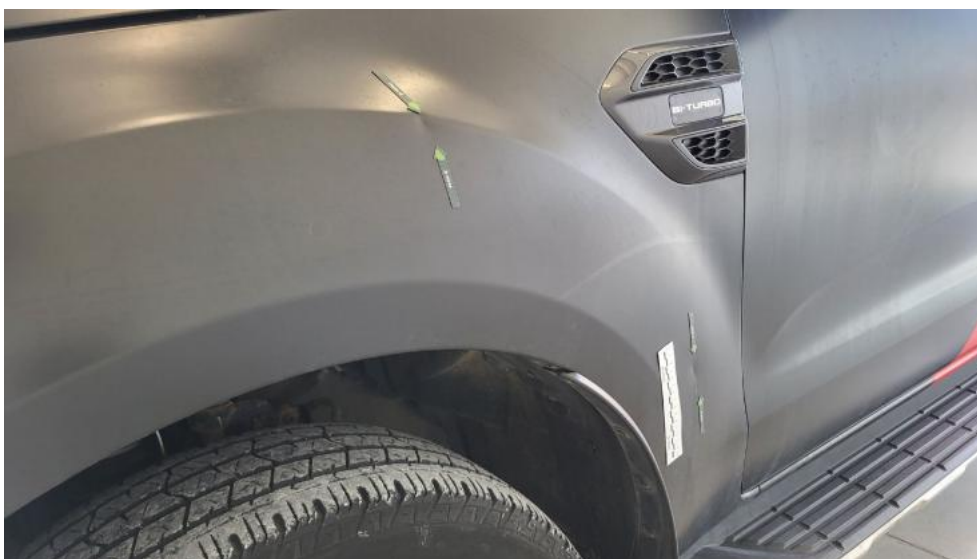
**Photo 57.**  
Błotnik przedni L - Wgniecenie/odkształcenie 1

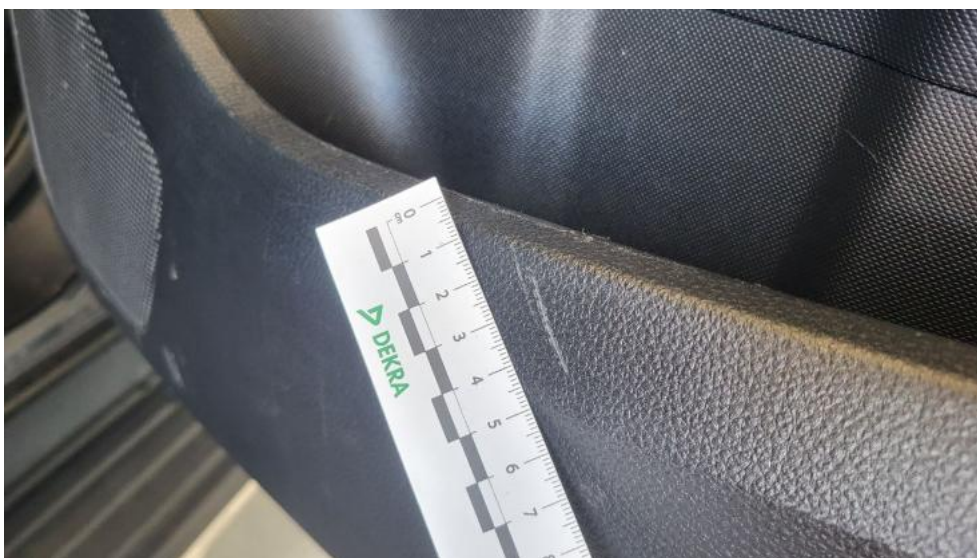
**Photo 58.**  
Tapicerka drzwi tylnych P - Rysa/odprysk 1

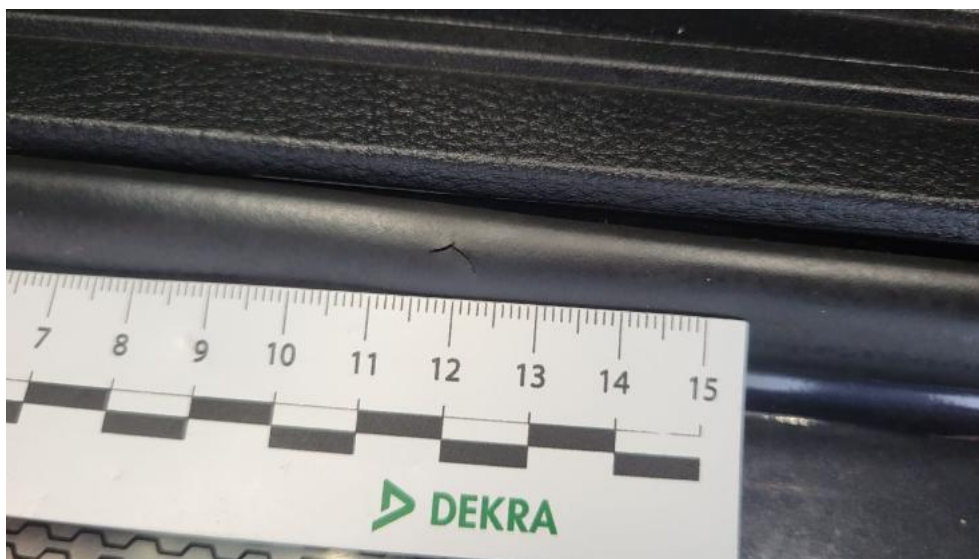
**Photo 59.**

Uszczelka drzwi przednich L - Pęknięcie/rozerwanie 1

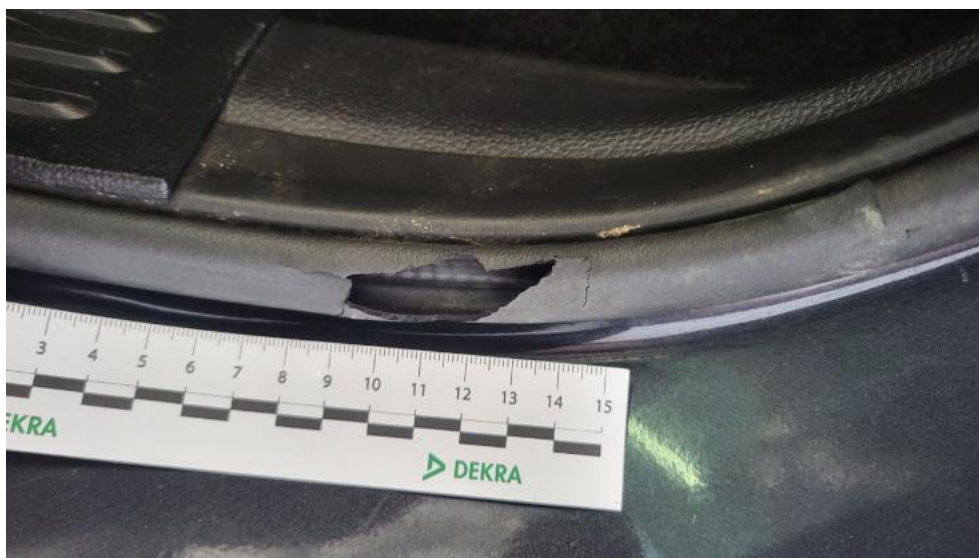
**Photo 60.**

Uszczelka drzwi tylnych L - Pęknięcie/rozerwanie 1

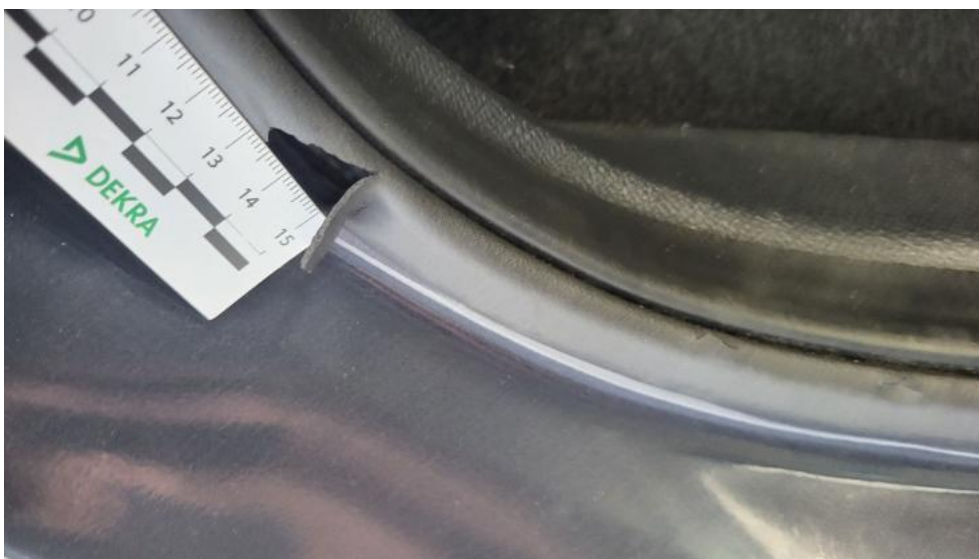
**Photo 61.**  
Uszczelka drzwi tylnych P - Pęknięcie/rozerwanie 1

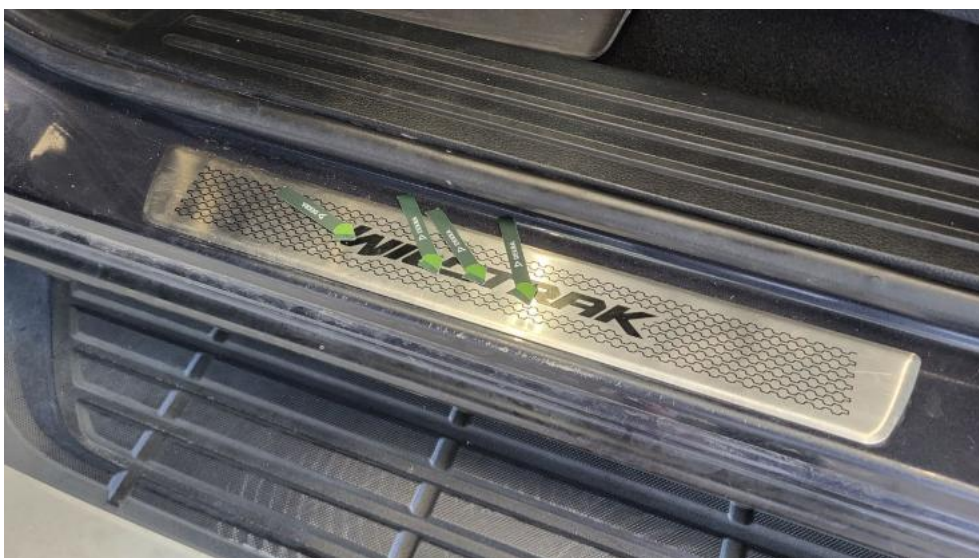
**Photo 62.**  
Listwy progowe lew. - Wgniecenie/odkształcenie 1

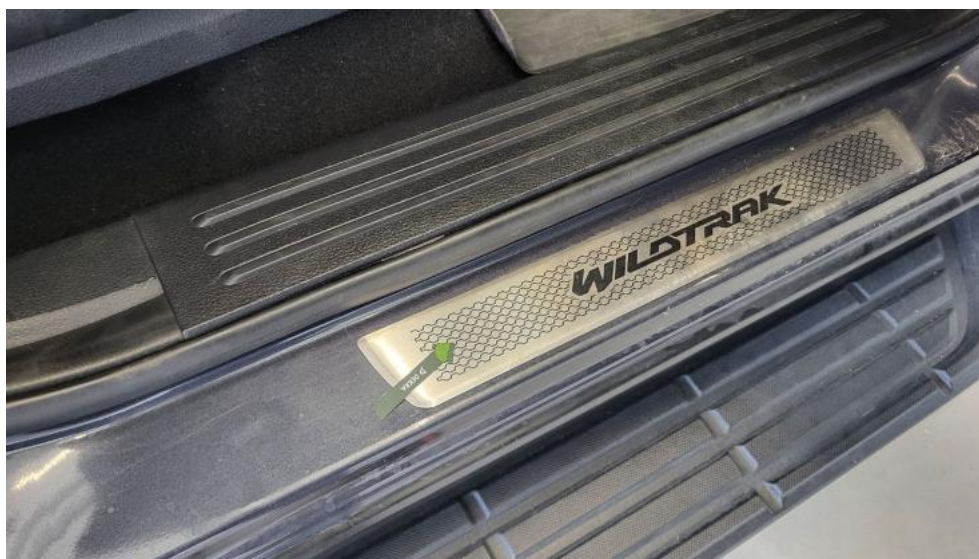
**Photo 63.**

Listwy progowe praw. - Wgniecenie/odkształcenie 1
