DEKRA's commission No. : PKOL(W)/LODZ/47479/26/05/22
 commission/ damage No. : 22/032968
 Date of commission: 22-05-2026

Group of objects (Eurotax)	jeeps
EC code (Eurotax)	0148180
Manufacturer	JEEP
Model	Gladiator 21-23
Type / version	Gladiator 3.0 V6 MultiJet Overland aut
Body type	PIC
Number of doors / seats	4/5
Curb weight [kg]	2285
Gross vehicle weight [kg]	2925
Wheelbase 1/2	3488
Engine type	Automatic ignition
Pollution reduction system	KSC
Emission standard	EURO 6
Engine capacity [ccm]	2987
Engine Power [hp/kW]	264/194
Gearbox	automatic 8- gear
Registration /record No.	KN7330G
VIN / serial number	1C6JJTFM8ML622404
Date of first registration	23-05-2022
Date of next. tech. test	23-05-2027
Year of manufacture	2021 (year has been verified with the manufacturer's base)
Readout [km]	88 030 (read)
Body color / type of coating	green/plain

Measurement of thickness of the vehicle lacquer coating

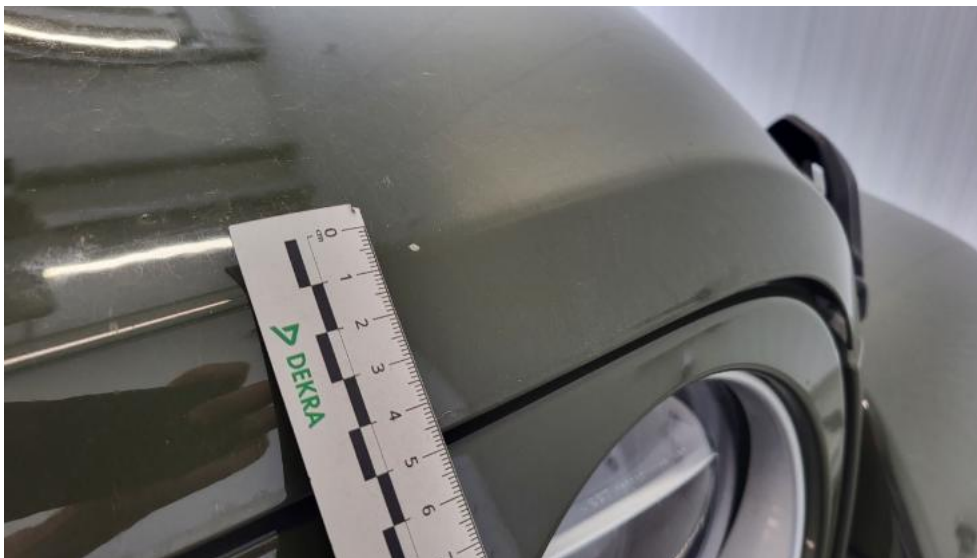
Photo 41.
Pokrywa komory silnika - Rysa/odprysk 1

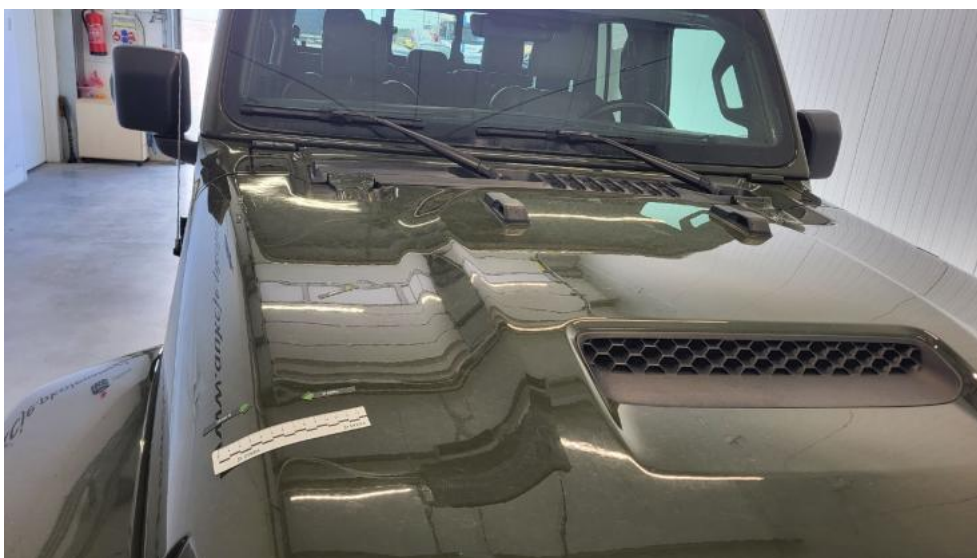
Photo 42.
Pokrywa komory silnika - Wgniecenie/odkształcenie 1

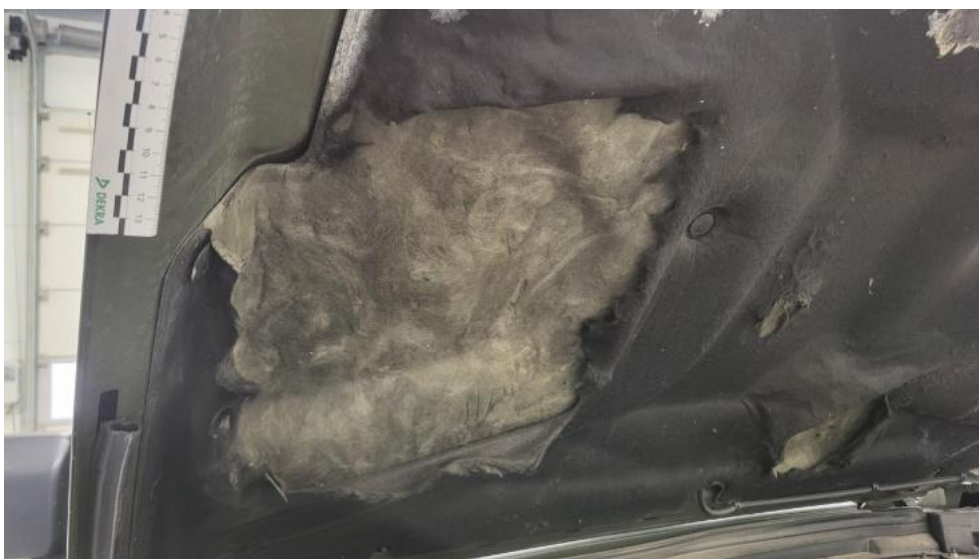
Photo 43.
Wykładzina pokrywy komory silnika - Pęknięcie/rozerwanie 1

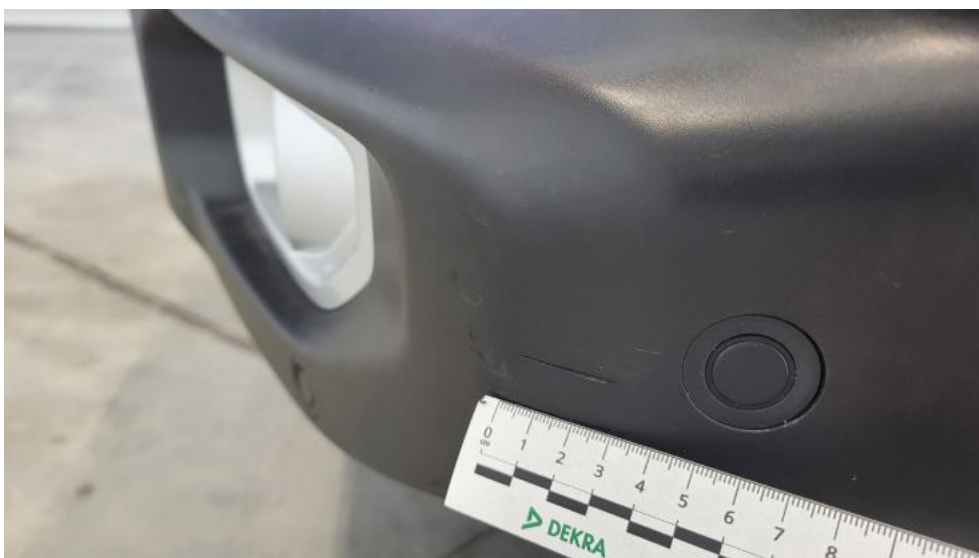
Photo 44.
Zderzak - Rysa/odprysk 1

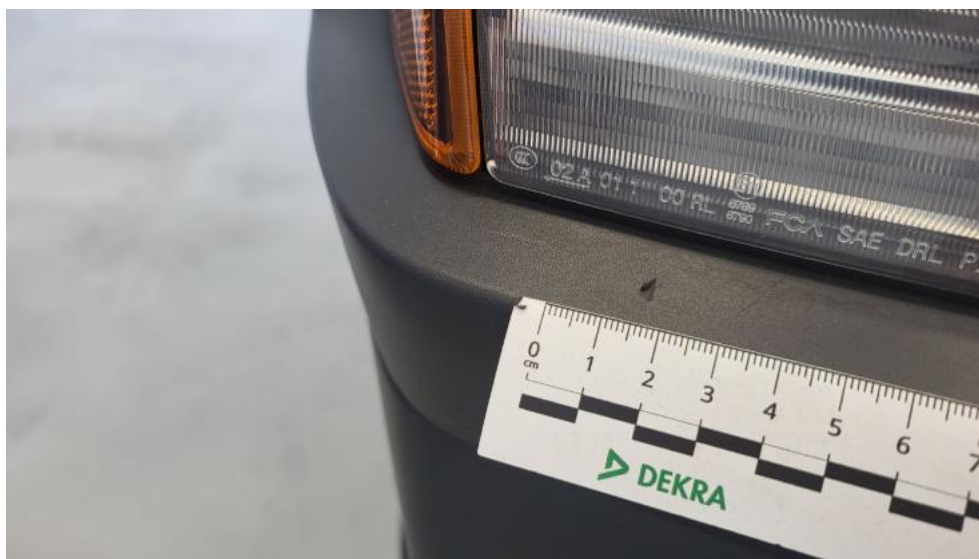
Photo 45.

Zderzak przedni cz P - Rysa/odprysk 1

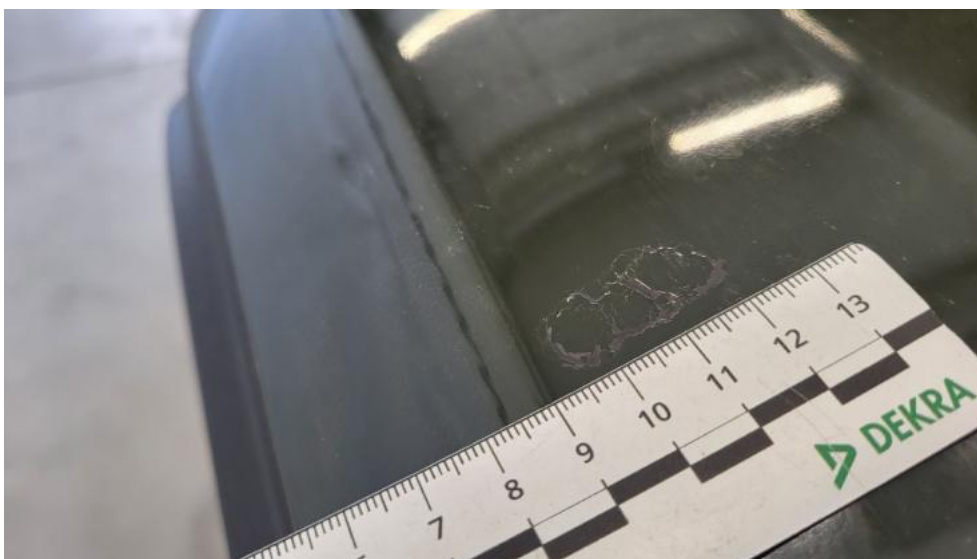
Photo 47.

Błotnik przedni P - Inne 1

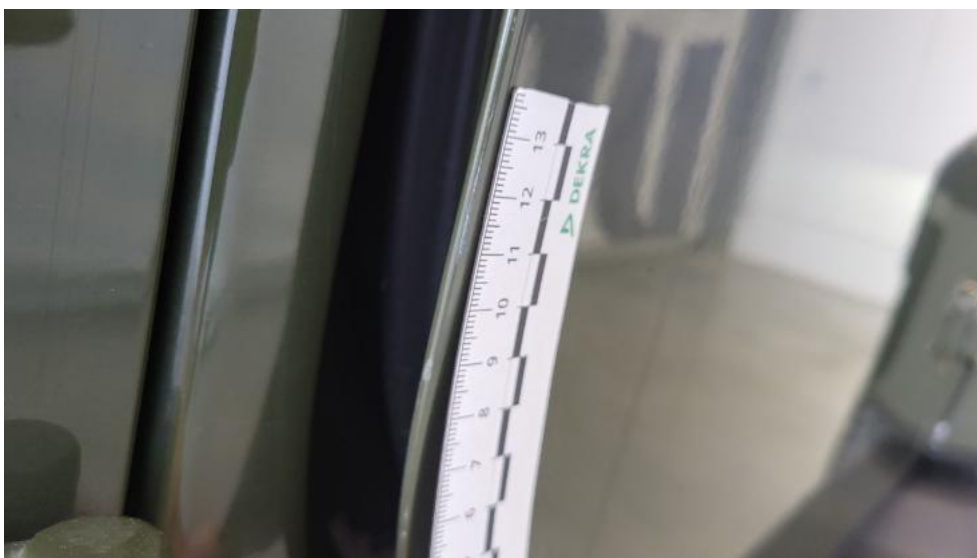
Photo 48.

Drzwi przednie P - Rysa/odprysk 1

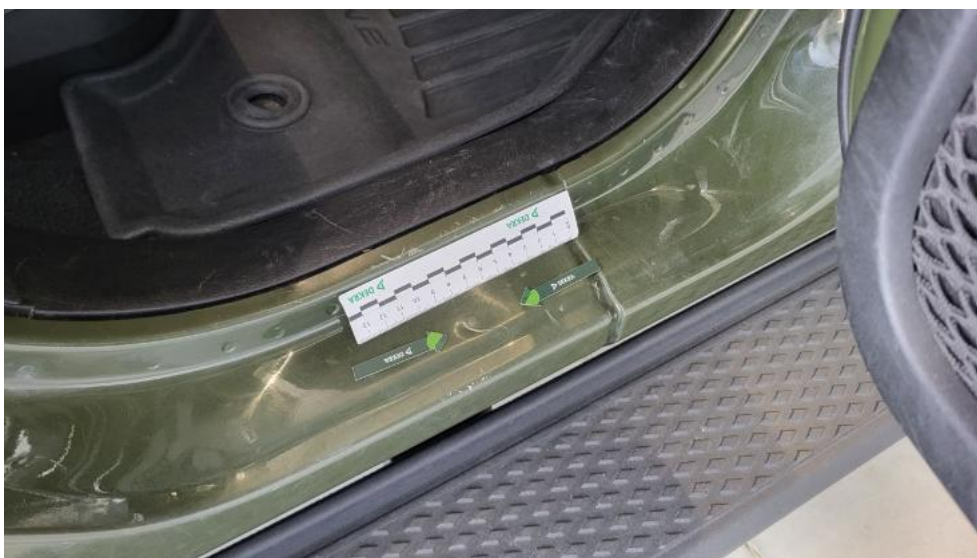
Photo 50.
Próg P - Wgniecenie/odkształcenie 1

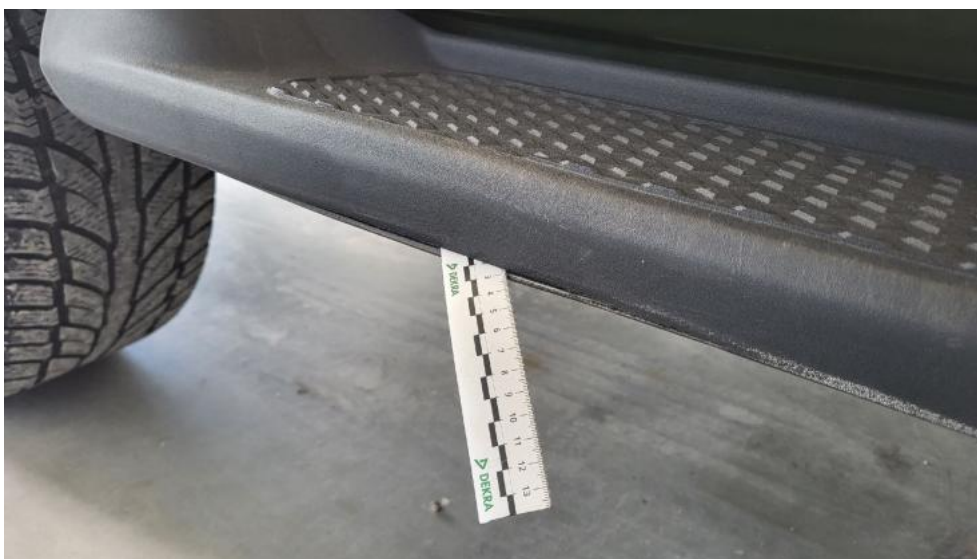
Photo 51.
Próg P - Inne 1

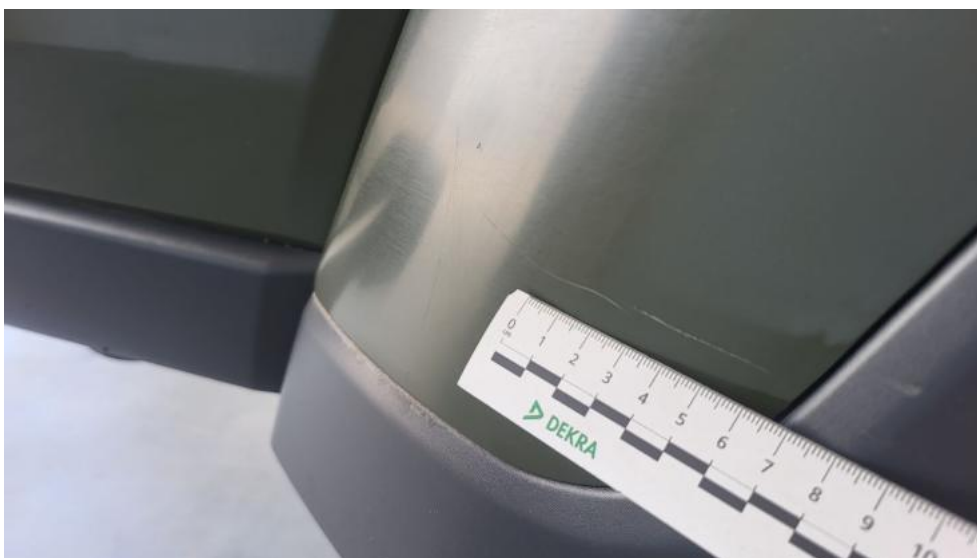
Photo 52.
Błotnik tylny P / Ściana boczna P - Rysa/odprysk 1

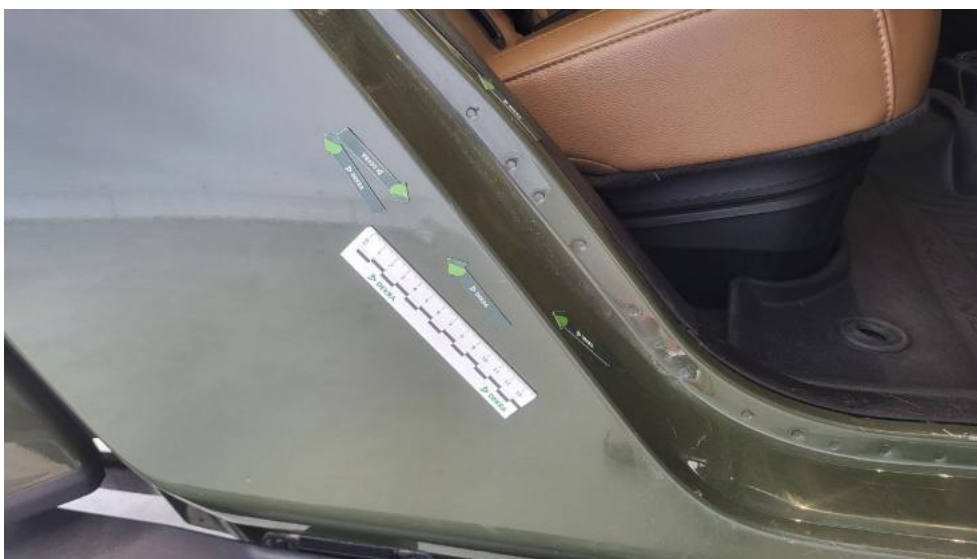
Photo 53.
Błotnik tylny P / Ściana boczna P - Wgniecenie/odkształcenie 1

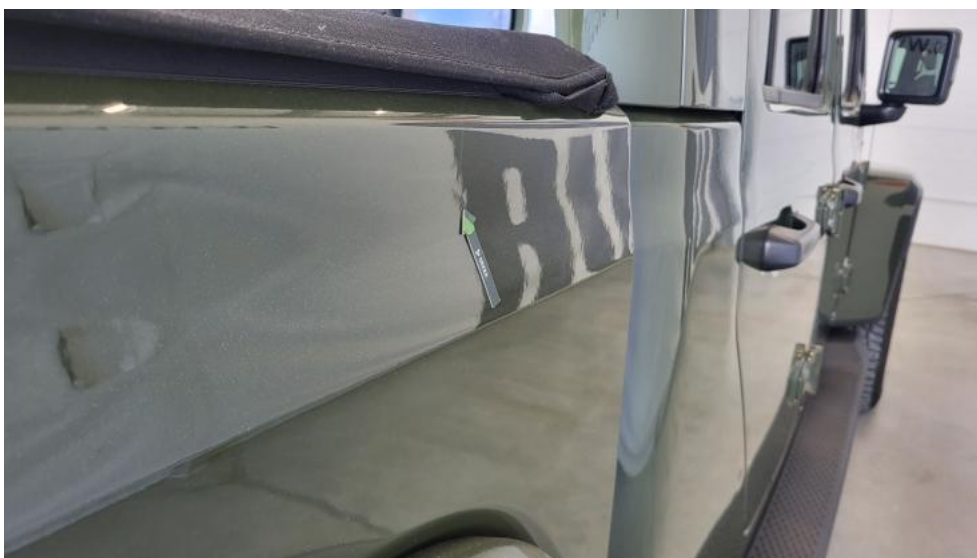
Photo 54.
Błotnik tylny P / Ściana boczna P - Wgniecenie/odkształcenie 2

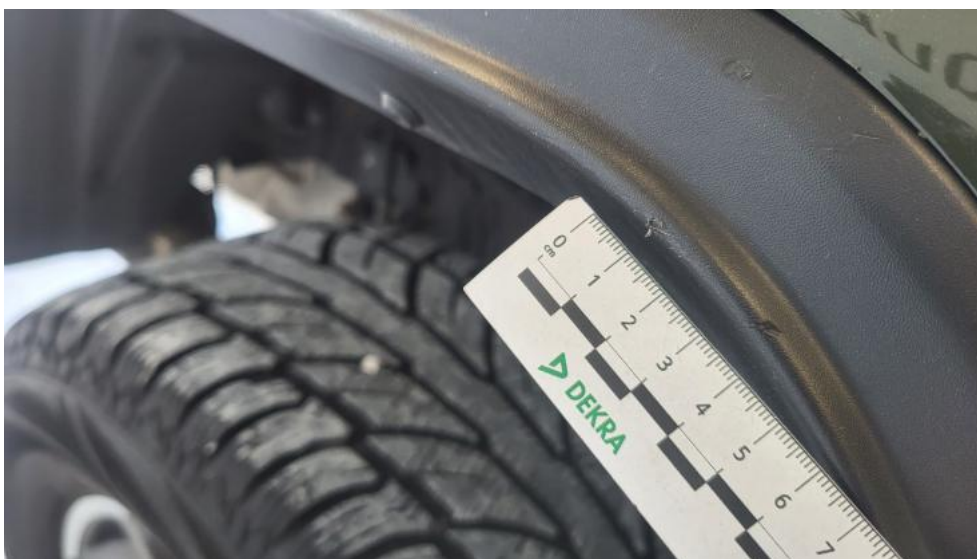
Photo 55.

Listwa krawędzi błotnika tył P - Rysa/odprysk 1

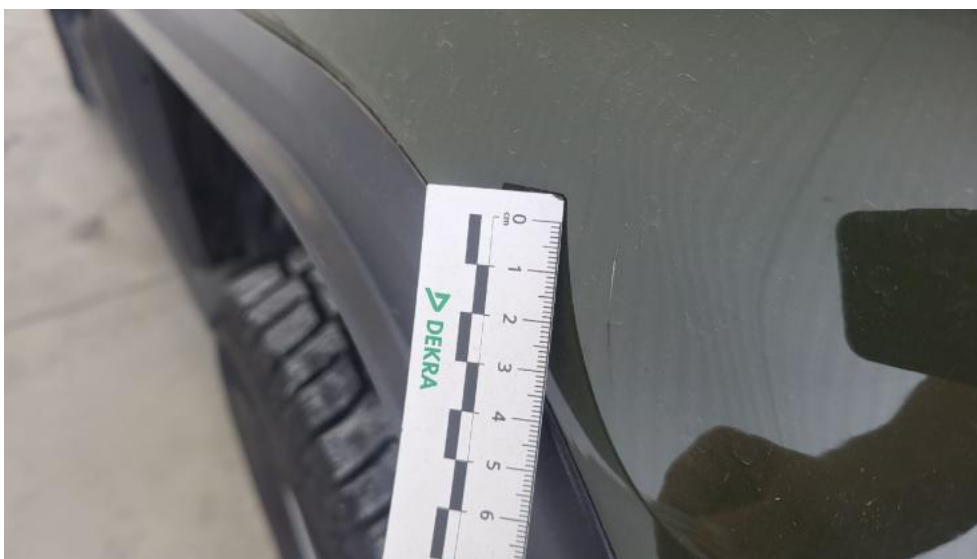
Photo 59.
Błotnik tylny L / Ściana boczna L - Rysa/odprysk 1

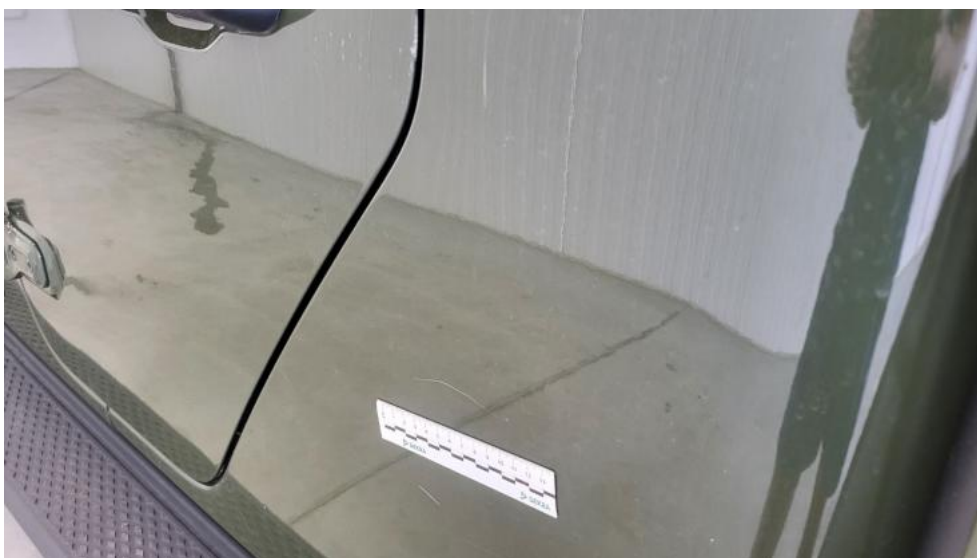
Photo 60.
Błotnik tylny L / Ściana boczna L - Rysa/odprysk 2

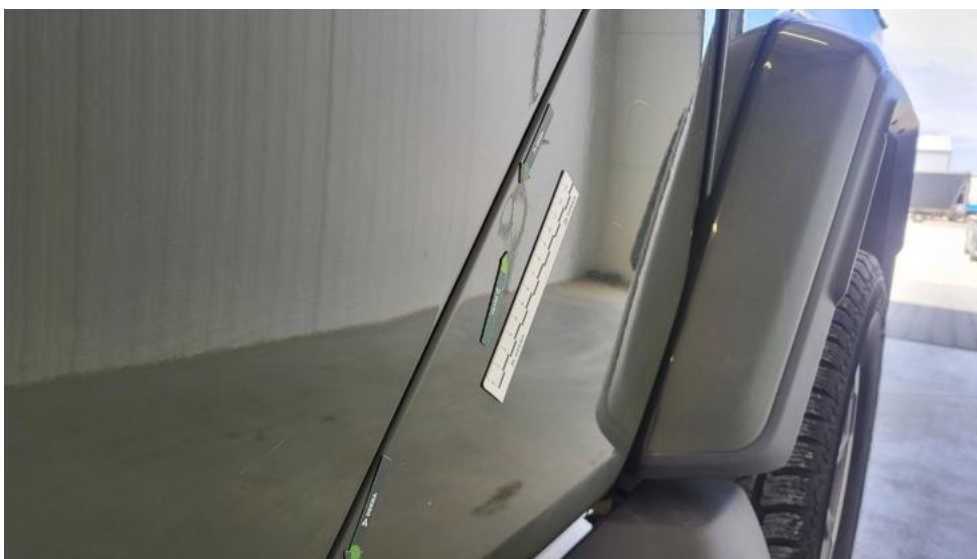
Photo 61.
Błotnik tylny L / Ściana boczna L - Wgniecenie/odkształcenie 1

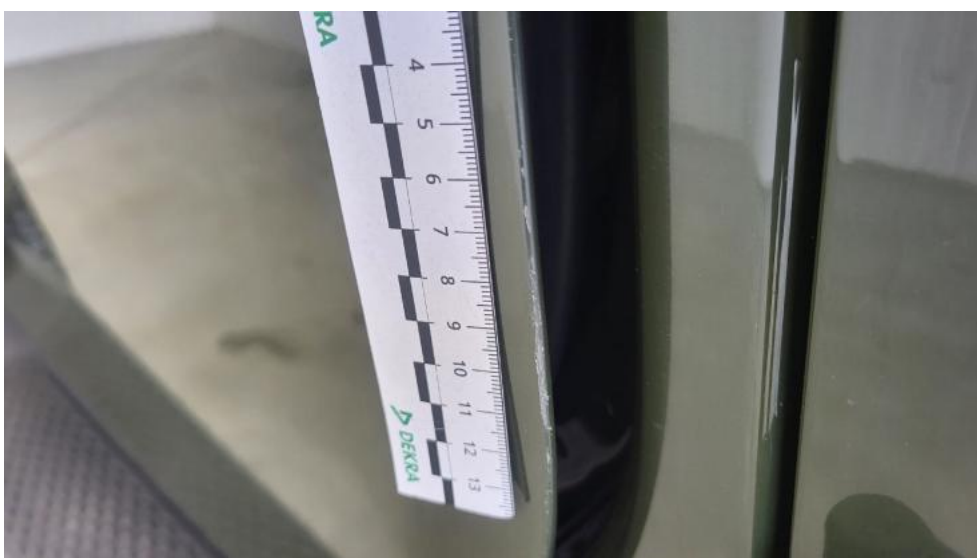
Photo 62.
Drzwi przed L - Rysa/odprysk 1

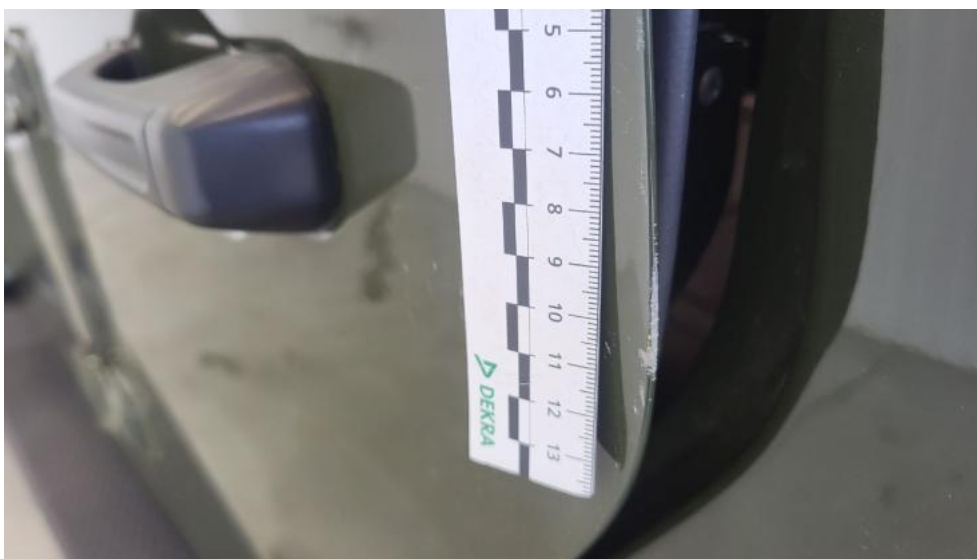
Photo 63.
Drzwi tylne L - Rysa/odprysk 1

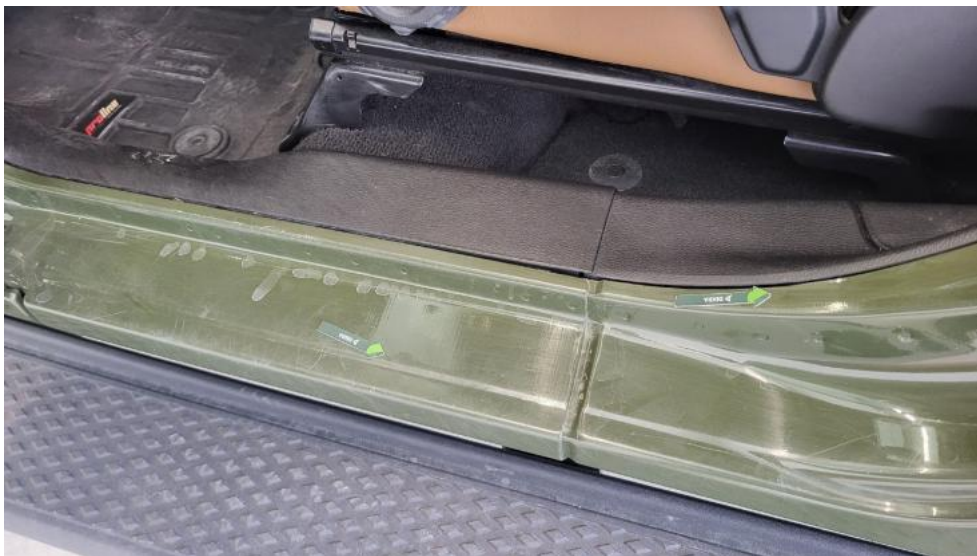
Photo 67.
Próg L - Wgniecenie/odkształcenie 1

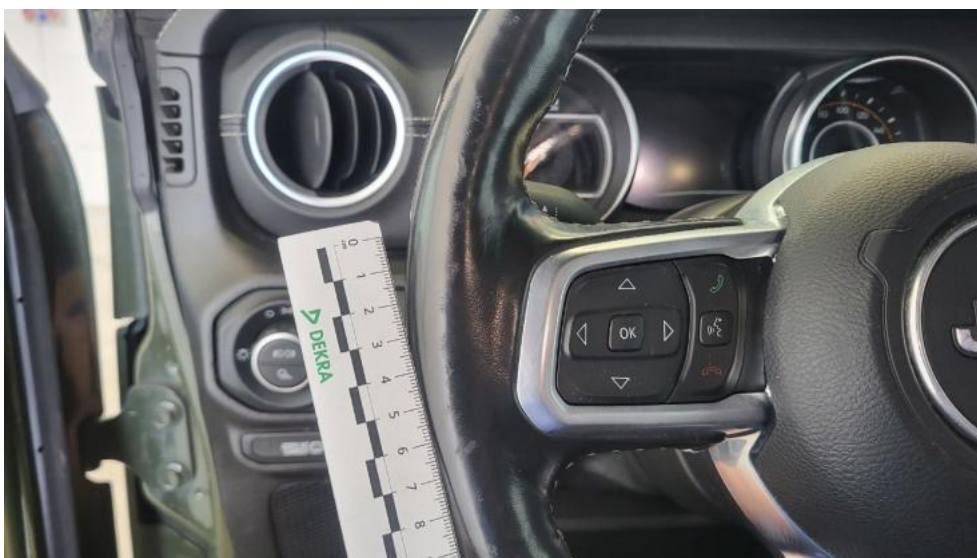
Photo 68.
Koło kierownicy - Rysa/odprysk 1

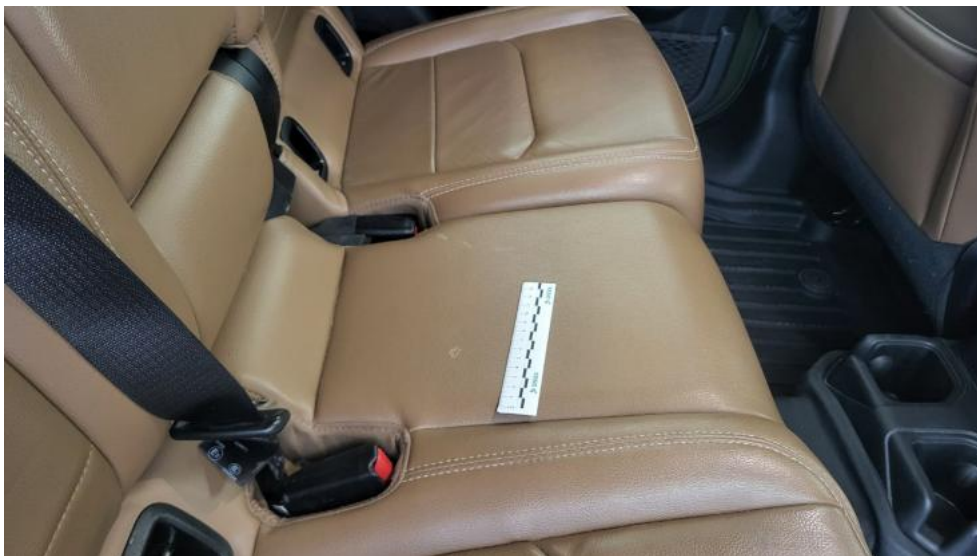
Photo 69.
Kanapa tyl. - Inne 1
