DEKRA's commission No. : PKOL(W)/LODZ/24306/25/04/02  
commission/ damage No. : 22/014581  
Date of commission: 02-04-2025

**Vehicle data**

| Manufacturer | AUDI |
| Type / version | SQ7 4.0 TDI Quattro Tiptr. |

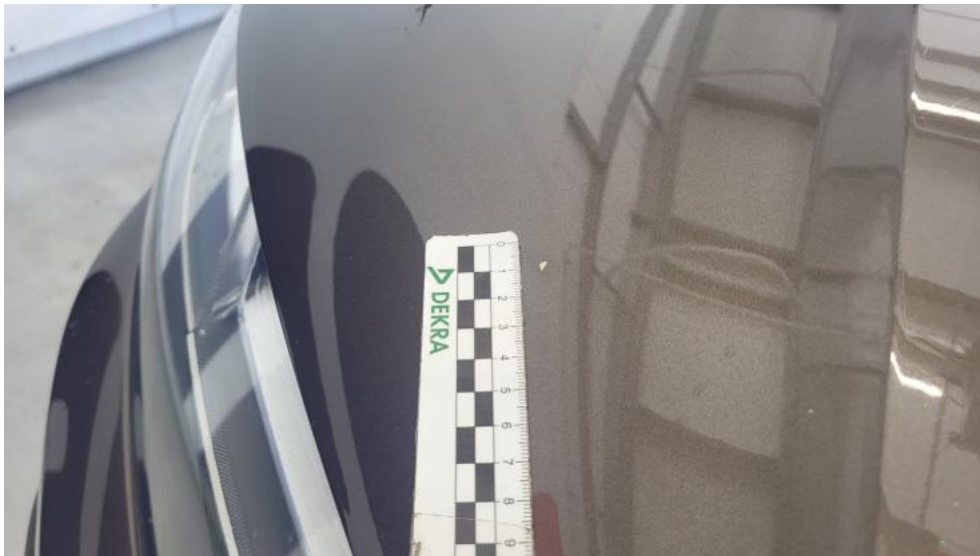
**Photo 41.**

Pokrywa komory silnika - Rysa/odprysk 1

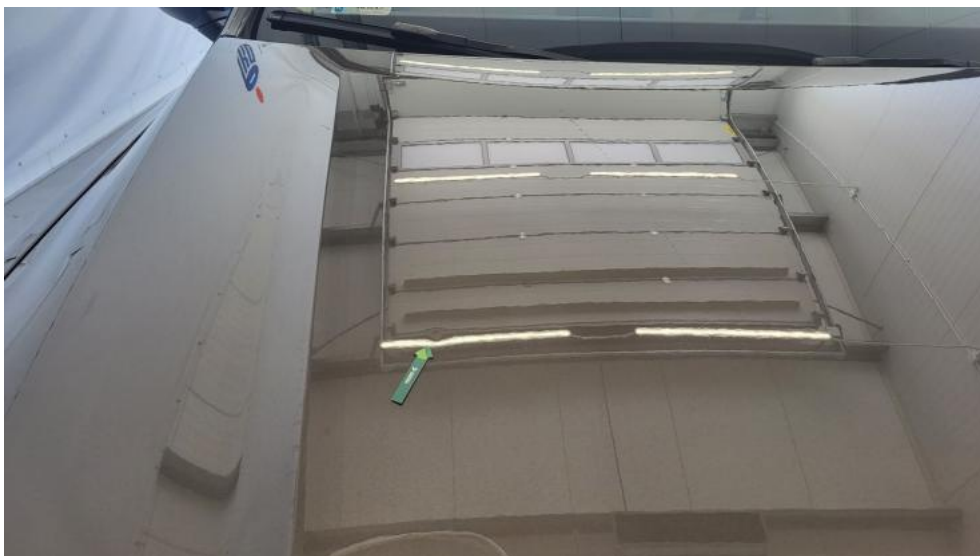
**Photo 42.**

Pokrywa komory silnika - Wgniecenie/odkształcenie 1

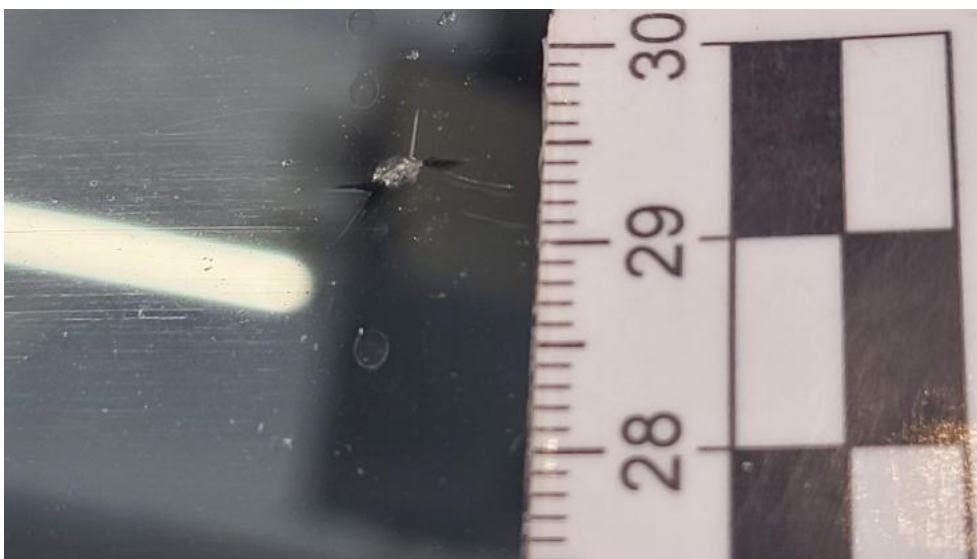
**Photo 45.**

Rysy na samochodzie. Aktywna kontrolka silnika. Odpryski na szybie czołowej. Mocowania podłogi bagażnika nie blokuje się do weryfikacji serwisowej.

Szyba czołowa - Pęknięcie/rozerwanie 1

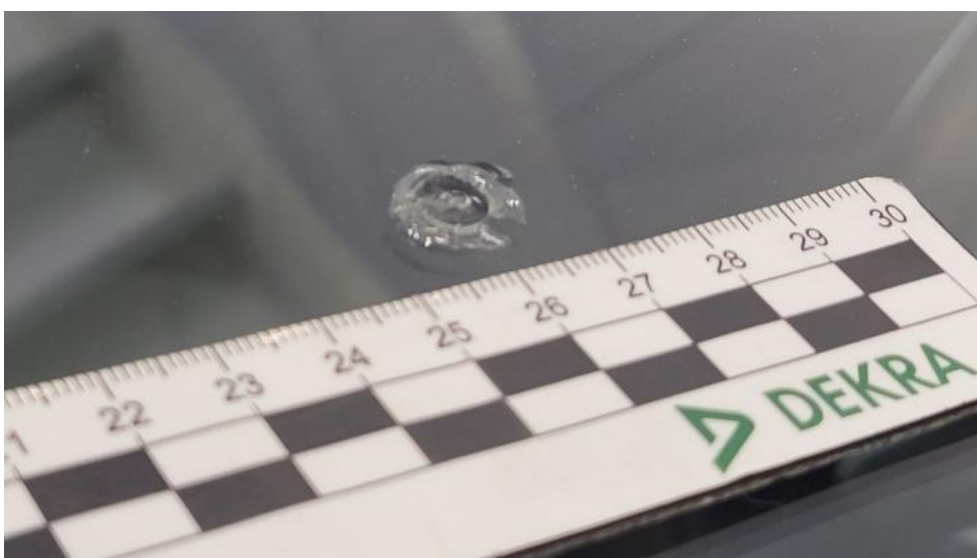
**Photo 46.**

Szyba czołowa - Pęknięcie/rozerwanie 2

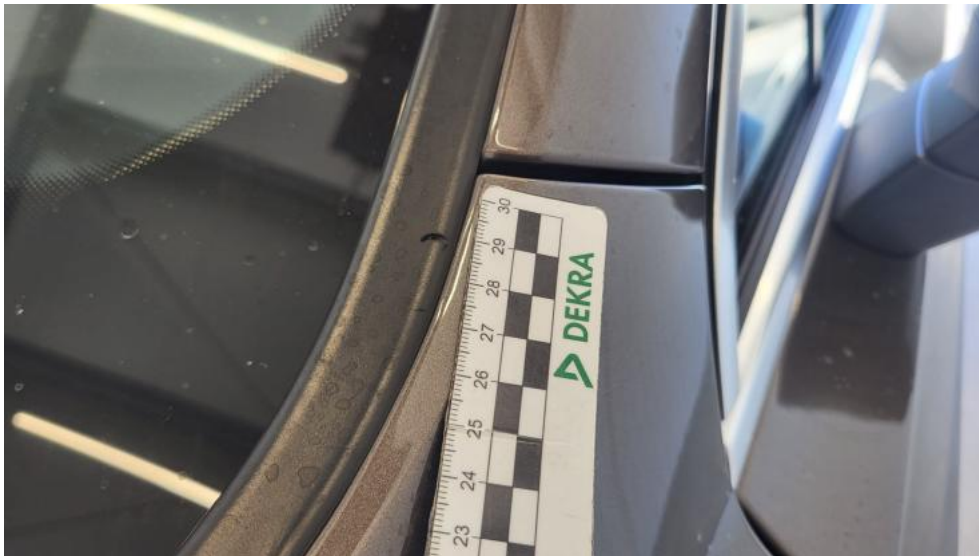
**Photo 47.**

Uszczelka/listwa szyby czołowej - Rysa/odprysk 1

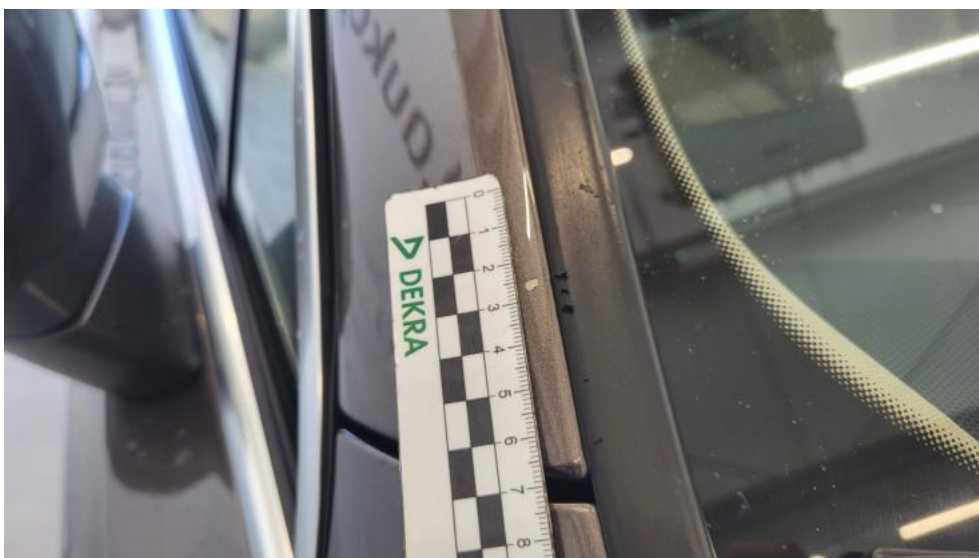
**Photo 48.**

Uszczelka/listwa szyby czołowej - Rysa/odprysk 2

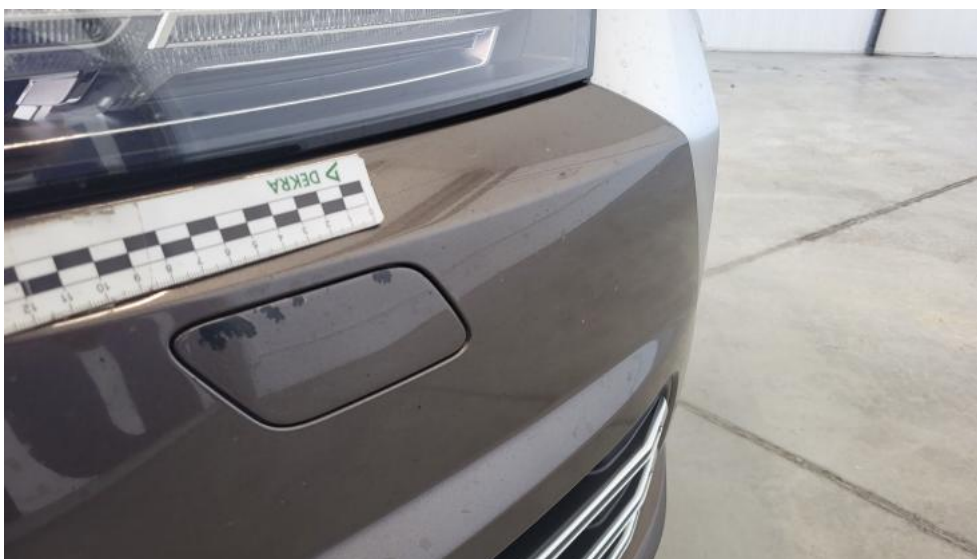
**Photo 49.**

Zaślepka prz haka hol. - Rysa/odprysk 1

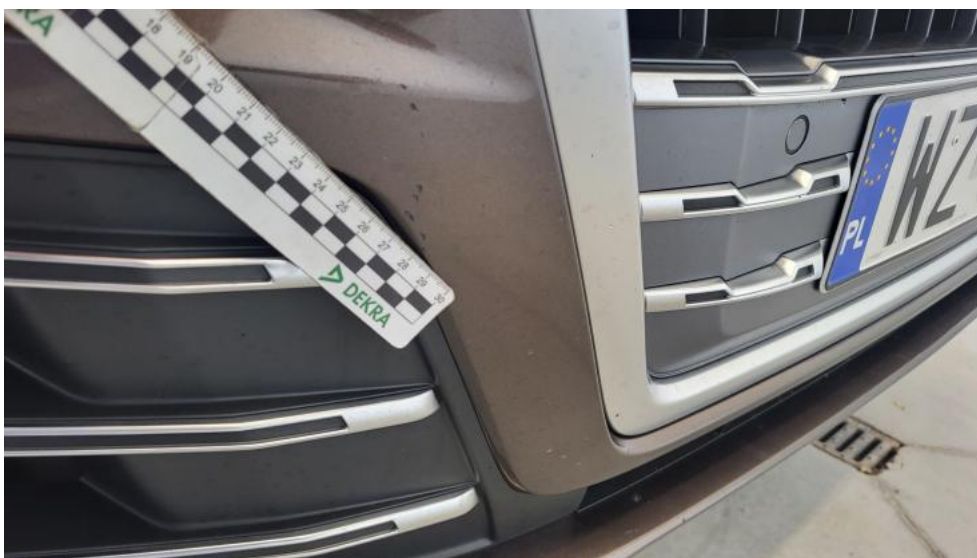
**Photo 50.**

Zderzak - Rysa/odprysk 1

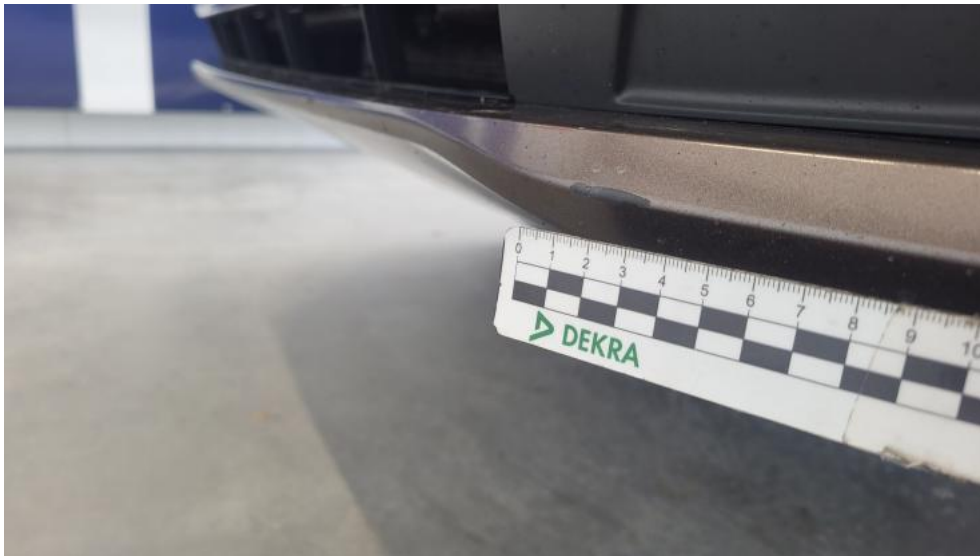
**Photo 51.**

Zderzak - Rysa/odprysk 2

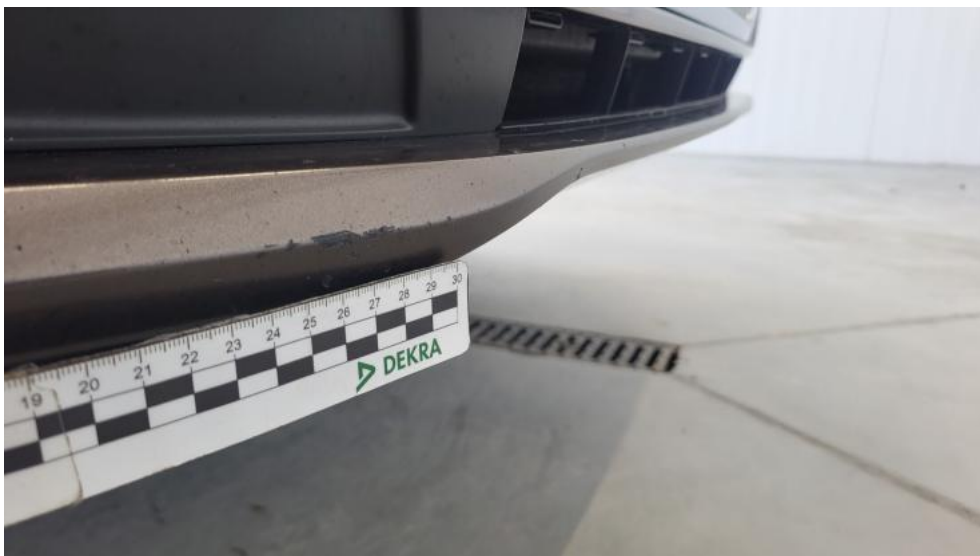
**Photo 52.**

Zderzak() - Rysa/odprysk 3

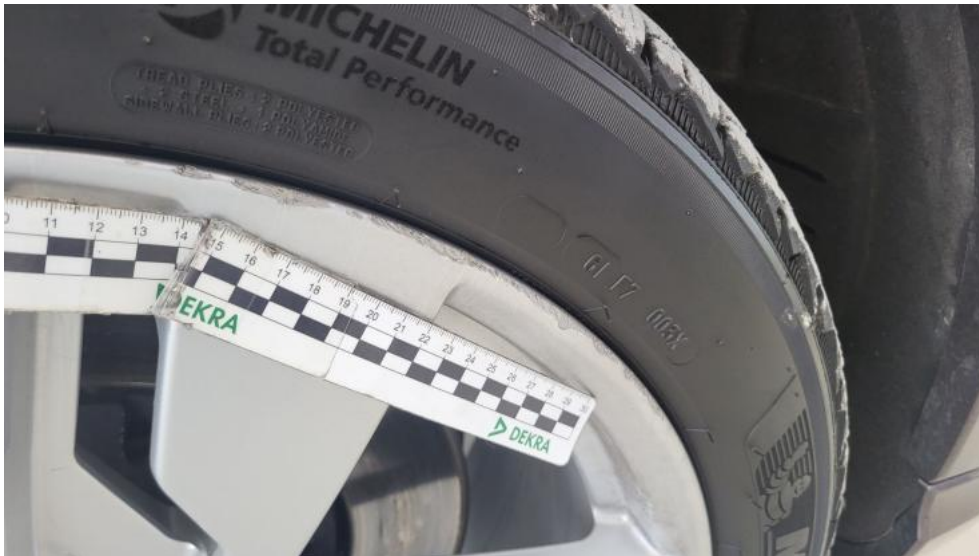
**Photo 53.**

Felga aluminiowa przednia P - Rysa/odprysk 1

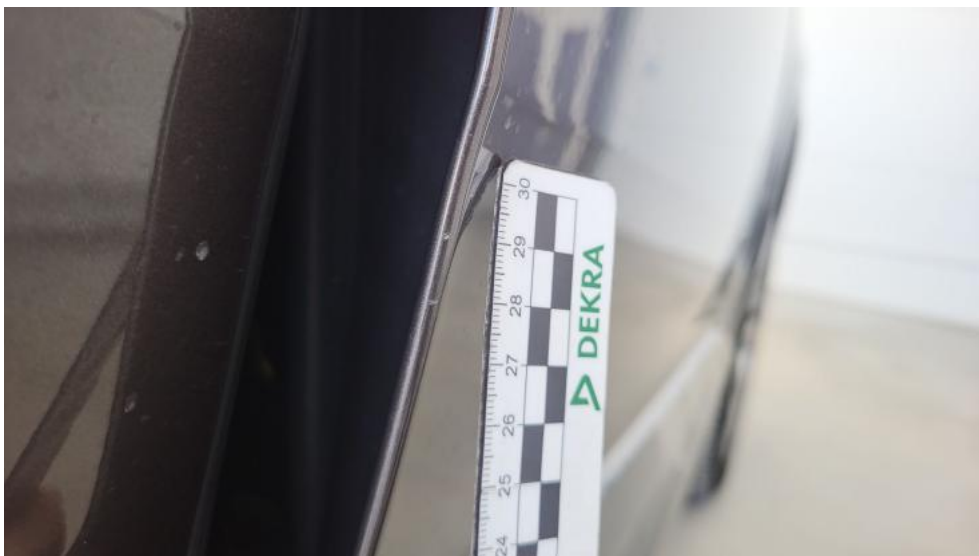
**Photo 54.**

Drzwi przednie P - Rysa/odprysk 1

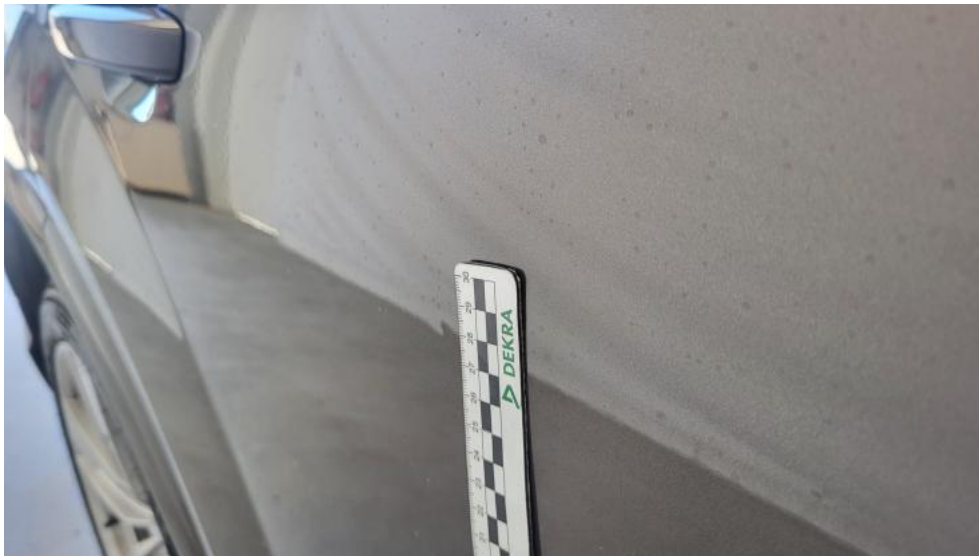
**Photo 55.**

Drzwi tylne P - Wgniecenie/odkształcenie 1

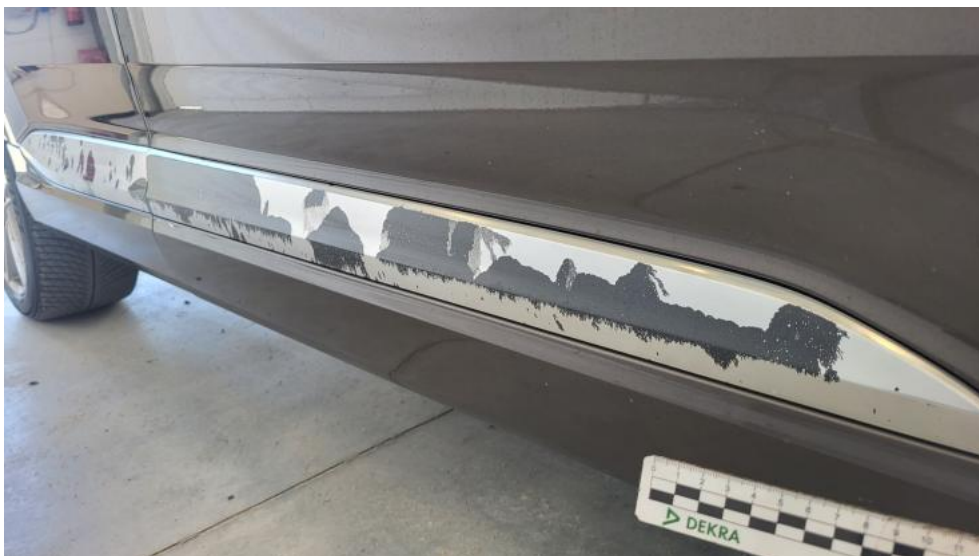
**Photo 56.**

Listwa drzwi przednich P - Inne 1

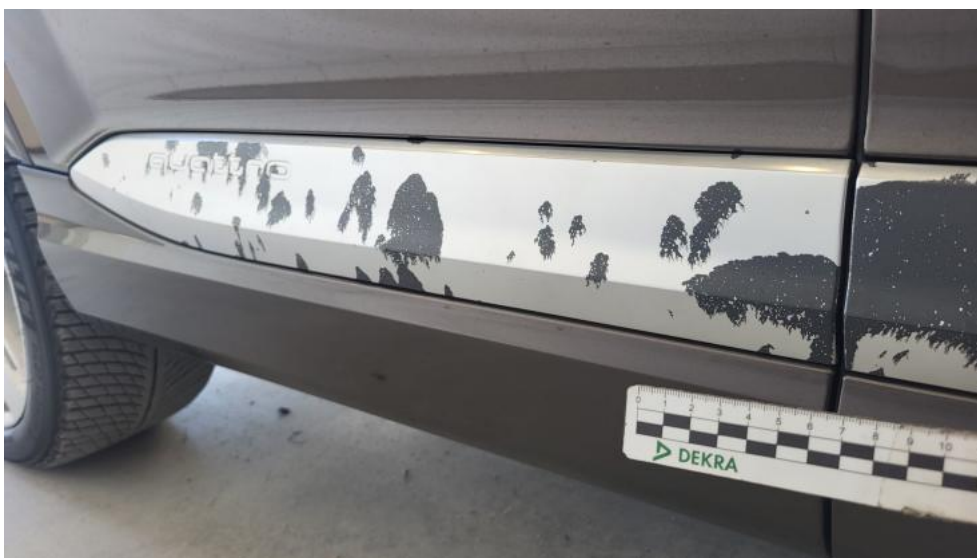
**Photo 58.**

Listwa drzwi tylnych P - Inne 1

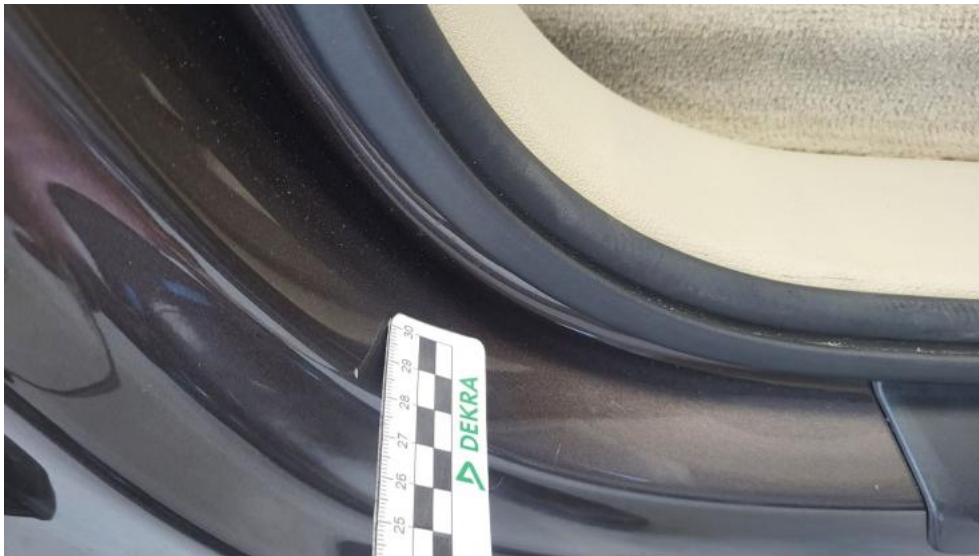
**Photo 59.**

Próg P - Rysa/odprysk 1

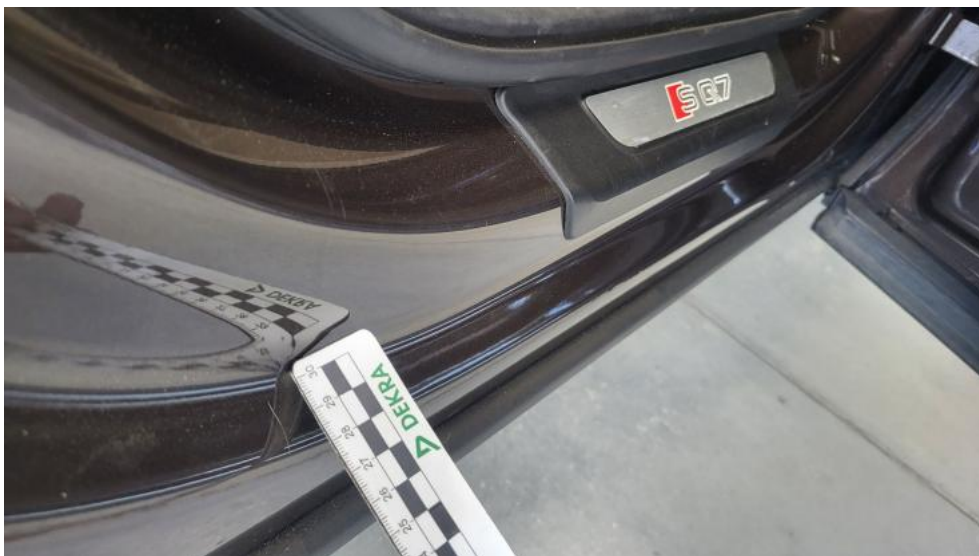
**Photo 60.**

Próg P - Rysa/odprysk 2

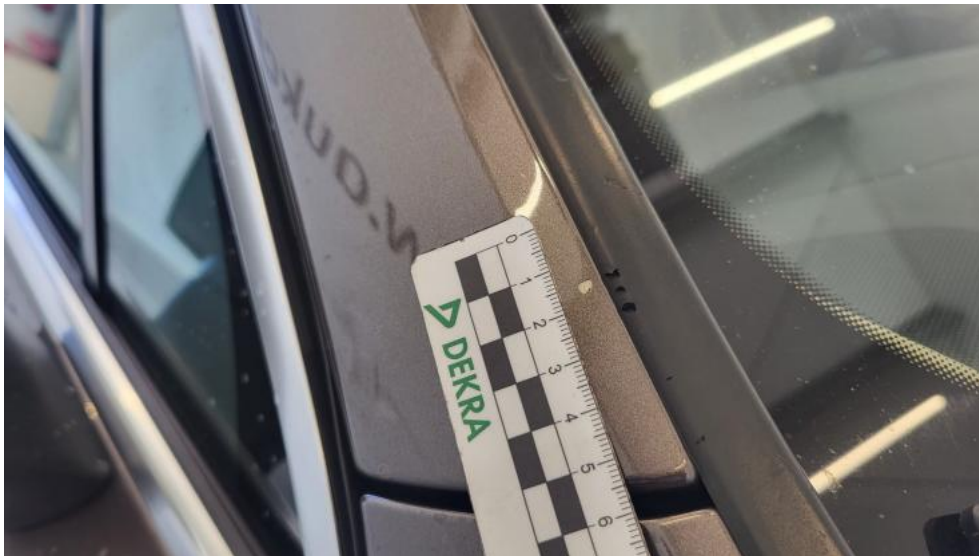
**Photo 61.**

Stupek przedni P - Rysa/odprysk 1

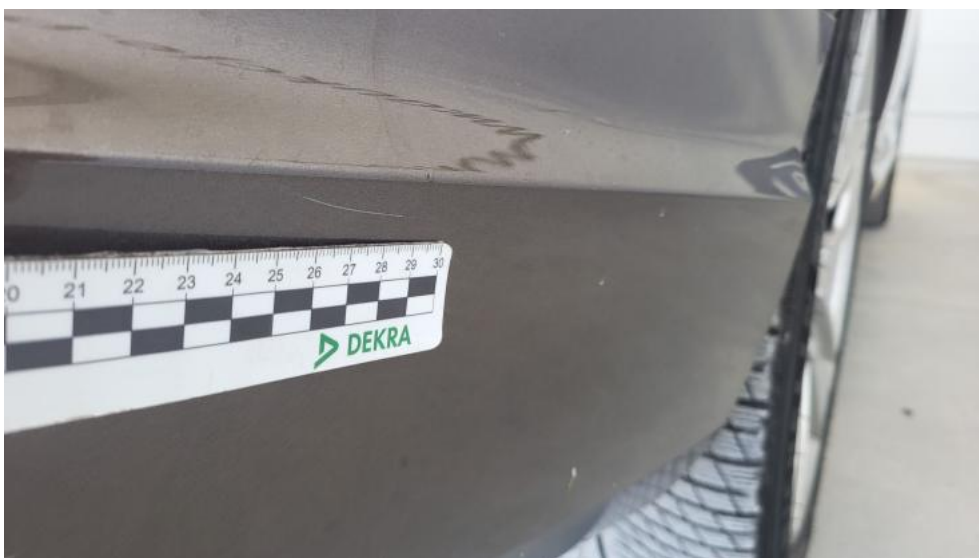
**Photo 62.**

Zderzak tylny - Rysa/odprysk 1

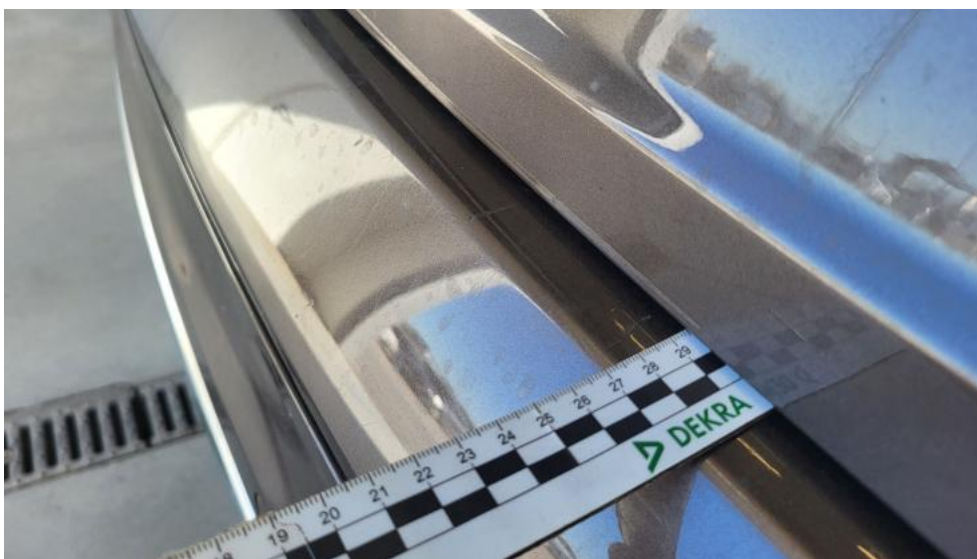
**Photo 63.**

Zderzak tylny - Rysa/odprysk 2

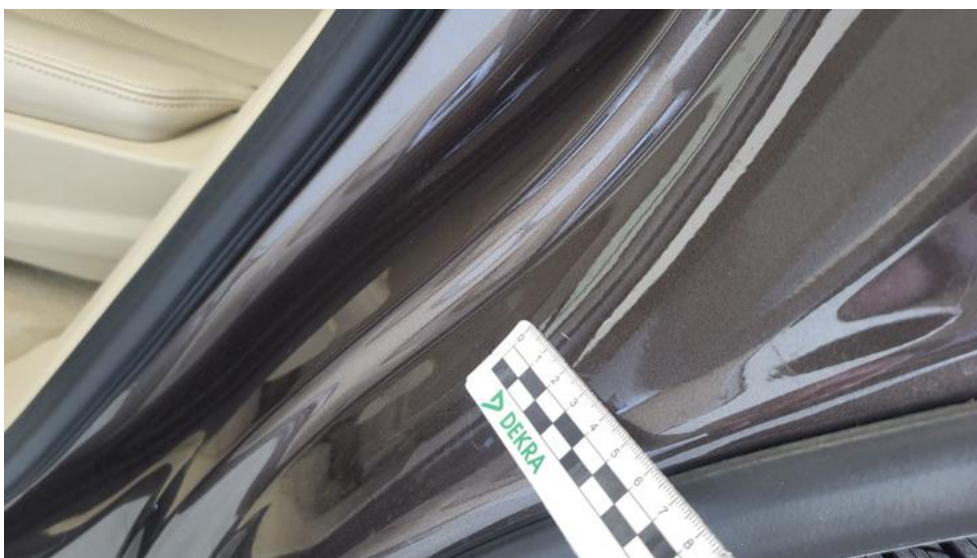
**Photo 64.**

Błotnik tylny L / Ściana boczna L - Rysa/odprysk 1

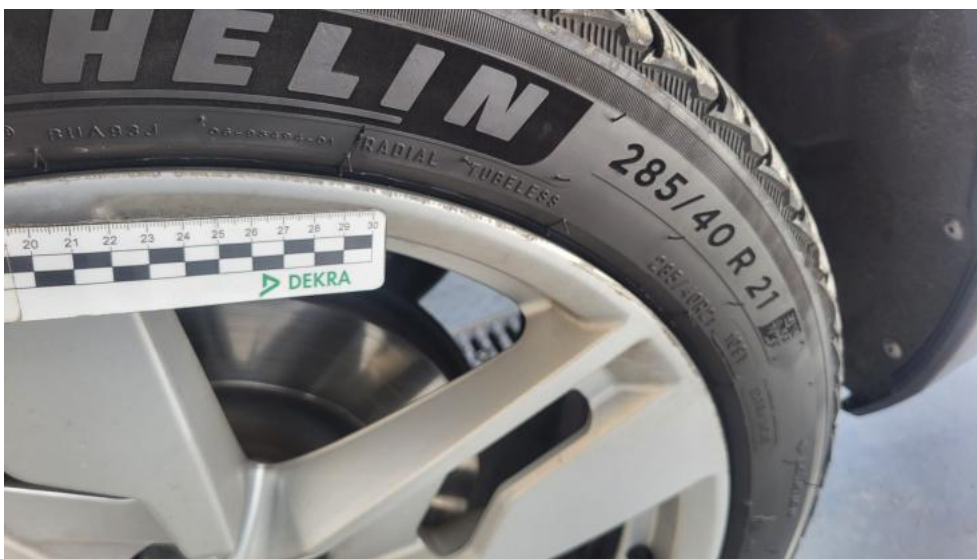
**Photo 65.**

Felga aluminiowa tylna L - Rysa/odprysk 1

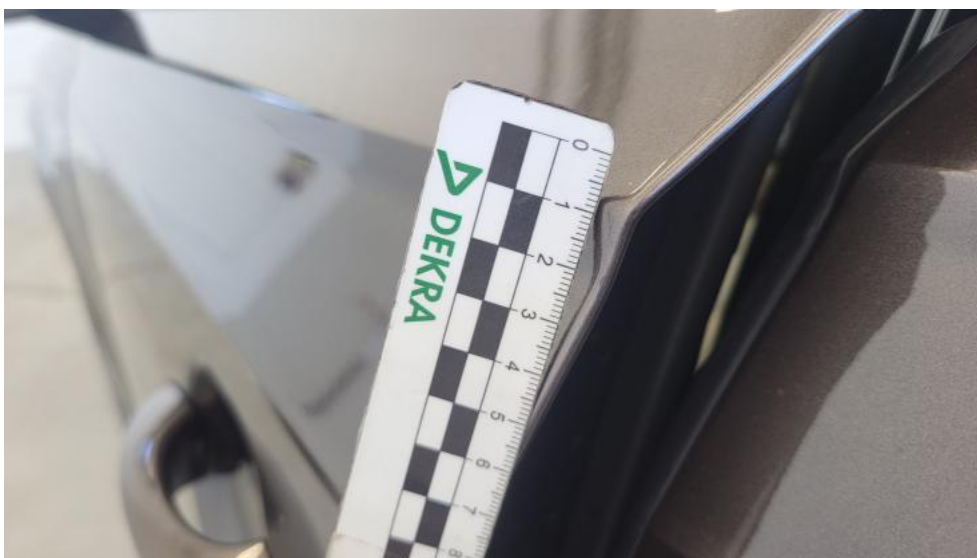
**Photo 66.**

Drzwi przed L - Rysa/odprysk 1

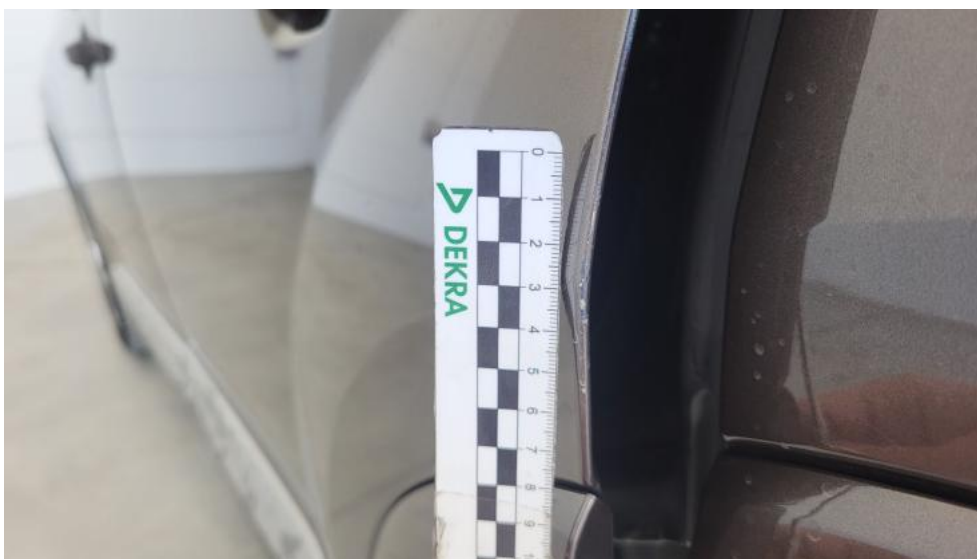
**Photo 67.**

Drzwi tylne L - Rysa/odprysk 1

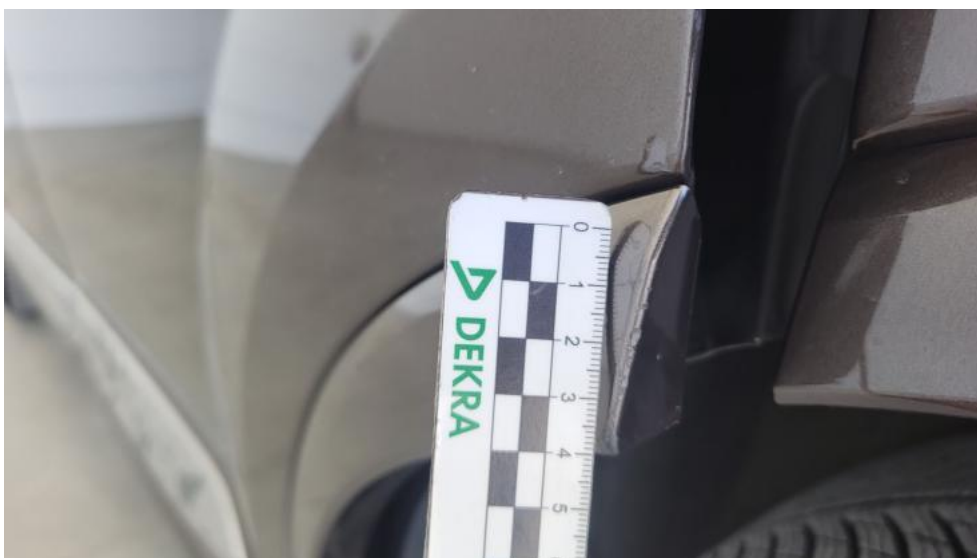
**Photo 68.**

Listwa drzwi przednich L - Rysa/odprysk 1

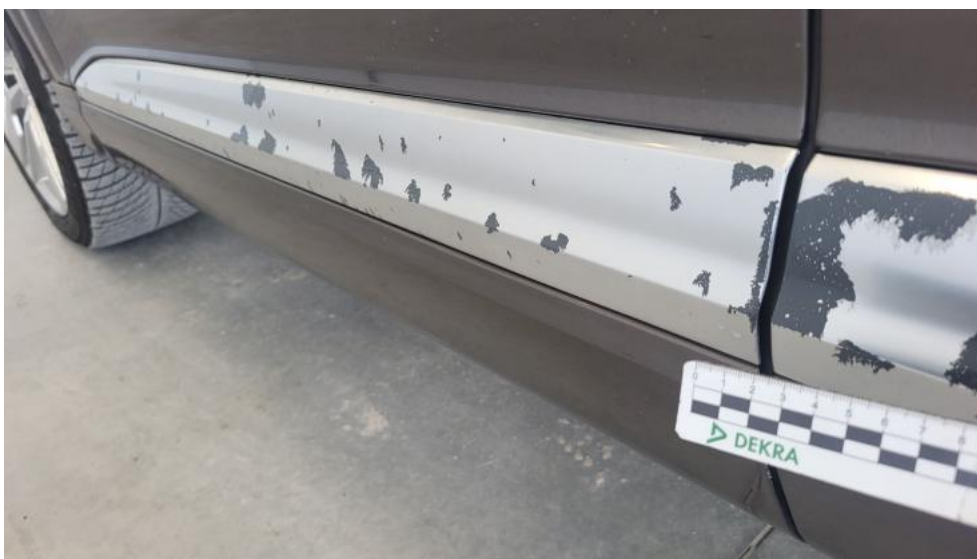
**Photo 69.**

Listwa drzwi przednich L - Inne 1

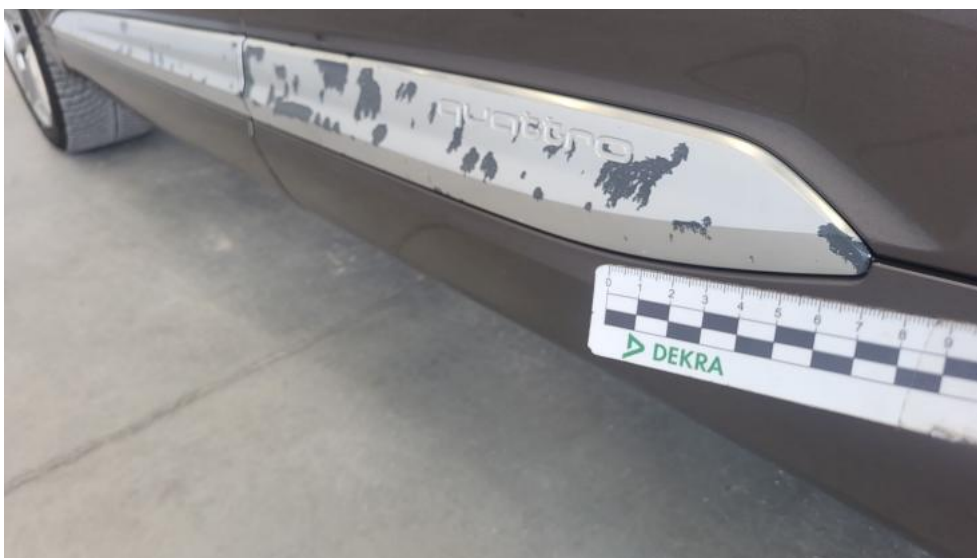
**Photo 70.**

Listwa drzwi tylnych L - Inne 1

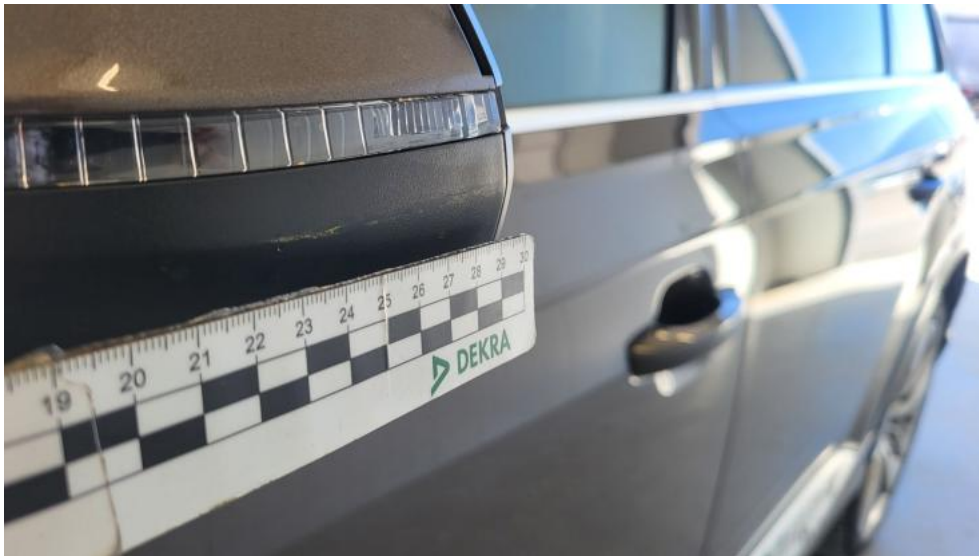
**Photo 71.**

Lusterko zew L - Rysa/odprysk 1

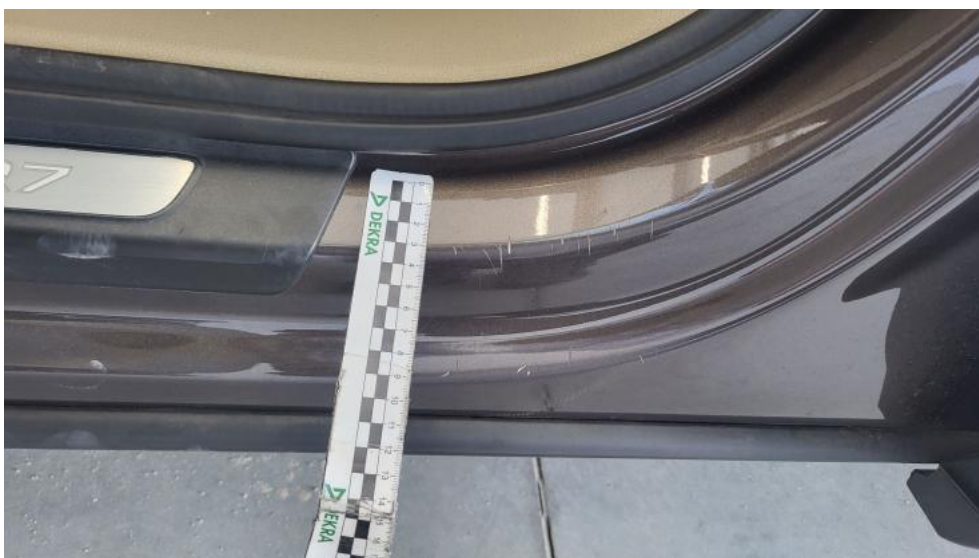
**Photo 72.**

Próg L - Rysa/odprysk 1

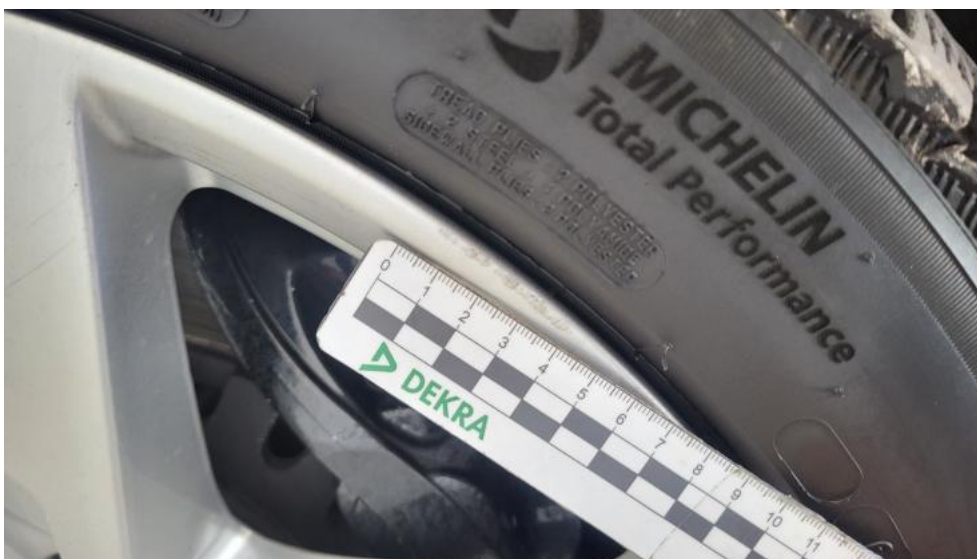
**Photo 73.**

Felga Aluminiowa przednia L - Rysa/odprysk 1

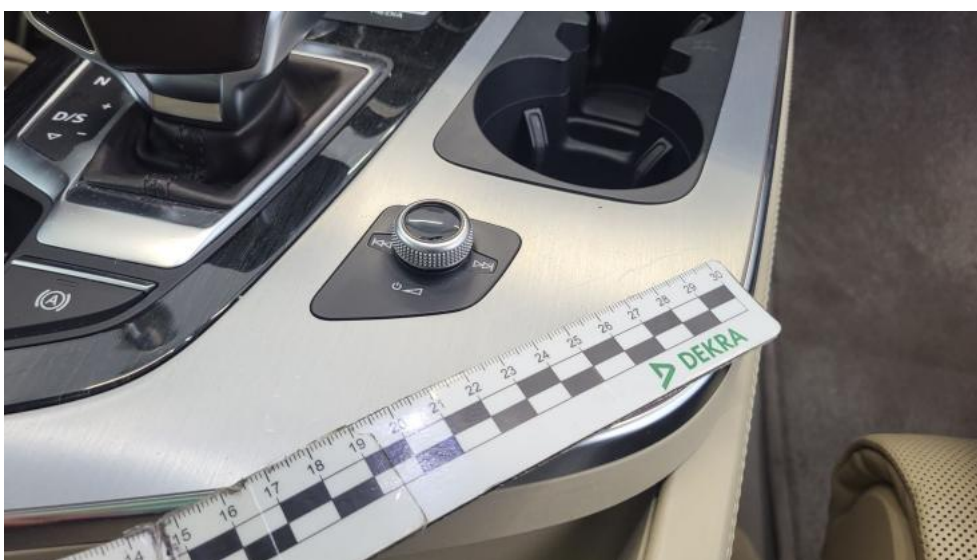
**Photo 74.**

Konsola tunelu śr. - Rysa/odprysk 1

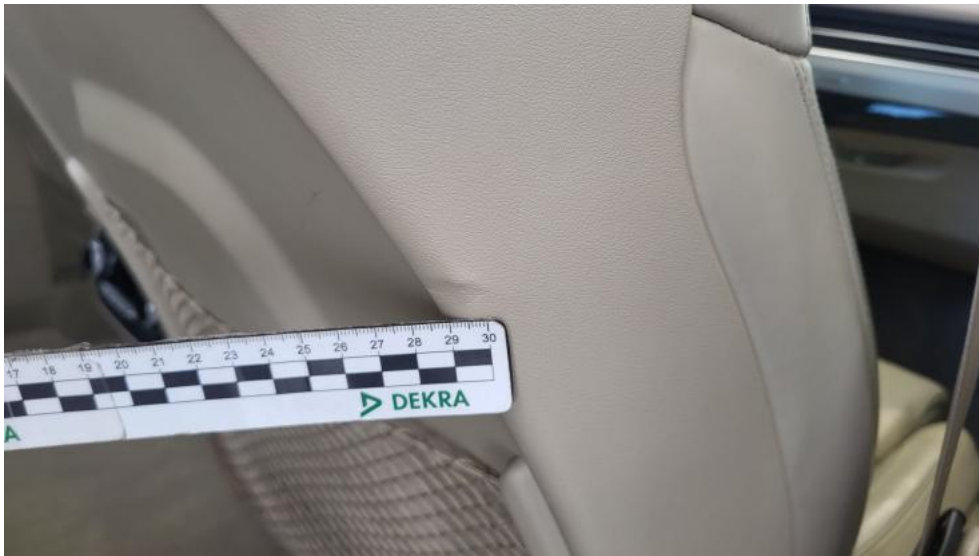
**Photo 77.**

Fotel prz. praw. - Wgniecenie/odkształcenie 1

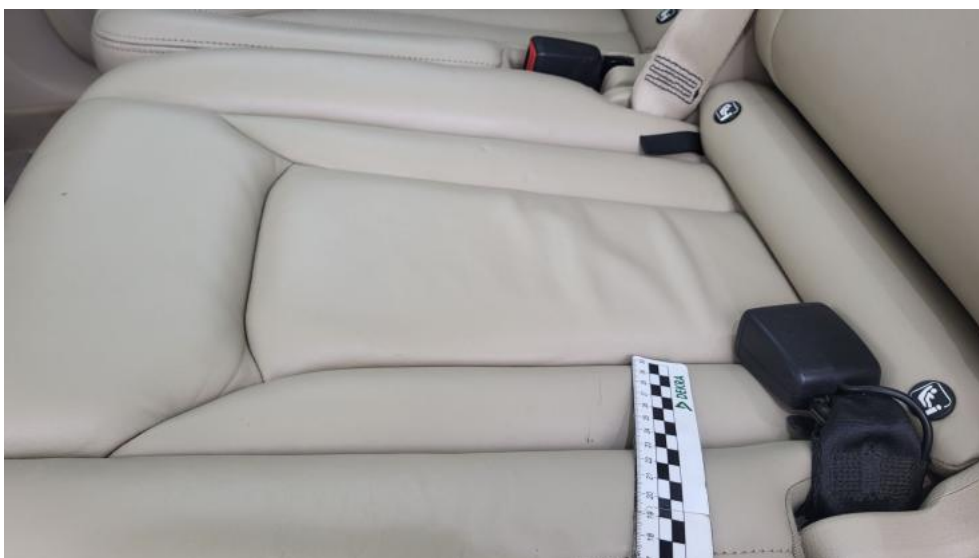
**Photo 78.**

Kanapa tyl. - Rysa/odprysk 1

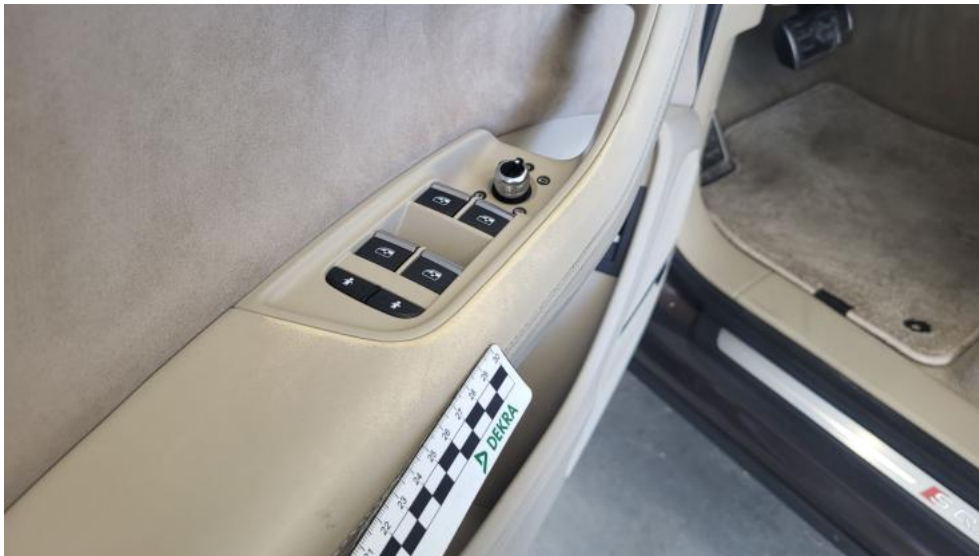
**Photo 79.**

Tapicerka drzwi przednich L - Inne 1

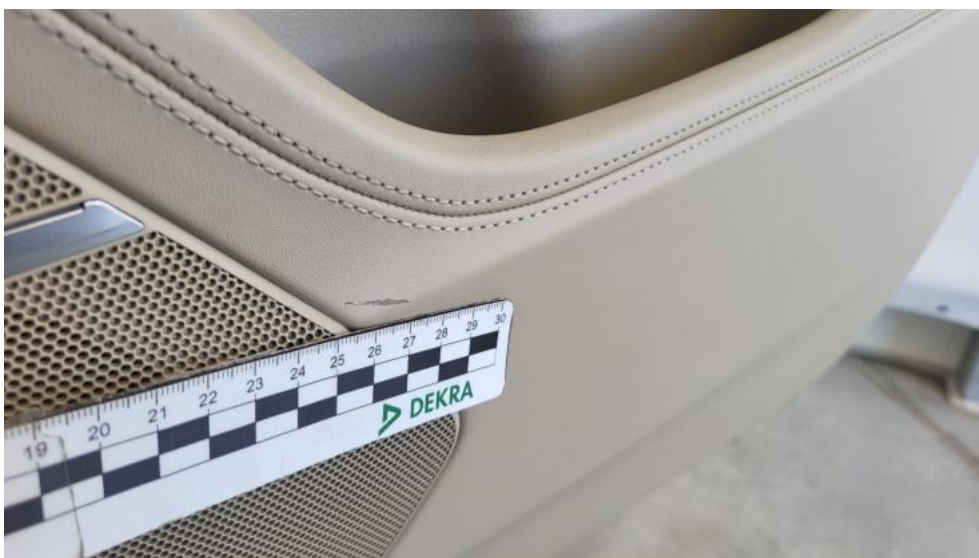
**Photo 80.**

Tapicerka drzwi przednich P - Rysa/odprysk 1

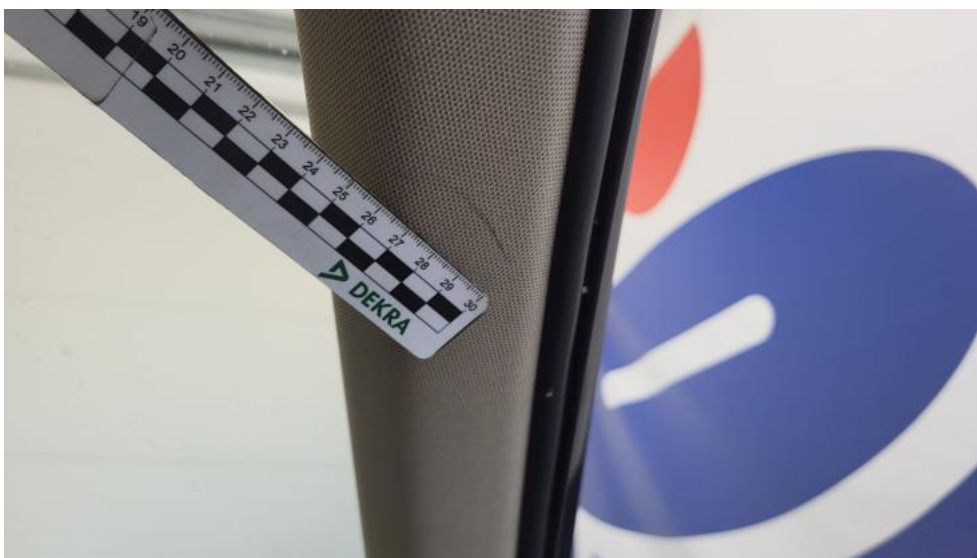
**Photo 82.**

Wykładzina(y) słupka przedniego P - Inne 1

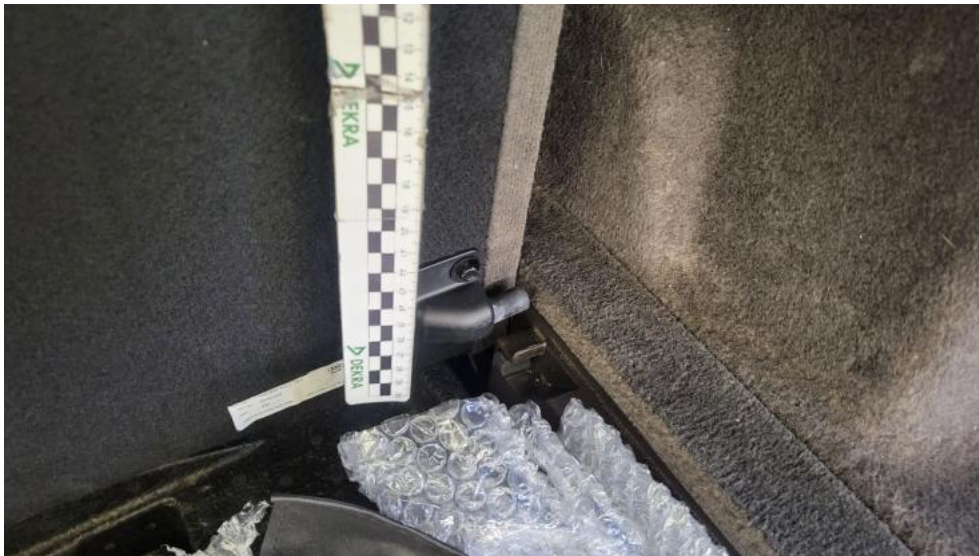
**Photo 83.**

Wykładzina podłogi bagażnika - Inne 1

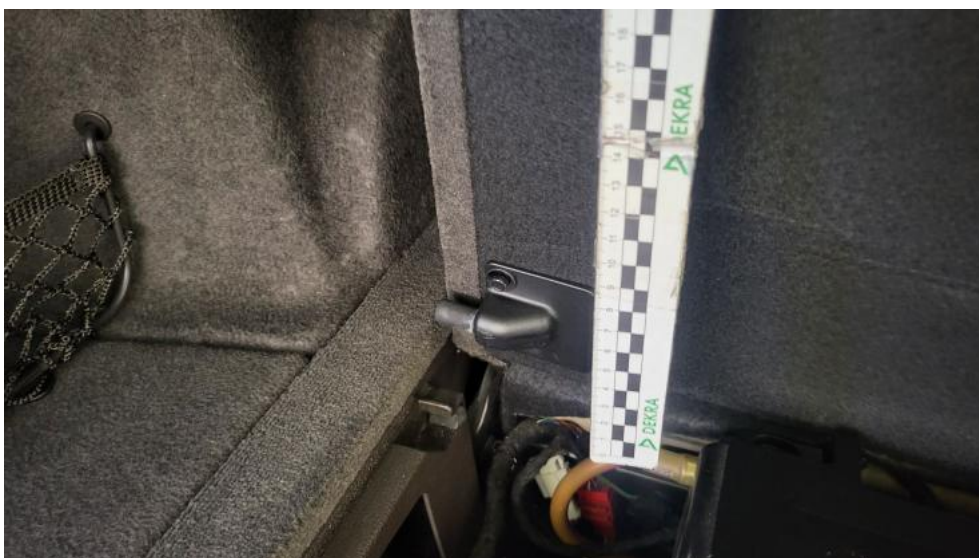
**Photo 84.**

Wykładzina podłogi bagażnika - Inne 2
