DEKRA's commission No. : PKOL(W)/LODZ/101984/25/12/23  
commission/ damage No. : 23/006622  
Date of commission: 23-12-2025

| Manufacturer | CUPRA |
| Type / version | Born 58kWh E-Boost |
| Registration /record No. | WP0013R |

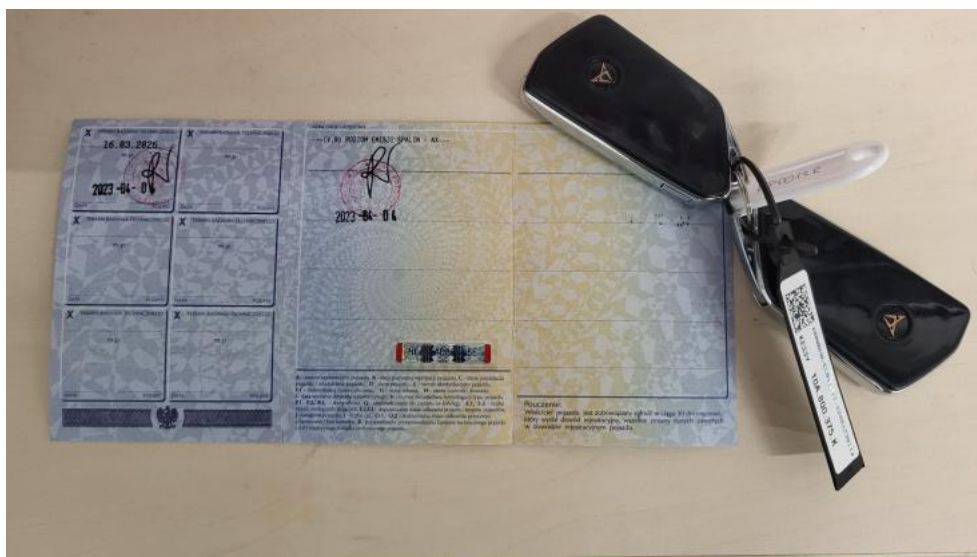
**Photo 33.**

Niesprawne przyciski funkcyjne w jednym z kluczyków, grot prawidłowy. Rysy na samochodzie. Pojazd elektryczny. Informacja: zalecane wykonanie przeglądu.

Dow. Rej. Str.2 i klucze

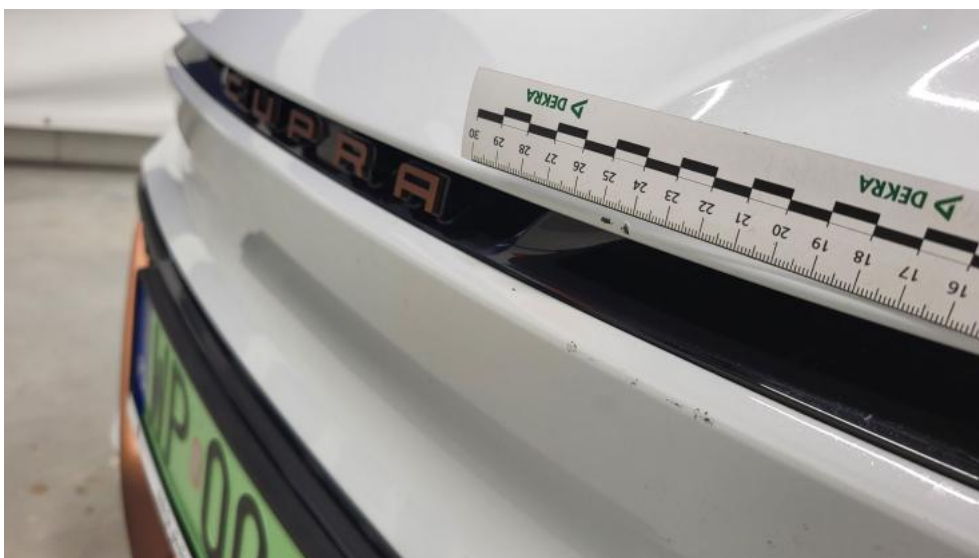
**Photo 42.**

Atrapa przednia - Wgniecenie/odkształcenie 1

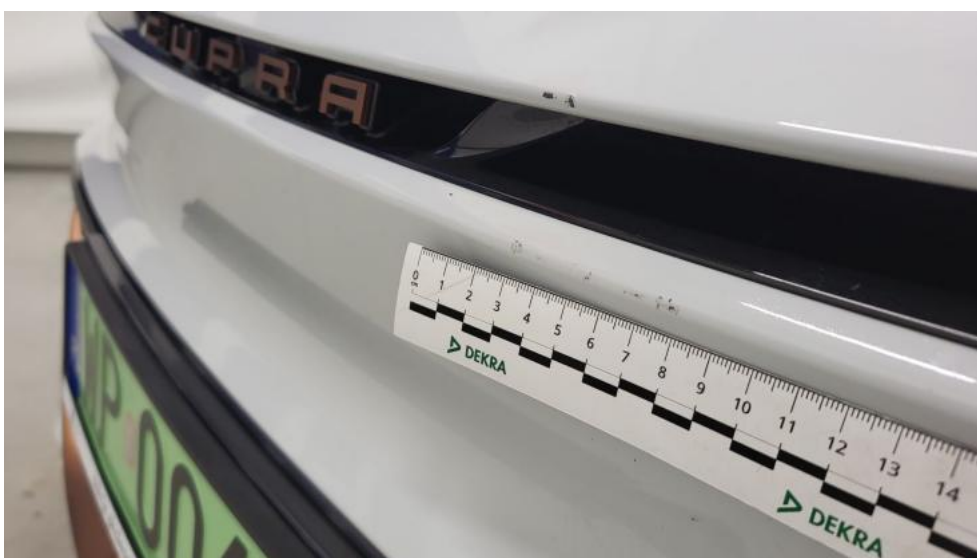
**Photo 44.**

Zderzak - Rysa/odprysk 1

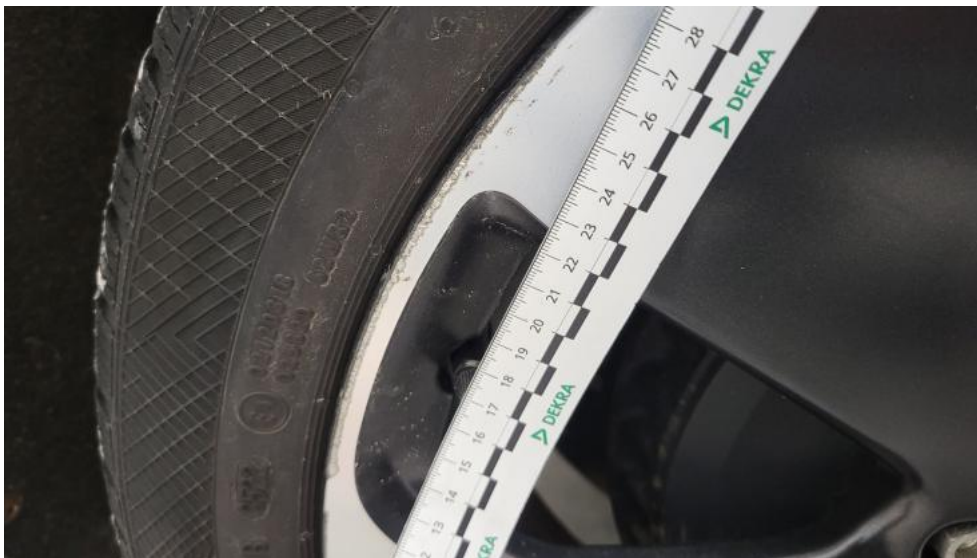
**Photo 47.**

Felga aluminiowa tylna P - Rysa/odprysk 1

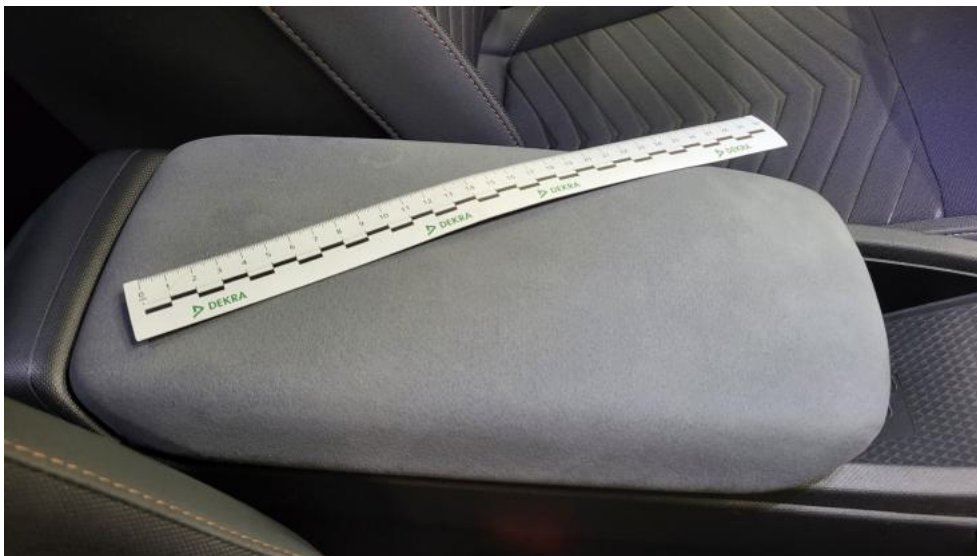
**Photo 49.**

Podłokietnik środkowy przedni - Inne 1

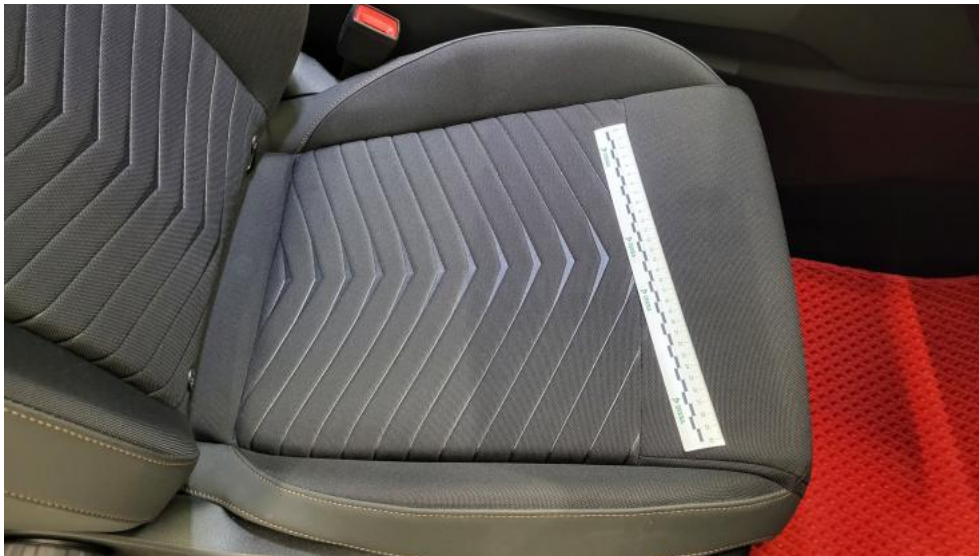
**Photo 51.**

Fotel prz. praw. - Inne 1

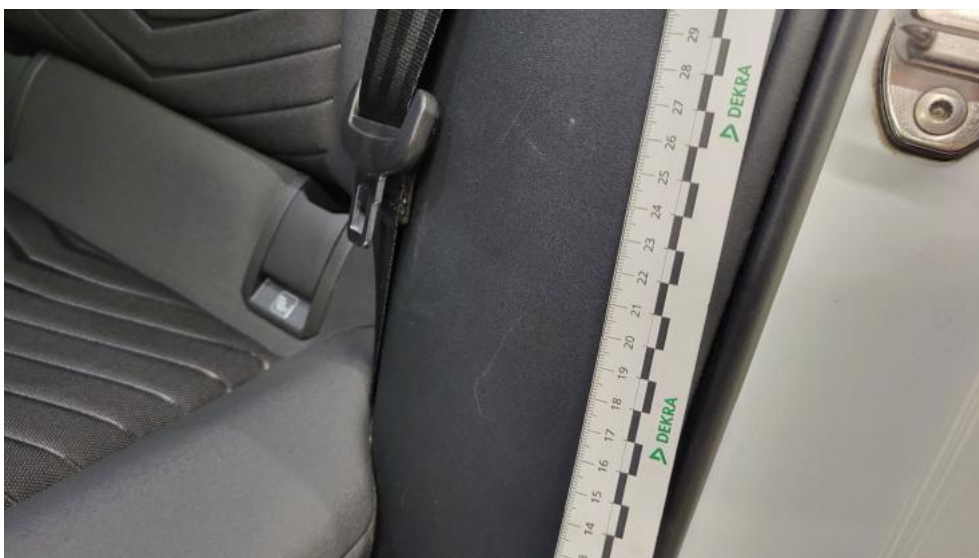
**Photo 52.**

Wykładzina(y) słupka tylnego L - Rysa/odprysk 1
