DEKRA's commission No. : PKOL(W)/LODZ/02270/26/01/12  
commission/ damage No. : 21/053854  
Date of commission: 12-01-2026

Group of objects (Eurotax)	jeeps
EC code (Eurotax)	0151586
Manufacturer	BMW
Model	X6 [G06] 19-23
Type / version	X6 M Competition
Body type	hatchback
Number of doors / seats	5/5
Curb weight [kg]	2320
Gross vehicle weight [kg]	3000
Wheelbase 1/2	2975
Engine type	spark ignition
Pollution reduction system	GPF
Engine capacity [ccm]	4395
Engine Power [hp/kW]	625/460
Gearbox	automatic
Registration /record No.	CB917NE
VIN / serial number	WBSCY010009J70612
Date of first registration	02-12-2021
Date of next. tech. test	02-12-2026
Year of manufacture	2021 (year has been verified with the manufacturer's base)
Readout [km]	141 326 (read)
Body color / type of coating	grafit/czarny/double-layered, metallized

Measurement of thickness of the vehicle lacquer coating

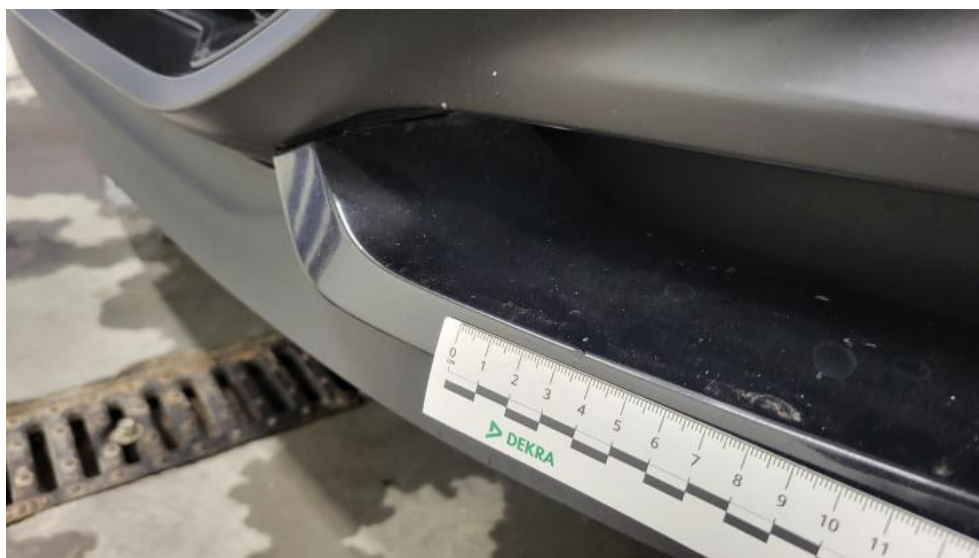
**Photo 48.**  
Kratka/zaślepka halogenu L - Rysa/odprysk 1

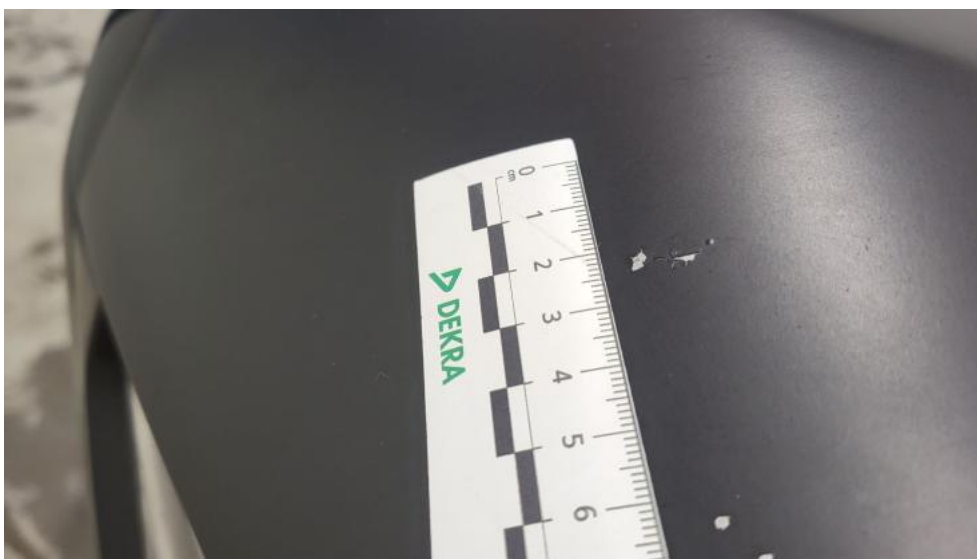
**Photo 49.**  
Pokrywa komory silnika - Rysa/odprysk 1

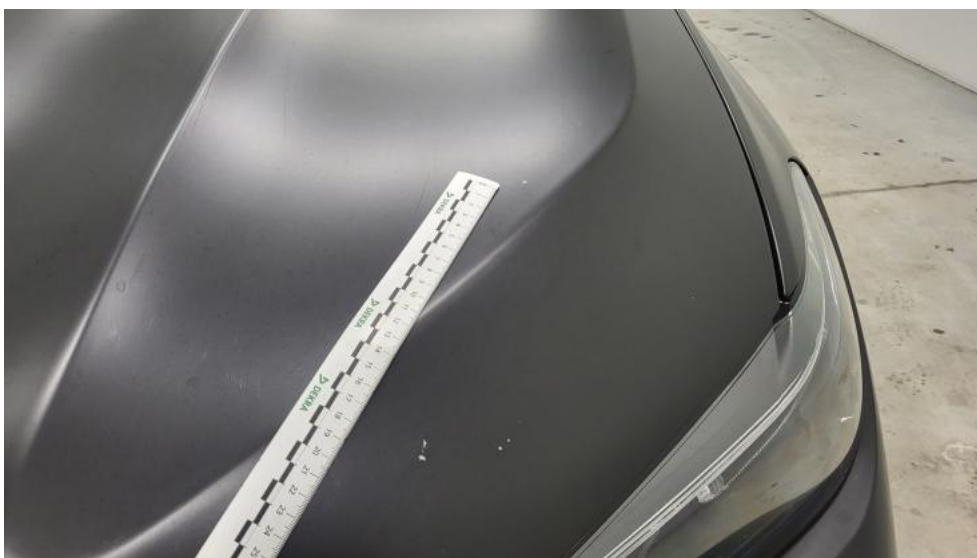
**Photo 50.**  
Pokrywa komory silnika - Inne 1

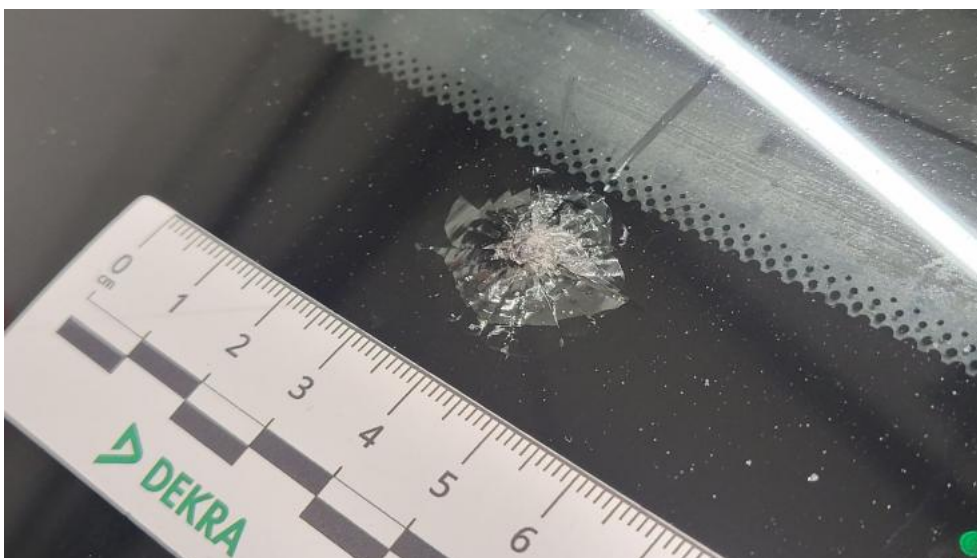
**Photo 52.**

Niesprawne przyciski funkcyjne w jednym z kluczyków, grot prawidłowy. Minął termin wymiany okładzin hamulcowych tylnych od 2500km. Minął termin kontroli wzrokowej i wymiany oleju silnikowego od 1700km. Aktywna kontrolka serwisu. Informacja niskie ciśnienie opon. Pojazd oklejony folią. Pomiar lakieru wykonany na folii na wszystkich elementach oprócz próg lewy/prawy, słupek środkowy lewy/prawy. Lakier grafitowy. Rysy na samochodzie. Odpryski na szybie czołowej.

Szyba czołowa - Pęknięcie/rozerwanie 1

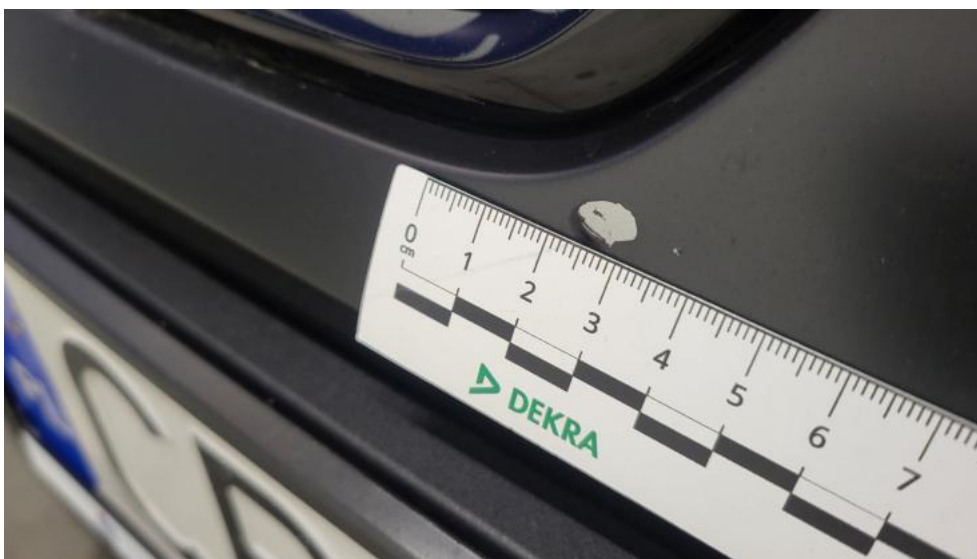
**Photo 53.**  
Zderzak - Rysa/odprysk 1

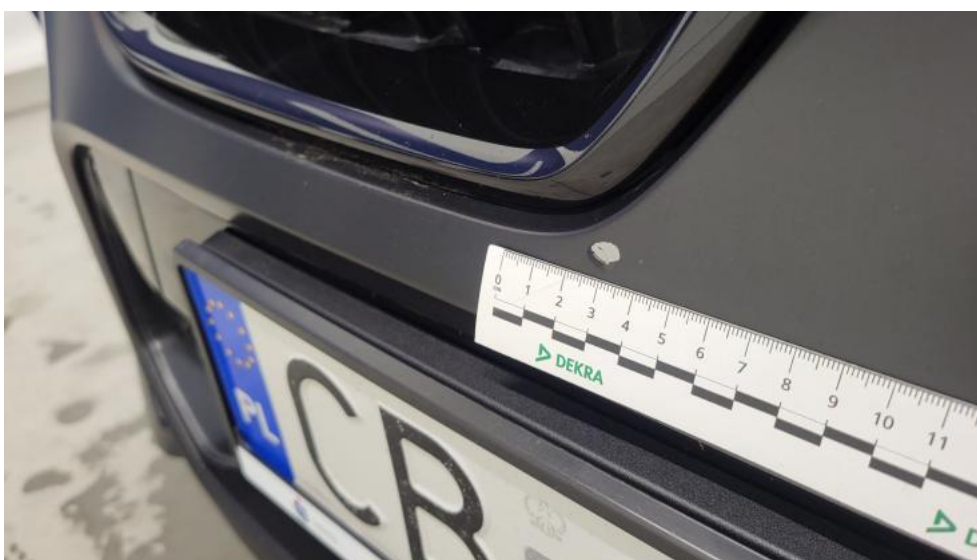
**Photo 54.**  
Zderzak - Inne 1

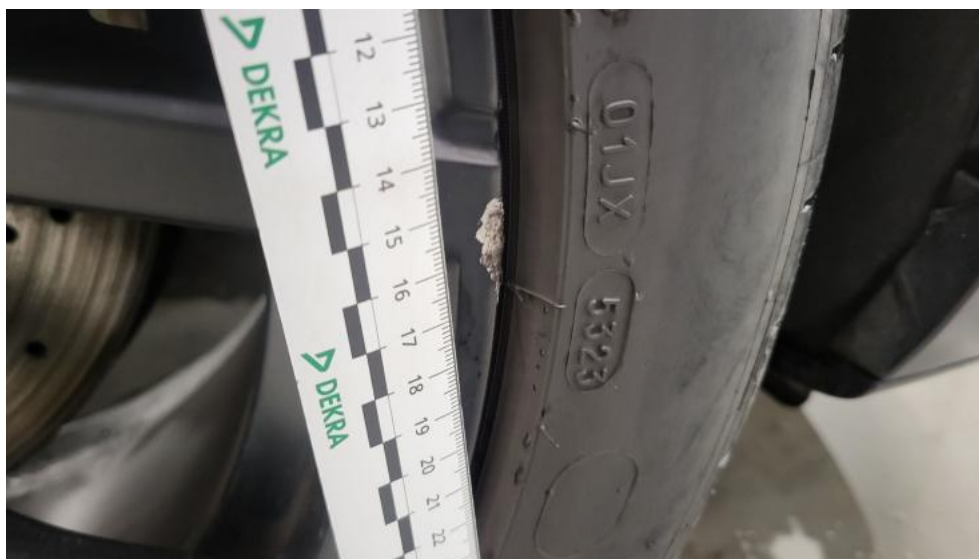
**Photo 55.**

Felga aluminiowa przednia P - Rysa/odprysk 1

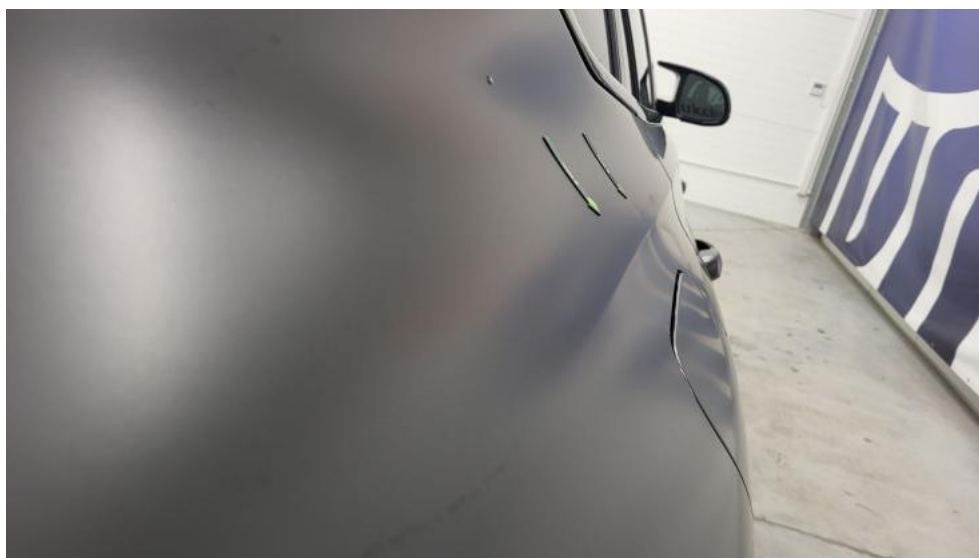
**Photo 56.**

Błotnik tylny P / Ściana boczna P - Wgniecenie/odkształcenie 1

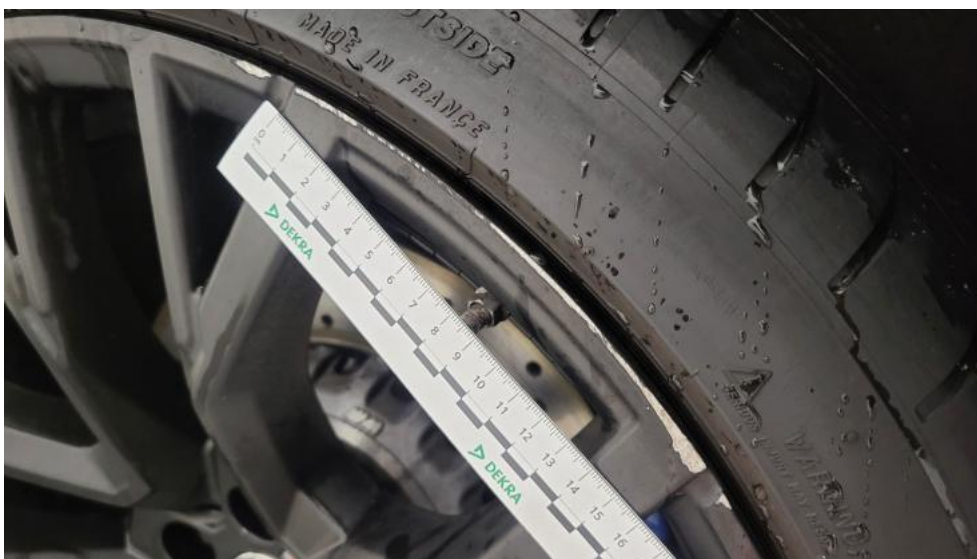
**Photo 57.**  
Felga aluminiowa tylna P - Rysa/odprysk 1

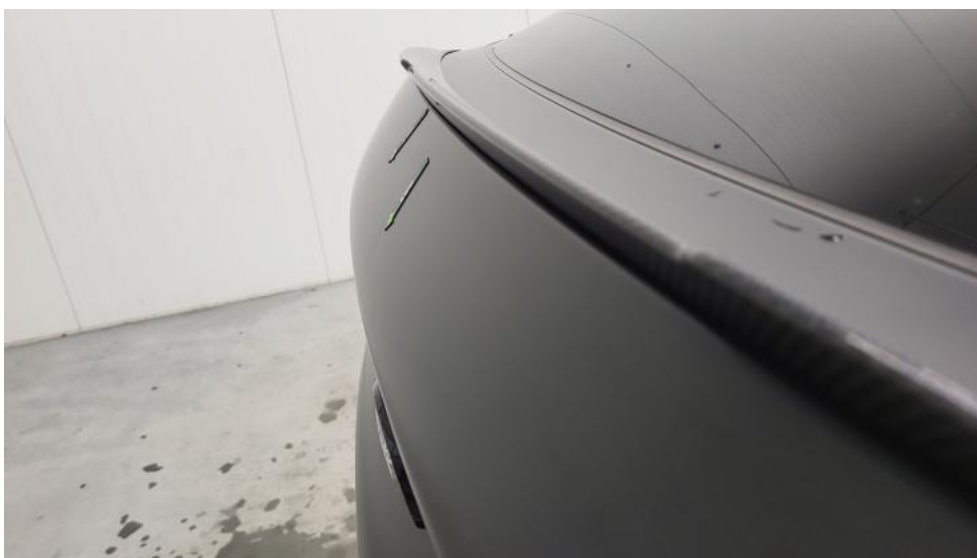
**Photo 58.**  
Pokrywy bagażnika - Wgniecenie/odkształcenie 1

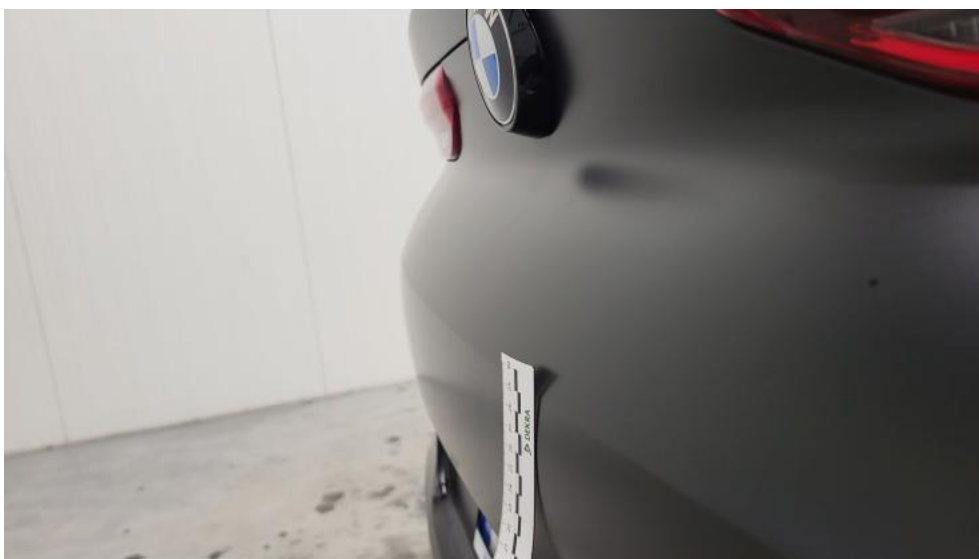
**Photo 59.**

Pokrywy bagażnika - Wgniecenie/odkształcenie 2

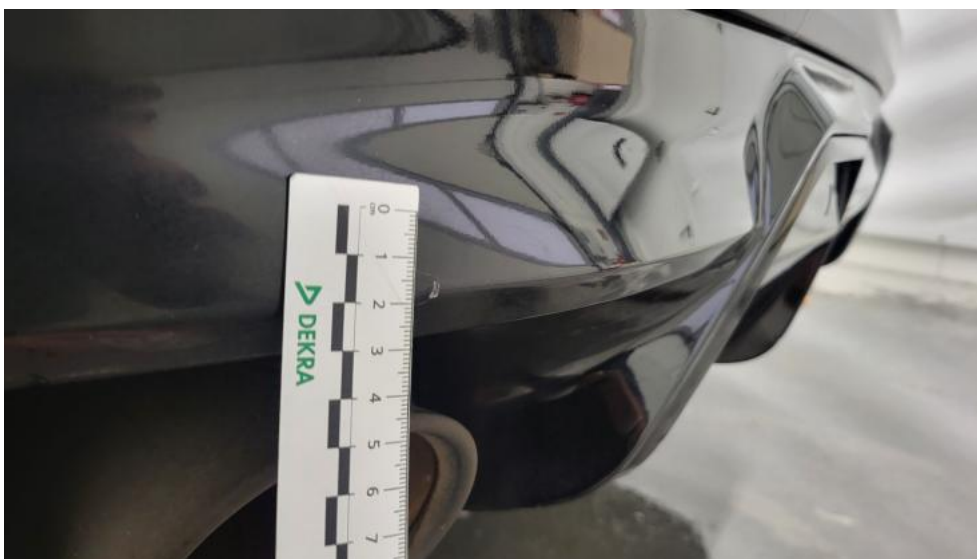
**Photo 61.**  
Spojler zderzaka tylnego - Rysa/odprysk 1

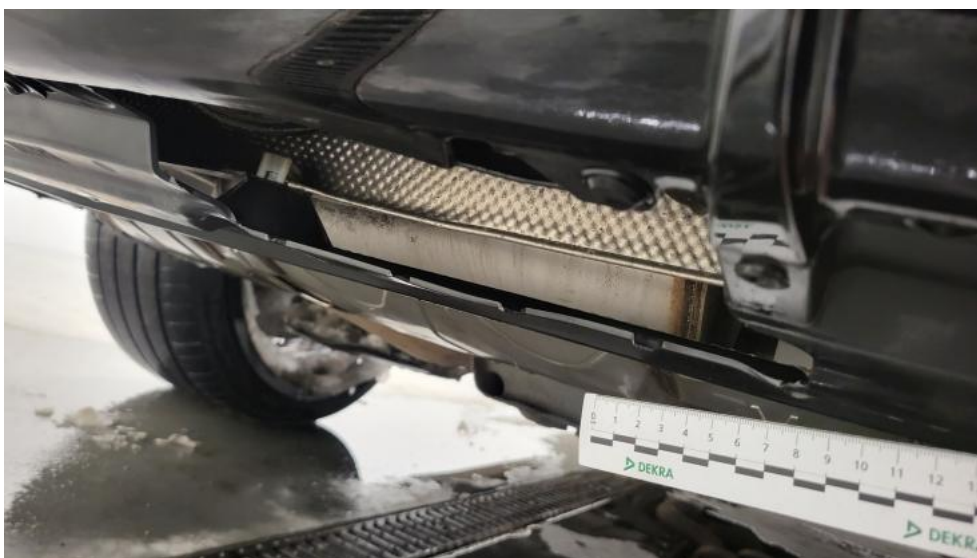
**Photo 62.**  
Spojler zderzaka tylnego - Pęknięcie/rozerwanie 1

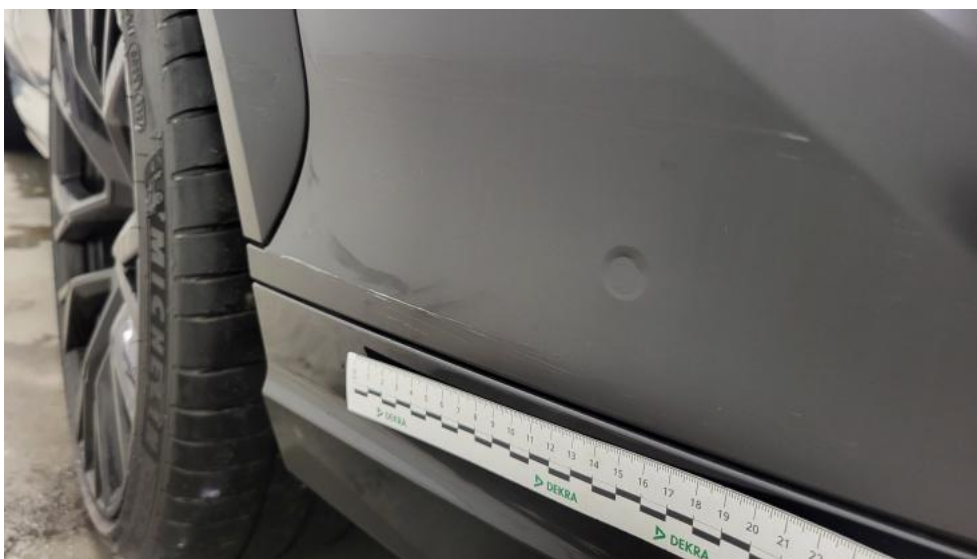
**Photo 63.**  
Zderzak tylny - Inne 1

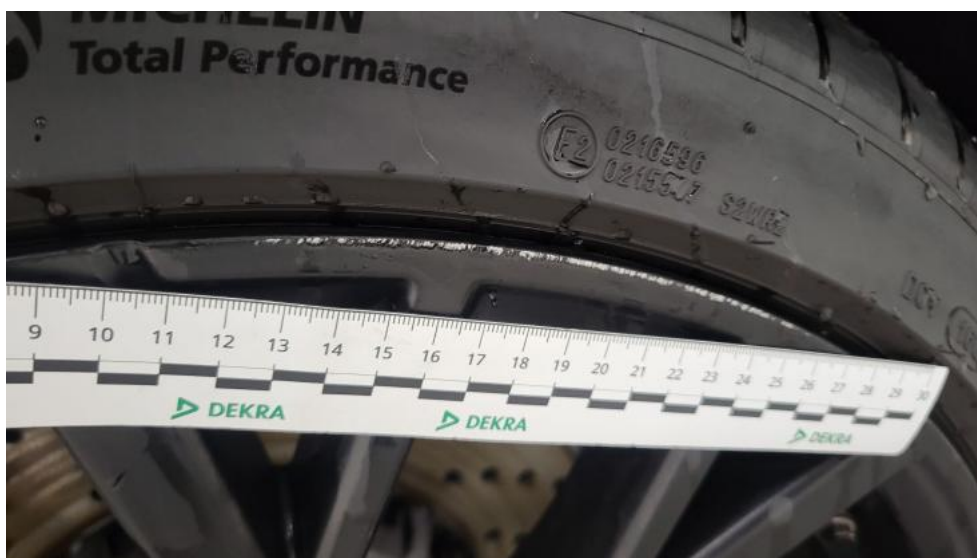
**Photo 64.**  
Felga aluminiowa tylna L - Rysa/odprysk 1

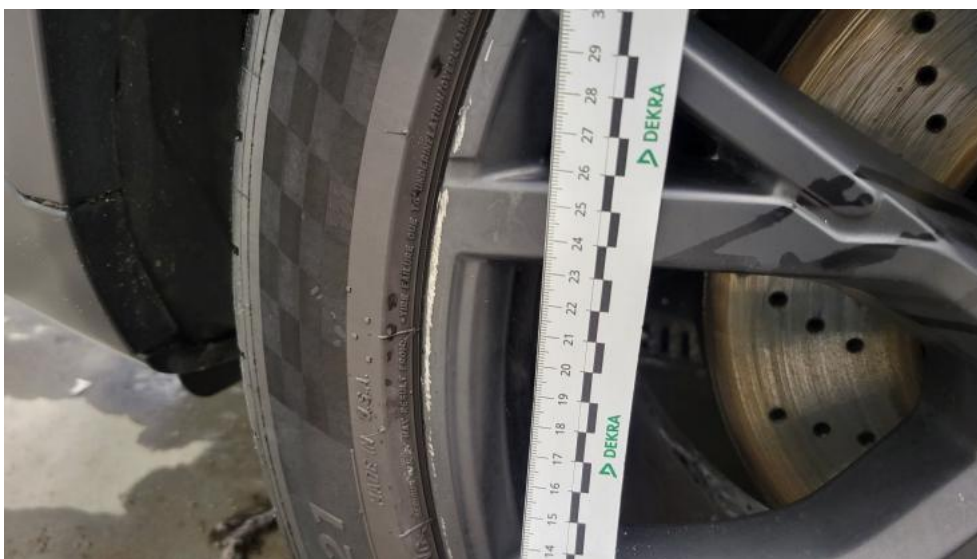
**Photo 65.**  
Felga Aluminiowa przednia L - Rysa/odprysk 1

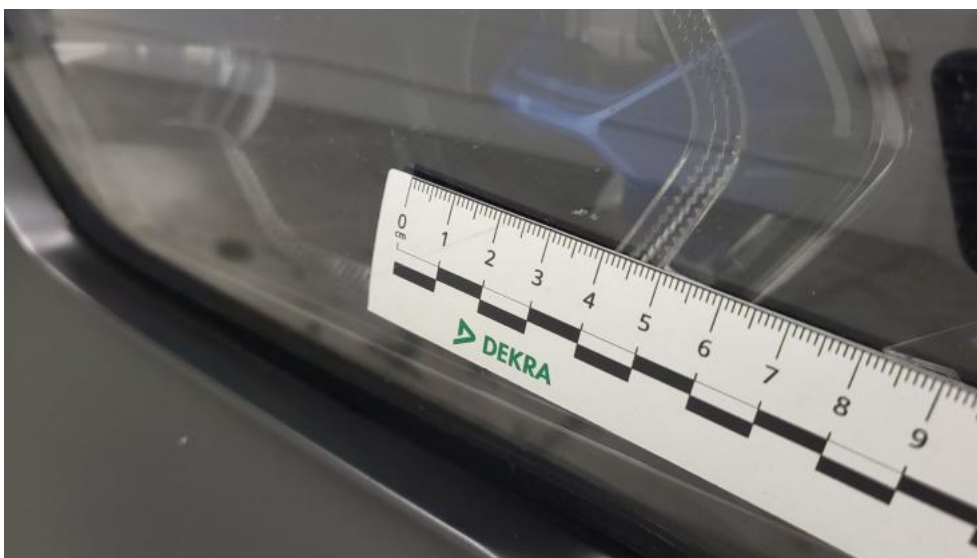
**Photo 66.**  
Reflektor L - Rysa/odprysk 1

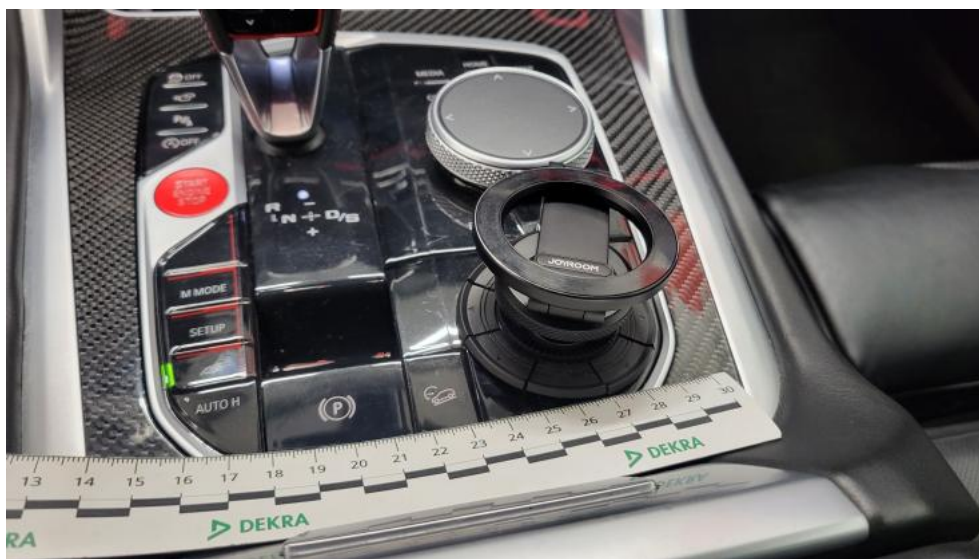
**Photo 67.**

Konsola tunelu śr. - Inne 1
