DEKRA's commission No. : PKOL(W)/LODZ/37821/25/05/26  
commission/ damage No. : 24/011022  
Date of commission: 26-05-2025

**Vehicle data**

| Manufacturer | MERCEDES-BENZ |
| Type / version | C 63 S AMG 9G-TRONIC |

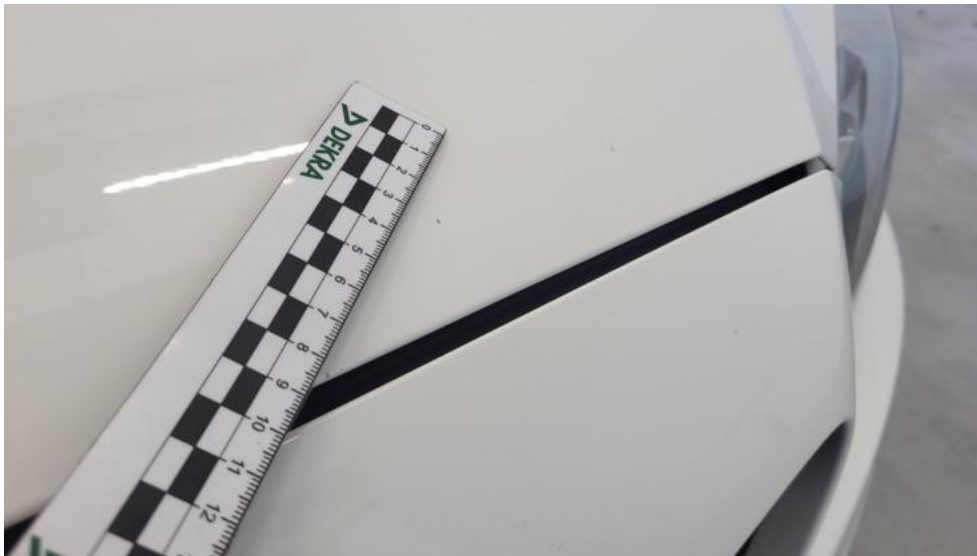
**Photo 45.**

Pokrywa komory silnika - Rysa/odprysk 1

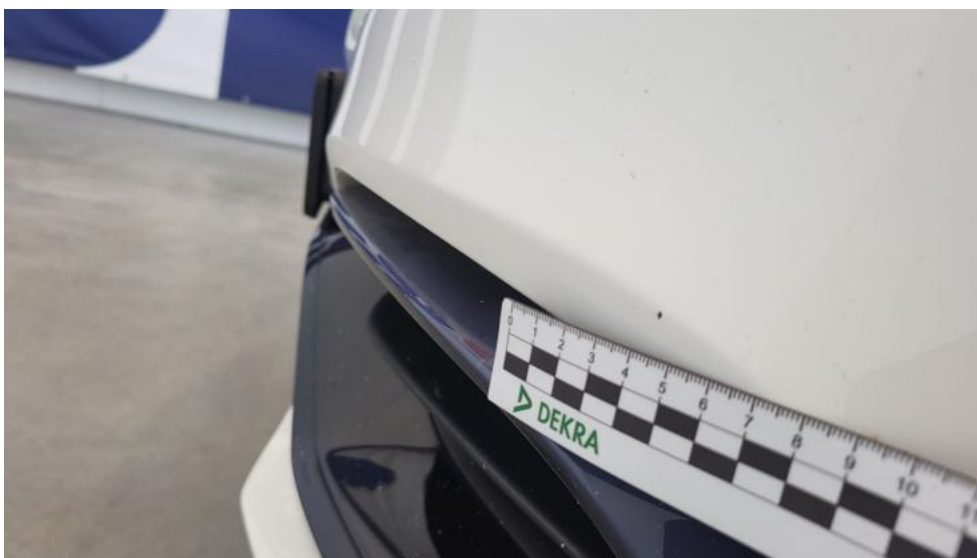
**Photo 46.**

Zderzak - Rysa/odprysk 1

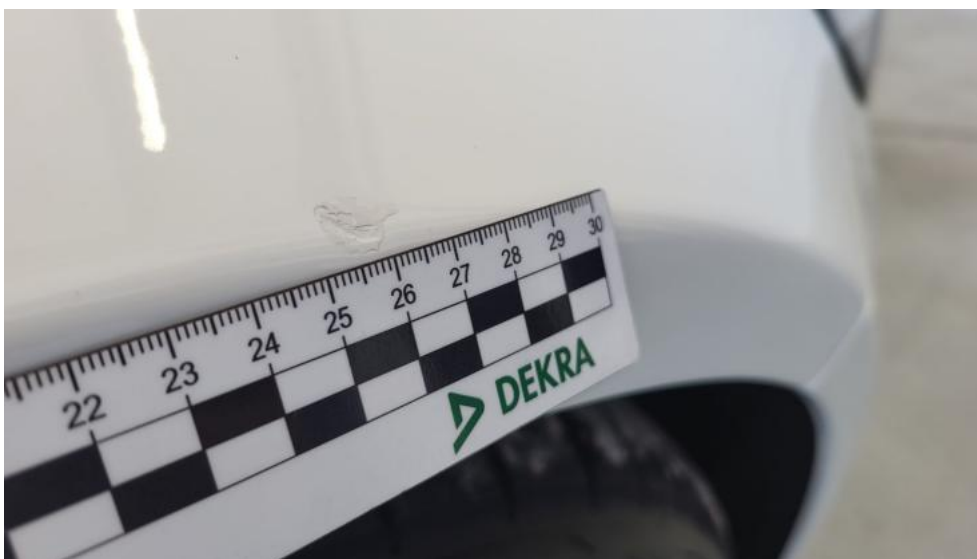
**Photo 47.**

Błotnik przedni P - Rysa/odprysk 1

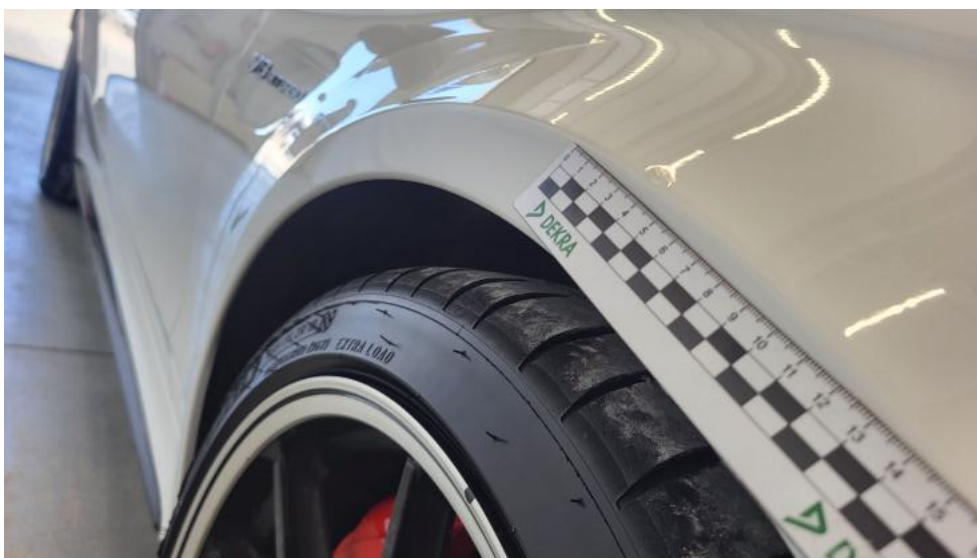
**Photo 48.**

Błotnik przedni P - Wgniecenie/odkształcenie 1

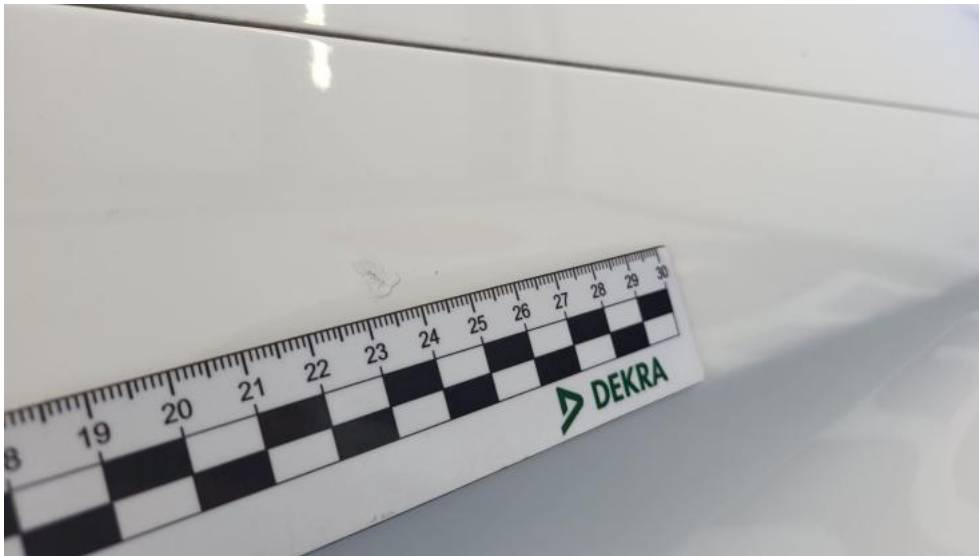
**Photo 49.**

Błotnik przedni P - Inne 1

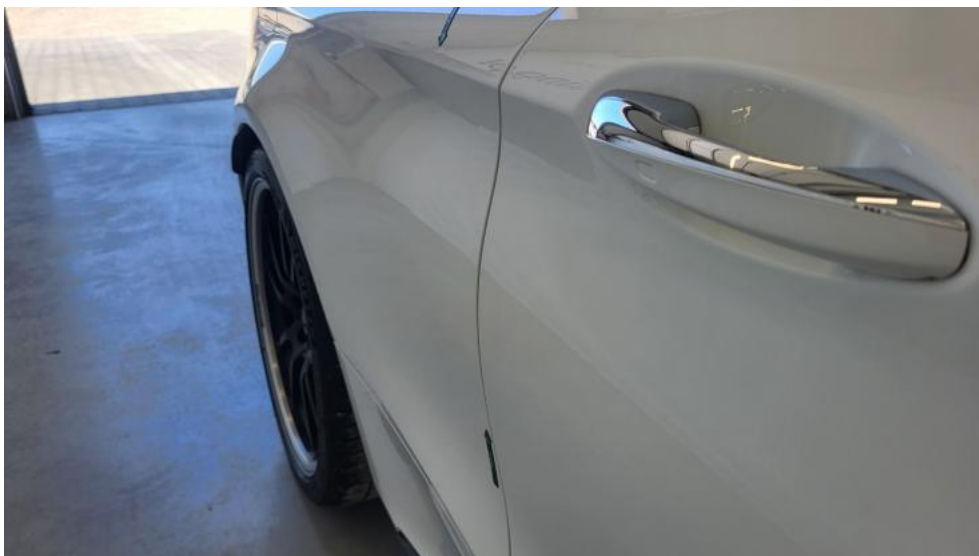
**Photo 50.**

Błotnik tylny P / Ściana boczna P - Wgniecenie/odkształcenie 1

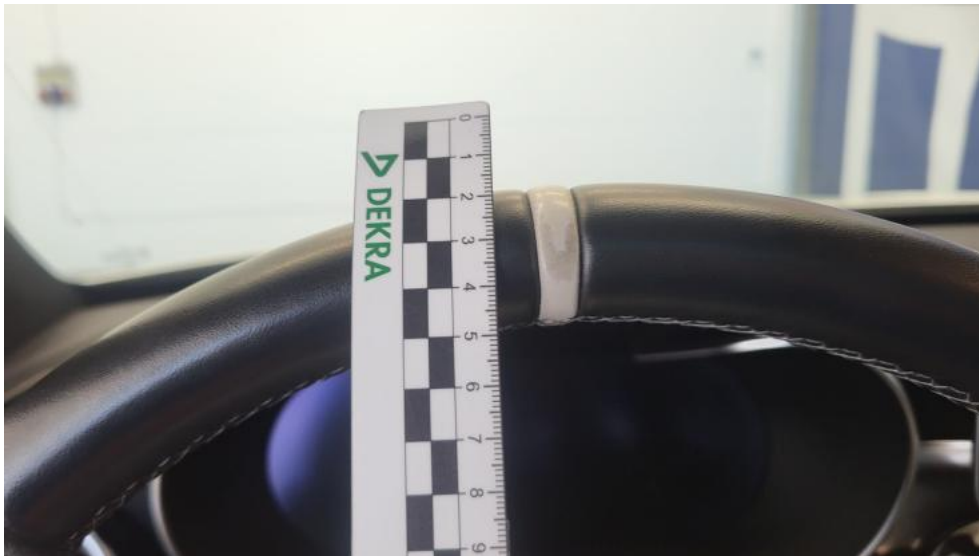
**Photo 51.**

Koło kierownicy - Inne 1

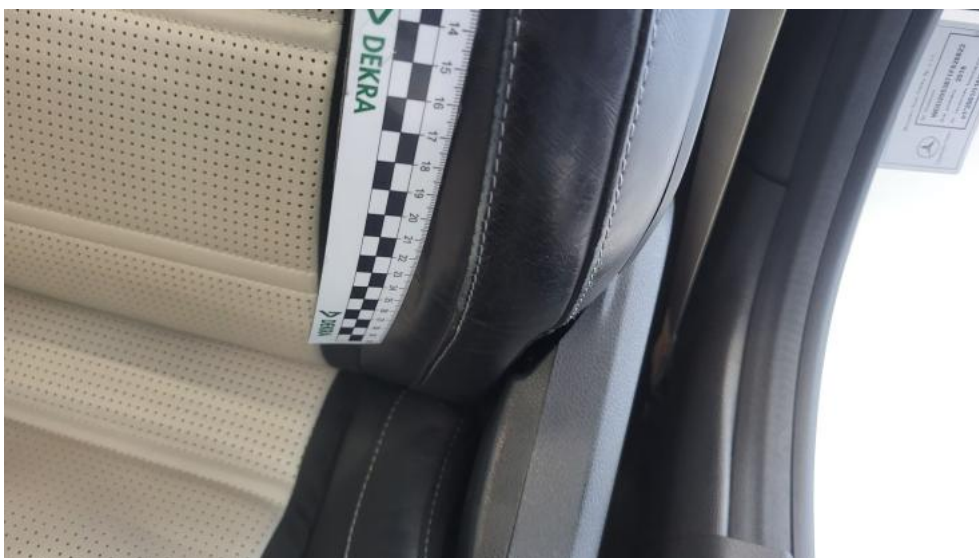
**Photo 52.**

Fotel prz. lew. - Inne 1
