DEKRA's commission No. : PKOL(W)/LODZ/19999/25/03/19
commission/ damage No. : 21/023301
Date of commission: 19-03-2025

Group of objects (Eurotax)	jeeps
EC code (Eurotax)	0131131
Manufacturer	JAGUAR
Model	I-Pace 18-23
Type / version	I-Pace EV400 AWD HSE
Body type	KOM
Number of doors / seats	5/5
Curb weight [kg]	2229
Gross vehicle weight [kg]	2670
Wheelbase 1/2	2990
Engine type	elektryczny
Pollution reduction system	-
Engine capacity [ccm]	0
Engine Power [hp/kW]	400/294
Gearbox	automatic 1- gear
Registration /record No.	DW5HK01
VIN / serial number	SADHA2B16L1F78787
Date of first registration	27-05-2019
Date of next. tech. test	06-03-2026
Year of manufacture	2019 (year has been verified with the manufacturer's base)
Readout [km]	129 930 (read)
Body color / type of coating	black/2-warstwowy metalik

Measurement of thickness of the vehicle lacquer coating

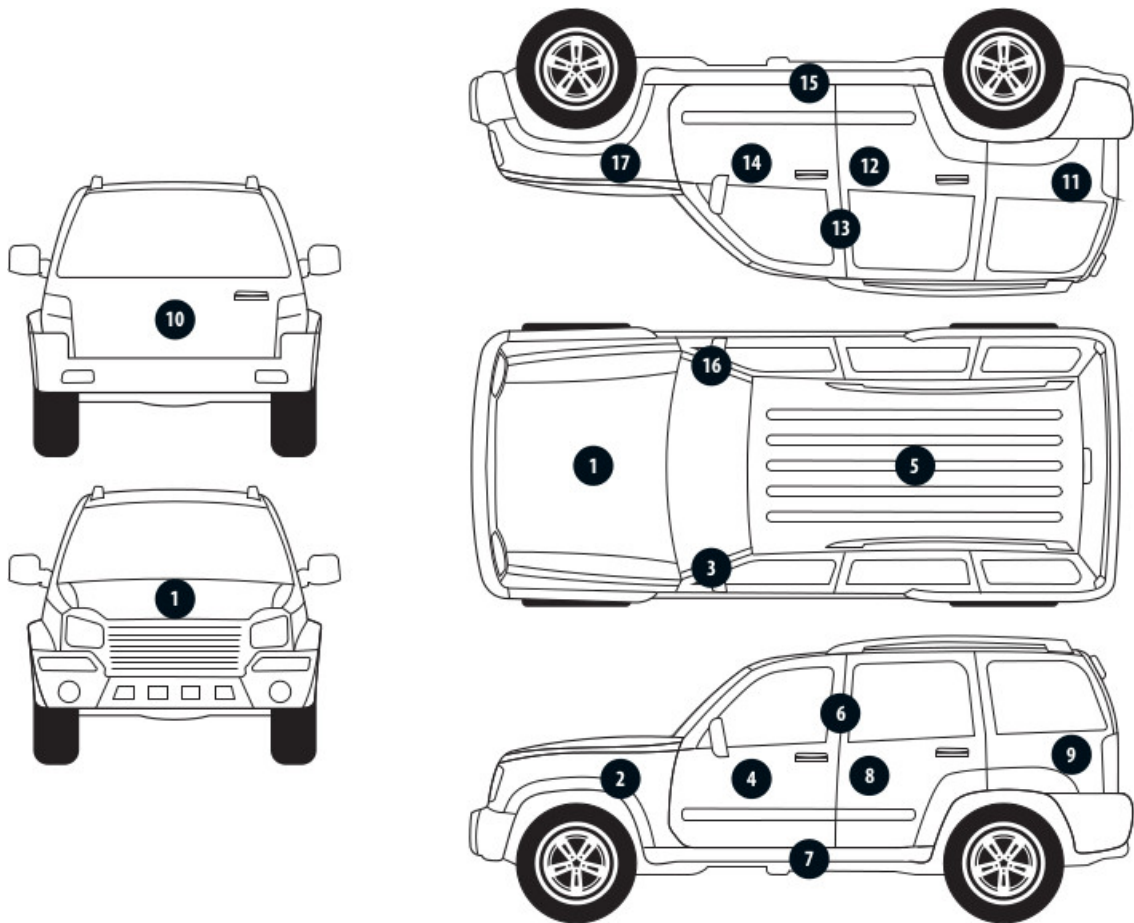
No. of controlled item	Controlled item	Measured range of thickness of the lacquer coat [μm]
1	Front cover	150 - 500
3	Left front pillar	to 150
4	Left front wall	to 150
5	Roof	to 150
6	Left middle pillar	to 150
7	Left side sill	to 150
8	Left rear wall	to 150
9	Left side wall	to 150
11	Side right wall	to 150
12	Rear right door	to 150
13	Middle right pillar	to 150
14	Front right door	to 150
15	Right side sill	to 150
16	Right front pillar	to 150

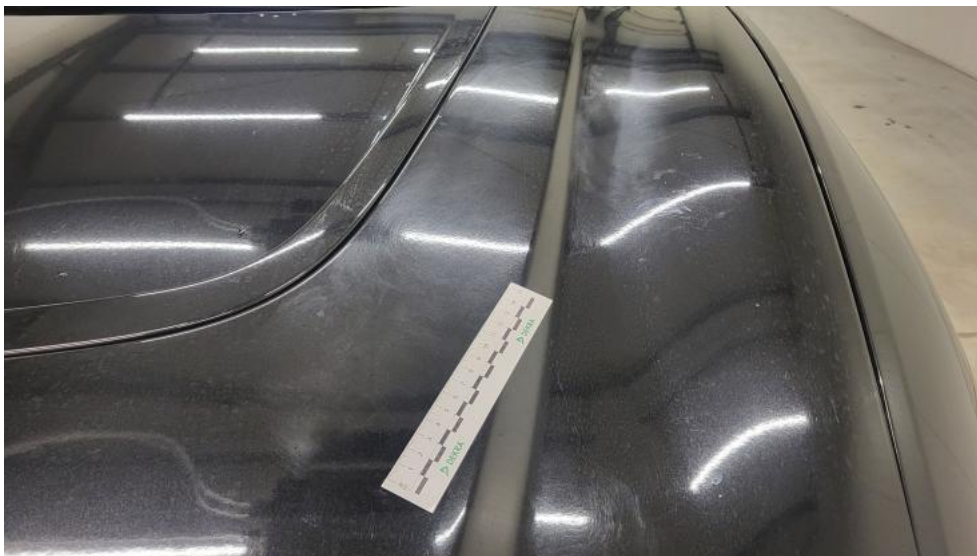
Photo 47.

Pokrywa komory silnika - Inne 1

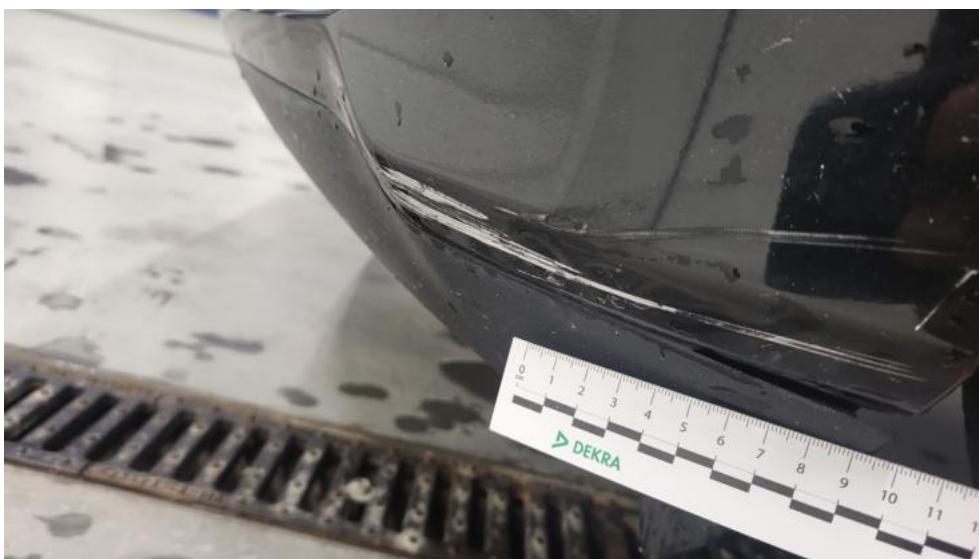
Photo 49.
Zderzak - Rysa/odprysk 1

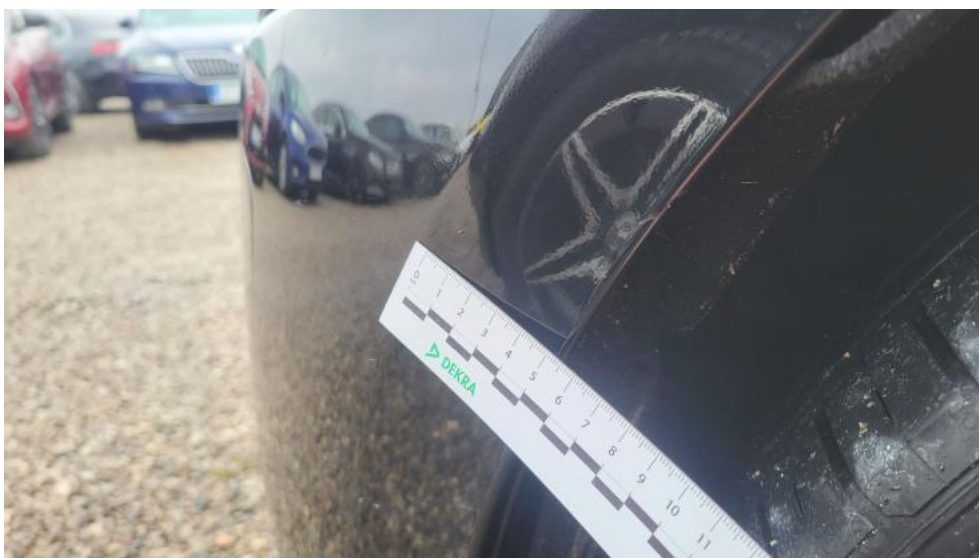
Photo 50.
Zderzak - Wgniecenie/odkształcenie 1

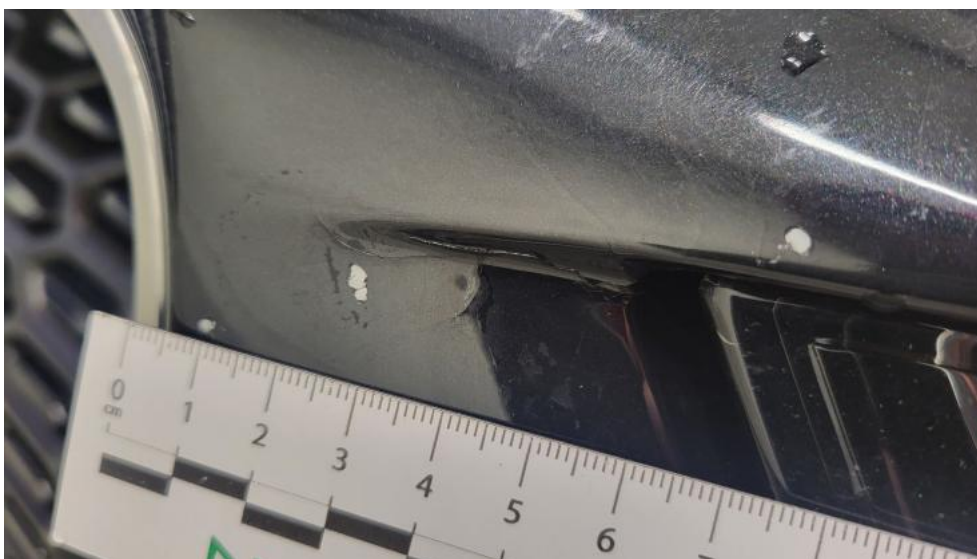
Photo 51.
Zderzak - Pęknięcie/rozerwanie 1

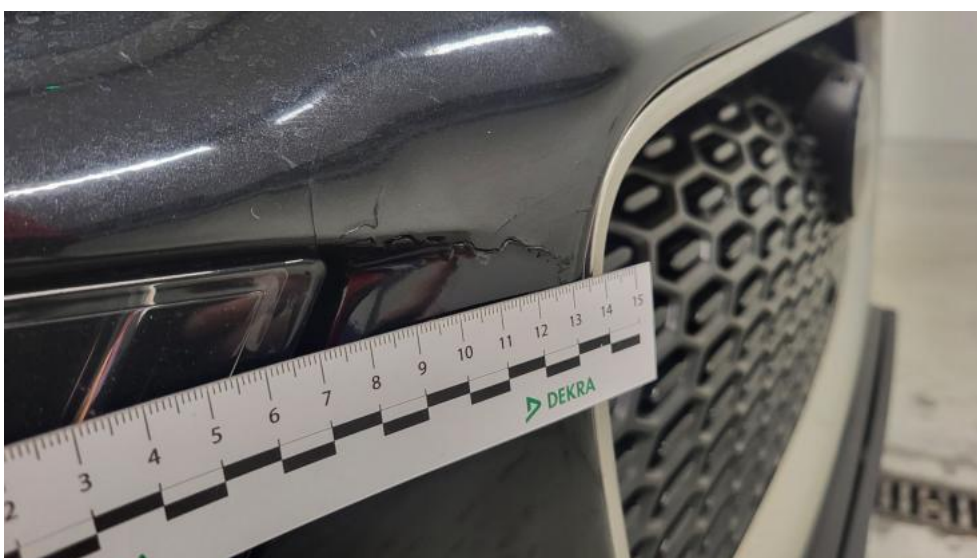
Photo 52.
Zderzak - Pęknięcie/rozerwanie 2

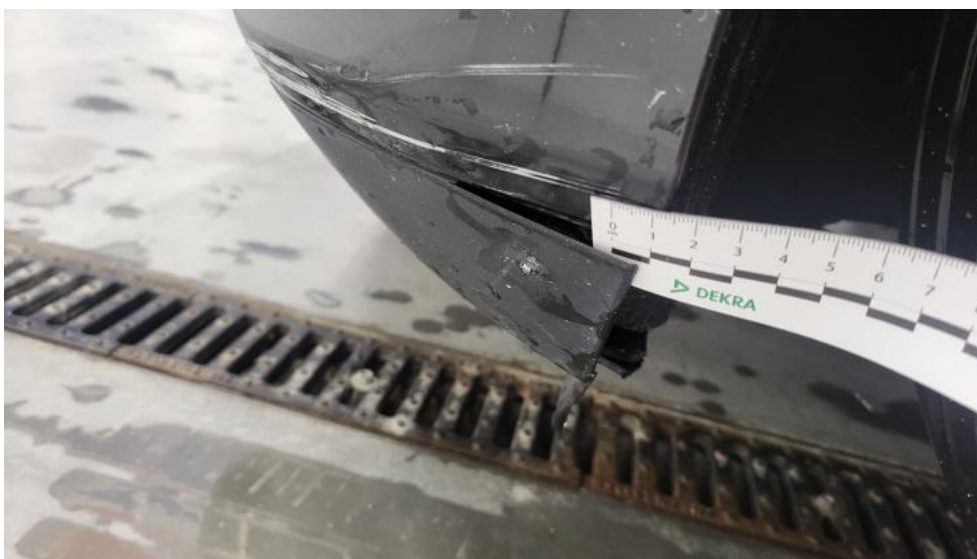
Photo 53.
Zderzak przedni cz dolna - Inne 1

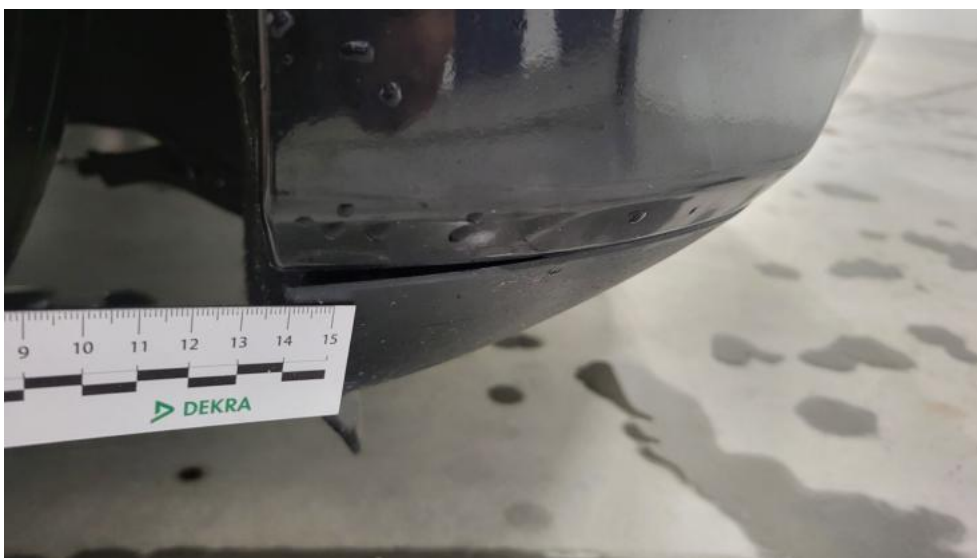
Photo 54.
Zderzak przedni cz dolna - Inne 2

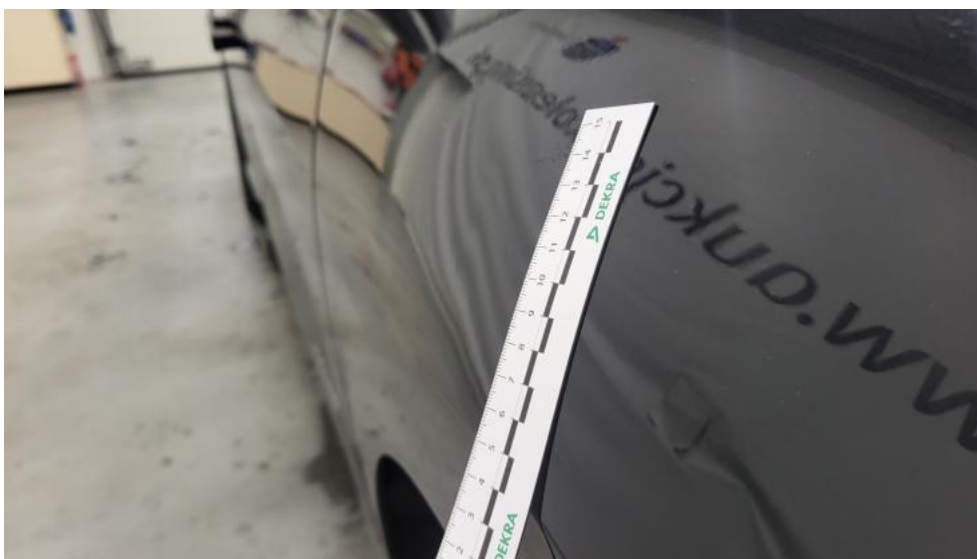
Photo 55.
Błotnik przedni P - Wgniecenie/odkształcenie 1

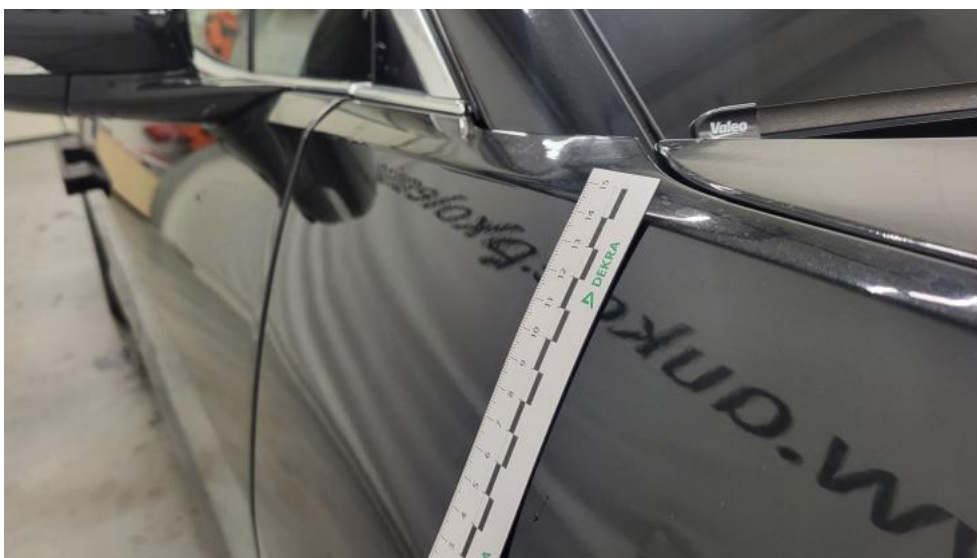
Photo 56.
Błotnik przedni P - Wgniecenie/odkształcenie 2

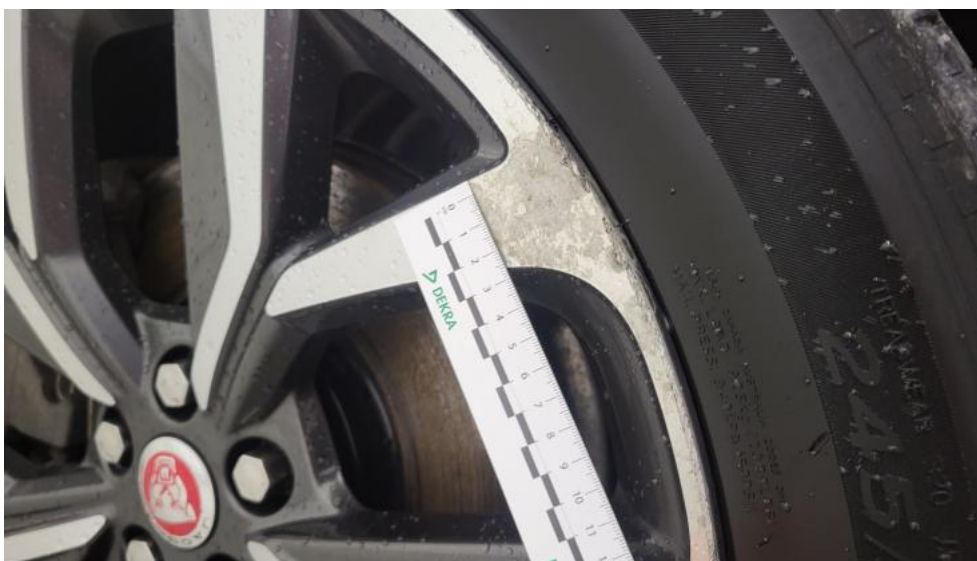
Photo 57.
Felga aluminiowa przednia P - Rysa/odprysk 1

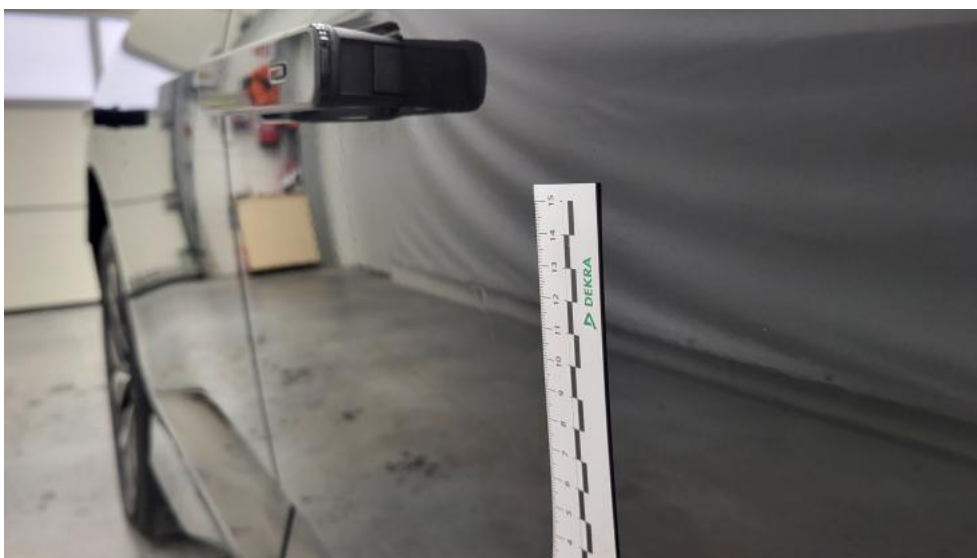
Photo 58.
Drzwi przednie P - Wgniecenie/odkształcenie 1

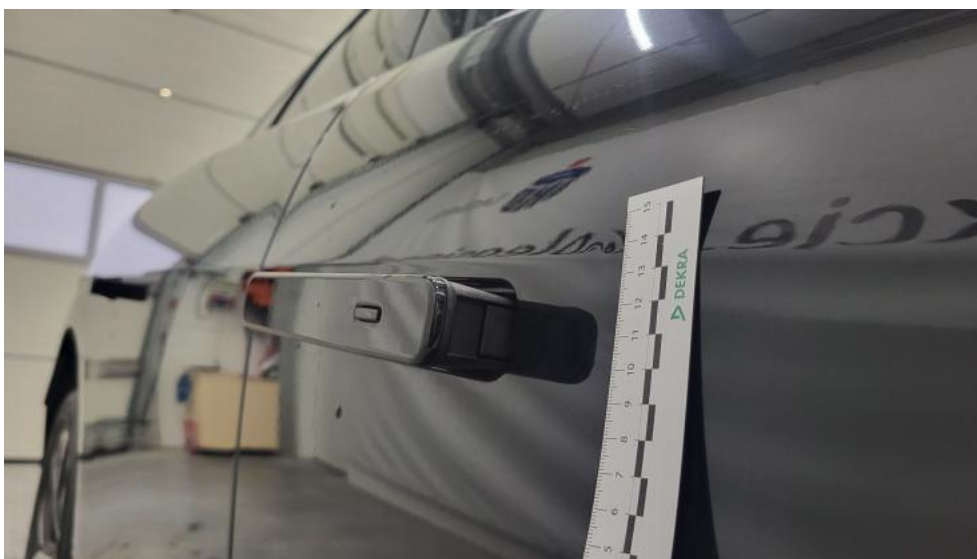
Photo 59.
Drzwi przednie P - Wgniecenie/odkształcenie 2

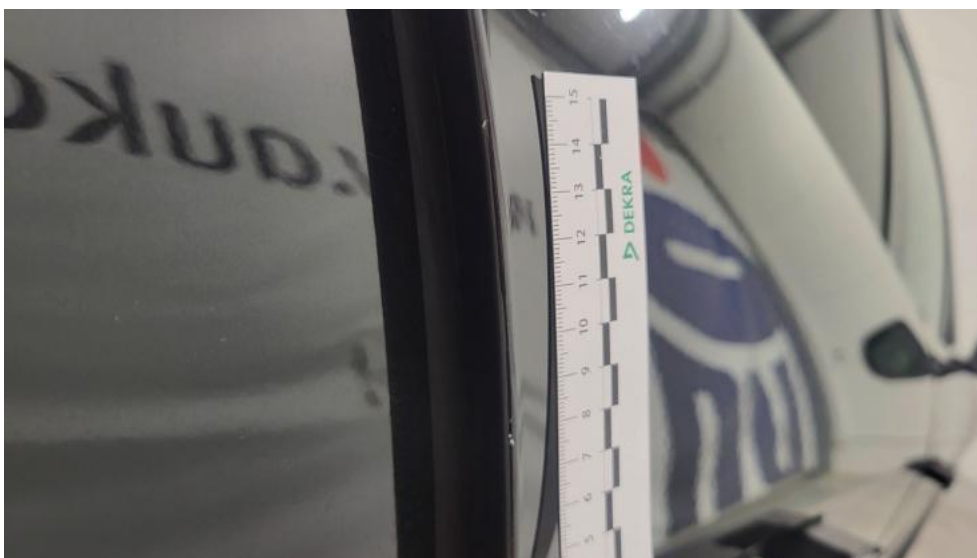
Photo 60.
Drzwi tylne P - Rysa/odprysk 1

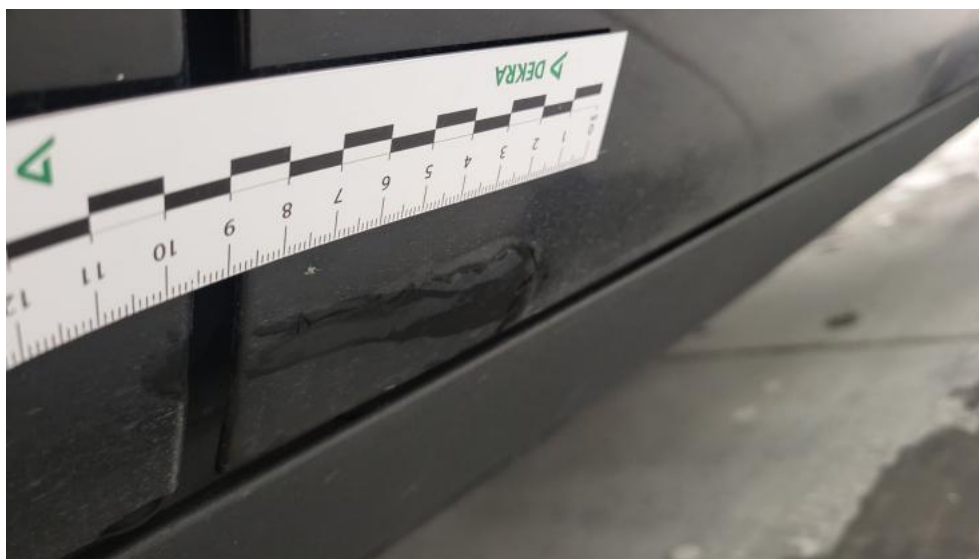
Photo 61.

Listwa drzwi przednich P - Inne 1

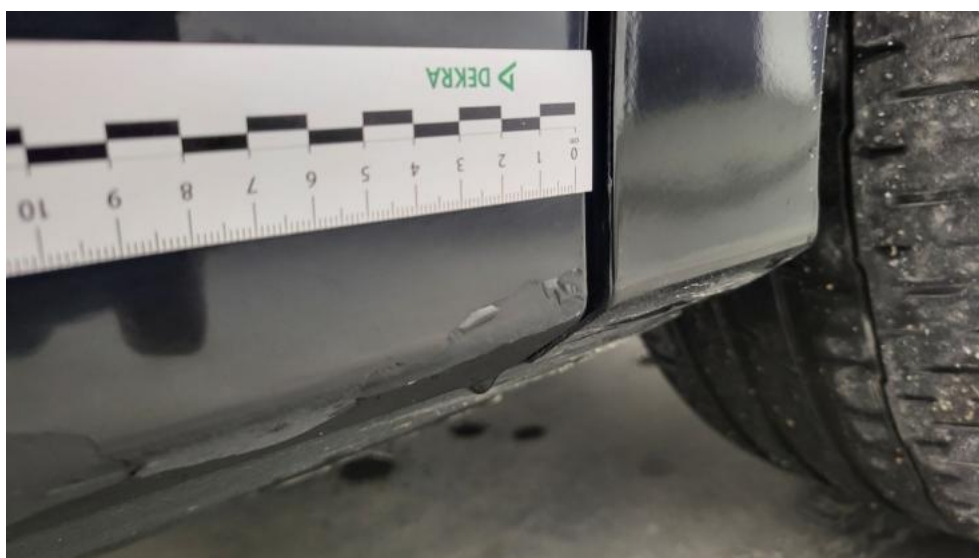
Photo 62.

Listwa drzwi przednich P - Inne 2

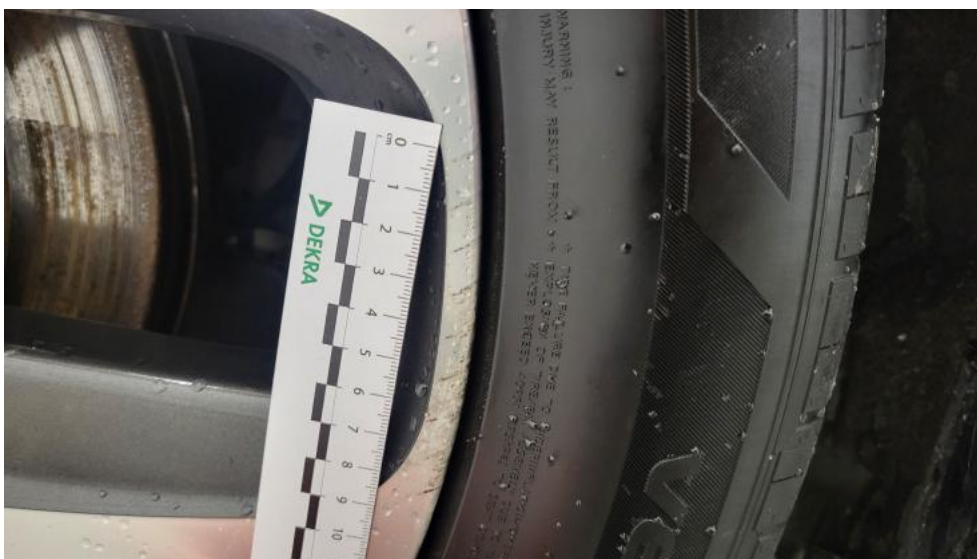
Photo 63.
Felga aluminiowa tylna P - Rysa/odprysk 1

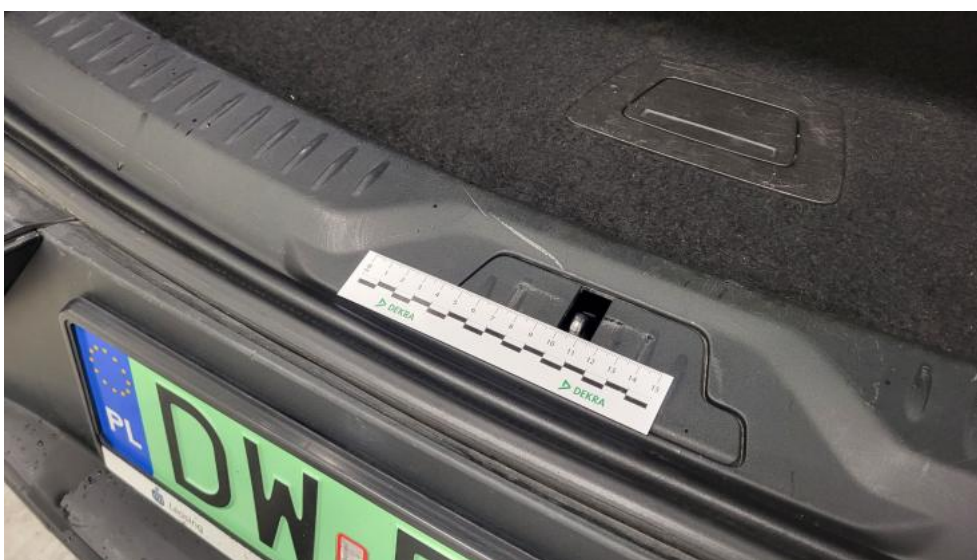
Photo 64.
Nakładka pokrywy tylnej - Rysa/odprysk 1

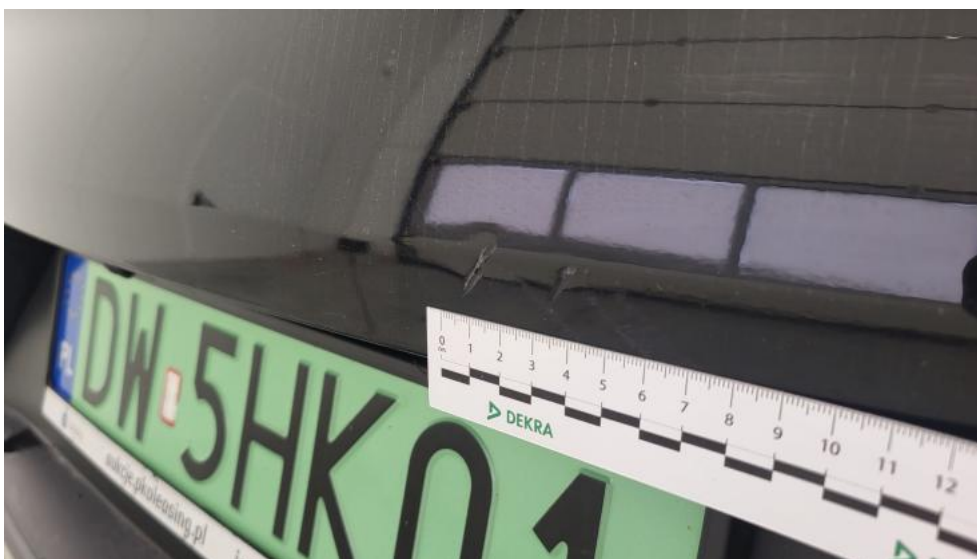
Photo 65.
Pokrywy bagażnika - Wgniecenie/odkształcenie 1

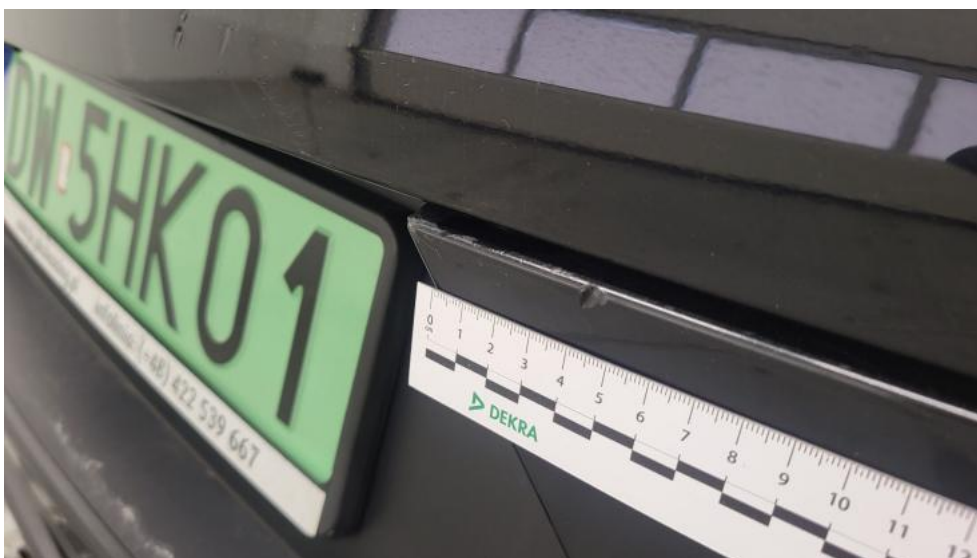
Photo 66.
Zderzak tylny - Rysa/odprysk 1

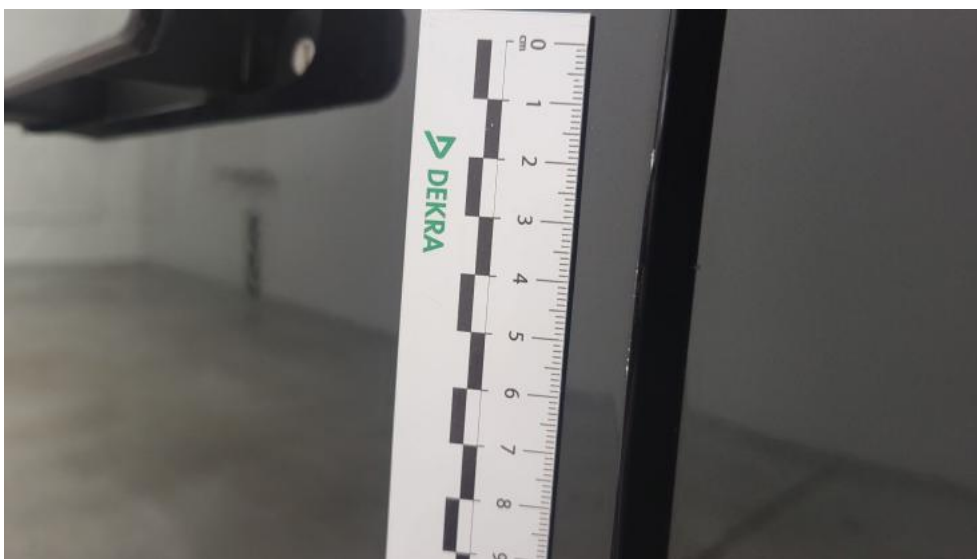
Photo 67.

Drzwi przed L - Rysa/odprysk 1

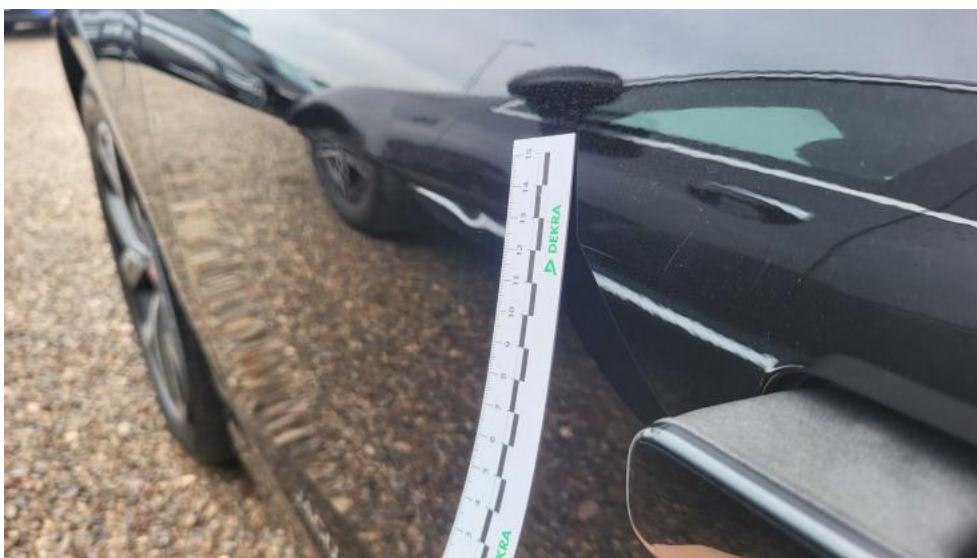
Photo 68.

Drzwi przed L - Wgniecenie/odkształcenie 1

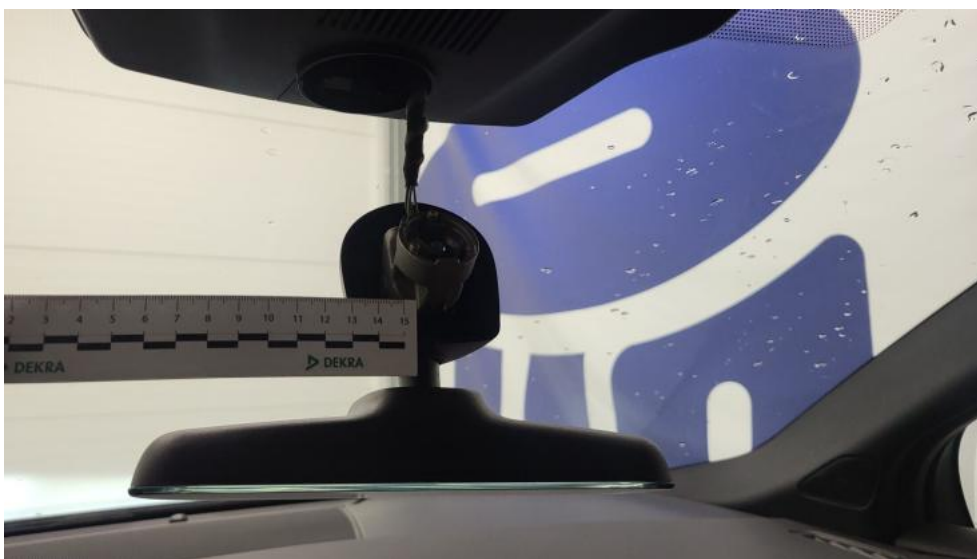
Photo 69.

Lusterko wsteczne wew - Inne 1

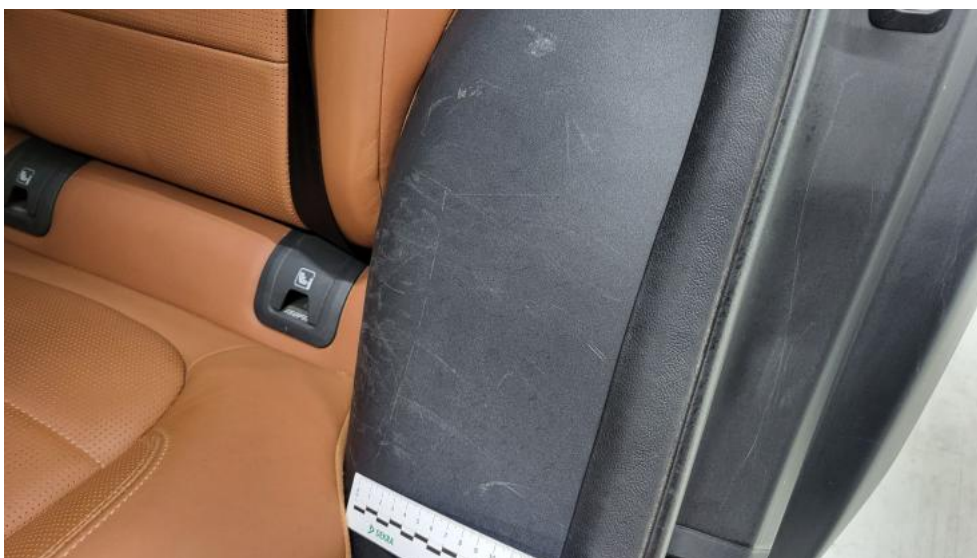
Photo 70.

Wykładzina(y) słupka tylnego L - Rysa/odprysk 1

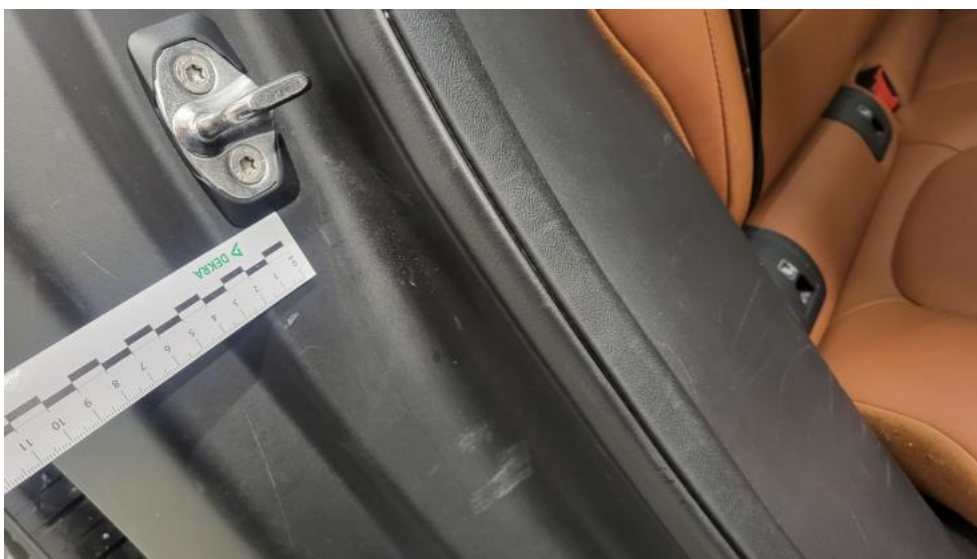
Photo 71.
Wykładzina(y) słupka tylnego P - Rysa/odprysk 1

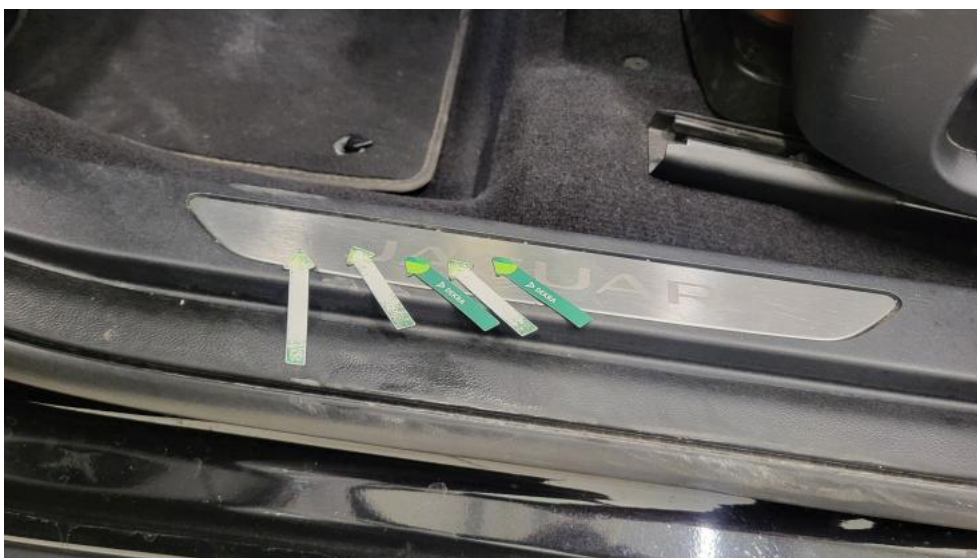
Photo 72.
Listwy progowe lew. - Wgniecenie/odkształcenie 1
