DEKRA's commission No. : PKOL(W)/LODZ/26416/25/04/10  
commission/ damage No. : FUTURA  
Date of commission: 10-04-2025

**Vehicle data**

| Manufacturer | HYUNDAI |
| Model | i30 20-24 |

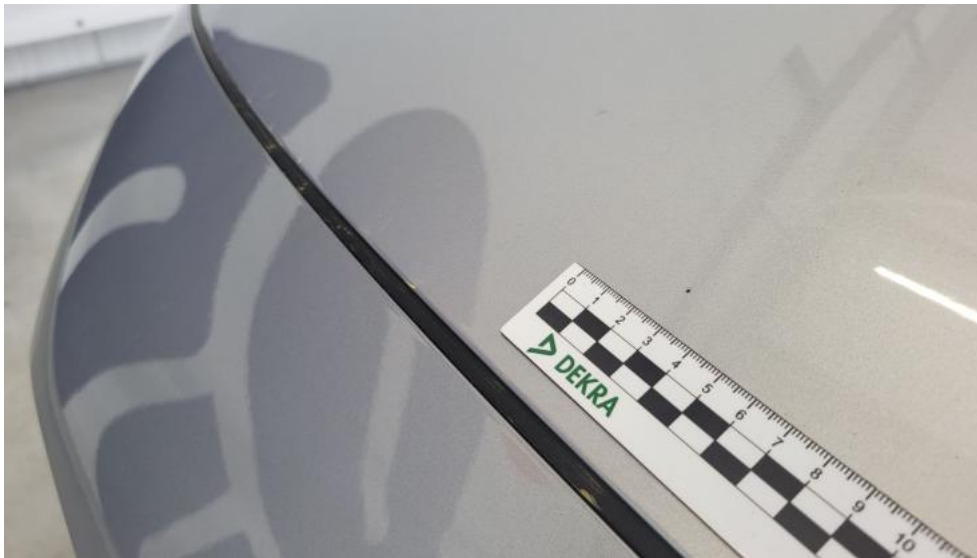
**Photo 37.**

Pokrywa komory silnika - Rysa/odprysk 1

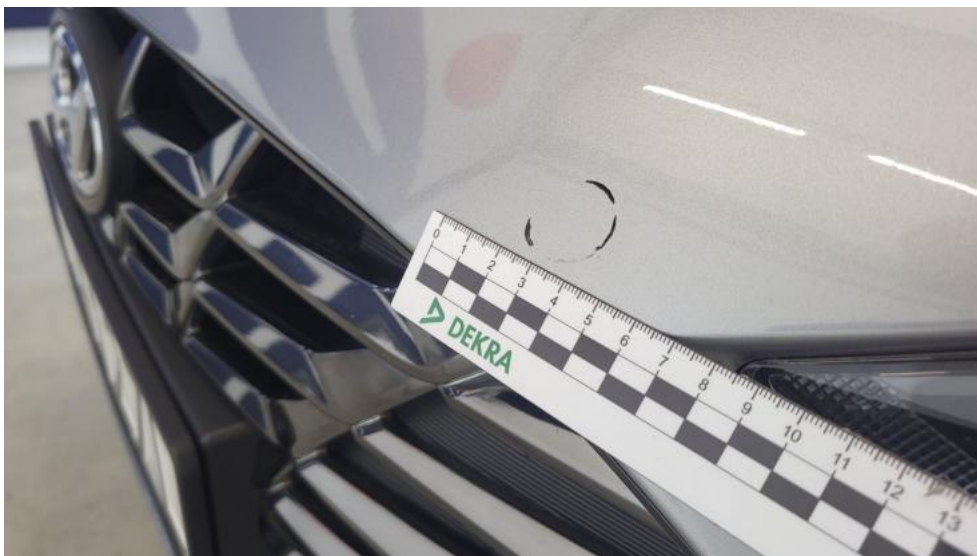
**Photo 38.**

Zderzak - Rysa/odprysk 1

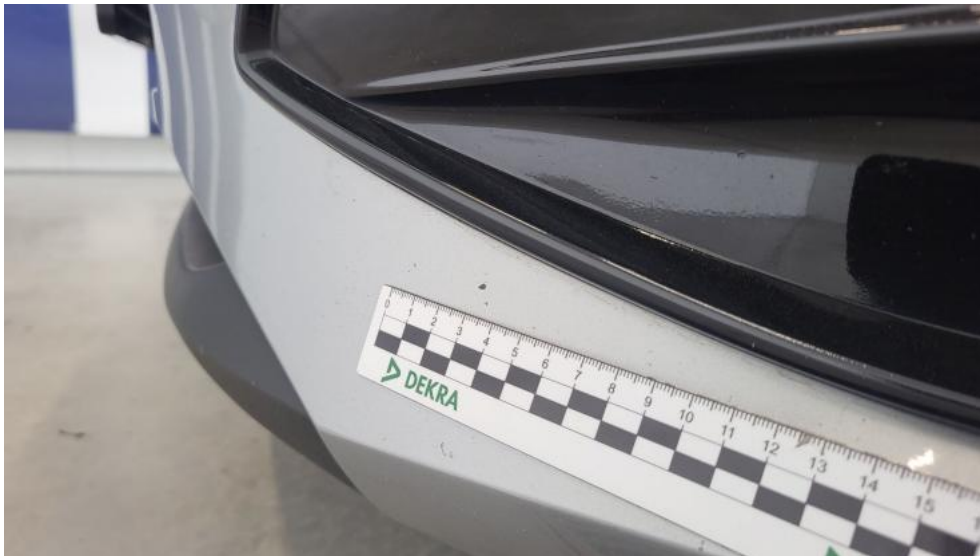
**Photo 39.**

Zderzak - Rysa/odprysk 2

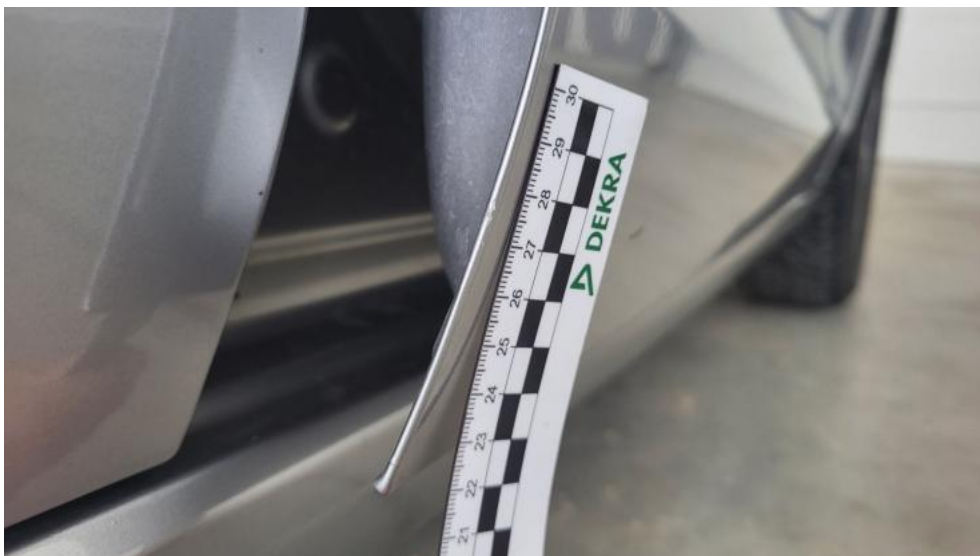
**Photo 40.**

Drzwi przednie P - Rysa/odprysk 1

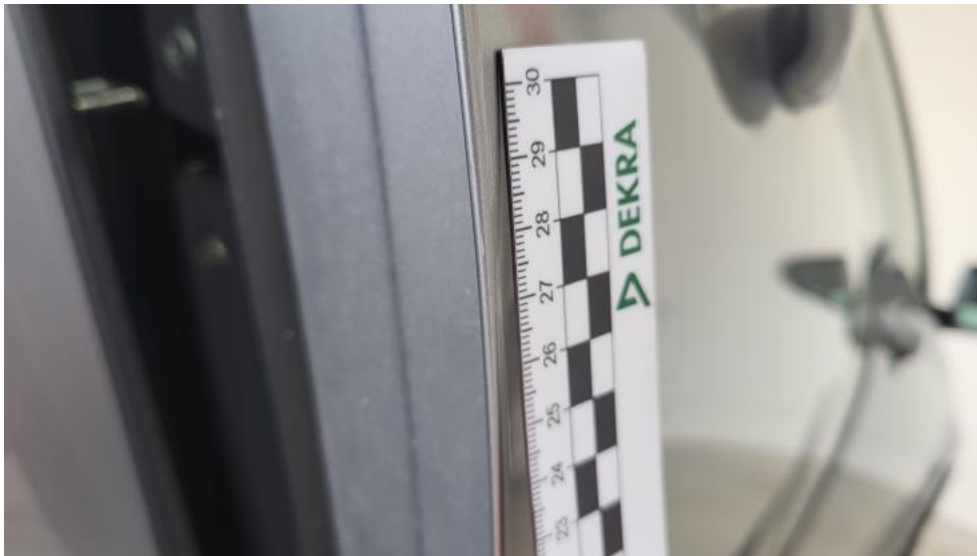
**Photo 41.**

Drzwi tylne P - Rysa/odprysk 1

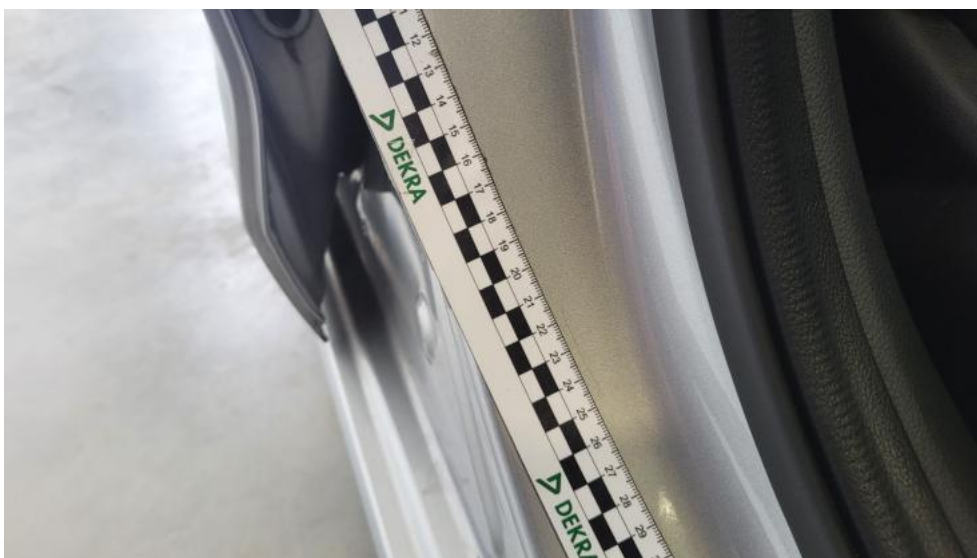
**Photo 42.**

Słupek środkowy P - Rysa/odprysk 1

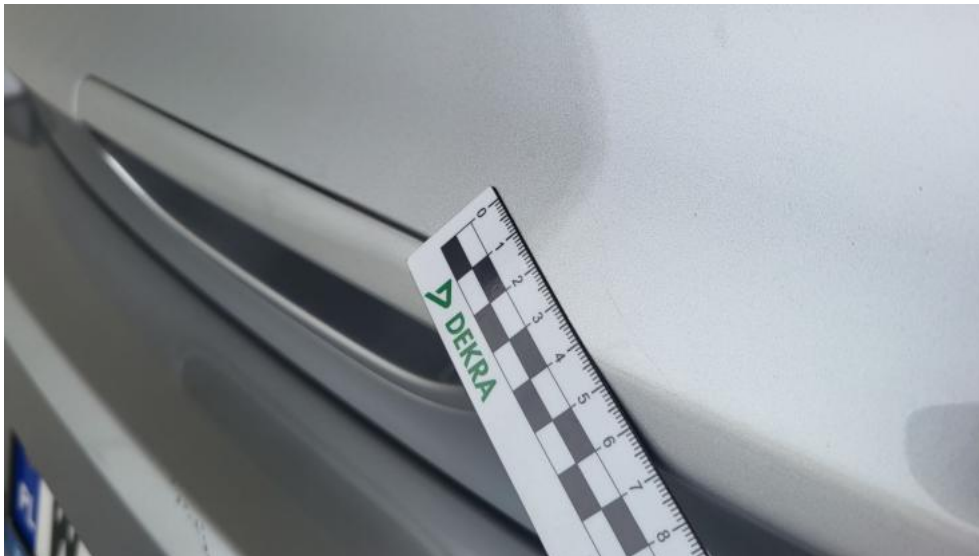
**Photo 45.**

Pokrywy bagażnika - Rysa/odprysk 1

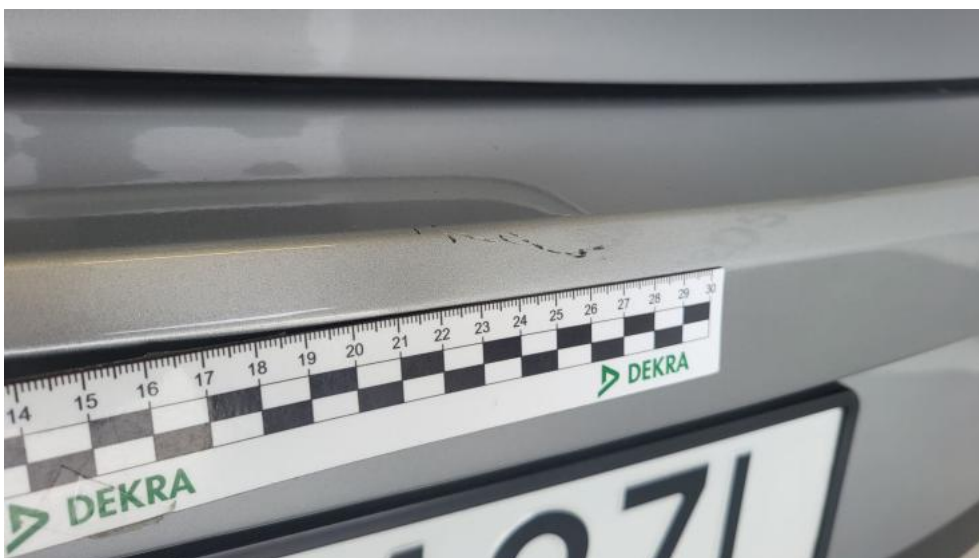
**Photo 46.**

Zderzak tylny - Rysa/odprysk 1

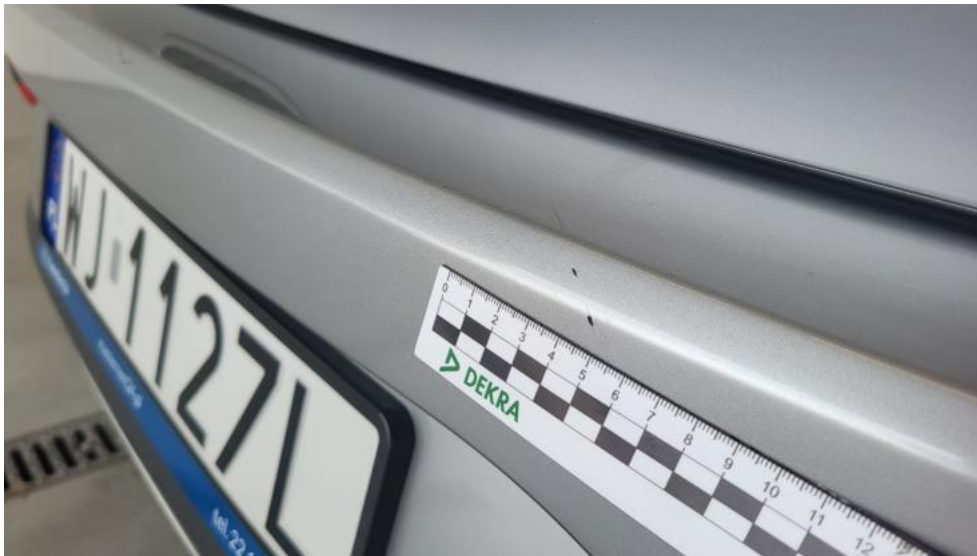
**Photo 47.**

Zderzak tylny - Rysa/odprysk 2

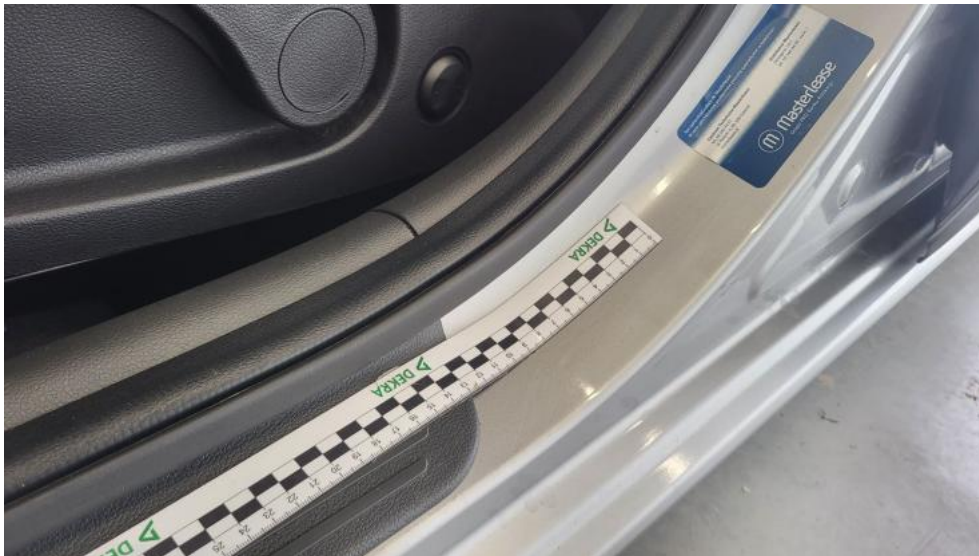
**Photo 53.**

Próg L - Rysa/odprysk 1

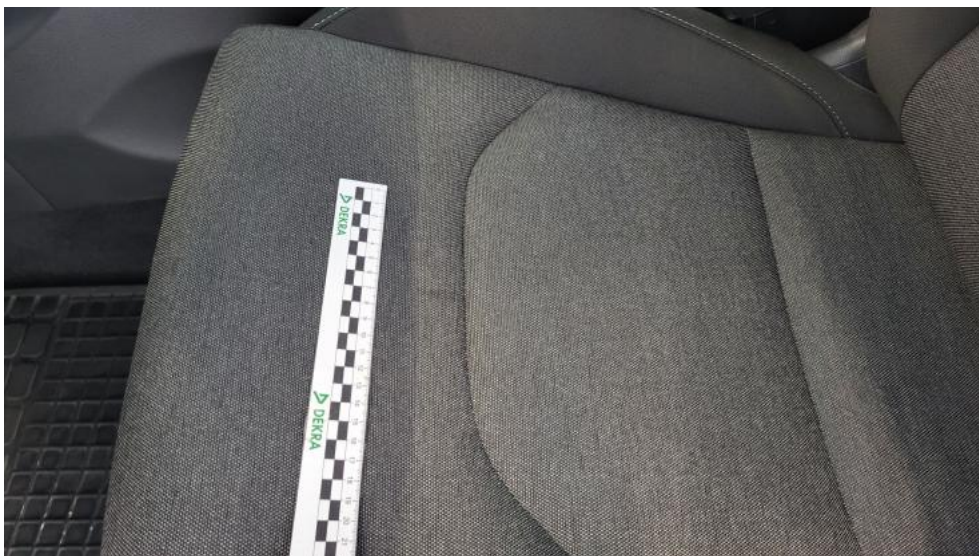
**Photo 54.**

Fotel prz. lew. - Inne 1
