DEKRA's commission No. : PKOL(W)/LODZ/19361/25/03/17
 commission/ damage No. : Futura
 Date of commission: 17-03-2025

Group of objects (Eurotax)	cars
EC code (Eurotax)	0137057
Manufacturer	FORD
Model	Mondeo Kombi 19-21
Type / version	Mondeo 2.0 EcoBlue Titanium AWD aut
Body type	KOM
Number of doors / seats	5/5
Curb weight [kg]	1812
Gross vehicle weight [kg]	2365
Wheelbase 1/2	2850
Engine type	Automatic ignition
Pollution reduction system	KSC
Engine capacity [ccm]	1997
Engine Power [hp/kW]	190/140
Gearbox	automatic
Registration /record No.	WD9395M
VIN / serial number	WF0FXXWPCFKU82233
Date of first registration	16-12-2019
Date of next. tech. test	25-11-2025
Year of manufacture	2019 (year has been verified with the manufacturer's base)
Readout [km]	181 542 (read)
Body color / type of coating	black/UNI

Measurement of thickness of the vehicle lacquer coating

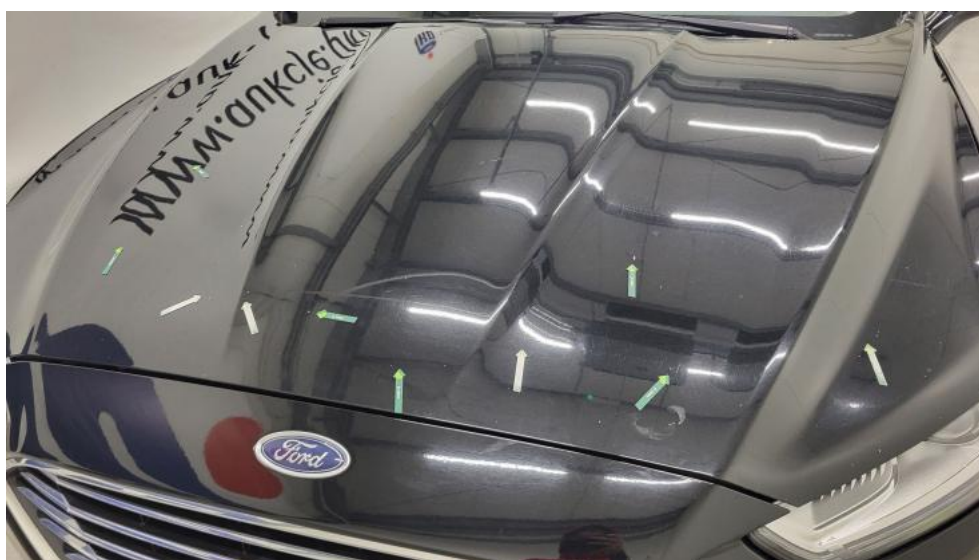
Photo 36.
Pokrywa komory silnika - Rysa/odprysk 1

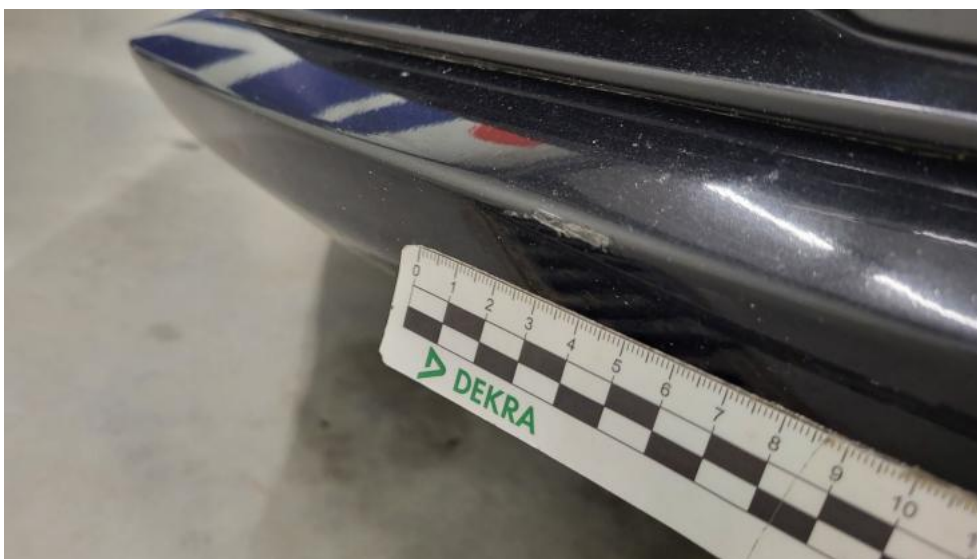
Photo 37.
Zderzak - Rysa/odprysk 1

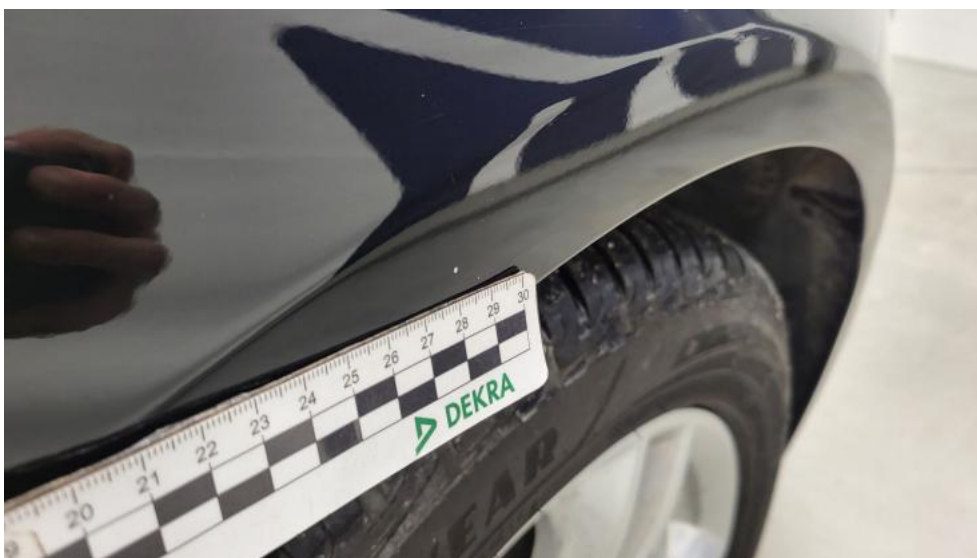
Photo 38.
Błotnik przedni P - Rysa/odprysk 1

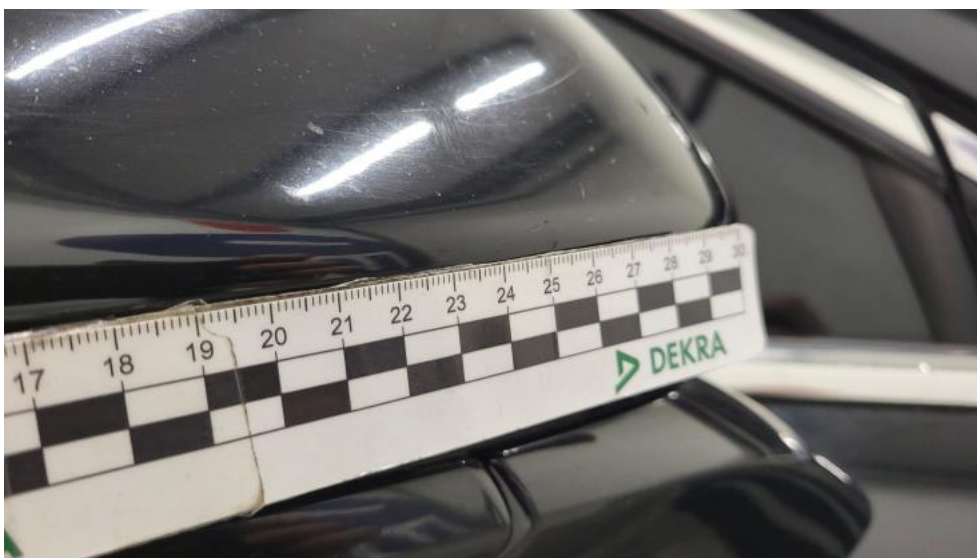
Photo 44.
Lusterko zew P - Rysa/odprysk 1

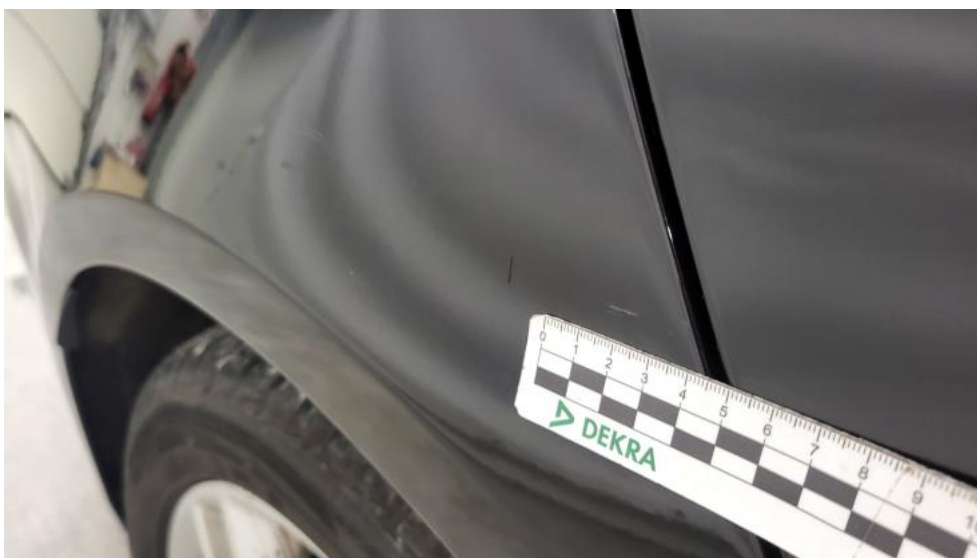
Photo 48.

Łotnik tylny P / Ściana boczna P - Rysa/odprysk 1

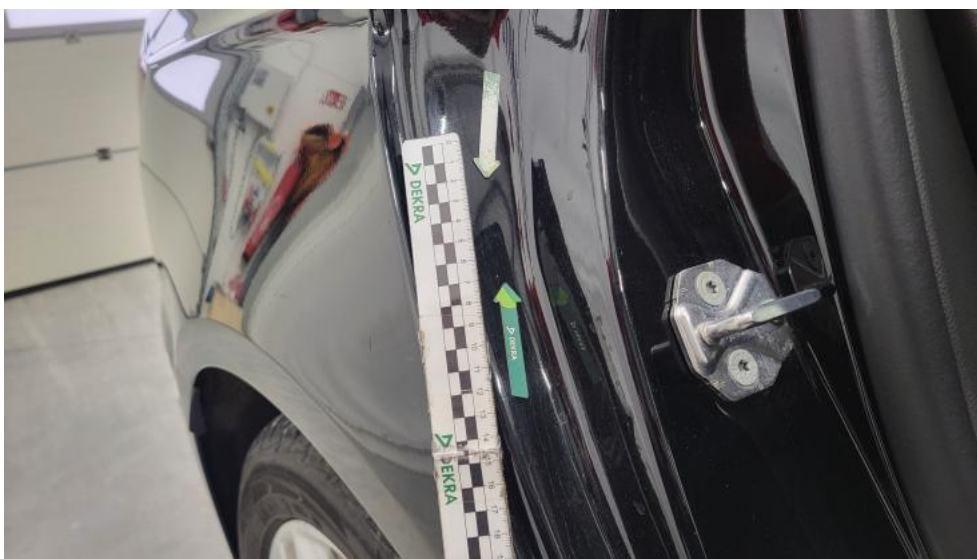
Photo 49.
Błotnik tylny P / Ściana boczna P - Wgniecenie/odkształcenie 1

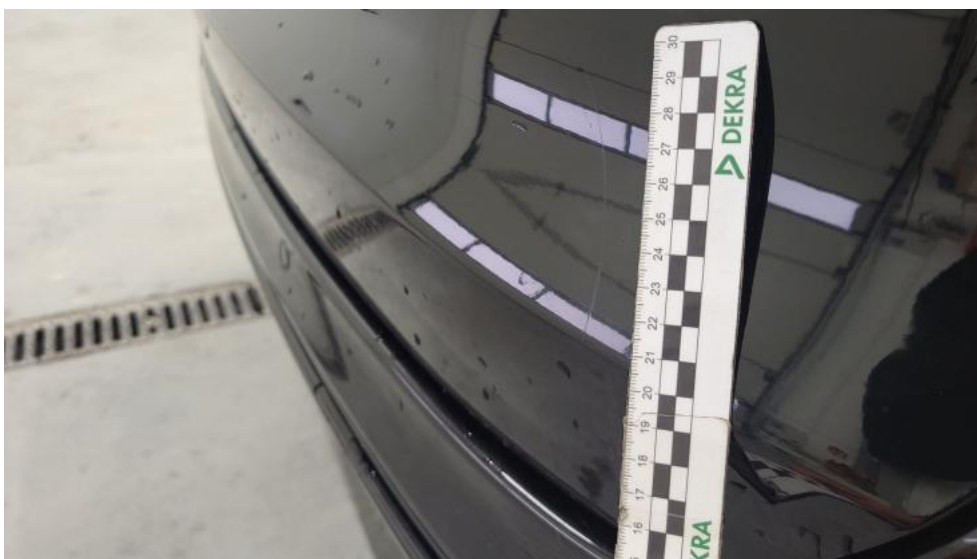
Photo 51.
Pokrywy bagażnika - Rysa/odprysk 1

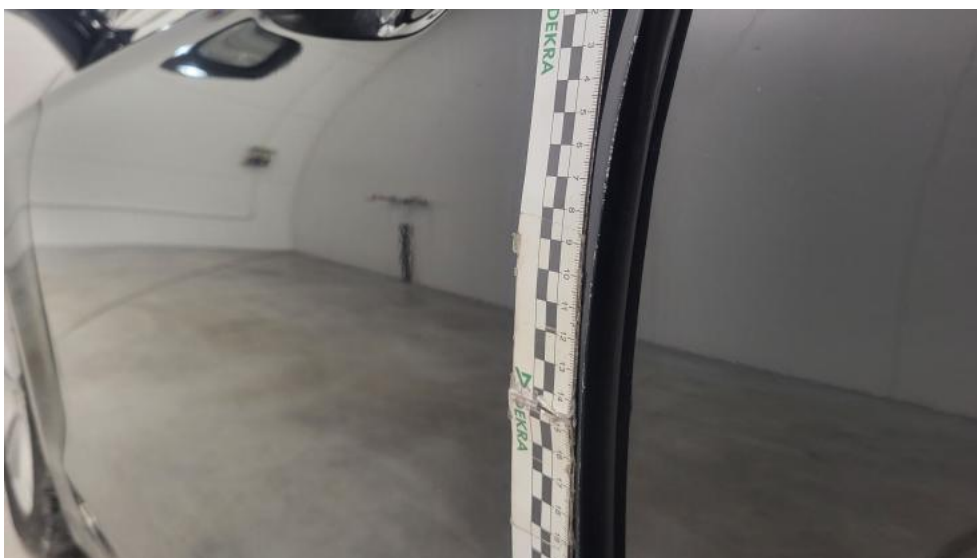
Photo 58.
Drzwi przed L - Rysa/odprysk 1

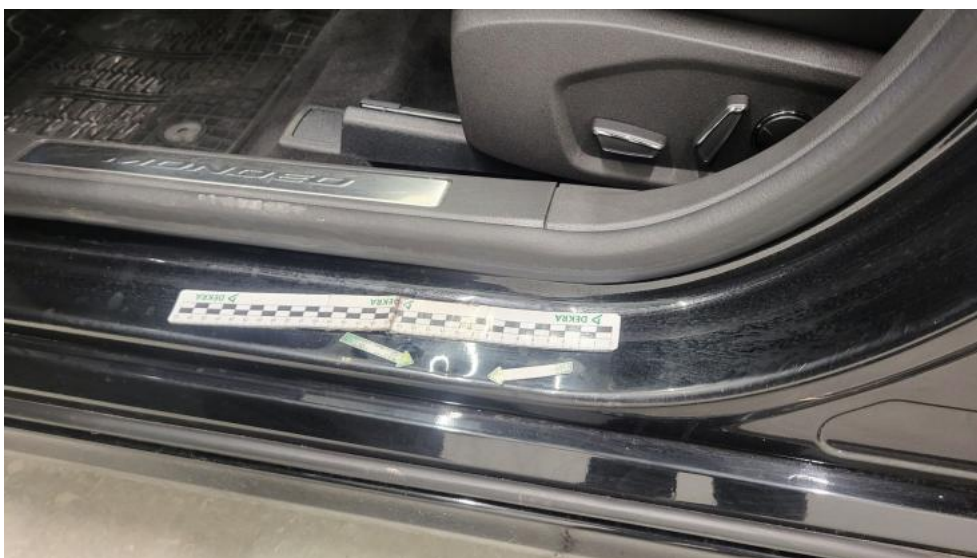
Photo 60.

Próg L - Wgniecenie/odkształcenie 1

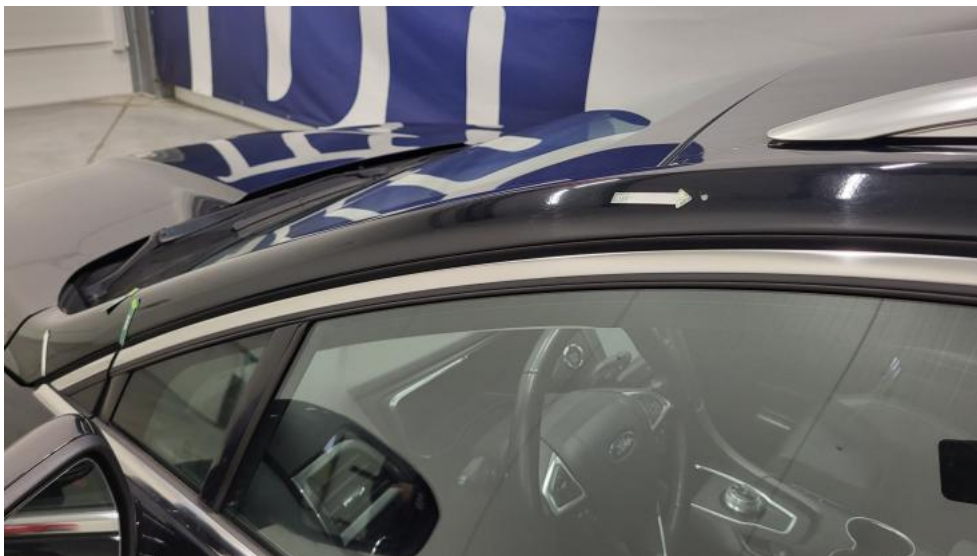
Photo 61.
Stupek przedni L - Rysa/odprysk 1

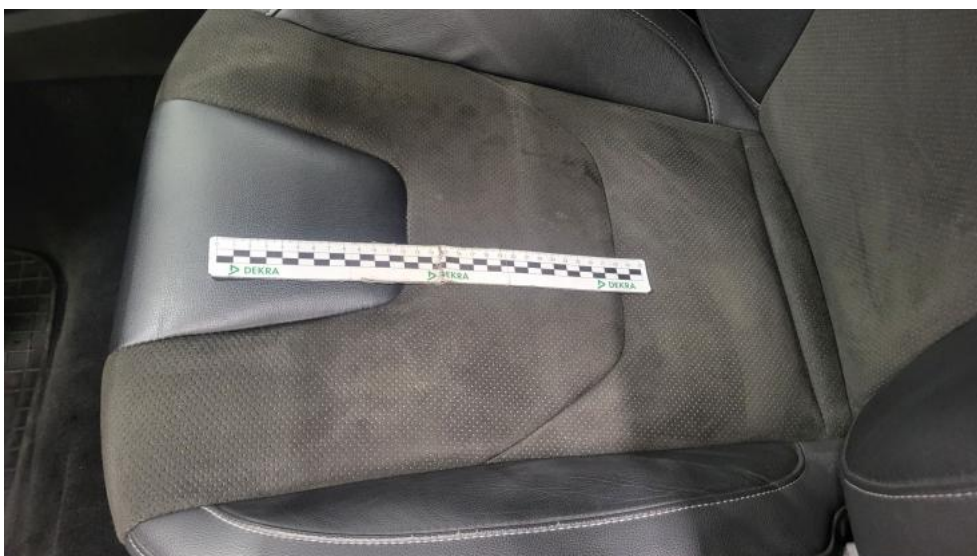
Photo 62.
Fotel prz. lew. - Inne 1
