DEKRA's commission No. : PKOL(W)/LODZ/22522/26/03/13
 commission/ damage No. : 22/037335
 Date of commission: 13-03-2026

Vehicle data

Measurement of thickness of the vehicle lacquer coating

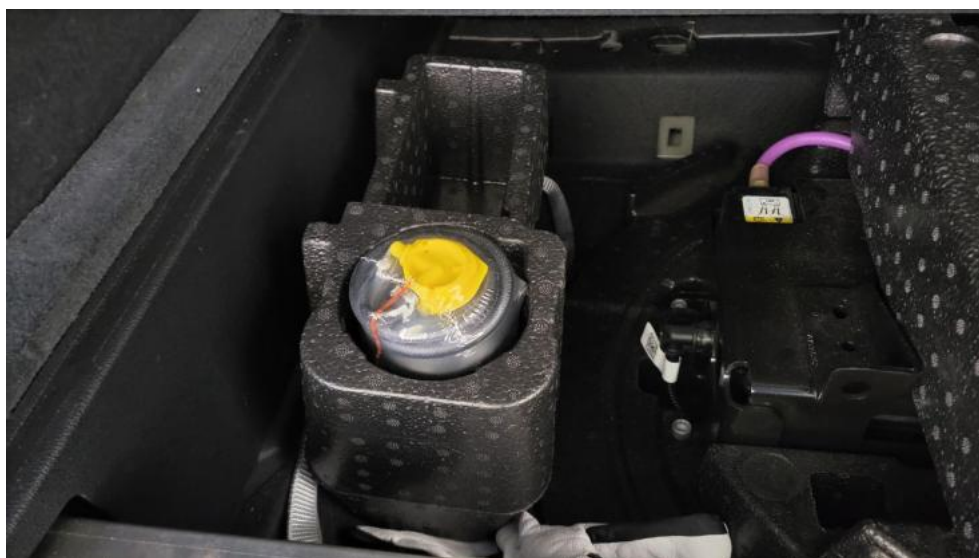
Photo 36.

Niesprawne przyciski funkcyjne w jednym z kluczyków, grot prawidłowy. Brak kompresora zestawu naprawczego. Brak zaślepki w tylnej kanapie. Rysy na samochodzie. Odpryski na szybie czołowej. Lusterka oklejone folią. Lusterko we wnętrzu pojazdu brak weryfikacji od jakiego pojazdu i jego sprawności.

Zestaw naprawczy koła

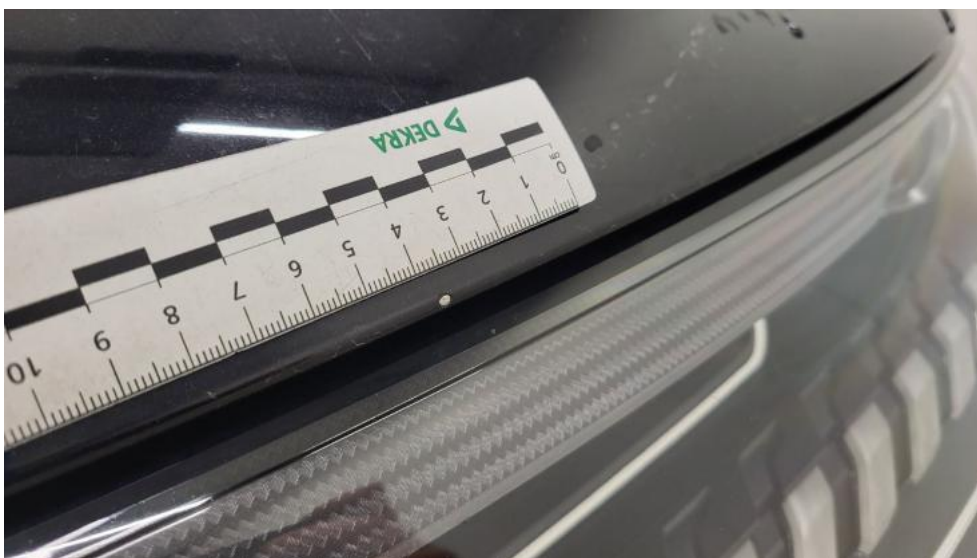
Photo 44.
Pokrywa komory silnika - Rysa/odprysk 1

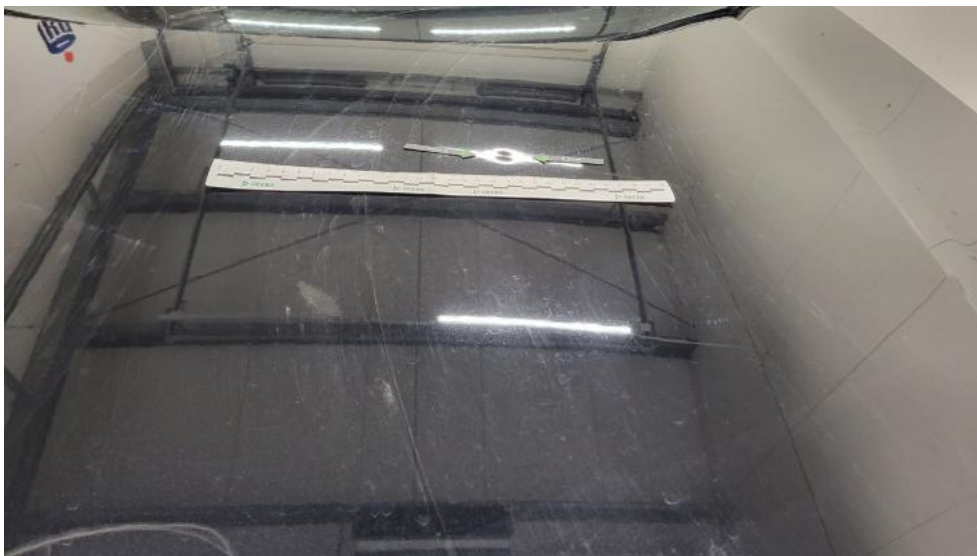
Photo 45.
Pokrywa komory silnika - Wgniecenie/odkształcenie 1

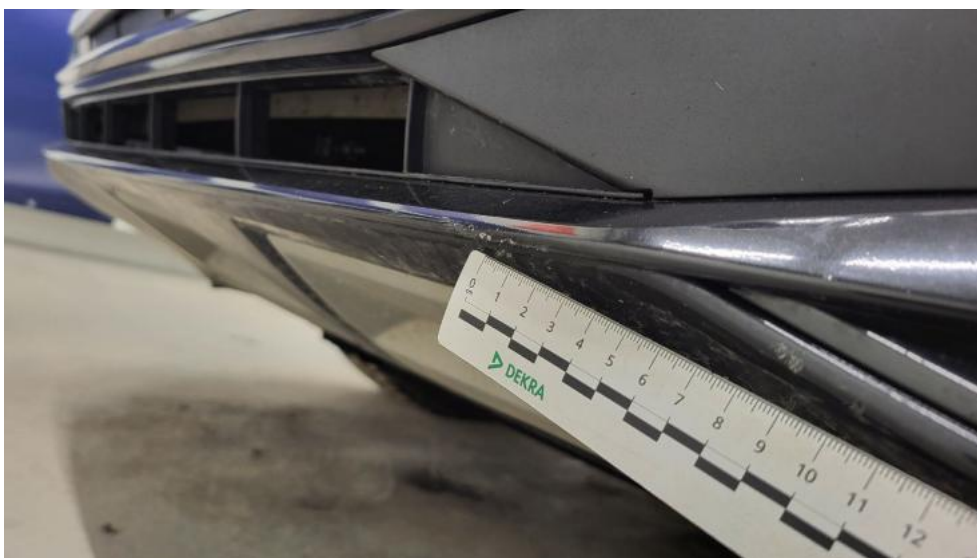
Photo 46.
Spoiler zderzaka przedniego - Rysa/odprysk 1

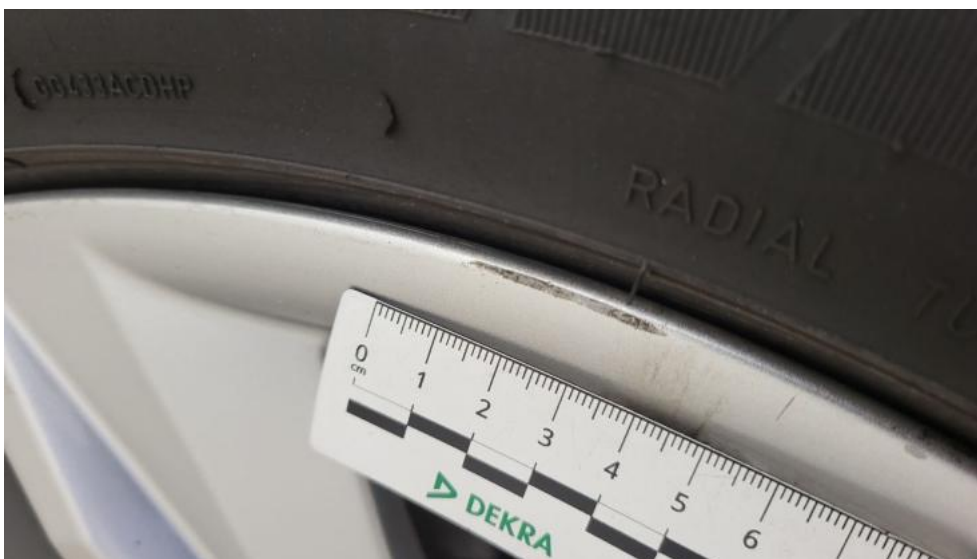
Photo 47.
Felga aluminiowa przednia P - Rysa/odprysk 1

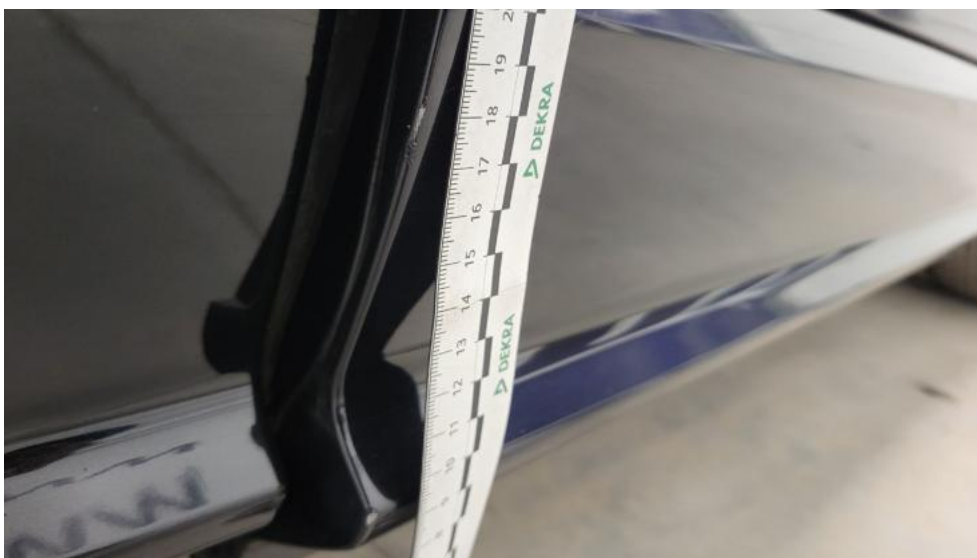
Photo 48.
Listwa drzwi przednich P - Rysa/odprysk 1

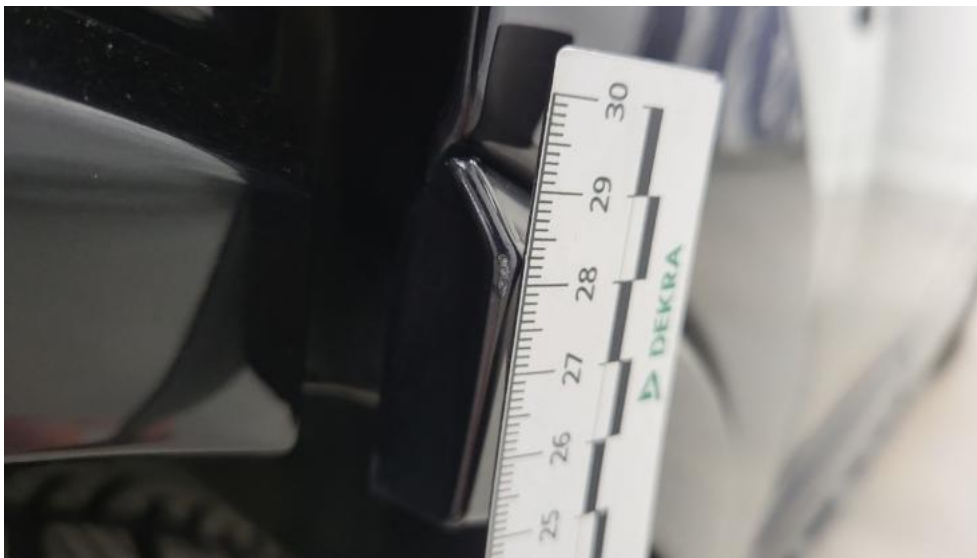
Photo 49.

Listwa drzwi tylnych P - Rysa/odprysk 1

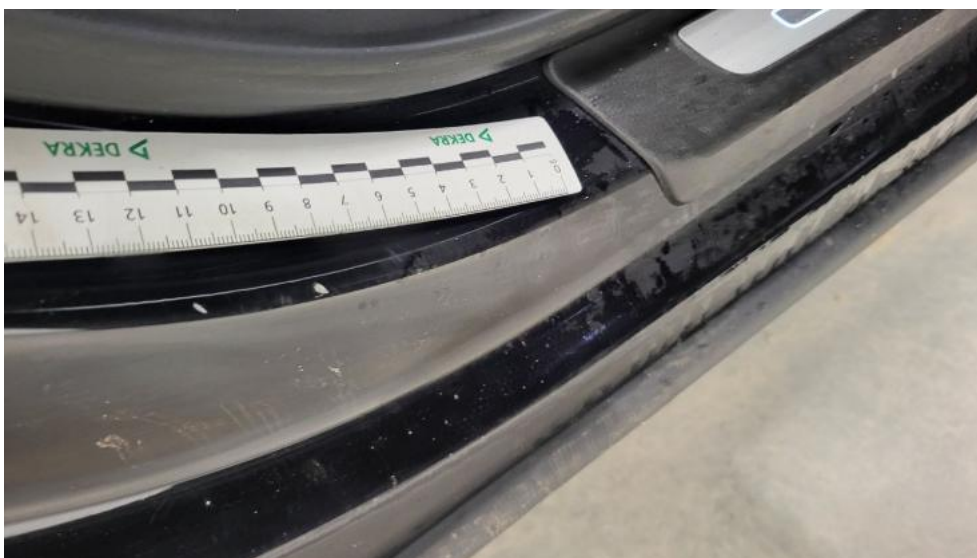
Photo 50.

Próg P - Rysa/odprysk 1

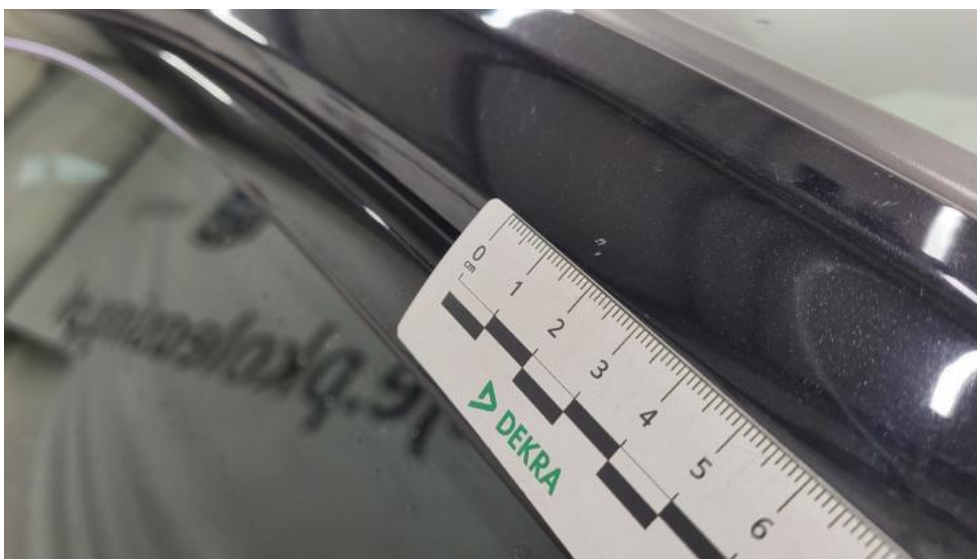
Photo 51.
Stupek przedni P - Rysa/odprysk 1

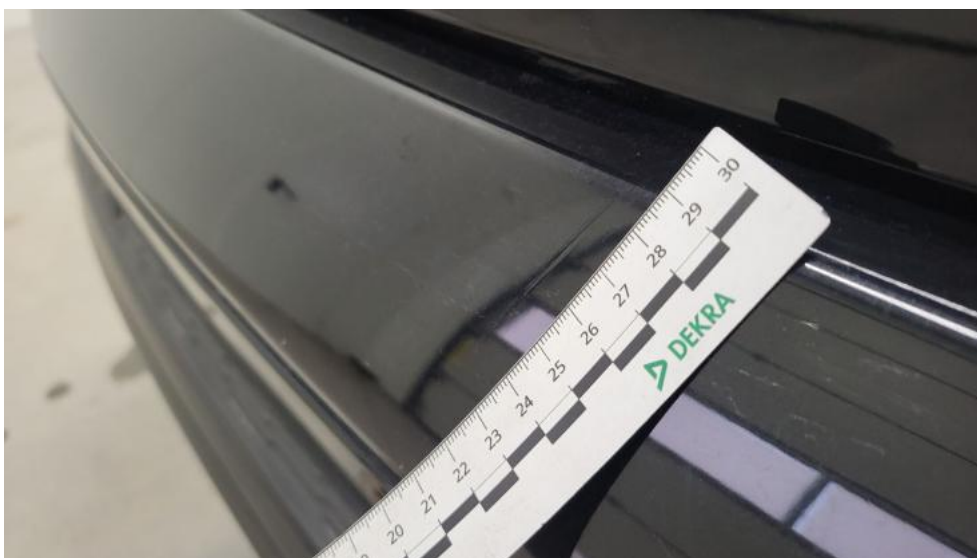
Photo 52.
Zderzak tylny - Wgniecenie/odkształcenie 1

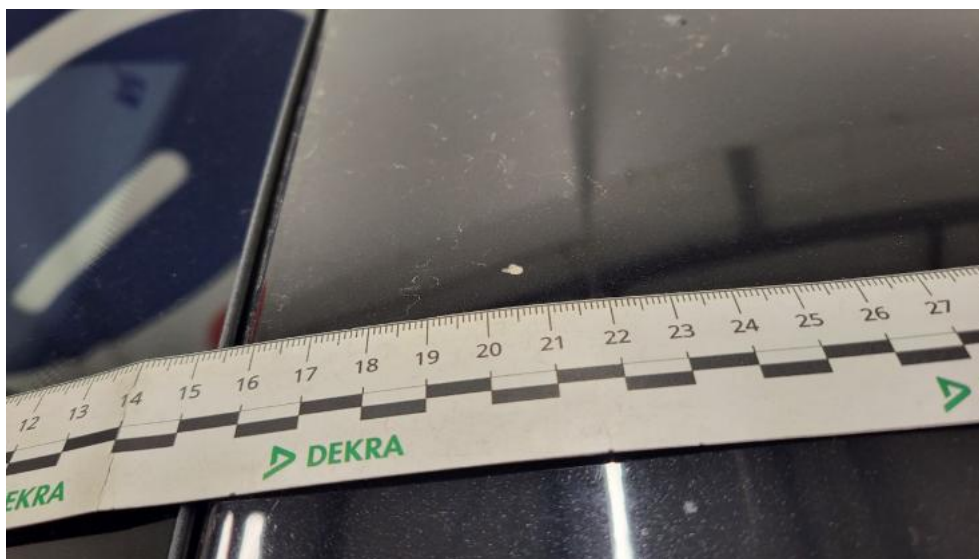
Photo 53.
Dach - Rysa/odprysk 1

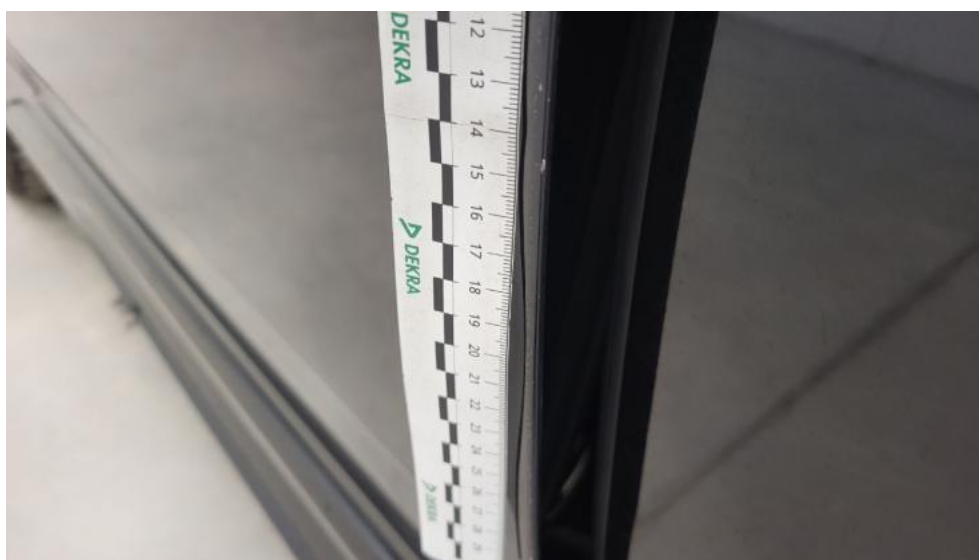
Photo 54.
Drzwi przed L - Rysa/odprysk 1

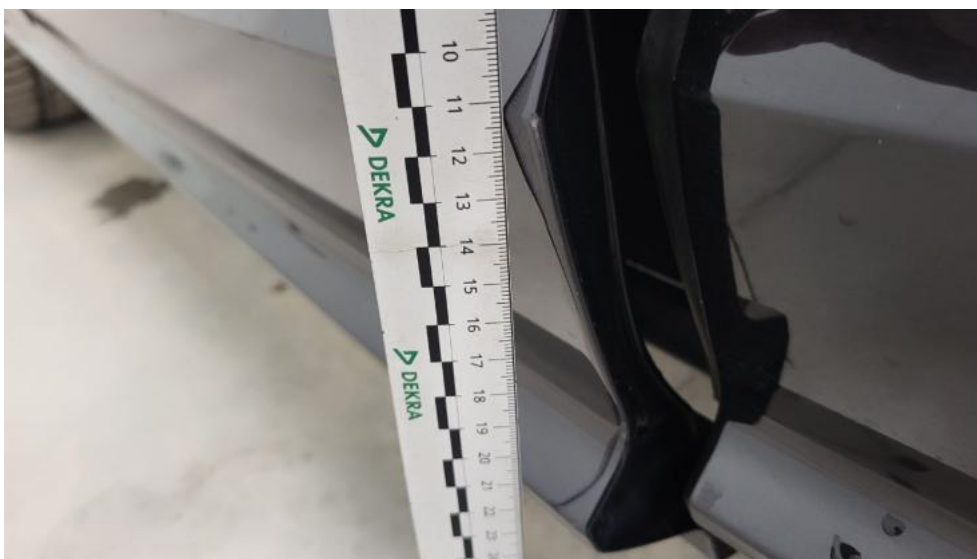
Photo 55.

Listwa drzwi przednich L - Rysa/odprysk 1

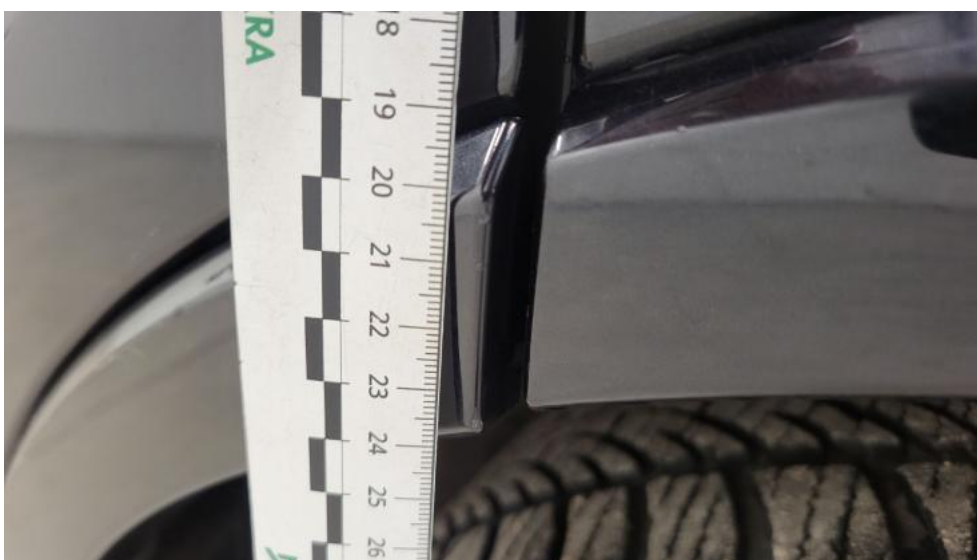
Photo 56.

Listwa drzwi tylnych L - Rysa/odprysk 1

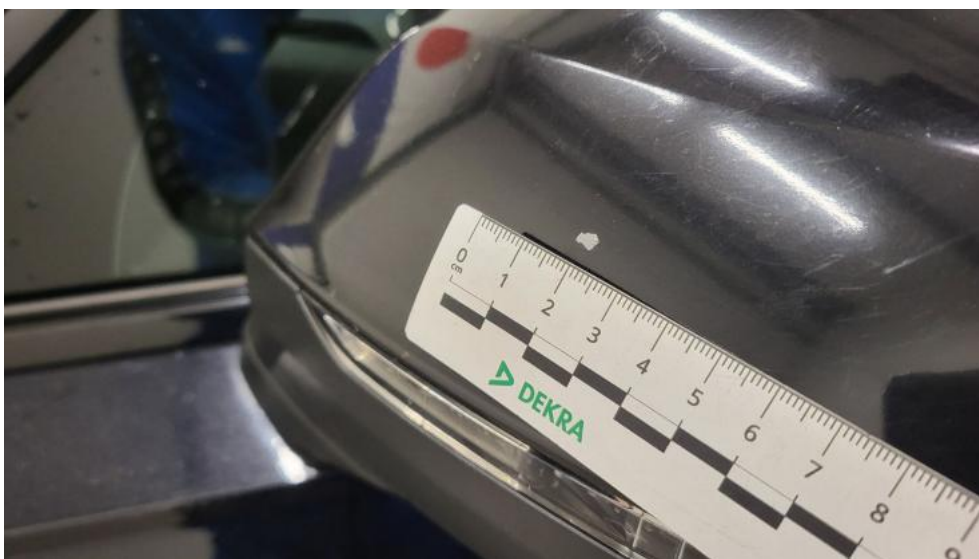
Photo 57.

Lusterko zew L - Rysa/odprysk 1

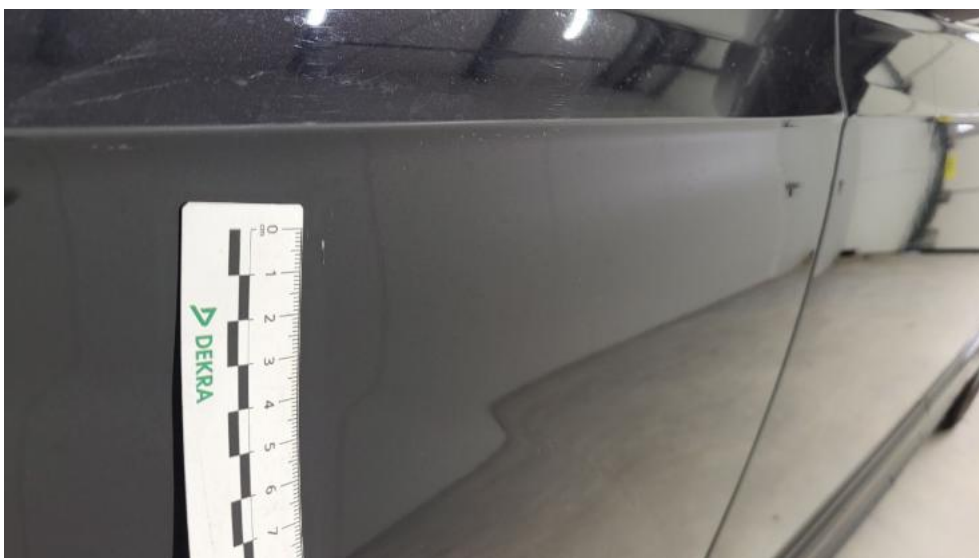
Photo 58.

Łotnik przedni L - Rysa/odprysk 1

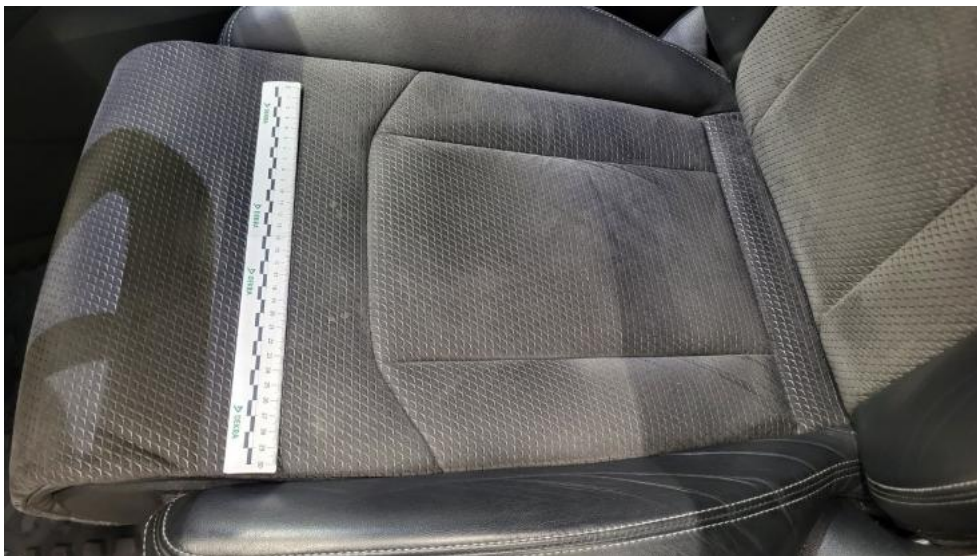
Photo 59.
Fotel prz. lew. - Inne 1

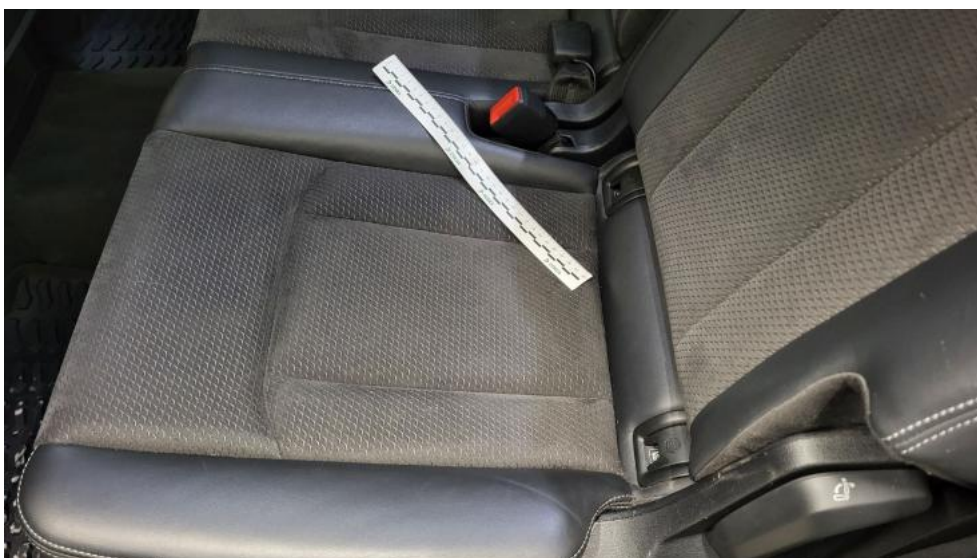
Photo 60.
Kanapa tyl. - Inne 1

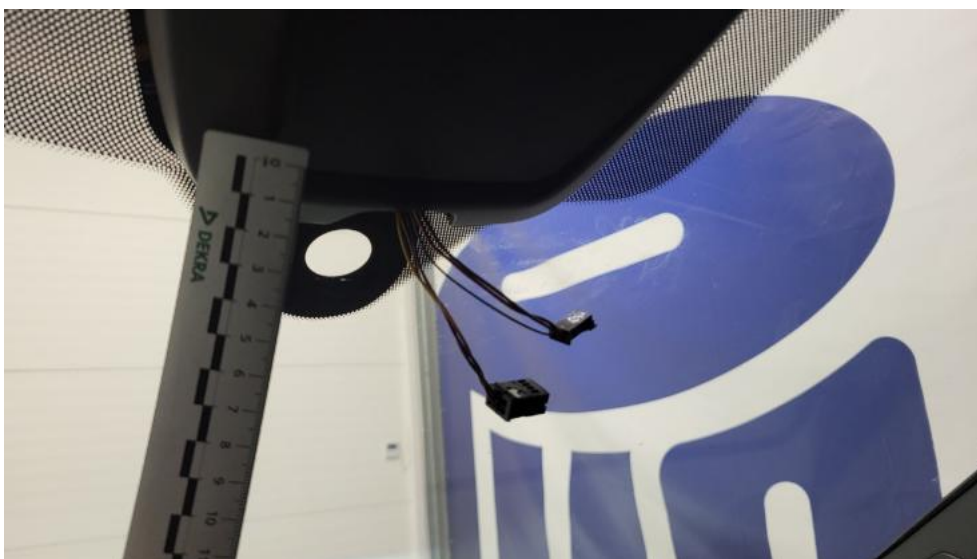
Photo 61.

Lusterko wsteczne wew - Inne 1
