DEKRA's commission No. : PKOL(W)/LODZ/18093/26/02/27  
commission/ damage No. : 22/005398  
Date of commission: 27-02-2026

**Vehicle data**

Group of objects (Eurotax)	jeeps
EC code (Eurotax)	0151342
Manufacturer	BMW
Model	X3 [G01] 21-24
Type / version	X3 xDrive30i mHEV M Sport sport-aut
Body type	KOM
Number of doors / seats	5/5
Curb weight [kg]	1810
Gross vehicle weight [kg]	2450
Wheelbase 1/2	2864
Engine type	spark ignition
Pollution reduction system	GPF
Engine capacity [ccm]	1998
Engine Power [hp/kW]	245/180
Gearbox	automatic
Registration /record No.	WZ712ET
VIN / serial number	WBA55DP050N133910
Date of first registration	24-02-2022
Date of next. tech. test	24-02-2027
Year of manufacture	2021 (year has been verified with the manufacturer's base)
Readout [km]	70 949 (read)
Body color / type of coating	granatowy/double-layered, metallized

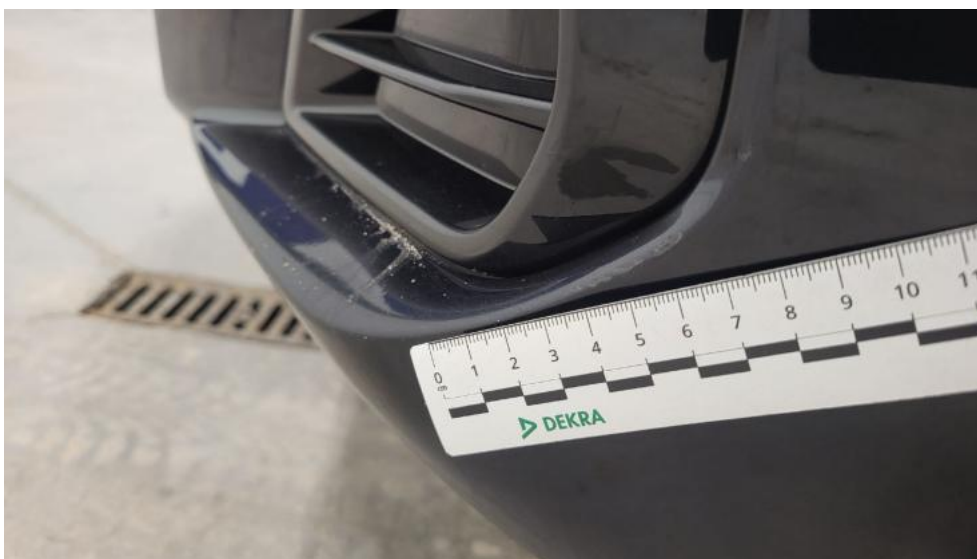
**Photo 41.**  
Zderzak - Rysa/odprysk 1

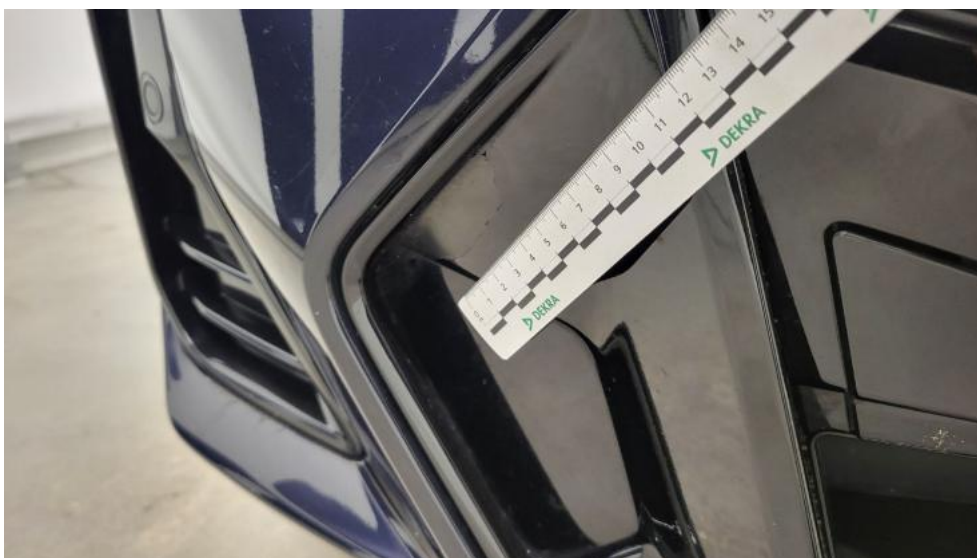
**Photo 42.**  
Zderzak przedni cz P - Inne 1

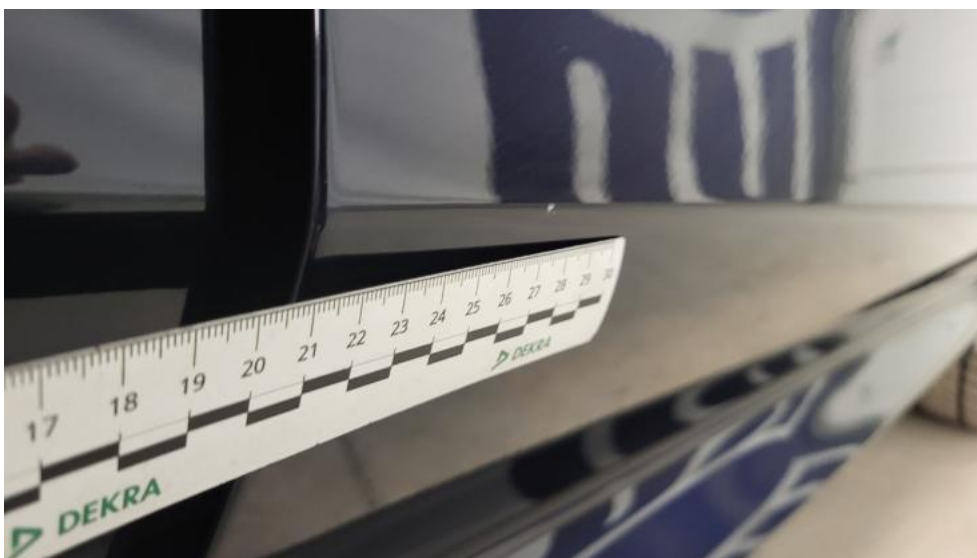
**Photo 44.**  
Drzwi przednie P - Rysa/odprysk 1

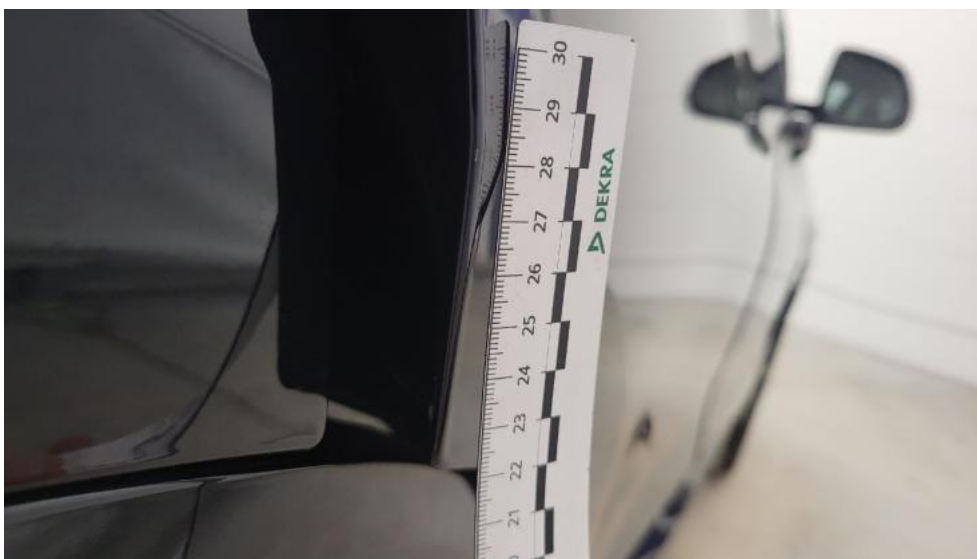
**Photo 45.**

Drzwi tylne P - Rysa/odprysk 1

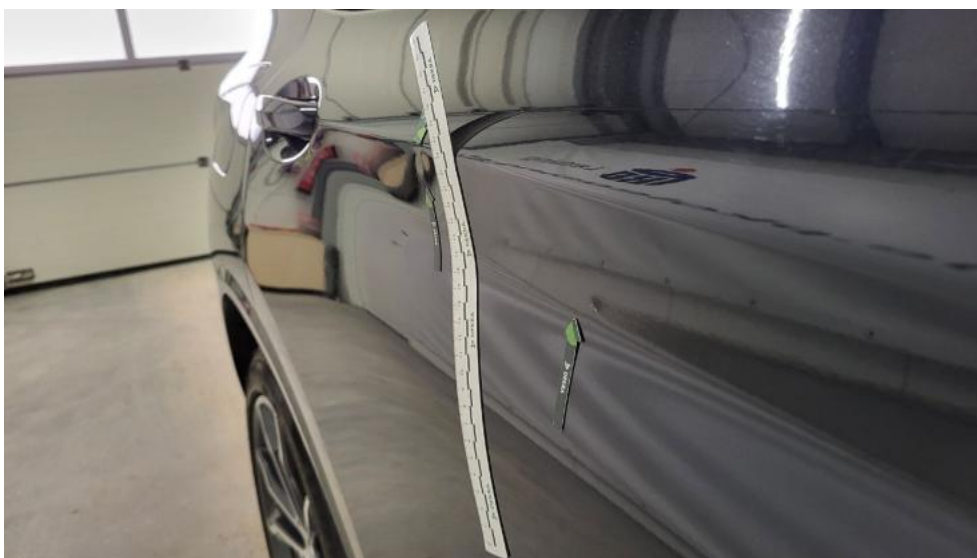
**Photo 46.**

Drzwi tylne P - Wgniecenie/odkształcenie 1

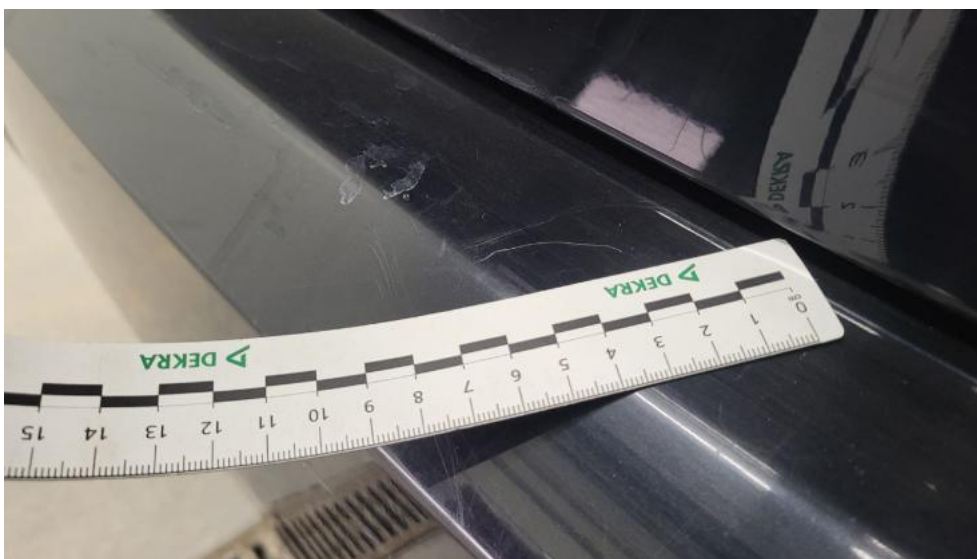
**Photo 47.**  
Zderzak tylny - Rysa/odprysk 1

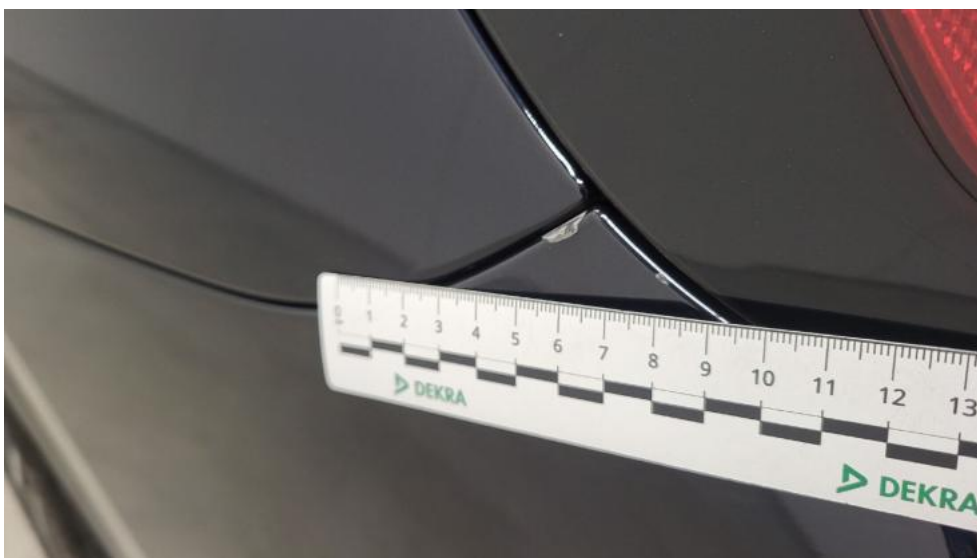
**Photo 48.**  
Zderzak tylny - Rysa/odprysk 2

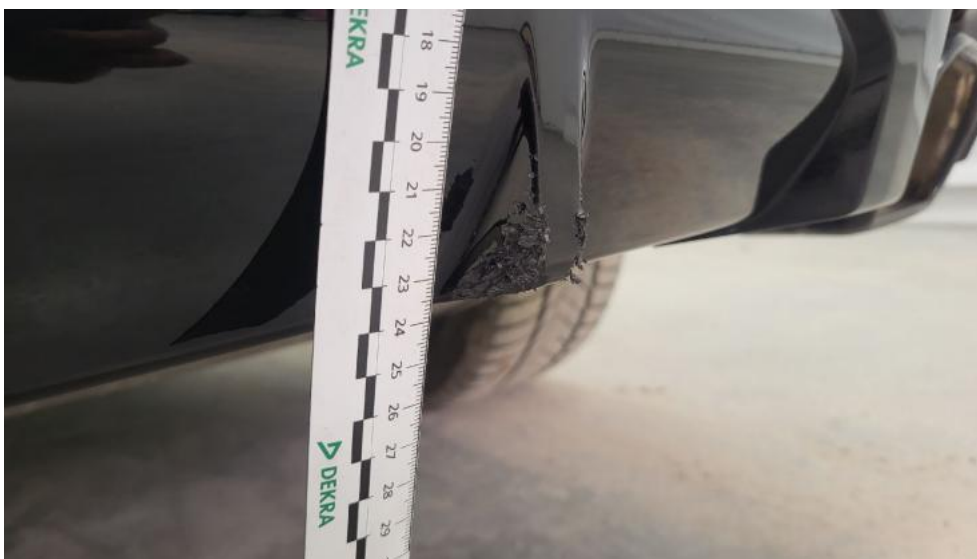
**Photo 51.**

Zderzak tylny cz dolna - Rysa/odprysk 2

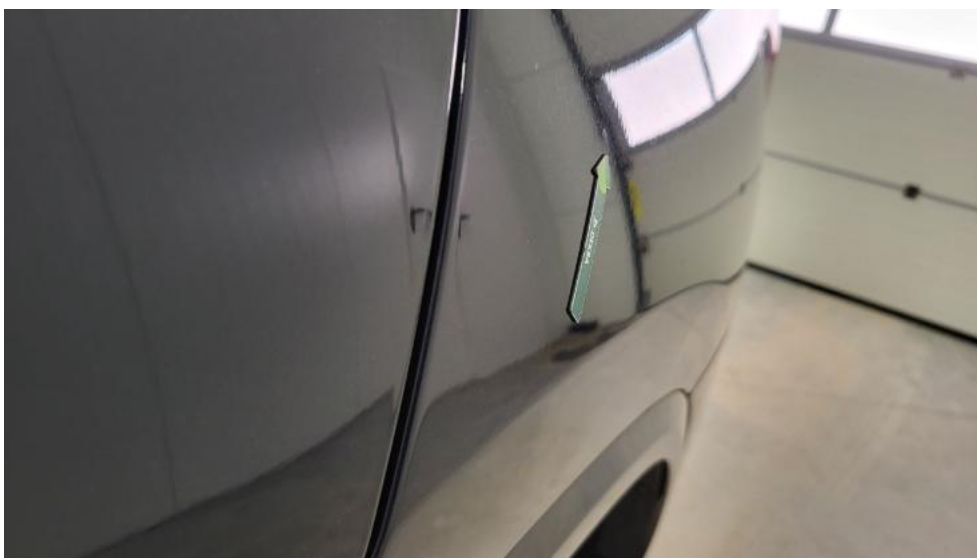
**Photo 52.**

Błotnik tylny L / Ściana boczna L - Wgniecenie/odkształcenie 1

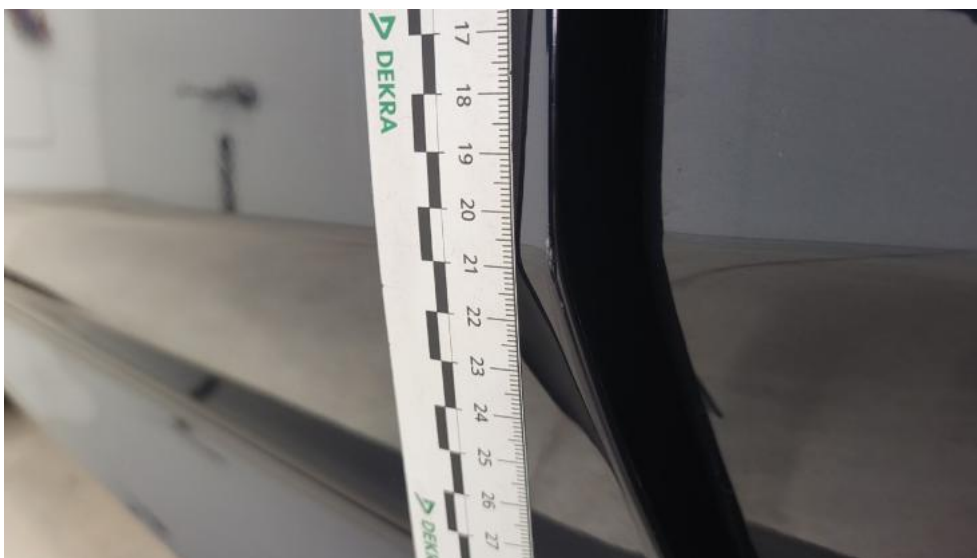
**Photo 54.**

Drzwi przed L - Rysa/odprysk 1

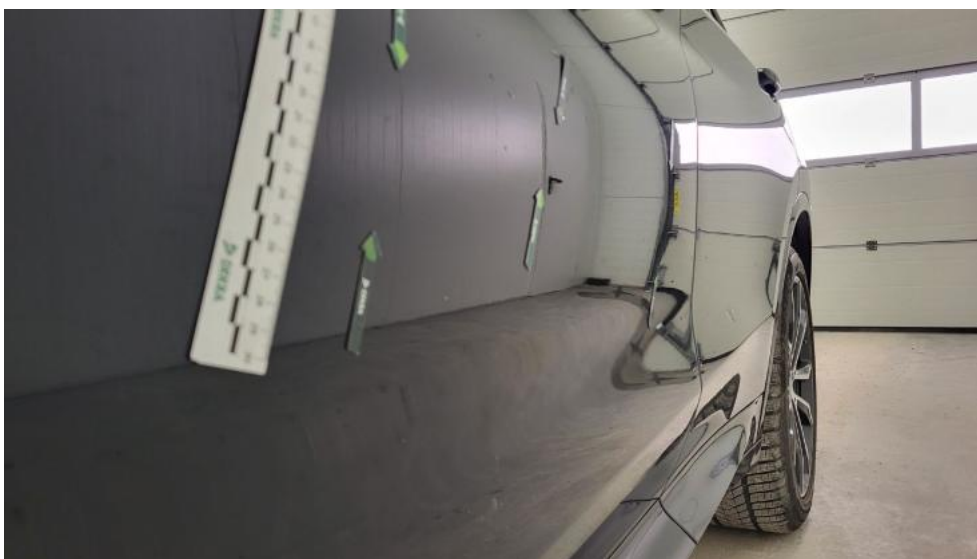
**Photo 55.**  
Drzwi przed L - Wgniecenie/odkształcenie 1

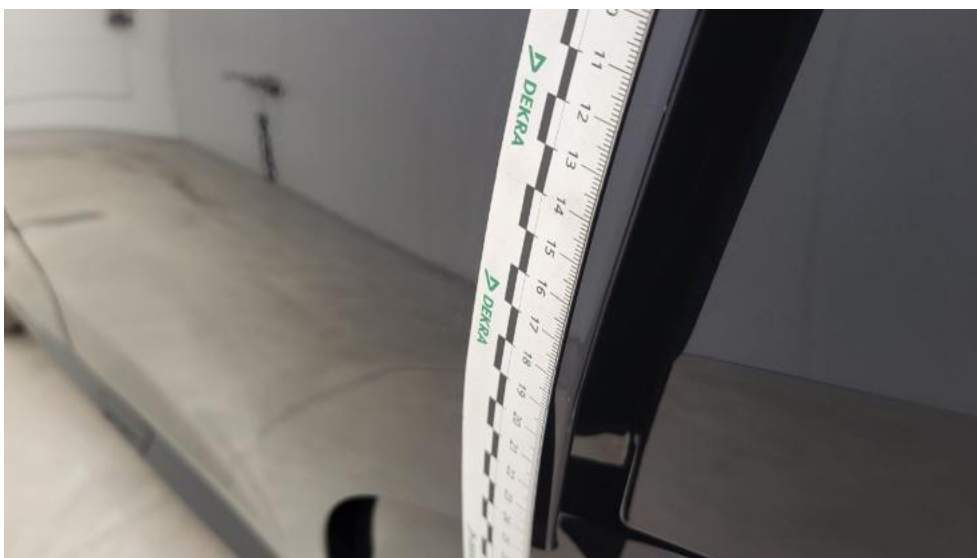
**Photo 56.**  
Drzwi tylne L - Rysa/odprysk 1

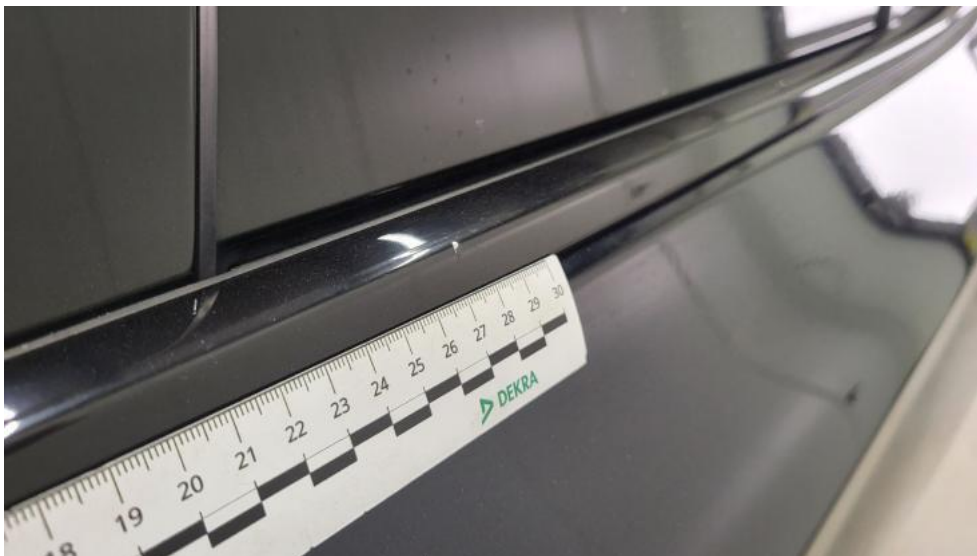
**Photo 57.**

Listwa drzwi tylnych L - Rysa/odprysk 1

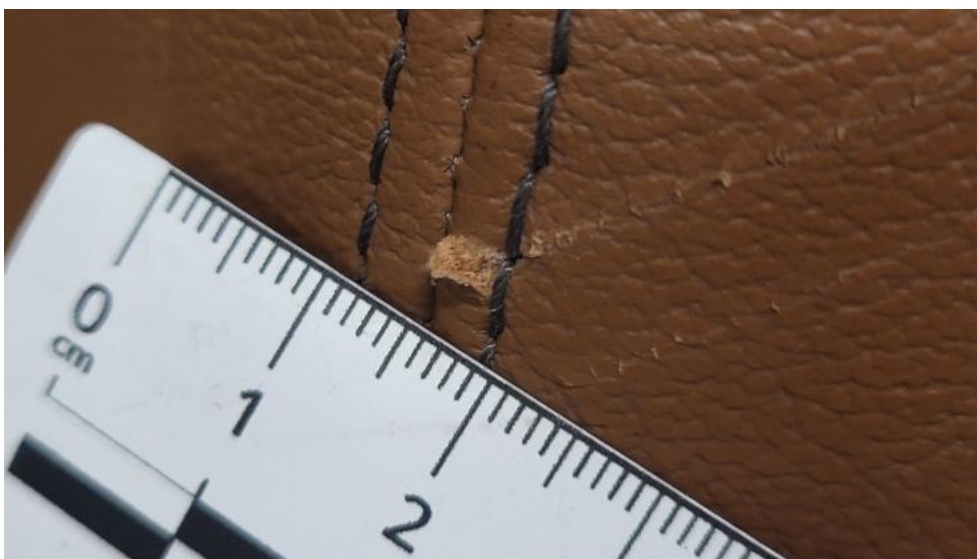
**Photo 61.**  
Fotel prz. lew. - Pęknięcie/rozerwanie 1

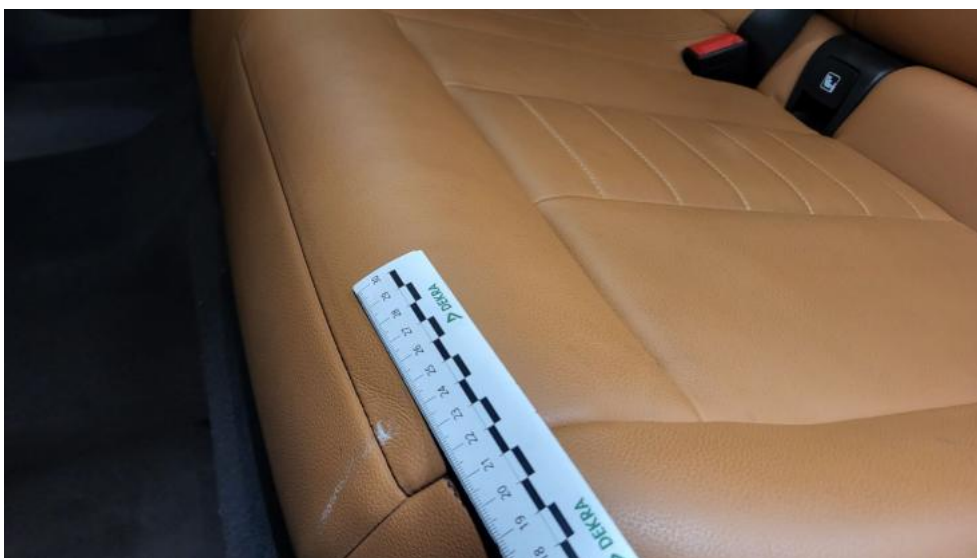
**Photo 62.**  
Kanapa tyl. - Inne 1
