DEKRA's commission No. : PKOL(W)/LODZ/23883/25/04/01  
commission/ damage No. : Futura  
Date of commission: 01-04-2025

PKO Leasing SA  
Świętokrzyska 36  
00-116 Warszawa

| Manufacturer | HYUNDAI |
| Type / version | Elantra 1.6 Executive |

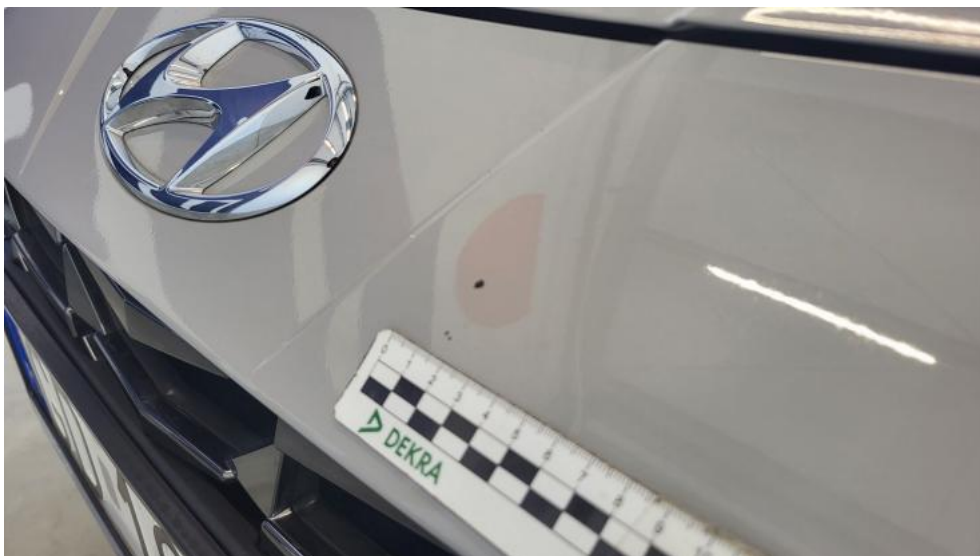
**Photo 36.**

Zderzak - Rysa/odprysk 1

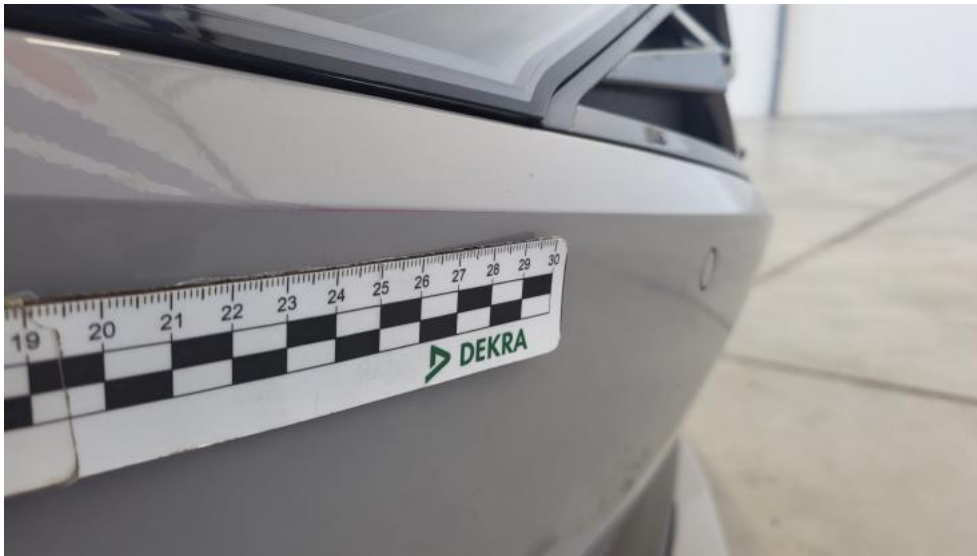
**Photo 37.**

Zderzak - Rysa/odprysk 2

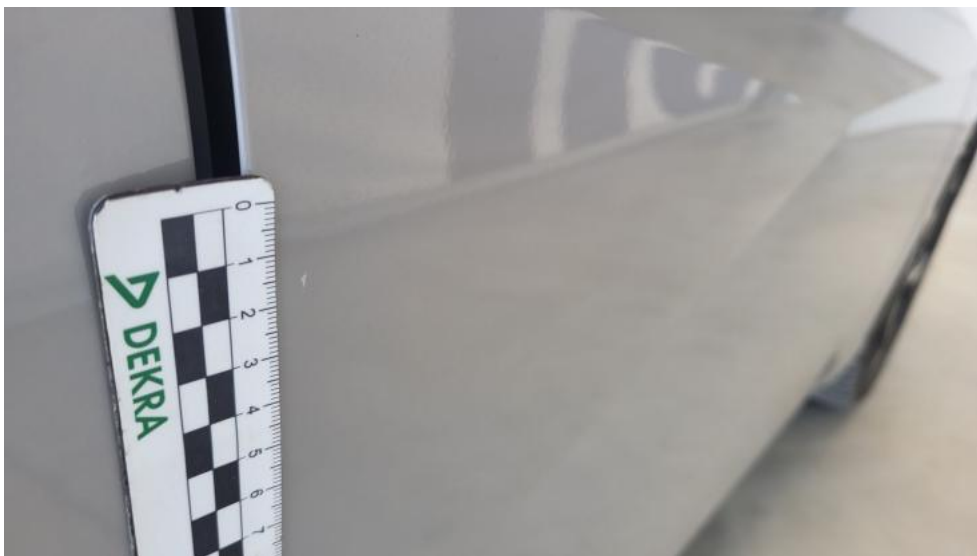
**Photo 38.**

Drzwi przednie P - Rysa/odprysk 1

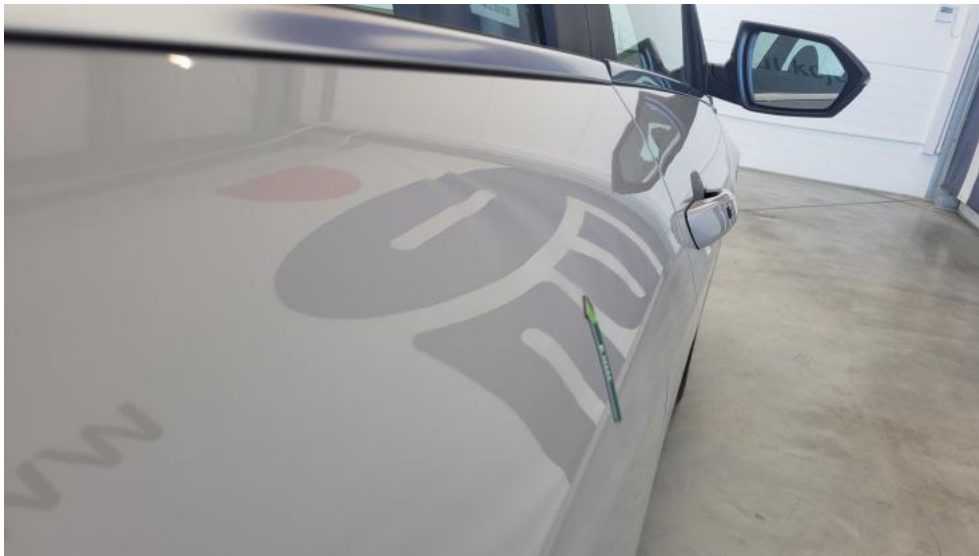
**Photo 39.**

Drzwi tylne P - Wgniecenie/odkształcenie 1

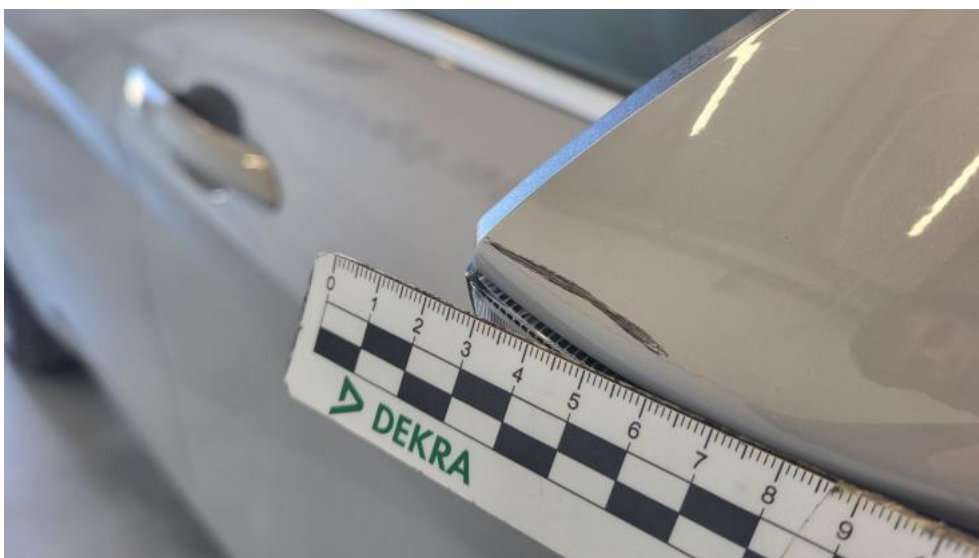
**Photo 40.**

Lusterko zew P - Inne 1

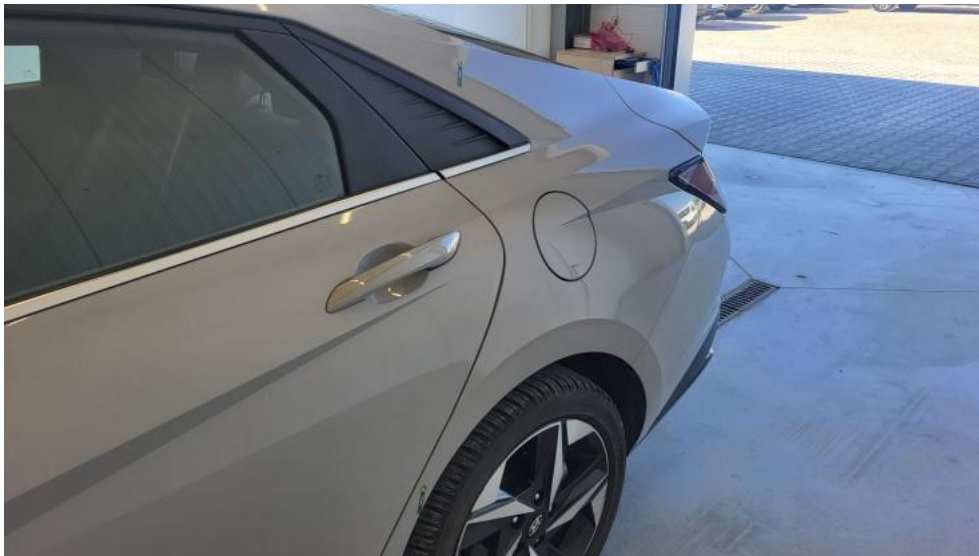
**Photo 41.**

Błotnik tylny L / Ściana boczna L - Wgniecenie/odkształcenie 1

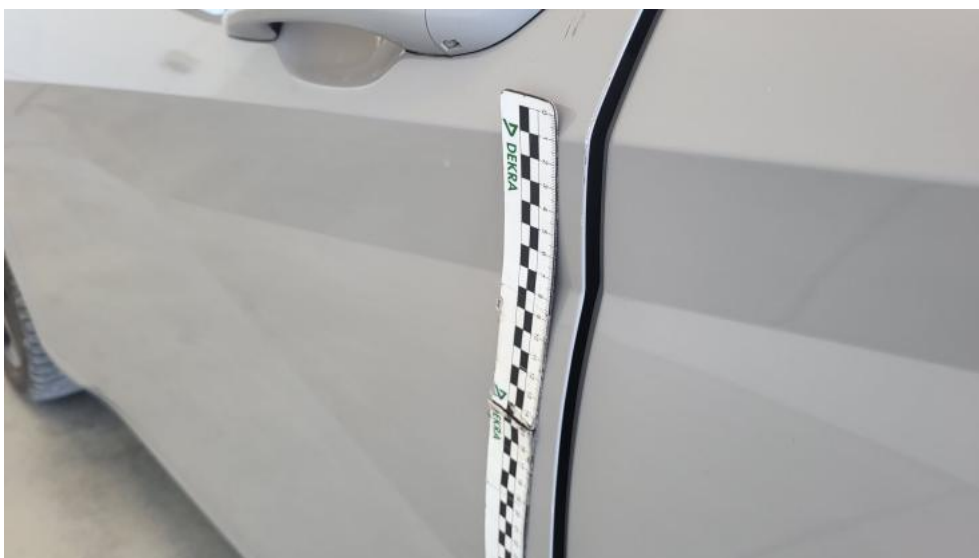
**Photo 42.**

Drzwi przed L - Rysa/odprysk 1

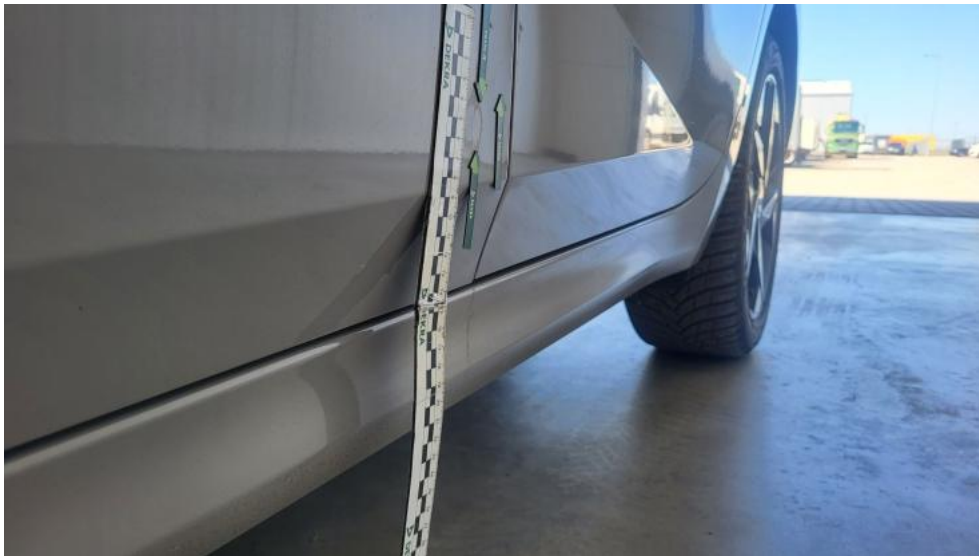
**Photo 43.**

Drzwi przed L - Wgniecenie/odkształcenie 1

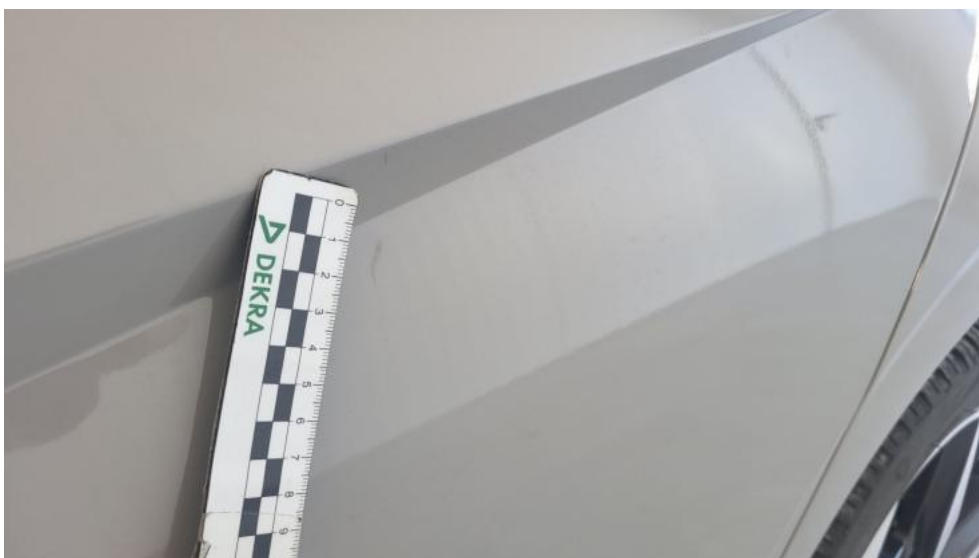
**Photo 44.**

Drzwi tylne L - Rysa/odprysk 1

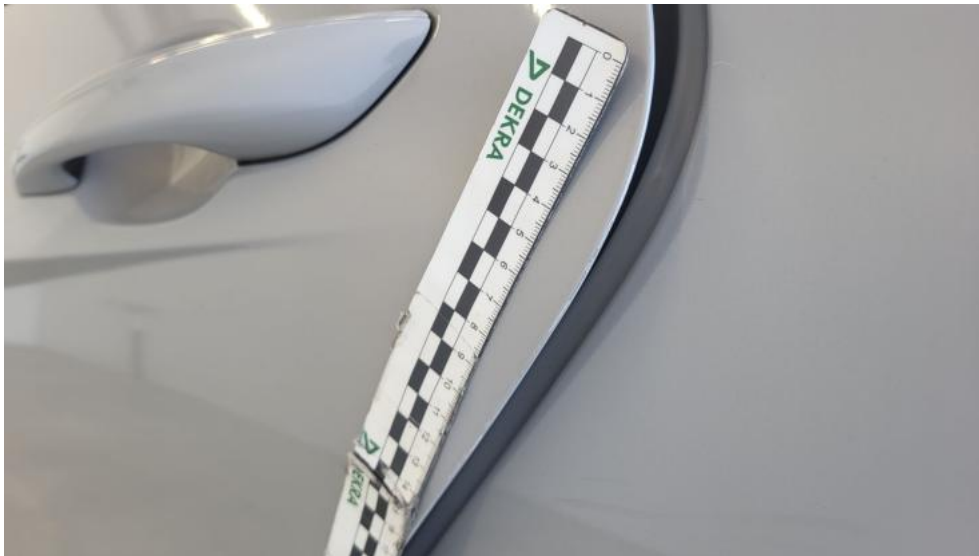
**Photo 45.**

Drzwi tylne L - Rysa/odprysk 2

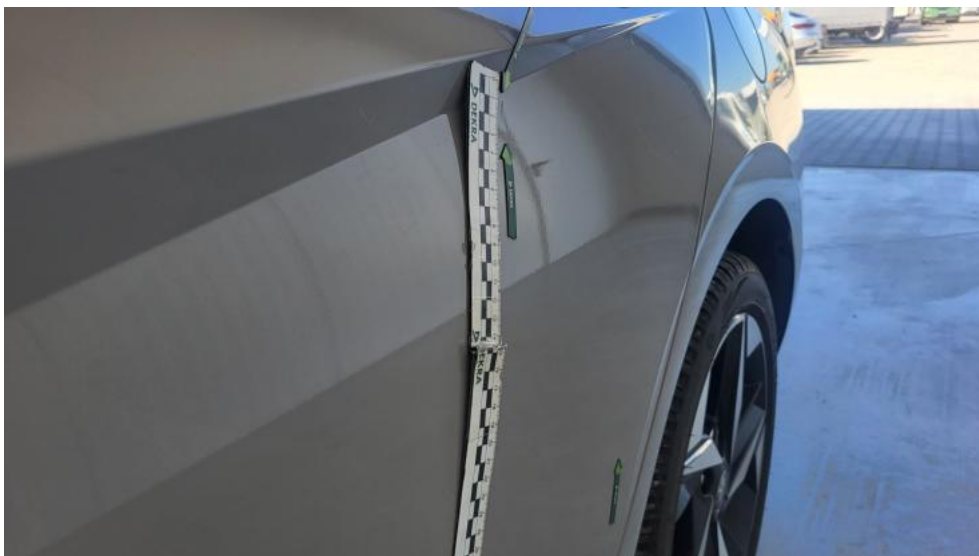
**Photo 46.**

Drzwi tylne L - Wgniecenie/odkształcenie 1
