DEKRA's commission No. : PKOL(W)/LODZ/99203/25/12/15  
commission/ damage No. : 01031/EF/23  
Date of commission: 15-12-2025

**Vehicle data**

| Manufacturer | TOYOTA |
| Model | Corolla Sedan 18-22 |

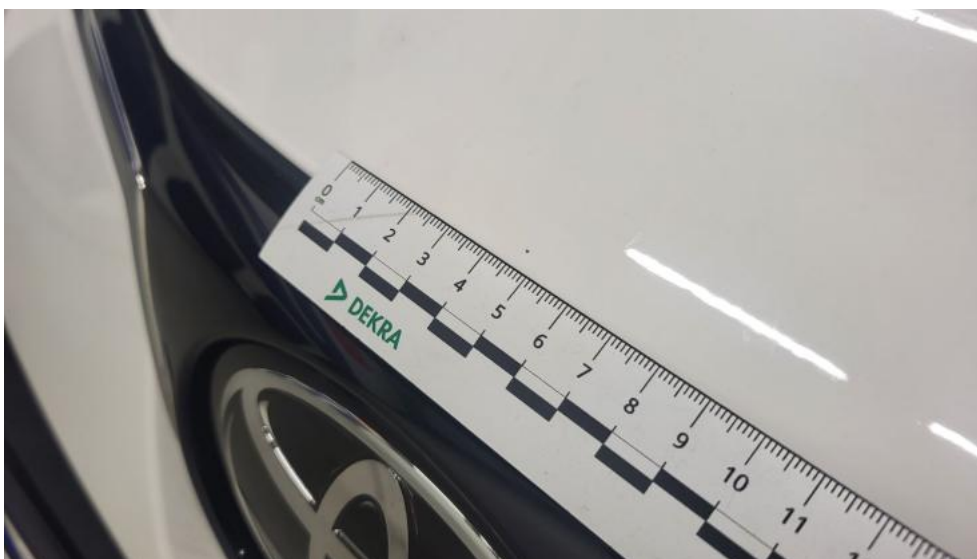
**Photo 35.**

Brak kołpaków. Rysy na samochodzie. Odpryski na szybie czołowej.

Pokrywa komory silnika - Rysa/odprysk 1

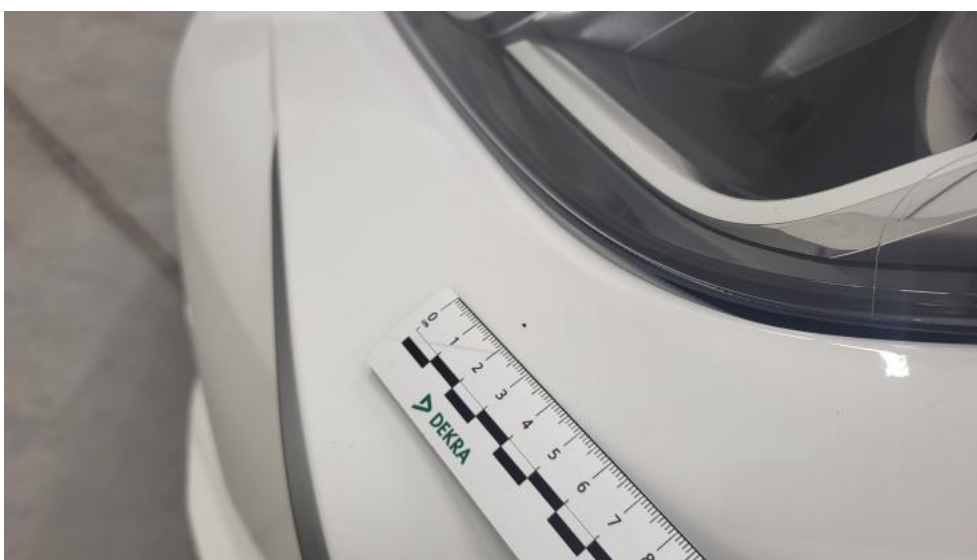
**Photo 36.**

Zderzak - Rysa/odprysk 1

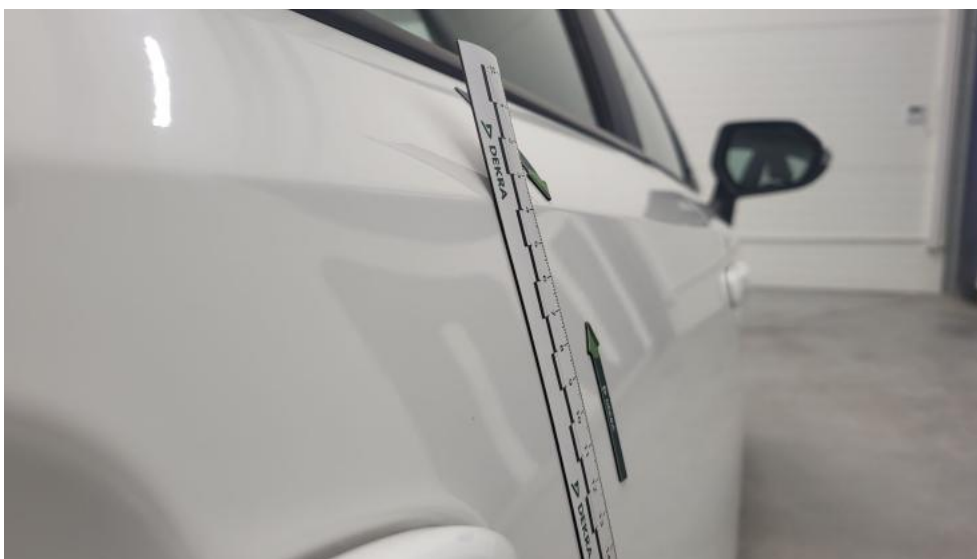
**Photo 37.**

Drzwi tylne P - Wgniecenie/odkształcenie 1

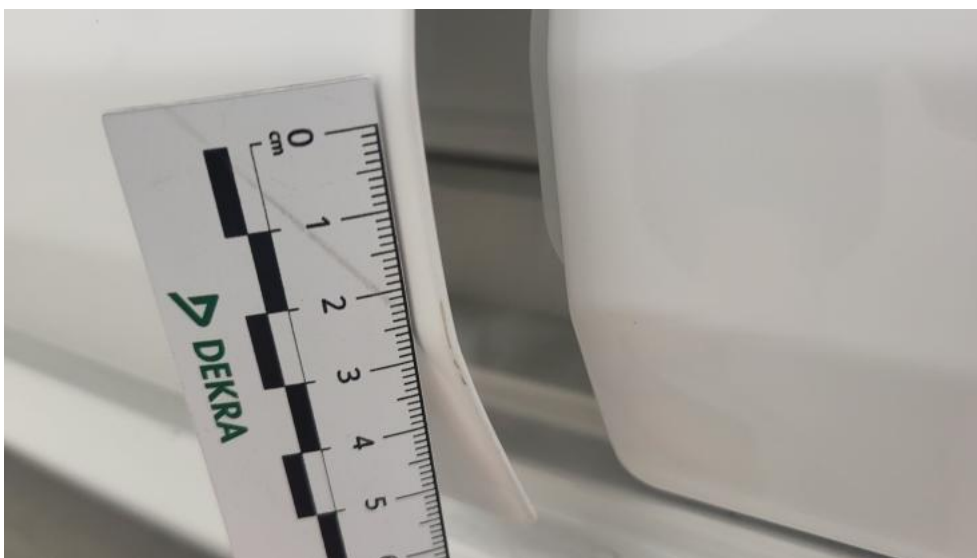
**Photo 38.**

Drzwi przed L - Rysa/odprysk 1

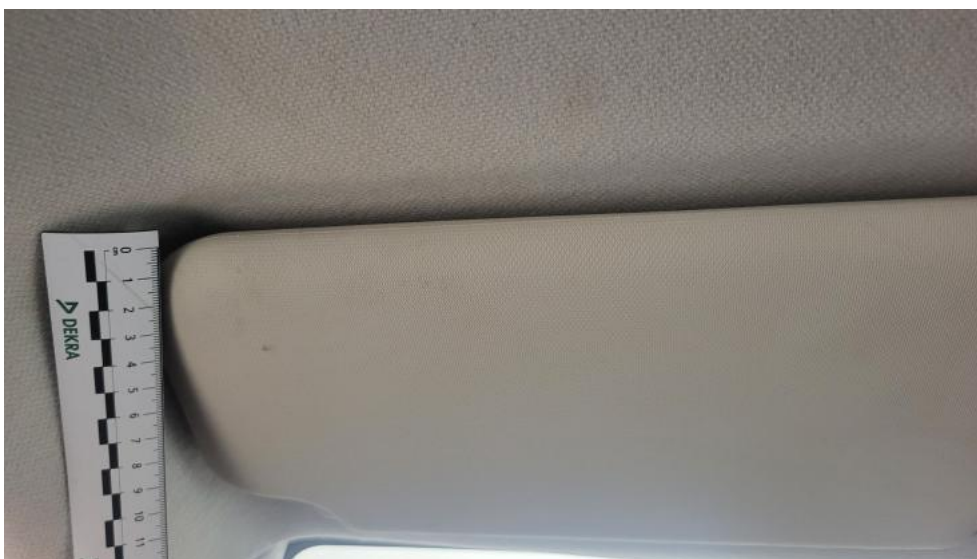
**Photo 39.**

Osłona p/słoneczna lewa - Inne 1

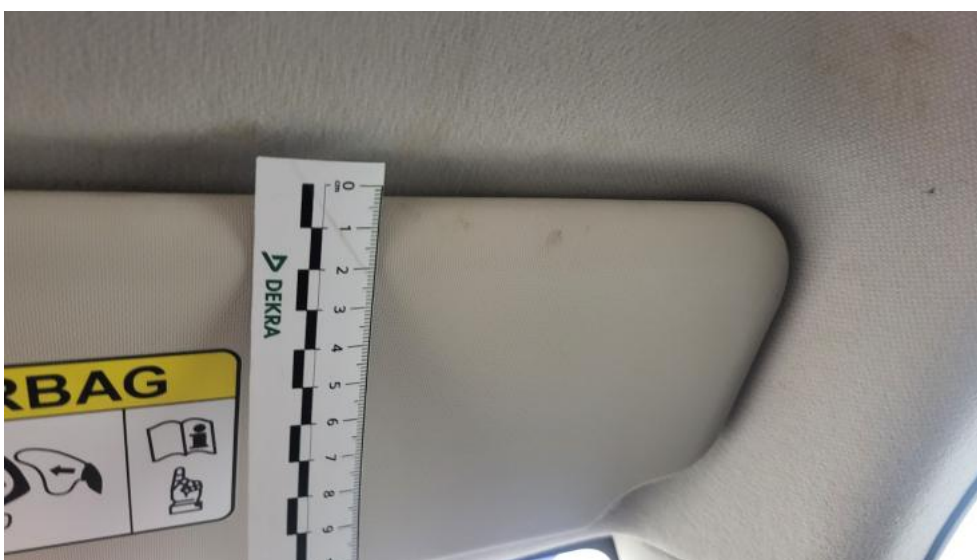
**Photo 40.**

Osłona p/słoneczna prawa - Inne 1

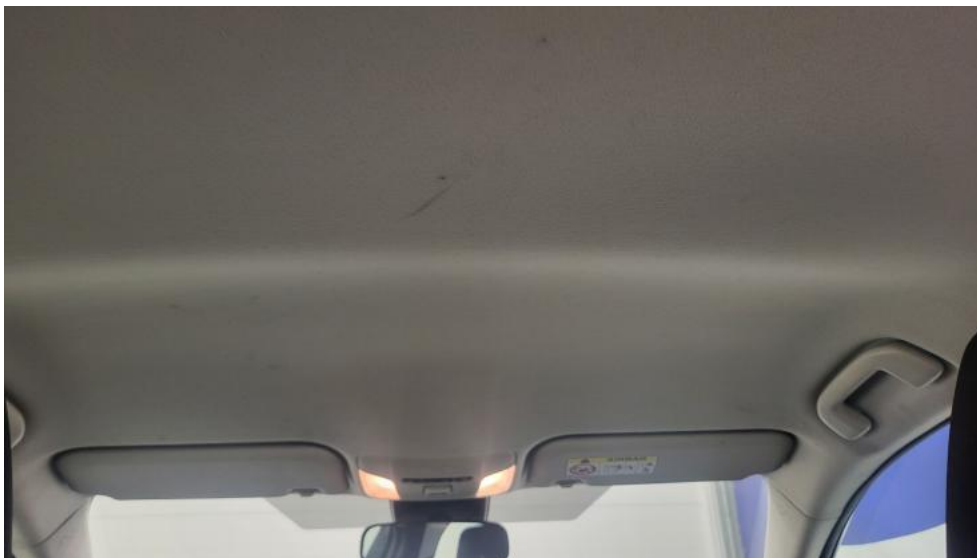
**Photo 41.**

Podsufitka - Inne 1
