DEKRA's commission No. : PKOL(W)/LODZ/92996/25/11/28  
commission/ damage No. : 22/033482  
Date of commission: 28-11-2025

| Manufacturer | BMW |
| Model | X6 [F16/F86] 14-19 |
| VIN / serial number | WBAKV610400W37594 |

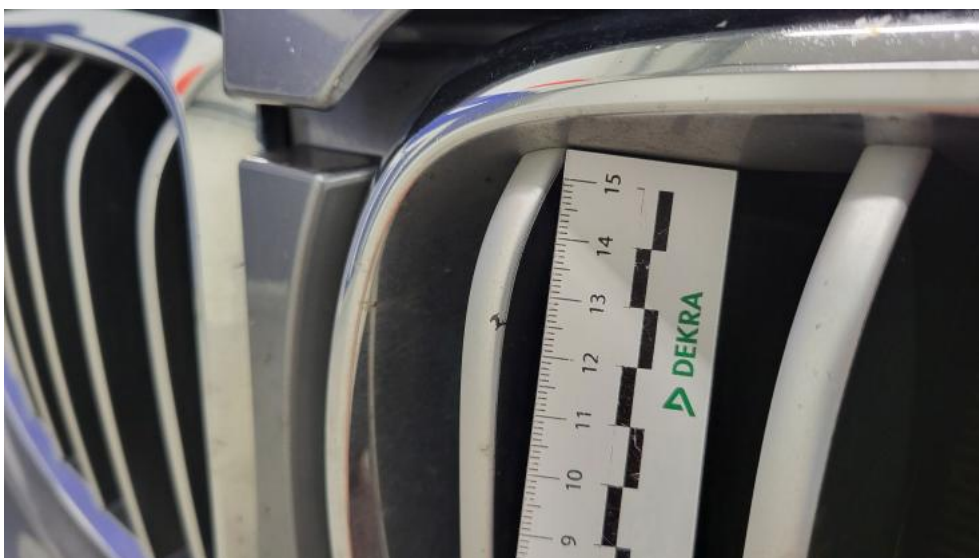
**Photo 42.**

Atrapa przednia - Rysa/odprysk 1

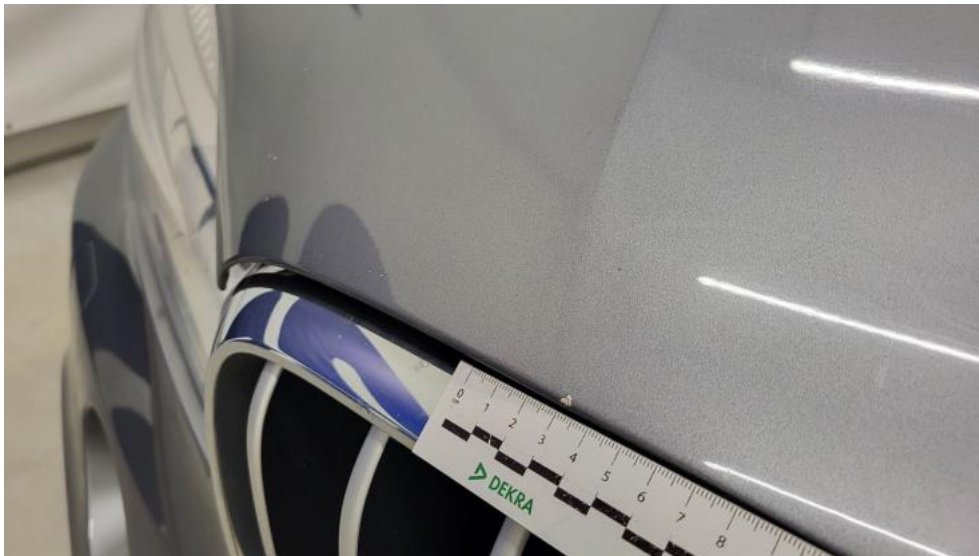
**Photo 43.**

Pokrywa komory silnika - Rysa/odprysk 1

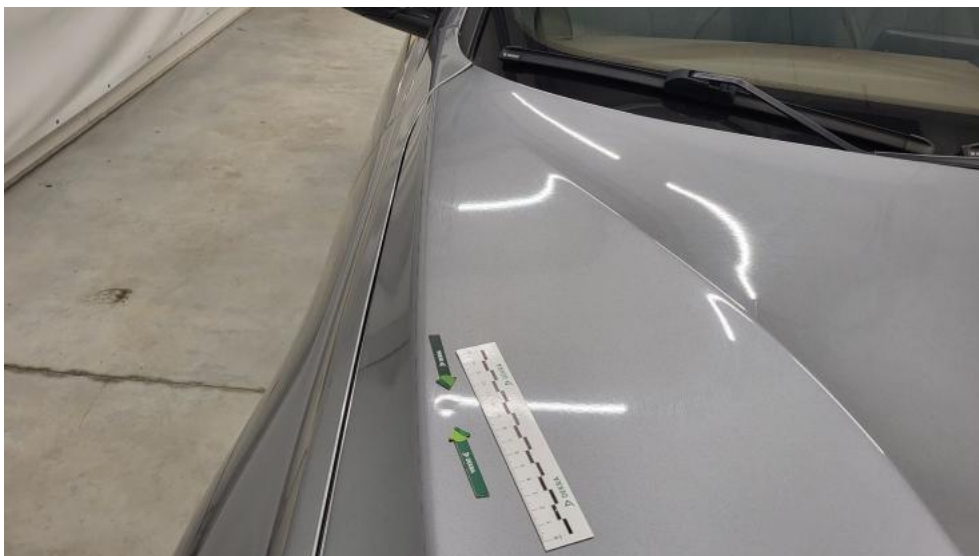
**Photo 44.**

Pokrywa komory silnika - Wgniecenie/odkształcenie 1

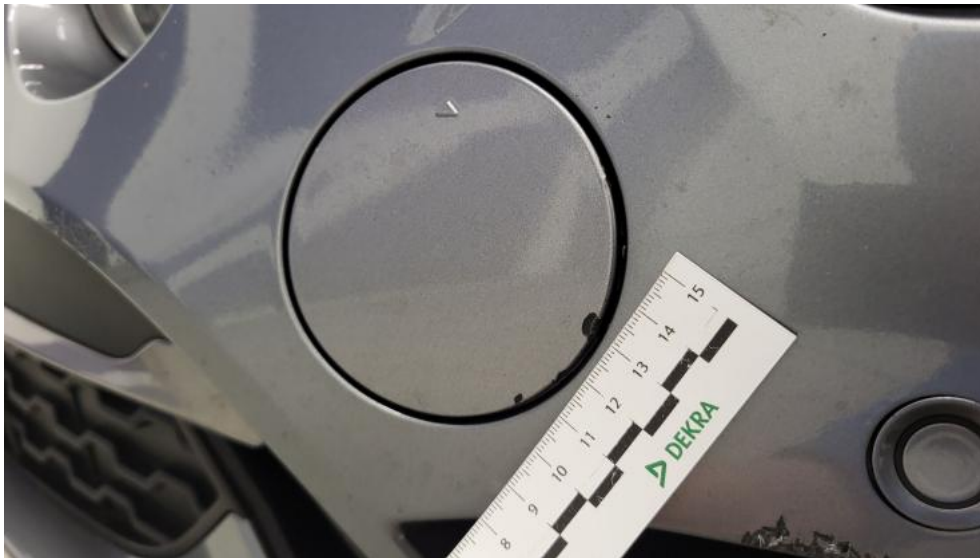
**Photo 45.**

Zaślepka prz haka hol. - Rysa/odprysk 1

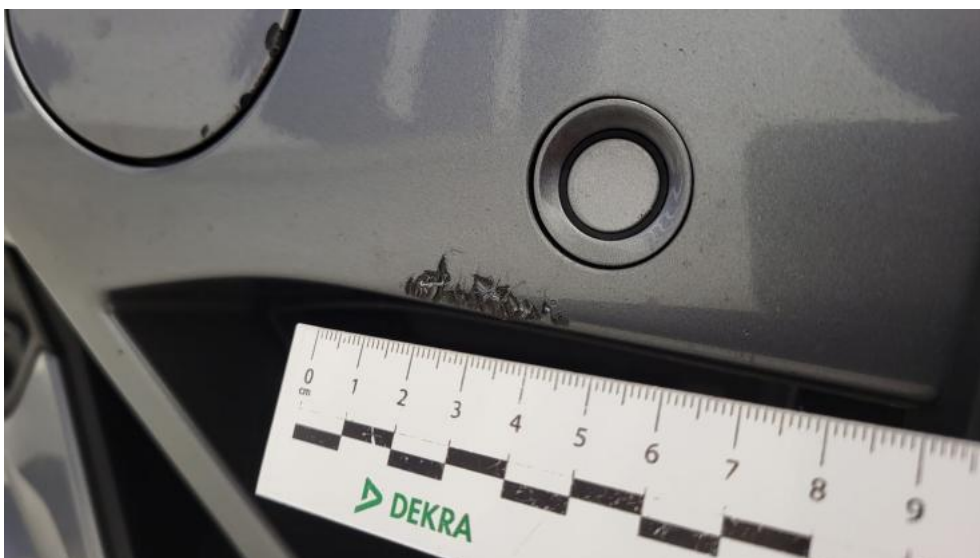
**Photo 46.**

Zderzak - Rysa/odprysk 1

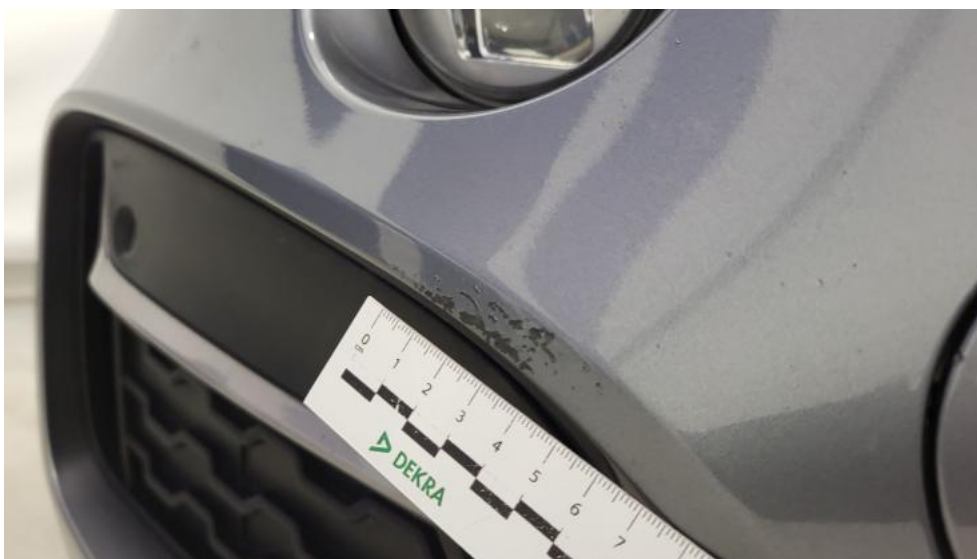
**Photo 47.**

Zderzak - Rysa/odprysk 2

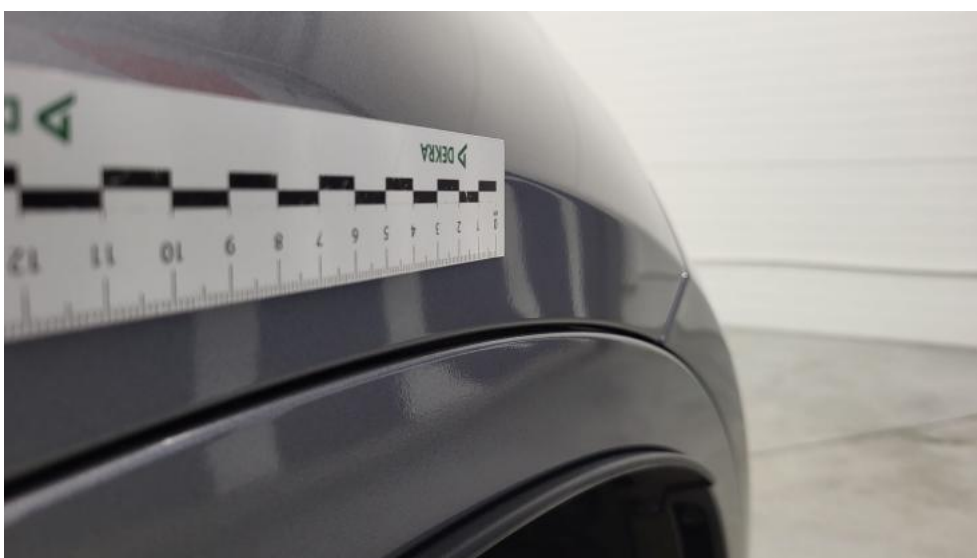
**Photo 48.**

Błotnik przedni P - Wgniecenie/odkształcenie 1

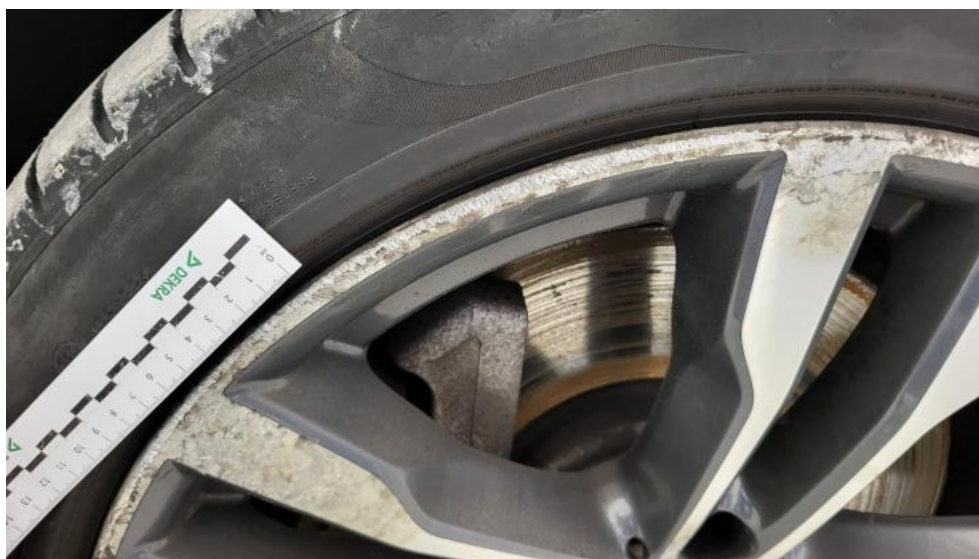
**Photo 49.**

Felga aluminiowa przednia P - Rysa/odprysk 1

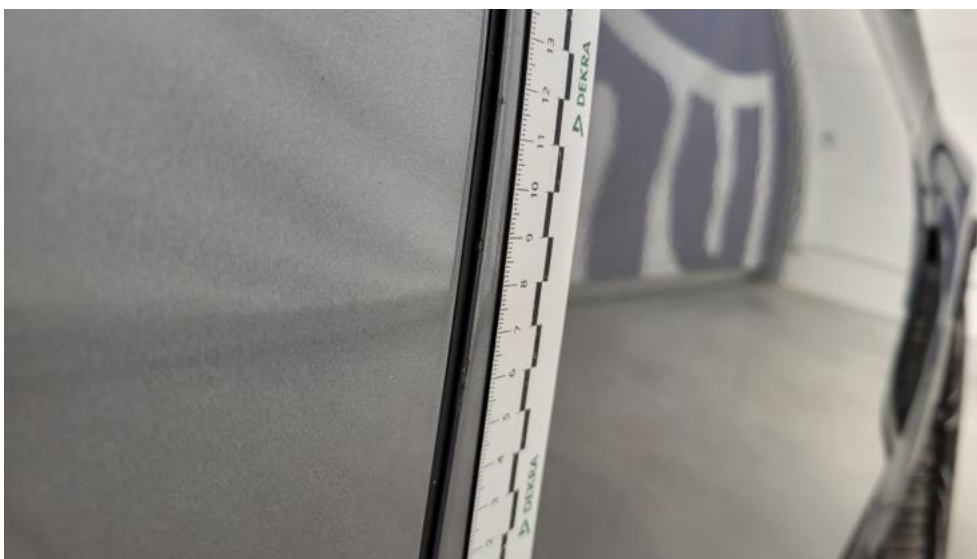
**Photo 51.**

Drzwi przednie P - Rysa/odprysk 1

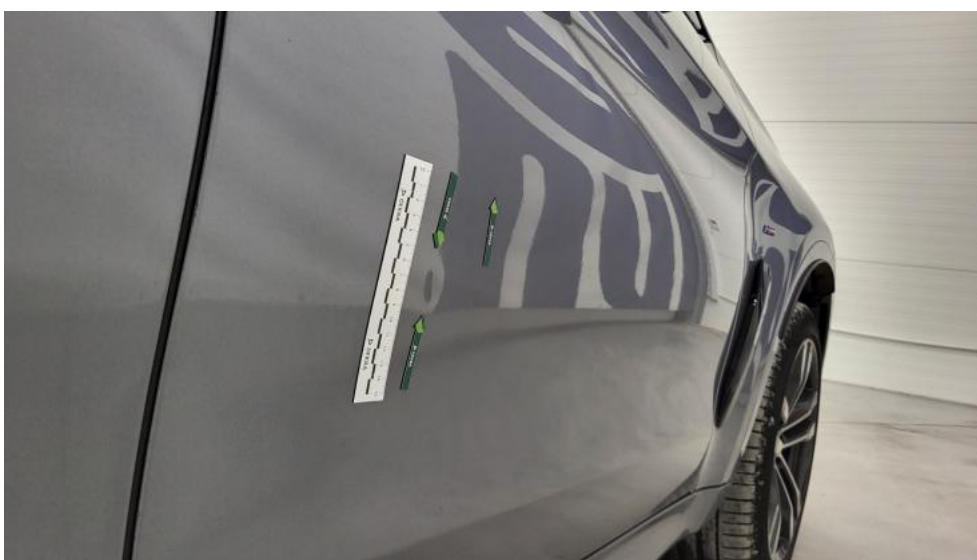
**Photo 52.**

Drzwi przednie P - Wgniecenie/odkształcenie 1

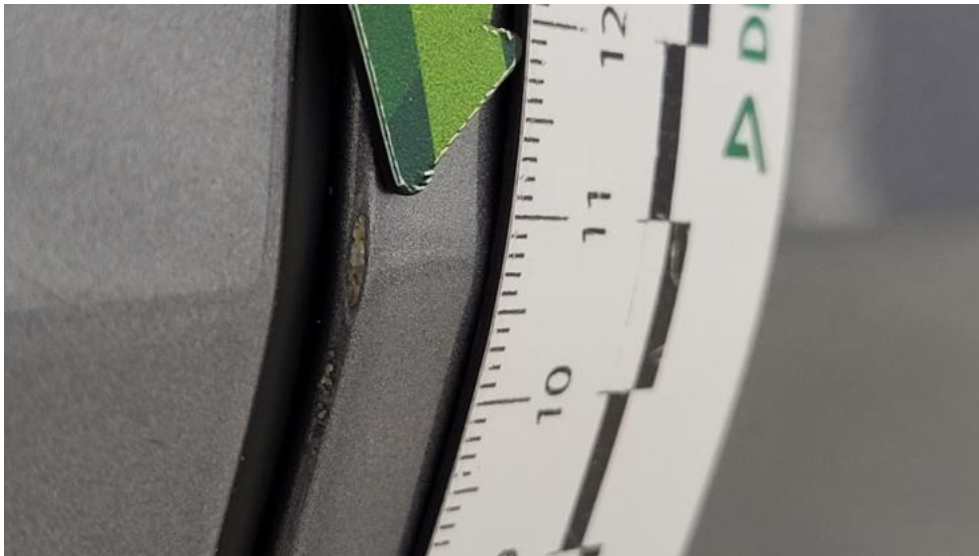
**Photo 53.**

Drzwi przednie P - Inne 1

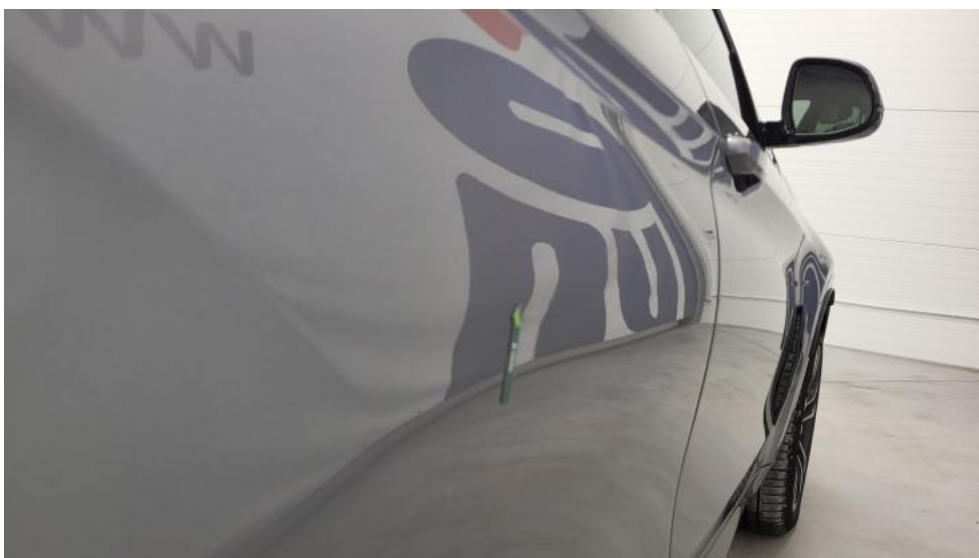
**Photo 54.**

Drzwi tylne P - Wgniecenie/odkształcenie 1

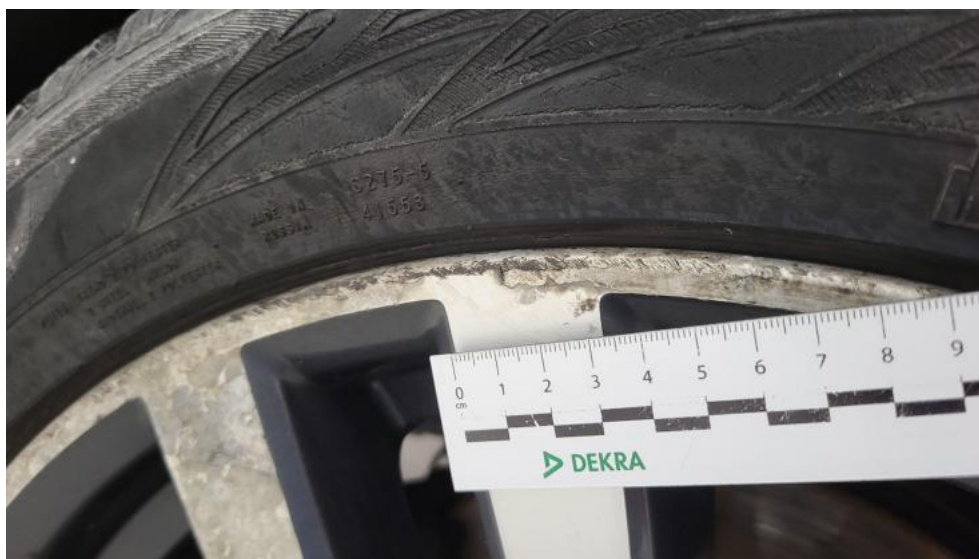
**Photo 57.**

Felga aluminiowa tylna P - Rysa/odprysk 1

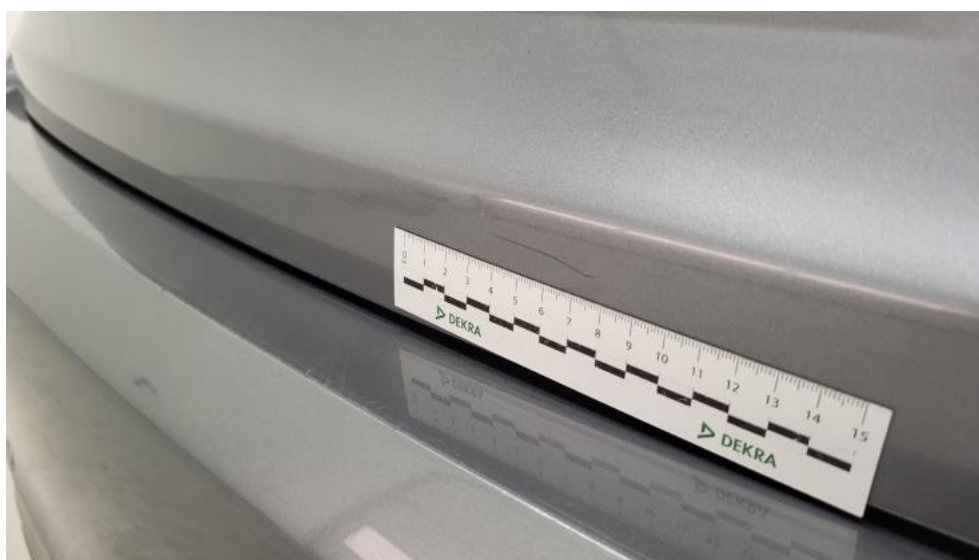
**Photo 58.**

Niesprawne elektryczne zamykanie/otwieranie pokrywy bagażnika. Rysy na samochodzie. Odpryski na szybie czołowej.

Pokrywy bagażnika - Rysa/odprysk 1

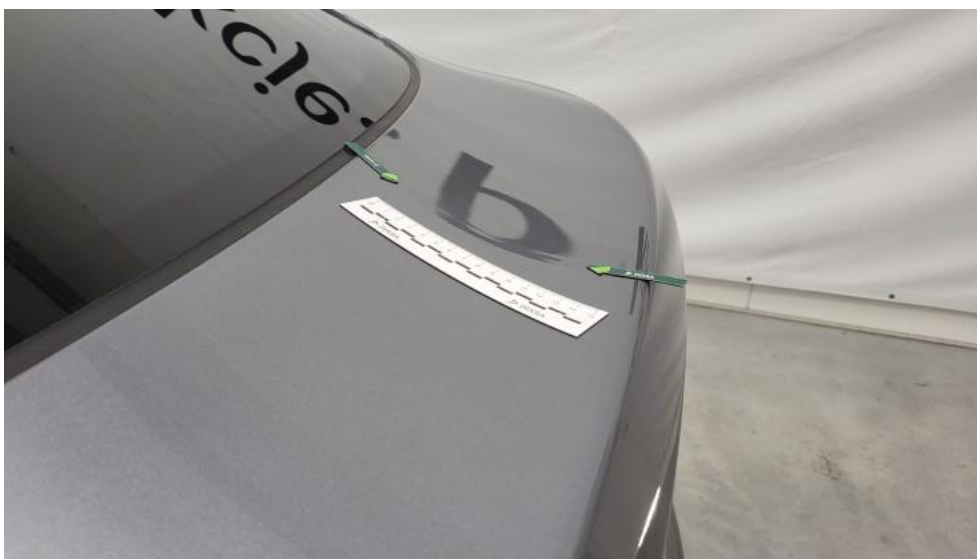
**Photo 59.**

Pokrywy bagażnika - Wgniecenie/odkształcenie 1

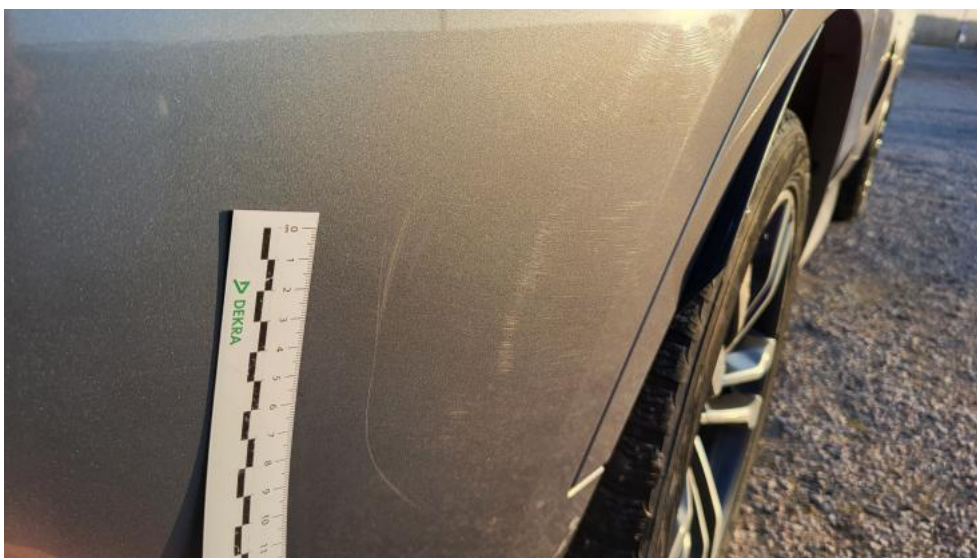
**Photo 60.**

Zderzak tylny - Rysa/odprysk 1

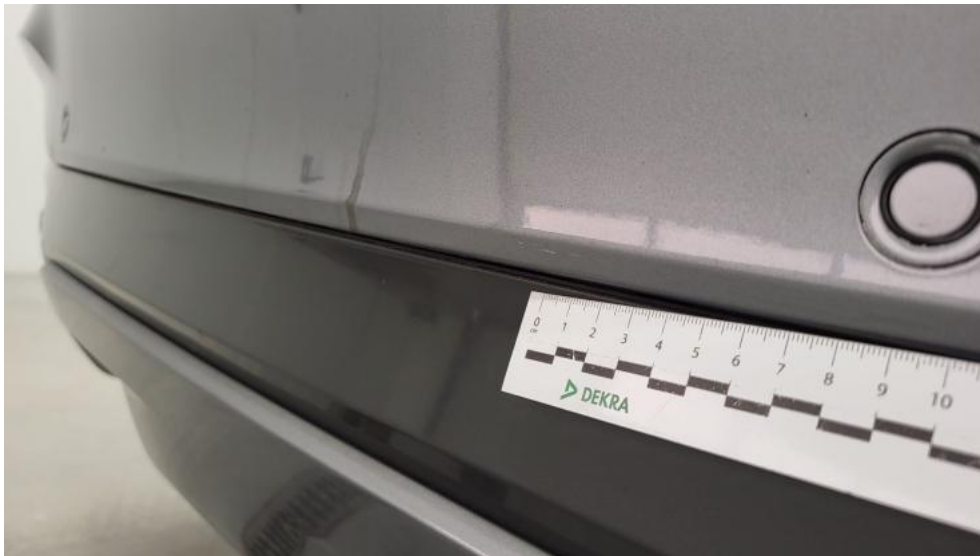
**Photo 61.**

Zderzak tylny - Rysa/odprysk 2

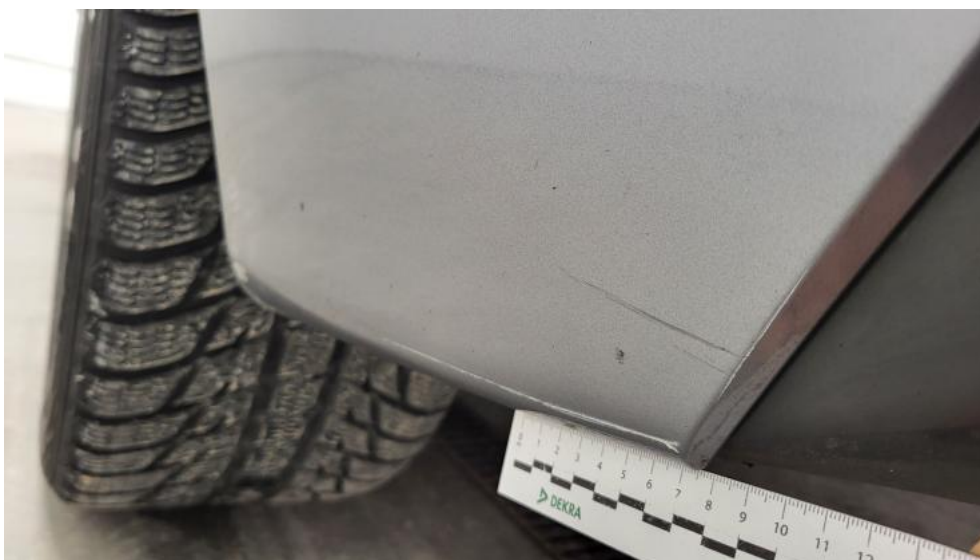
**Photo 62.**

Zderzak tylny() - Rysa/odprysk 3

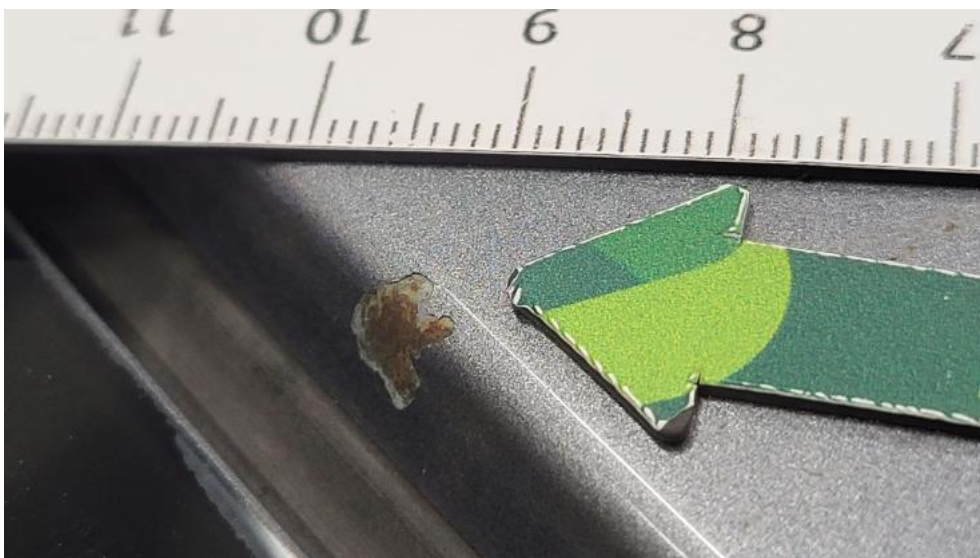
**Photo 64.**

Dach - Inne 1

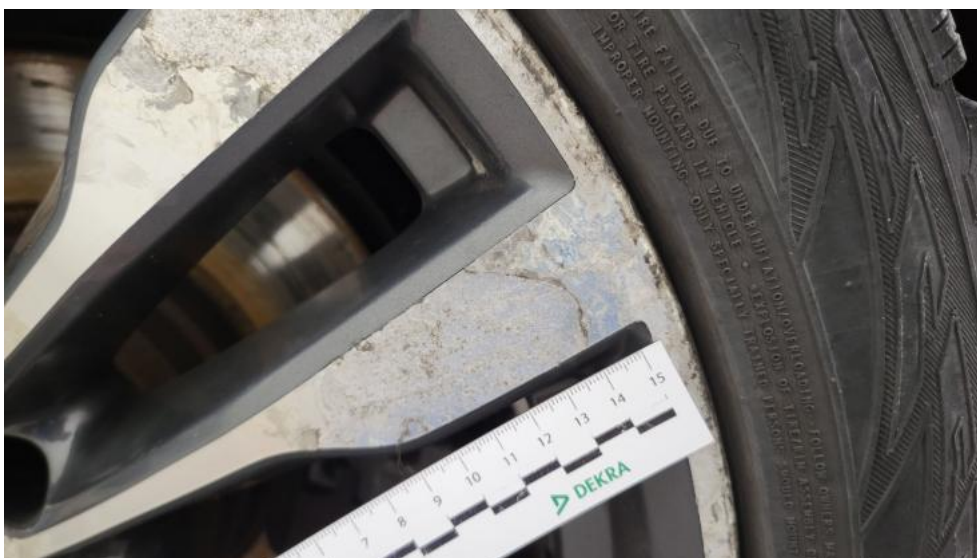
**Photo 66.**

Felga aluminiowa tylna L - Rysa/odprysk 1

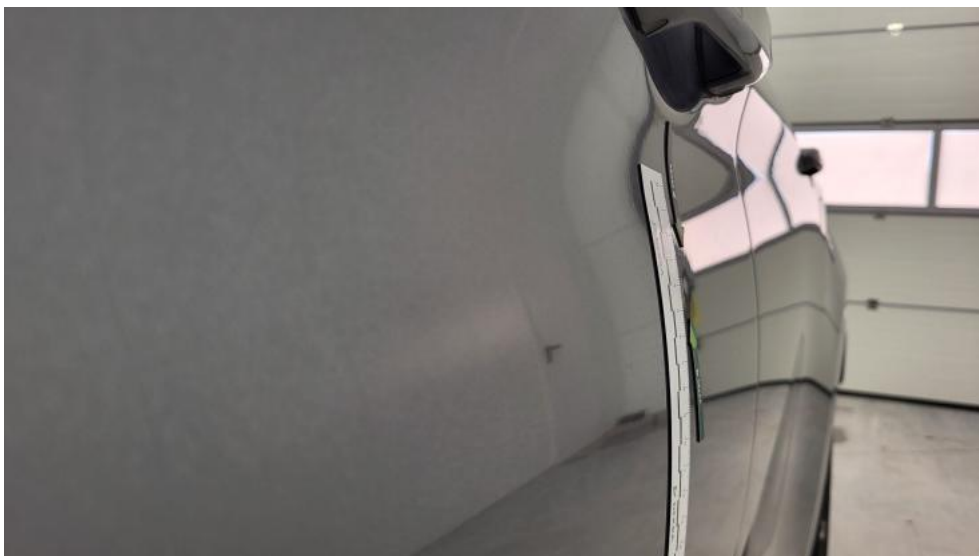
**Photo 68.**

Drzwi przed L - Wgniecenie/odkształcenie 1

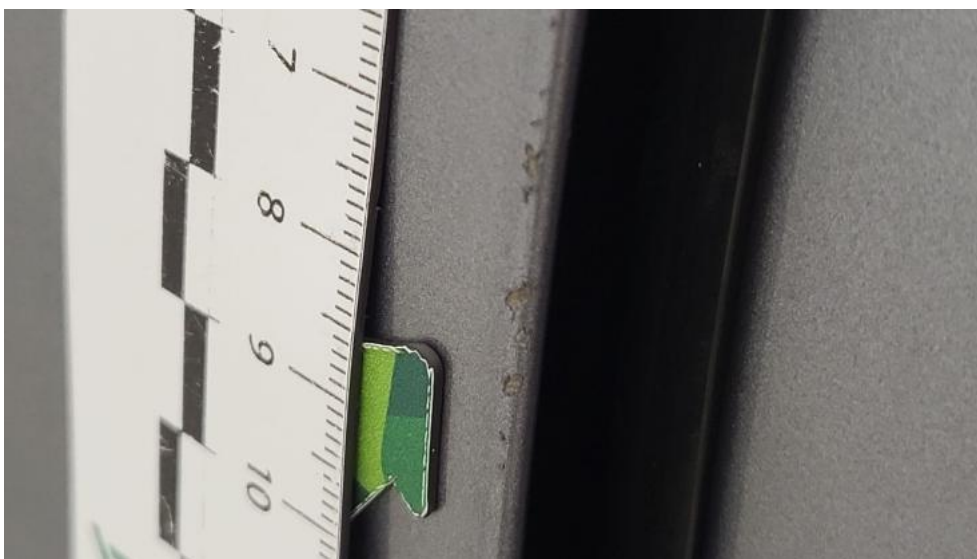
**Photo 69.**

Drzwi przed L - Inne 1

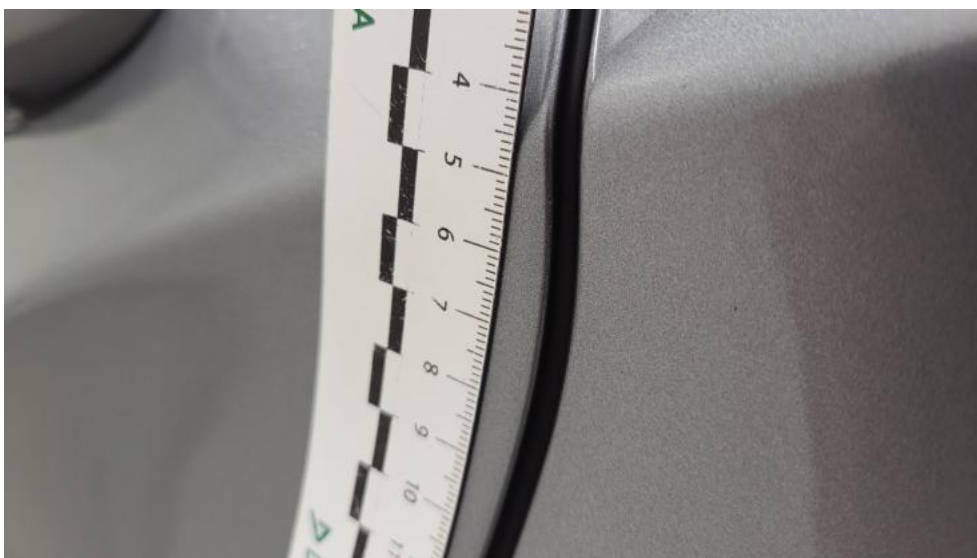
**Photo 70.**

Drzwi tylne L - Rysa/odprysk 1

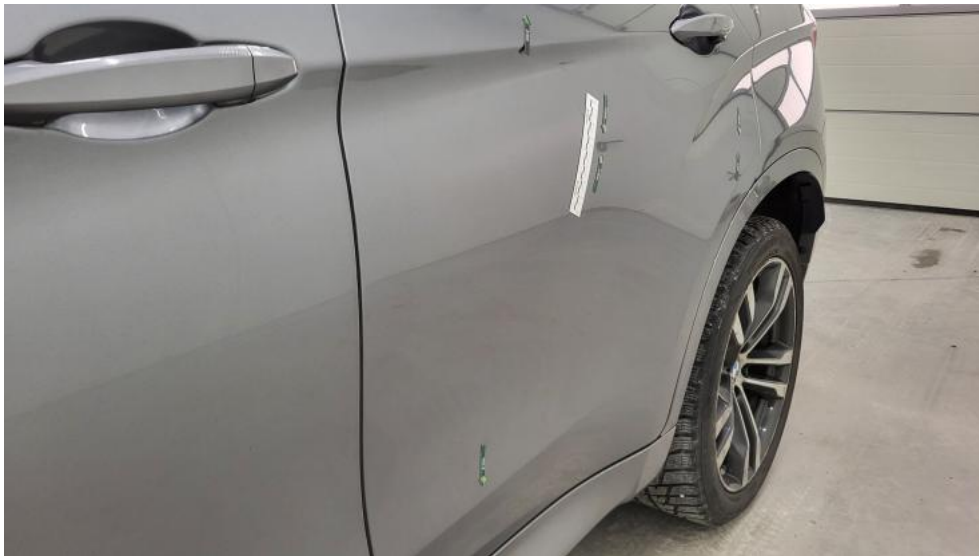
**Photo 71.**

Drzwi tylne L - Wgniecenie/odkształcenie 1

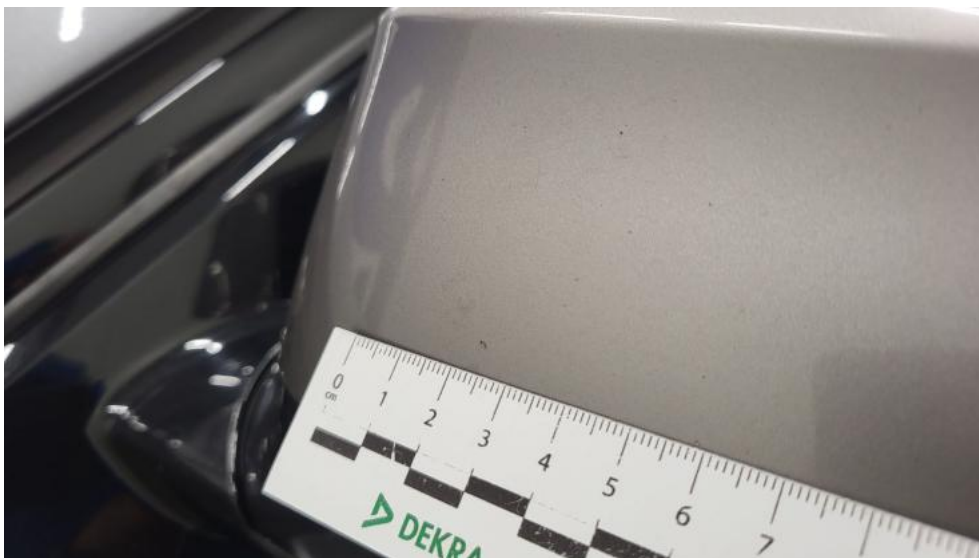
**Photo 72.**

Lusterko zew L - Rysa/odprysk 1

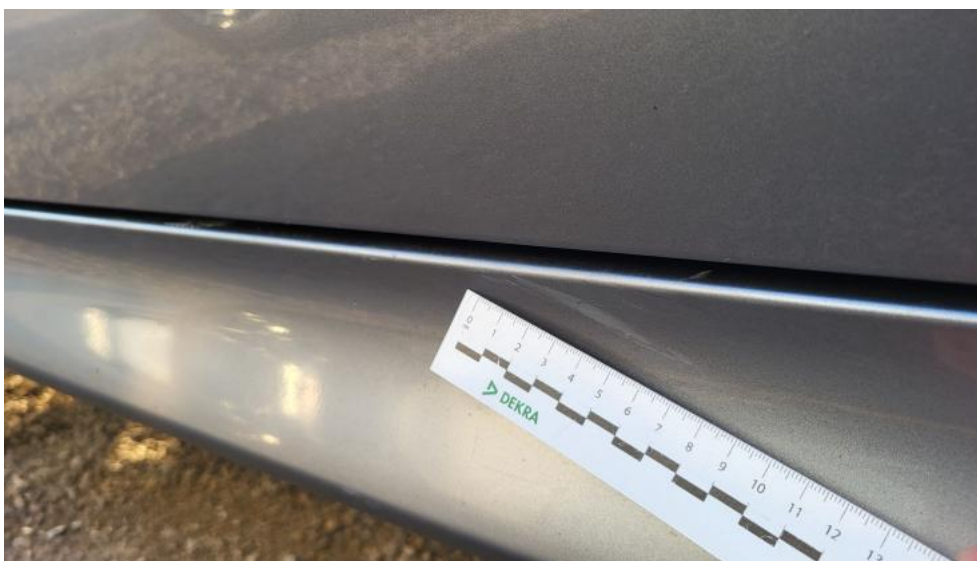
**Photo 73.**

Próg L - Rysa/odprysk 1

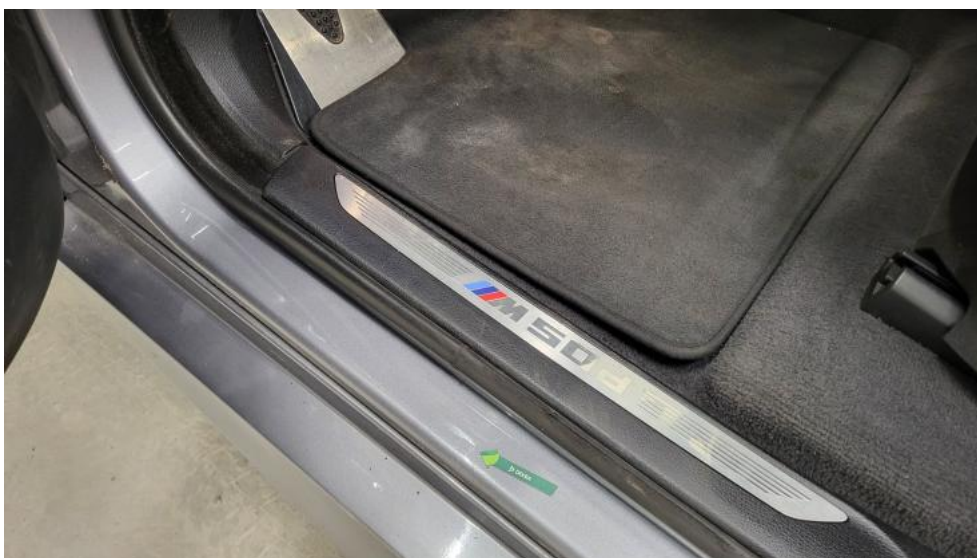
**Photo 74.**

Próg L - Wgniecenie/odkształcenie 1

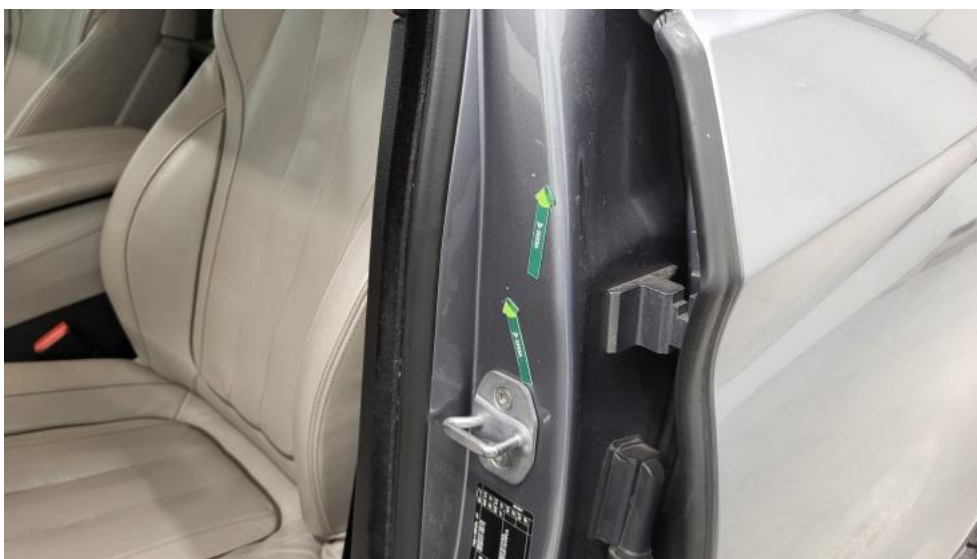
**Photo 75.**

Słupek środkowy L - Wgniecenie/odkształcenie 1

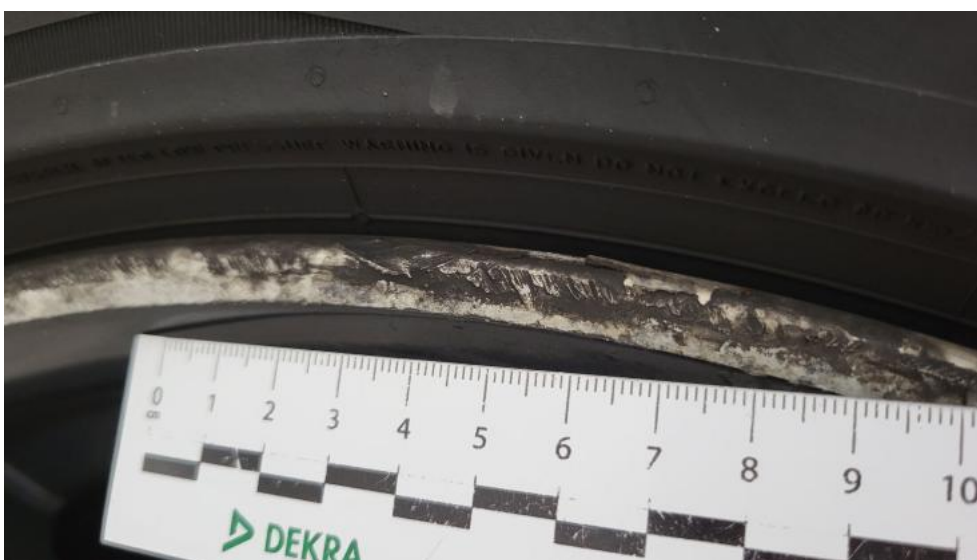
**Photo 76.**

Felga Aluminiowa przednia L - Rysa/odprysk 1

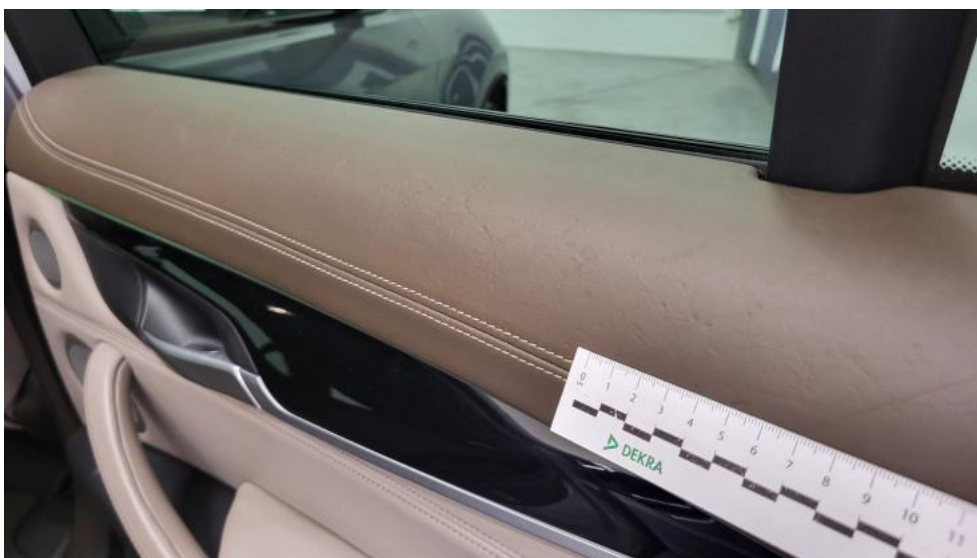
**Photo 82.**

Tapicerka drzwi tylnych P - Wgniecenie/odkształcenie 1

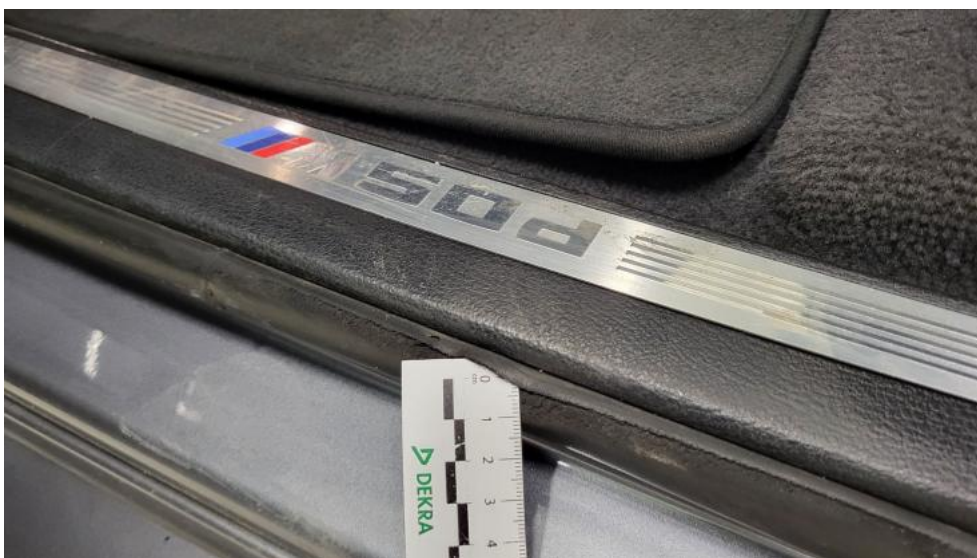
**Photo 84.**

Uszczelka drzwi przednich L - Pęknięcie/rozerwanie 1

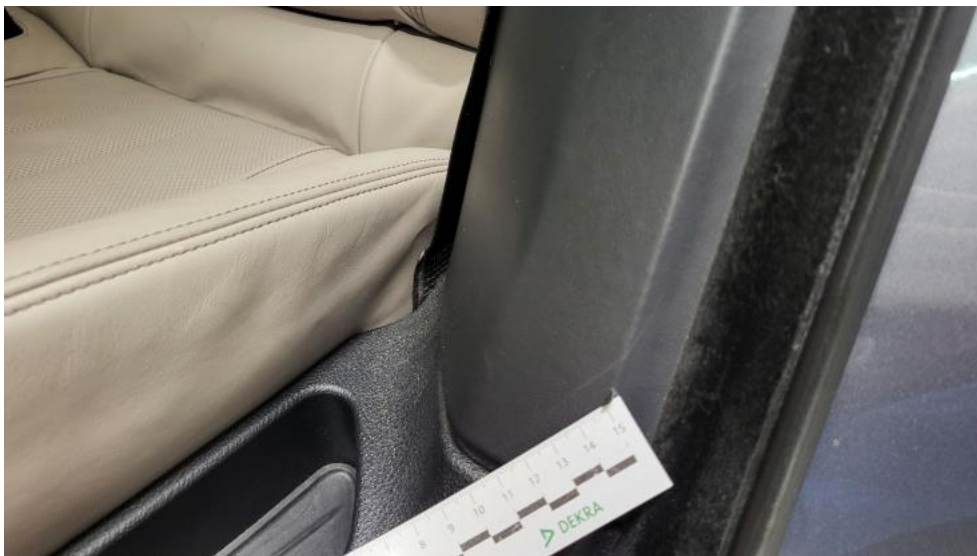
**Photo 85.**

Wykładzina(y) słupka tylnego L - Pęknięcie/rozerwanie 1

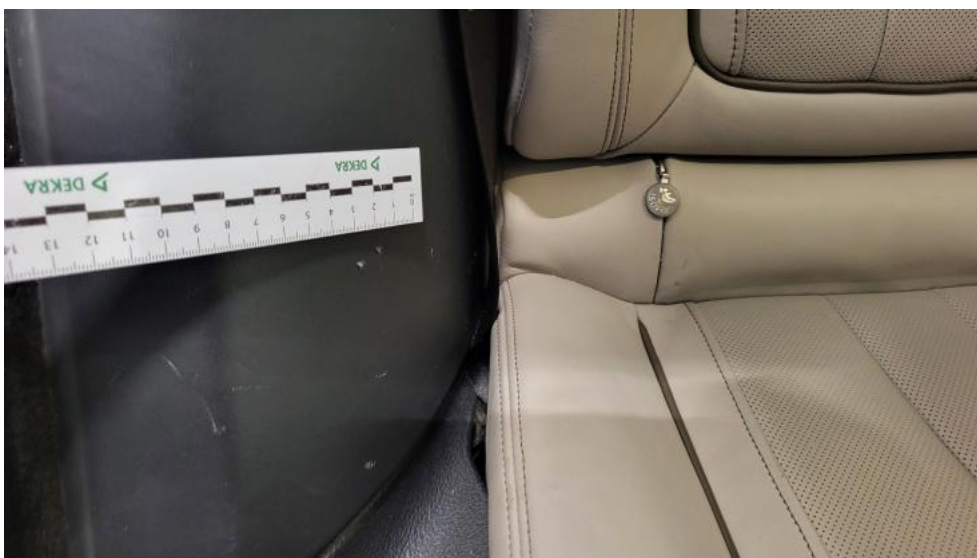
**Photo 86.**

Wykładzina(y) słupka tylnego P - Rysa/odprysk 1
