DEKRA's commission No. : PKOL(W)/LODZ/49564/26/05/27  
commission/ damage No. : PS23/01953  
Date of commission: 27-05-2026

**Vehicle data**

| Model | Seria 3 [G20] 18-22 |
| Type / version | 320e Sport Line aut |

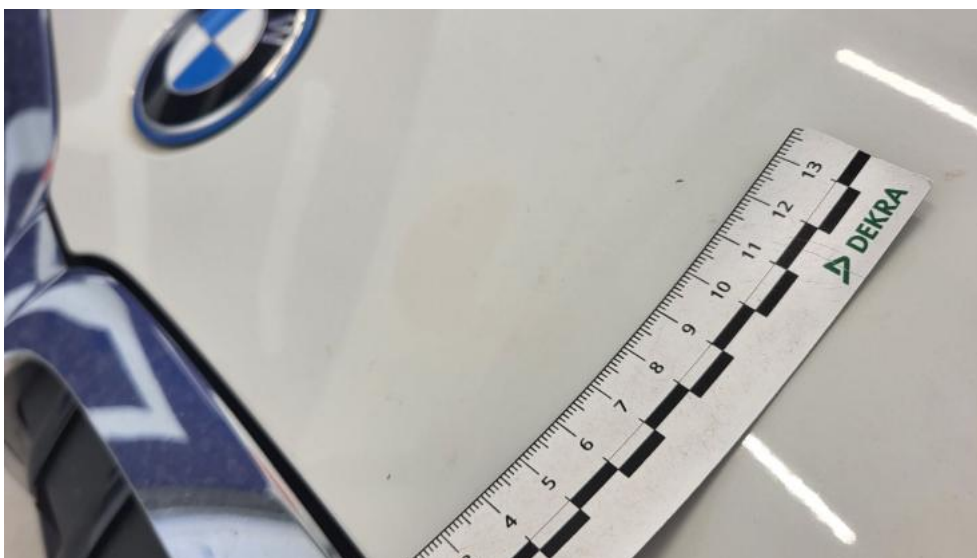
**Photo 40.**

Pokrywa komory silnika - Rysa/odprysk 1

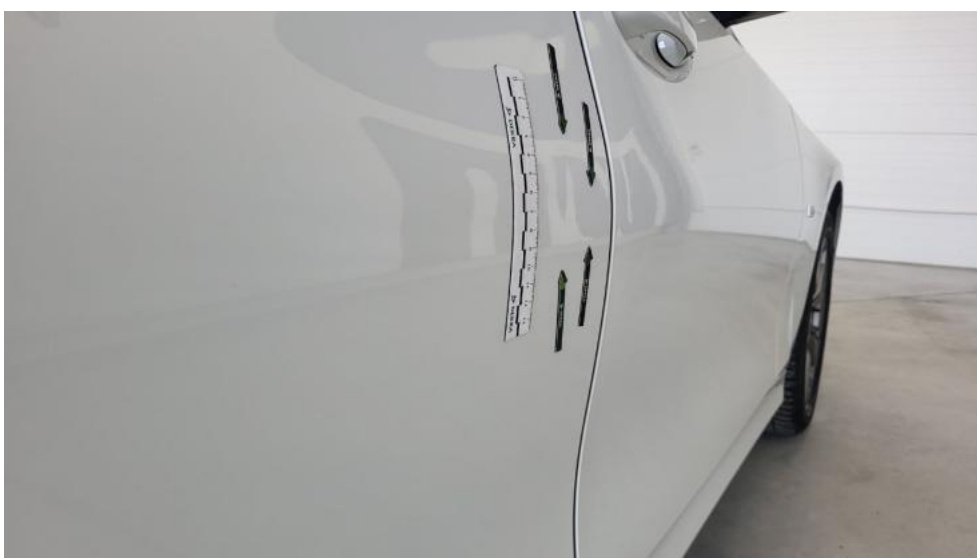
**Photo 44.**

Drzwi tylne P - Wgniecenie/odkształcenie 1

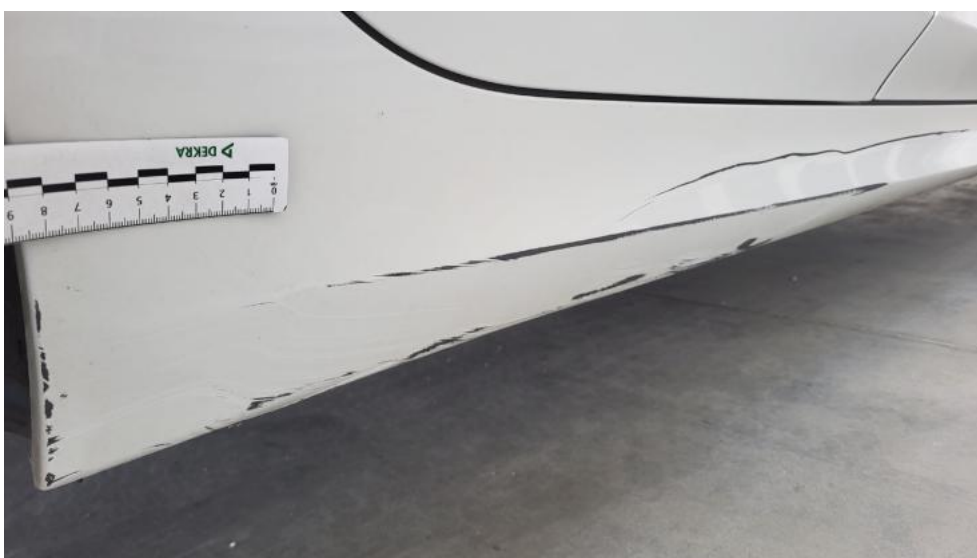
**Photo 46.**

Próg P - Rysa/odprysk 2

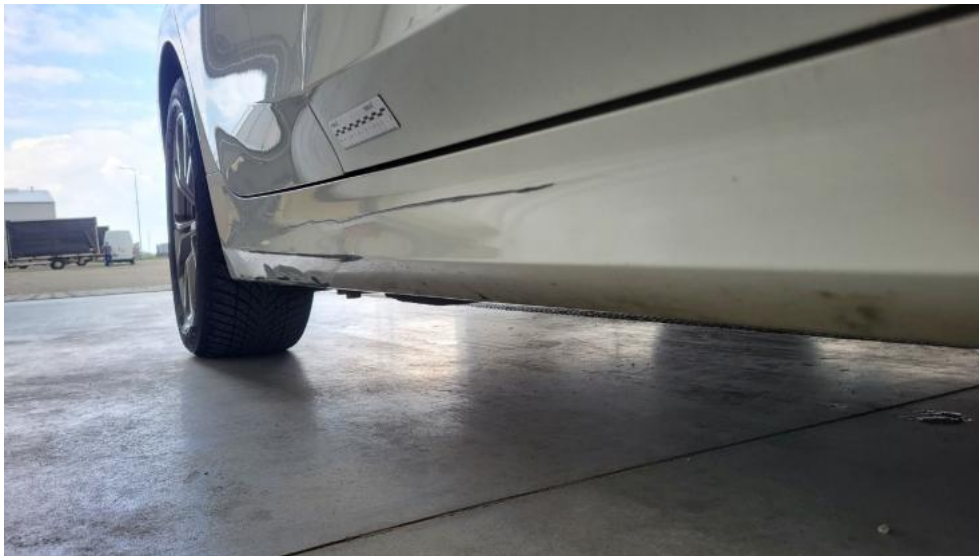
**Photo 47.**

Próg P - Wgniecenie/odkształcenie 1

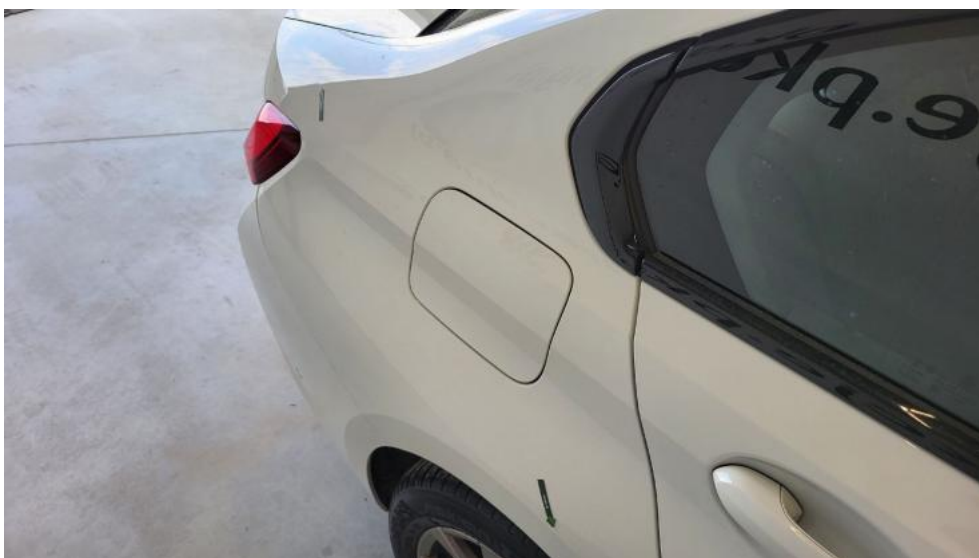
**Photo 48.**

Błotnik tylny P / Ściana boczna P - Wgniecenie/odkształcenie 1

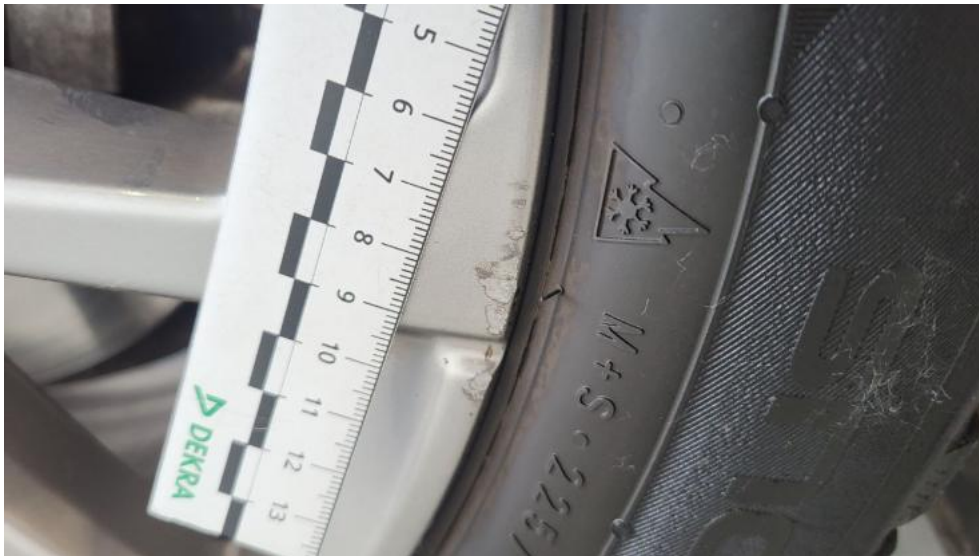
**Photo 49.**

Felga aluminiowa tylna P - Rysa/odprysk 1

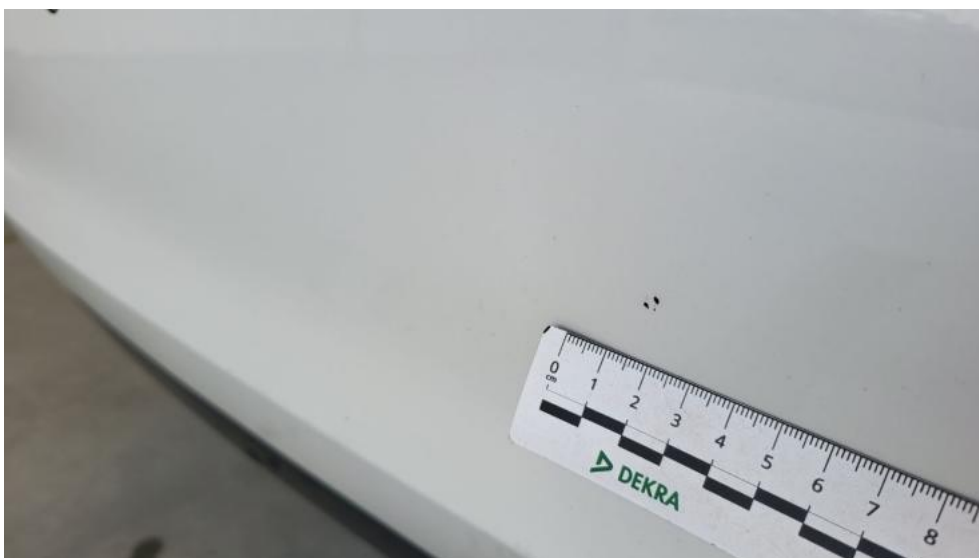
**Photo 50.**

Zderzak tylny - Rysa/odprysk 1

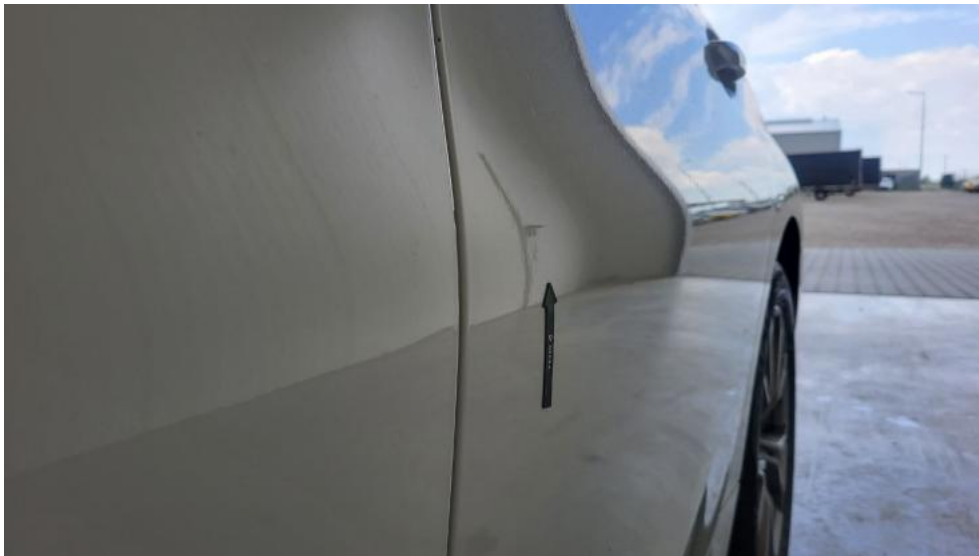
**Photo 55.**

Drzwi tylne L - Wgniecenie/odkształcenie 1

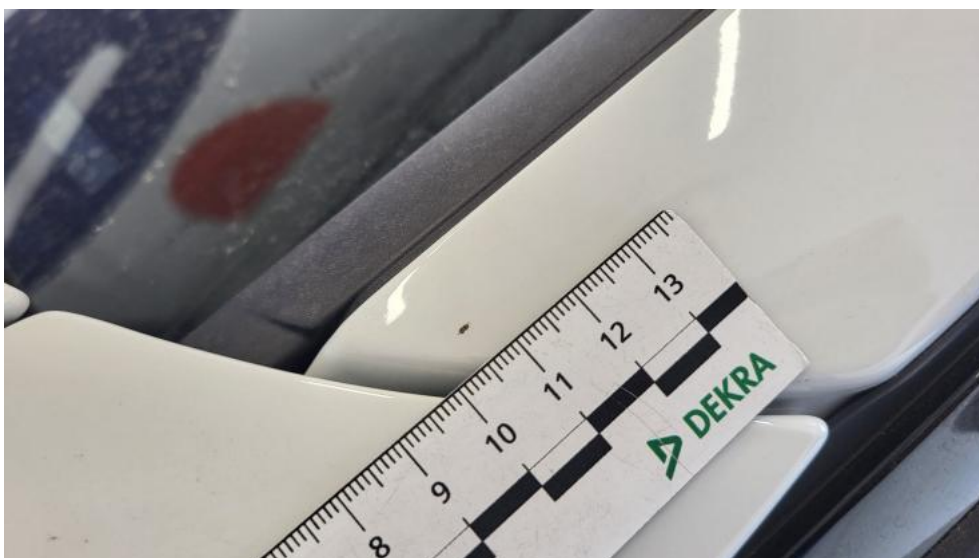
**Photo 56.**

Słupek przedni L - Rysa/odprysk 1

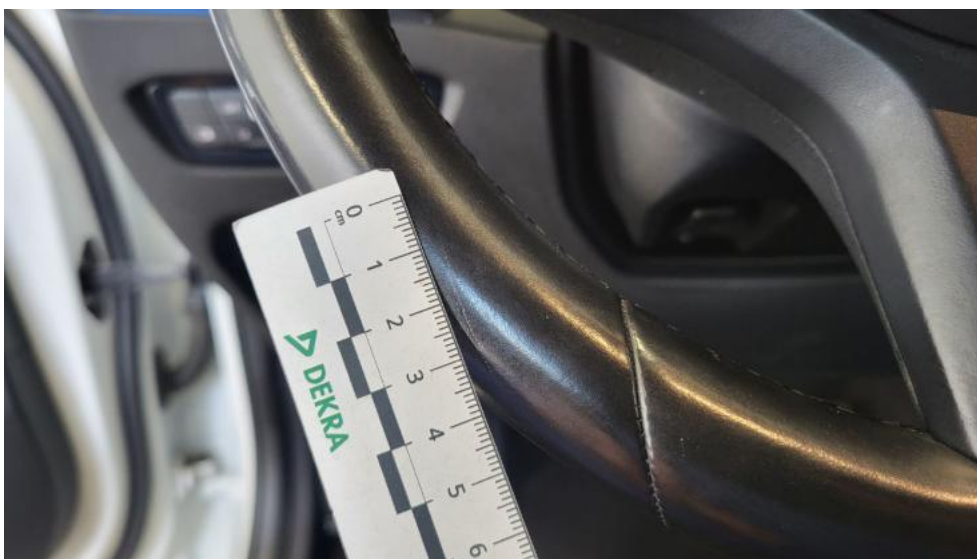
**Photo 59.**

Koło kierownicy - Rysa/odprysk 1

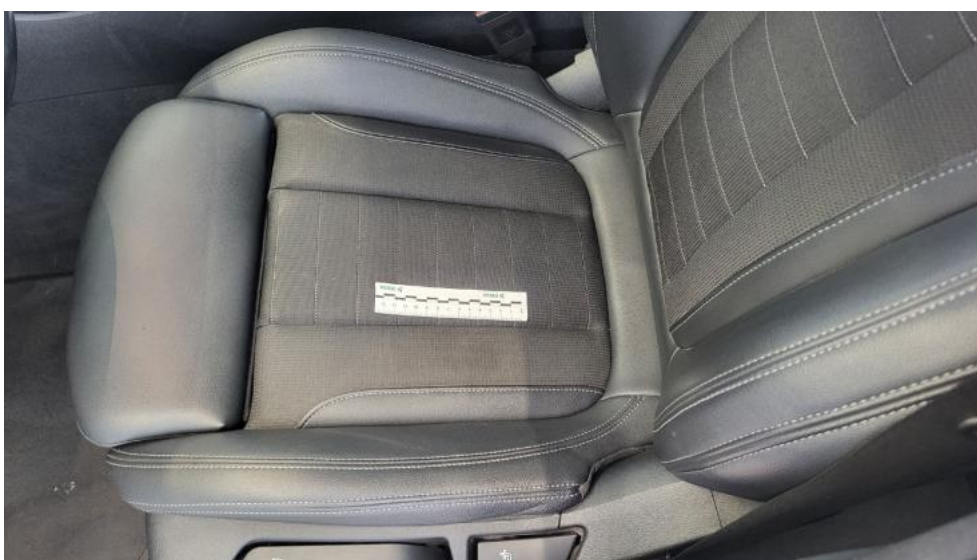
**Photo 60.**

Fotel prz. lew. - Inne 1

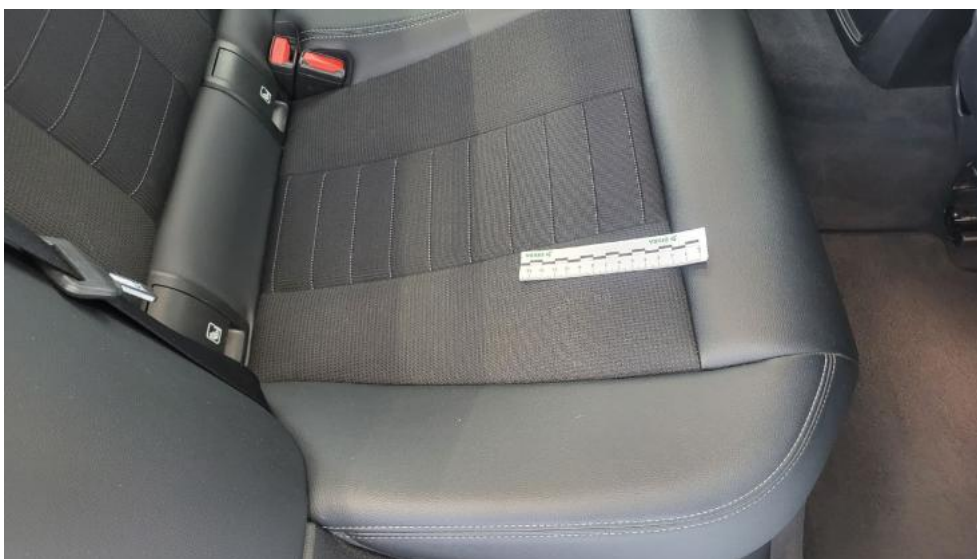
**Photo 63.**

Kanapa tyl. - Inne 2
