DEKRA's commission No. : PKOL(W)/LODZ/76711/26/08/17  
commission/ damage No. : 25/009788  
Date of commission: 17-08-2026

| Manufacturer | MAZDA |
| Type / version | CX-5 2.5 Skypassion AWD aut |
| Registration /record No. | SK7F425 |

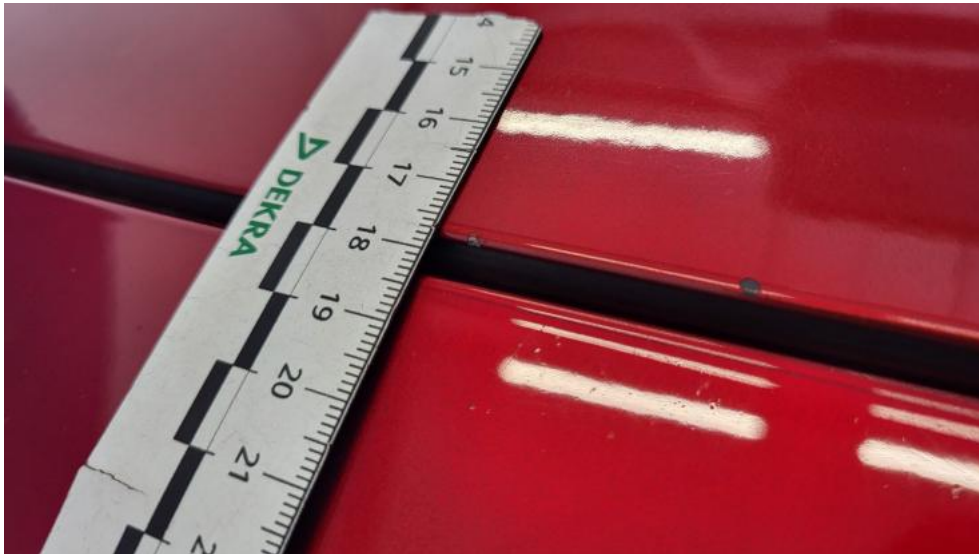
**Photo 41.**

Pokrywa komory silnika - Rysa/odprysk 1

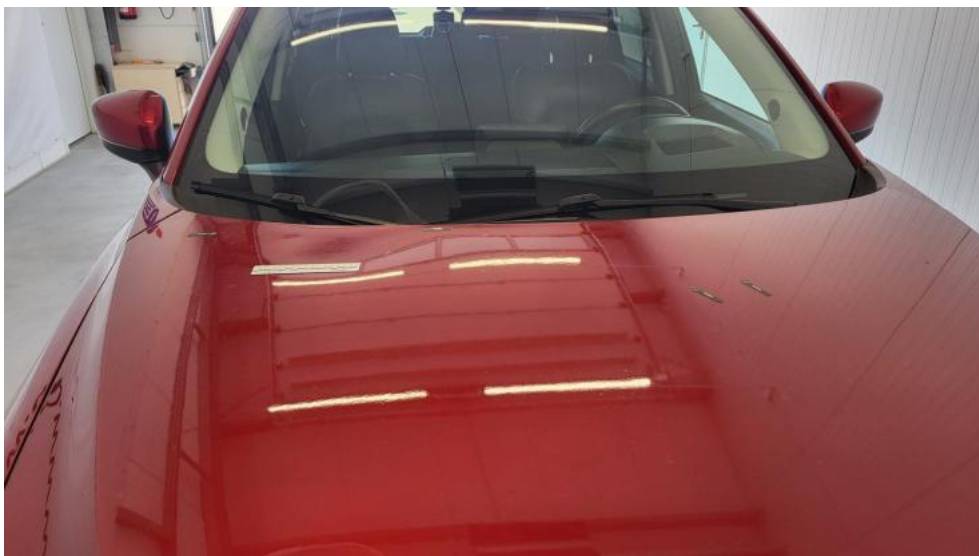
**Photo 42.**

Pokrywa komory silnika - Wgniecenie/odkształcenie 1

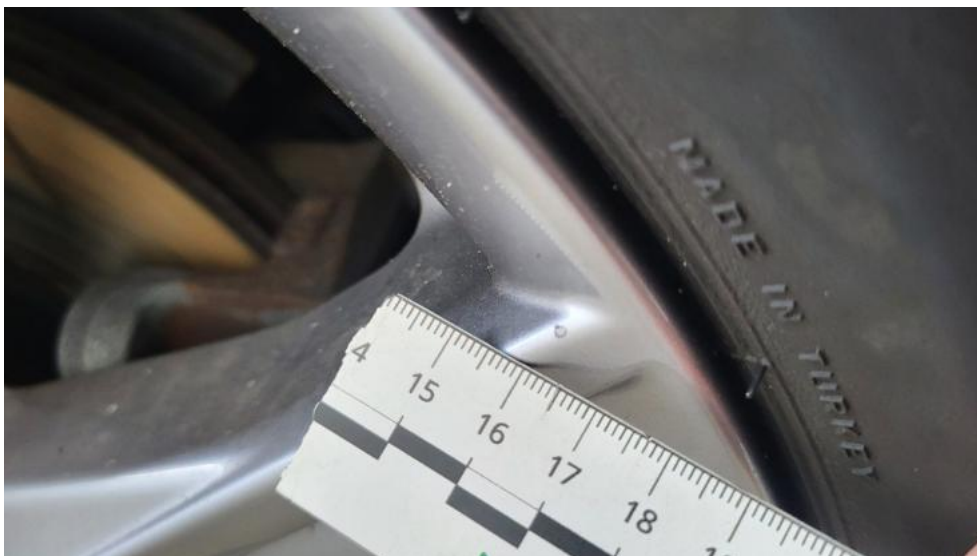
**Photo 43.**

Felga aluminiowa przednia P - Rysa/odprysk 1

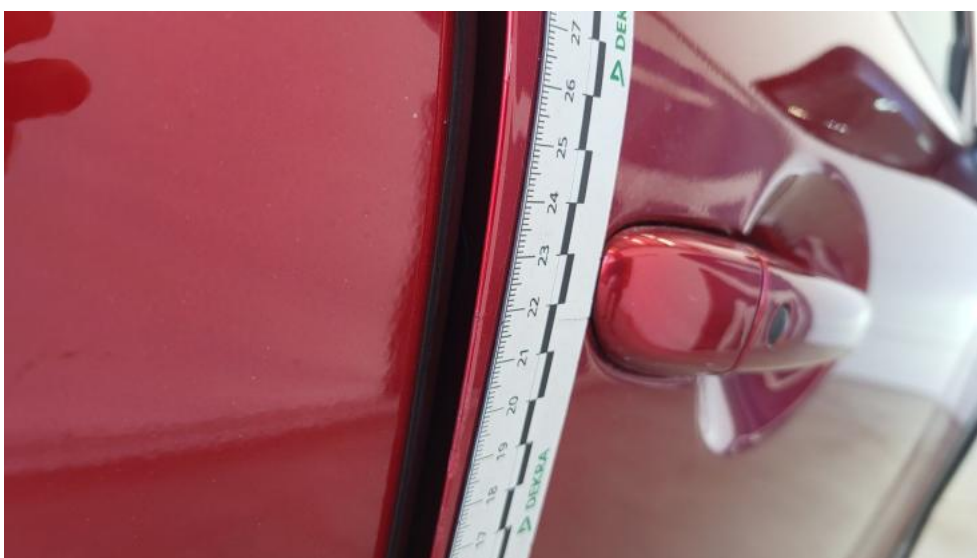
**Photo 44.**

Drzwi przednie P - Rysa/odprysk 1

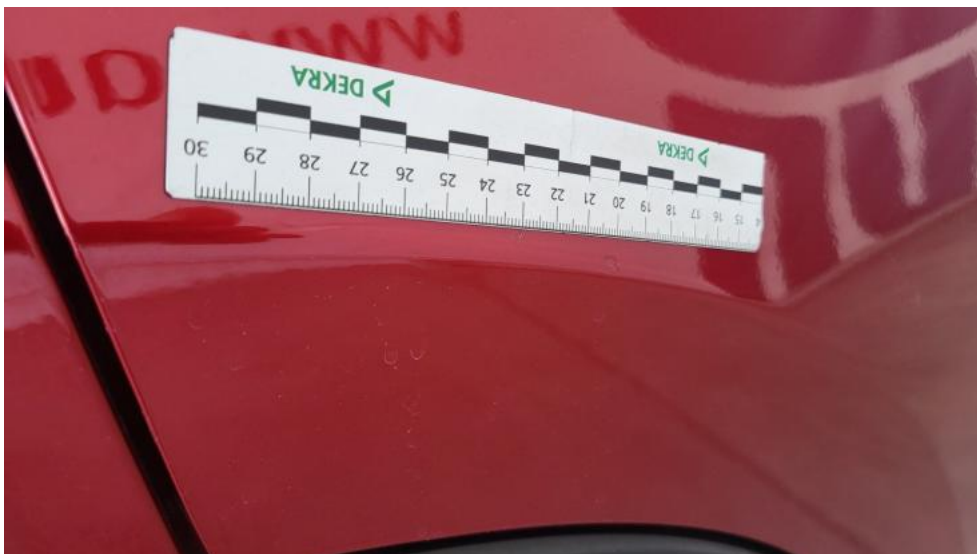
**Photo 45.**

Drzwi tylne P - Rysa/odprysk 1

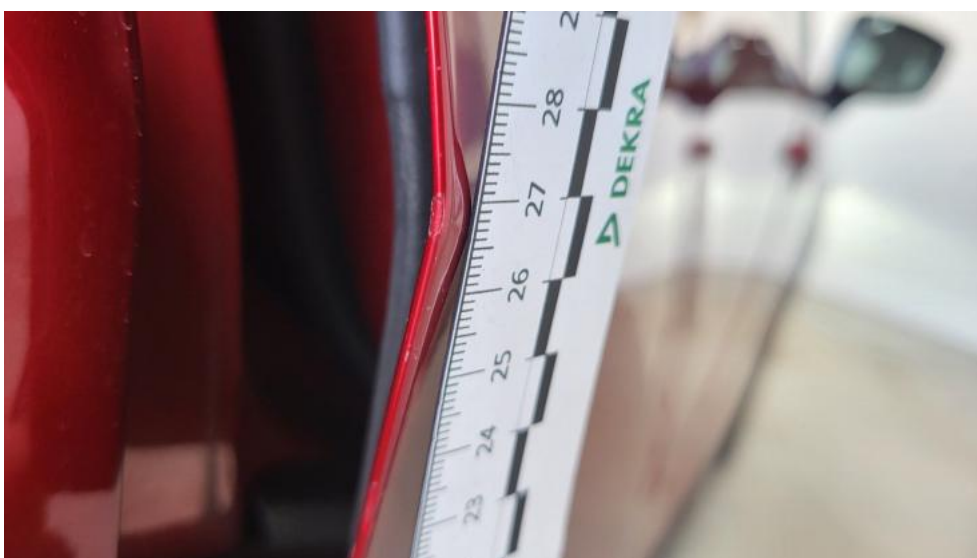
**Photo 46.**

Drzwi tylne P - Rysa/odprysk 2

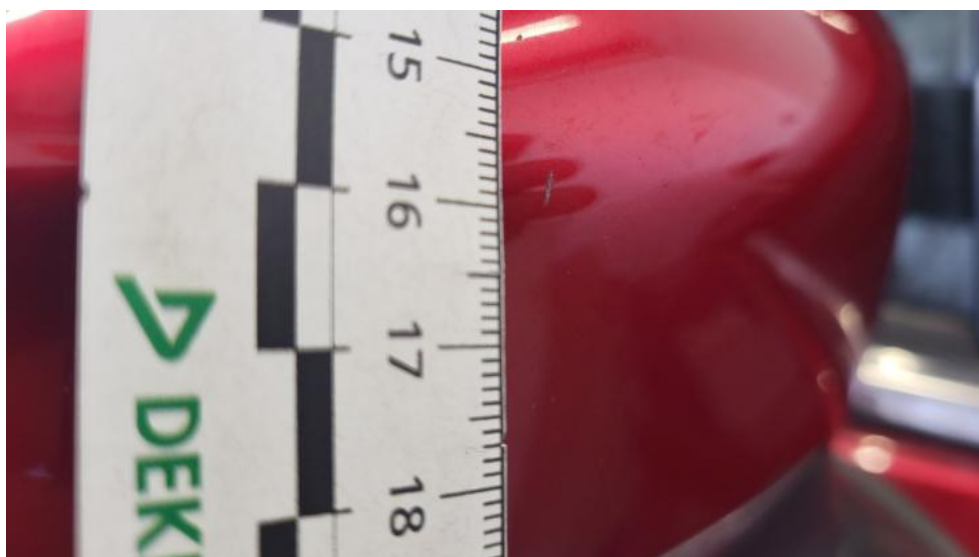
**Photo 47.**

Lusterko zew P - Rysa/odprysk 1

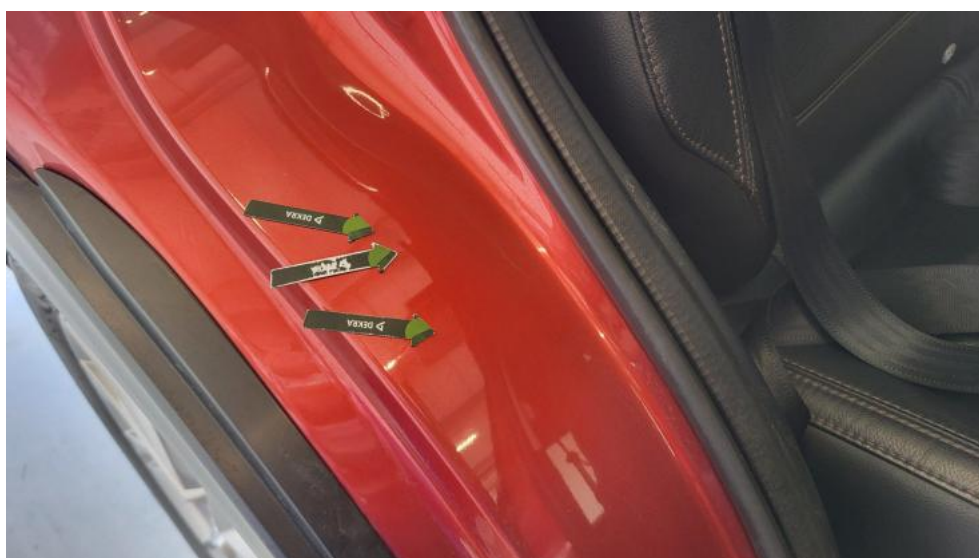
**Photo 48.**

Łotnik tylny P / Ściana boczna P - Wgniecenie/odkształcenie 1

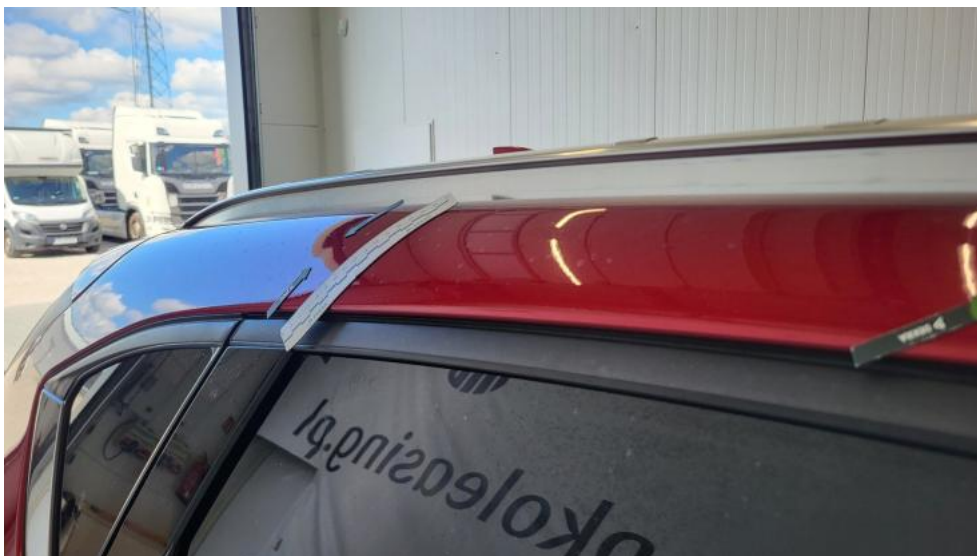
**Photo 49.**

Błotnik tylny P / Ściana boczna P - Wgniecenie/odkształcenie 2

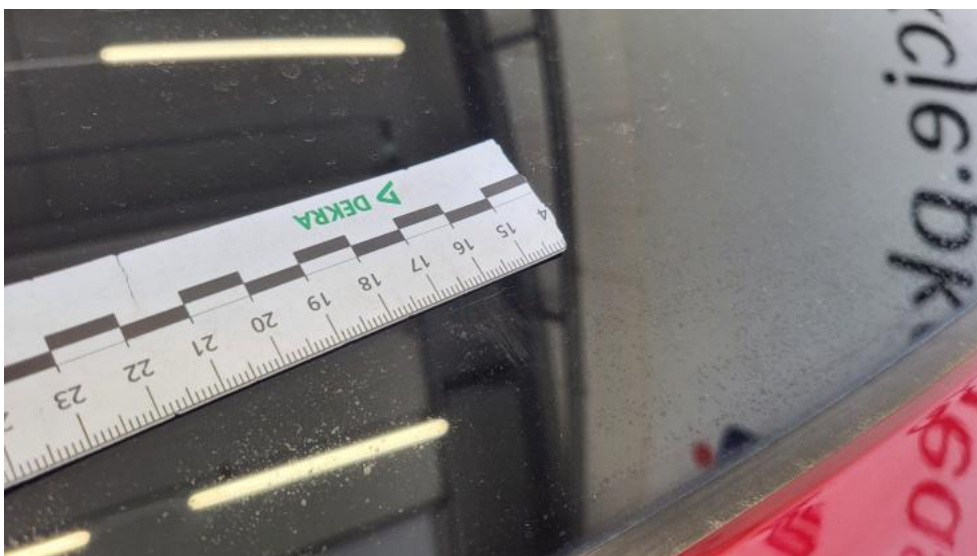
**Photo 50.**

Szyba tylna - Rysa/odprysk 1

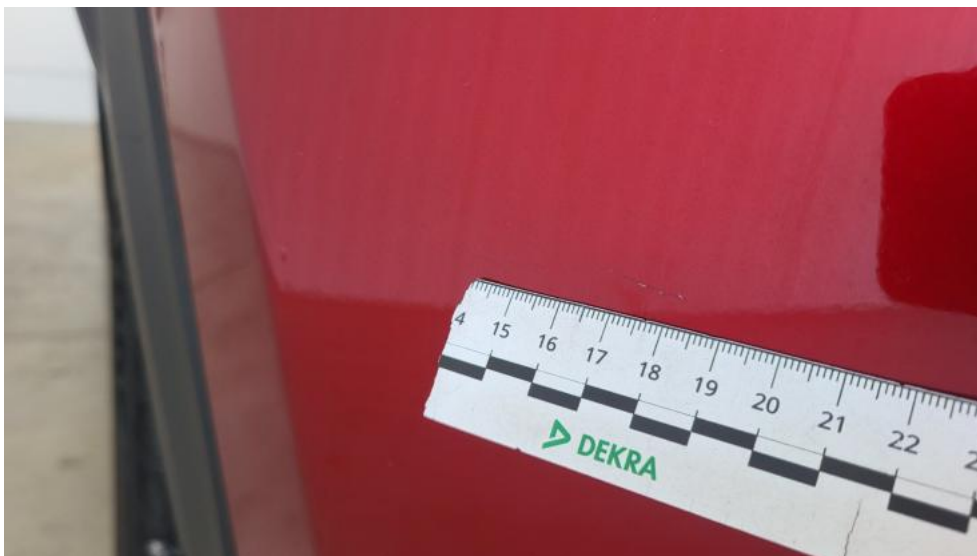
**Photo 51.**

Zderzak tylny - Rysa/odprysk 1

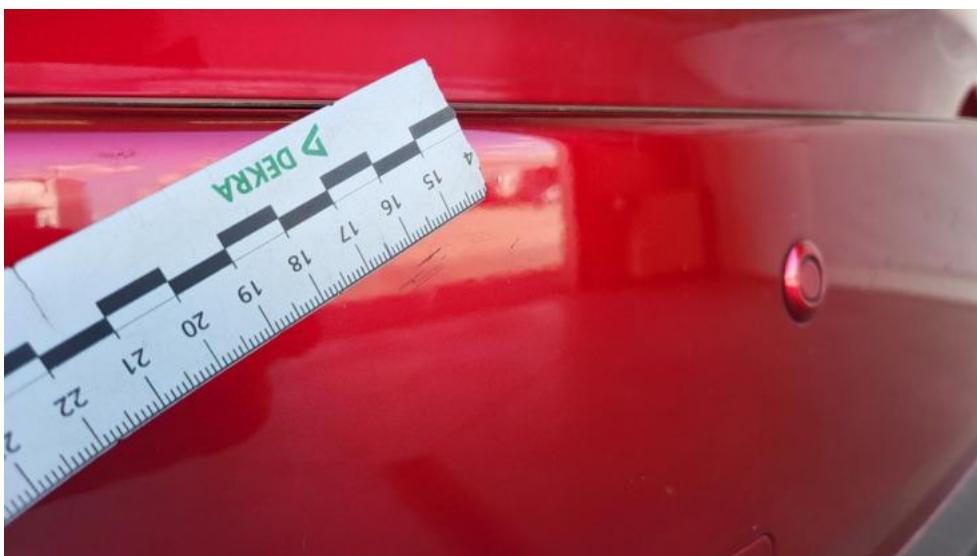
**Photo 52.**

Zderzak tylny - Rysa/odprysk 2

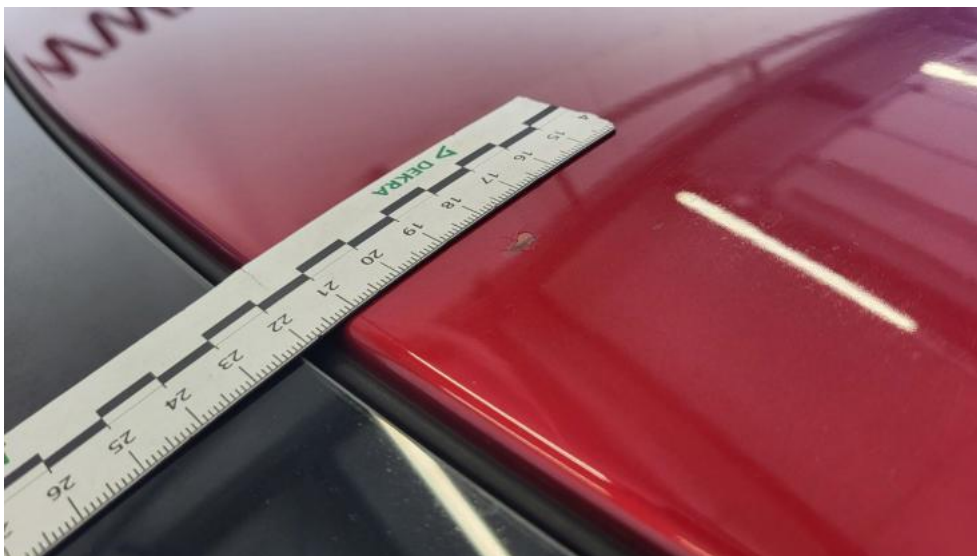
**Photo 53.**

Dach - Rysa/odprysk 1

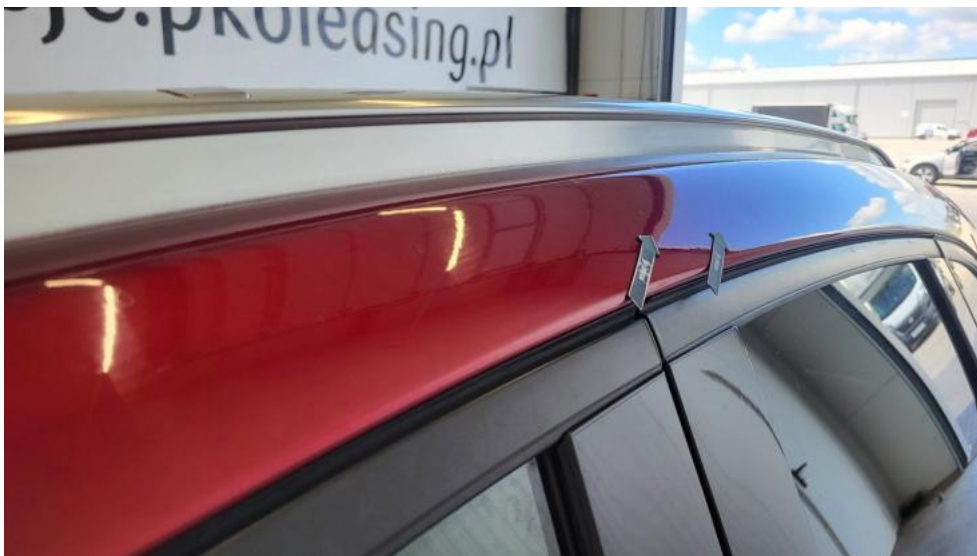
**Photo 55.**

Błotnik tylny L / Ściana boczna L - Wgniecenie/odkształcenie 1

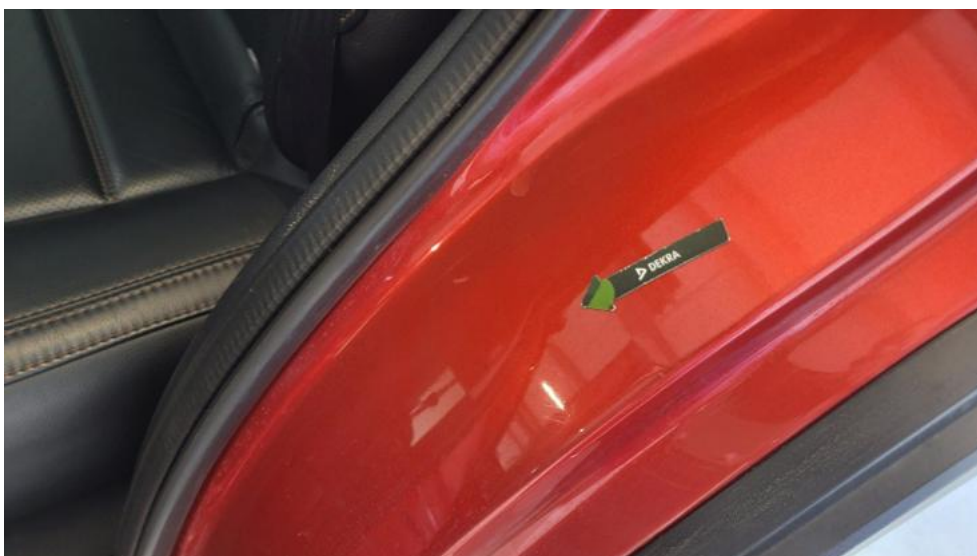
**Photo 56.**

Błotnik tylny L / Ściana boczna L - Wgniecenie/odkształcenie 2

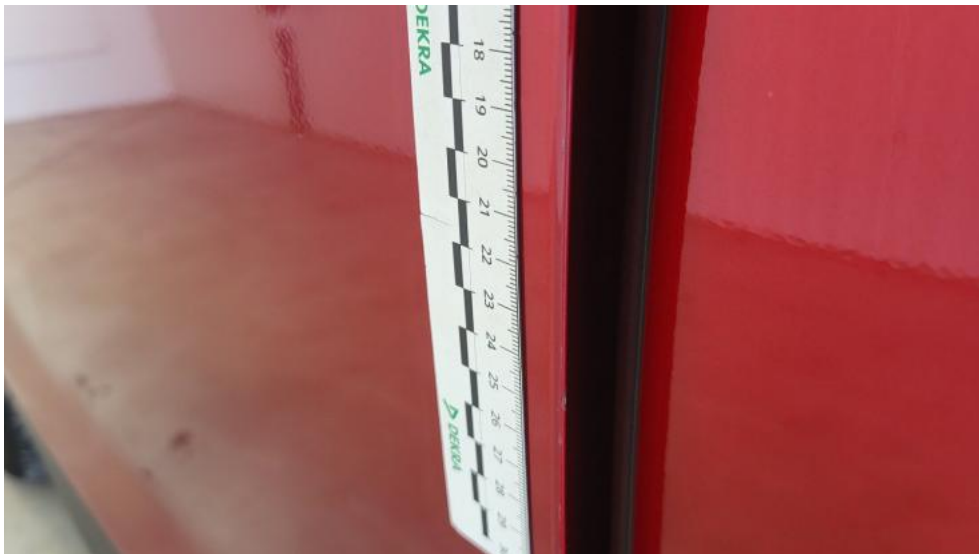
**Photo 57.**

Drzwi przed L - Rysa/odprysk 1

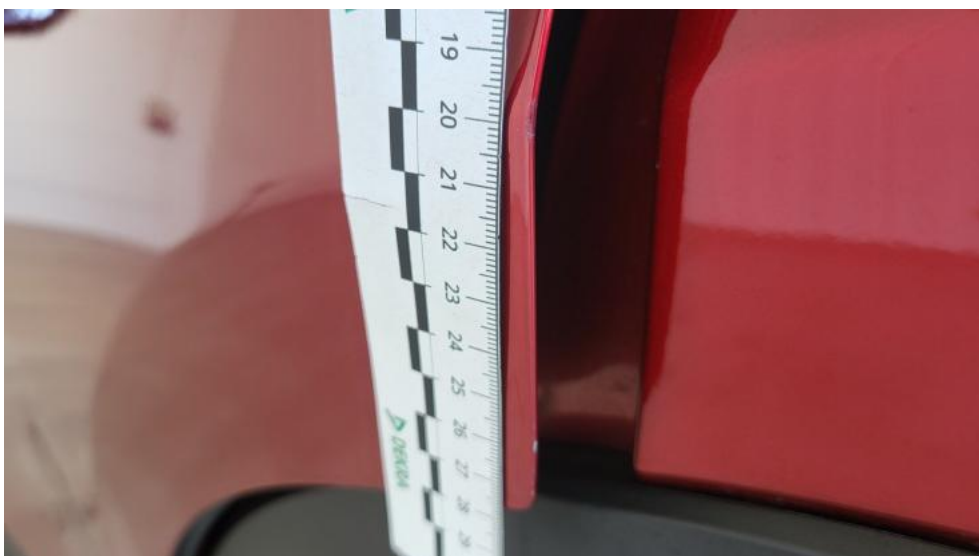
**Photo 58.**

Drzwi tylne L - Rysa/odprysk 1

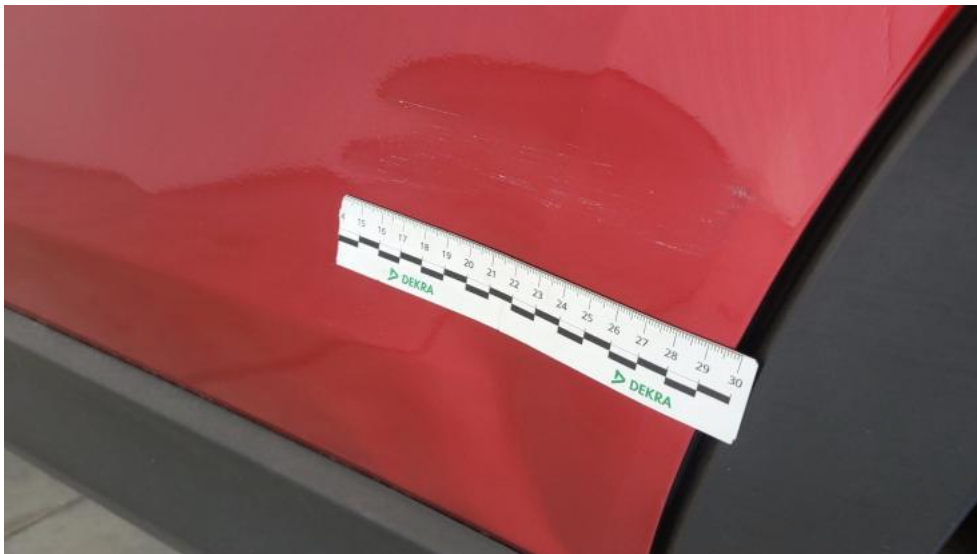
**Photo 59.**

Drzwi tylne L - Rysa/odprysk 2

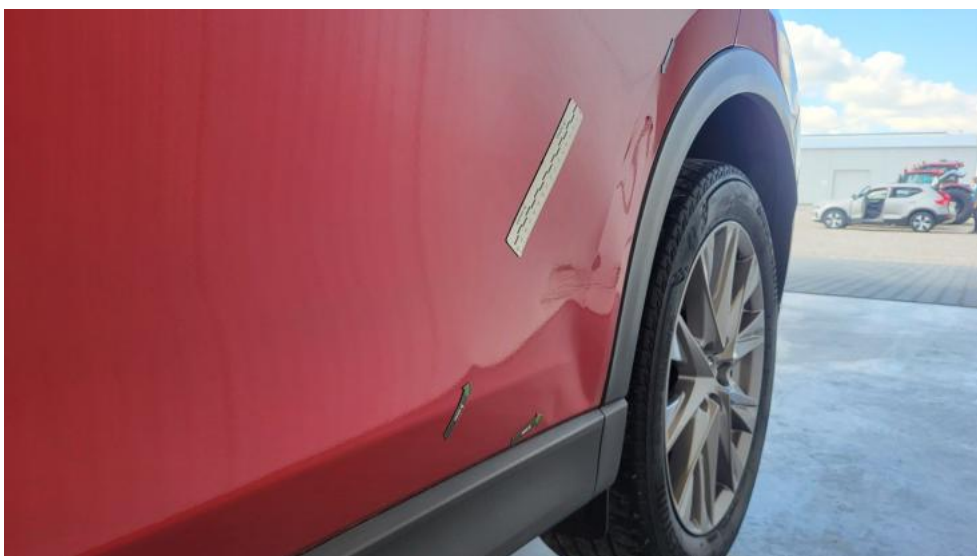
**Photo 60.**

Drzwi tylne L - Wgniecenie/odkształcenie 1

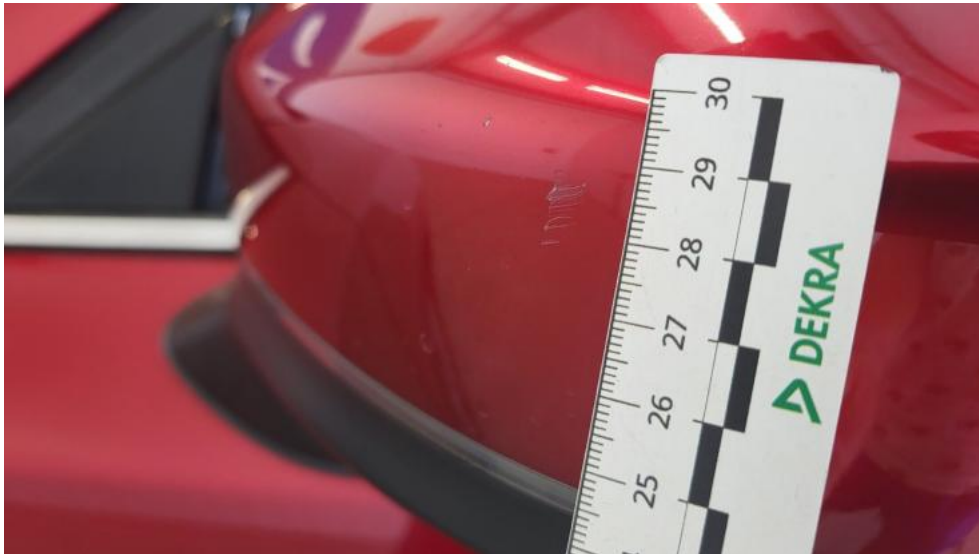
**Photo 61.**

Lusterko zew L - Rysa/odprysk 1

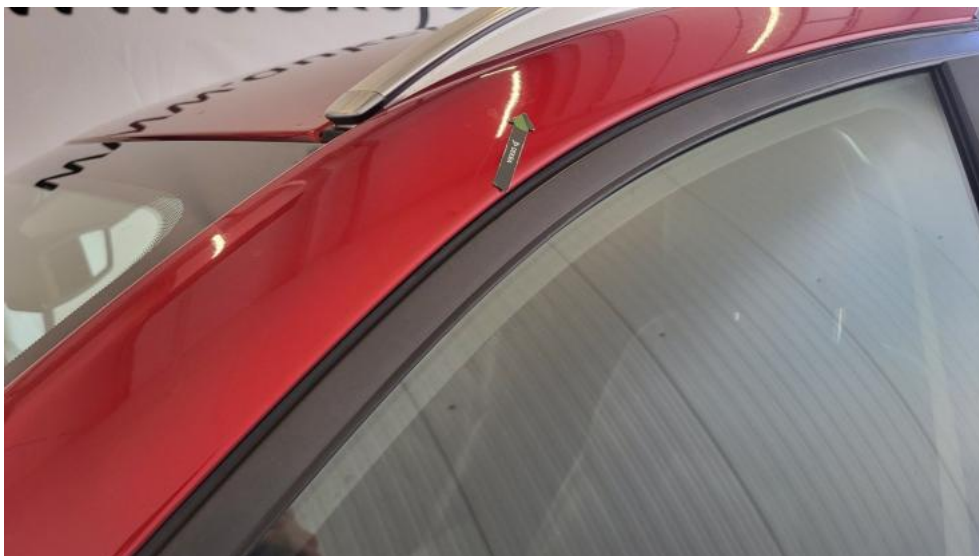
**Photo 62.**

Słupek przedni L - Wgniecenie/odkształcenie 1

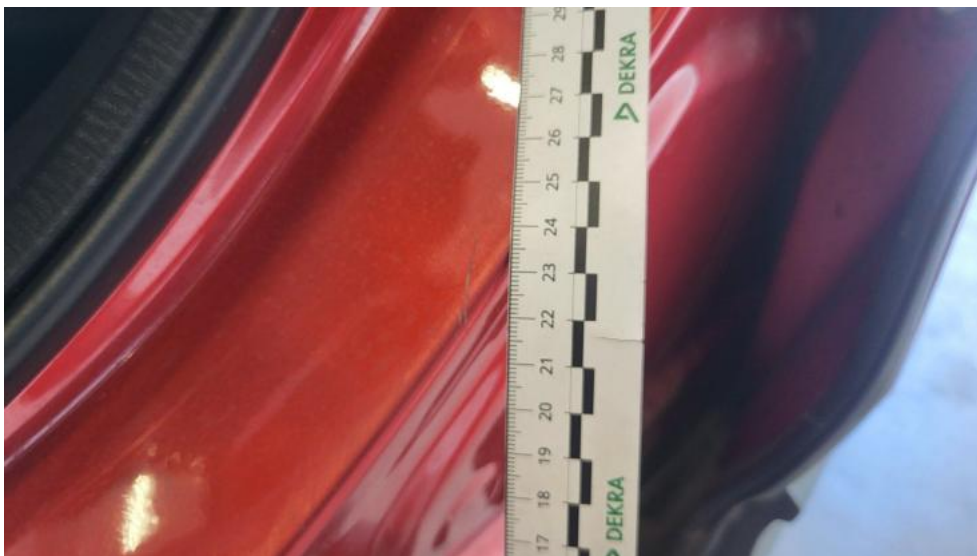
**Photo 63.**

Słupek środkowy L - Rysa/odprysk 1

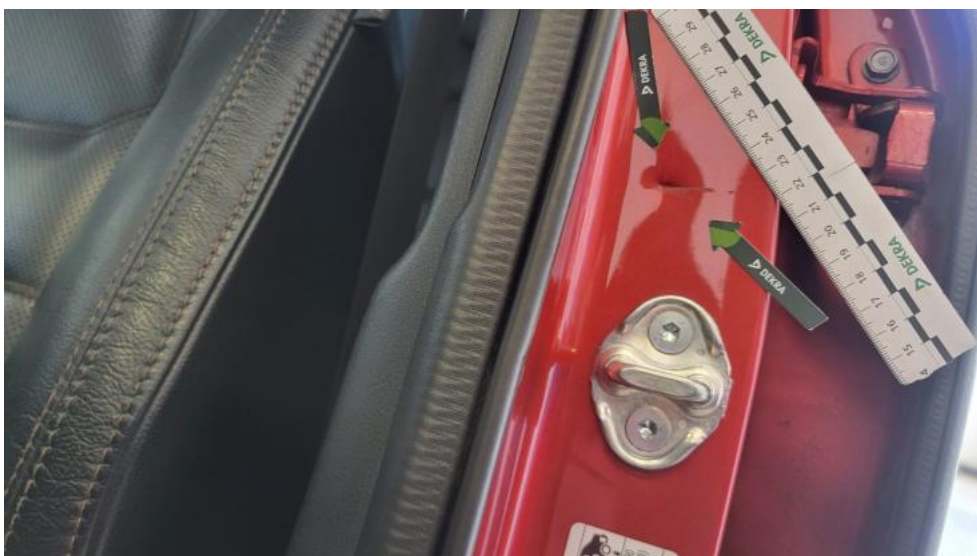
**Photo 64.**

Słupek środkowy L - Wgniecenie/odkształcenie 1

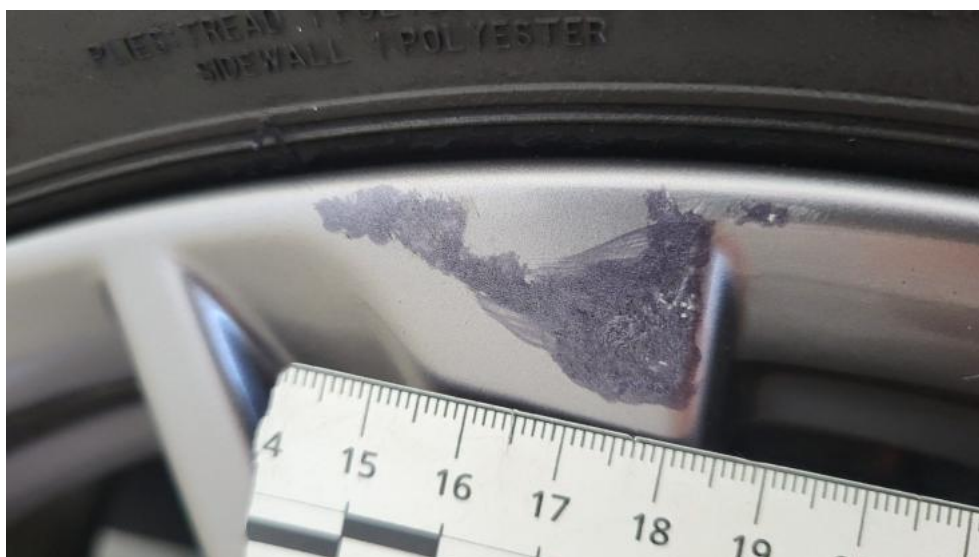
**Photo 65.**

Felga Aluminiowa przednia L - Inne 1

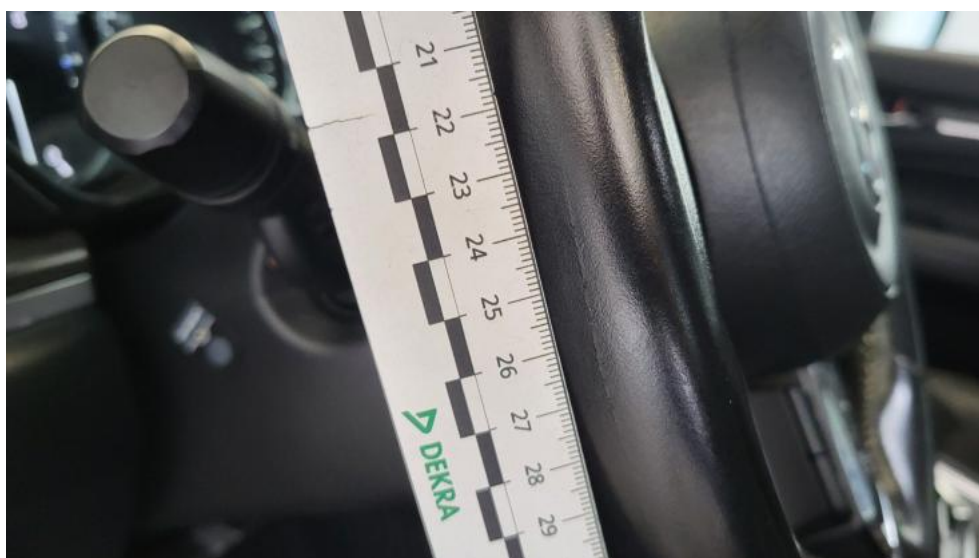
**Photo 66.**

Koło kierownicy - Rysa/odprysk 1

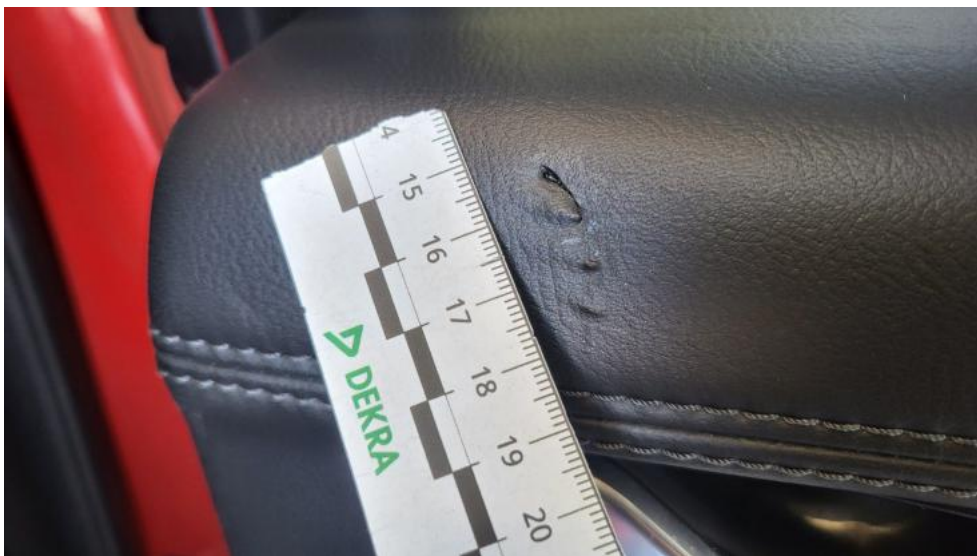
**Photo 67.**

Tapicerka drzwi tylnych P - Pęknięcie/rozerwanie 1

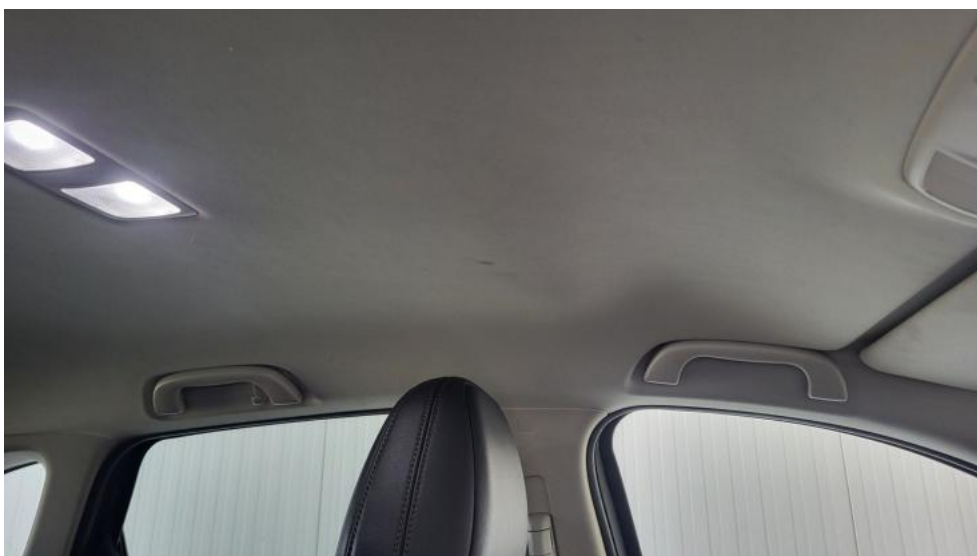
**Photo 68.**

Podsufitka - Inne 1

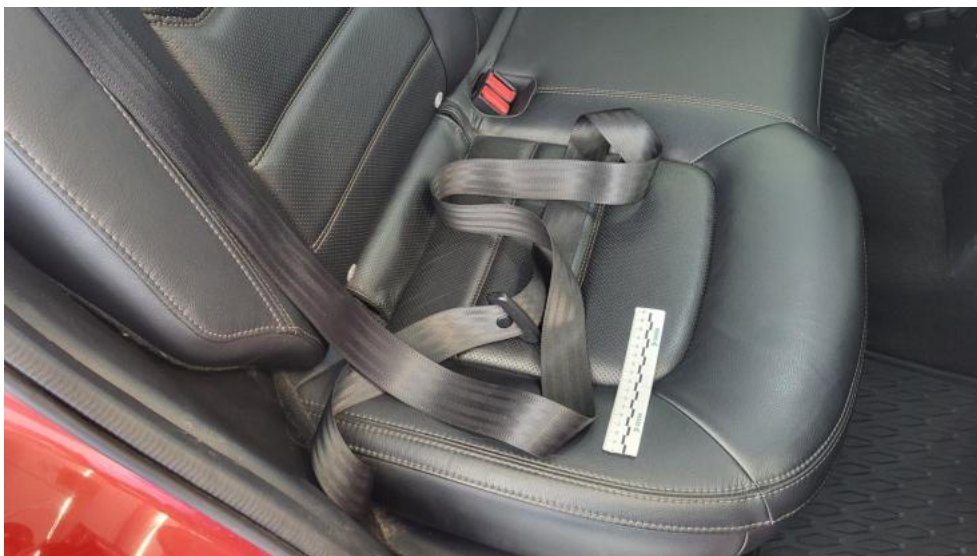
**Photo 70.**

Brak półki bagażnika. Odpryski na szybie czołowej. Nie zwija się tylny prawy pas bezpieczeństwa. Podwyższona wartość grubości powłoki lakierowej wymaga dodatkowego sprawdzenia czy jest to powłoka fabryczna czy renowacyjna.

Pas bezpieczeństwa tylny prawy - Inne 1
